Response to Physical Impacts on Coral Reefs in Puerto Rico and the USVI

2015 Report

Successful collaboration between government agencies, NGO's and volunteers to rescue corals and minimize additional impacts after the M/V Aubi grounding

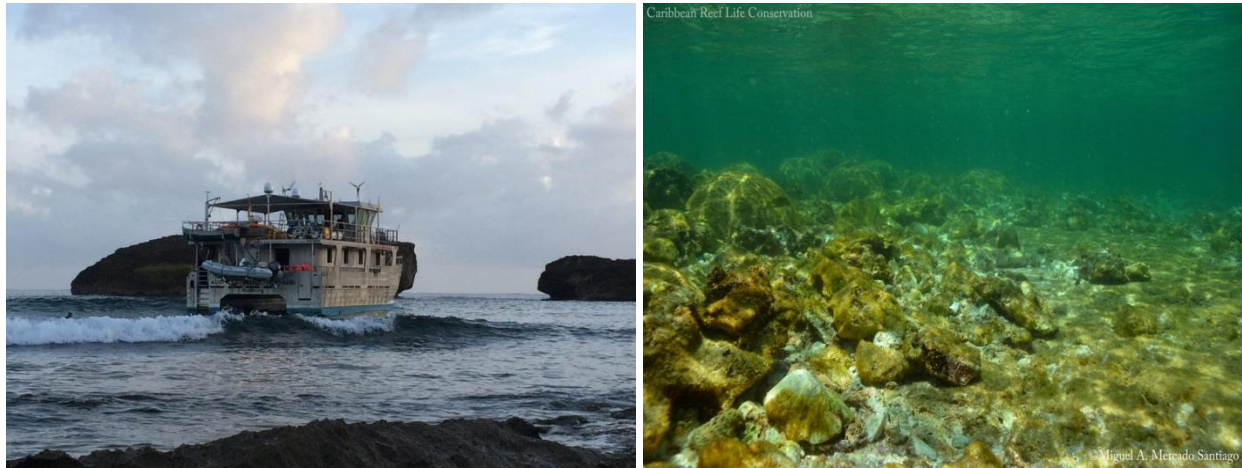
Figure 1: Left Photo: M/V Aubi aground near La Cueva del Indio in Arecibo, PR. Right Photo: Section of the M/V Aubi grounding site showing the flattened impacted reef on the right, rubble berm in the middle and unimpacted coral to the left of the berm. (Photo on right: Miguel A. Mercado)

While an oil spill was prevented, the grounding resulted in significant impacts to coral reef resources flattening 366m² of reef, damaging thousands of medium to large corals which were broken, dislodged, buried, or destroyed, and creating two large berms of coral and rubble (Figures 1 and 3). The majority of corals impacted were *Psuedodiploria* (Brain Coral) and *A. palmata* (Elkhorn). During the 24 hours the vessel was aground the two of the vessel hull's slowly shifted towards the south grinding up the reef slowly as it moved. This created two large berms of coral and reef rubble that demark the center and southern edge of the site. The berms were 3' tall and 4-5' wide and about 40' long and had many live but buried corals within them. The grounding also generated a significant amount of loose rubble that ranged in size from a few inches to multiple feet. The rubble while typically a secondary matter at grounding sites posed an immediate risk since it had buried many live corals and, when mobilized by swells, would impact areas containing healthy colonies of ESA listed *Acropora palmata* (Elkhorn) and other species (Figure 4). The damage at this site, from a 49' catamaran, is on par with damage seen at some of the larger tanker grounding sites and certainly the worst coral damage from a recreational vessel seen in many years.

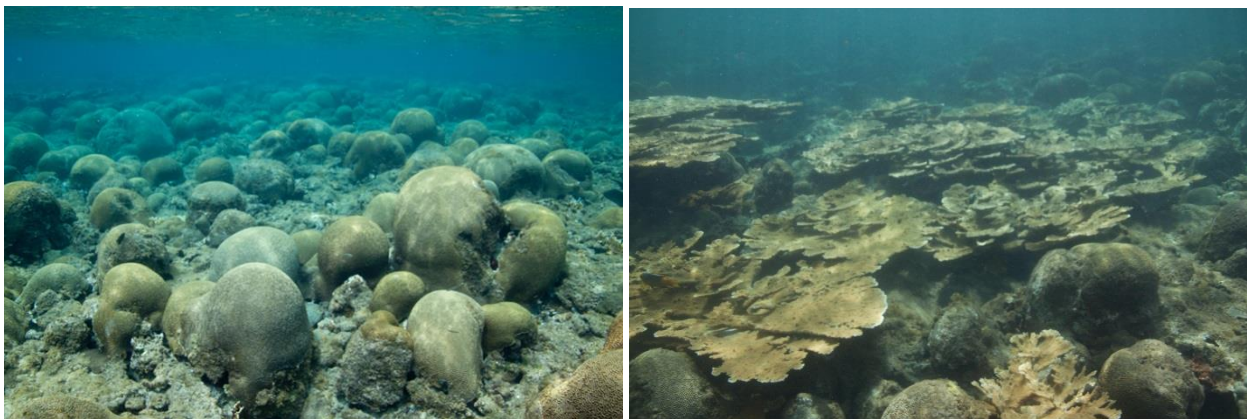
Figure 2: Unimpacted reef adjacent to the M/V Aubi grounding site.

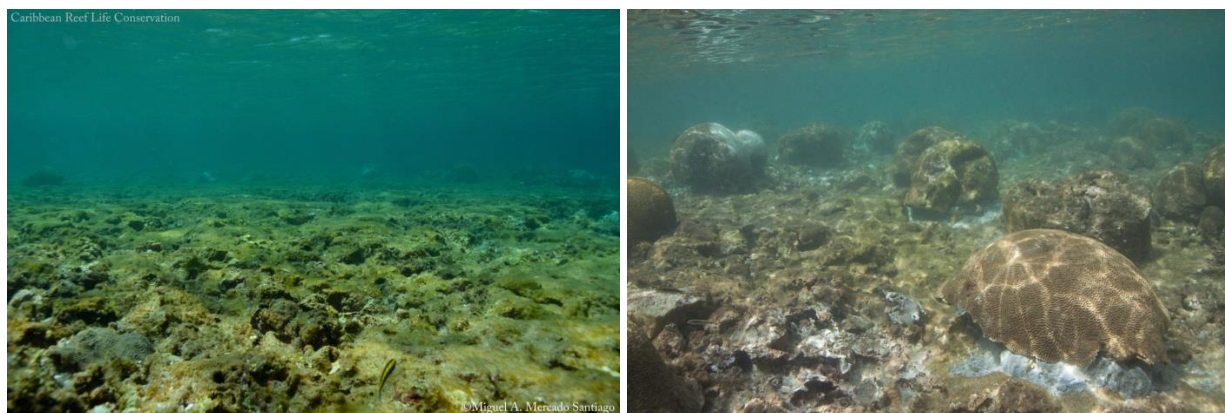
Figure 3: Reef flattened by M/V Aubi on left (Photo by Miguel A. Mercado). Reattached corals on the right.

Once the seas improved again, NOAA RC mobilized a restoration crew led by Sea Ventures using an emergency response fund set up with support from SERO, CRCP, and ARD. Approximately 1,500 corals, including 100 fragments of *Acropora palmata*, were reattached and 10m³ of material were removed from the site during the restoration (Figure 5). Thanks to the efforts by everyone involved, impacts to coral resources were minimized after the grounding.

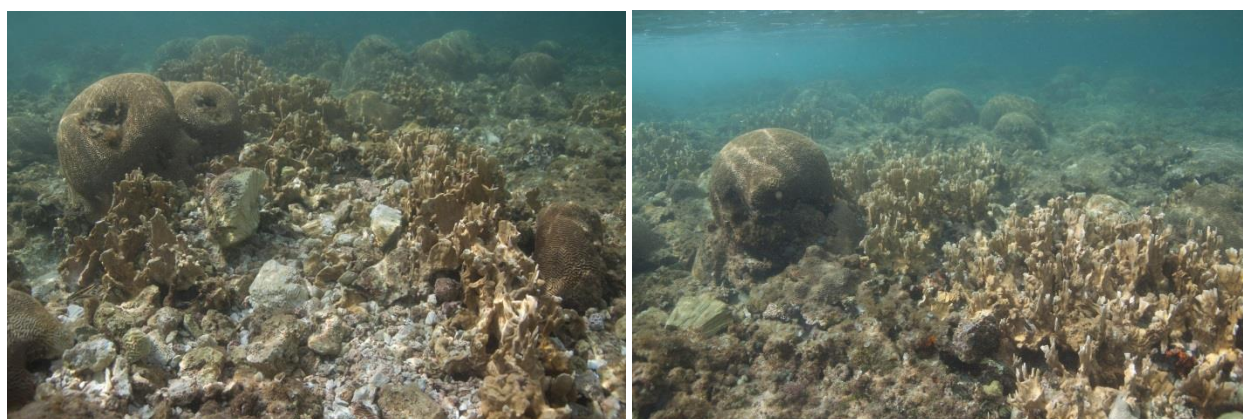
Figure 4: Reef impacted by rubble movement on left. Reef not impacted by rubble movement on right.

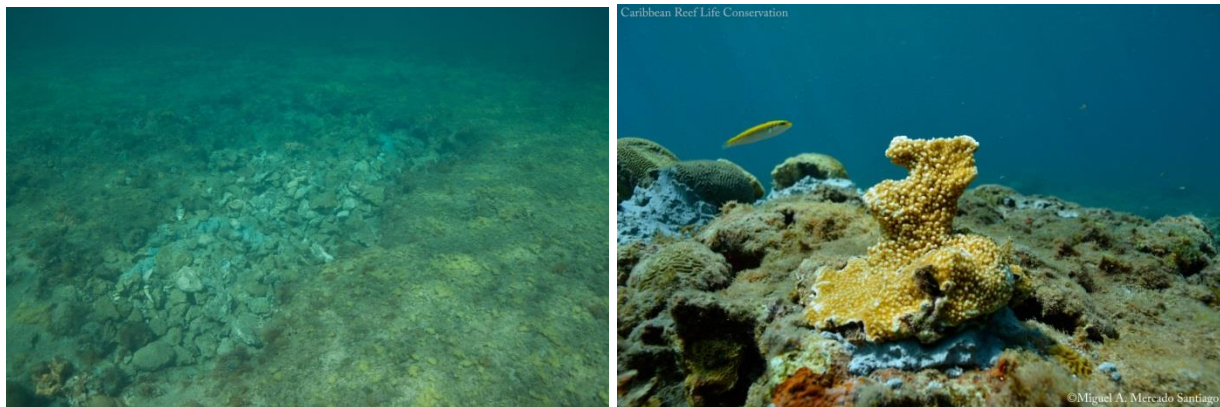
Figure 5: Deeper offshore depression site filled with rubble from the M/V Aubi groundings site on left. Reattached fragment of *A. palmata* reattached on right (Photo by Miguel A Mercado).

were able to salvage over 800 medium (<1m) to large (>1m) coral colonies including smaller fragments of colonies) and move them into deeper water adjacent to the site for temporary holding. An additional ~75 very large colonies of *Diploria* were righted but unable to be moved due to size. Using buckets and their hands, the team filled kayaks with corals and rubble to transport them offshore into deeper water. They were able to fill 50 loads of rubble into open kayaks/small boats and float them further offshore into deeper water to a site that PRDNER approved for dumping (Figure 5).
