# MELVILLE CONDITION SURVEY

Rhode Island Port Authority and  
Economic Development Corporation

MAY, 1982

RE: Melville Condition Survey  
CEM No. 4001

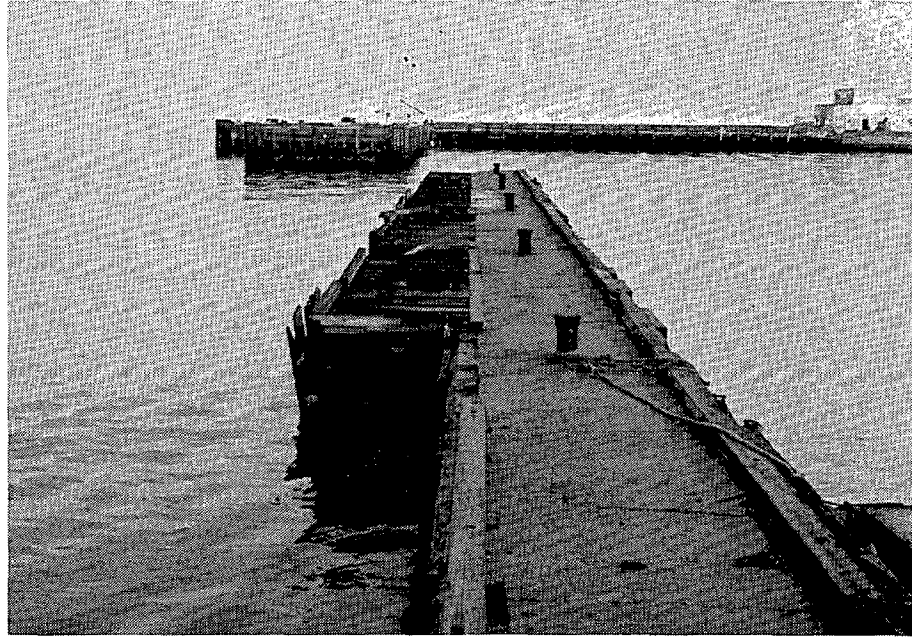
Granite and Timber Pier: The granite block/timber pier located at the end of the South Fueling Pier requires moderate rehabilitation. (See photo 3) Figure No. 4 indicates the typical construction of the Pier. The concrete cap which provides a portion of the deck area is cracked and shows signs of movement. The timber pile supported, timber deck portion of the pier is severely deteriorated and requires

PHOTO 3 - GRANITE PIER LOCATED AT THE NORTH END  
OF THE SOUTH FUELING PIER. NOTE THE DETERIORATED  
TIMBER SECTION AND THE STEEL PIPE BOLLARDS

almost total rehabilitation. The majority of the support piles can be reused. Fittings for this pier consist of 6 - 12 inch diameter steel pipes which were fit vertically between the granite blocks. The pipes (bollards) are located along the centerline of the granite section of the pier. The pipes appear to be adequate for berthing small vessels, but their capacities (allowable line pulls) cannot be accurately calculated because of the unknown pipe embedment lengths and extent or existence of any additional construction techniques used during their placement. No design drawings were located for this area.

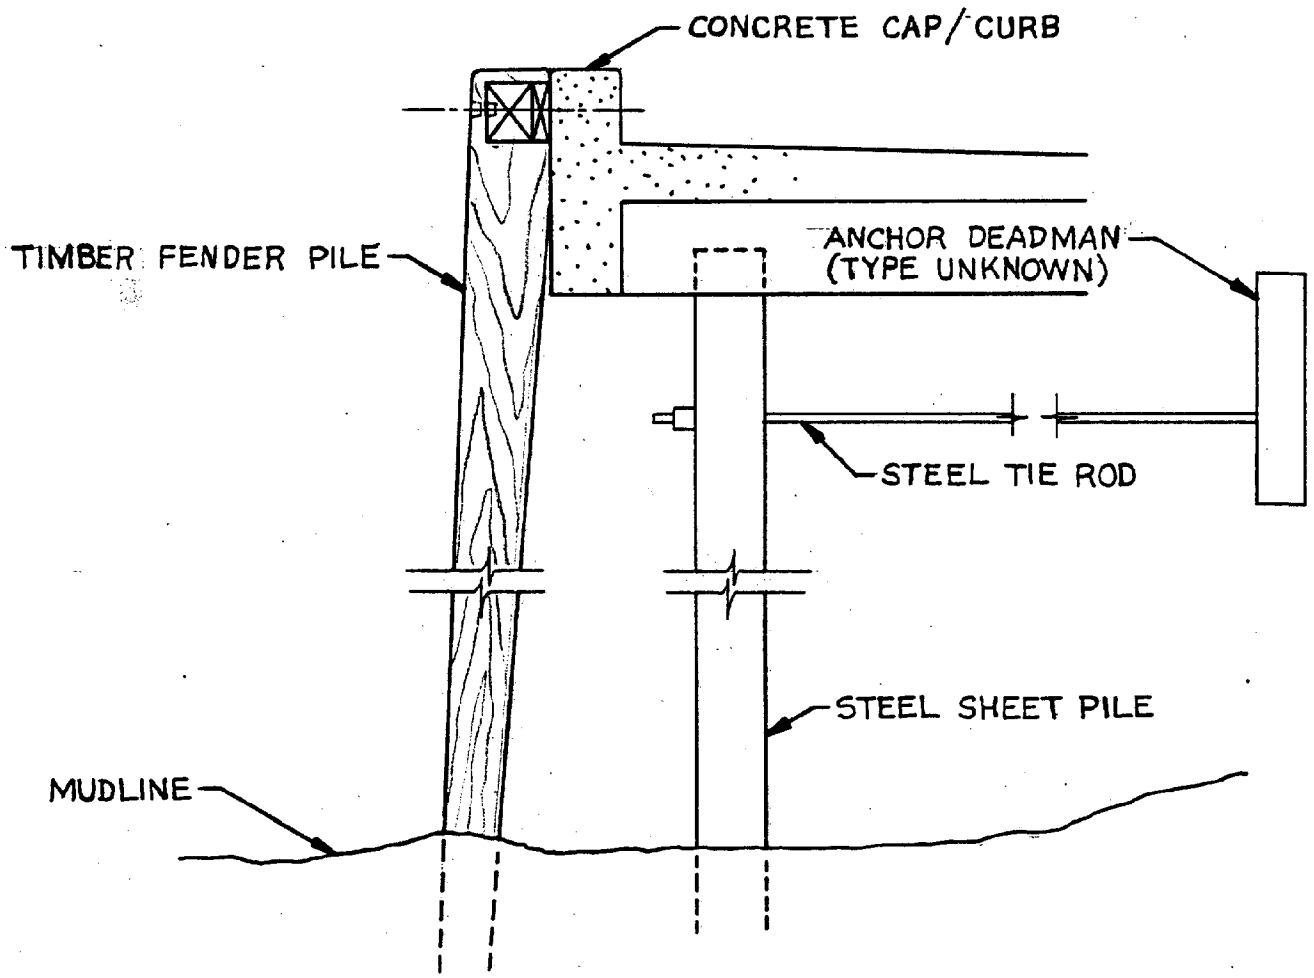
<b>MELVILLE CONDITION SURVEY</b>	
<b>TYPICAL FENDER SYSTEM &amp; SHEETPILE BULKHEAD</b>	
DATE	FIGURE NO.
MAY 1982	6

Sheetpile Bulkhead: The condition of the steel sheetpile bulkhead is typically poor. Figure No. 6 presents a typical section of the steel sheetpile bulkhead and concrete cap. The concrete curb topside has suffered moderate damage (cracking and spalling). In addition, the underside of the cantilevered deck slab shows signs of deterioration and stress (cracking and spalling). The fender system along the

bulkhead is almost non-existent and requires total replacement. Station 0+00 through 0+50 and station 3+50 through 5+75 were visually inspected during the diver inspection survey. Other bulkhead areas were blocked by berth vessels. The condition of the sheetpile bulkhead below water appeared to be fair with a light marine growth. Bottom conditions were somewhat steep at the base of the bulkhead with some light steel scrap scattered along the base of the bulkhead.

Inspection at the waterline (low tide) revealed a different set of conditions. The majority of the bulkhead exhibited advanced steel sheetpile deterioration with large holes in the outboard flange. See Photo 6. This common occurrence in older steel sheetpile bulkheads is caused by the continuous cyclic exposure to salt water and air (due to the continuous tidal fluctuations, wind and wave splash) which amplifies the oxidation (rusting) of the steel bulkhead. Deterioration of this type severely reduces the section modulus of the steel sheeting and therefore substantially reduces structural capability of the bulkhead. The few remaining fender piles revealed marine borer attack at the waterline. See photo 3.

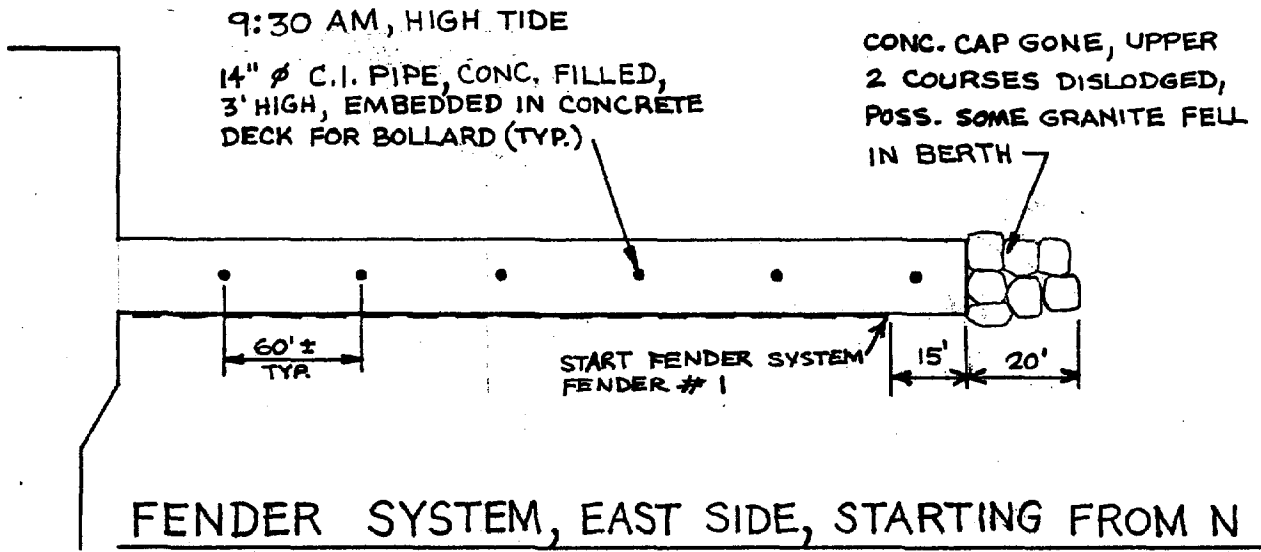
<u>FENDER #</u>	<u>PILE</u>	<u>CHOCK</u>	<u>WALE</u>
1	ROTTED @ BOLT	✓	✓
2	MISSING	✓	✓
3	MISSING	✓	✓
4	MISSING	ROTTED	✓
5	MISSING	ROTTED	✓
6	MISSING	MISSING	SPLIT & ROTTED
7	FALLEN, LEANING ON NO. 8, ROTTED @ TOP	MISSING	SPLIT & ROTTED
8	MINOR ROT @ TOP	MISSING	SPLIT & ROTTED
9	ROTTED @ TOP	ROTTED	ROTTED
10	MISSING	ROTTED	ROTTED
11	MISSING (LEANING AGAINST 12)	ROTTED	ROTTED
12	ROTTED @ TOP	ROTTED	ROTTED
13	ROTTED, LEANING AGAINST NO. 12	ROTTED	ROTTED

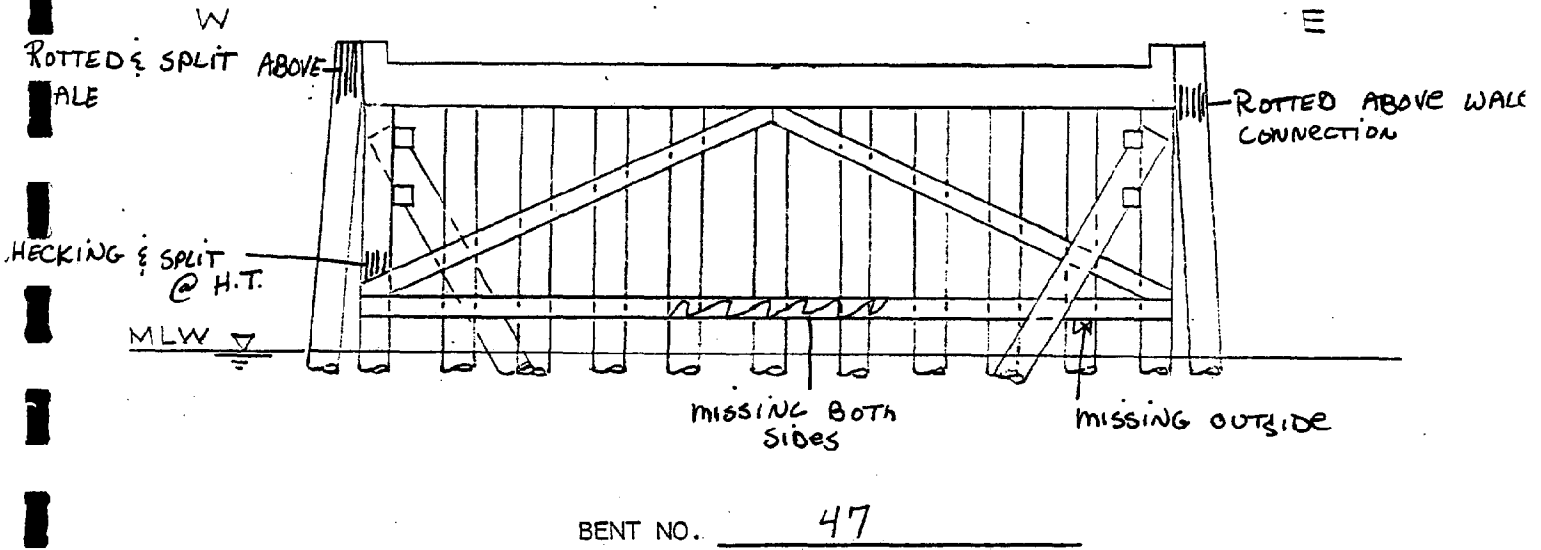
NOTE SCUPPERS ON WEST FACE OF PIER ARE PLUGGED WITH CONCRETE  
PILES SPLITTING ON FACE @ H.T.

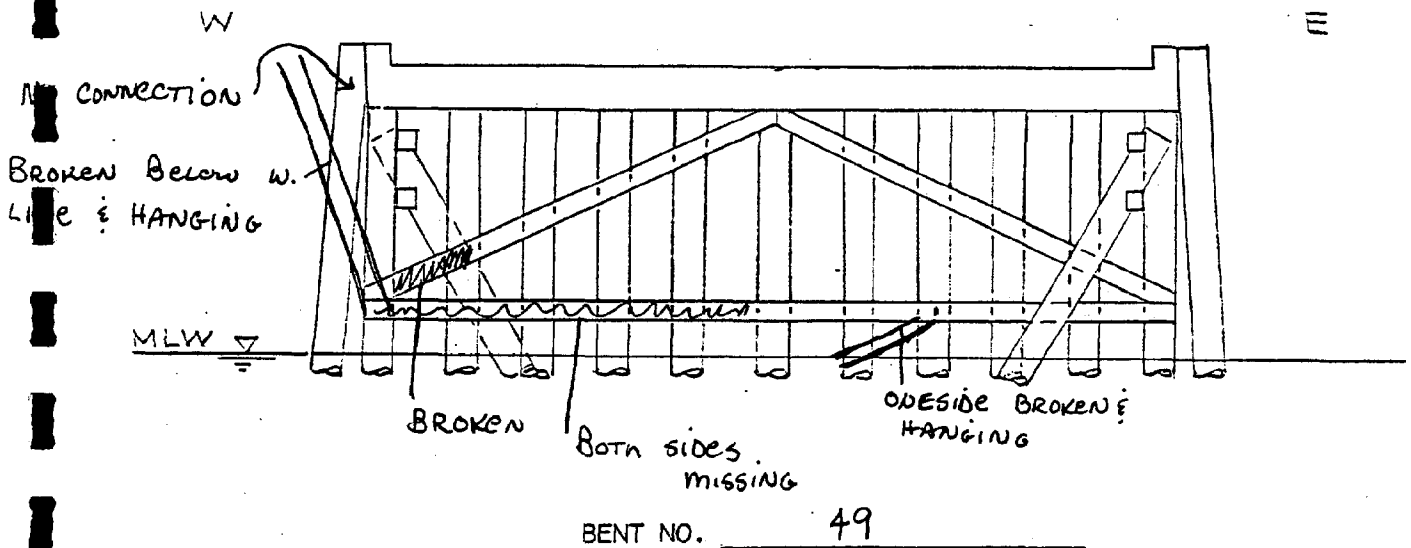
CABLE HANGING UNDER PIER

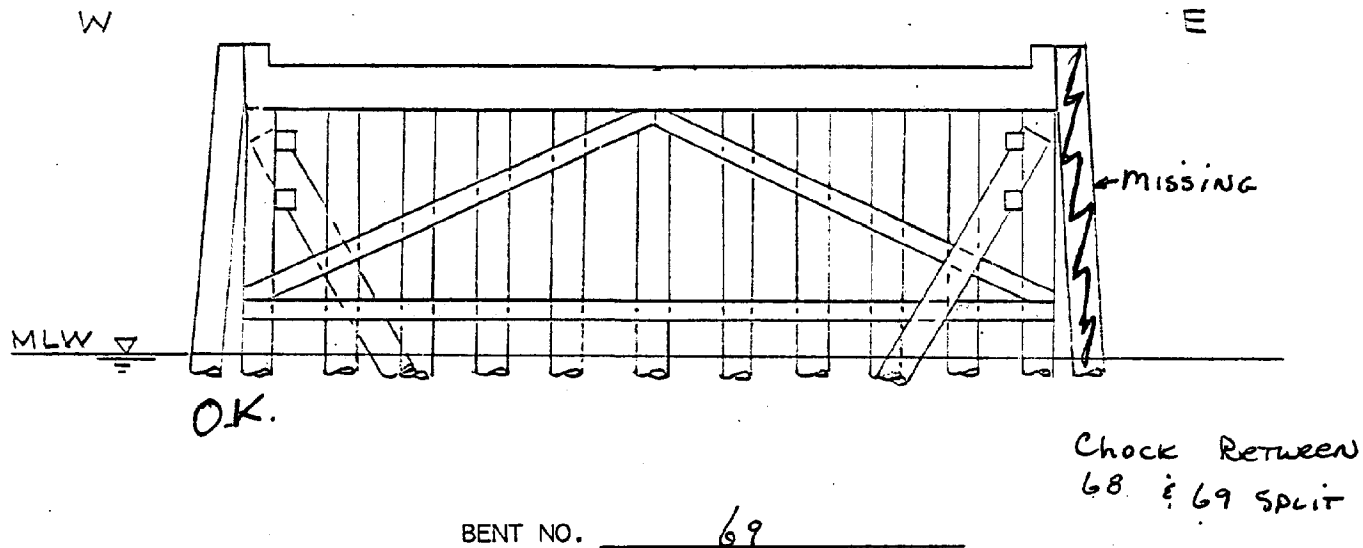
2 PLATES - 2 BOLTS EAST SIDE UNDER CONCRETE

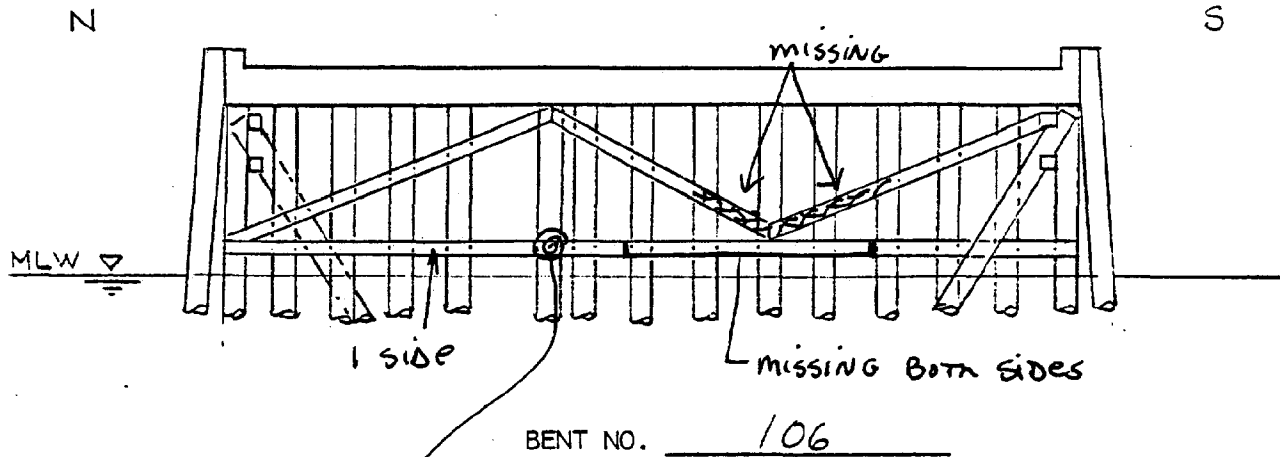
BIG HOLE IN PILE LOOKS LIKE ROT AROUND BOLT  
 LOWER BRACE LOOKS BAD

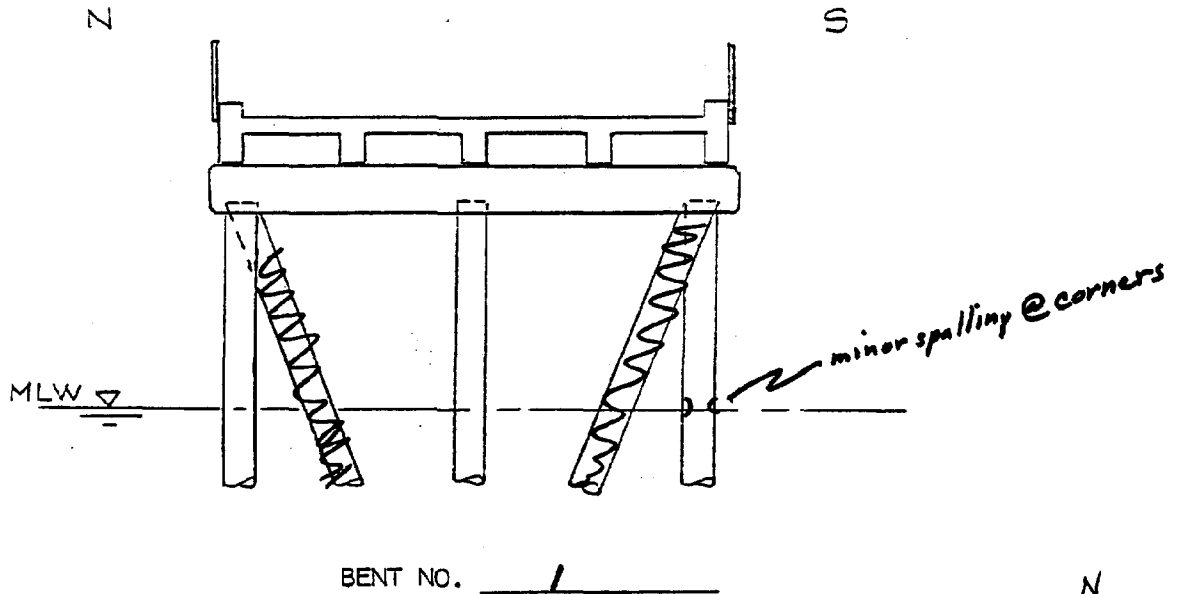
No batter piles bent 1  
Piles are 18"  $\square$  conc piles

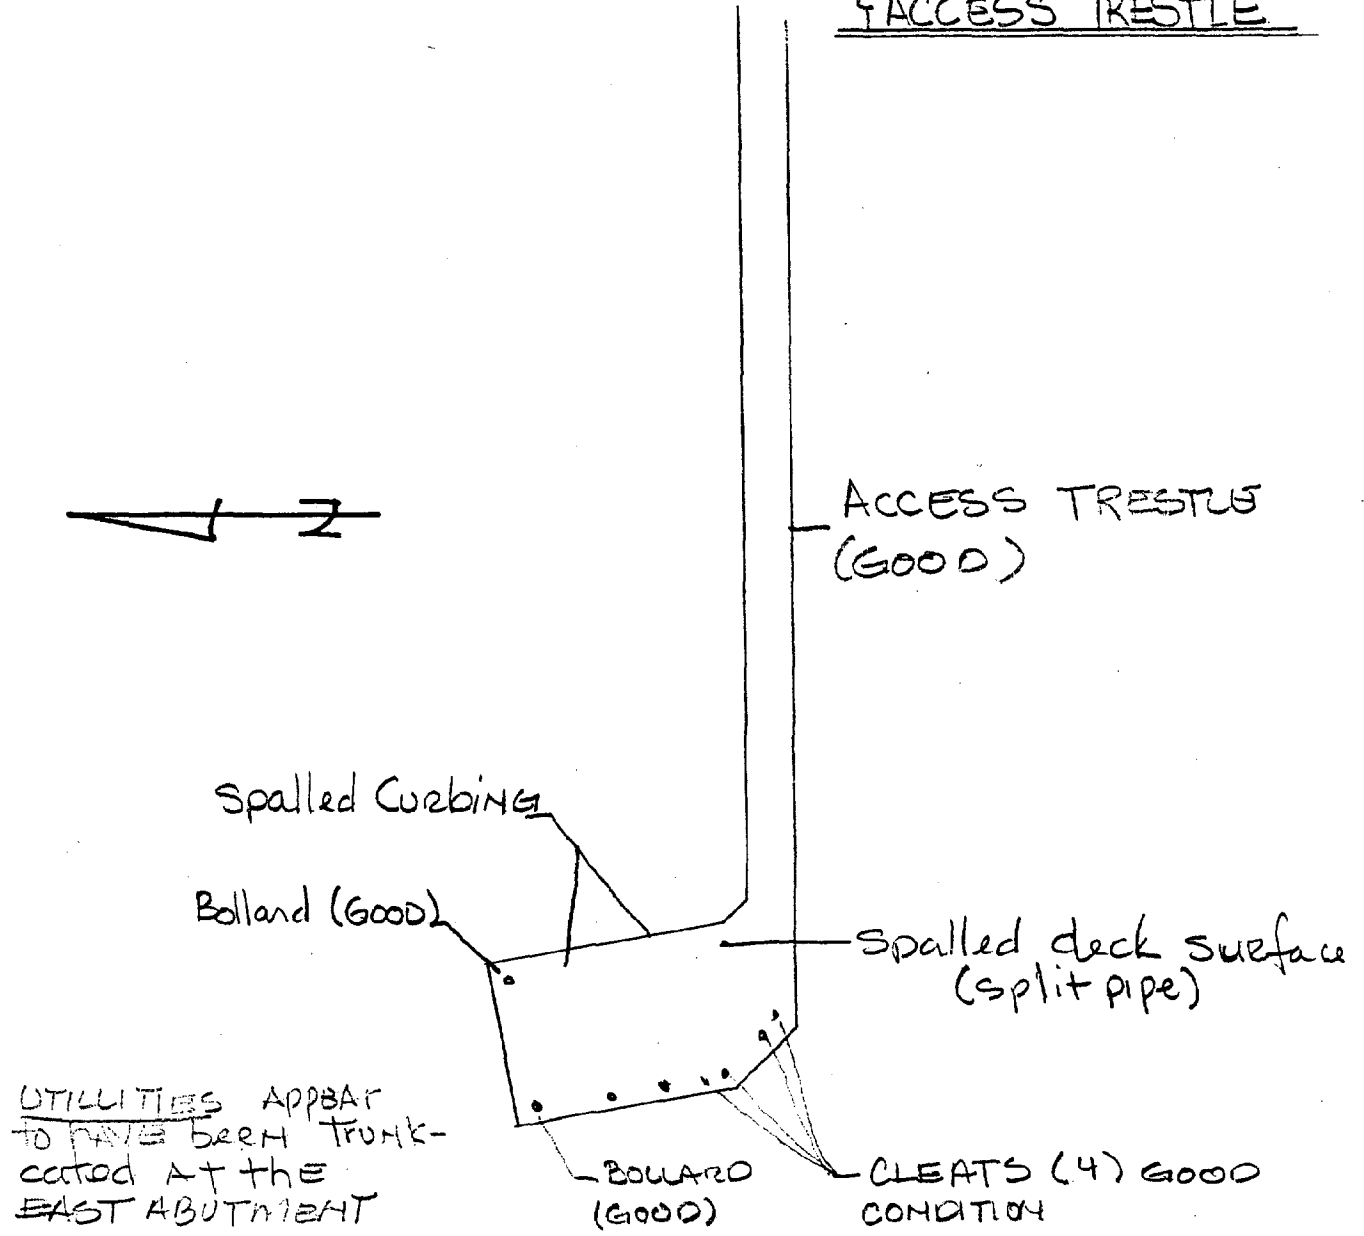
FBM PIER HEAD  
& ACCESS TRESTLE

Pier & Trestle appear in EXCELLENT  
CONDITION WITH ONLY FEW  
EXCEPTIONS
