Preliminary Report:
Archeological and Engineering Expedition
Monitor Marine Sanctuary

August 1-26, 1979

U.S. National Oceanic and Atmospheric Administration
Office of Coastal Zone Management

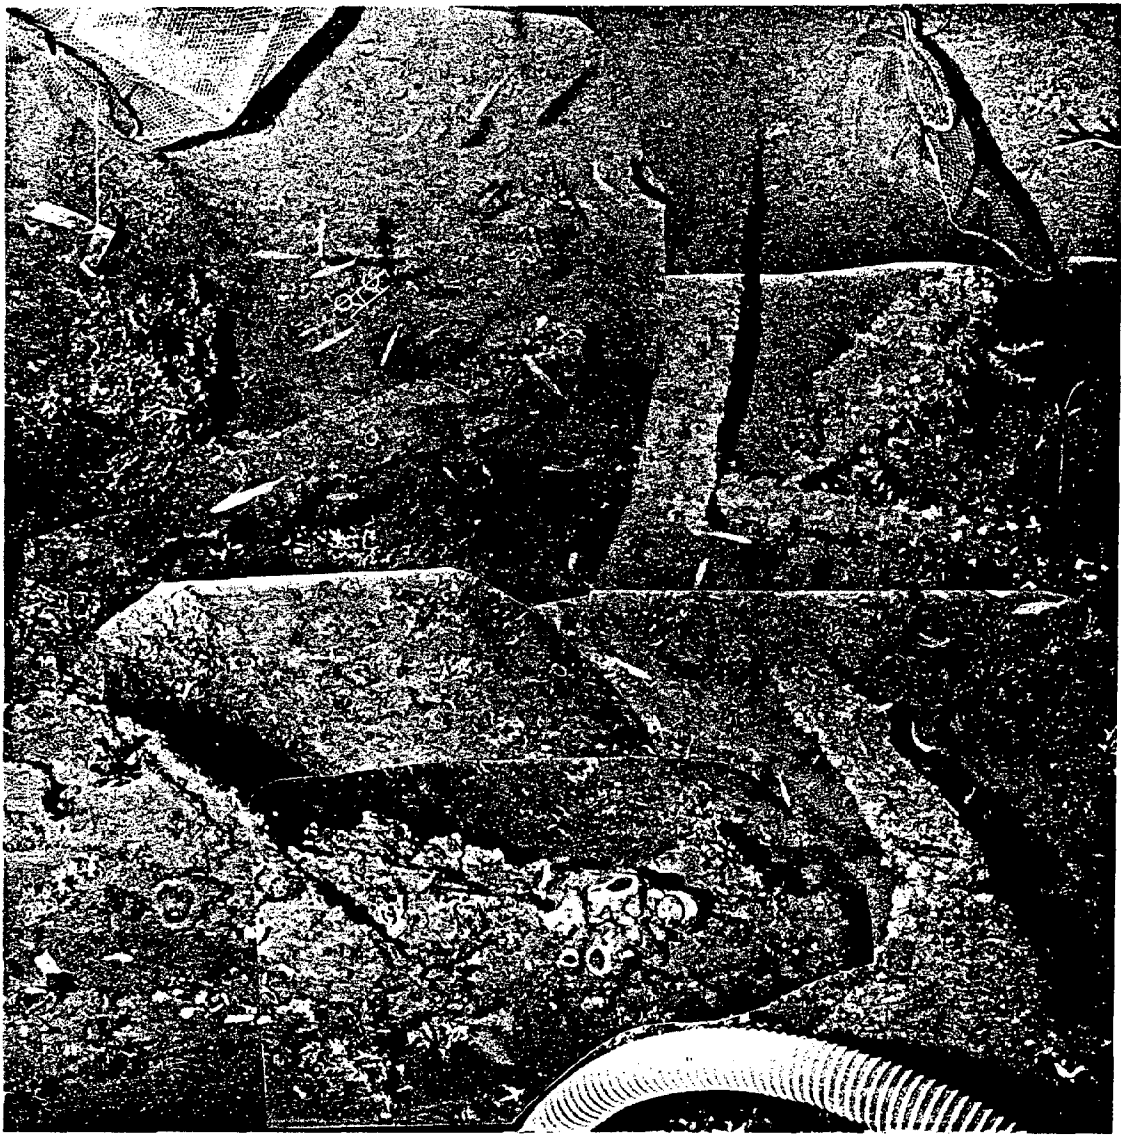
Figure 4. Photomosaic documentation of material exposed after excavation of the first 6 inches of sediment.
