# **SHORE EROSION STUDY**

SHORELINE EROSION AND BLUFF STABILITY ALONG LAKE MICHIGAN  
AND LAKE SUPERIOR SHORELINES OF WISCONSIN

### **RACINE COUNTY**

**FEBRUARY 1977**

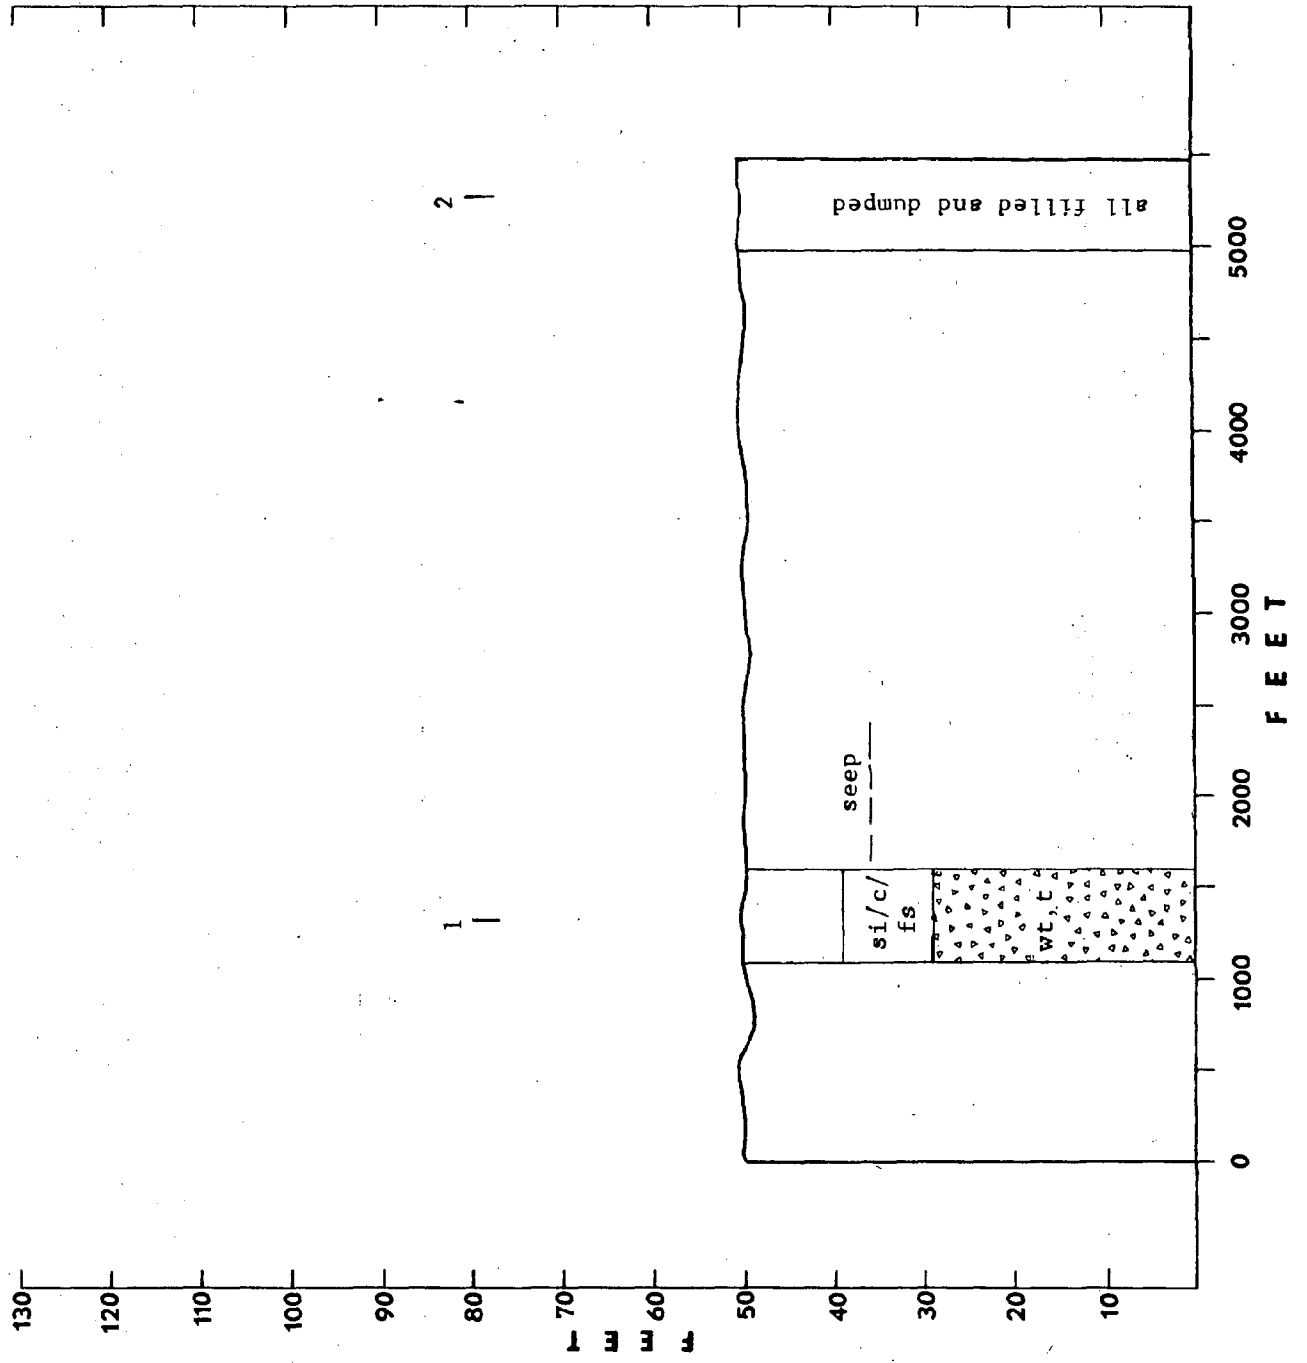
I. 3 N., R. 23 E., Sec. 21

1. BLUFF	a-fairly stable	b-failing by slump and some flow with seep zones near top of bluff; artificially graded and planted	c-fairly stable seep in sand near upper part of bluff	d-artificial fill; bluff has been graded and retains its former height only at considerable distance from lakeshore; fill consists of stone, brick, glass, concrete, and refuse.
2. TOE	a-till, gray clayey, Wadsworth	b-fill, iron, glass, brick, stone and refuse		
3. BEACH	a-no beach

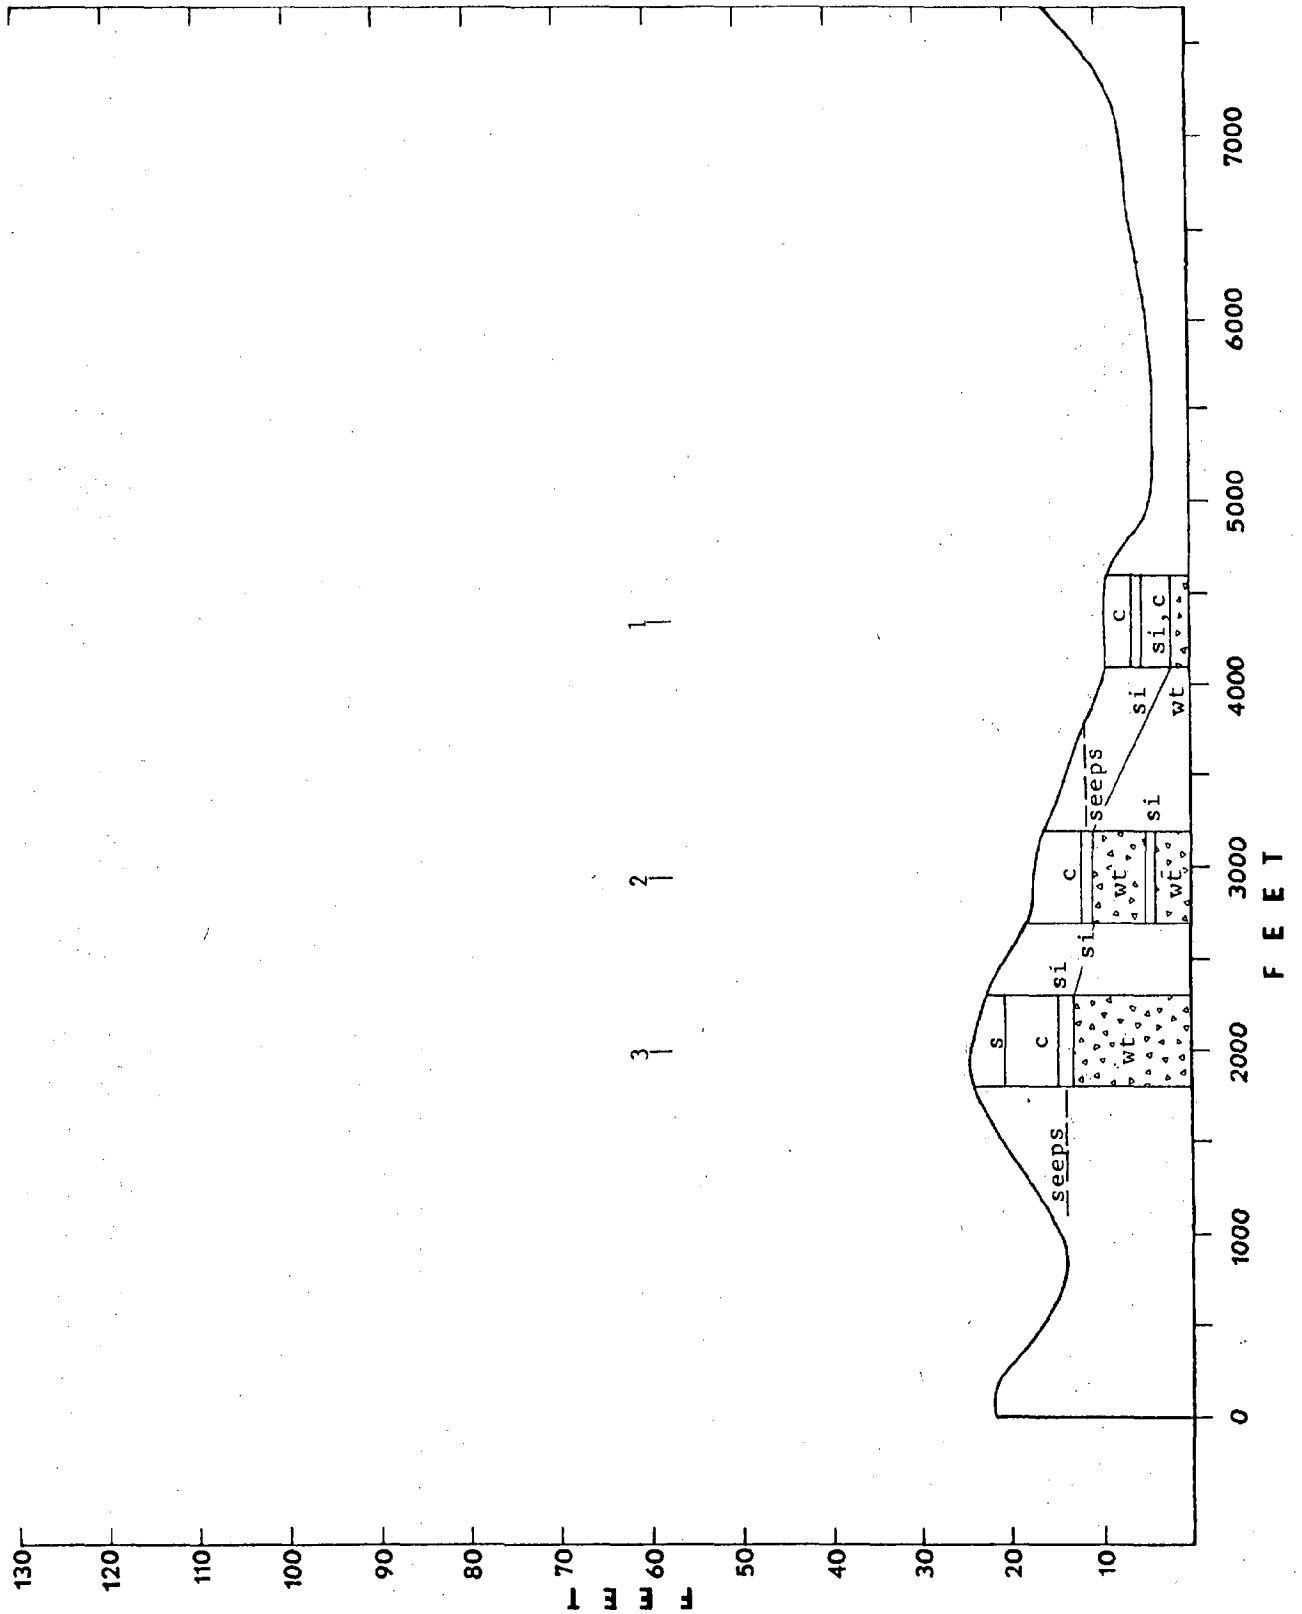
T. 4 N., R. 22 E., Sec. 27

1. BLUFF	a-mostly man-made material forms bluff face, small slump blocks in places.	b-stabilized by vegetation in some places, marked by small slump blocks and scalloped bluff edge in other places, seep zones present at and above mid-bluff	c-bluff behind wide beach grassed and stable	d-low bluff, subject to slump and toe erosion
	e-virtually no bluff present, minor toe erosion at upper edge of beach

2. TOE	a-concealed by artificial fill, debris dumped along shore and over bluff (broken concrete, asphalt, dolomite blocks, etc)	b-clayey till, concealed in most places by debris, revetments, and bulkheads.	c-appears mostly sand, largely concealed by vegetation

3. BEACH	a-0 to 5 ft. generally absent, covered by dumped debris	b-beach width variable, 5 to 65 ft. dependent on structures, sand, pebbles, cobbles	c-no beach, protective structures to water's edge	d-10 to 100 ft., sand accretion due to groins, some gravel
	e-5 to 10 ft., mostly gravel	f-10 to 30 ft., mostly pebbles and cobbles, little sand

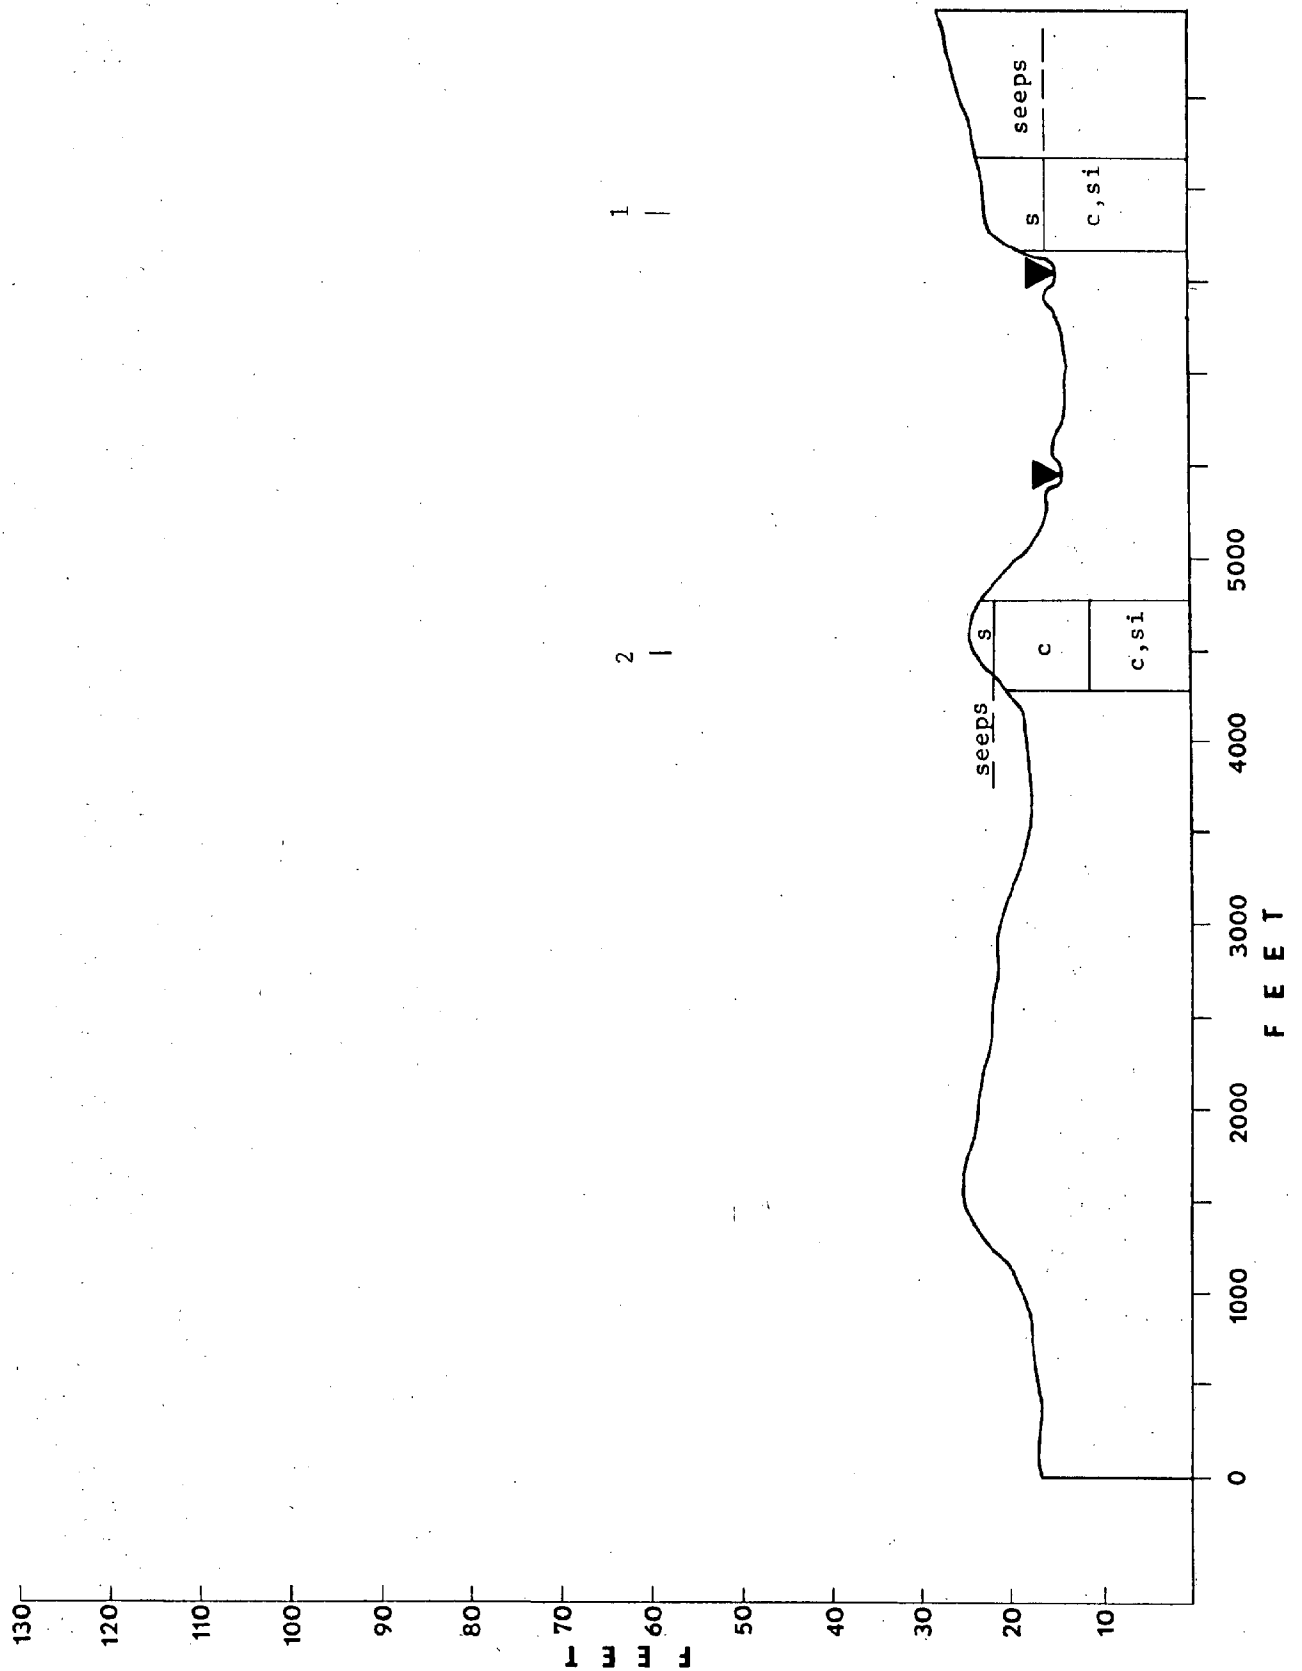
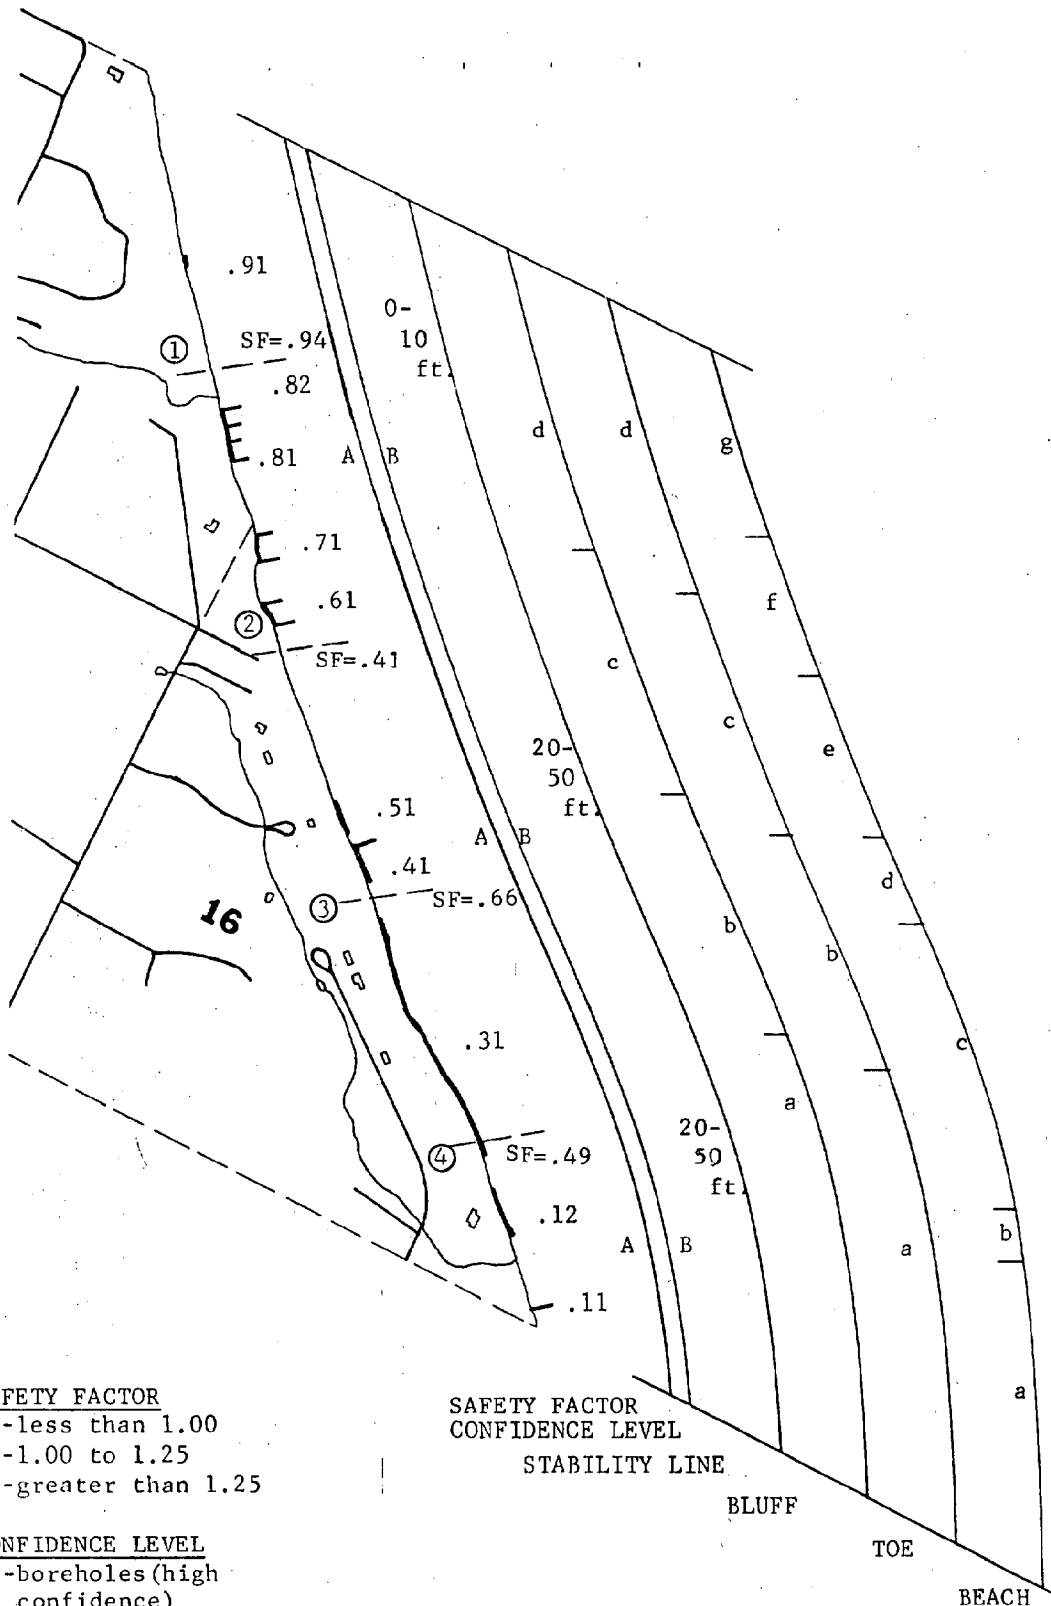
T. 4 N., R. 23 E., Sec. 21/22

1. BLUFF	a-slopes stable	b-slump blocks; fresh slump scars at bluff edge	c-slump blocks in some places; scars partially healed.	d-a few small slumps now; some evidence of past slumps through old slump scars; not much active slumping or other slope failure. Bluff is fairly low, vegetated and protected by shore protection structures.
	e-partly stabilized, partly failing by small slumps.	f-low bluff; sodded, but failing due to small debris falls at base.	g-bluff terraced and sodded. stable. some toe erosion.	h-some active slumping.
	i-fairly stable bluff edge moderately straight, little failure, minor erosion

2. TOE	a-probably sand	b-pinkish brown lacustrine clay and some sand	c-massive gray lacustrine silt	d-this slope is stabilized by terracing and sodding, exp. stabilization project.
	e-lacustrine silts and clays

3. BEACH	a-20 to 40 ft., pebbles, little sand	b-0-10 ft., stone revetment on beach, pebbles and cobbles	c-20 to 60 ft., sand and pebbles	d-5 to 20 ft.,
	e-0 to 5 ft., junk revetment	f-10 to 20 ft., sand to cobbles	g-25 to 55 ft., 30 to 40 ft. wide in most places, sand and pebbles

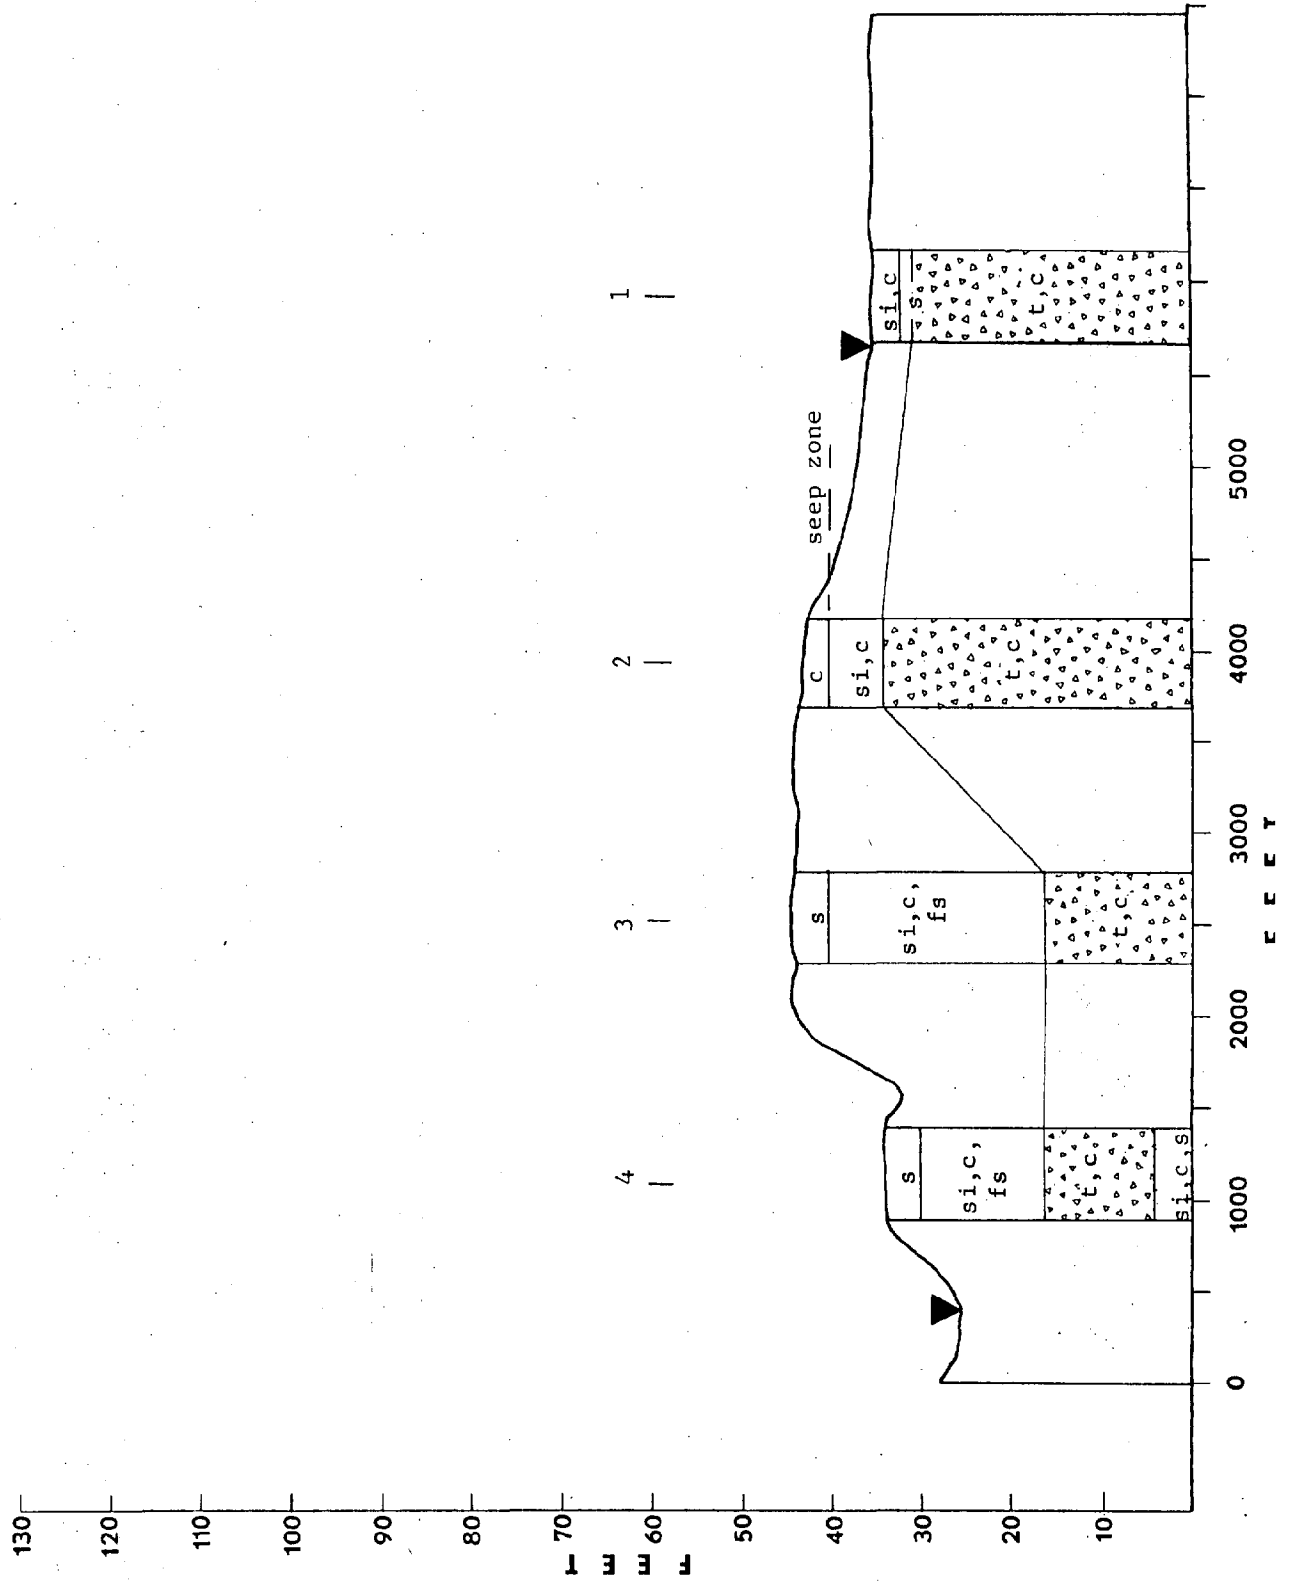
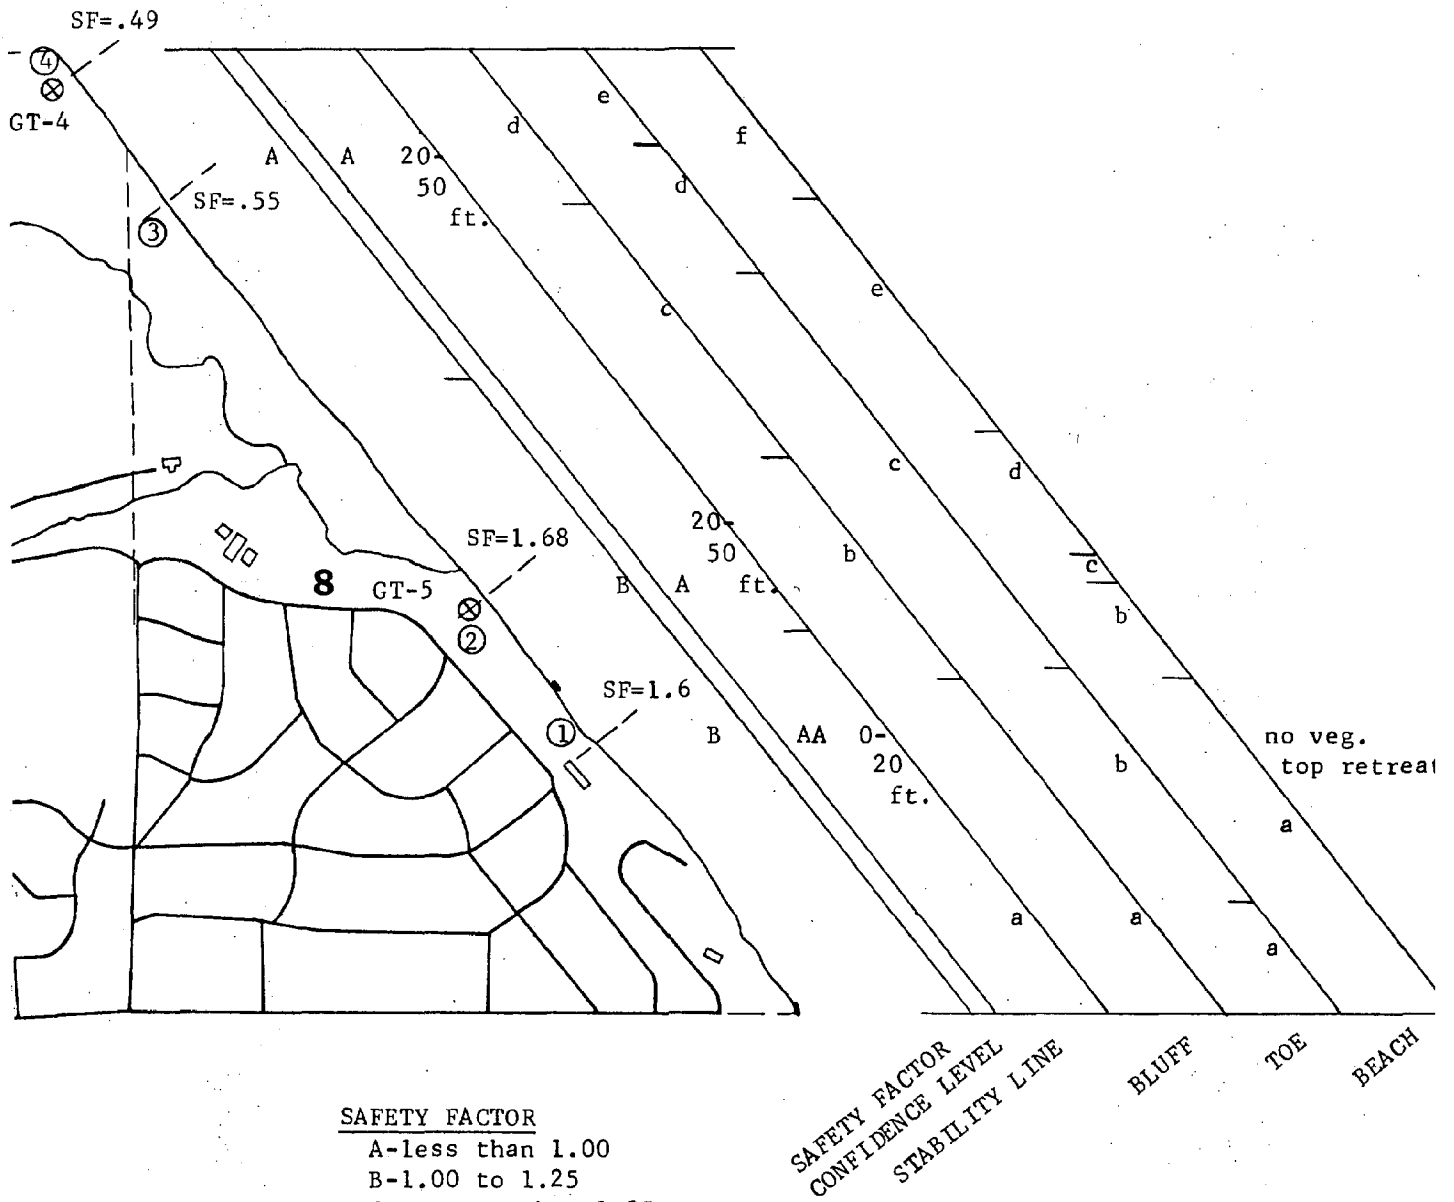
I.4 N., R. 23 E., Sec. 16/17

1. BLUFF	a-slump and flow	b-some slump blocks, very little vegetation, considerable flow evident	c-large slump blocks; vegetation scant and confined to slumps, are also modified by flow.	d-slump blocks and earth flow
2. TOE	a-massive lacustrine silts and clays	b-till, gray clayey	c-till, gray clayey	d-till, gray clayey-Wadsworth
3. BEACH	a-mostly about 35-40 ft. wide, but narrower at north end north of creek mouth. sand, pebbles, and cobbles	b-no beach; terraced gabion structure	c-beach 20-30 ft. wide. sand and gravel	d-beach 15-20 ft. wide
	e-beach 30-40 ft. wide. sand and gravel	f-beach 20-30 ft. wide. sand accretion around groins	g-beach is mostly 30-75 ft. wide. narrows to about 5 ft. at northern extremity of section. widest at end just south of stream mouth where groins have resulted in accretion. sand, pebbles, and cobbles.

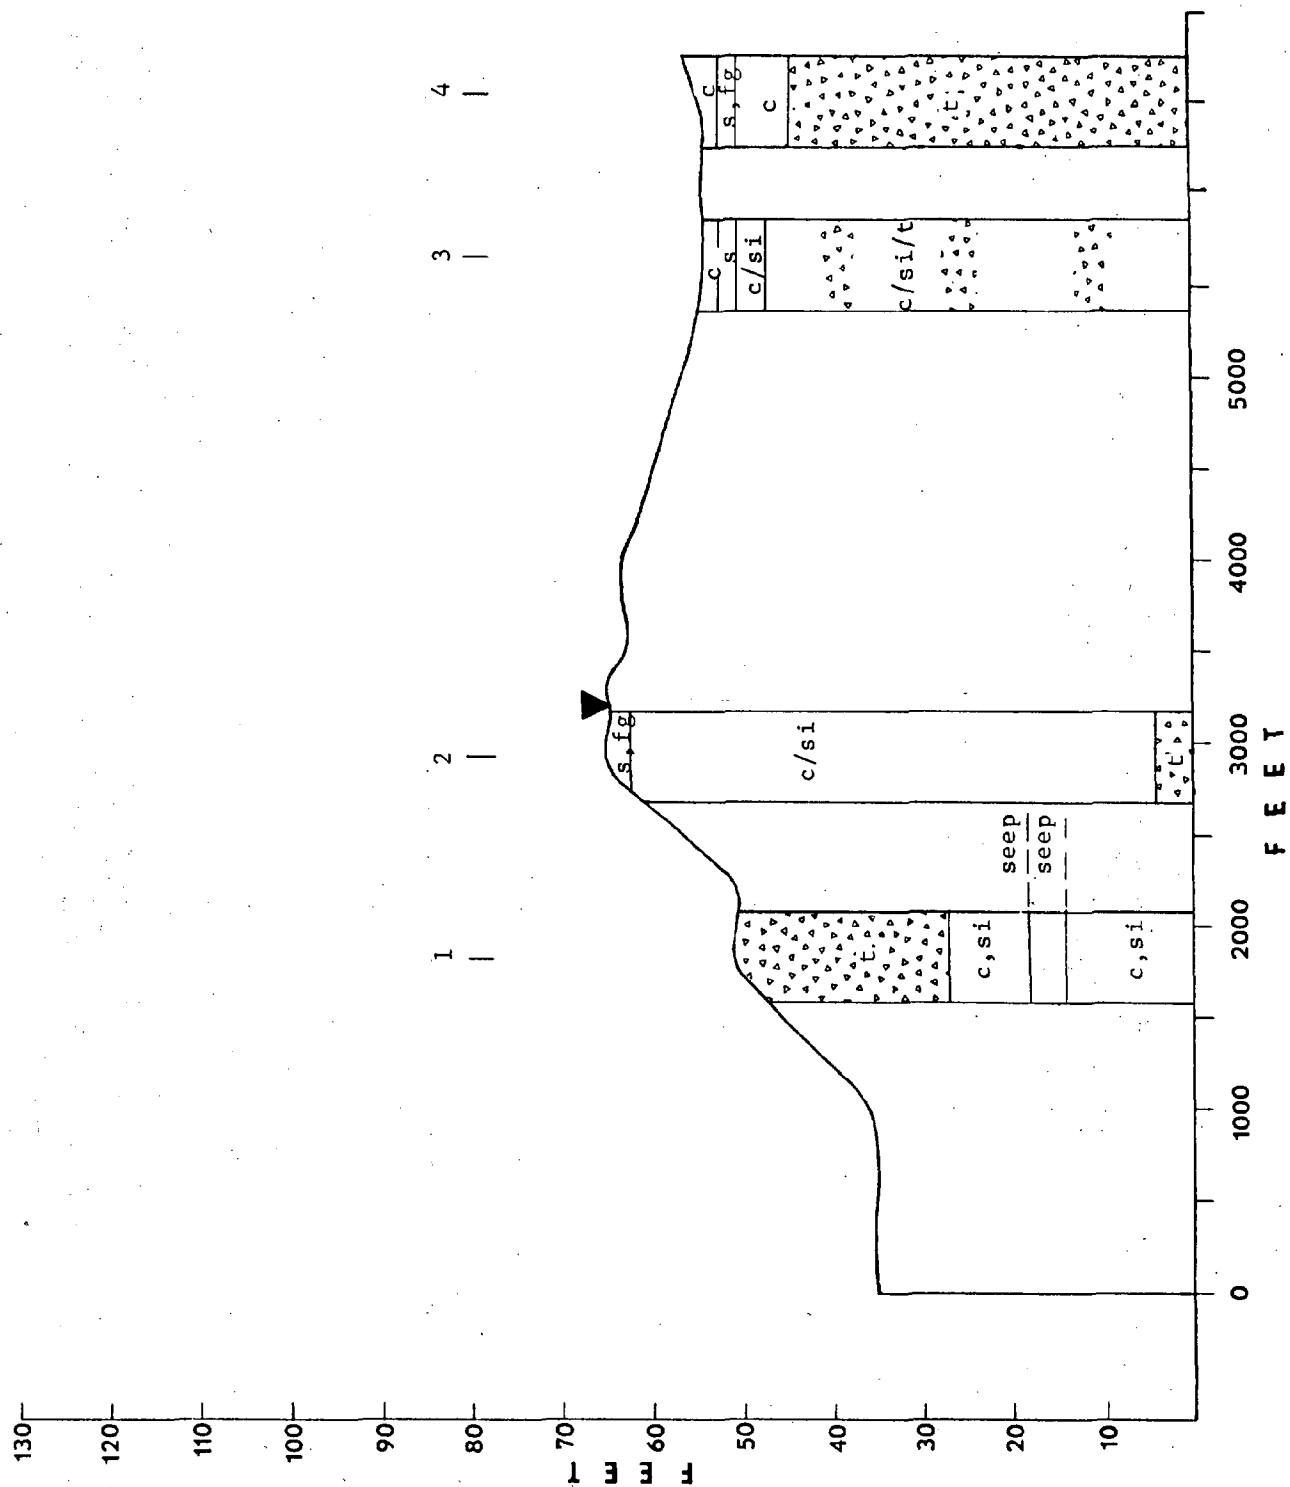
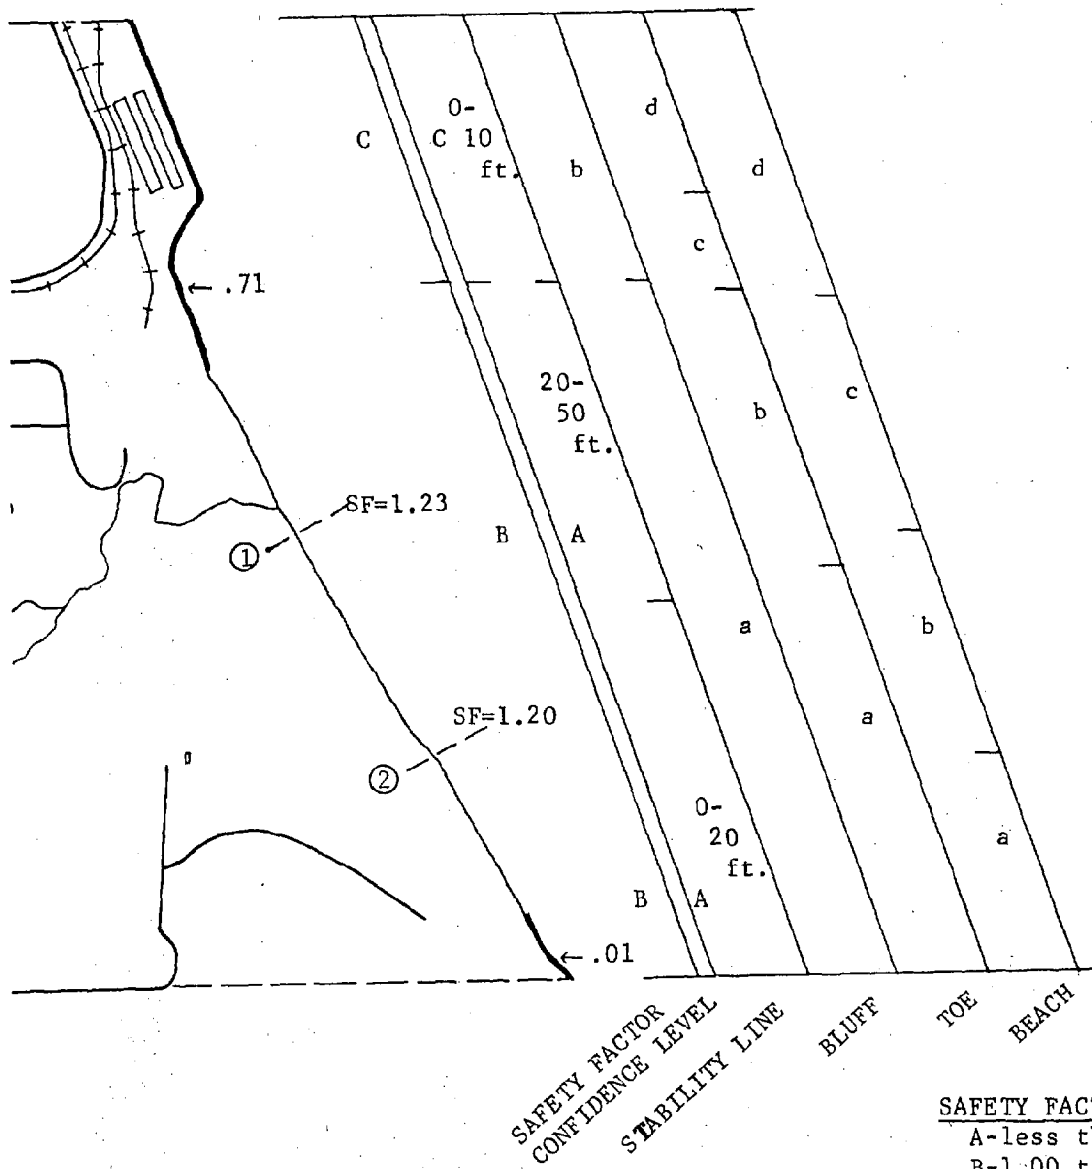
T. 4 N., R. 23 E., Sec. 7/8

1. BLUFF	a-smaller slump units	b-larger slump units modified by secondary slumps and flows	c-large, massive slump blocks produce distinctly scalloped bluff edge, modified by smaller slumps and flows, compound slumps.	d-bluff steepens, recent debris fall and slide, seep in sand 8 ft. above beach, toe erosion

2. TOE	a-mostly covered; smaller slump units, mainly till	b-lacustrine silts and clays in place, and slump units	c-till, concealed in many places by slump blocks, both simple and compound, and by debris flows which also act as toe materials	d-till with some interbedded lacustrine silts
	e-till, mostly in place

3. BEACH	a-generally 15 to 20 ft., except at extreme south end of section where less than 5 ft. wide, sand and gravel	b-beach width variable, 0 to 20 ft., compound slump blocks cover part of beach.	c-20 to 30 ft., stream mouth	d-beach width fairly uniform 15 to 20 ft., sand and gravel
	e-beach width variable, 0 to 15 ft., slump block and debris flow materials cover beach sediments at several places.	f-beach 10 to 20 ft., sand and gravel

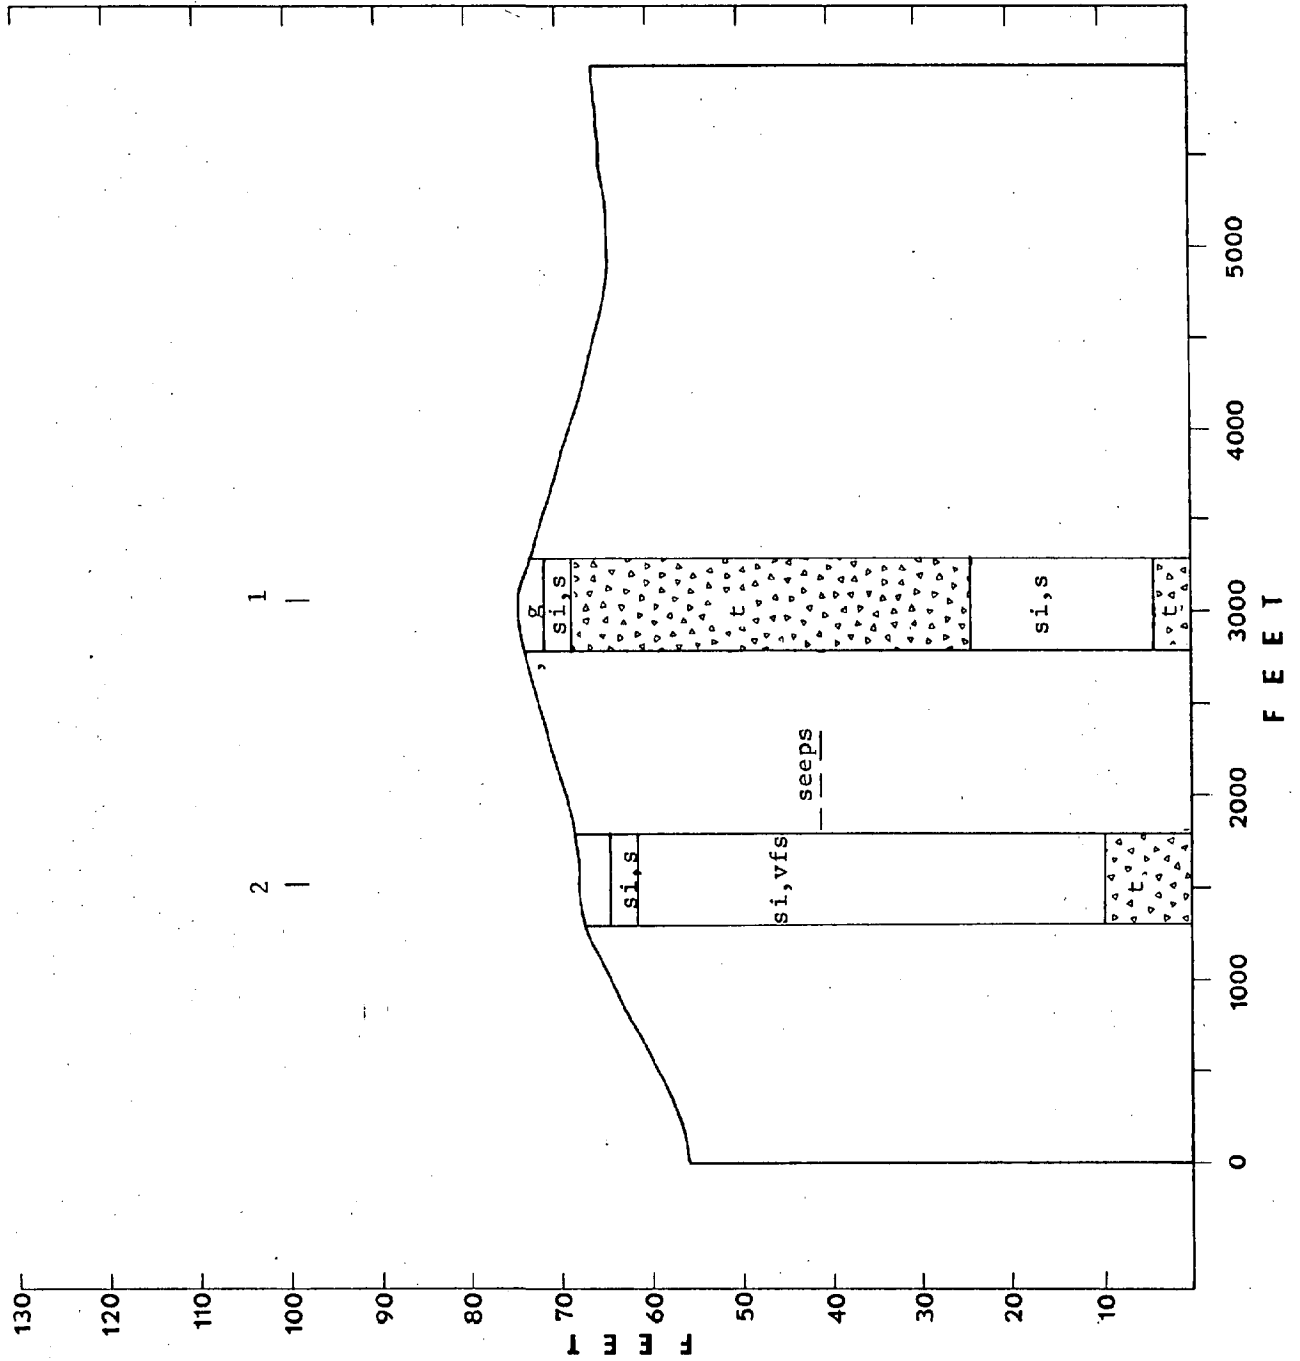
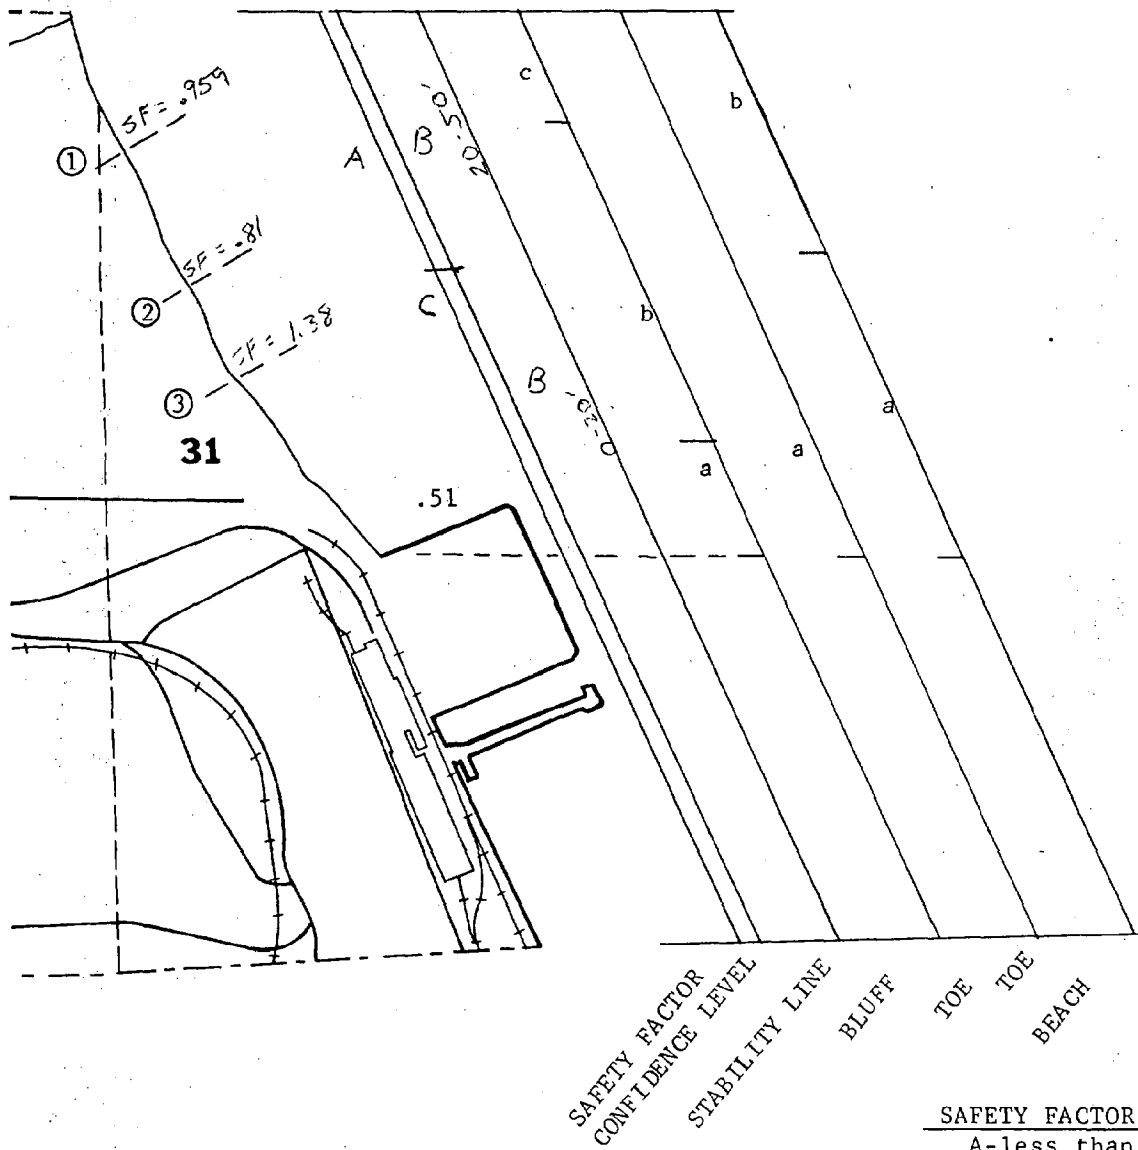
**T. 4 N., R. 23 E., Sec. 6**

1. BLUFF	a-entire bluff is unstable, lacks vegetation, and is subject to slope failure. edge of bluff distinctly scalloped throughout; upper part of bluff face marked by numerous slump scarps; middle part of bluff covered with simple and compound slump blocks, mainly of rotational variety; failure also taking place by toe erosion and consequent debris fall, particularly north of stream mouth near middle of section, where large debris falls are present; debris slides also present at several places.		b-bluff behind area of artificial fill is graded and sodded; appears fairly stable

2. TOE	a-till mostly in place, but also in slump blocks, also some lacustrine silts in slump blocks	b-till; some in place, some in slump blocks, some in debris falls	c-dolomite blocks (revetment)	d-dolomite blocks and corrugated sheet-steel piling (bulkhead)

3. BEACH	a-10 to 15 ft., sand and gravel	b-generally 5 to 10 ft., but less than 5 ft. in some places, sand and gravel	c-0 to 5 ft., except 10 to 15 ft. at mouth of stream, sand and gravel, boulders	d-no beach
