SHORE EROSION STUDY

APPENDIX 3

SHORELINE EROSION AND BLUFF STABILITY ALONG LAKE MICHIGAN
AND LAKE SUPERIOR SHORELINES OF WISCONSIN

MILWAUKEE COUNTY

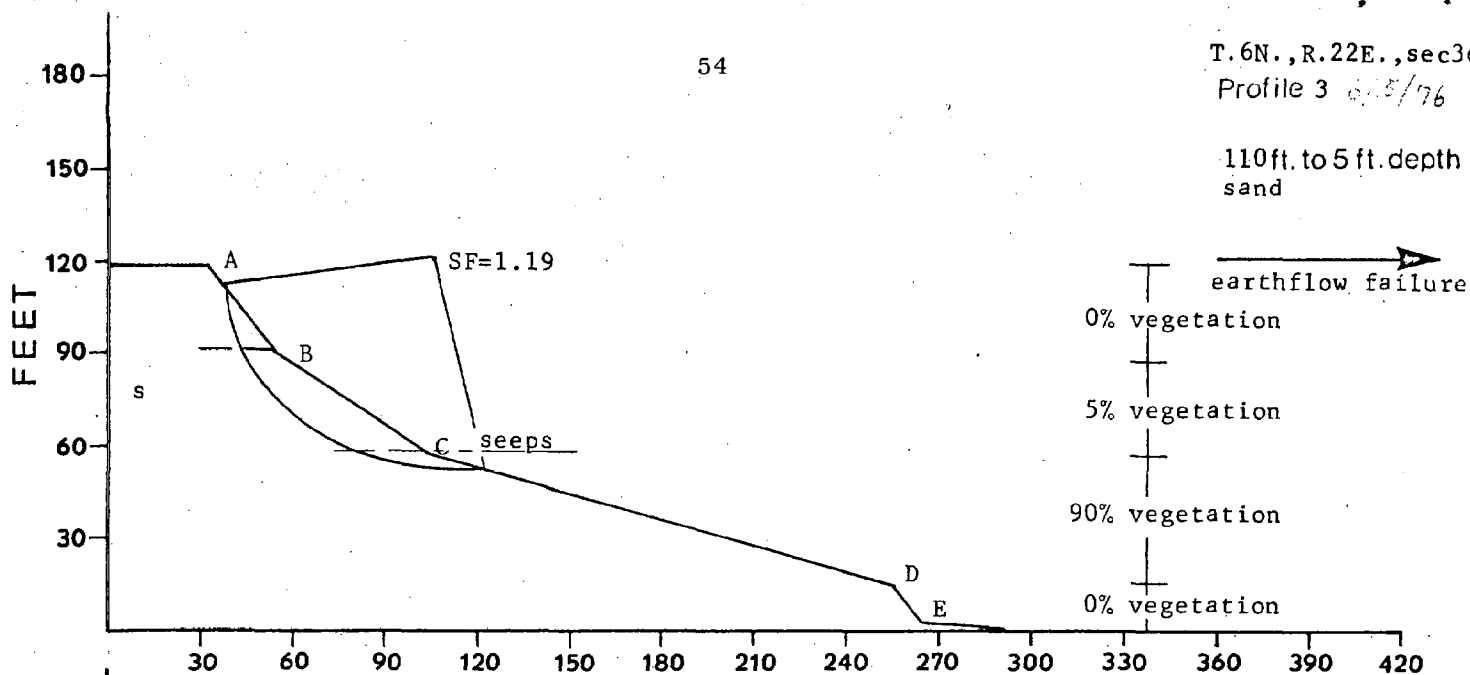
T. 6N., R. 22E., sec 30
Profile 3 6/5/76

110 ft. to 5 ft. depth
sand

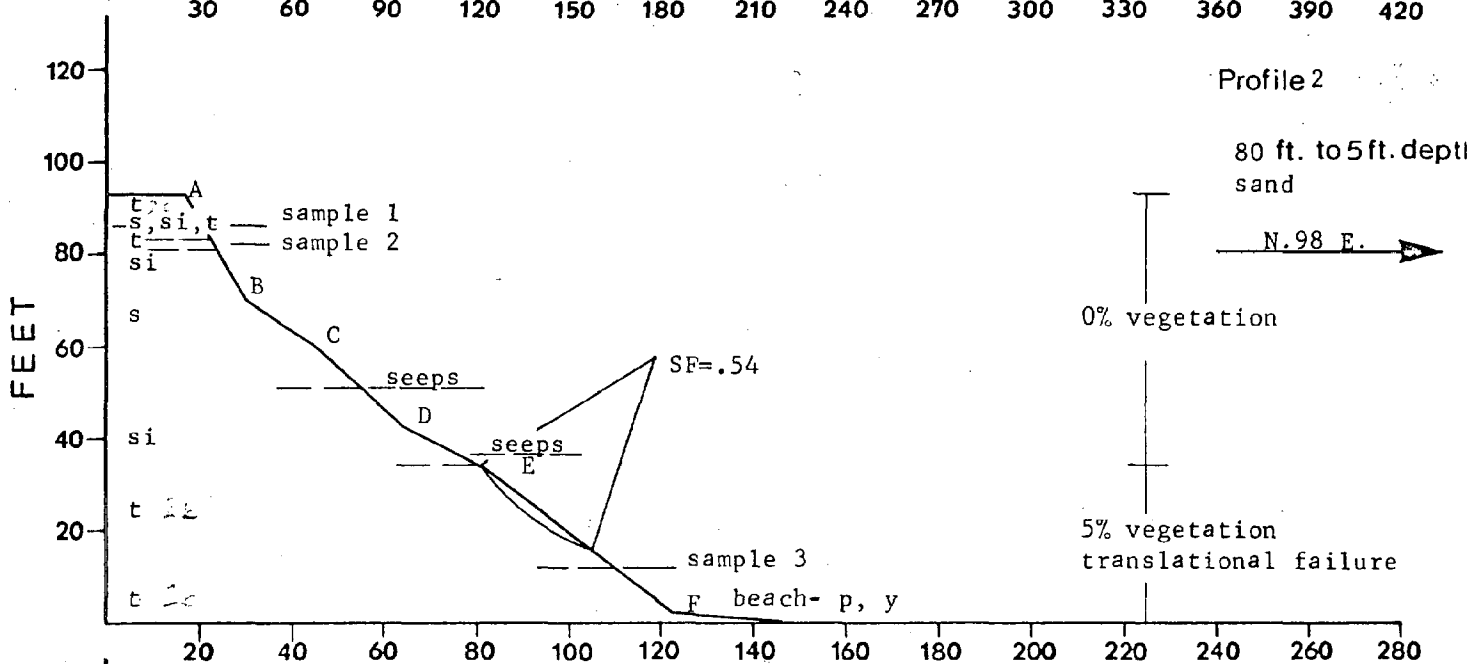
Profile 2

80 ft. to 5 ft. depth
sand

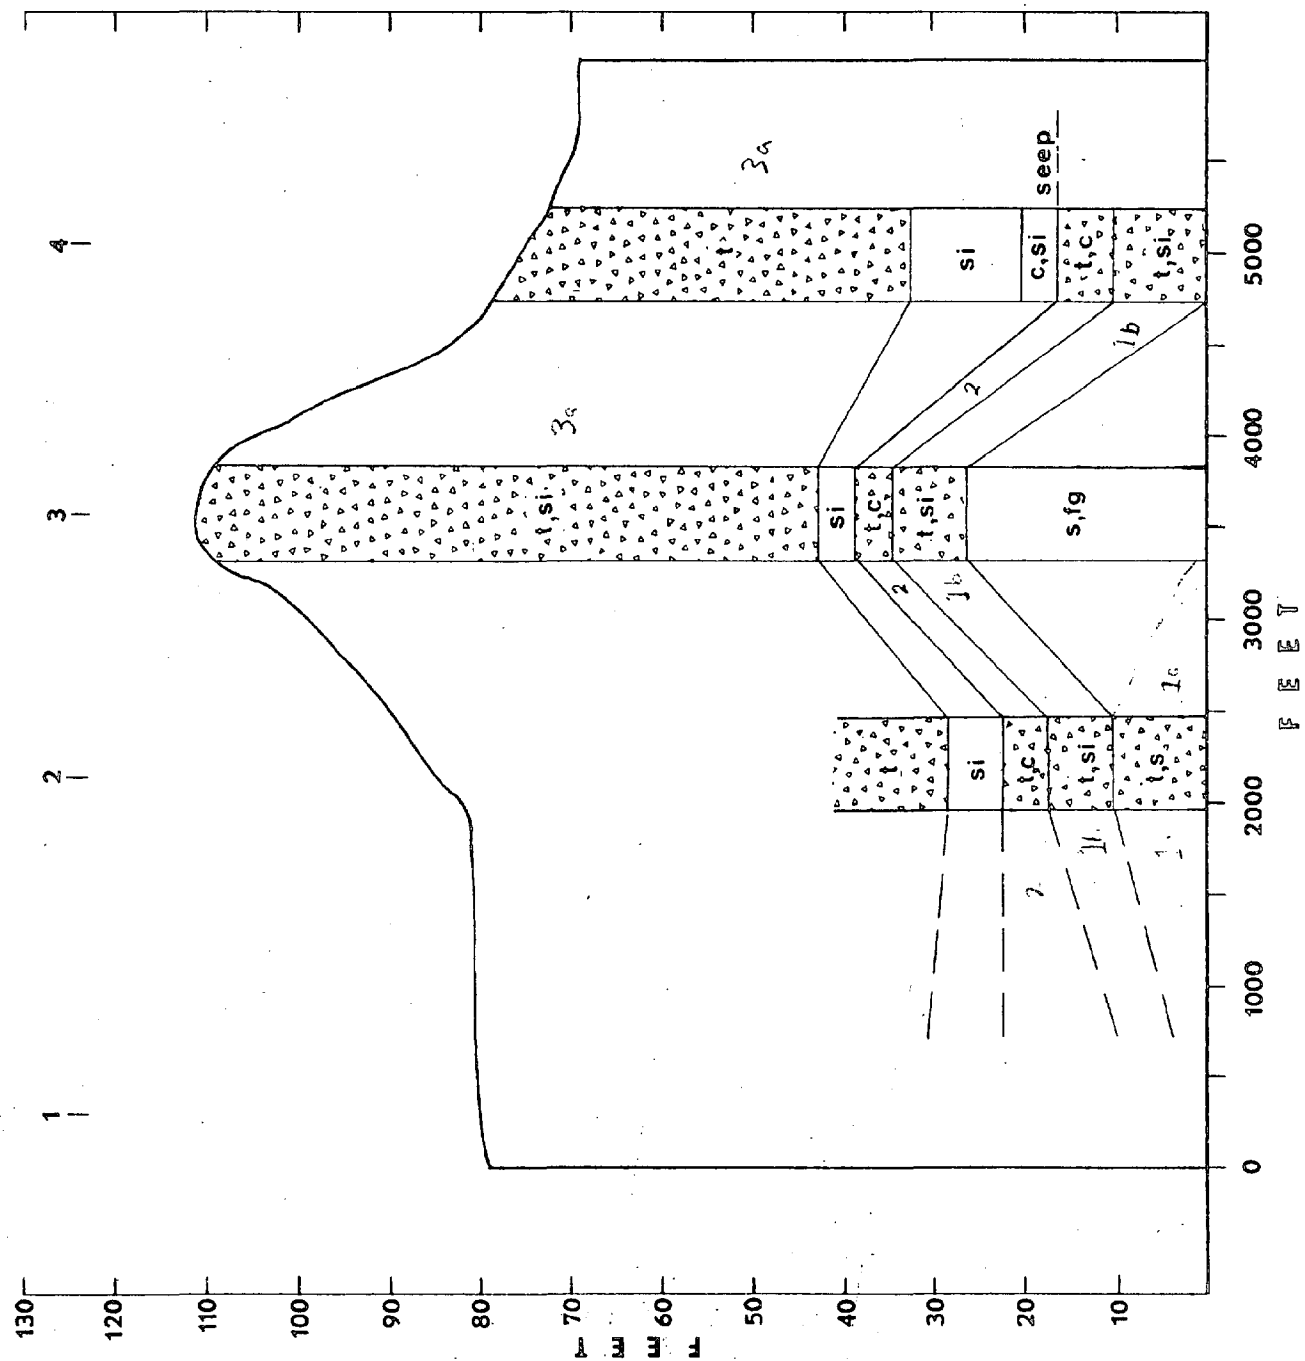
45 ft. to 5 ft. depth
sand

- 100% vegetation
- relatively stable
