**WET-PIT MINING IMPACT ASSESSMENT:
COASTAL ZONE OF PUERTO RICO**

Andrea Handler Ruiz and Rojeanne Salles O'Farrill

Office of Coastal Resources Management (OCRM)
National Oceanic and Atmospheric Administration (NOAA)

Task 7.2
May 1988

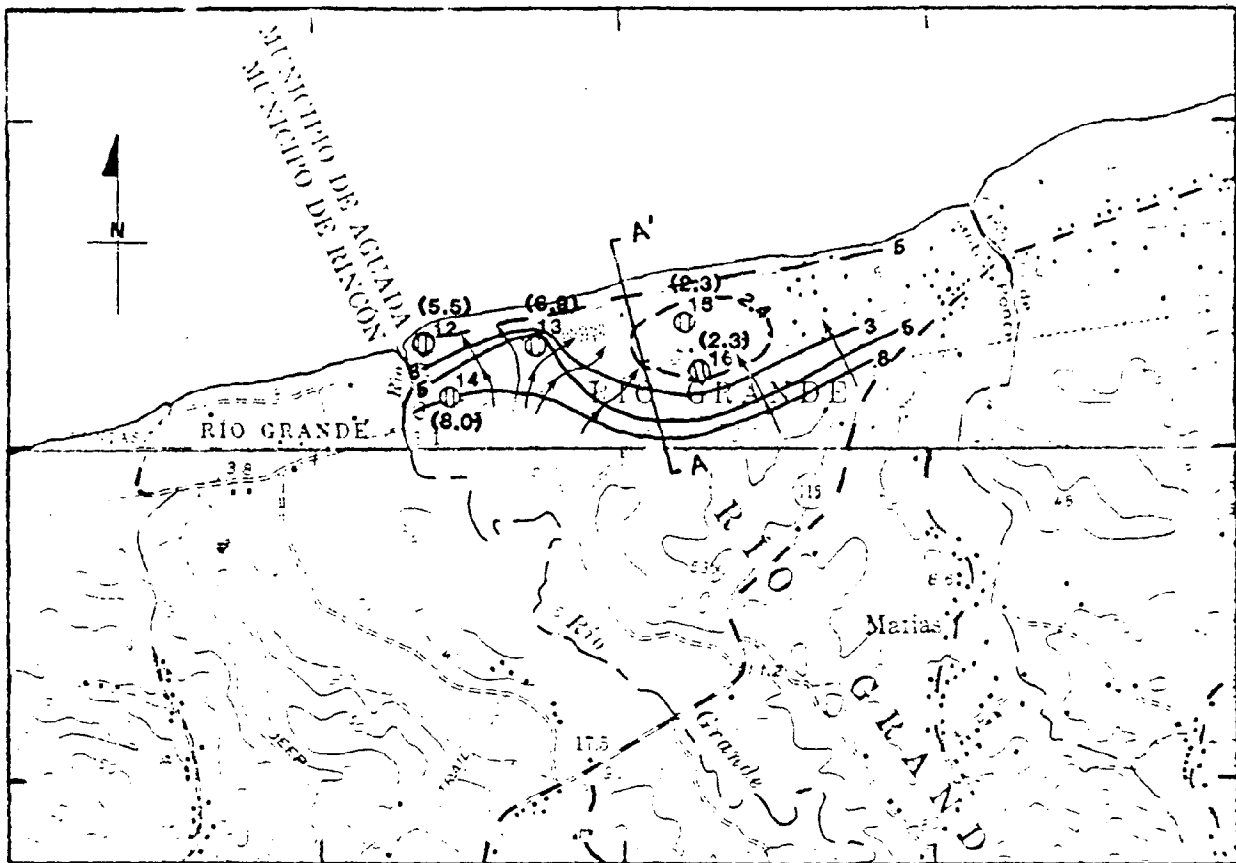
Figure 27 Water-table configuration map in the Aguada sand-extraction site.

Sand extraction operations in the Aguada site apparently have caused changes in the hydrology of the area. Three existing hydrogeologic features in the area seem to exert some control, to varying degrees, in the hydraulics of the ground-water system; (1) the unextracted sand deposits on the east that are of relatively

high permeability, (2) the limestone unit underneath (Cibao Formation) that is also very permeable, and (3) the backfilled material apparently of relatively low permeability. The sand deposits seems to be the most conspicuous hydrologic feature. Their high permeability permits greater movement of ground water through this area causing the flow lines to converge (fig. 27). Hydraulic gradients along these sand deposits are relatively flat (fig. 28). On the other hand, the western portion of the study area, where sand extraction operations have occurred and the site backfilled with lower permeability material, is characterized by steeper slopes and the existence of a localized water-table mound. Flow lines in this particular area exhibits a pattern of divergence (fig.27). Water levels in the dune apparently have not been depressed by sand extraction operations (contrary to what occurred in Ponce) as they still remain high (fig. 28). The water-table mound described above probably has maintained the water levels from dropping in the dune.
