**EVALUATION OF GREAT LAKES  
SHORE PROTECTION STRUCTURES**

**PROJECT REPORT**

**Michigan Department of Natural Resources  
Coastal Management Program  
Land and Water Division**

**December, 1988**

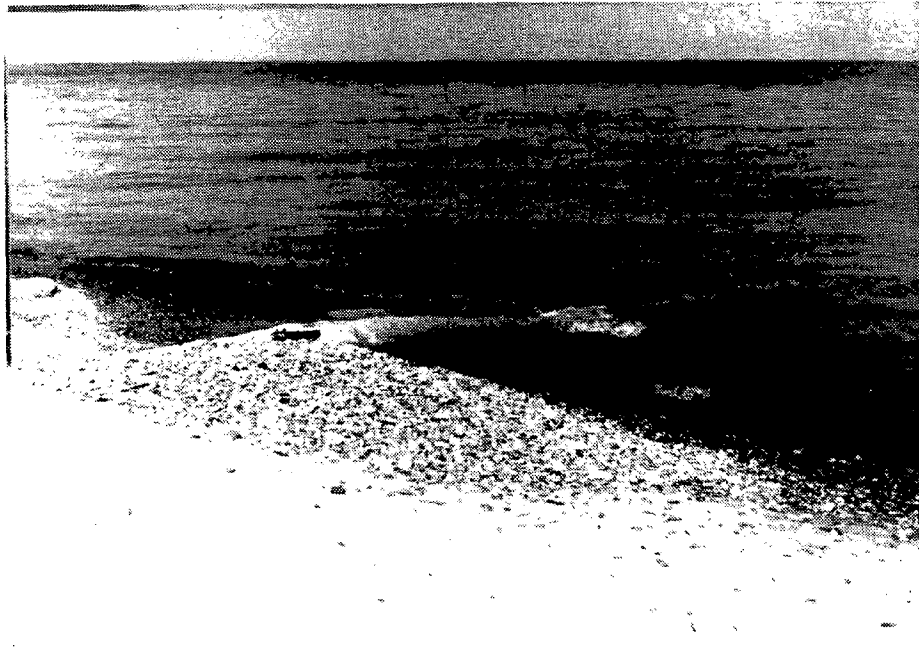
**Figure B3.** Site A: Third groin from northern side of property, looking only at end that is one bag high. Note significant filling of cobble on north side of groin with beach level on southern side nearly 18 inches lower.

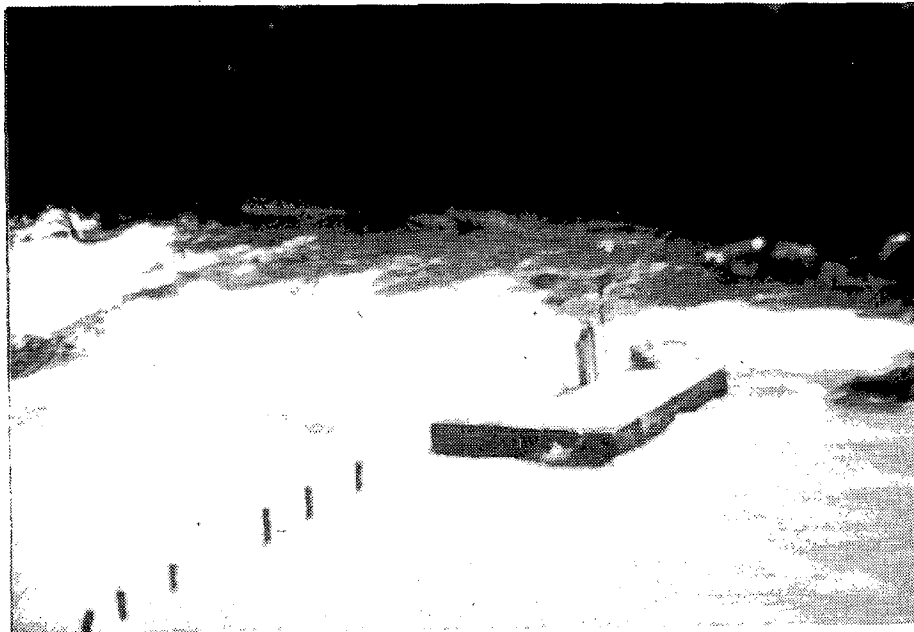
A key factor at this particular site is the presence of a large foundation block (Fig. B4) which serves as an anchor for an aerial tramway that provides transport to the top of the bluff. This foundation block is perhaps 15 by 20 feet in plan dimension and is located at the southern side of the Warren property. The farthest landward portion of this foundation is located approximately 60-70 feet seaward from the toe of the bluff. The beach is nearly 75 feet wide on the north side of the foundation block and there is essentially no beach to the south, so this is clearly acting as a groin in this region where the littoral transport is generally towards the south. This conclusion was reinforced by the inspection of aerial photographs at the Detroit District U.S. Army Corps of Engineers office. The foundation block was present in 1977, but there is almost no beach to the north with a somewhat broader beach to the south. Water is present behind the foundation block. This condition holds up to April of 1980 at which time the foundation block was approximately 100 feet offshore. No aerial photographs were available from then until April of 1986, at which time the concrete blocks are present on the shoreline and the foundation block is attached to the shoreline. Between April and October of 1986 (during which time the lake levels continued to rise) the beach increased in width and that trend has continued up to the present. It is fairly apparent that the placement of the original rows of concrete

blocks in the early 1980's stabilized the shoreline in the immediate vicinity of the foundation block and this resulted in a blockage of the southerly littoral drift at the site. This in turn has built a fairly broad beach for several hundred feet up the shoreline to the north.

It is concluded that the presence of this foundation block dominates the beach processes at the particular location. It has served as a fairly long groin and has stabilized the beach over the same location that the concrete blocks were intended to protect. Therefore, it is not possible to determine whether or not they have been effective. However, the one thing that is obvious is that on a sand beach, they would sink into the beach relatively rapidly and not be particularly useful. It is quite possible that even on the clay foundation that the blocks are apparently resting on, the absence of the sand trapped by the "groin" would result in erosion at the blocks and further undermining. This statement is made in light of the observations of beaches in front of sea walls at various locations along the Great Lakes shorelines.

**Figure B4.** Site B: Aerial photograph of concrete foundation block for tramway, at southern edge of property. The shoreline is at the outside edge of block on the north side and at the landward edge to the south.

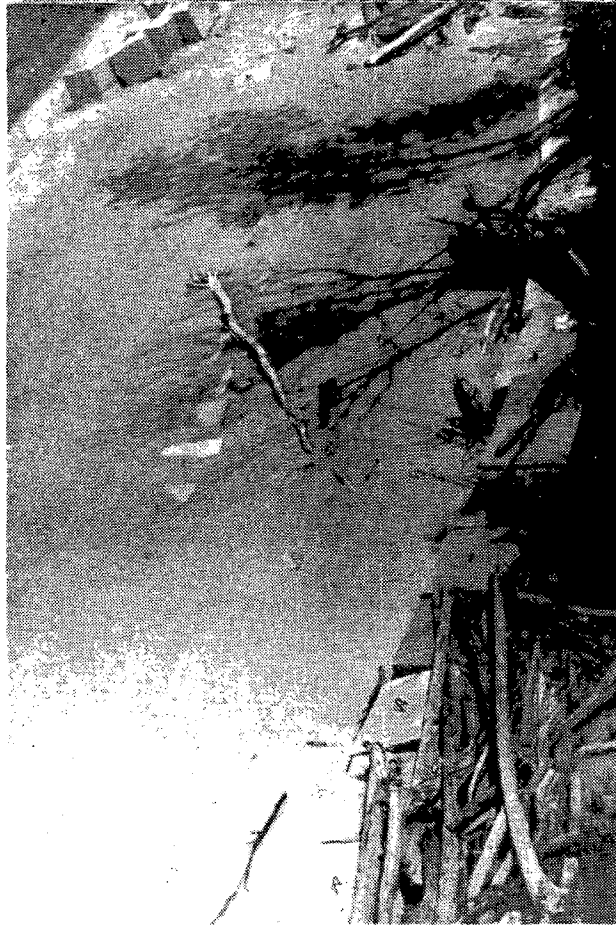
**Figure B5.** Site B: View of concrete blocks towards southern side of property. Note row of blocks at right, located at toe of bluff. A second row is almost completely buried in the sand to the left of the first row and a few random blocks such as those in upper left have been recently placed on existing beach.

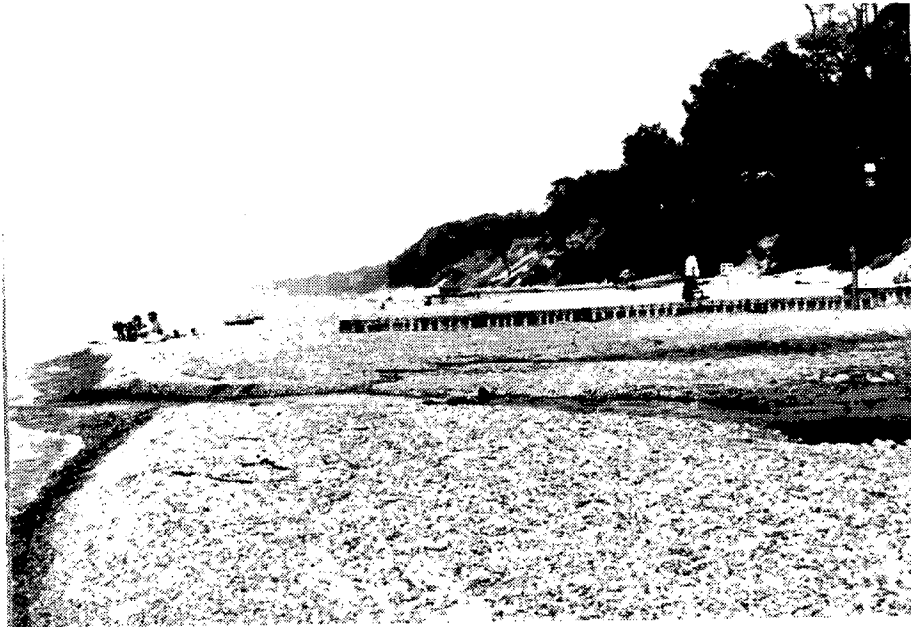
**Figure B9.** Site D: View of retaining wall from the south side of creek. Decrease in beach width to the north is possible to make out from photograph.

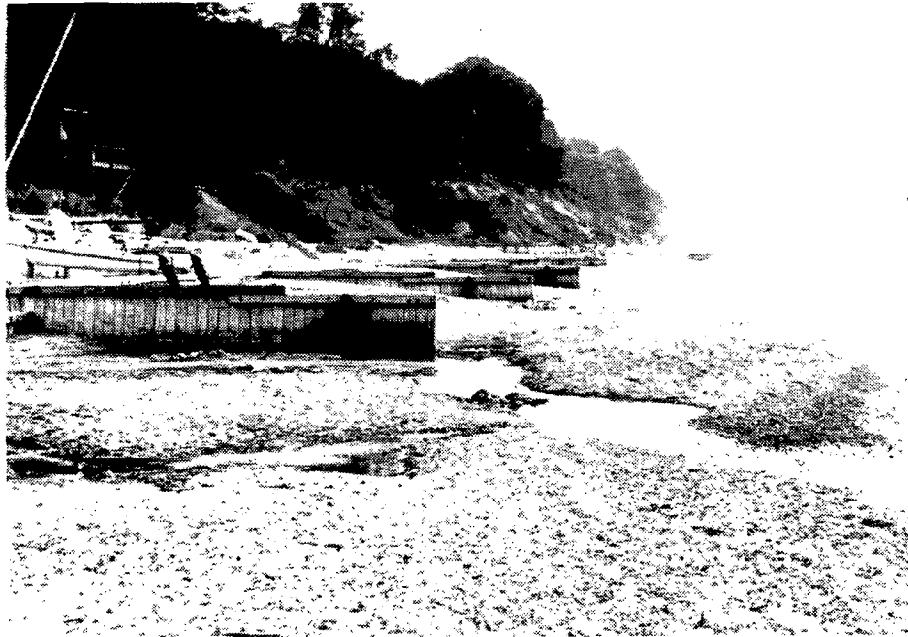
**Figure B10.** Site D: View of groin system on south side of creek. Decrease in beach width to the south is fairly clear in this photograph.

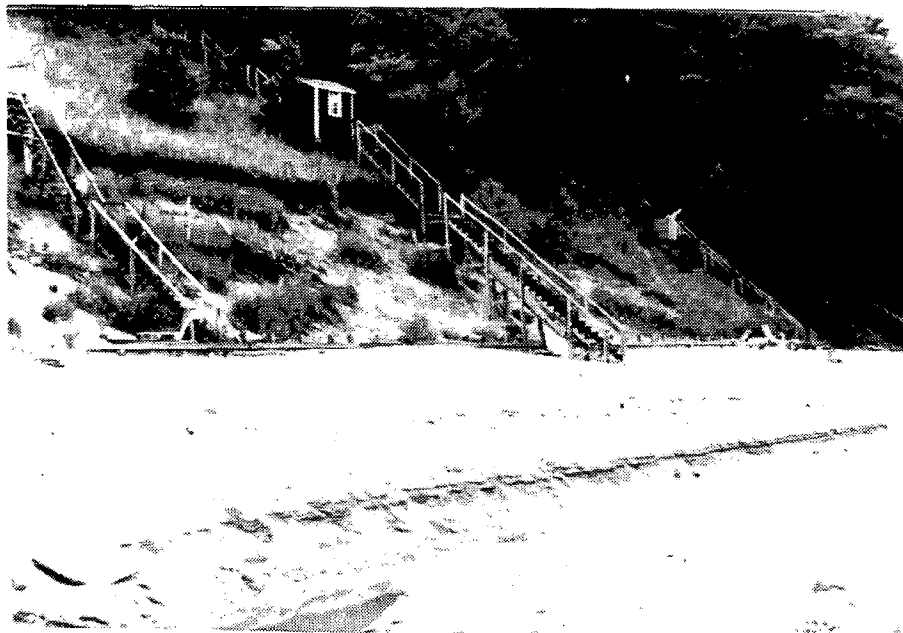
**Figure B11.** Site E: Top of retaining wall is visible at toe of bluff. Straight line in foreground is where beach level drops immediately at shoreline with beach perched more than 12 inches above water level. View is towards south.

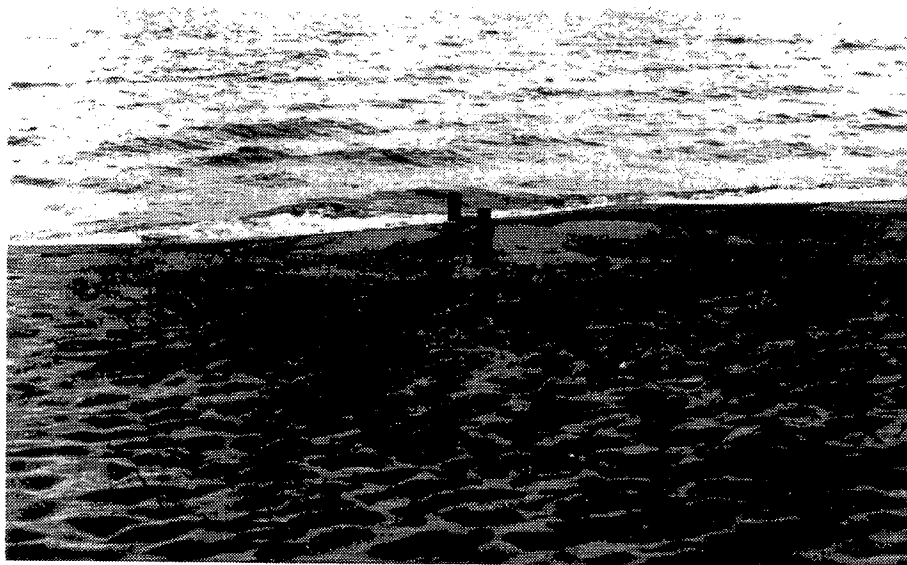
**Figure B13.** Site F: Looking offshore along top of nearly completely buried groin. Horizontal members are not visible.

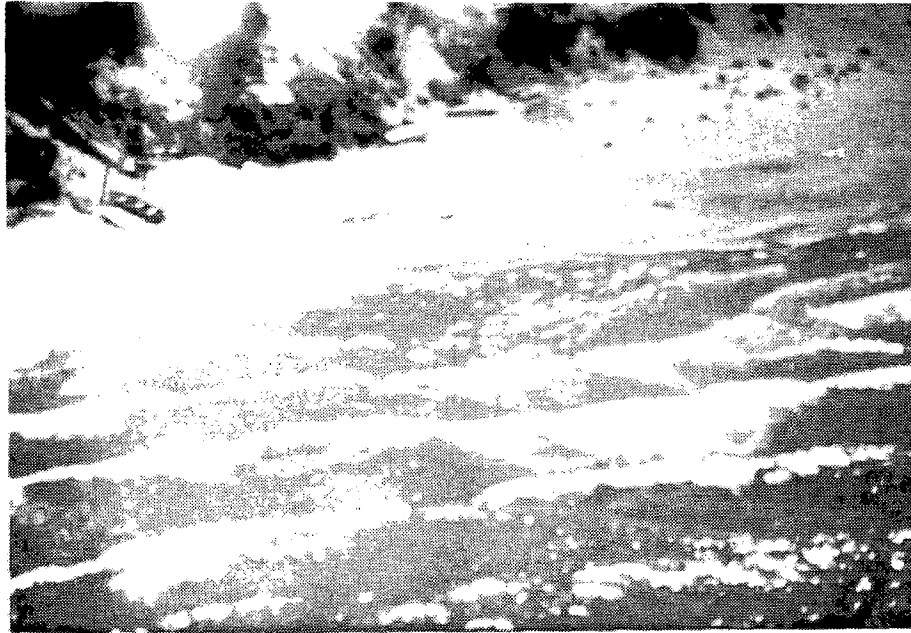
**Figure B18.** Site G: Aerial view of property. End of groin is visible in upper center of photograph. Beach is slightly narrower just to north of groin end.

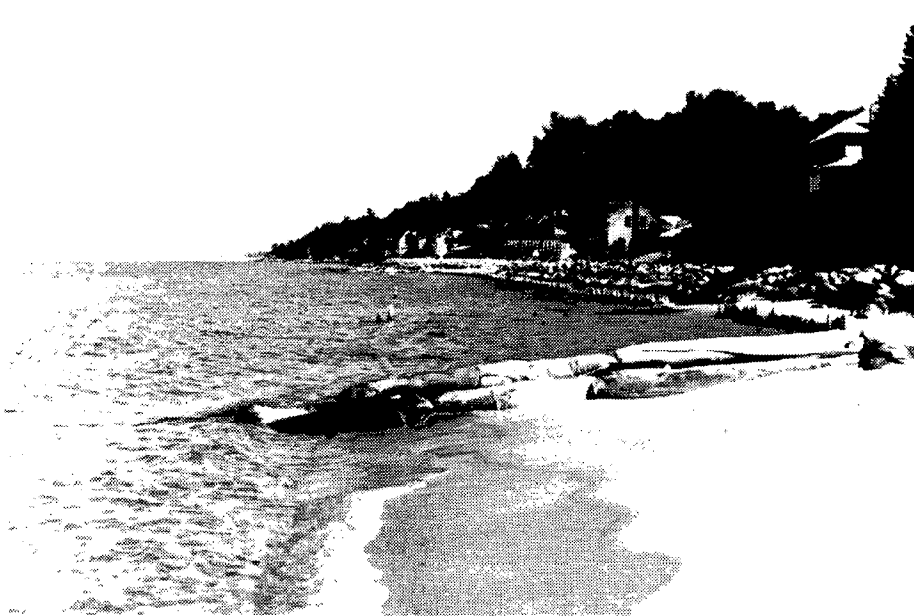
**Figure B24.** Sites I and J: Tube groin (part of Reid permit) on south boundary of Epworth property. Note accumulation of beach on south side of groin and slight accumulation behind other tube groins to north (in vicinity of old timber retaining wall).

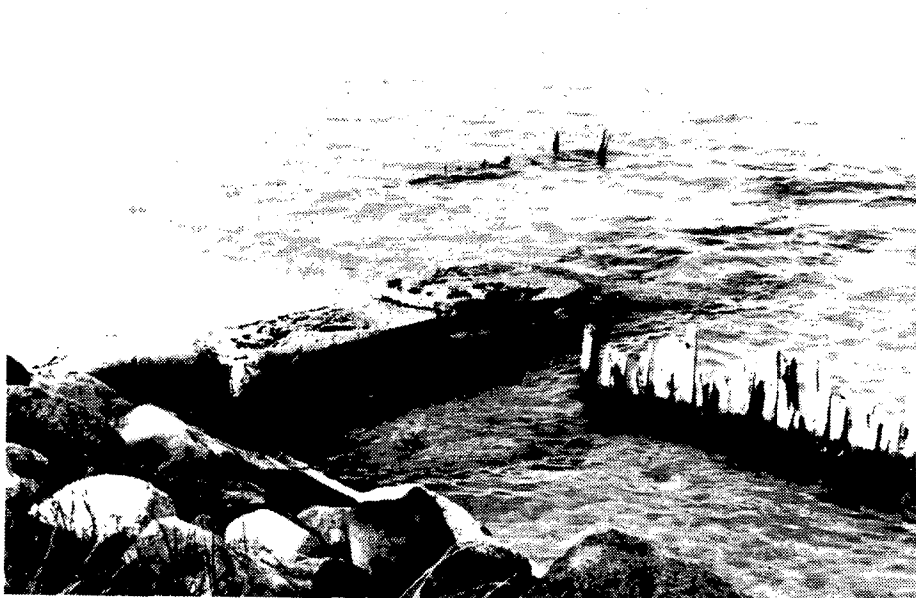
A problem that was noted with several of the concrete filled tube groins was damage to the groin surface (Fig. B25). There were five sites inspected where this type of groin had been installed sometime between July and November of 1987 and thus had been in place only a year at most at the time of the site inspection. Of these, three sites (considering the tube groin system on the Epworth and Reid properties, sites I and J, as one because they were installed at the same time) had already experienced some degree of damage, in all cases on the tops of the offshore ends of the groins. Because of the very short time since the installation at these sites, this raises some question about the long term integrity of the structures. Additional site visits in another year or two would be very valuable in determining the durability of this type of groin.

**Figure B25.** Site J. Tube groin just to north of one in Fig. B24. Note damage to groin top and sand accumulation on south side.

\* The issue of damage to the concrete filled tube groins to see if they have as long a useful life as some of the other possible groin systems.

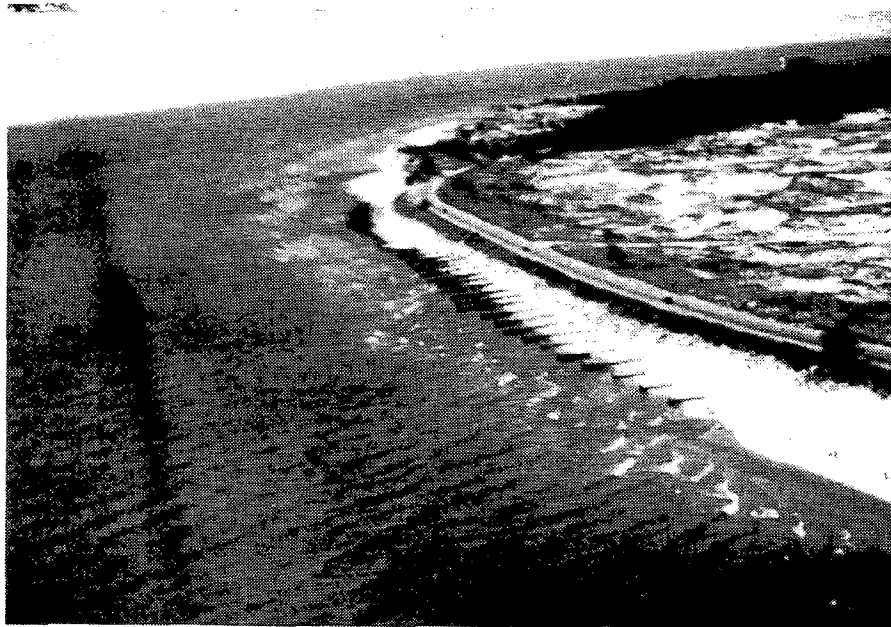
**Figure B29.** Site K: Aerial view of southern end of long groin field. Note that groins in southern portion of groin field at lower right are completely filled.

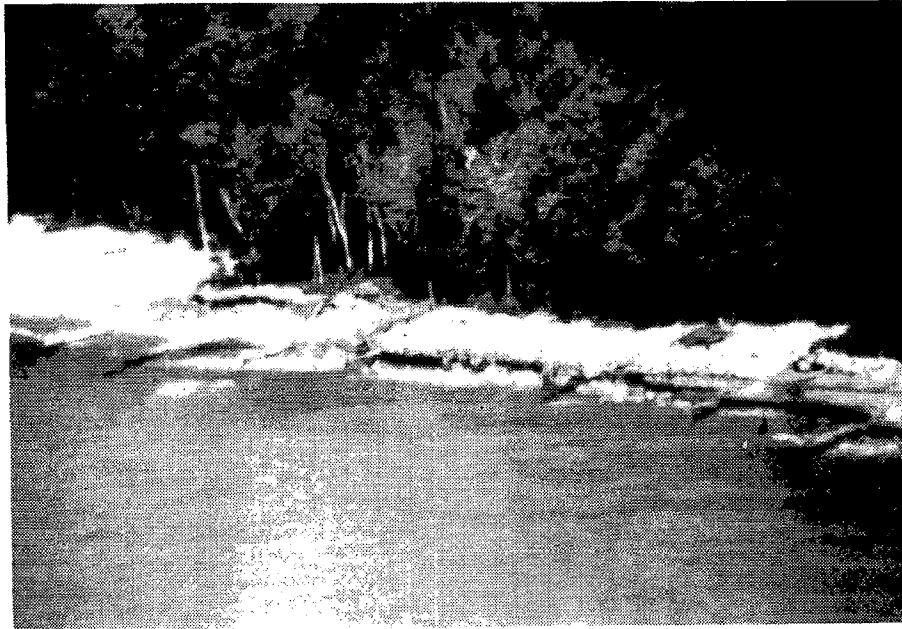
**Figure B42.** Site O: Aerial view of short revetment at north side of property. Recession of shoreline to north of revetment is visible at left center of photo.

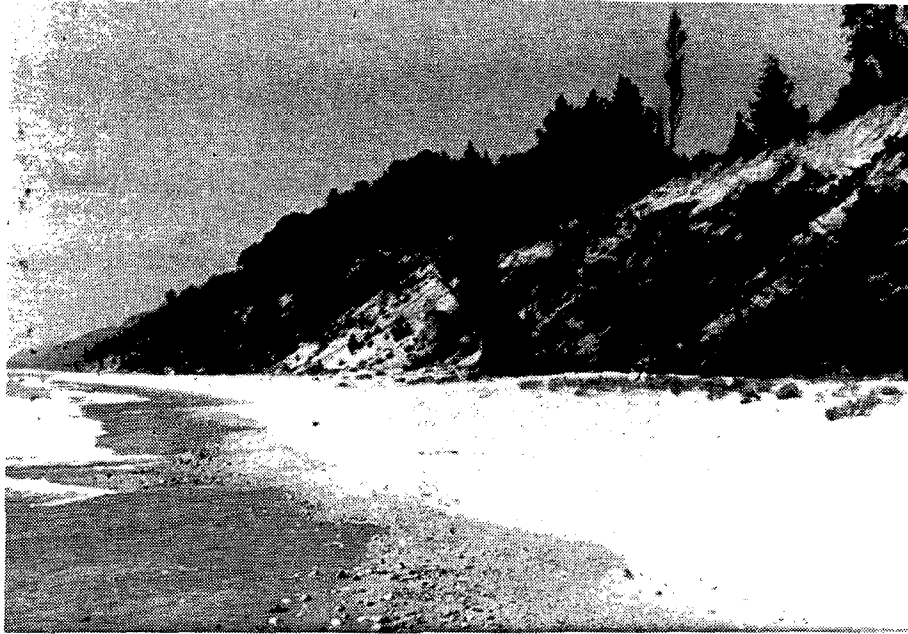
**Figure B44.** Site P: Looking north across site. Slight recession in beach to north of site is between this site and site Q. Still farther north, shoreline recedes again at far right of photo.

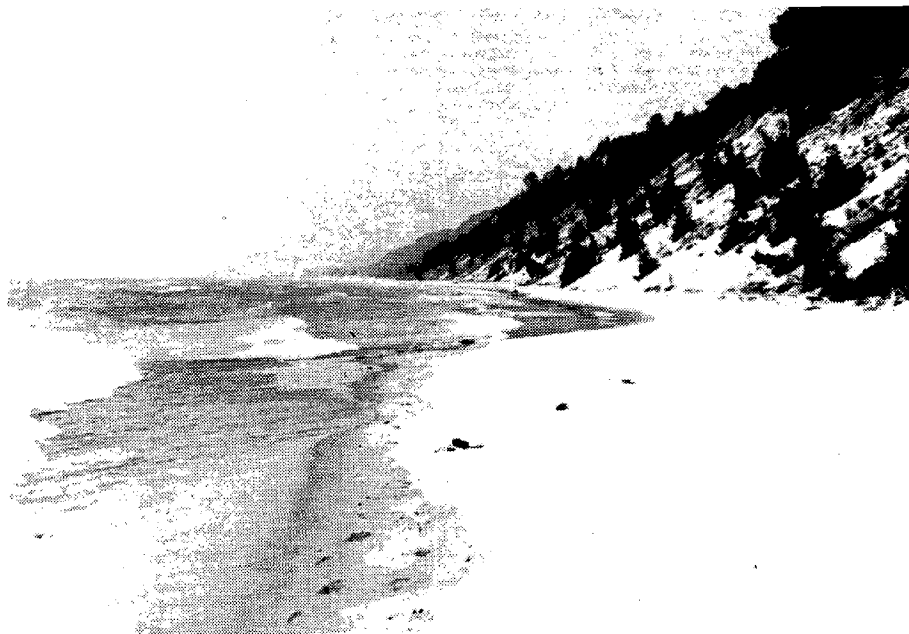
**Figure B47.** Site Q: Looking to the north from the southern side of the site. Note reduction in beach width immediately north of most northern groin in system.

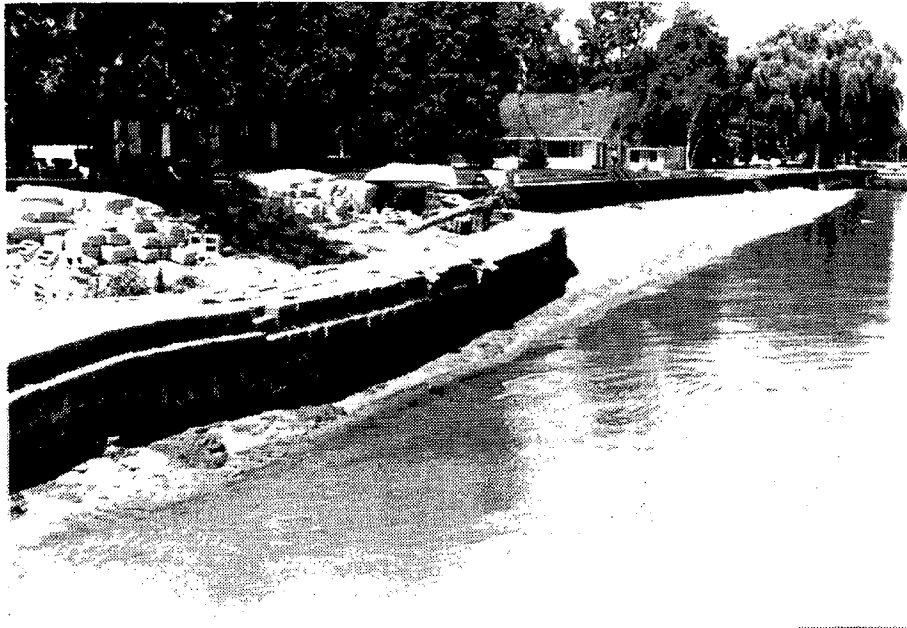
**Figure B65.** Site Z: Existing sandgrabber wall at site. Note lakeward displacement relative to seawall to north. Also note that only half of lower block is buried.

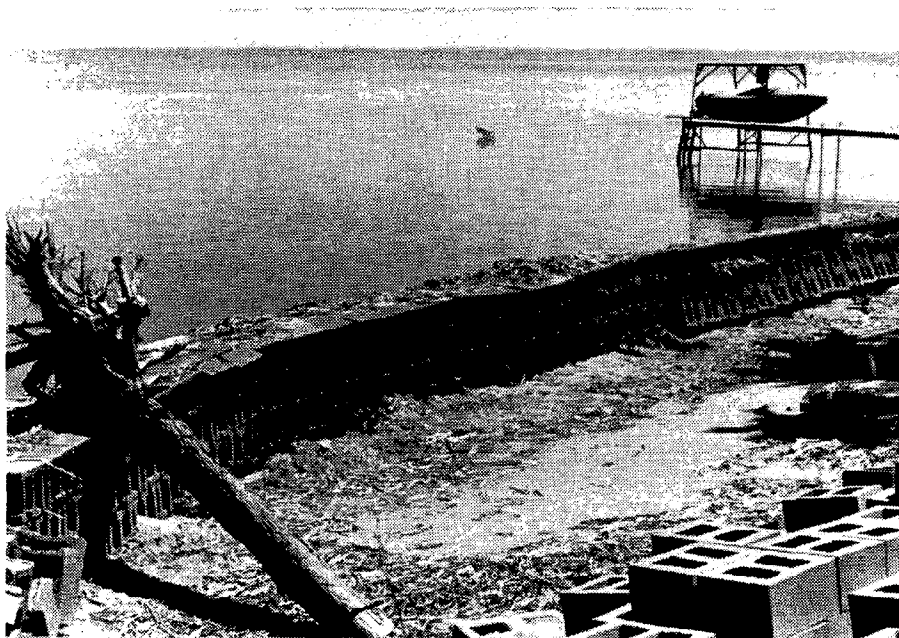
**Figure B66.** Site Z: Backside of sandgrabber wall, sand level behind slightly higher than in front. Also note tree trunk washed over wall during high water.

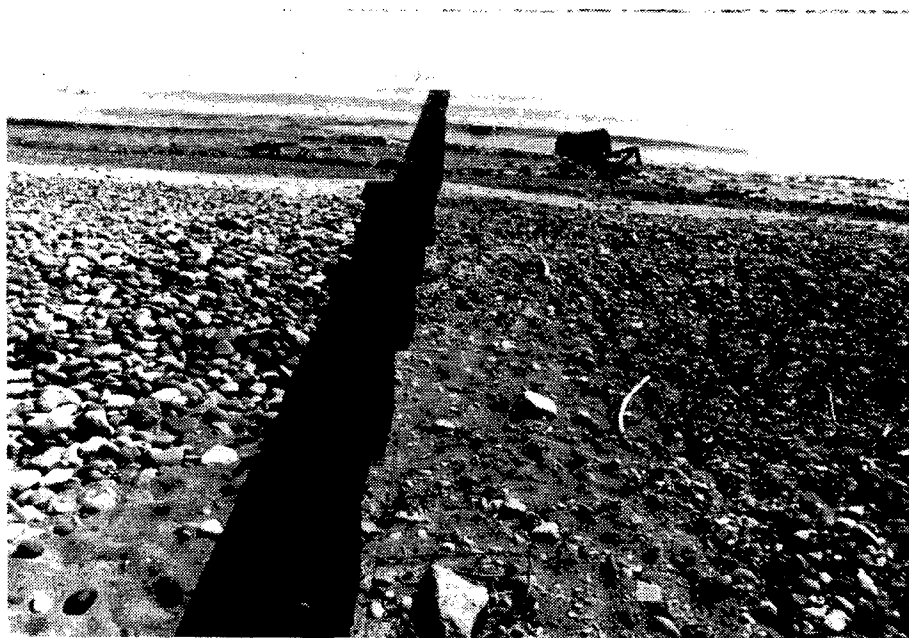
**Figure B76.** Site II: Looking offshore along most southern groin. Littoral drift is left to right. Note coarse cobble on updrift side of groin.
