U.S. DEPARTMENT OF COMMERCE
National Oceanic and Atmospheric Administration
NATIONAL MARINE FISHERIES SERVICE
Pacific Islands Fisheries Science Center
1845 Wasp Blvd. Bldg. 176 • Honolulu, Hawaii 96818
(808) 725-5300

PROJECT REPORT

VESSEL: NOAA Ship *Oscar Elton Sette*, SE-16-07
(Note: This Project has subsequently been deemed SE-17-01.)

TYPE OF OPERATION: Insular Bottomfish Survey

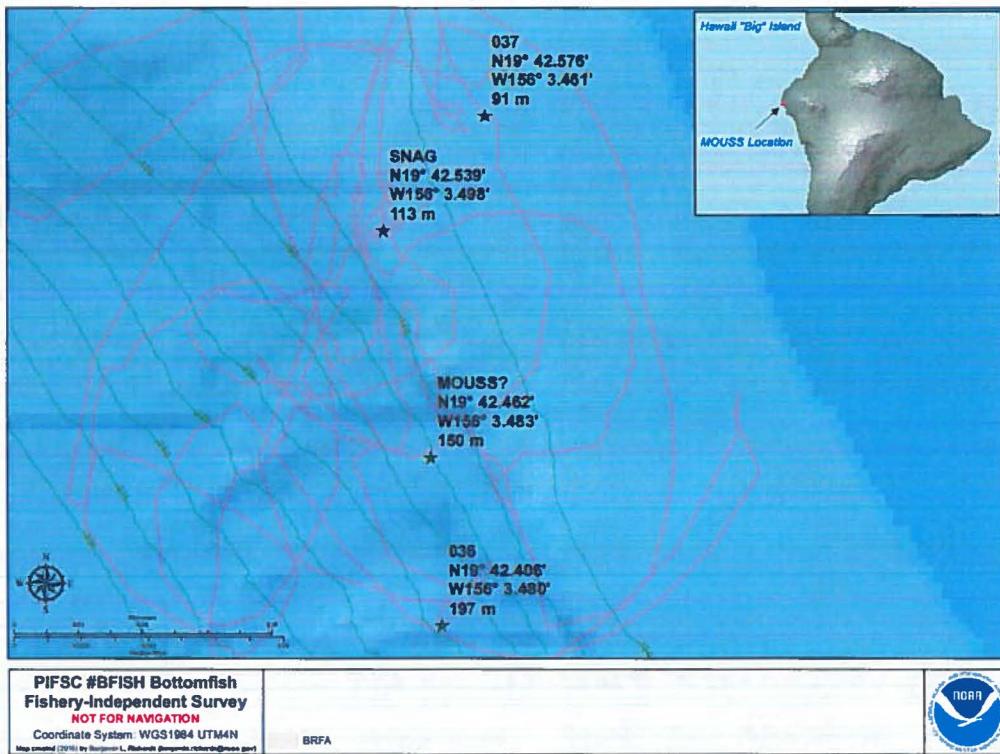
7. On 28 October, one MOUSS unit became fouled on the seafloor within PSU 2549 and could not be recovered (Figure 2). The unit remains at approximately N19° 42.467' x W156° 3.482' at a depth of 150 m. A full report is provided in Appendix 1 to this report.

Figure 3. A map showing the approximate location where the Pacific Islands Fisheries Science Center (PIFSC) Modular Optical Underwater Survey System (MOUSS) was lost during recovery from PSU 2549 on October 28, 2016. The green stars indicate the initial drop location (036), the location where the surface line became snagged on the seafloor (SNAG), the position of the 19' SAFE Boat when the surface line parted (037), and the approximate location of the MOUSS (MOUSS?) based on the length of surface line that had been recovered

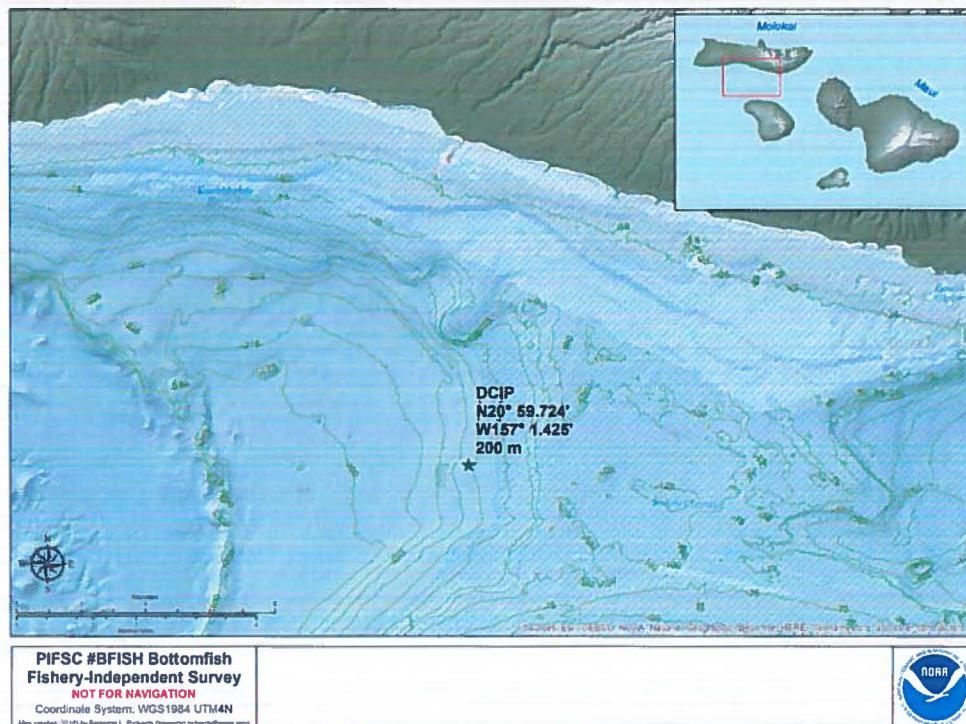
3. On 03 November, one DCIP unit became fouled in the propellers of SE within PSU 2549 and could not be recovered (Figure 4). The unit remains at approximately N20° 59.724' x W157° 1.425' at a depth of 200 m. A full report is provided in Appendix 2 to this report.

Figure 4. A map showing the approximate location where the Pacific Islands Fisheries Science Center (PIFSC) Drop Camera Instrument Package (DCIP) was lost during recovery on November 3, 2016.

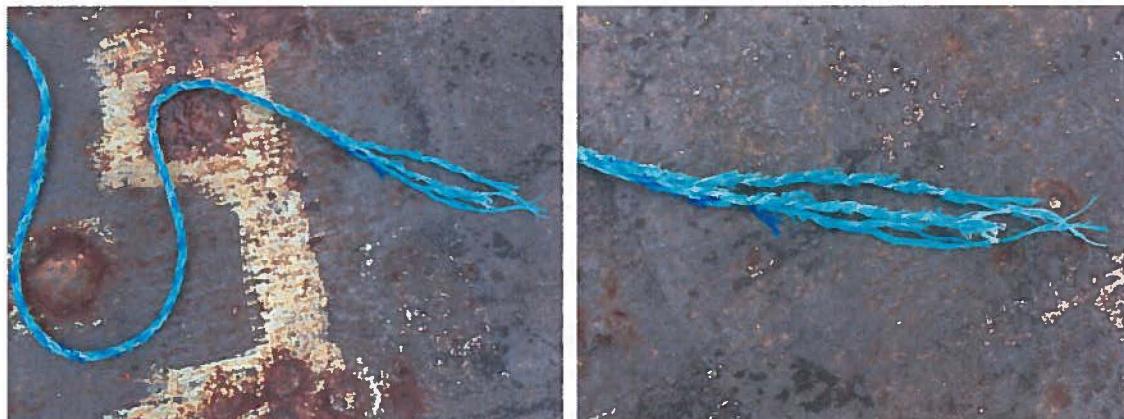
Figure 1 Images showing the parted surface line connecting the MOUSS to the surface buoys.

out. Instinctively, we took a waypoint called 037, And hauled the parted line into the boat. That is how we lost the MOUSS.

It's worth mentioning that the stuck point seemed to be in about 85 Meters of water, and the amount of rope that was hauled back (from the part back to the white line) was only 150 feet of green or a total of 350 feet of line....meaning that its very likely the rest of the line is on the other side of the obstruction/ rock.

1. Shorten length of surface line to reduce likelihood of entanglement on the seafloor.
2. Develop modular surface line allowing for adjustment of length based on drop depth and current speed.
3. Do not deploy MOUSS in currents greater than 2 knots.
4. Develop burn-wire or similar system allowing MOUSS and subsurface floats to be remotely severed from both anchor and surface line, allowing MOUSS to float to surface if anchor or surface lines become fouled on the seafloor.
5. Develop variable buoyancy system allowing MOUSS to be deployed without surface tether but also without the need to jettison anchors.
6. Consider incorporation of small ROV in MOUSS operations allowing for inspection and potential disentanglement of fouled MOUSS.

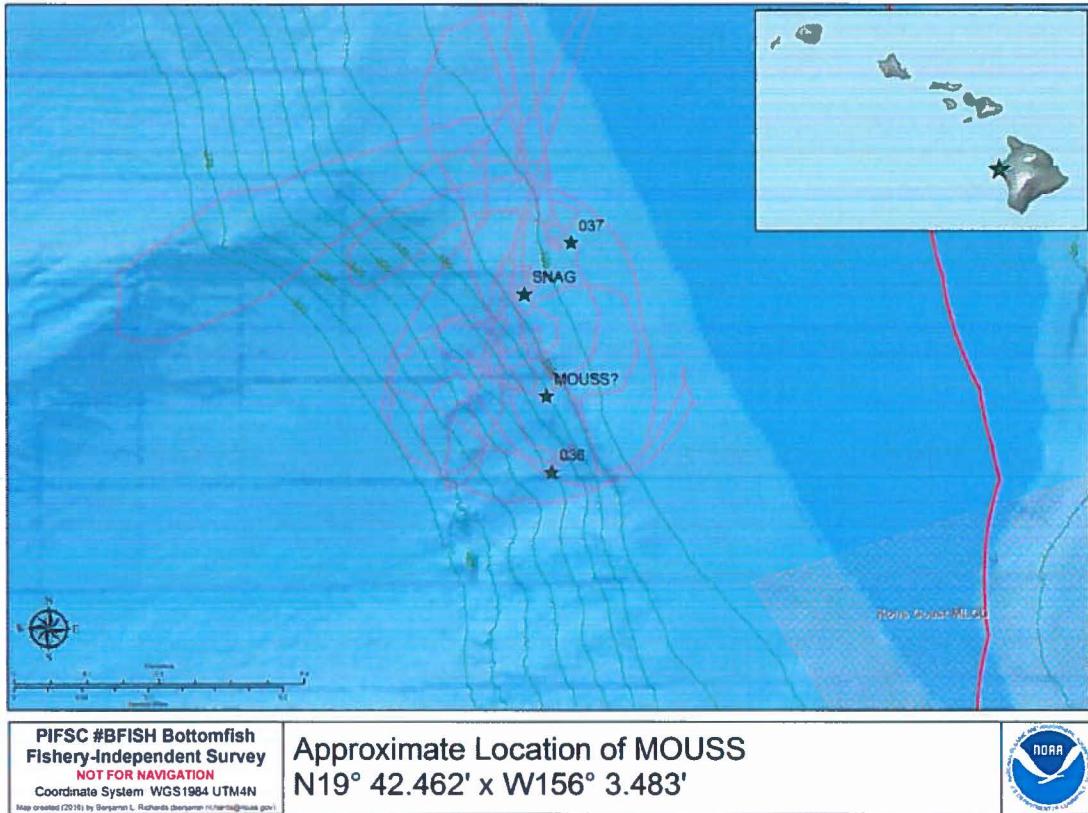
On the morning of October 29, 2016, a MOUSS team including personnel involved in the initial recovery attempt as well as the most experienced coxswains and MOUSS handlers returned to the site and attempted to recover the MOUSS unit using a "line pinching" grappling hook (Figure 2). After two unsuccessful hours, the team aborted their recovery attempt. At present, the MOUSS is located in the vicinity of N19° 42.462' x W156° 3.483' at a depth of 90 – 140 meters (Figure 3).

Figure 3. Approximate location of the MOUSS camera system including the deployment location (036) and the location where the surface line appeared to be snagged on the bottom. The track of the survey vessel Rubber Duck during the recovery attempt is shown in purple.

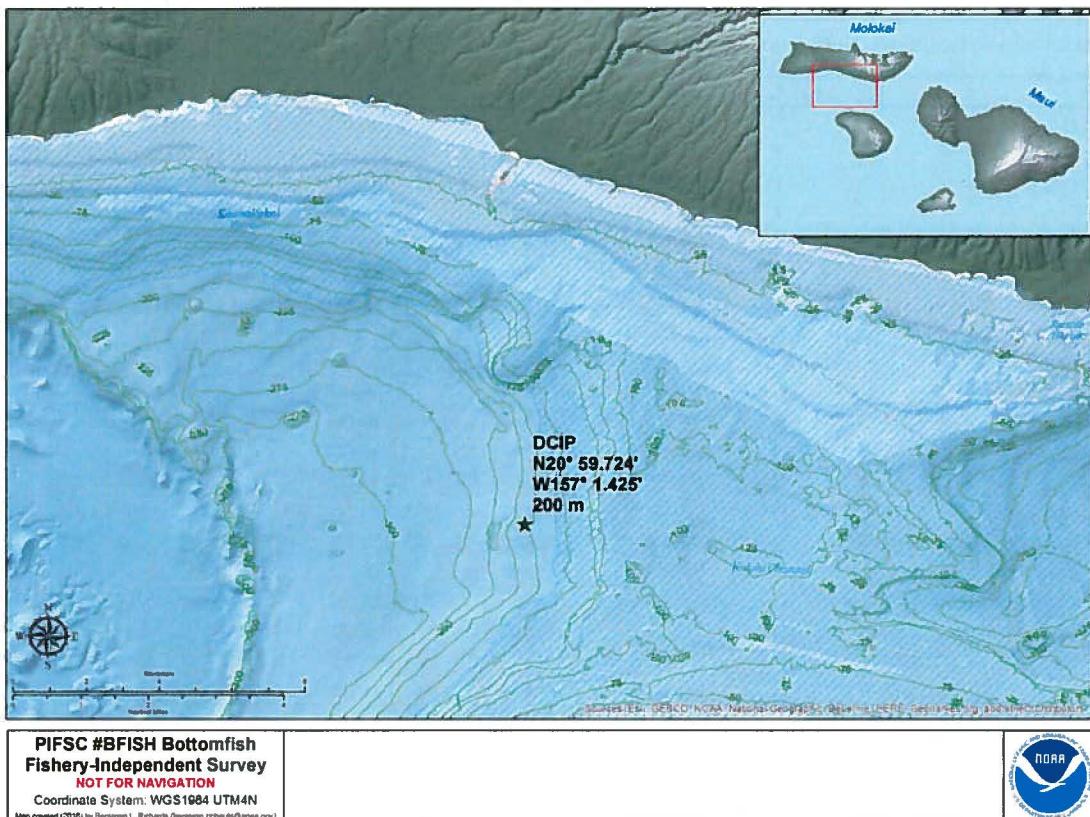
On November 3, 2016 at 10:58 am HST, the PIFSC Drop Camera Instrument Package (DCIP) (Table 1) became entangled in the propellers and or rudders of the NOAA Ship Oscar Elton Sette (OES) and was lost. The approximate location of this loss was $20^{\circ} 59.724' \times 157^{\circ} 01.425'$ in approximately 200 meters of water (Figure 1).

Figure 1 A map showing the approximate location of the Drop Camera Instrument Package (DCIP) following loss during research project SE1607 aboard NOAA Ship Oscar Elton Sette. The DCIP remains south of the island of Molokai in approximately 200 meters of water at N $20^{\circ} 59.724'$ x W $157^{\circ} 01.425'$.

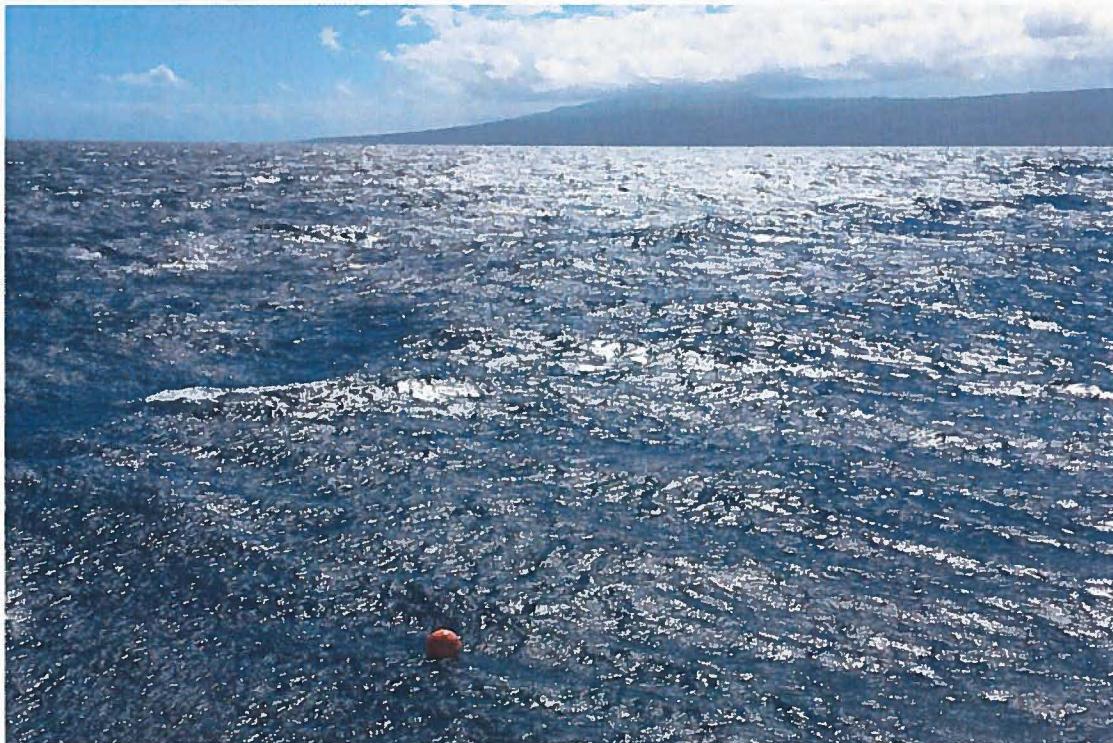
Prior to the incident, the OES was engaged in a routine recovery of the DCIP. Conditions were within normal operating limits with winds at 25 knots, but seas at only 3 feet due to the lee effect of the island of Molokai. The DCIP acoustic release was triggered at 10:42am HST and the DCIP was sighted at the surface at 10:48am HST. The OES approached the DCIP for recovery but was not able to get within grappling range during the first approach. The OES began to fall off the wind to starboard and the helmsman began backing down towards the DCIP to bring it alongside the port quarter. This brought the DCIP within grappling reach and the deck department tossed the grapple and got a good hook on the DCIP surface float line, per standard protocol. The line handler then began walking the DCIP forward toward the port side longline pit. As he was walking forward, he felt a tug and the line began to pull through his hands toward the stern. Personnel on the OES fantail heard multiple "thunk" sounds coming from the port side stern and the Operations Officer called an "all stop" on propulsion. The ship remained dead in the water while the situation was assessed. A single DCIP subsurface float was noted on the surface, floating freely off the stern of the ship (Figure 2).

Figure 2 DCIP sub-surface float on the surface off the stern of the NOAA Ship Oscar Elton Sette following loss of DCIP

1. Ensure helmsman has appropriate qualifications and experience to perform recovery given wind and sea conditions at time of recovery.
2. When possible, secure recovery-side propulsion during recovery.
3. Do not attempt to recover DCIP aft of the cut-out doors.
4. Bring DCIP down the recovery-side of the ship. If recovery is not possible, reposition for a second attempt. Do not back down on gear.
5. Maximum winds speed for DCIP operations should be set at 25 knots.

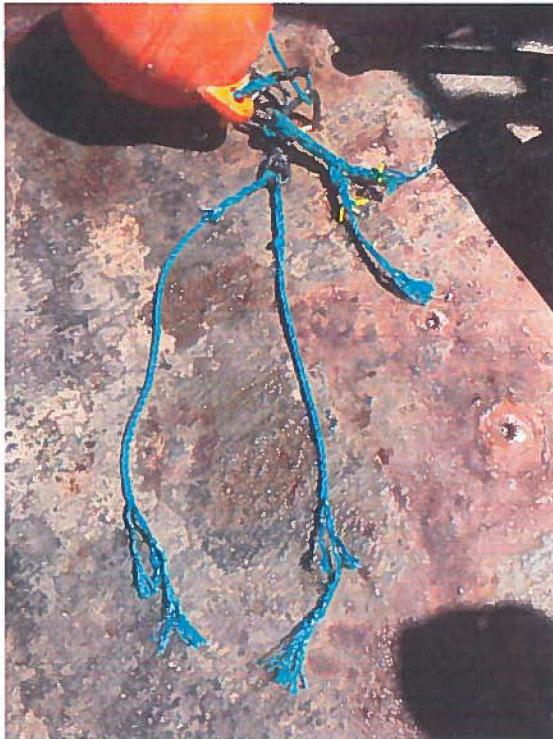
Figure 3 DCIP sub-surface float and frame bridle.

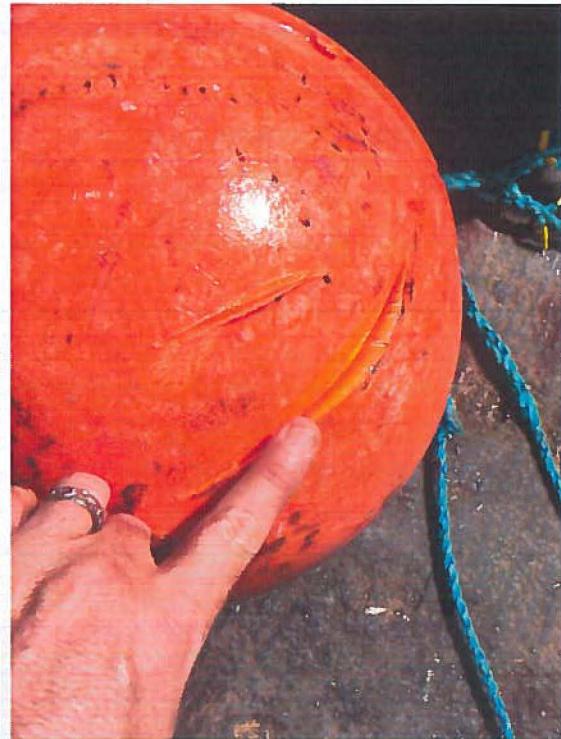
Following inspection of the OES, efforts were made to recover the DCIP sub-surface buoys sighted at the surface. One sub-surface float was recovered with remaining pieces of the frame bridle lines and hardware (Figure 3). The sub-surface float showed cut marks consistent with propeller strikes (Figure 4).

Figure 4 DCIP sub-surface float showing evidence of propeller strike.
