Okeanos Explorer ROV Dive Summary: EX-19-04, Dive 02, July 27, 2019

Dive Purpose	Test and demonstrate integration of Kraken SeaVision® System
--------------	--

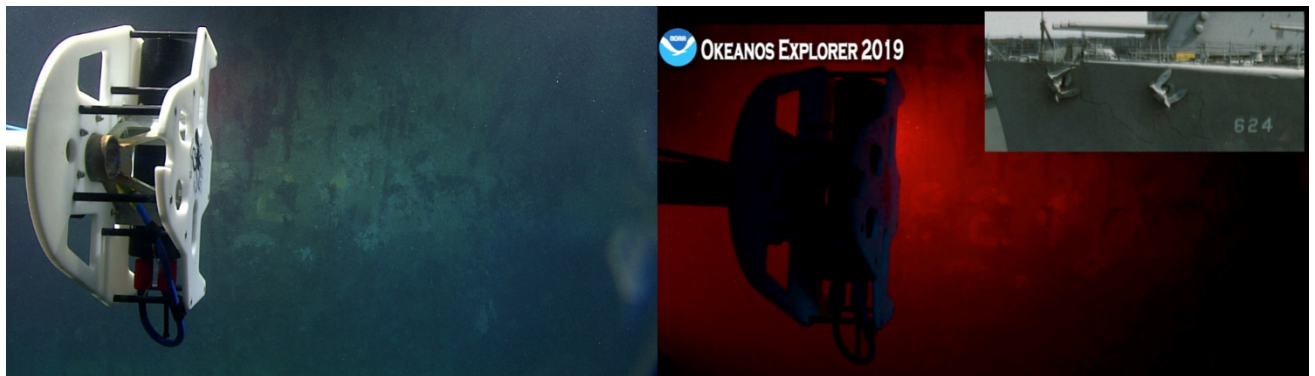
Images from ROV *Deep Discoverer* looking at the ship's number on the starboard bow of the wreck. Inset shows a historic photo of the ship port side, with a view of the hull numbers. The digits "6," "2," and "4" are clearly visible. Combined with the position of the wreck and the features found while exploring it, the team was able to confirm that the wreck is indeed the USS *Baldwin*.

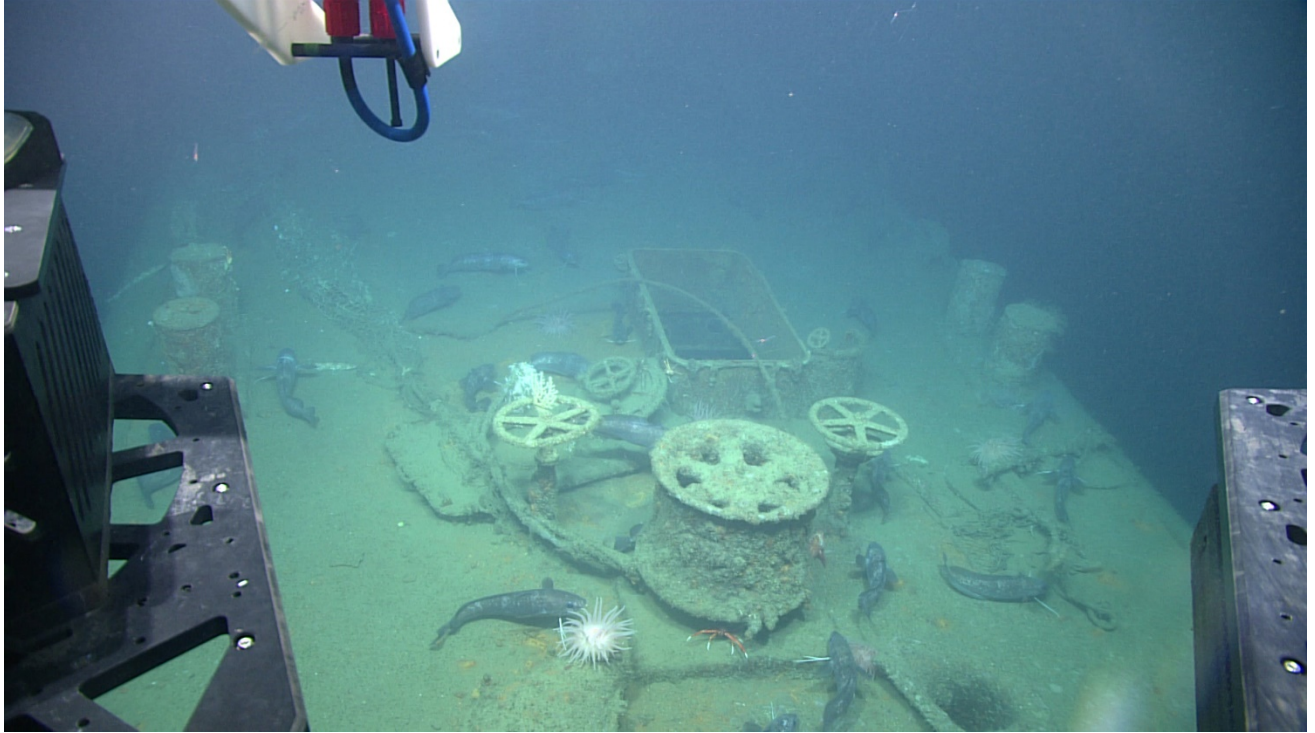
Image from ROV *Deep Discoverer* looking down at a capstan on the forward deck, with the prow towards the bottom of the image. Note the hake fish aggregated on the ship

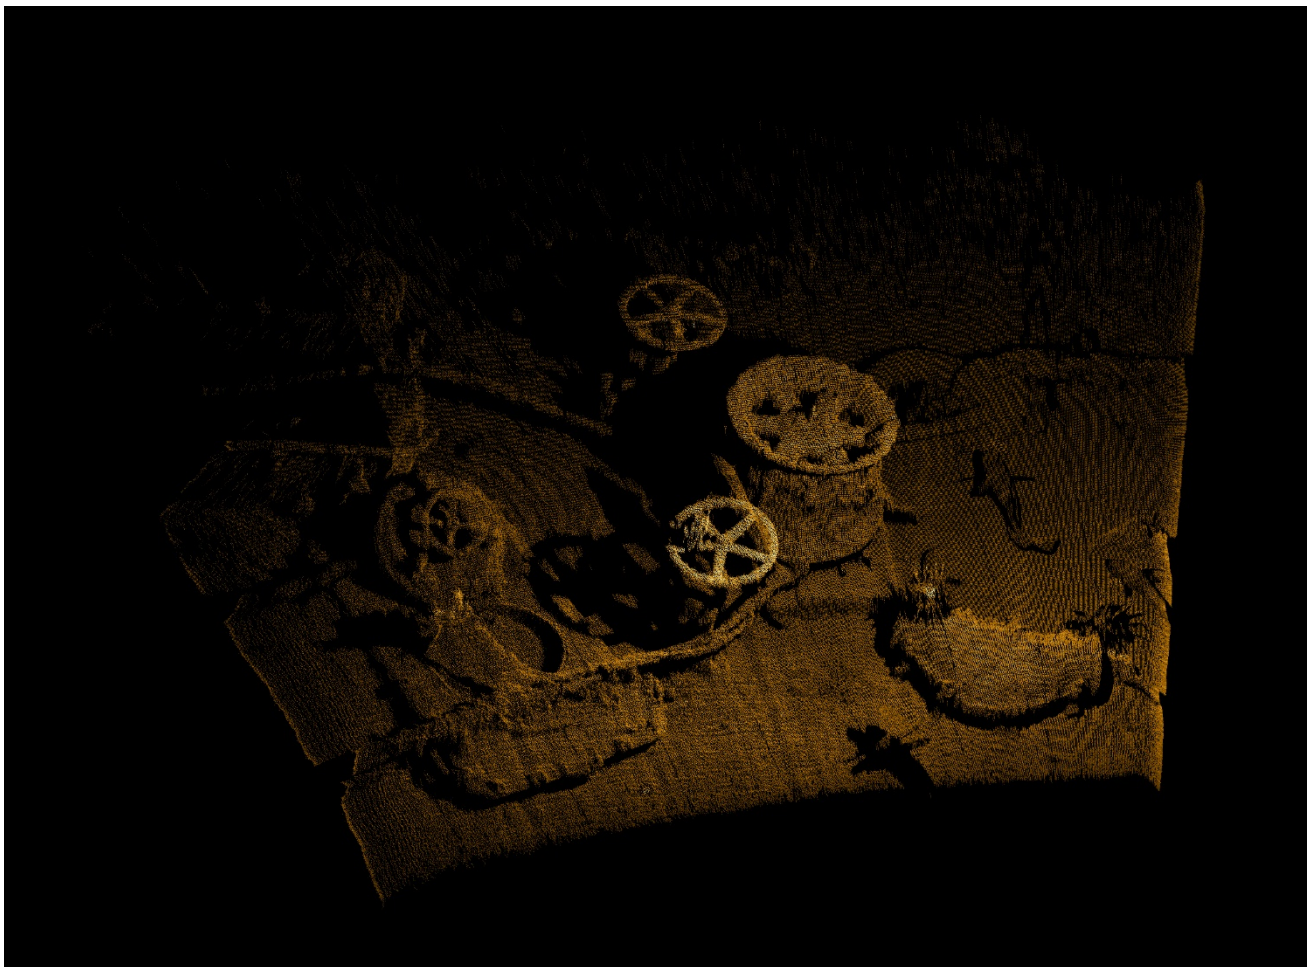
3D high-resolution point-cloud rendering of the forward deck and capstan.

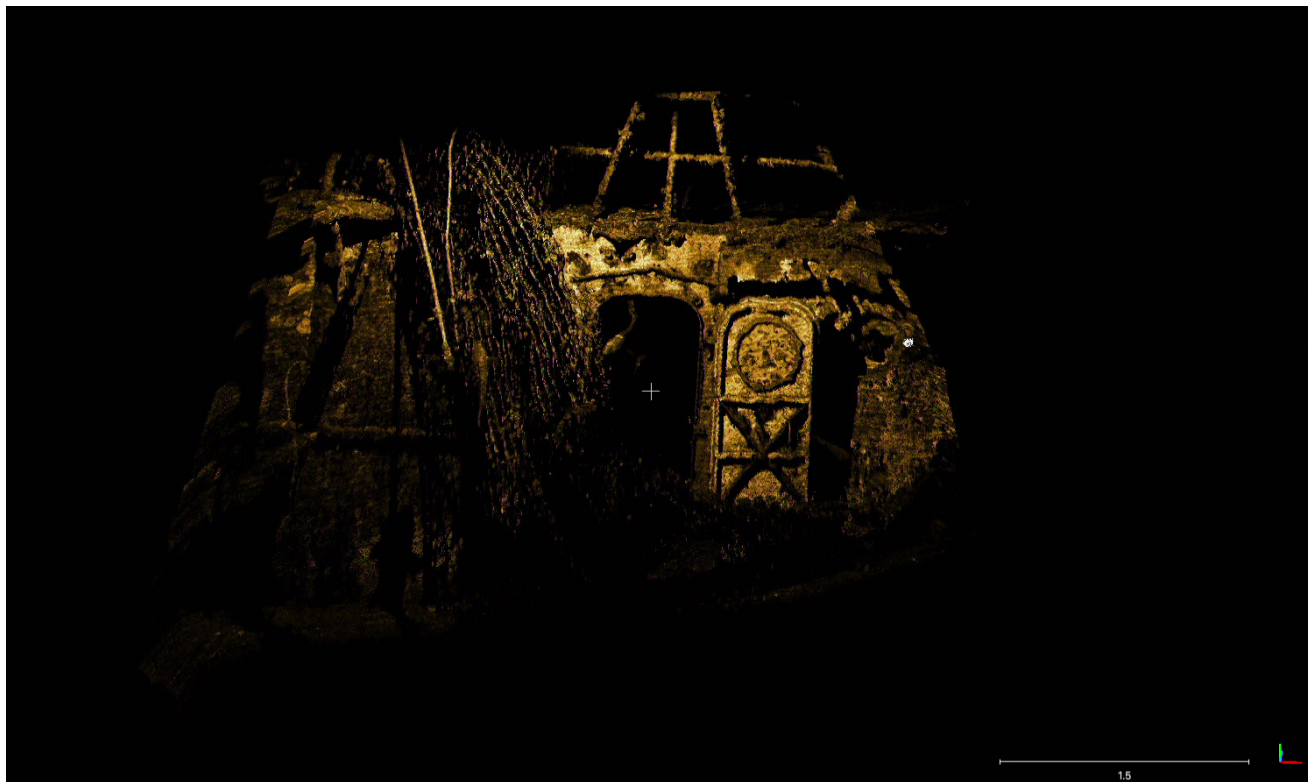
3D scan of the starboard flybridge with the open door into the bridge. The scan shows one of the many fishing nets entangled in the wreck.

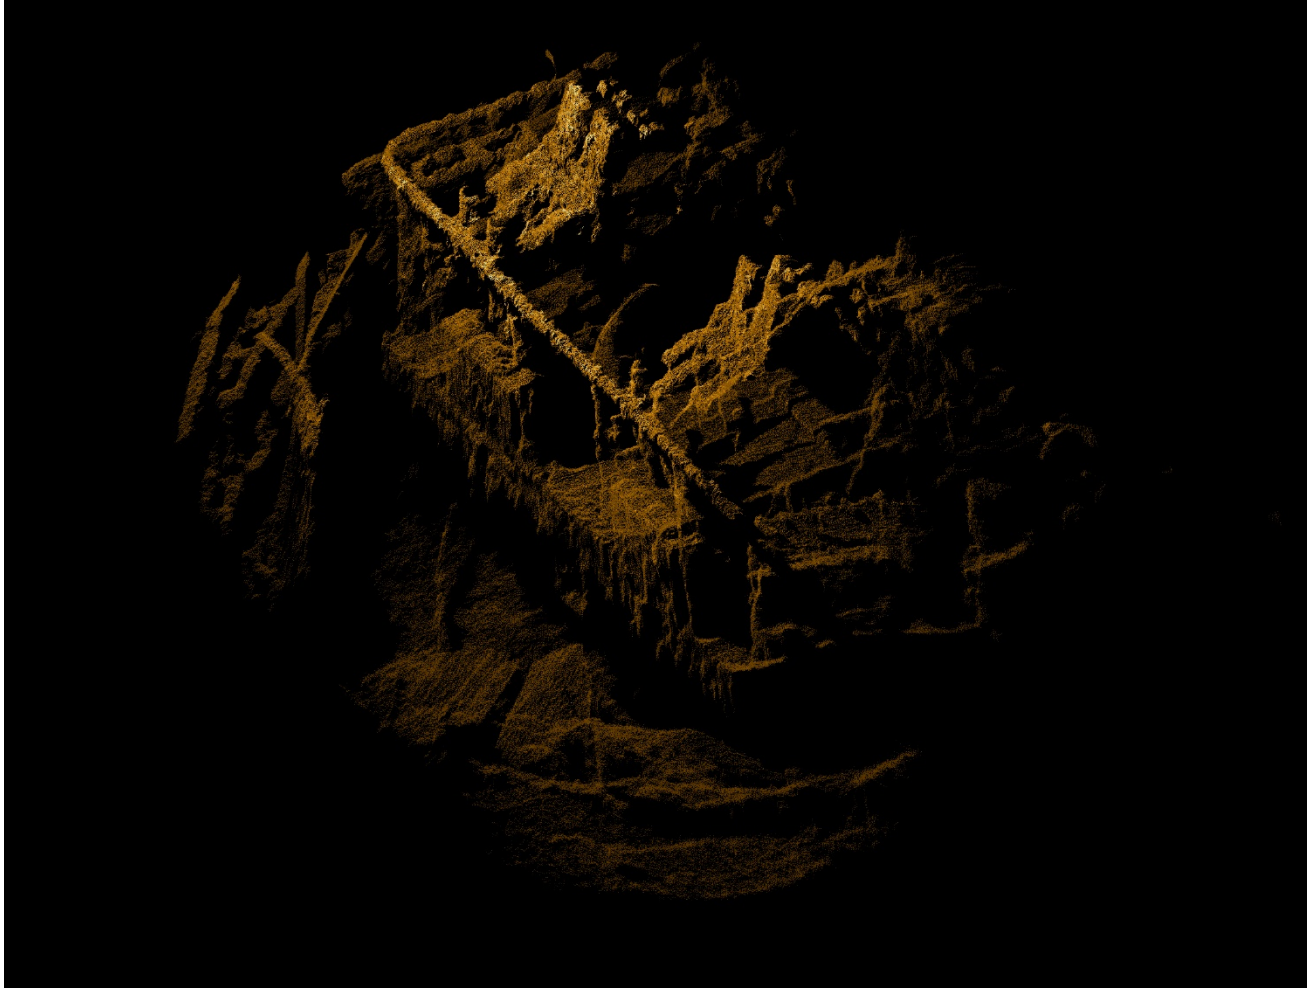
3D high-resolution point cloud of the port after 40 millimeter anti-aircraft Bofors gun bases, the barrel breaches were removed while in reserve status. Laser scanning was completed from the starboard side of the Baldwin.

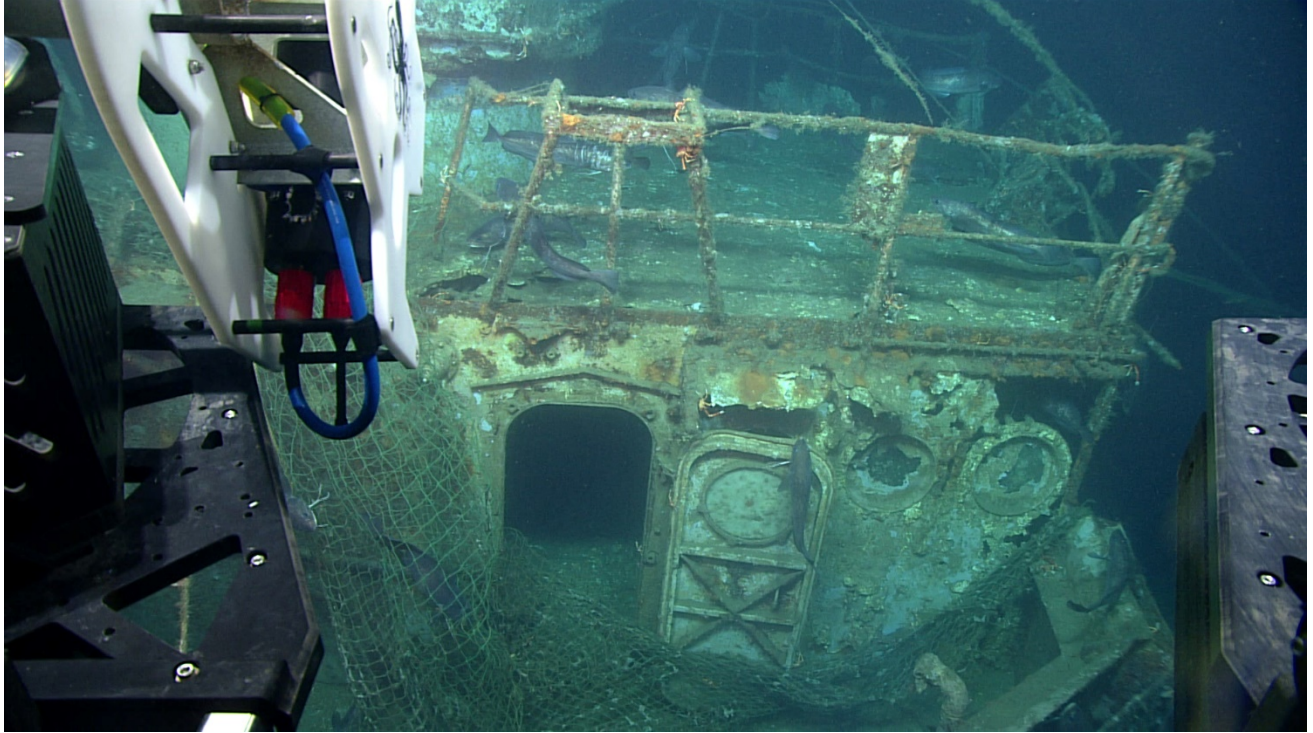
Open hatch and derelict fishing gear.
