Service Assessment

Super Typhoon Paka December 2 thru 21, 1997

U.S. DEPARTMENT OF COMMERCE
National Oceanic and Atmospheric Administration
National Weather Service
Honolulu, Hawaii

June 1998

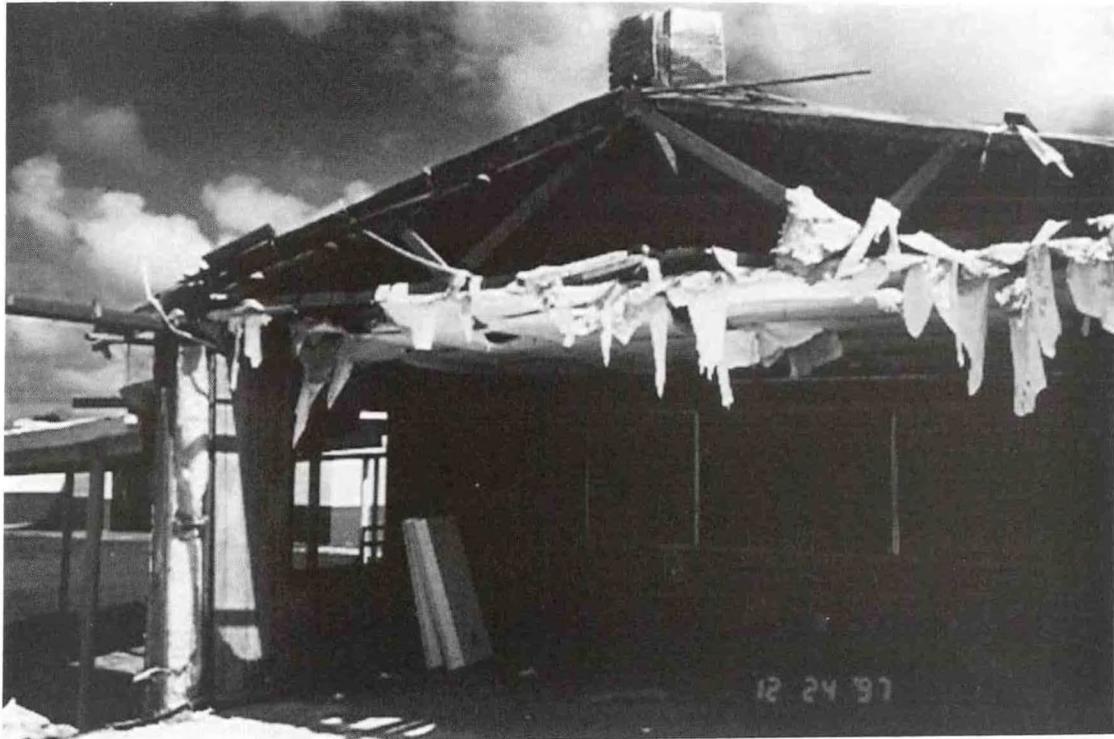
Figure 6: This destroyed school room was not an engineered structure and was attached to the concrete slab only by some small nails. *

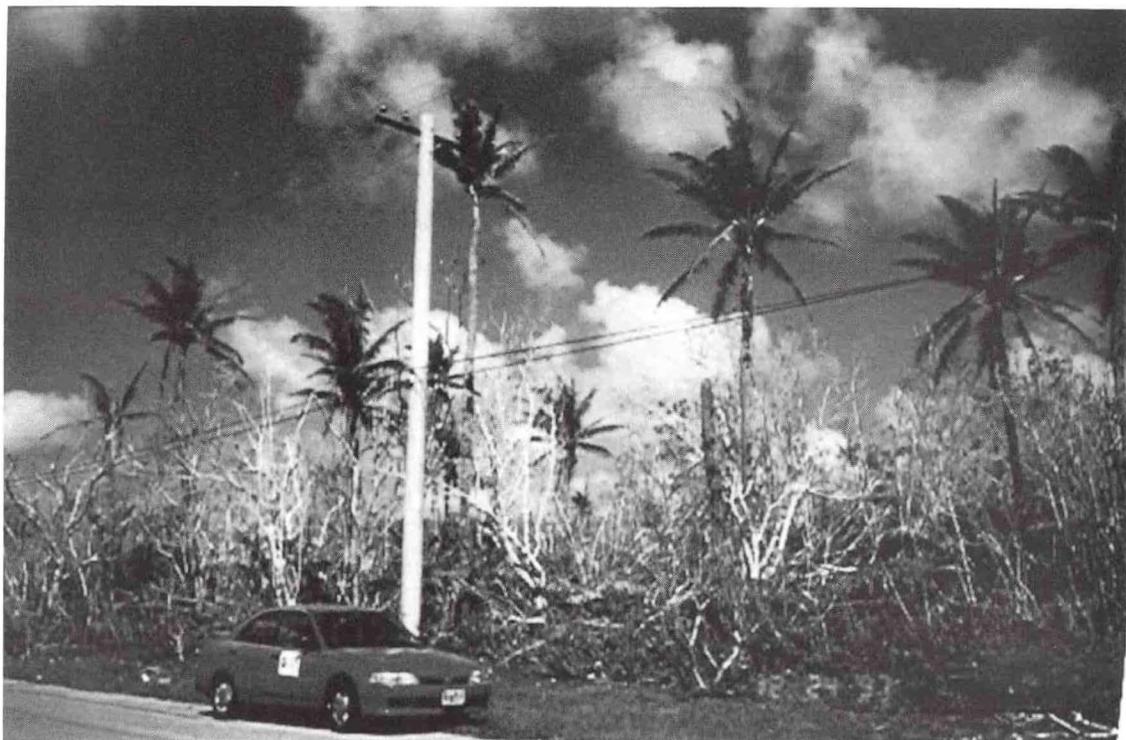
Figure 7: Just southwest of Andersen Air Force Base the concrete poles and the majority of palm trees, especially those trees away from the coast, handled Paka well. Leafy vegetation was most often denuded. *

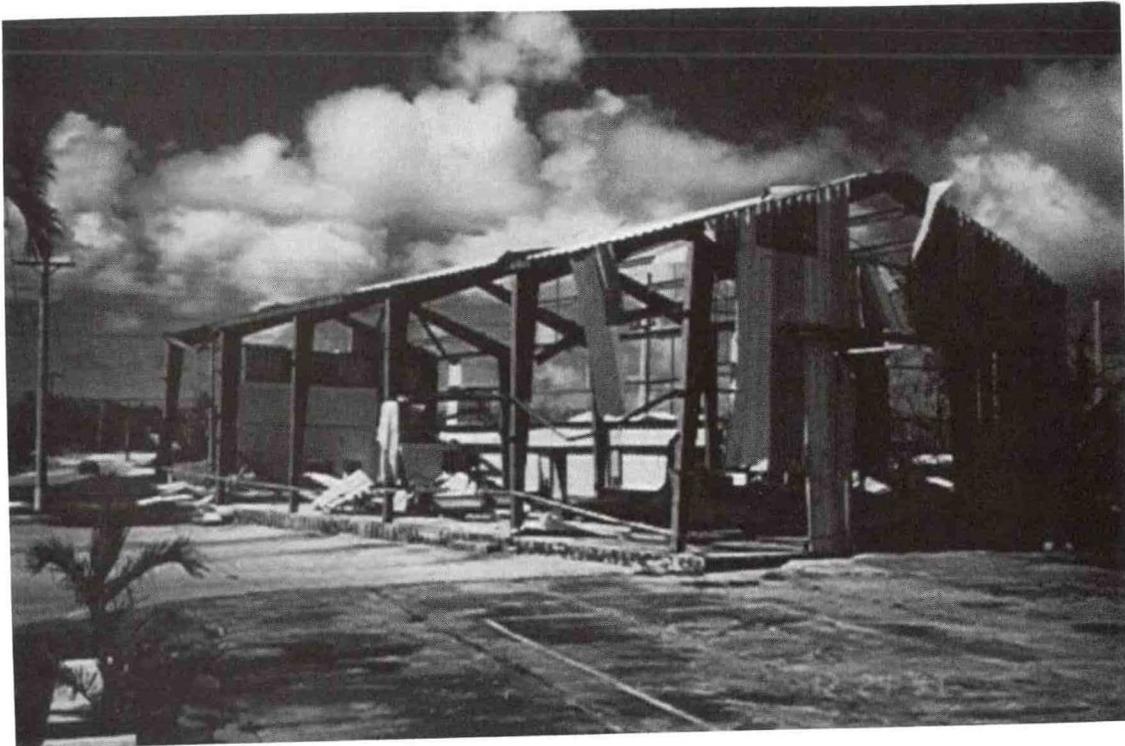
Fig. 8: A devastated warehouse that was first compromised by flying debris. Once the wind entered the building the sheet metal was easily blown out, and away from the support beams.*

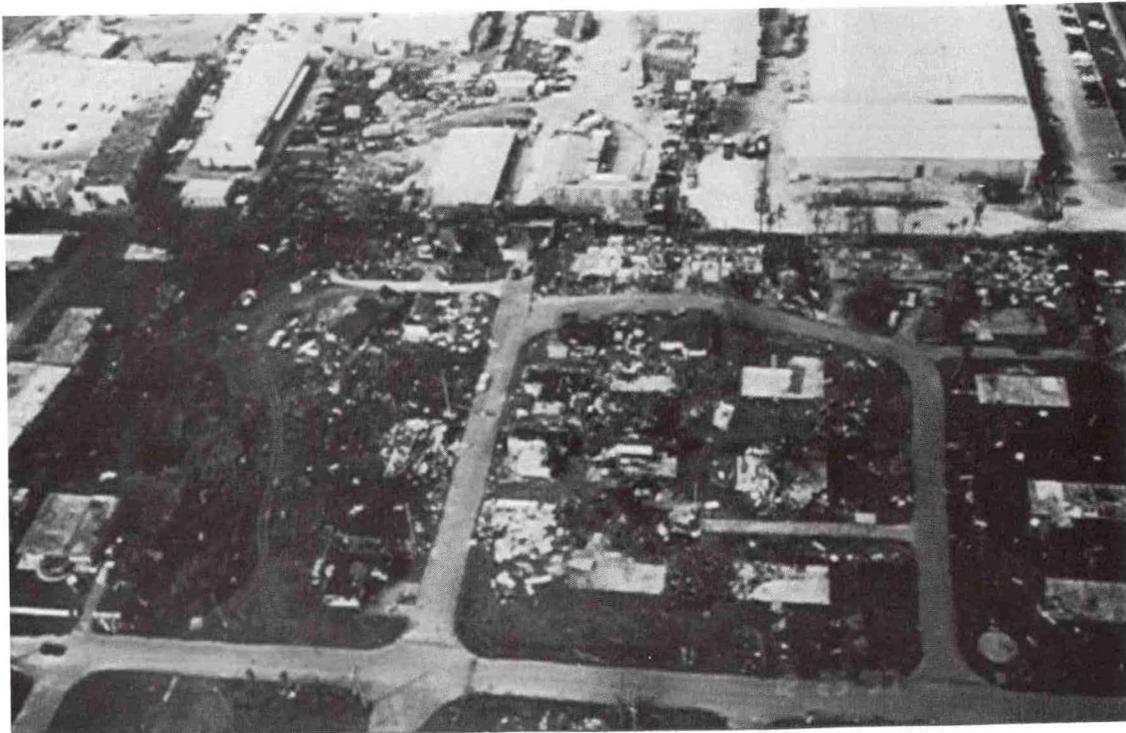
Fig. 9: This aerial view demonstrates that newer, engineered structures escaped with minor cosmetic damage but older wood buildings suffered greatly. This area is between Apra Harbor and Tumon.*

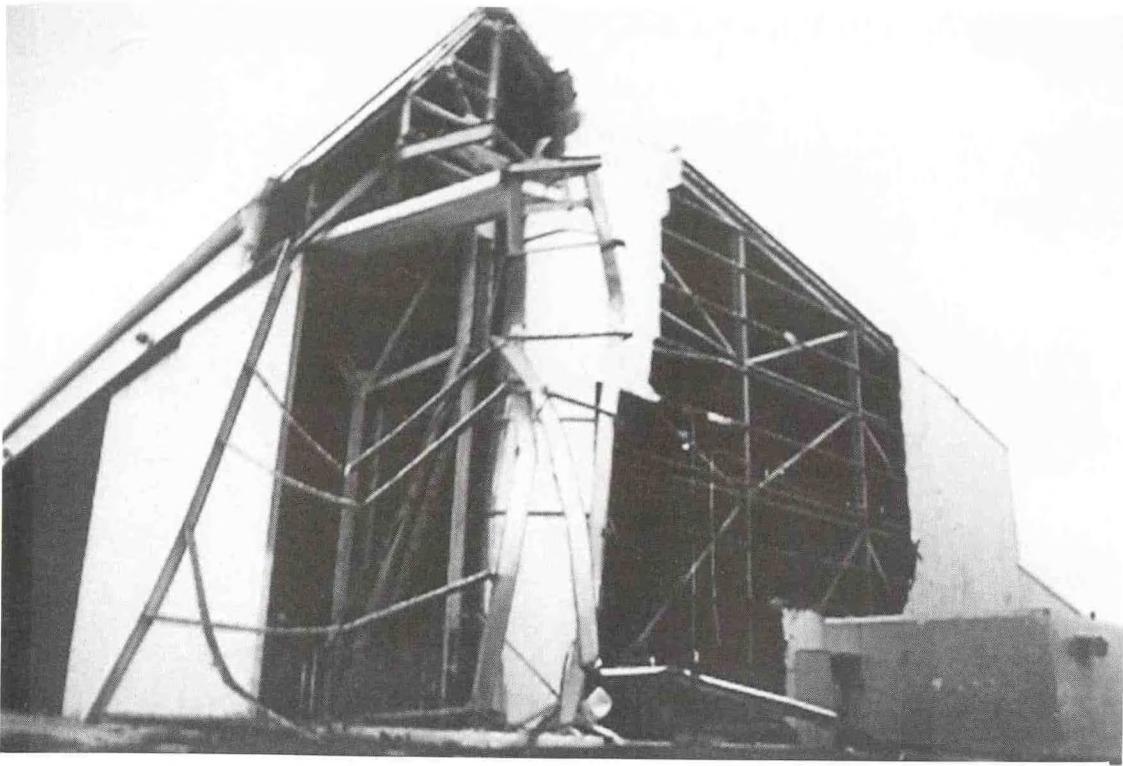
Figure 10: This damaged hangar at Andersen Air Force base is well exposed to the wind and appears to have been damaged when the winds came from the southwest. **

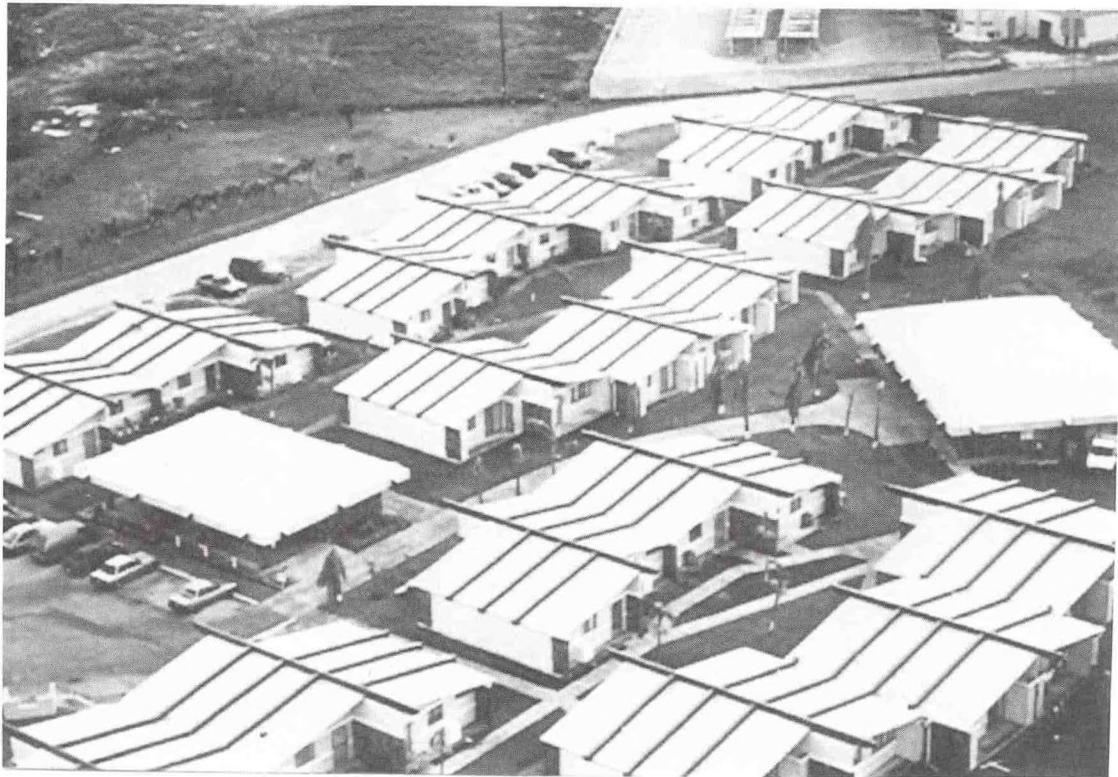
Figure 11: Houses only 100 meters from Tumon Bay, built according to the new building codes, survived the winds with only minor cosmetic damage. **

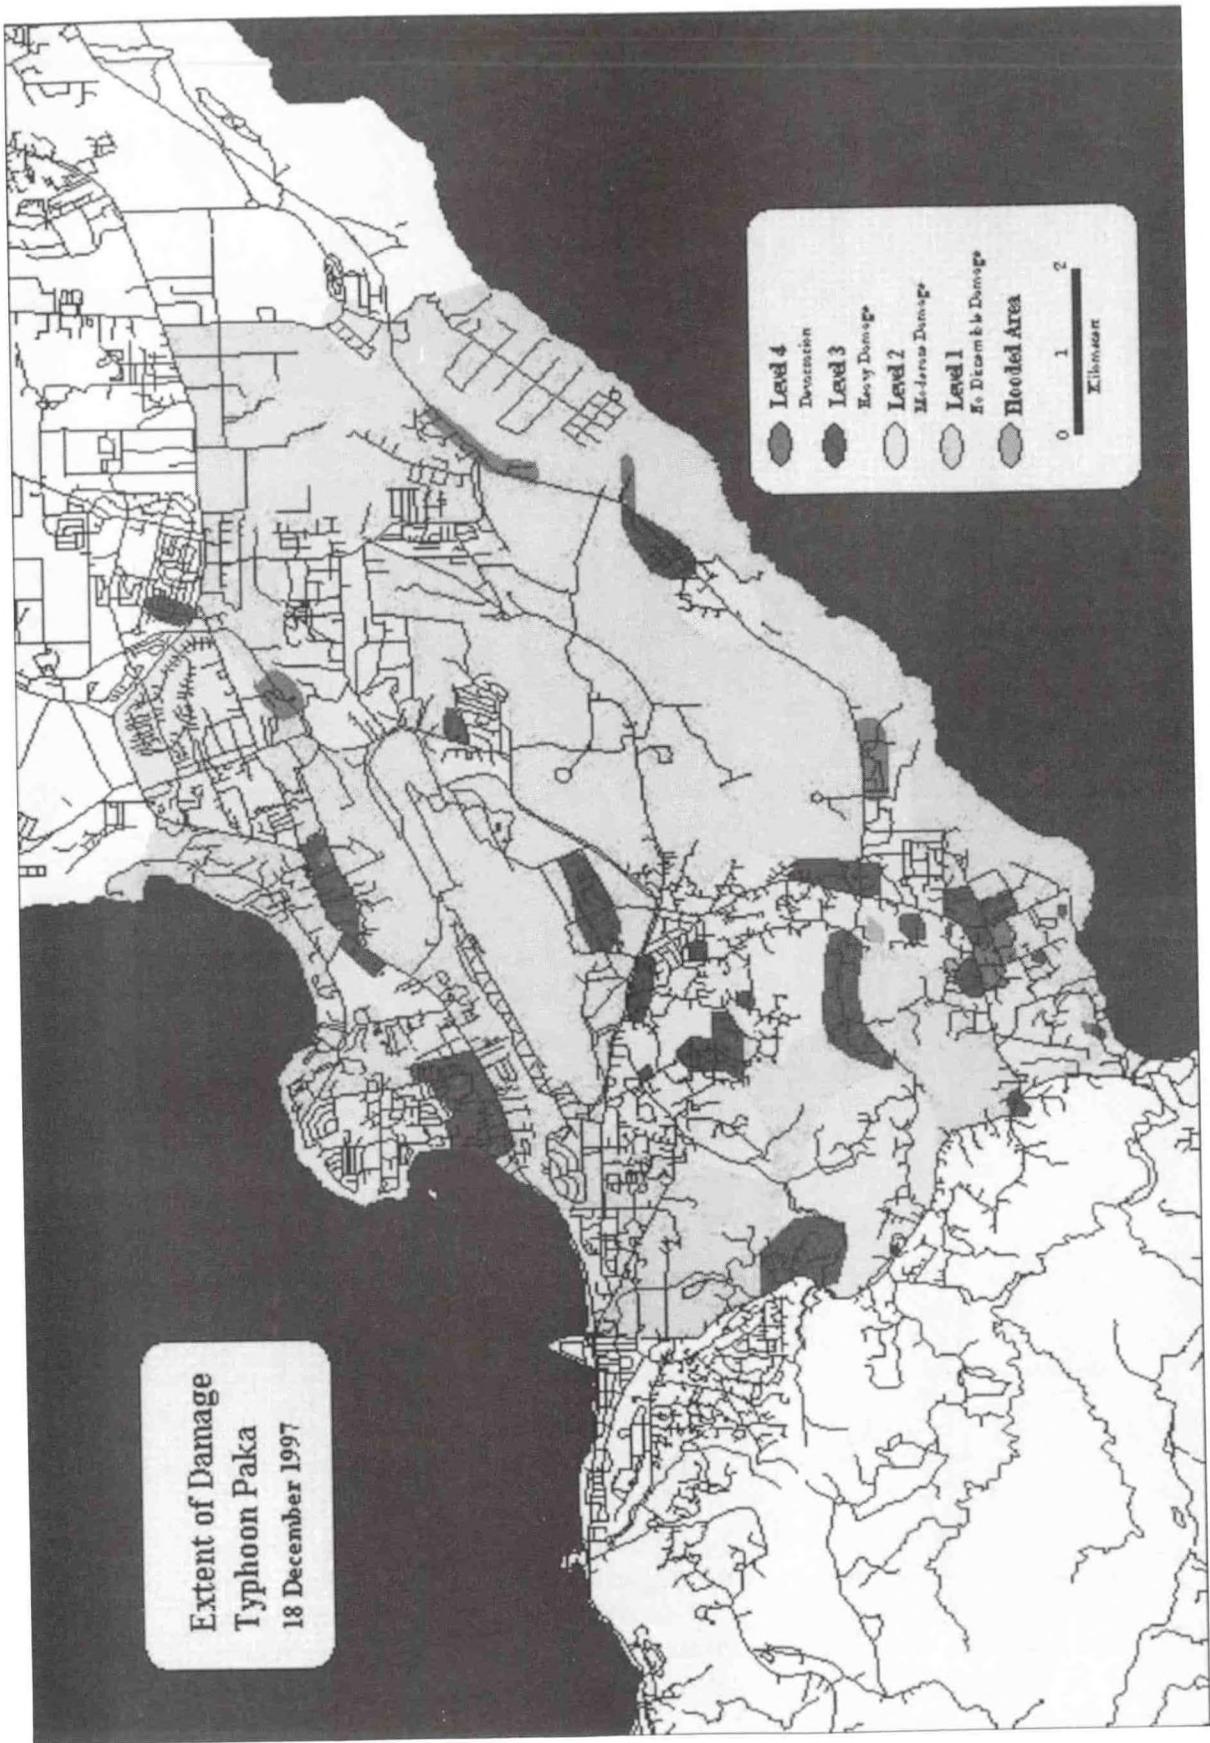
Figure 13: Preliminary Damage Index

Interviews with the public demonstrate that the duration (8-10 hours of greater than 64 kts sustained) of the destructive winds, in conjunction with an evening and night passage, gave them the perception that Paka was the worst of the typhoons in the last 25 years (see Figure 12). This includes Omar (1992) and Pamela (1976). Vegetation damage was impressive due to the duration of the winds and the heavy rains. Damage estimates ranged upward of 600 million U.S. dollars (GOV Guam, Super Typhoon Paka, 1998) (see Figure 13).
