COASTAL EROSION ALONG OCEANSIDE LITTORAL CELL,
SAN DIEGO COUNTY, CALIFORNIA

Gerald G. Kuhn
Geological Research Division
Scripps Institution of Oceanography
University of California, San Diego
La Jolla, California 92093CIRCULATING COPY
Sea Grant Repository

Abstract

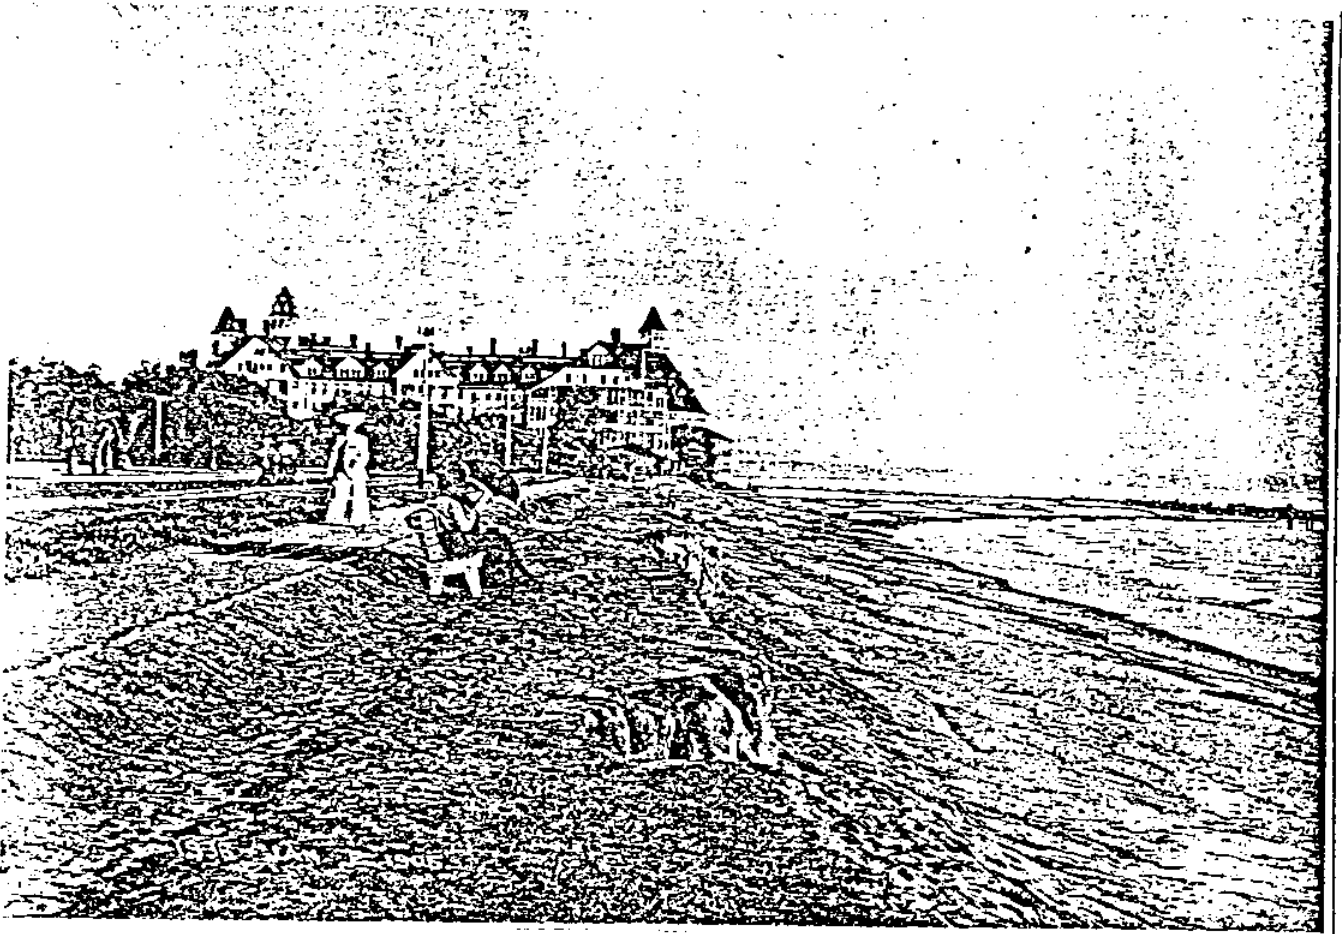
A classic example of this occurred in 1905, affecting the low-lying cliffs at Coronado, San Diego County, California (Figure 2.A) (Shepard and Grant, 1947). This erosion was produced by large waves, but an underlying cause may have been the building of the 7500-ft-long Zuniga jetty the year before along North Island in San Diego Bay. In 1905 wave attack during winter storms produced the disastrous effects seen in Figure 2.B. More than 110 ft of the beach cliff was eroded in March of that year.

Figure 2. A. (Before) View looking south toward the Hotel Del Coronado, San Diego, California. January 2, 1905; photo: U.S. Grant

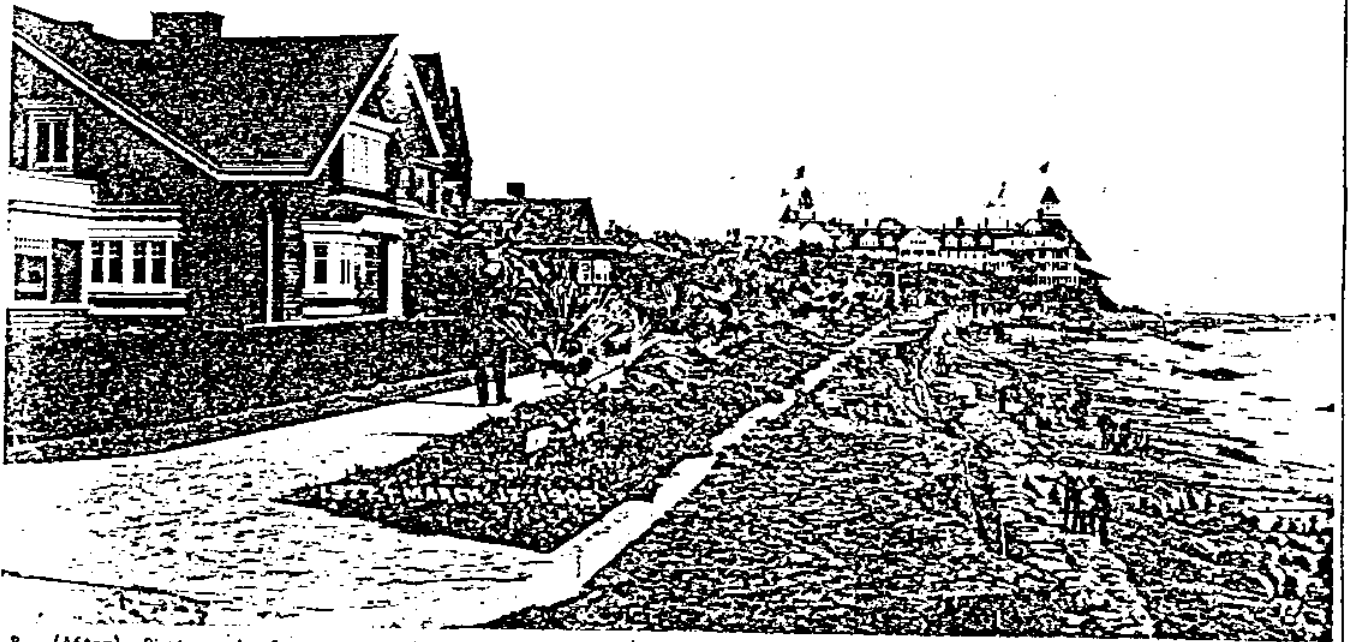
8. (After) Photograph of same area taken March 17, 1905 after severe storms eroded more than 110 ft of beach cliff sediments. 30,000 sandbags were placed north and south of hotel. Photo: U.S. Grant IV.

Note: Ocean Boulevard vanished all the way back to curb in front of homes in photo.

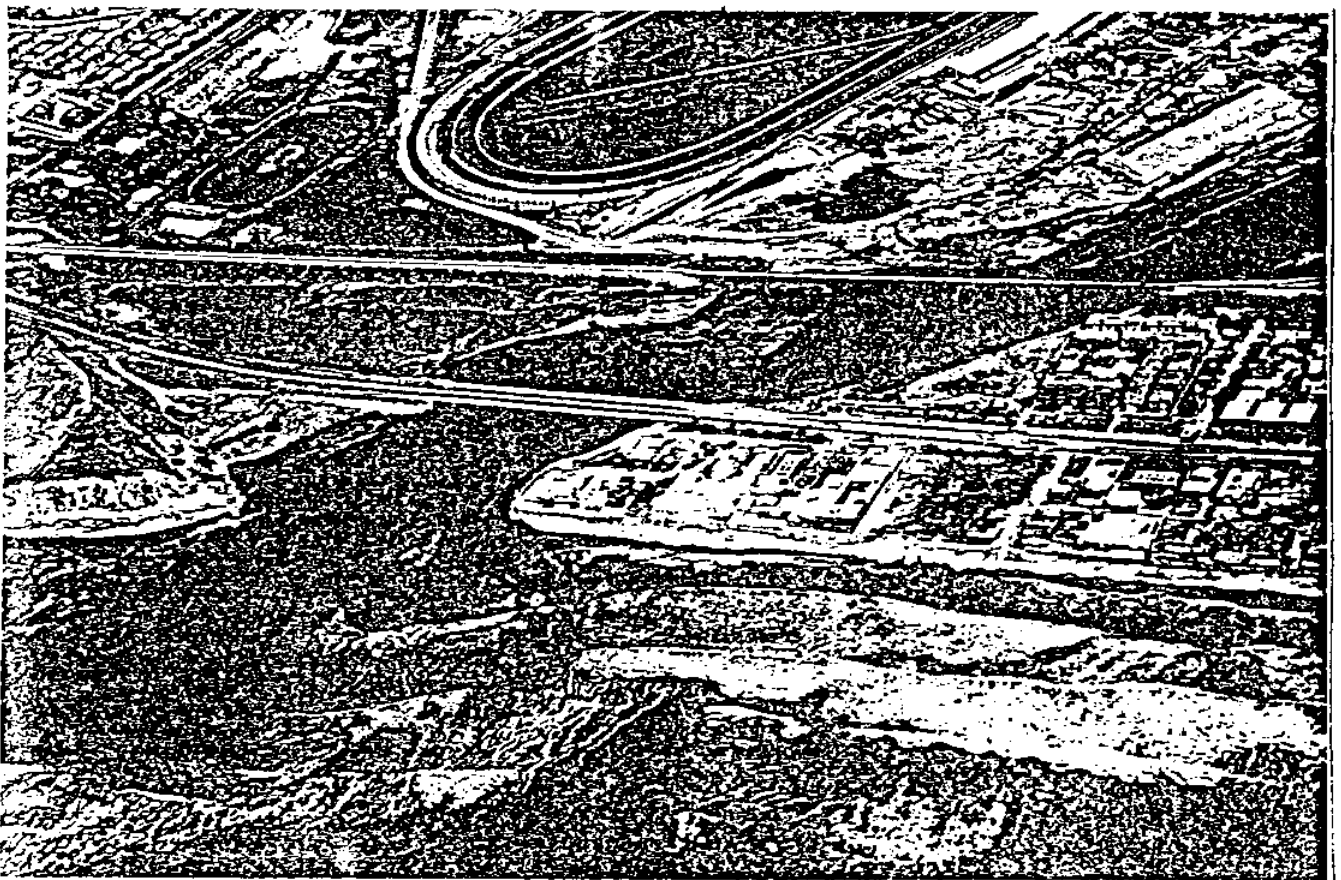
Del Mar. Houses have, in recent years, been constructed directly on the beach sand (Figure 3.A). During the winters of 1978-80 storms at sea, coupled with river flooding, caused erosion of the beach and houses were endangered at Del Mar (Figure 3.B) (Kuhn and Shepard, 1980).

B. 1980. Winter (February) view of same area at Del Mar as in Fig. 3.A. Photo: SIO/OLR - L. Ford. Note: San Dieguito River is open to the sea during a stormy period and beach is being eroded.

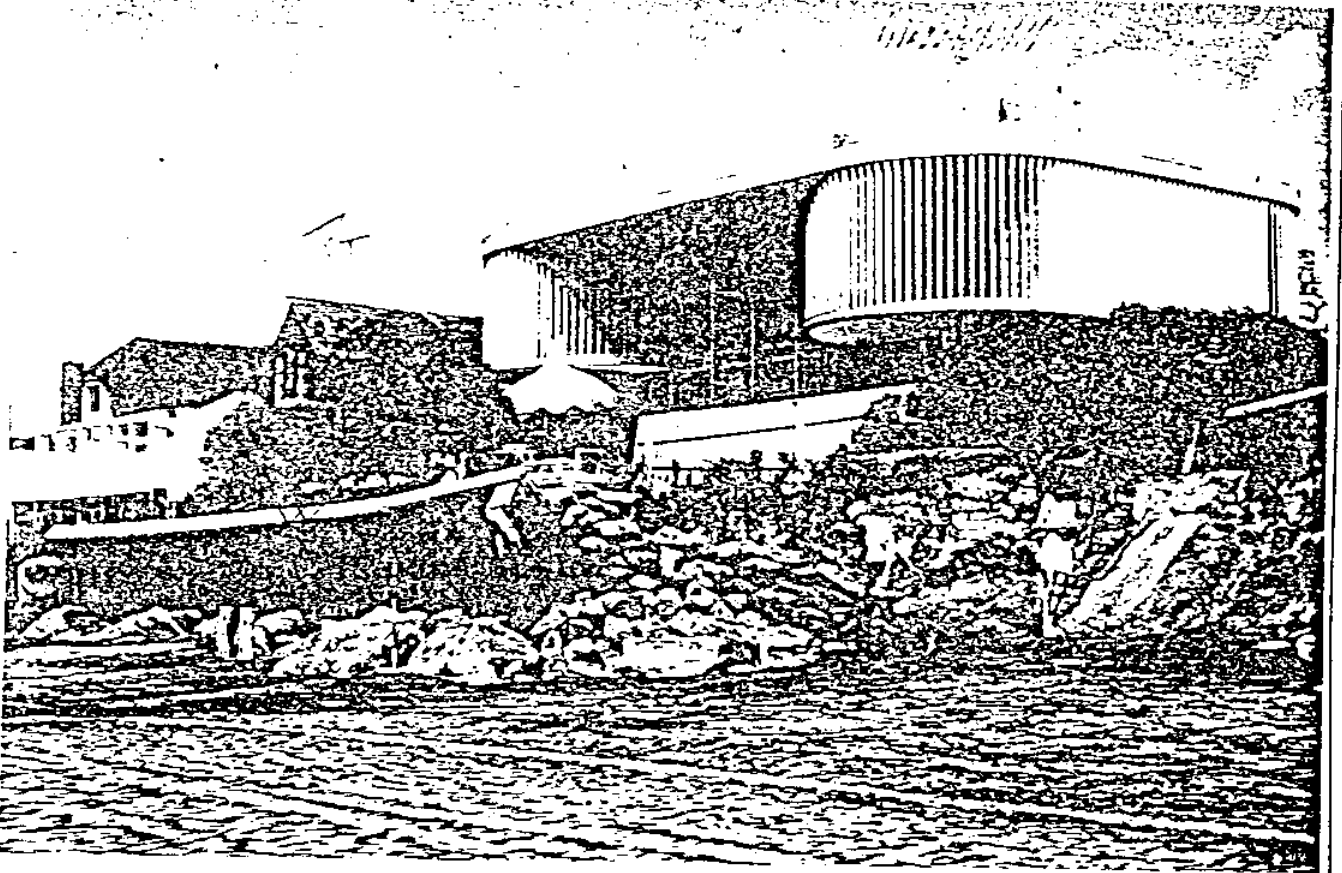
During storms of January through April 1978 and February 1980 beach sand levels dipped to a very low point, storm waves and high tides undercut the slope toe, and unprotected lots located adjacent to artificial projections were eroded landward in a short period of time (Figure 4).

Figure 4. A. March 1978 view of eroded beach at Del Mar, California. Wooden seawall collapsed and adjacent unprotected lots were eroded. Photo courtesy of Sea Grant/G. Kuhn: March 5, 1978.

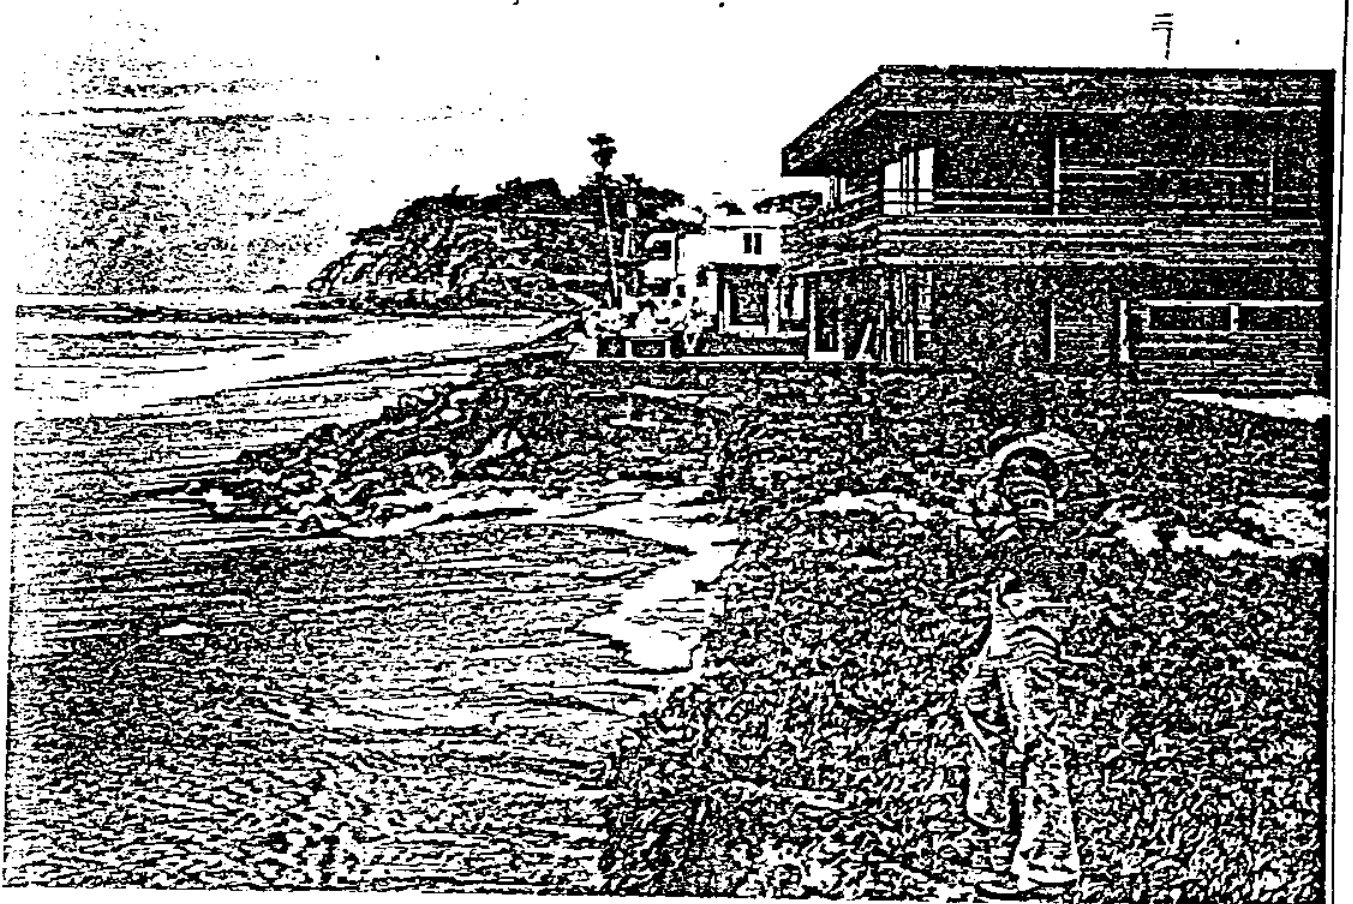
B. February 1980 view of beach erosion at Del Mar, California. Photo: G. Kuhn. Note: Concrete dumped on beach in front of house accelerated erosion of adjacent unprotected lots.

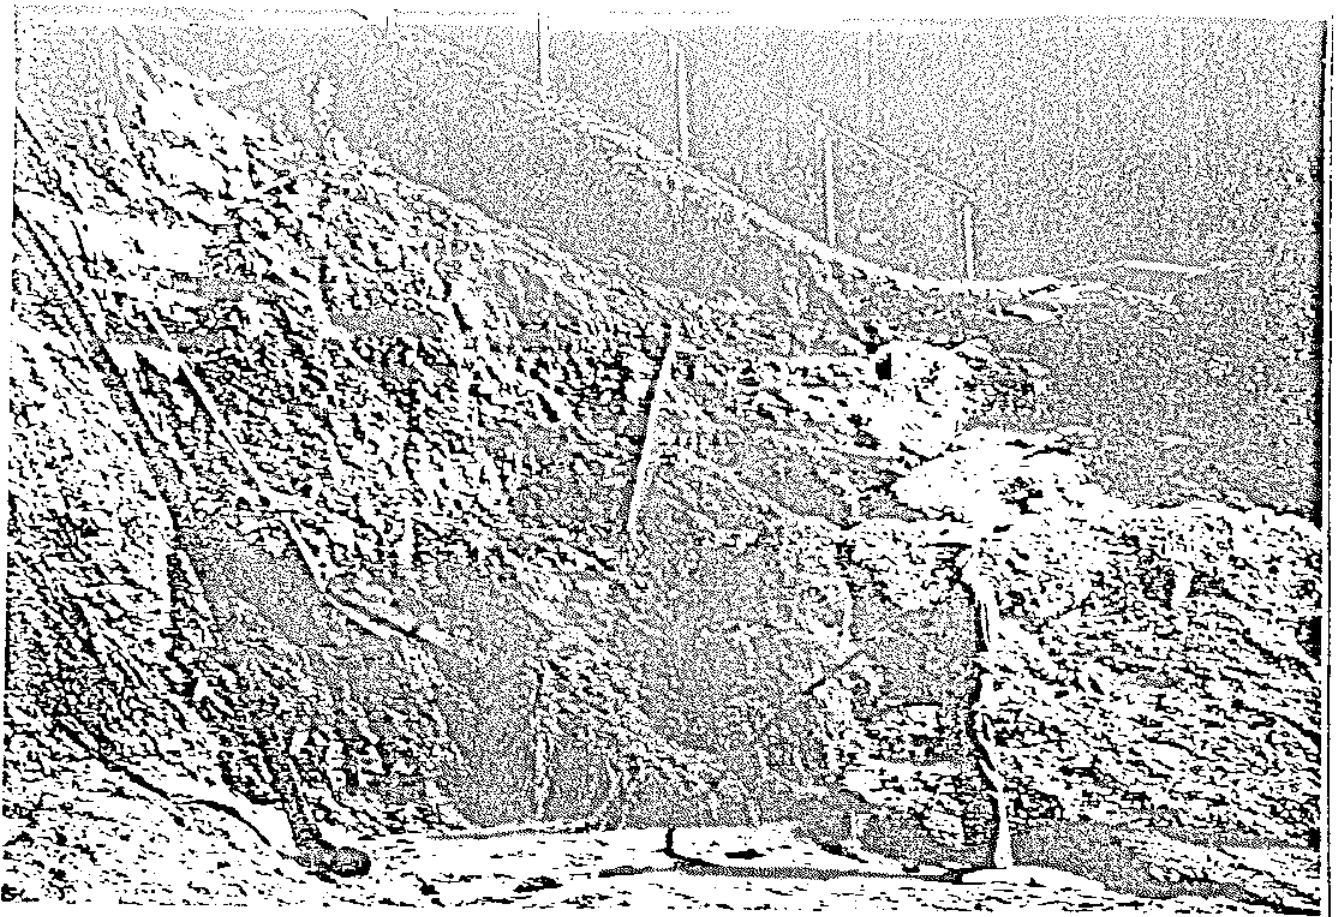
Figure 5. C. March 1978 view of unprotected eroded lot adjacent to lot seen in Figure 5.C. Note: The lot was eroded 12-15 ft landward when waves were focused on the site. Photo: Sea Grant/G. Kuhn, March 14, 1978.

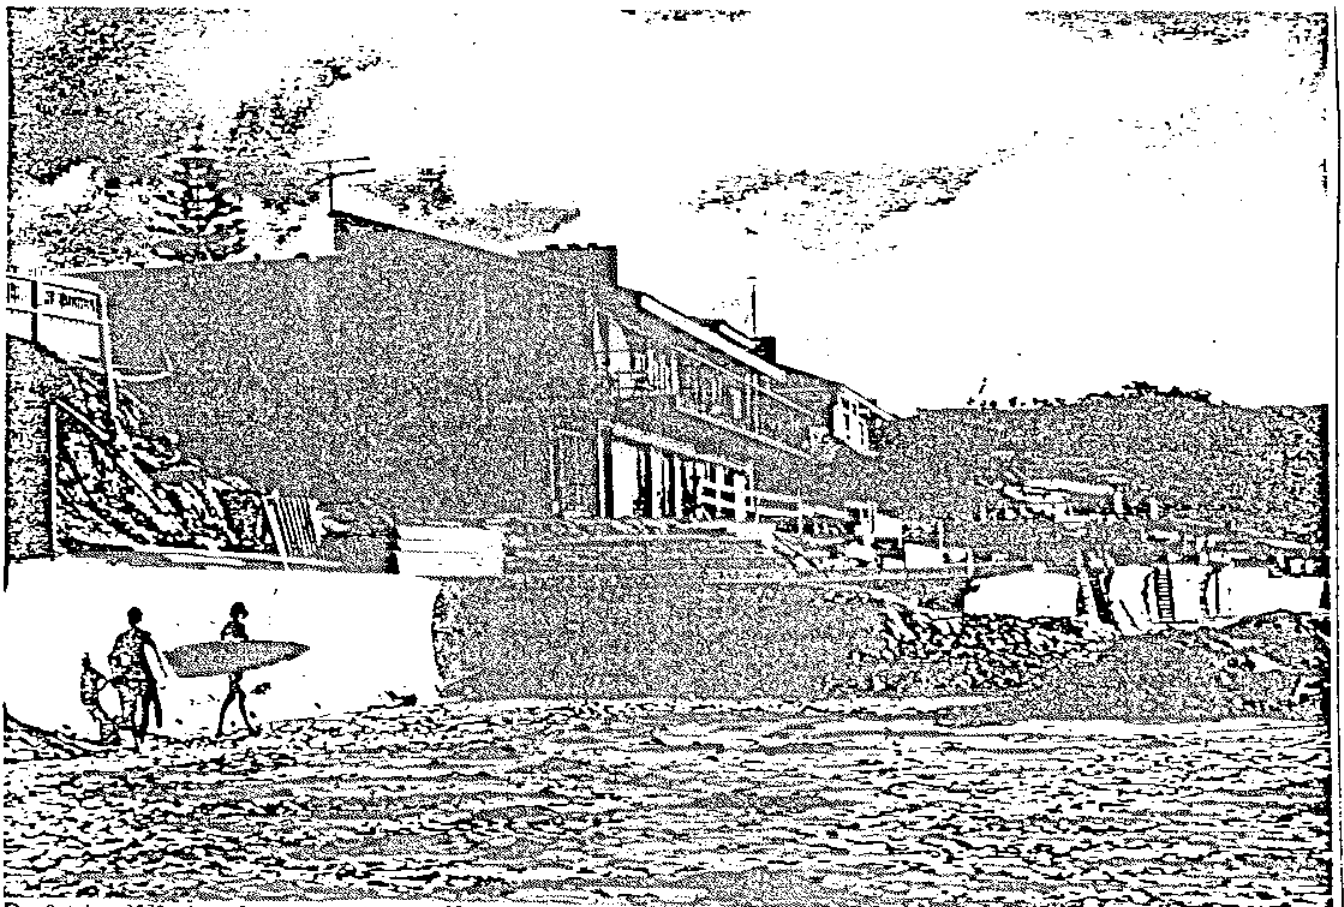
D. October 1979 view of new concrete seawall at same location as Figures 5.B-D. Note: A single, uniformly designed seawall was constructed in front of all houses along this specific area. Photo: Sea Grant/G. Kuhn, October 13, 1979.

storm surf and high perigean spring tides, as well as by rain gullying, erosion again occurred along these cliffs. The residents were threatened with loss of their property and went to desperate measures to stop the erosion. Old car bodies were placed at the slope toe in one case (Figure 5.B) and later riprap was placed at these sites and cemented in place, and temporary seawalls were installed. This was only partially successful as the houses had to be reinforced in various places to prevent their collapse. Adjacent unprotected lots were even more severely eroded during the storm period (Figure 5.C). In 1979 a concrete seawall was constructed along most of this area (Figure 5.D).

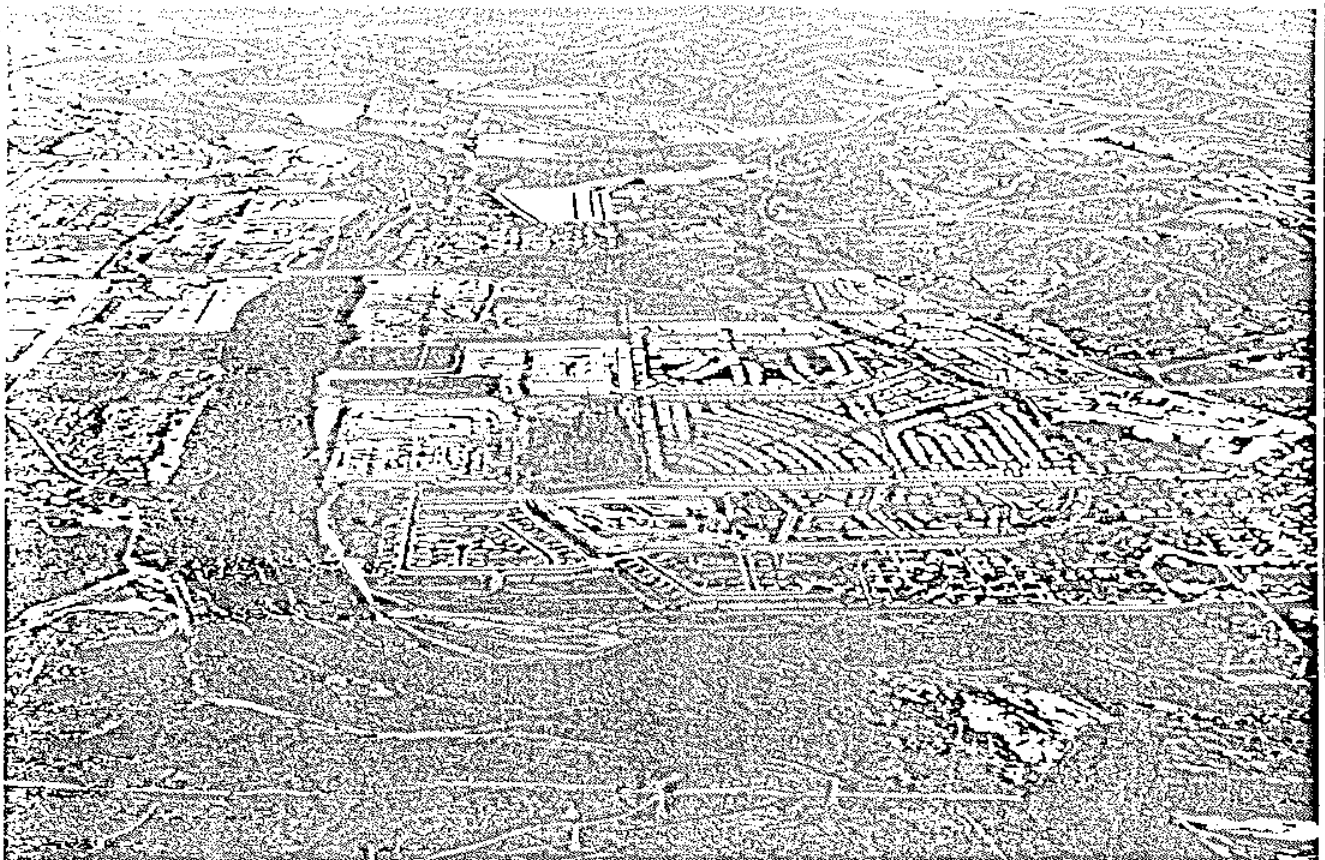
Figure 7. A. Flooding in the San Luis Rey River east of Oceanside, California; February 1980. Note extensive development located directly in the flood plain. Photo: G. Kuhn.

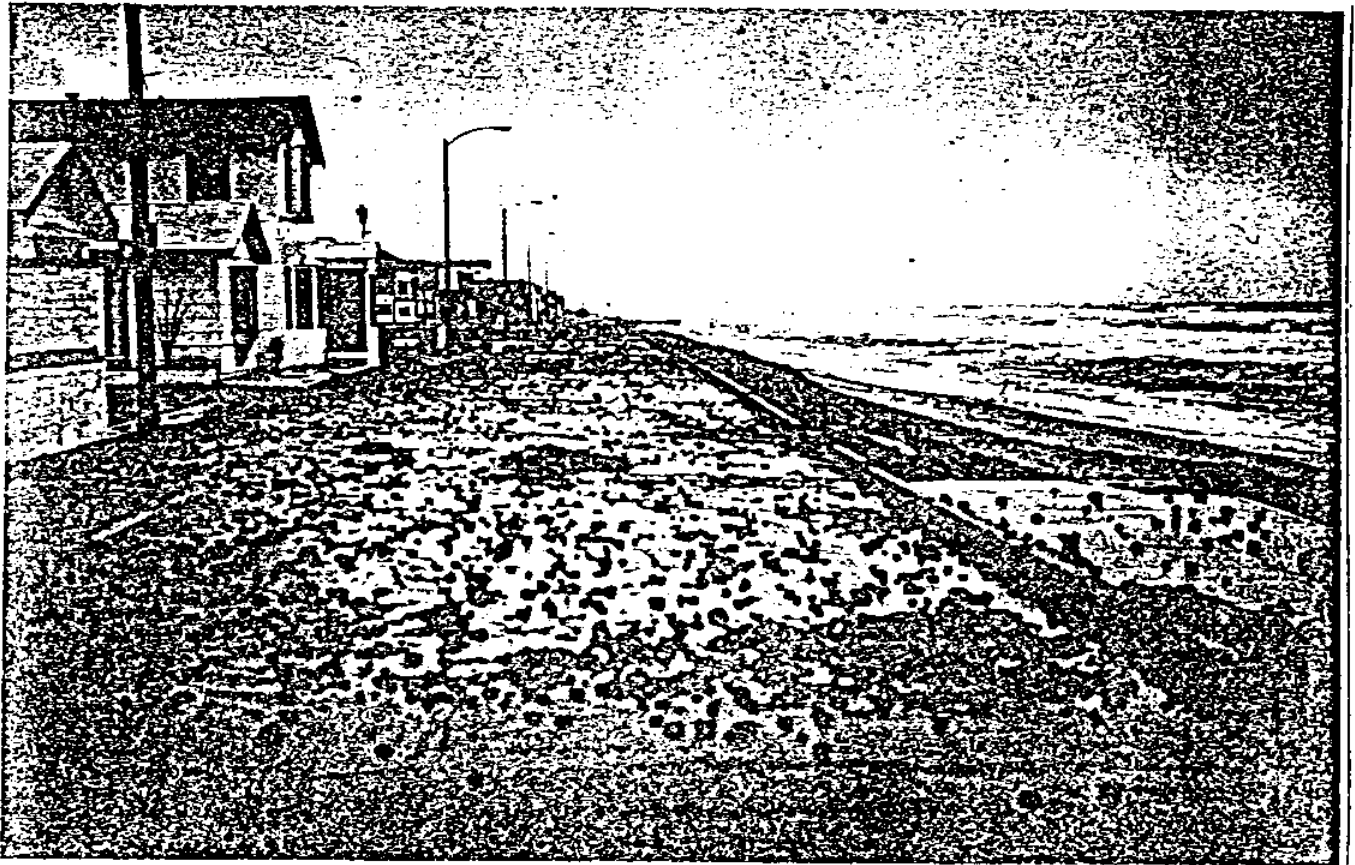
B. March 1978. Same view as Fig. 9.A. Beach cobbles were withdrawn by waves and thrown through the air. Buildings along the shore at Oceanside, Calif. were damaged. Photo: Sea Grant/G. Kuhn, March 4, 1978.

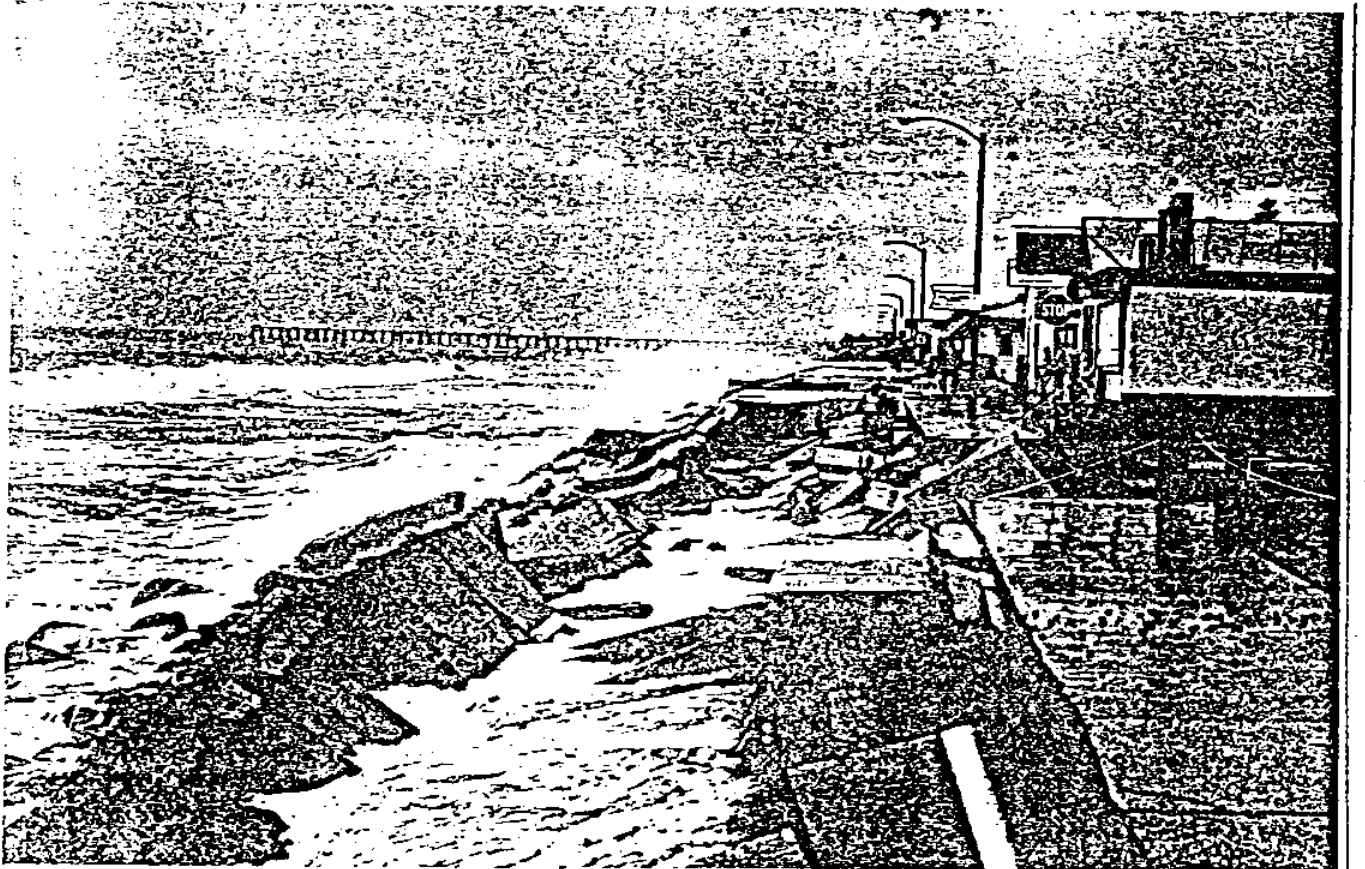
B. (After) February 1980 view looking along same site as Fig. 10.A. The road and seawall were undermined and collapsed February 12-15, 1980. Photo: G. Kuhn,

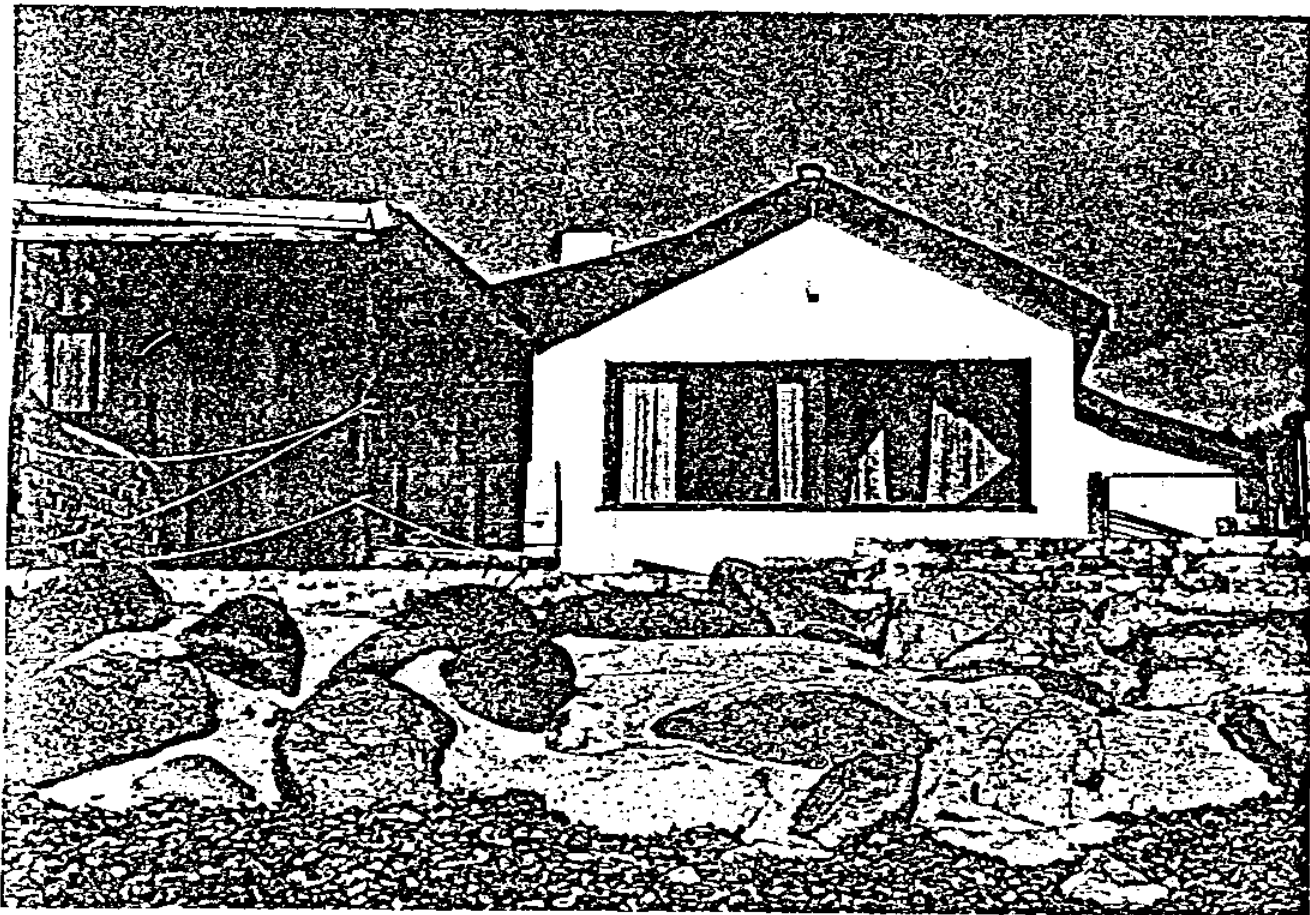
B. 1980. View of house damaged by beach cobbles. Note that windows were broken and roof collapsed as cobbles were withdrawn during storm period of only 1-2-meter waves. Photo: G. Kuhn, Feb. 17, 1980.

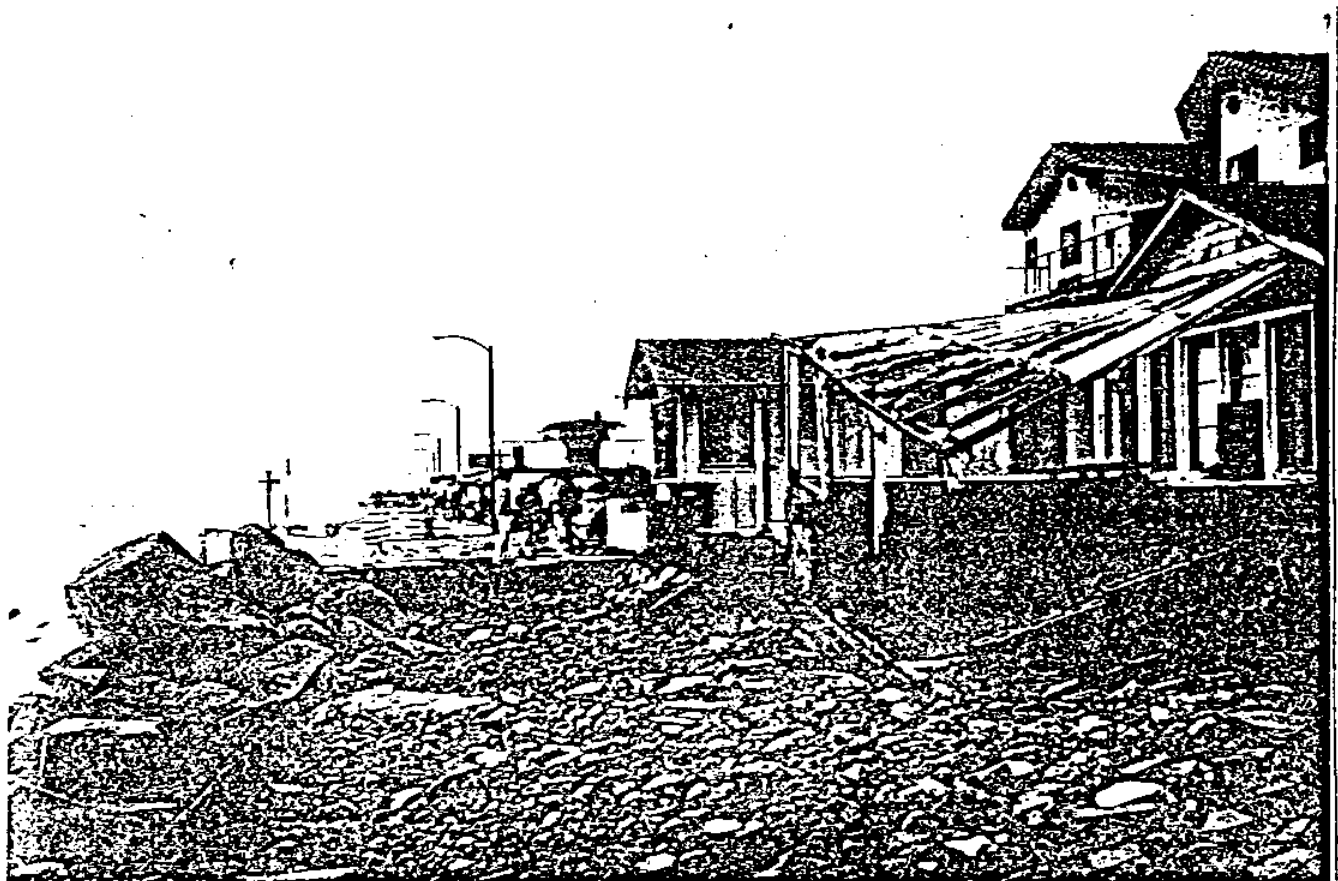
B. (After) Same view in 1980 showing wave and beach cobble abrasion which damaged houses along the shore during storms in Feb. 1980. Property damaged occurred during relatively small (4-6 ft) swell. Photo: Sea Grant, Feb. 17, 1980.

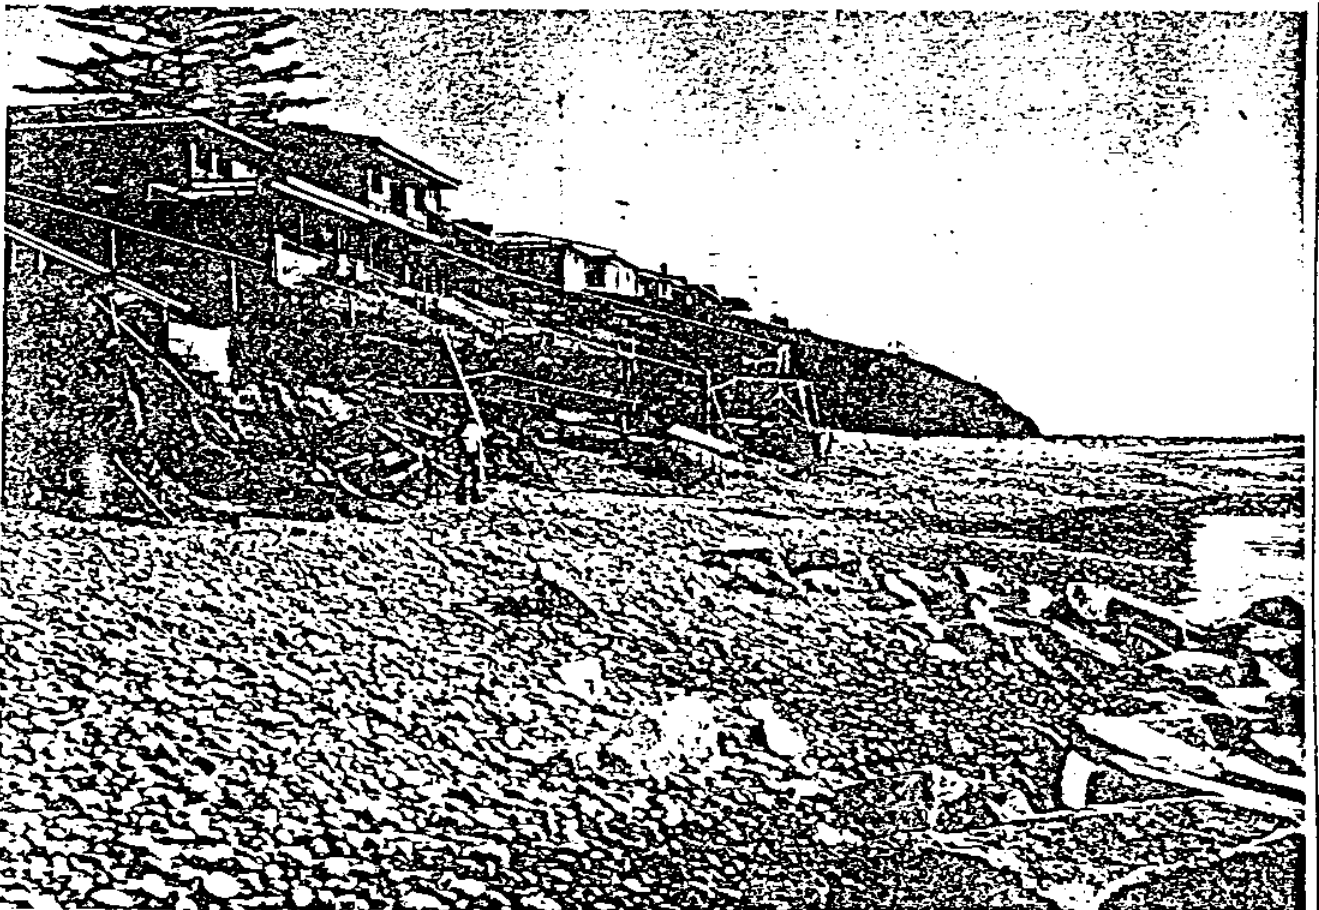
B. March 1978 view of same site as 13.A. Sand levels dipped to very low point and beach cobbles abraded under and around fences, stairways and walls. Photo: Sea Grant/G. Kuhn, March 16, 1978.

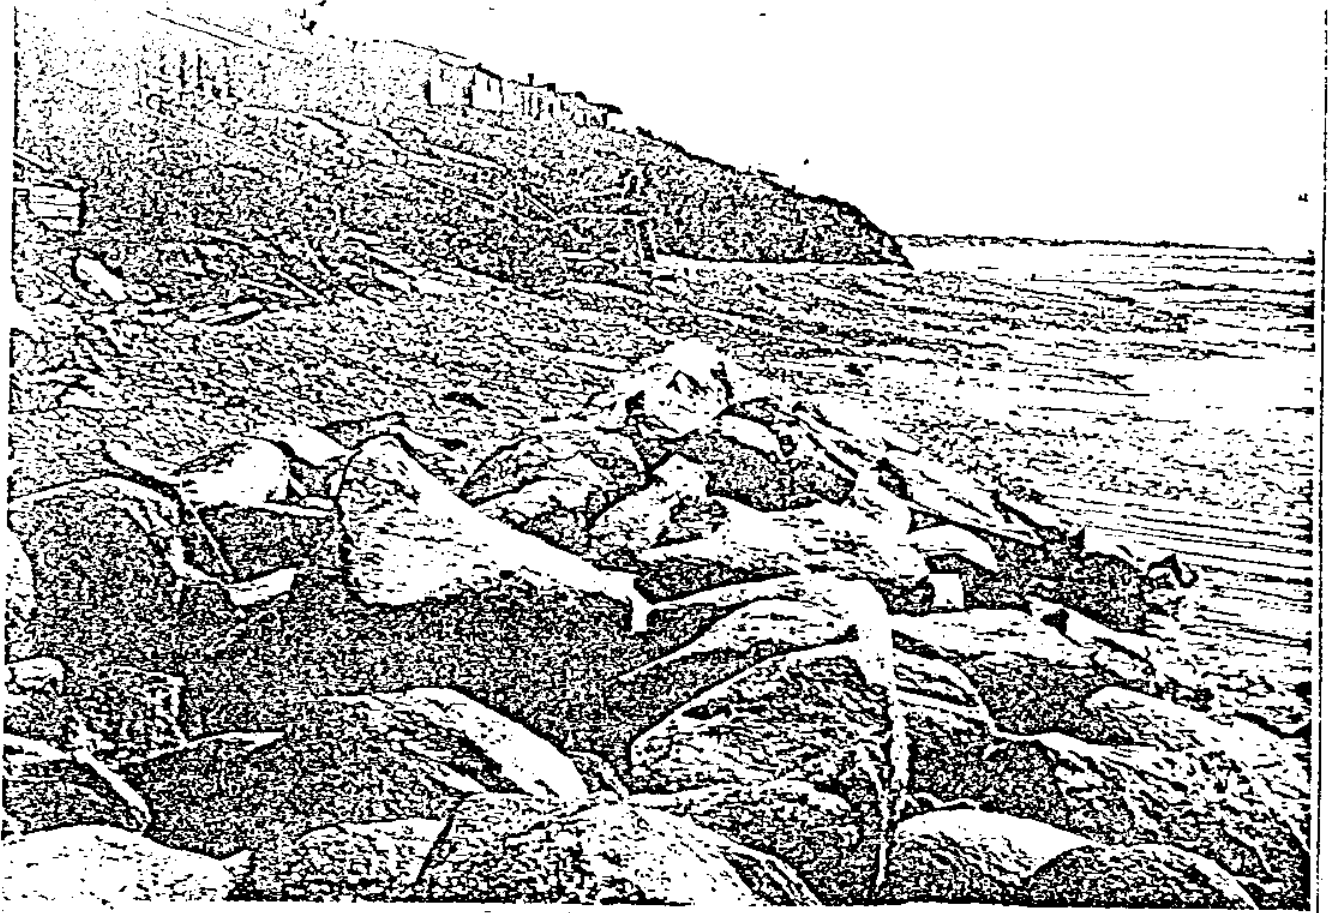
C. April view of same site as 13.A & B. Large riprap was placed adjacent to shore. Waves refracted around riprap and accelerated erosion on adjacent properties. Photo: Sea Grant/G. Kuhn, April 1, 1978.

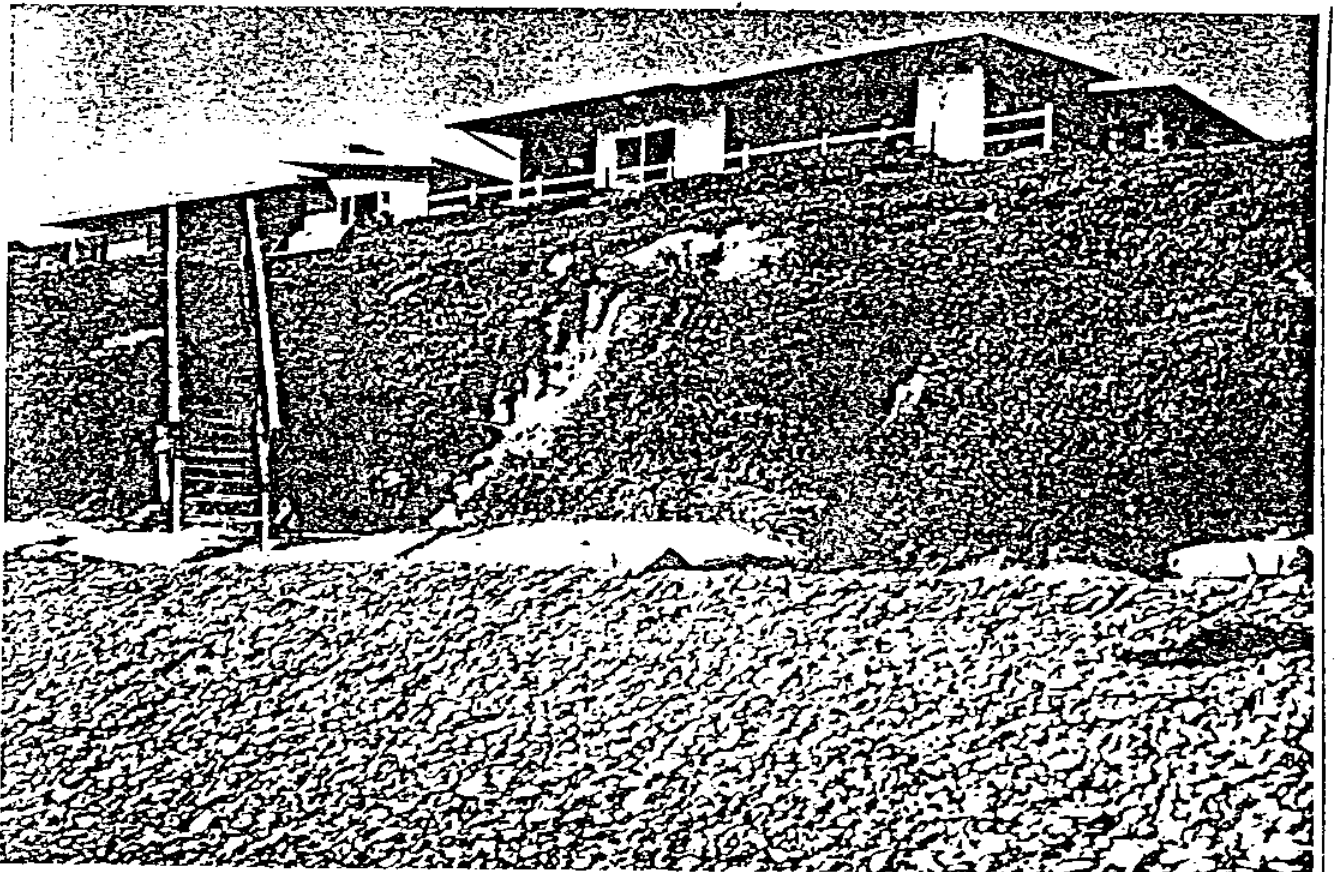
B. June 1978. View of same site as 14.A. Note height to which beach cobbles have moved. Photo: Sea Grant/G. Kuhn, June 3, 1978.

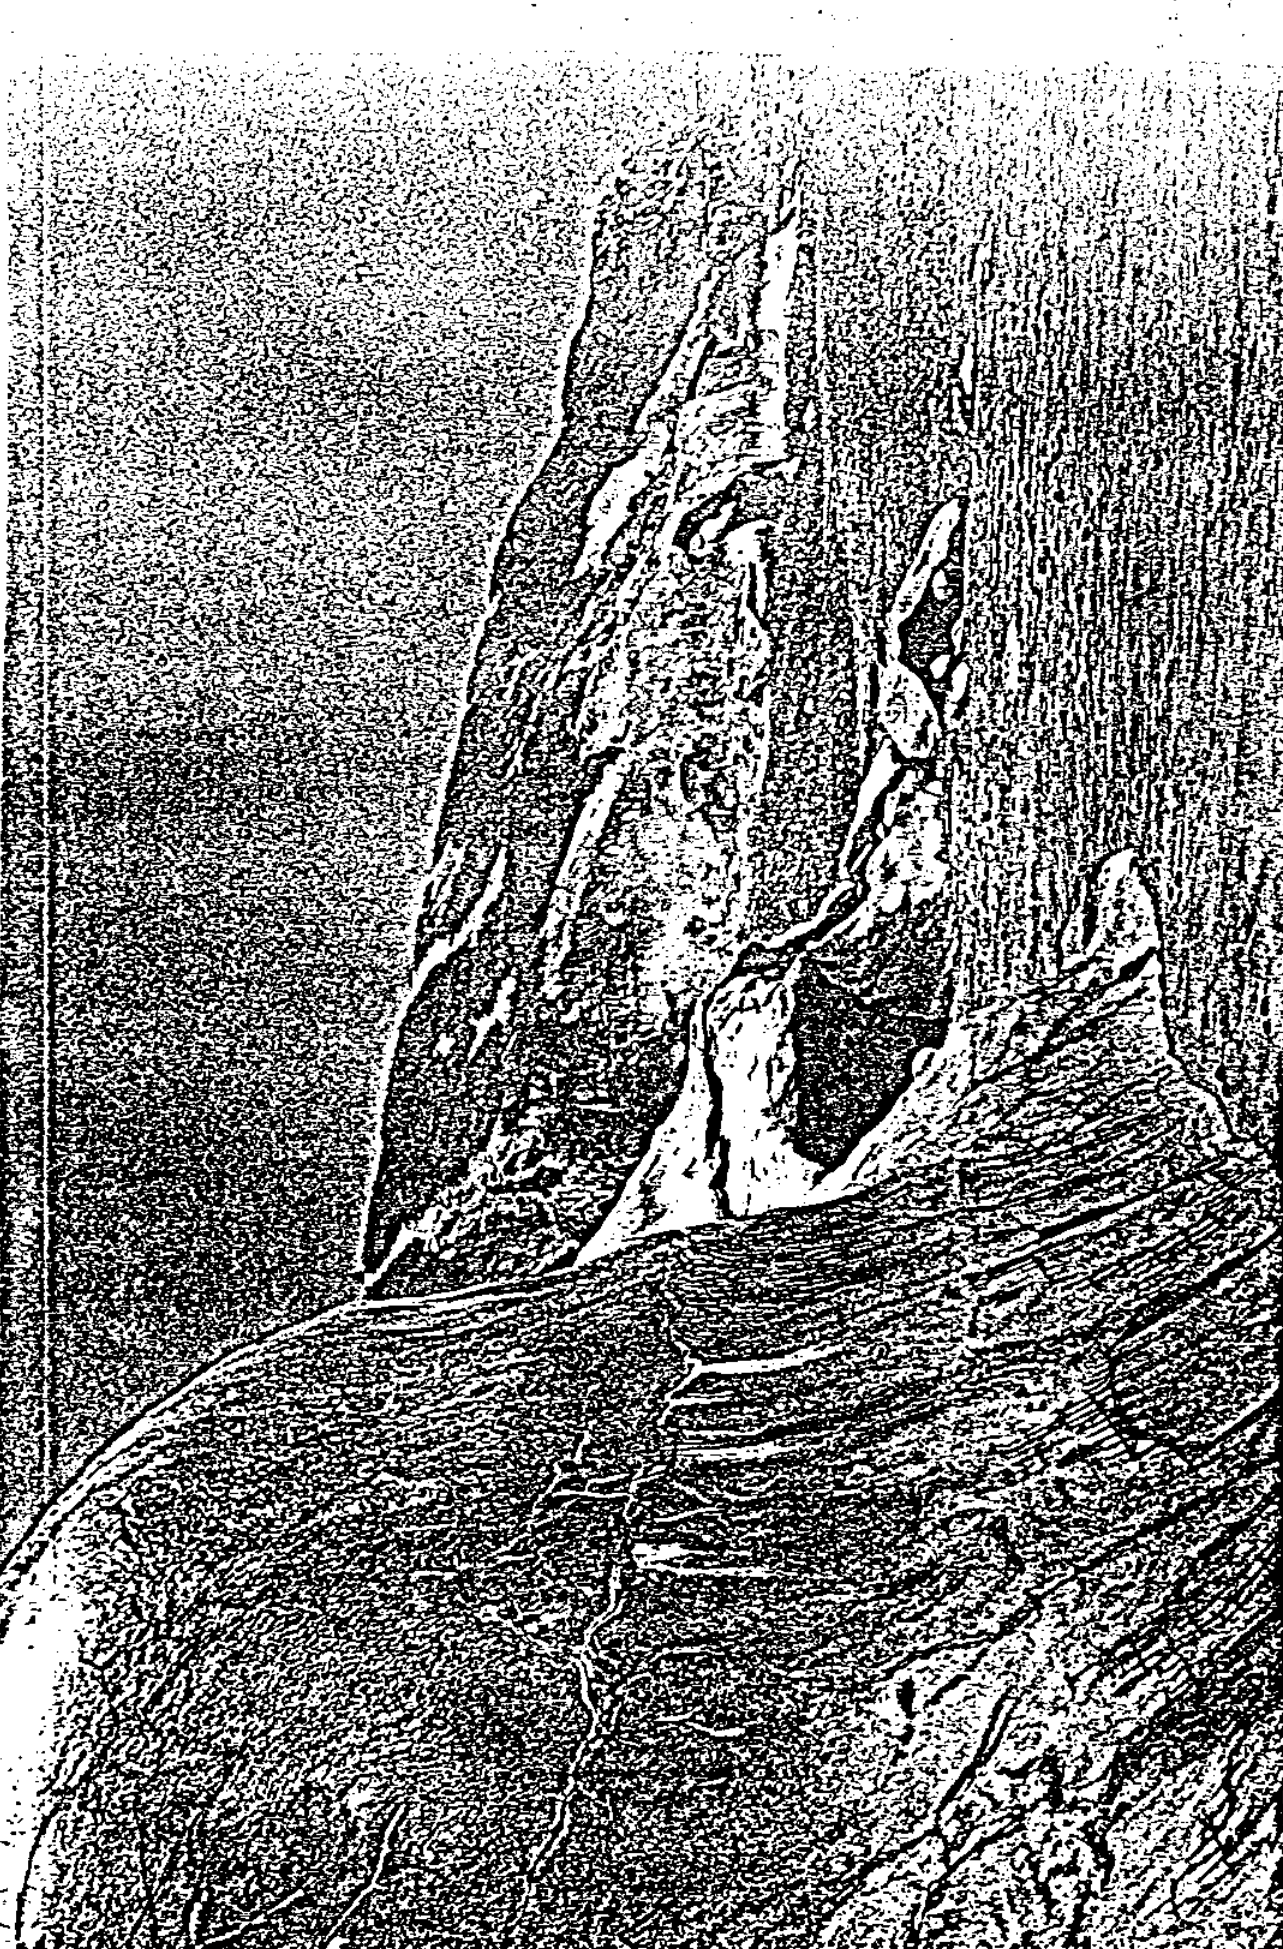
Fig. 15

Figure 15. 1979 view along the beach at Carlsbad, California. "Shotcrete" which was placed on these cliffs has collapsed from the landward side as a result of groundwater spring sapping undermining its support and beach cobble abrasion on the seaward side. Note that the beach cobbles have abraded through the shotcrete to the underlying wire mesh.

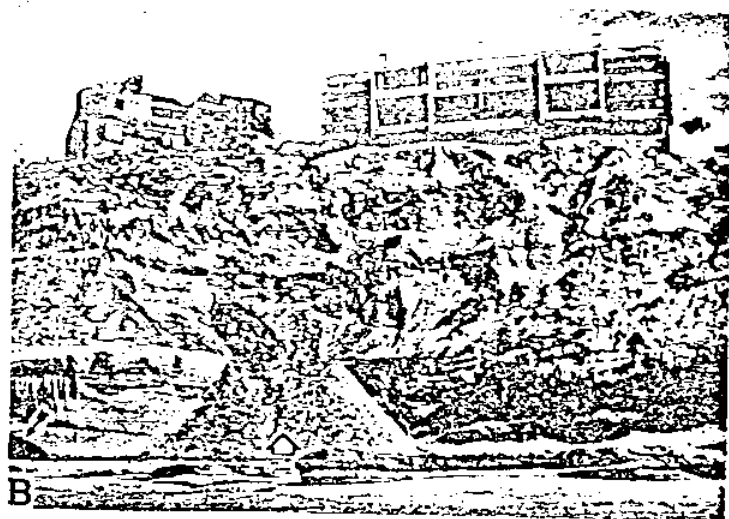
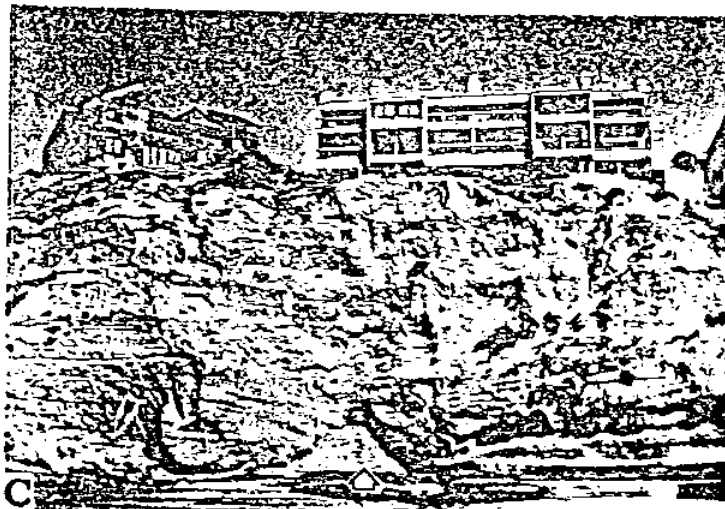
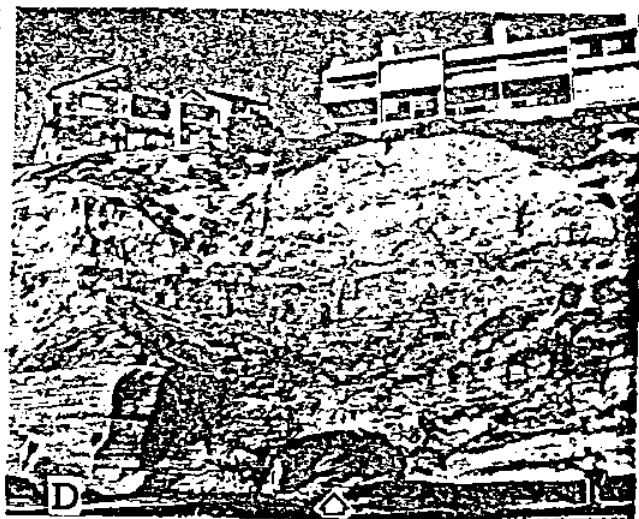
B. 1975 view of large sea-cave roof collapse. Note that the upper sands have also collapsed to the beach. Photo: G.G.Kuhn, April 1975.

C. A second sea cave collapsed in 1977. Photo: G.G.Kuhn, March 10, 1977.

D. View along the base of this cliff at the same site as 16 A, B, C, seen above. Photo was taken following the storms of February through April, 1978. Note: the recently enlarged sea cave is a result of beach cobble abrasion during periods of high tides. Photo: Sea Grant/G.G.Kuhn, June 10, 1978.
