COASTAL EROSION ALONG OCEANSIDE LITTORAL CELL,
SAN DIEGO COUNTY, CALIFORNIA

Gerald G. Kuhn
Geological Research Division
Scripps Institution of Oceanography
University of California, San Diego
La Jolla, California 92093CIRCULATING COPY
Sea Grant Repository

Abstract

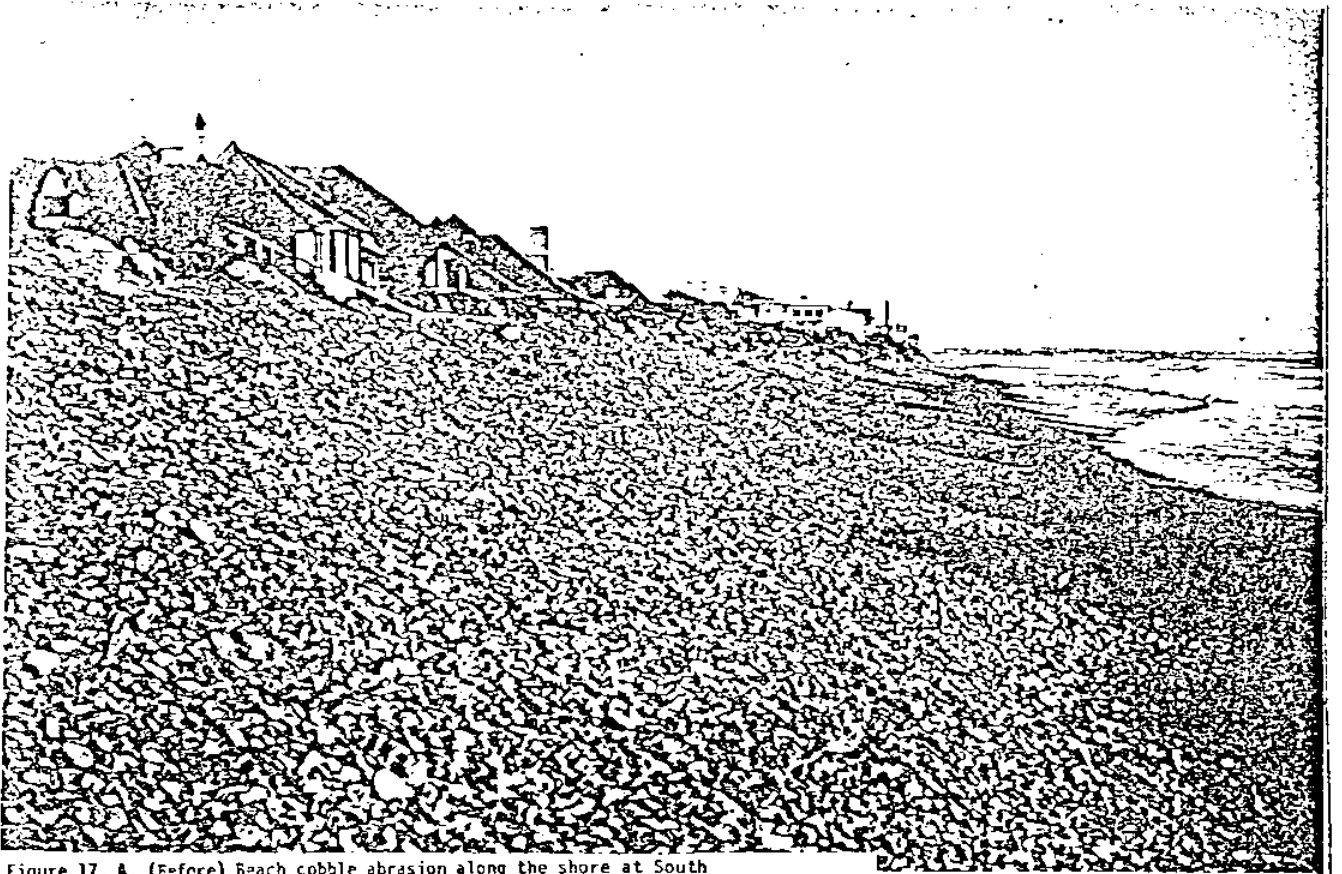
Figure 17. A. (Before) Beach cobble abrasion along the shore at South Oceanside. Cobbles moved up beach 18-20 feet and covered riprap seawall in places; eroded lawns directly behind seawall. Photo; Sea Grant/G.G.Kuhn, January 1978.

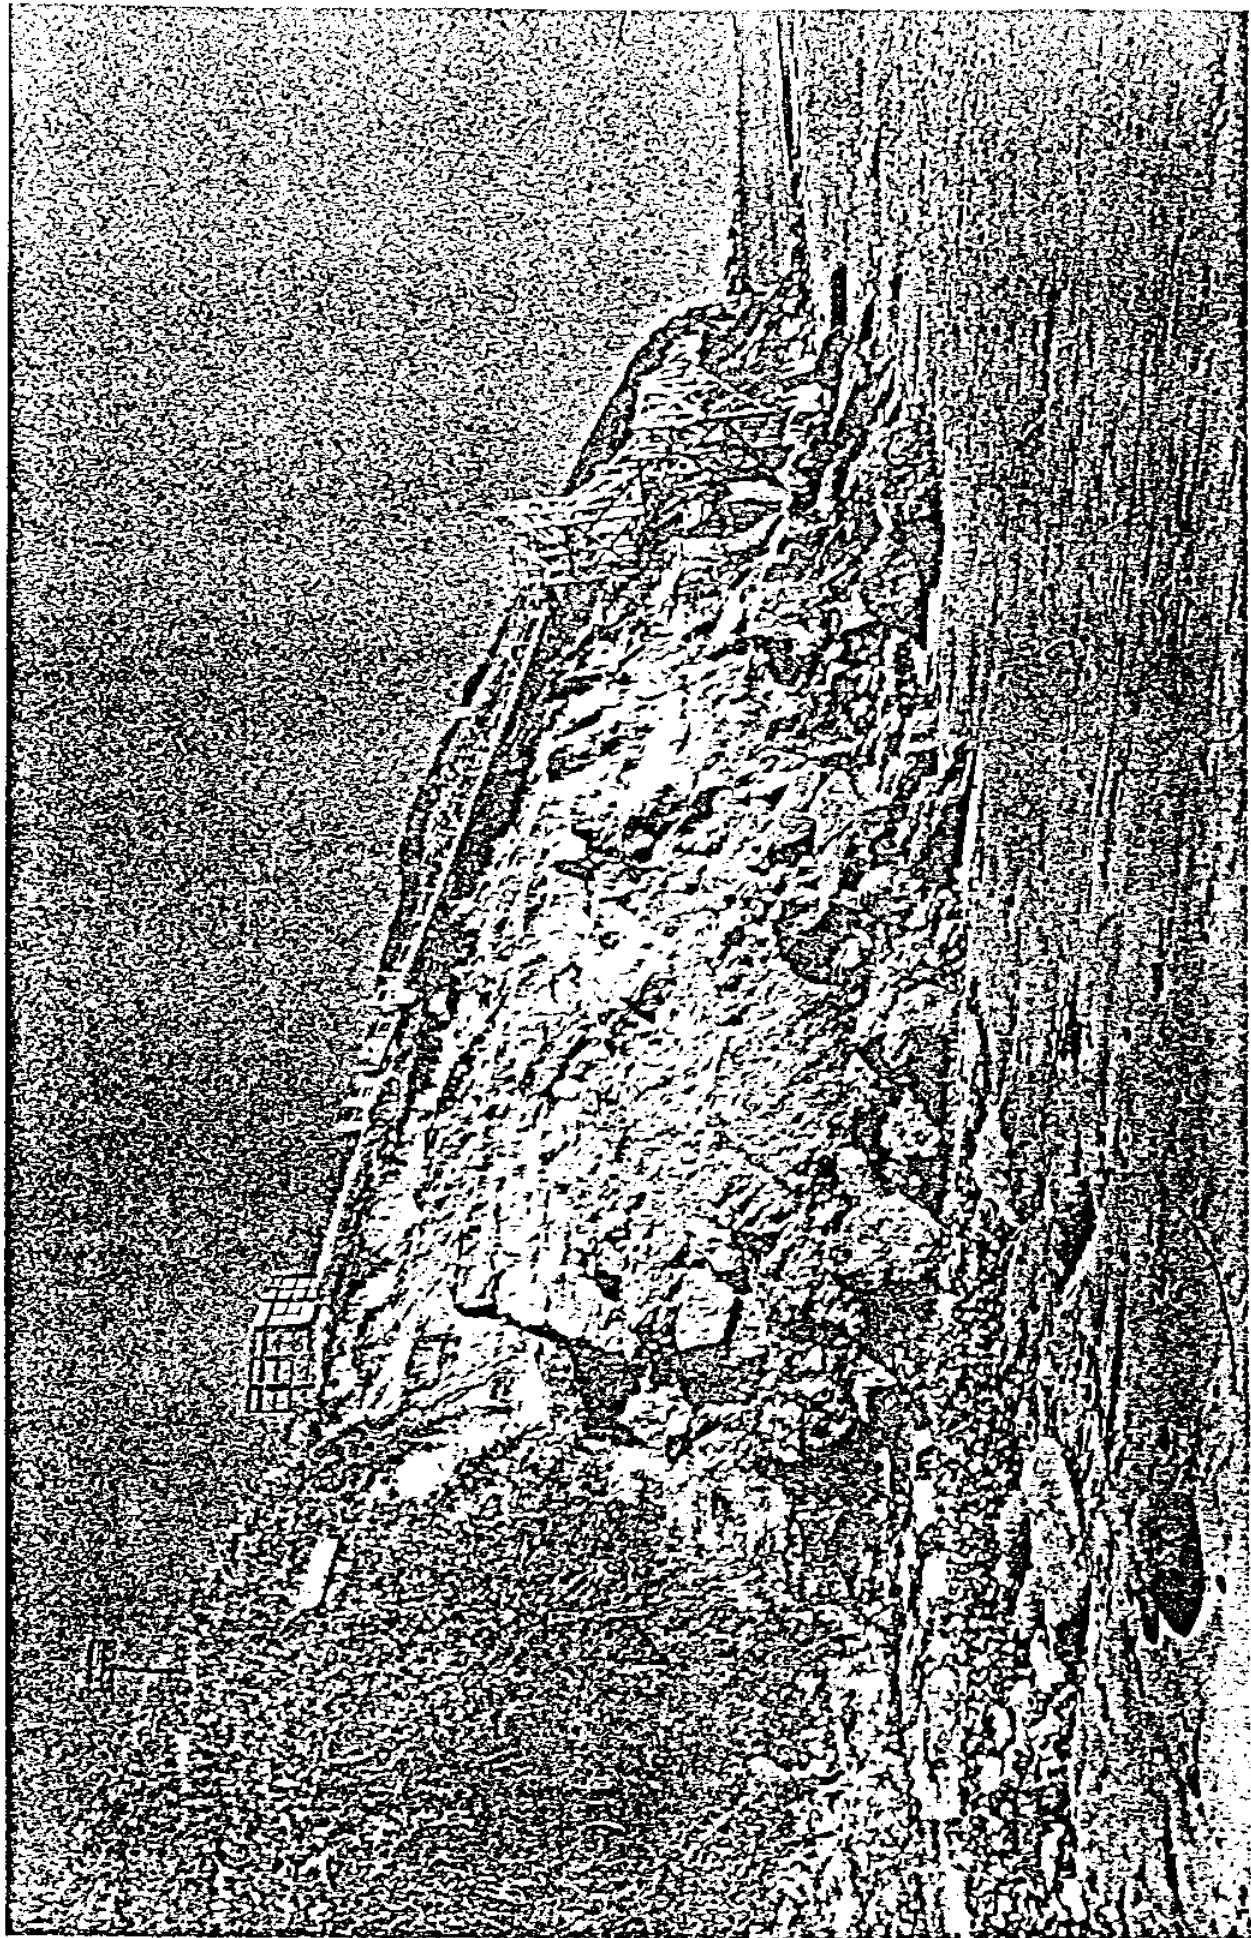
This extensive watering has lead to at least three important effects: It has caused a slow but steady increase in the water table, even during the dry period which preceded the rains of 1978. This has added weight to the cliff material which contributes to development of landslides. It has lubricated surfaces along which slides and block falls are initiated, and in some cases has greatly increased solution in the underlying rocks. specific sites that evidenced erosion during the drought years prior to 1978 are continuing to collapse. Large sections of cliff face have separated along parallel joint sets (Figures 19-21).

Figure 19. 1978 photo looking southeast along the face of the cliff that collapsed at the self-realization fellowship property in Encinitas on April 26, 1978.

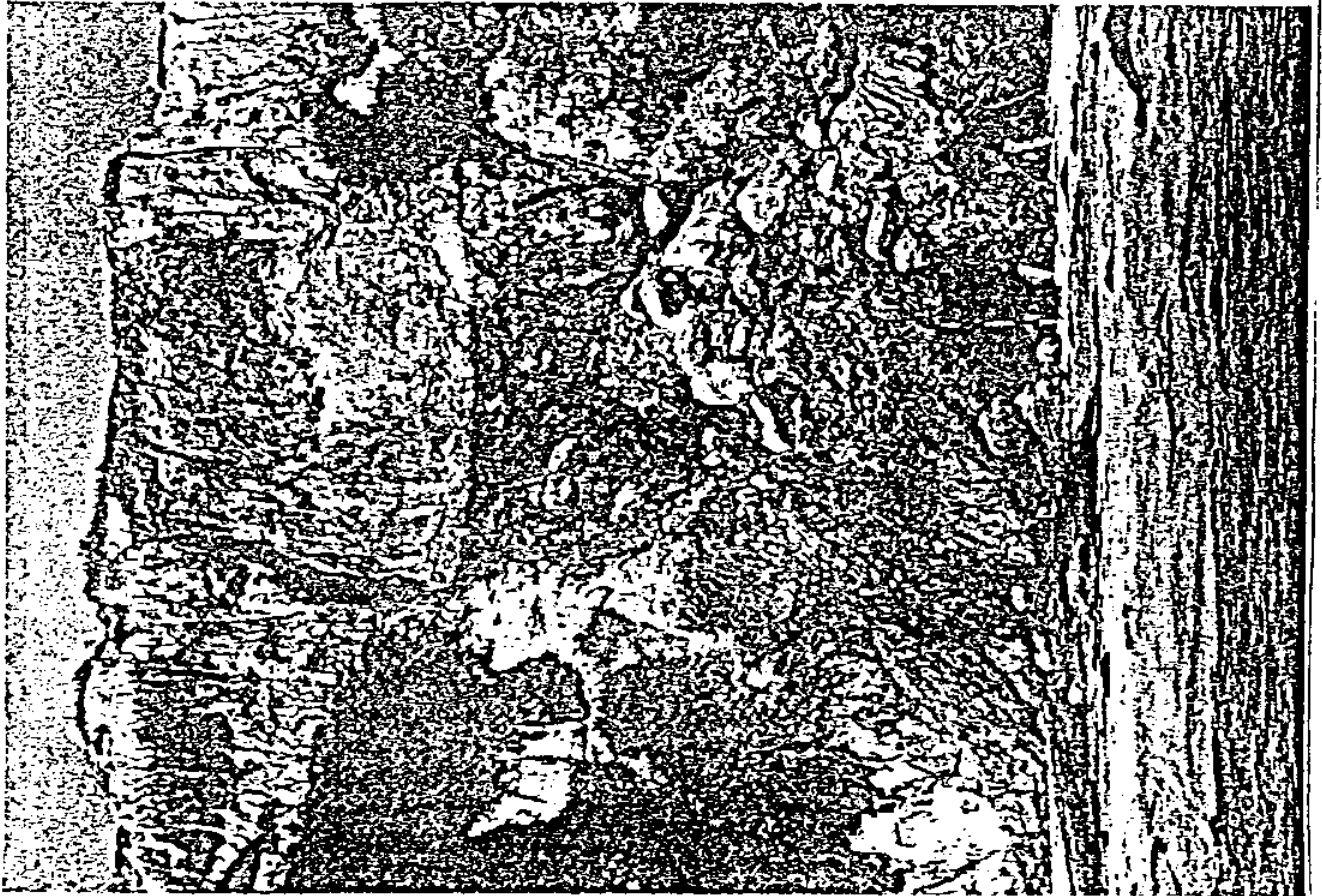
Figure 20. A. August 1979 view of recent cliff failure at Del Mar, California.
Note: Cliff failure occurred as a result of a rise in the ground water table from watering of non-native vegetation inland of the sea cliff. Photo: Sea Grant/G.G. Kuhn; August 22, 1979.

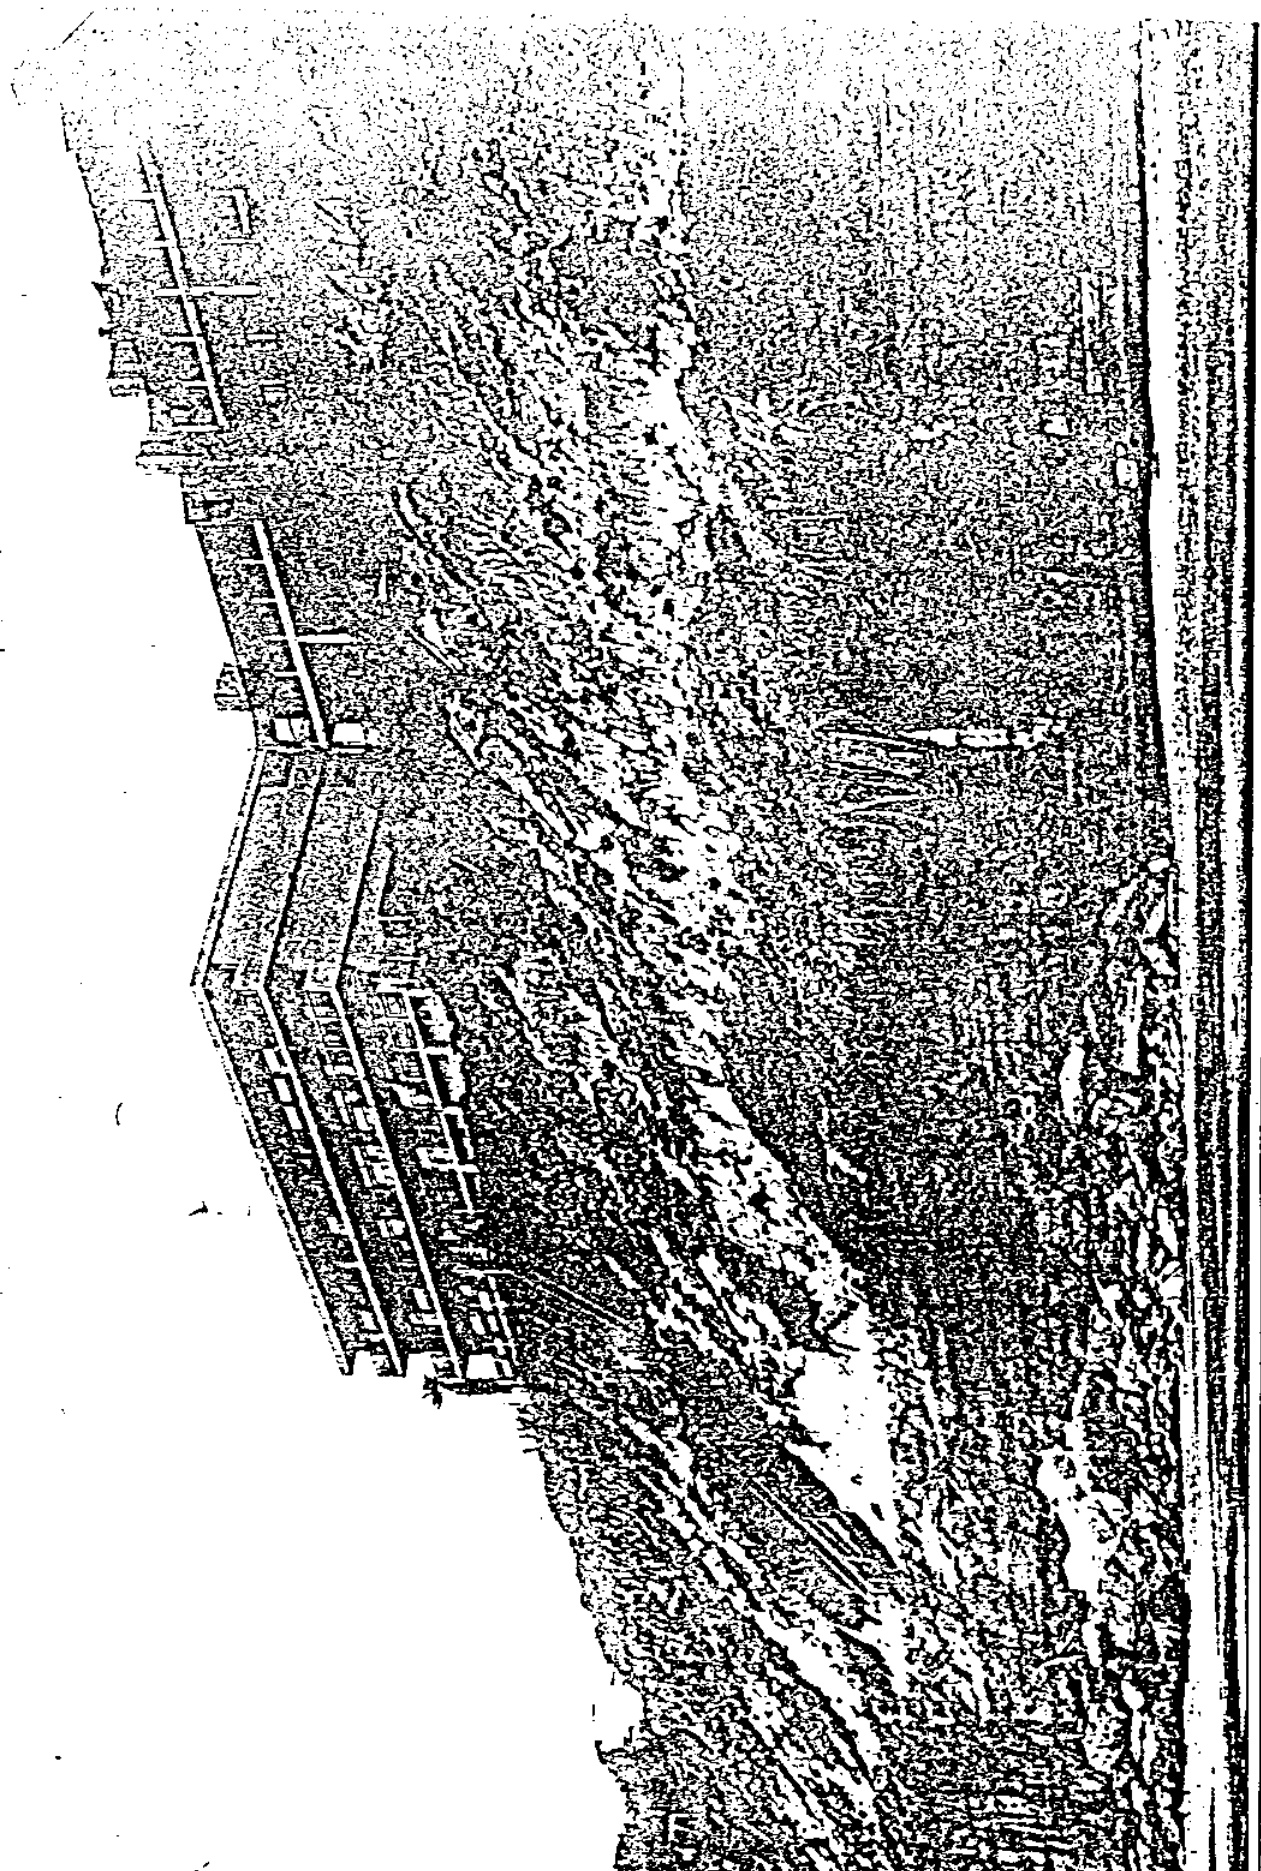
Figure 21. A. Blockfall on the beach at the foot of F street, Encinitas, California. The cliff collapsed and crushed the apartment beach access stairway on November 30, 1977. Note the wet condition of the cliff face. Photo: G.G. Kuhn, December 10, 1977.

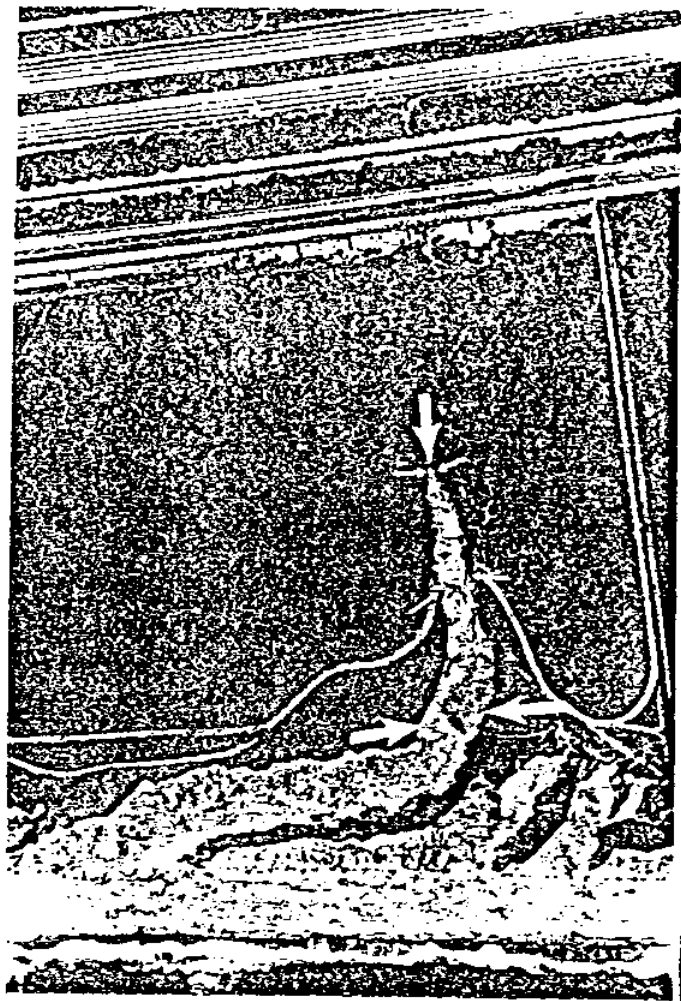
At another location no canyon existed perpendicular to the shoreline prior to the 1969 storms (Figure 22.B). Between 1968 and 1976 a new canyon began to cut headward, reaching about 60 ft inland. During January and February of 1978 approximately 160 ft of headward erosion occurred. On February 14, 1980 another 5 ft of headward erosion

C. (After). March 1980 vertical aerial photograph showing development of 460 feet canyon perpendicular to the shoreline. It was actually cut 235 feet on February 20, 1980 alone. Photo: U.S.Navy, March 1, 1980.

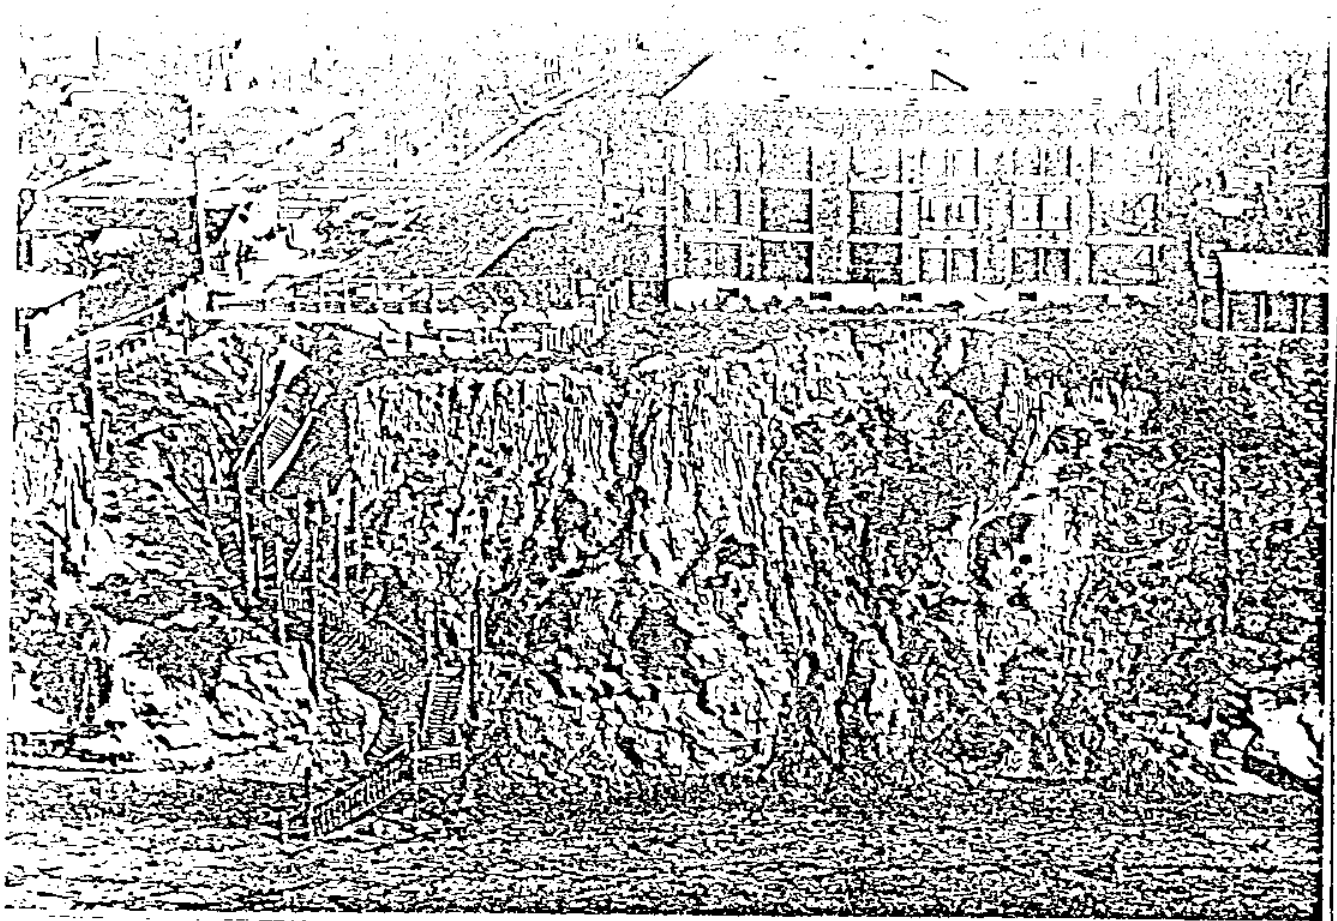
Figure 23. A. March 1980. Oblique view of eroding bluffs at D street, Encinitas, California. Note: (1) The stairway collapse at the bluff top at the street end; (2) the recent slope failure located directly in front of large building. Photo: Sea Grant/ O.L.R. - L.Ford, March, 1980.

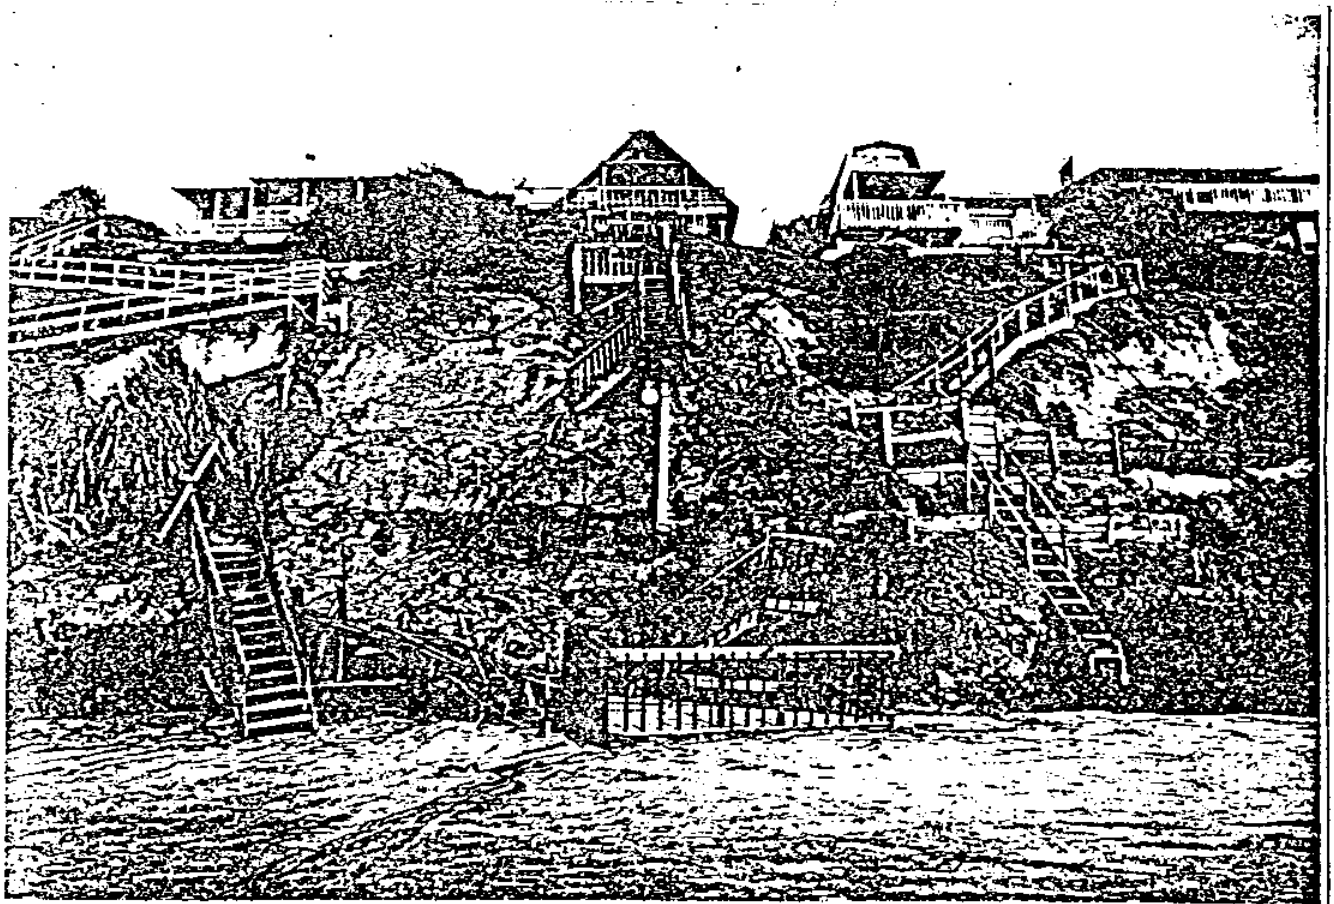
Figure 24. A. January 1978 view of private beach access stairways along the bluffs at Leucadia, California. Note: One large stairway collapsed during a period of intense sediment saturation between January 14-20, 1978. Photo: Sea Grant/G.G.Kuhn, January 29, 1978.

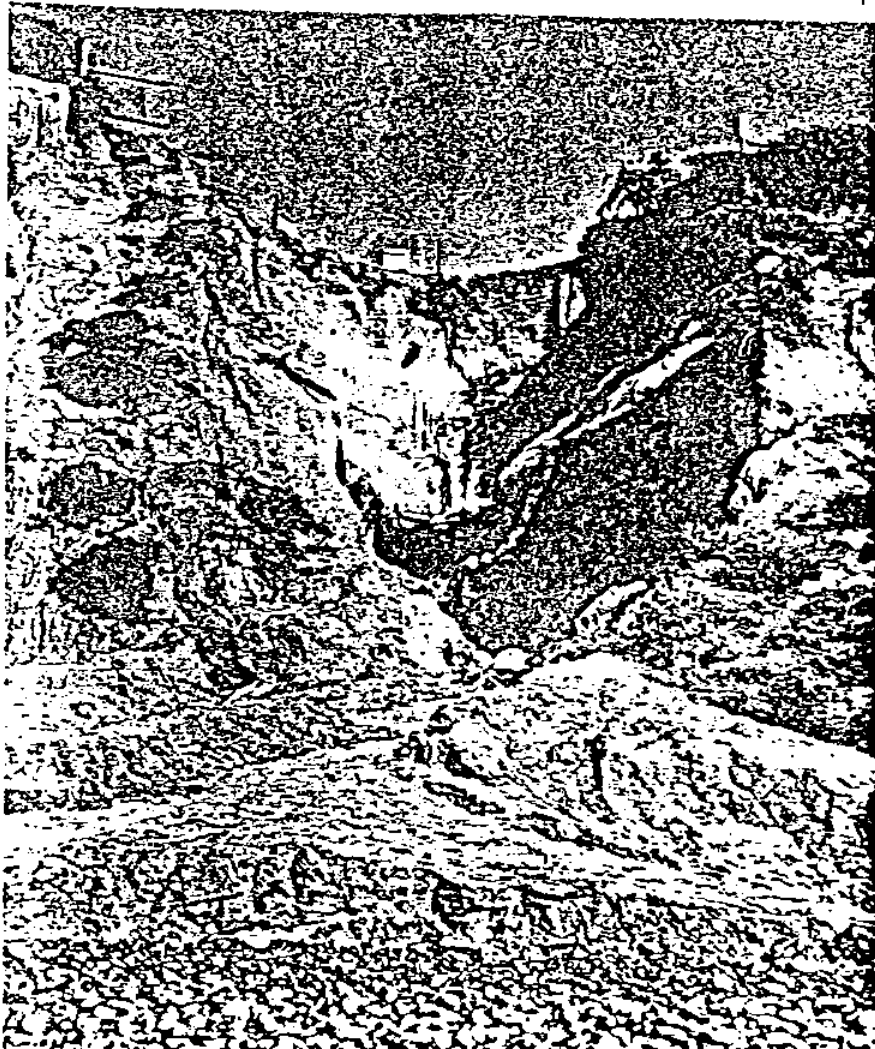
B. (After). 1979 view at the same location following the collapse of storm drain pipe, which caused severe gullying of the bluff face. Photo: Sea Grant/G.G.Kuhn, February 11, 1979.

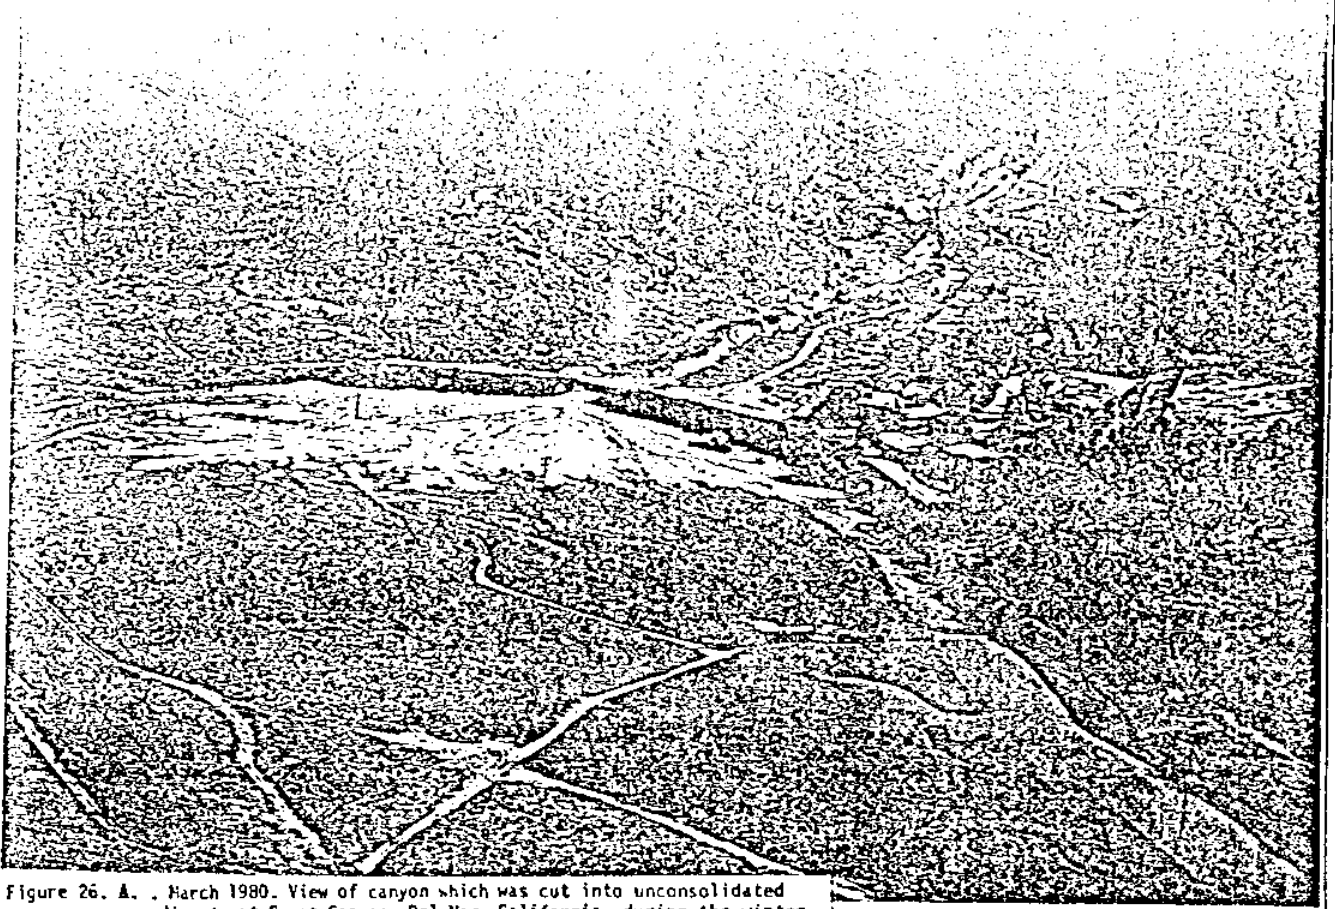
Figure 26. A. . March 1980. View of canyon which was cut into unconsolidated sediments at Crest Canyon, Del Mar, California, during the winter of 1977-1978. Note; an arrow points to a culvert/storm drain upcanyon and under housing subdivision. Photo: SIO/OLR-L.Ford, March 1980.

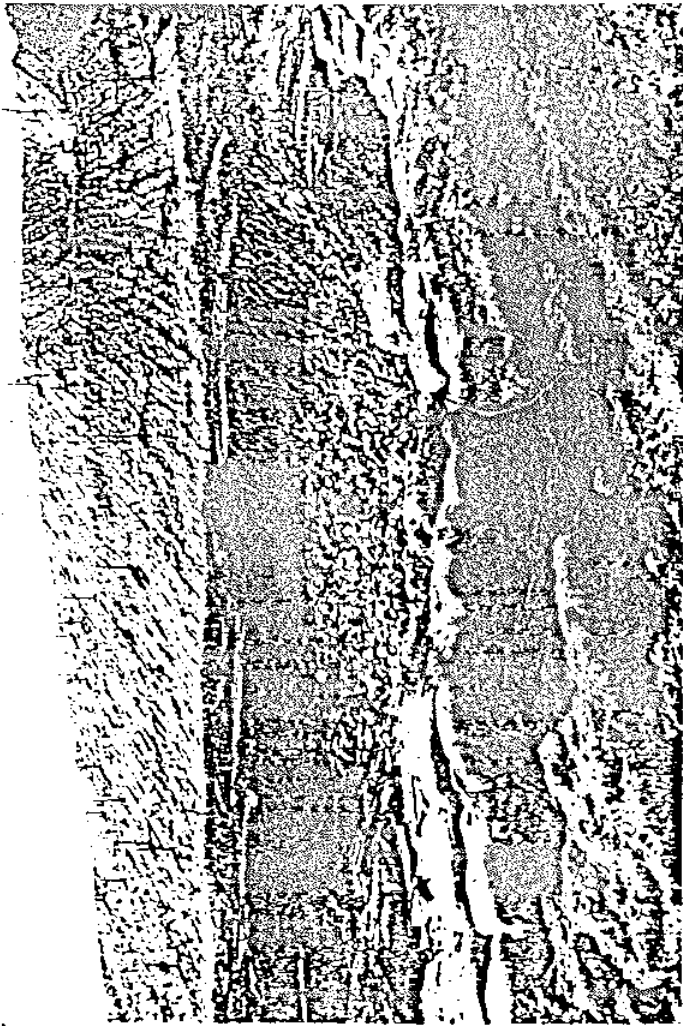
Figure 29. B. Same view as 29A, siltation basin eroded. Photo: S10/OLR-L.Ford, January, 1977.

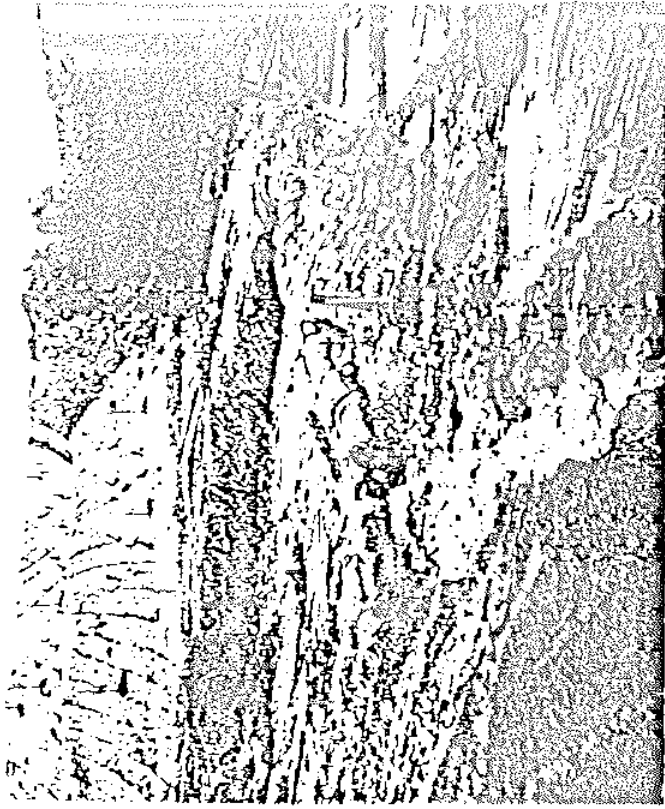
Figure 29. C. Same location as 29B, view looking northeast. Note: sandbags and filter rock have been scattered and a new gully is being cut. Photo: S10/OLR-L.Ford, January, 1977.

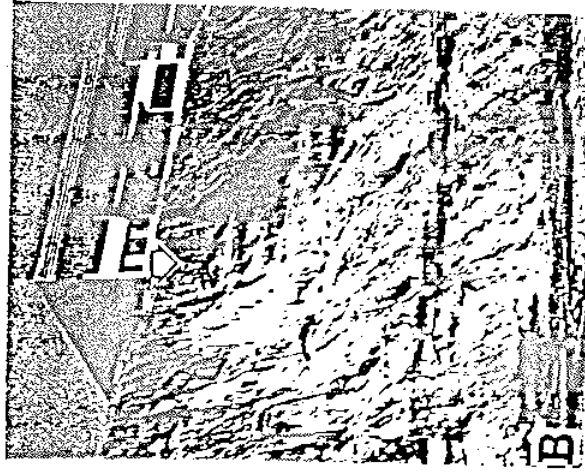
E. May 1979 view of same site as 31C. Note: The cribwall completed before it was completed. Photo: Sea Grant/ G.G. Kuhn, May 4, 1979.

the entire structure rotated and collapsed, leaving debris and sediment resting on the seawall below (Figure 31.E). Within a week following the collapse the debris was removed and sections of the sidewalk along the bluff top collapsed. Surface water was seen to flow down the bluff face (Figure 31.F).
