COASTAL PROTECTION STRUCTURES AND THEIR EFFECTIVENESS

**KIM FULTON-BENNETT
AND GARY B. GRIGGS**

UNIVERSITY OF CALIFORNIA AT SANTA CRUZ

1986

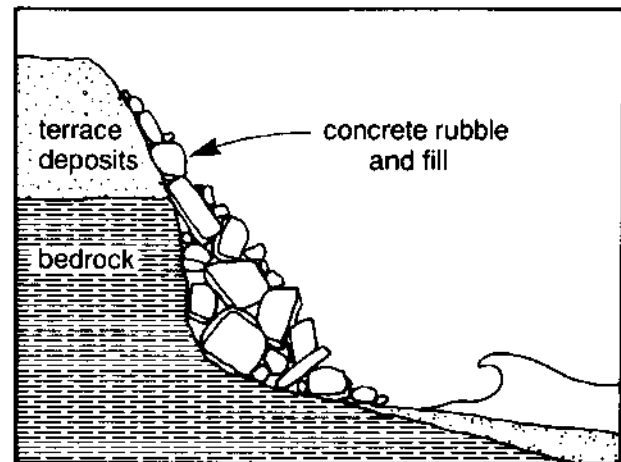
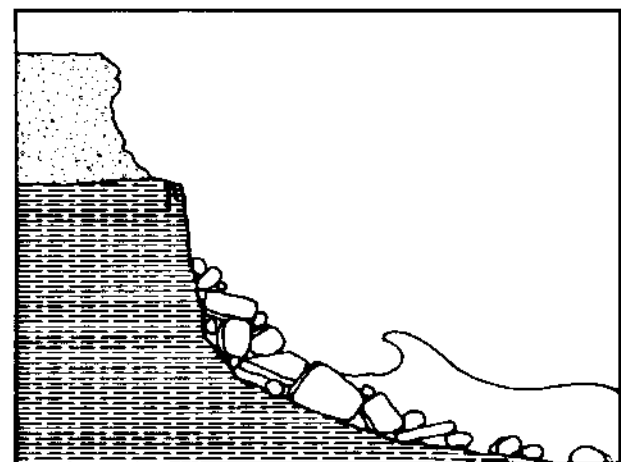
Typical failure of concrete rubble and fill.

Before wave attack

After partial erosion of fill

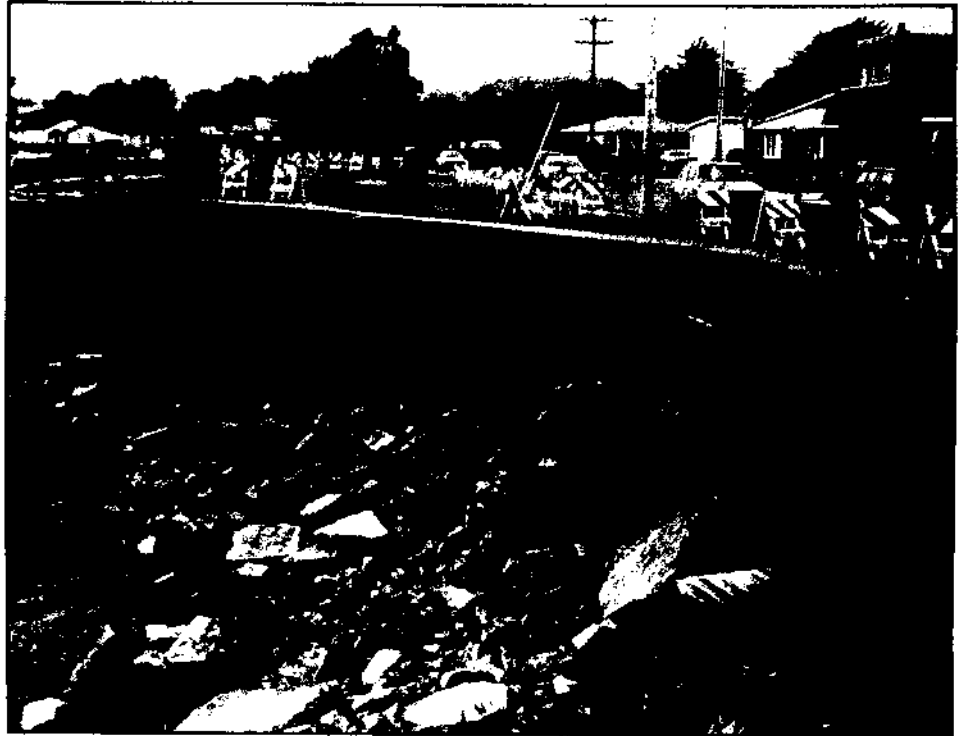
Figure 5
Concrete debris has been scattered across a low terrace by wave action (Site II).

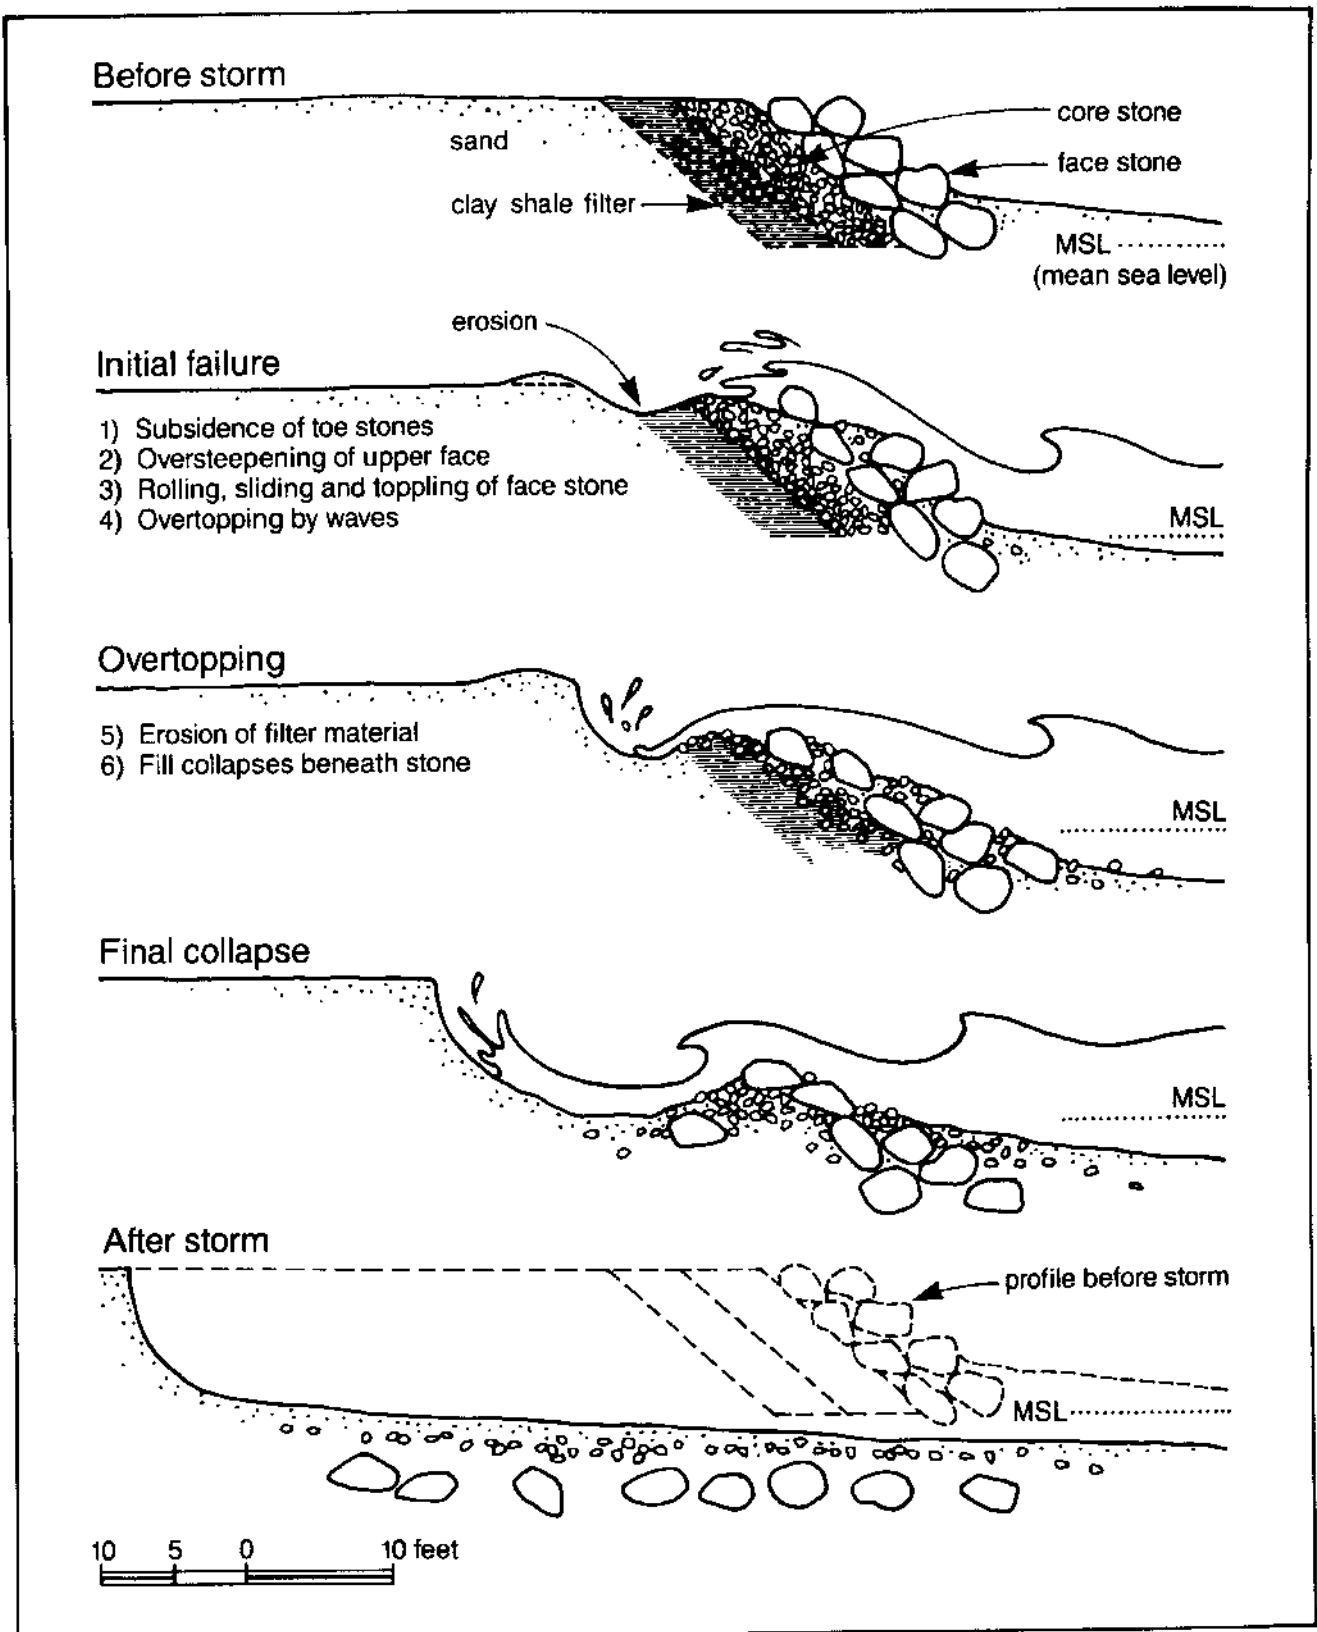
Figure 10

Collapse of a rip rap revetment along Australia coast (after Smith and Chapman (1982)). Due to the availability of rock and difficulty of working in the surf zone, the Australian approach is often that settlement is expected and more rock will be added as needed.

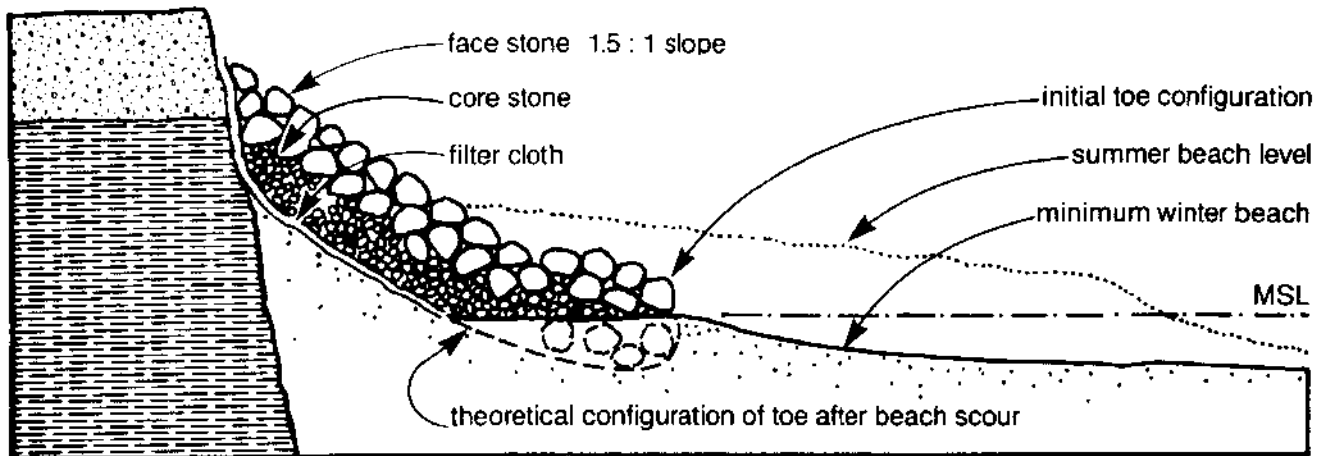
Figure IIa
 Initial revetment configuration and theoretical "hinging" of revetment toe.

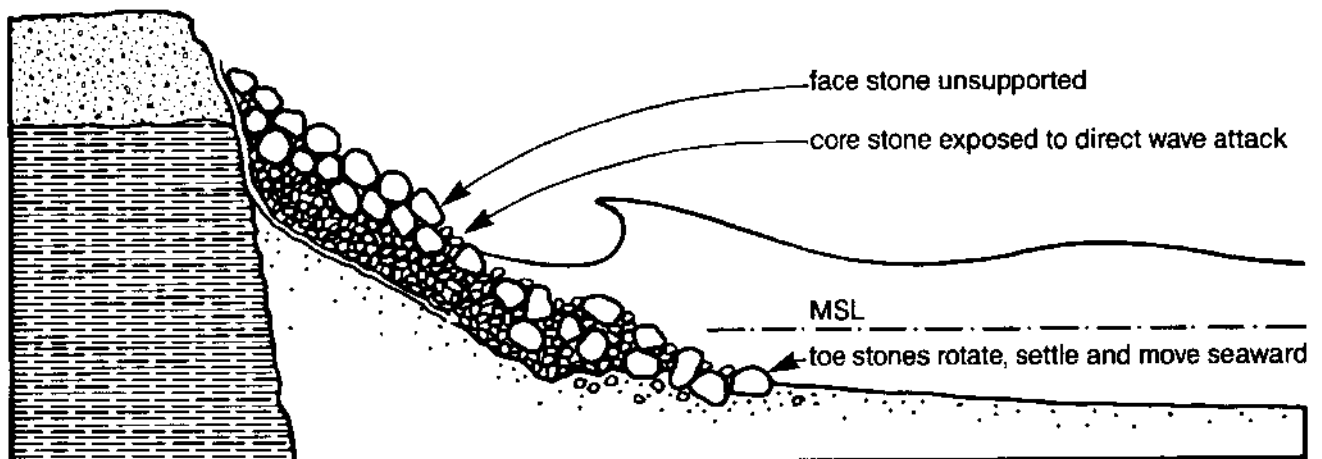
Figure IIb
 Initial stages of observed toe failure (may be very rapid); note both seaward and downward movement of rock.

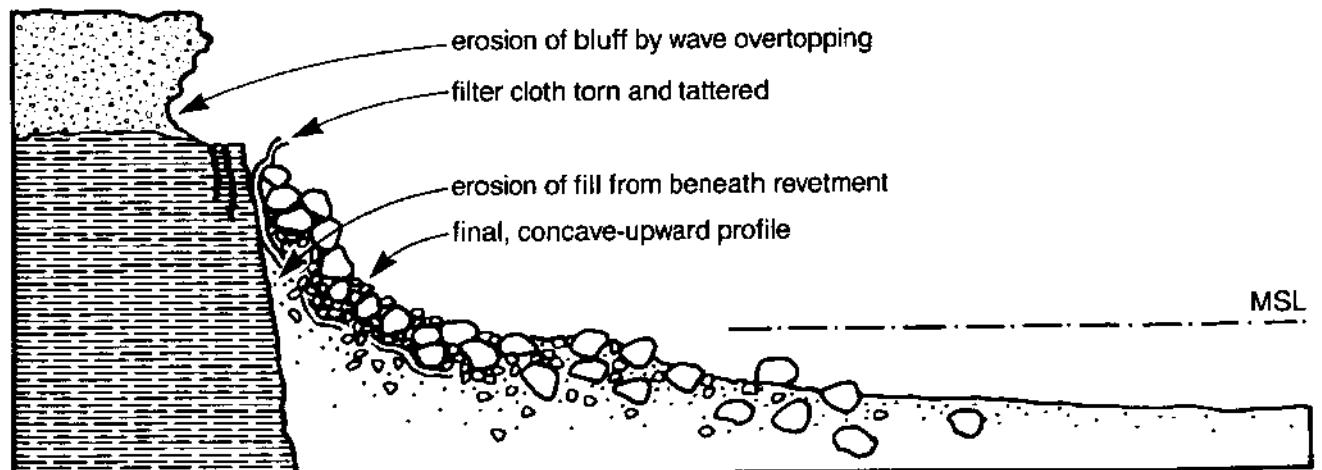
Figure IIc
 Final states of observed revetment failure.

After their toe stones have rotated or settled, many rip rap walls assume a concave-upward profile (Figure 11C), in which the upper rocks are supported at a relatively steep angle, and are susceptible to toppling by large waves. This concave-upward profile, with its flattened toe, may cause waves to reform and break directly on the structure, especially during high tide.

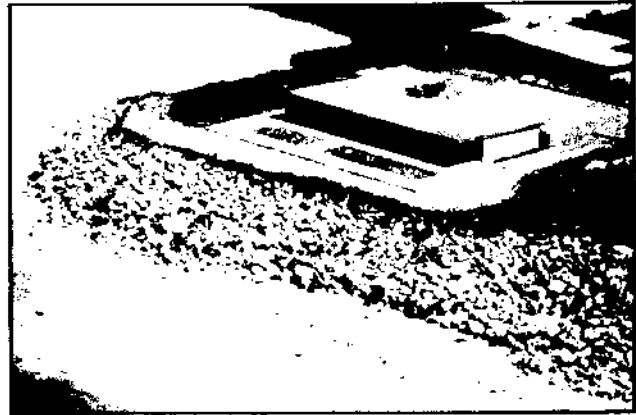
Figure 12

A total of 5500 tons of rip rap has been placed or replaced at this property 10 times over the past 30 years at a cost of over \$150,000 (Site 14).

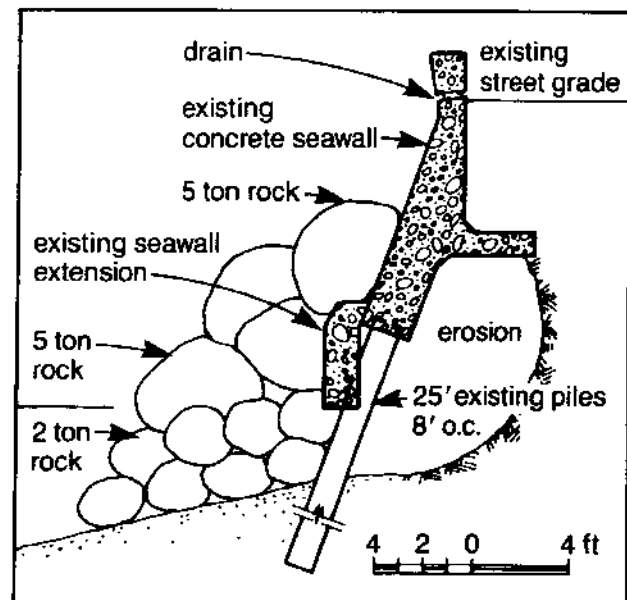
Figure 19

Erosion beneath concrete seawall and proposed rip rap at Rockaway Beach (Site 6).

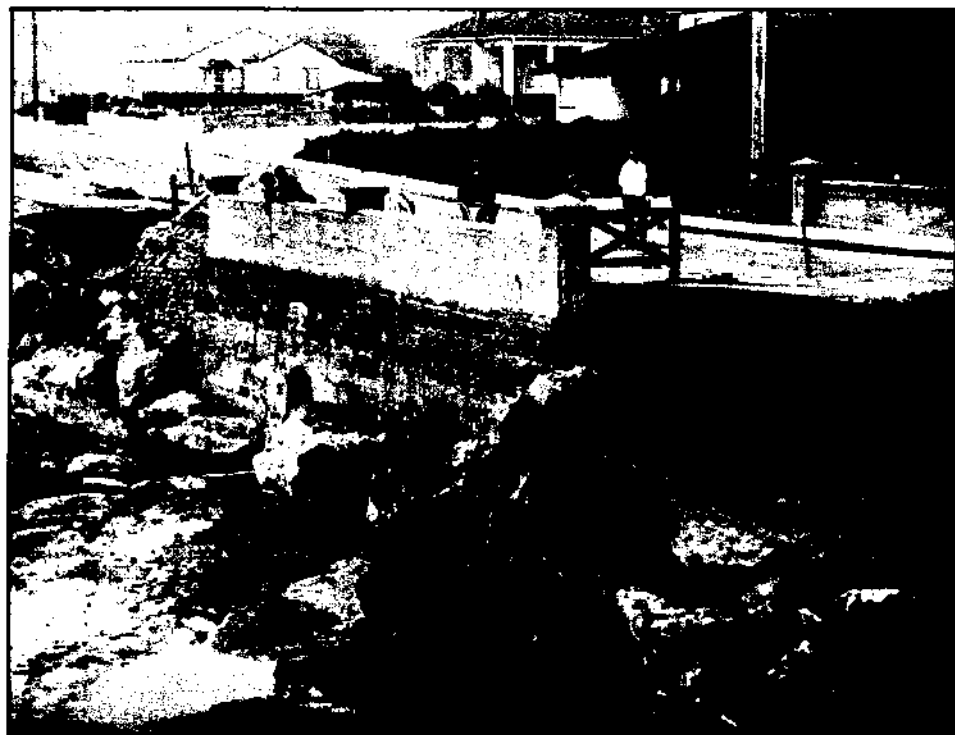
Figure 21

Outflanking of a short concrete seawall and undercutting of a sidewalk occurred during severe storm conditions (Site II).

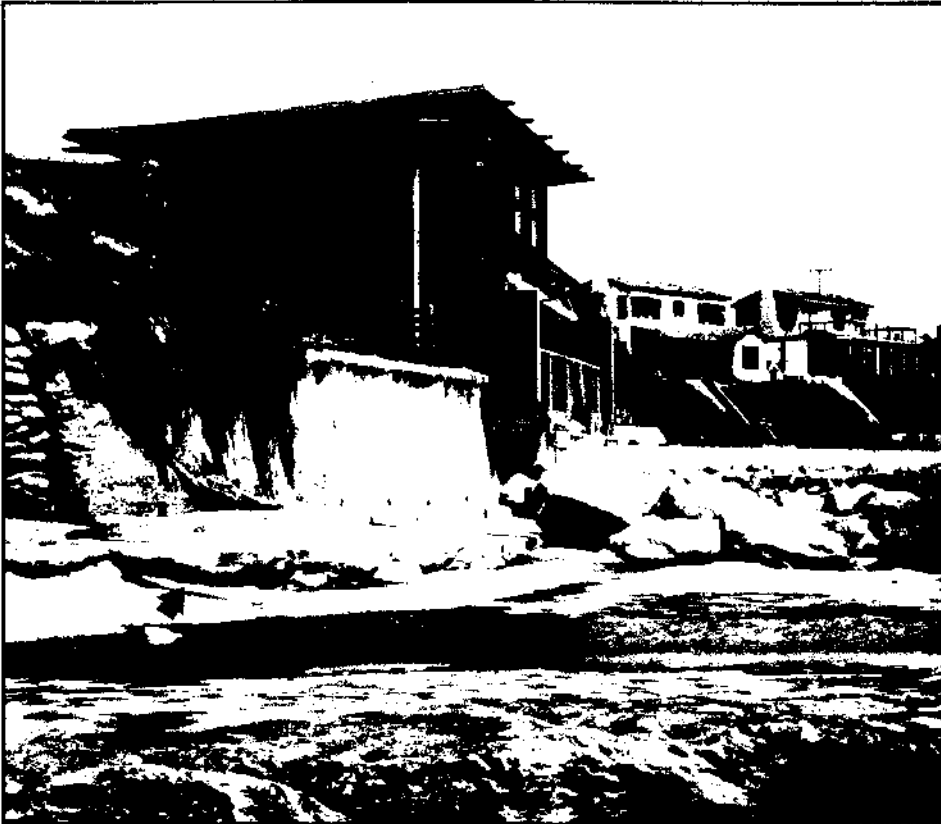
Figure 22
Scour beneath the base of a concrete seawall (at arrow) (Site 16).

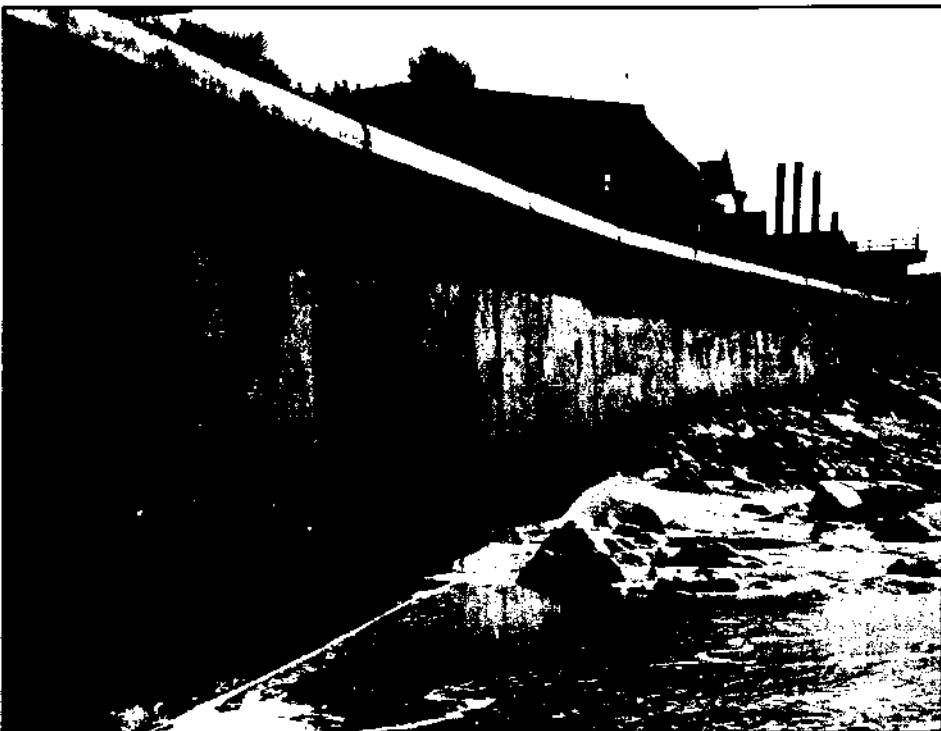
A new concrete sheet pile seawall placed at Site No. 26 in late 1985 was severely damaged when exposed to storm waves within a month of construction. Severe wave scour dropped sand levels below four inch diameter weep holes and exposed approximately 12 vertical feet of the wall (Figure 23).

Figure 23
Wave scour has lowered beach sand levels in front of a concrete sheet pile seawall to approximately +4 feet MLLW and exposed weep holes.

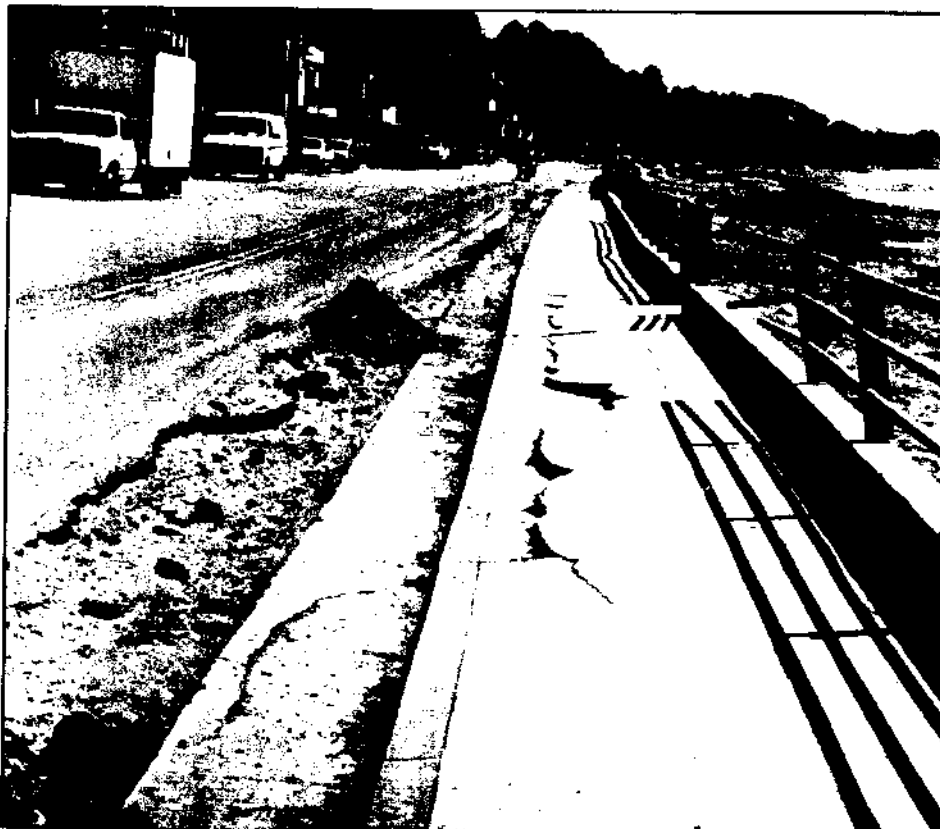
Figure 31
Overtopping of this seawall and clogging of drain system led to piping through underlying fill and collapse of pavement (Site 25).

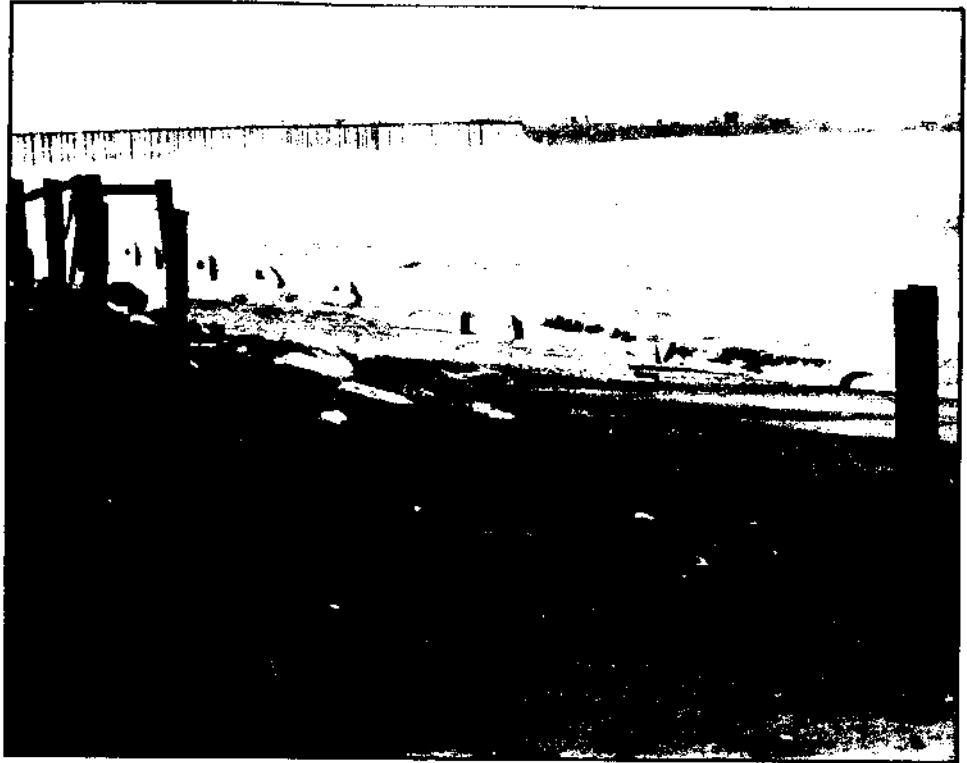
Figure 32
Loss of timber lagging and failure of pilings. This wooden wall was heavily damaged within four months of completion. Note remnants of two earlier walls in the surf zone (Site 22).

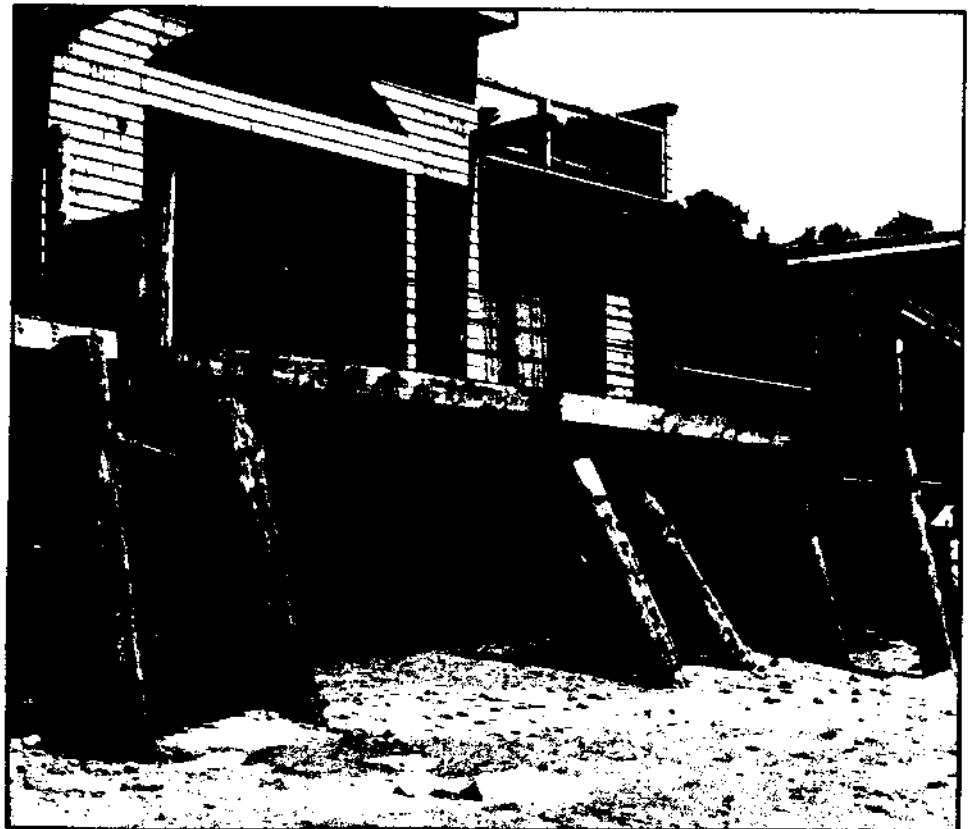
Figure 33
Removal of lagging and collapse of wooden seawall due to scour and wave impact (Site 26).

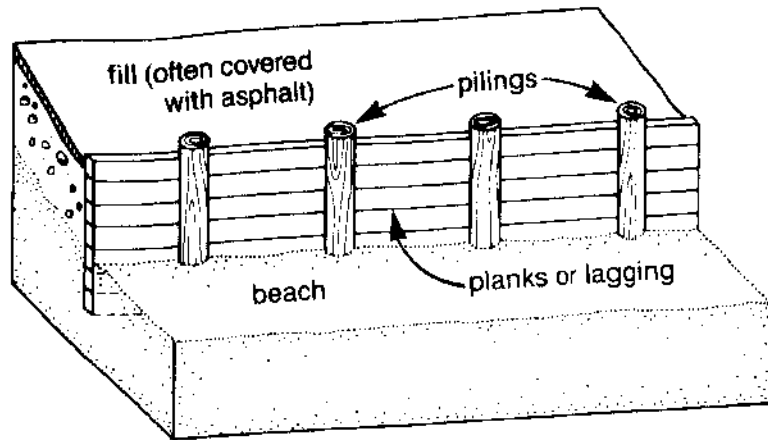
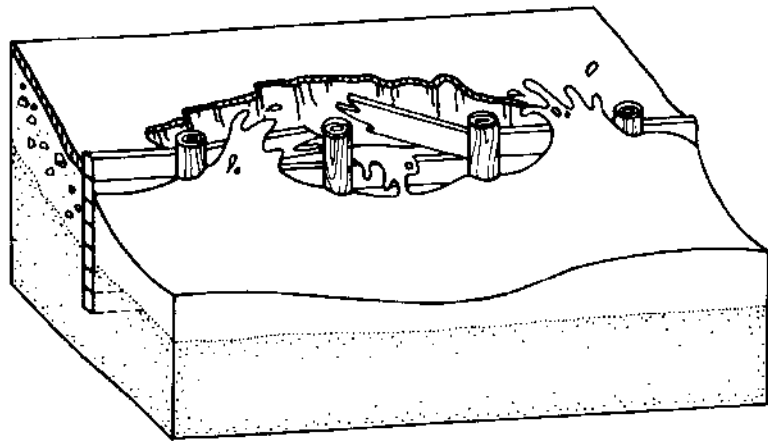
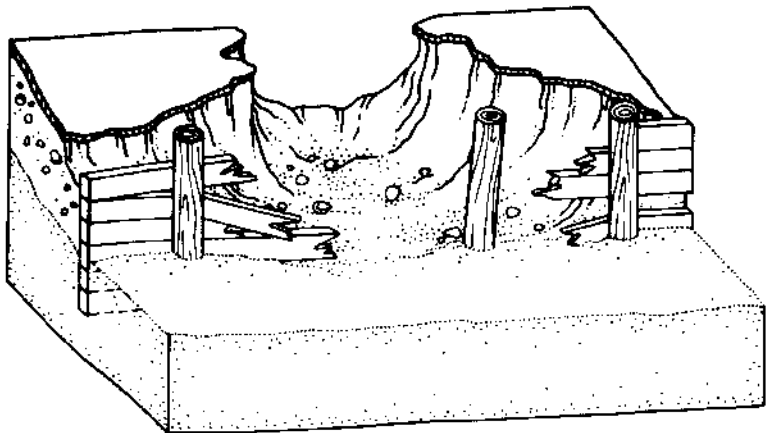
Figure 35
Progressive lateral failure of
wood seawall.

A. Initial summer conditions

B. Overtopping by storm waves and failure of lagging

C. Failure of wall and loss of fill
