LOCATION AND ASSESSMENT OF HURRICANE ANDREW DAMAGED VESSELS ON BISCAYNE BAY AND ADJOINING SHORE AREAS

VOL. 1: TEXT AND APPENDICES

Location and Assessment of Hurricane Andrew Damaged Vessels on Biscayne Bay and Adjoining Shore Areas

Project No. PD-92-10
Grant No. NA89AA-D-SG-053

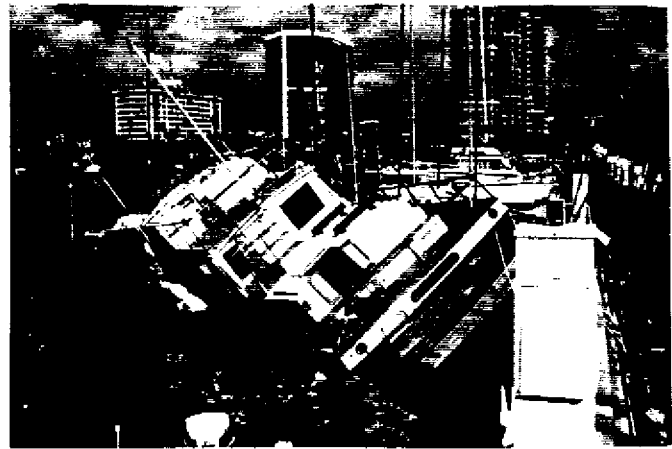
Photo 2: Partially Submerged Vessel, Dinner Key

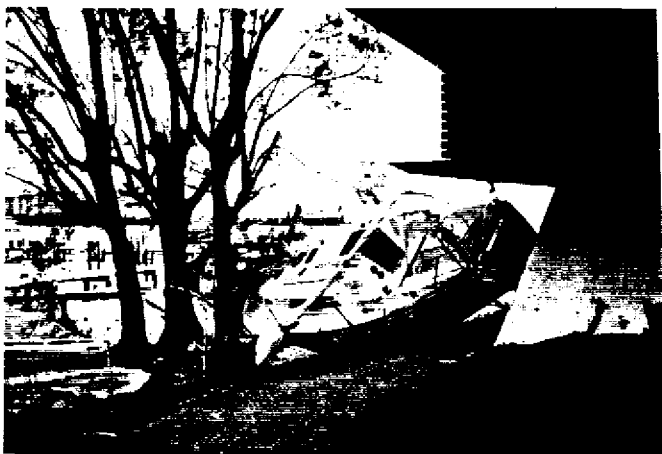
Photo 3: Wrecked, Aground Vessel, Pier House Restaurant, Coral Gables

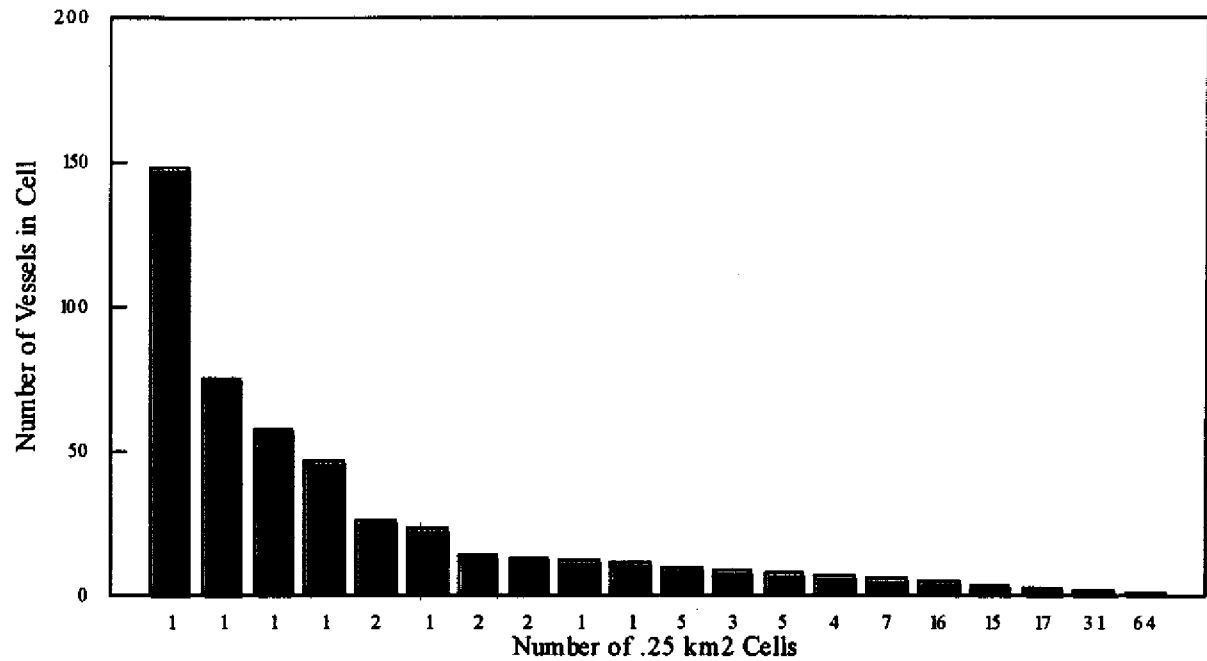
Figure 10: Concentrations of Hurricane Damaged Vessels

storm's northwall and within the "dangerous semi-circle," account for high damaged vessel concentrations; about 325 cases were clustered in 4 (0.25 km²) locations (Figure 10).

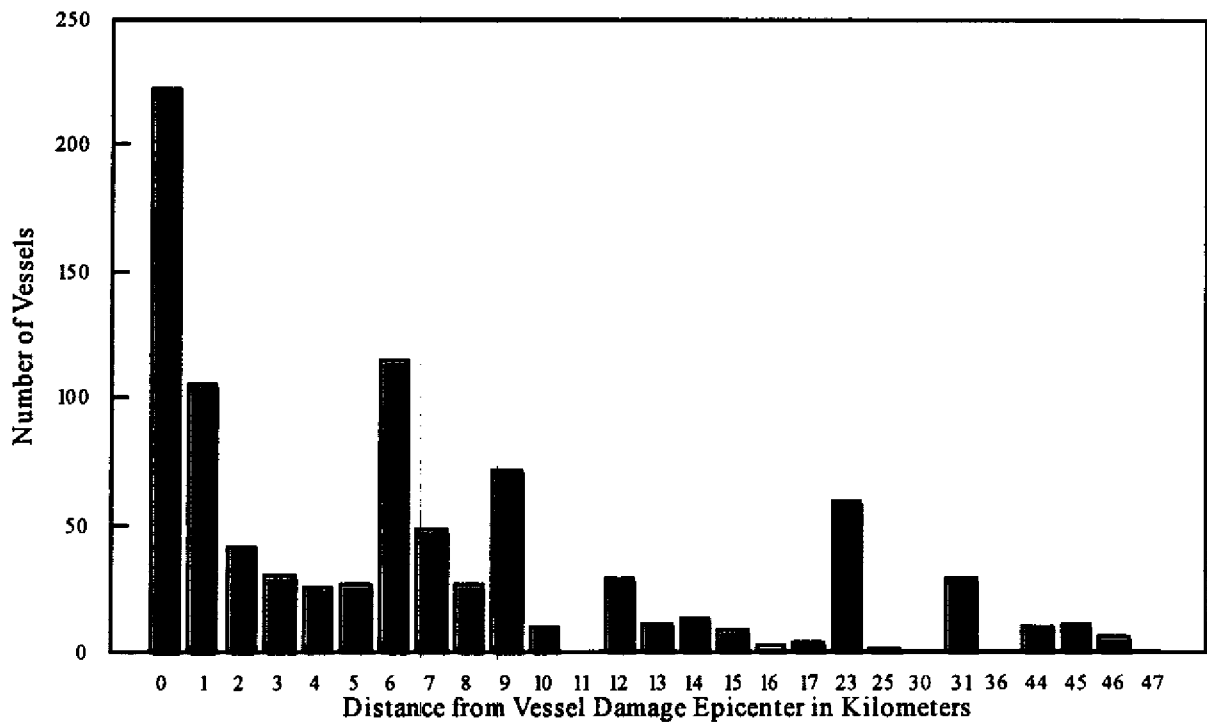
Figure 11: Density Distribution of Hurricane Damaged Vessels and Distance from Damage Epicenter

The site of greatest devastation -- the damage epicenter -- was landward of Picnic Islands, Dinner Key (UTM 5770740/2845272). More than one-third of damaged and sunken vessels were situated less than 2 km from this epicenter. The high densities of vessels at some locations, as at Dinner Key, Coral Gables Waterway, Coral Bay, combined with their location on the fringe of the

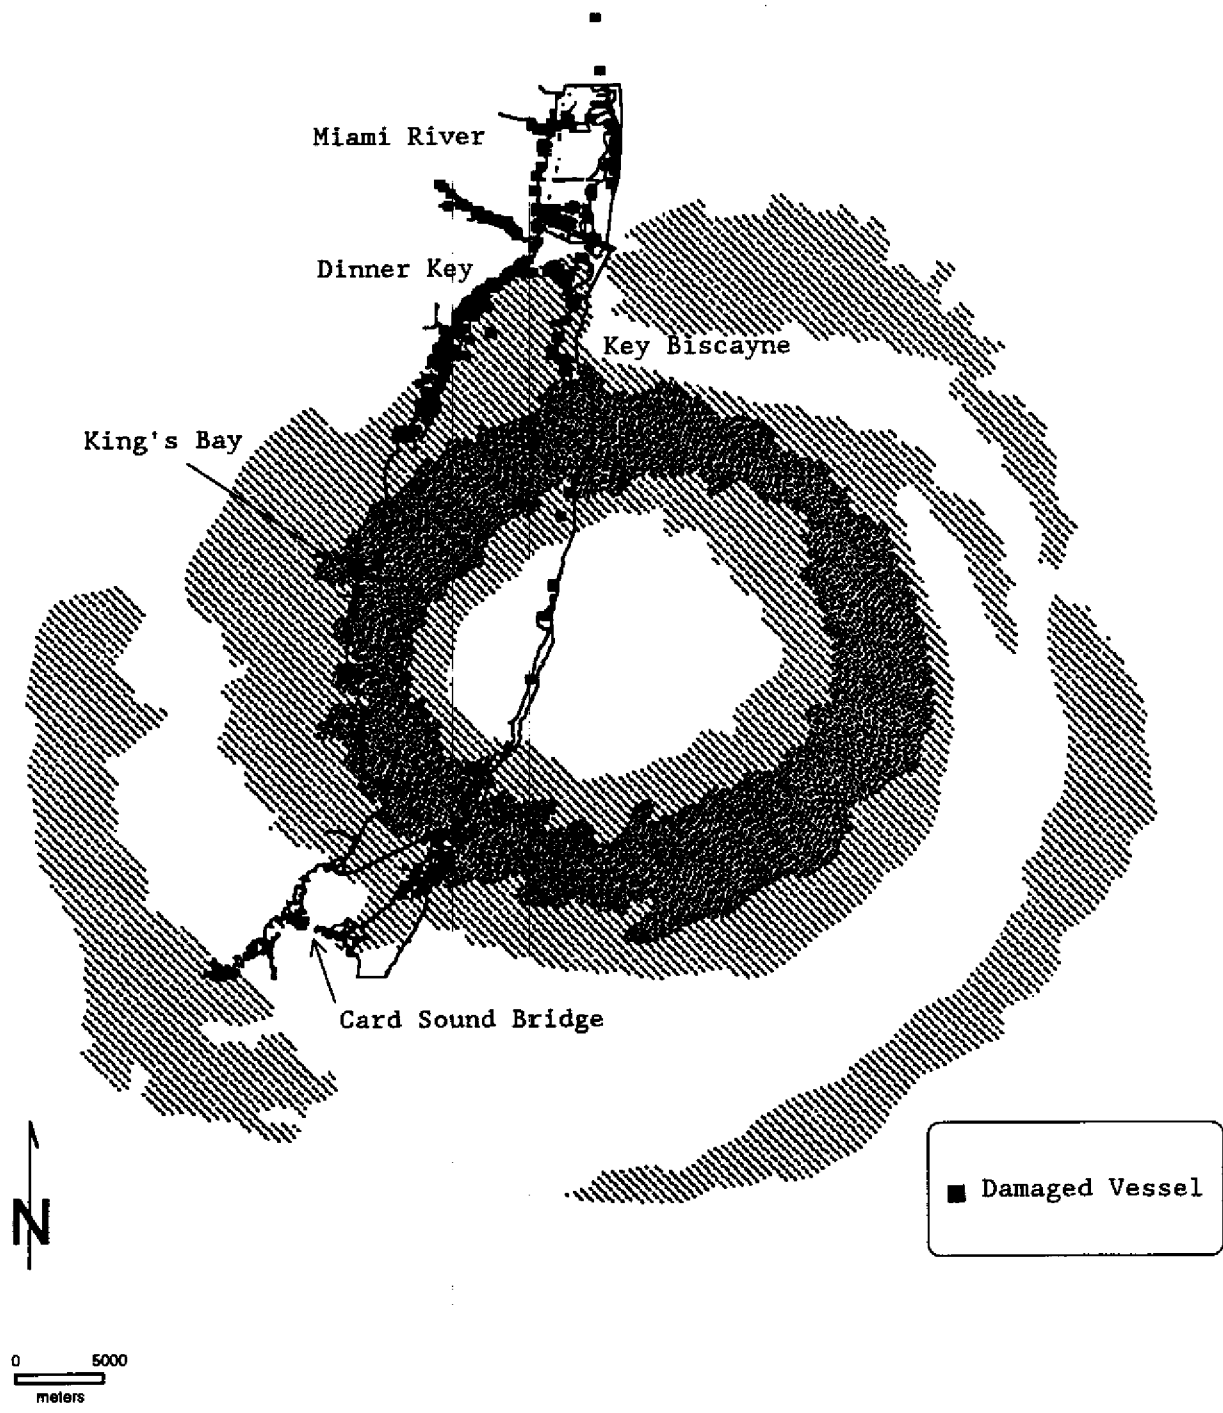
Figure 12: Location of Hurricane Damaged Vessels in Relation to Storm at Landfall (Radar Miami, August 24, 1992, 8:30 UTC)

Hurricane Andrew's landfall in the Ragged Keys placed Miami's moored recreational vessels within the "dangerous semi-circle" of the storm's track. This fleet was exposed to Category 4 hurricane force winds plus the forward speed of the storm (Figure 12). A total of 918 hurricane damaged vessels were identified within the area south of the 79th St. Causeway (north), north of the Card Sound Bridge (south), and seaward from 100 m landward of the shoreline. Roughly, and equally, one-third of the damaged vessels were completely or partially submerged, damaged but floating, and damaged aground (Table 2).

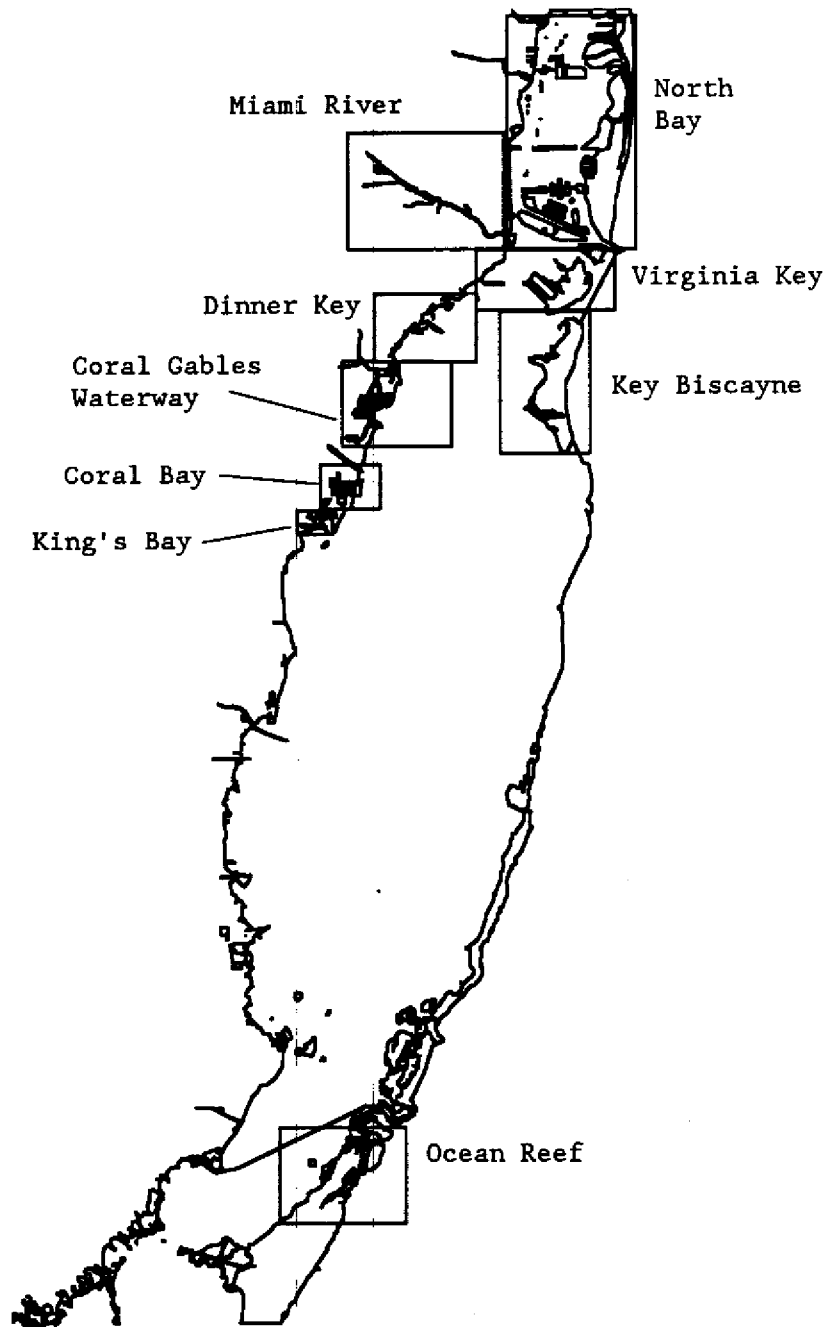
Figure 13: Principal Locations of Potential Impact by Damaged Vessels

Nine geographic areas of potential impact from hurricane and derelict vessel damage and sinkings were identified (Figure 13). Table 8 shows that Dinner Key covered the largest area (145.63 ha) followed by North Bay, Coral Gables Waterway, Key Biscayne, Virginia Key, Miami River.
