ASSESSMENT OF THE BREAKWATER  
STRUCTURES AT CLINTON REEF MARINA,  
PORT CLINTON, OHIO

Charles E. Herdendorf  
Center for Lake Erie Area Research

Clinton Reef Marina  
Port Clinton, Ohio 43452

June 1987

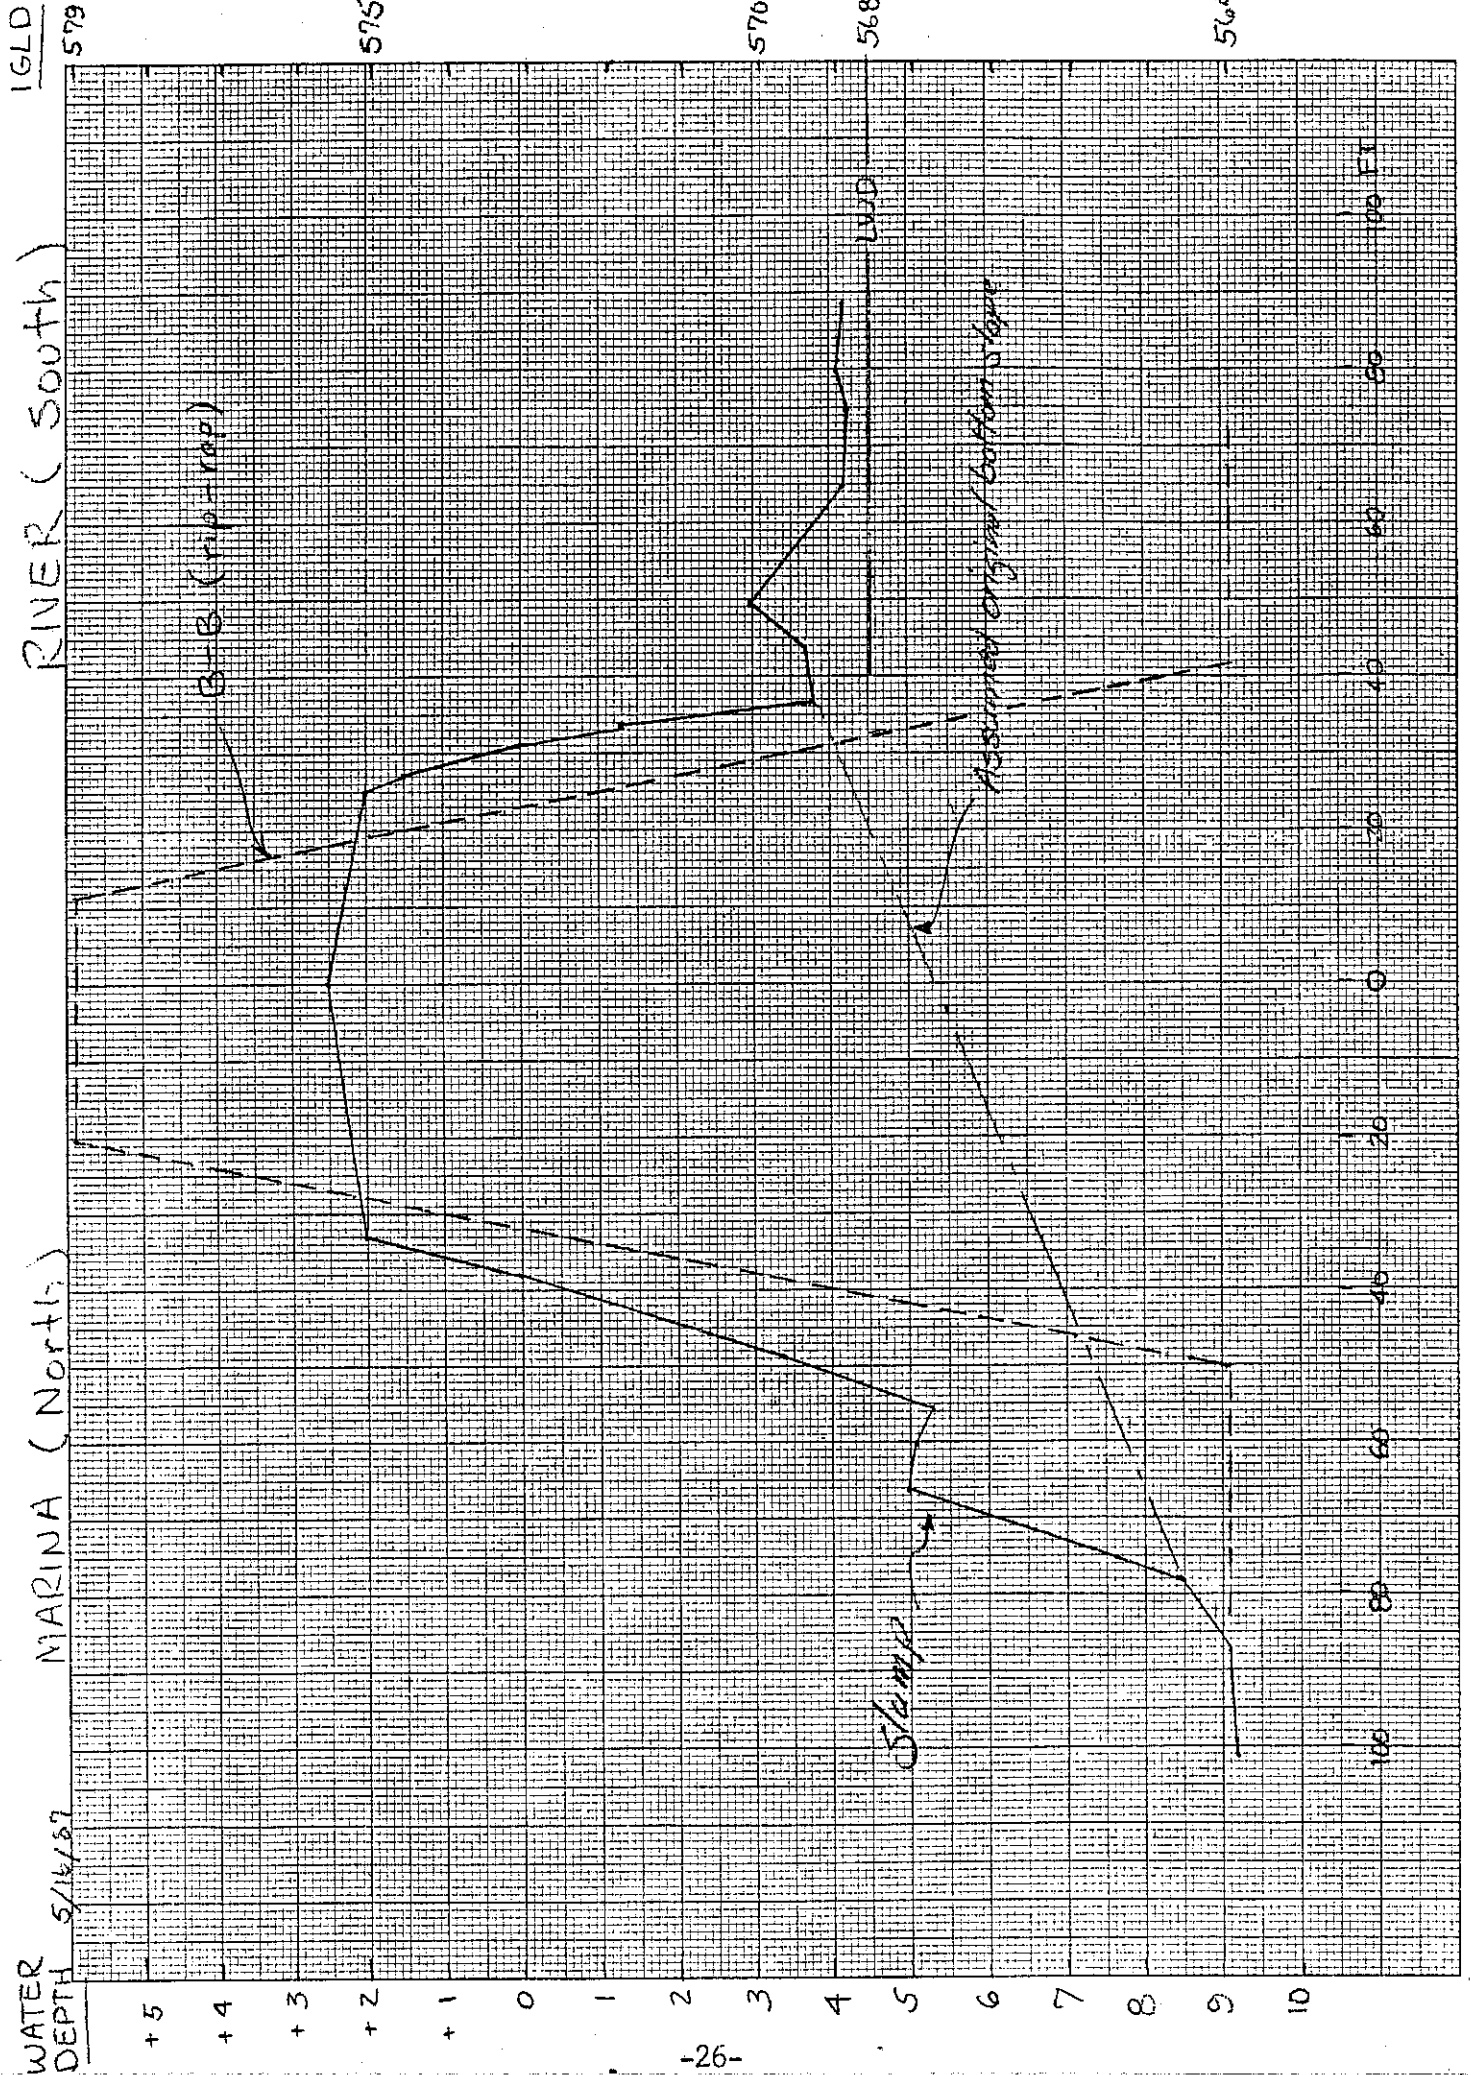
Figure 4. Depth Profile line at Station 1.

The east arm of the south breakwater (Figures 4-5) has a mean cross-sectional area within 0.5% of the plan. At the water line, this structure is about 14 ft wider than the plan and 43 ft wider at its base. The west arm appears to have suffered more underwater slumping (Figures 6-7), thereby exceeding the plan cross-sectional area by 13%. At the water line, the west arm is also 14 ft wider than the plan, but its base is 64 ft wider.

Station:	<u>1</u>	<u>2</u>	<u>3</u>	<u>4</u>	<u>5</u>	<u>6</u>	<u>MEAN</u>
	-27.9%	+26.8%	+12.0%	+14.8%	+22.7%	+14.4%	+10.4%

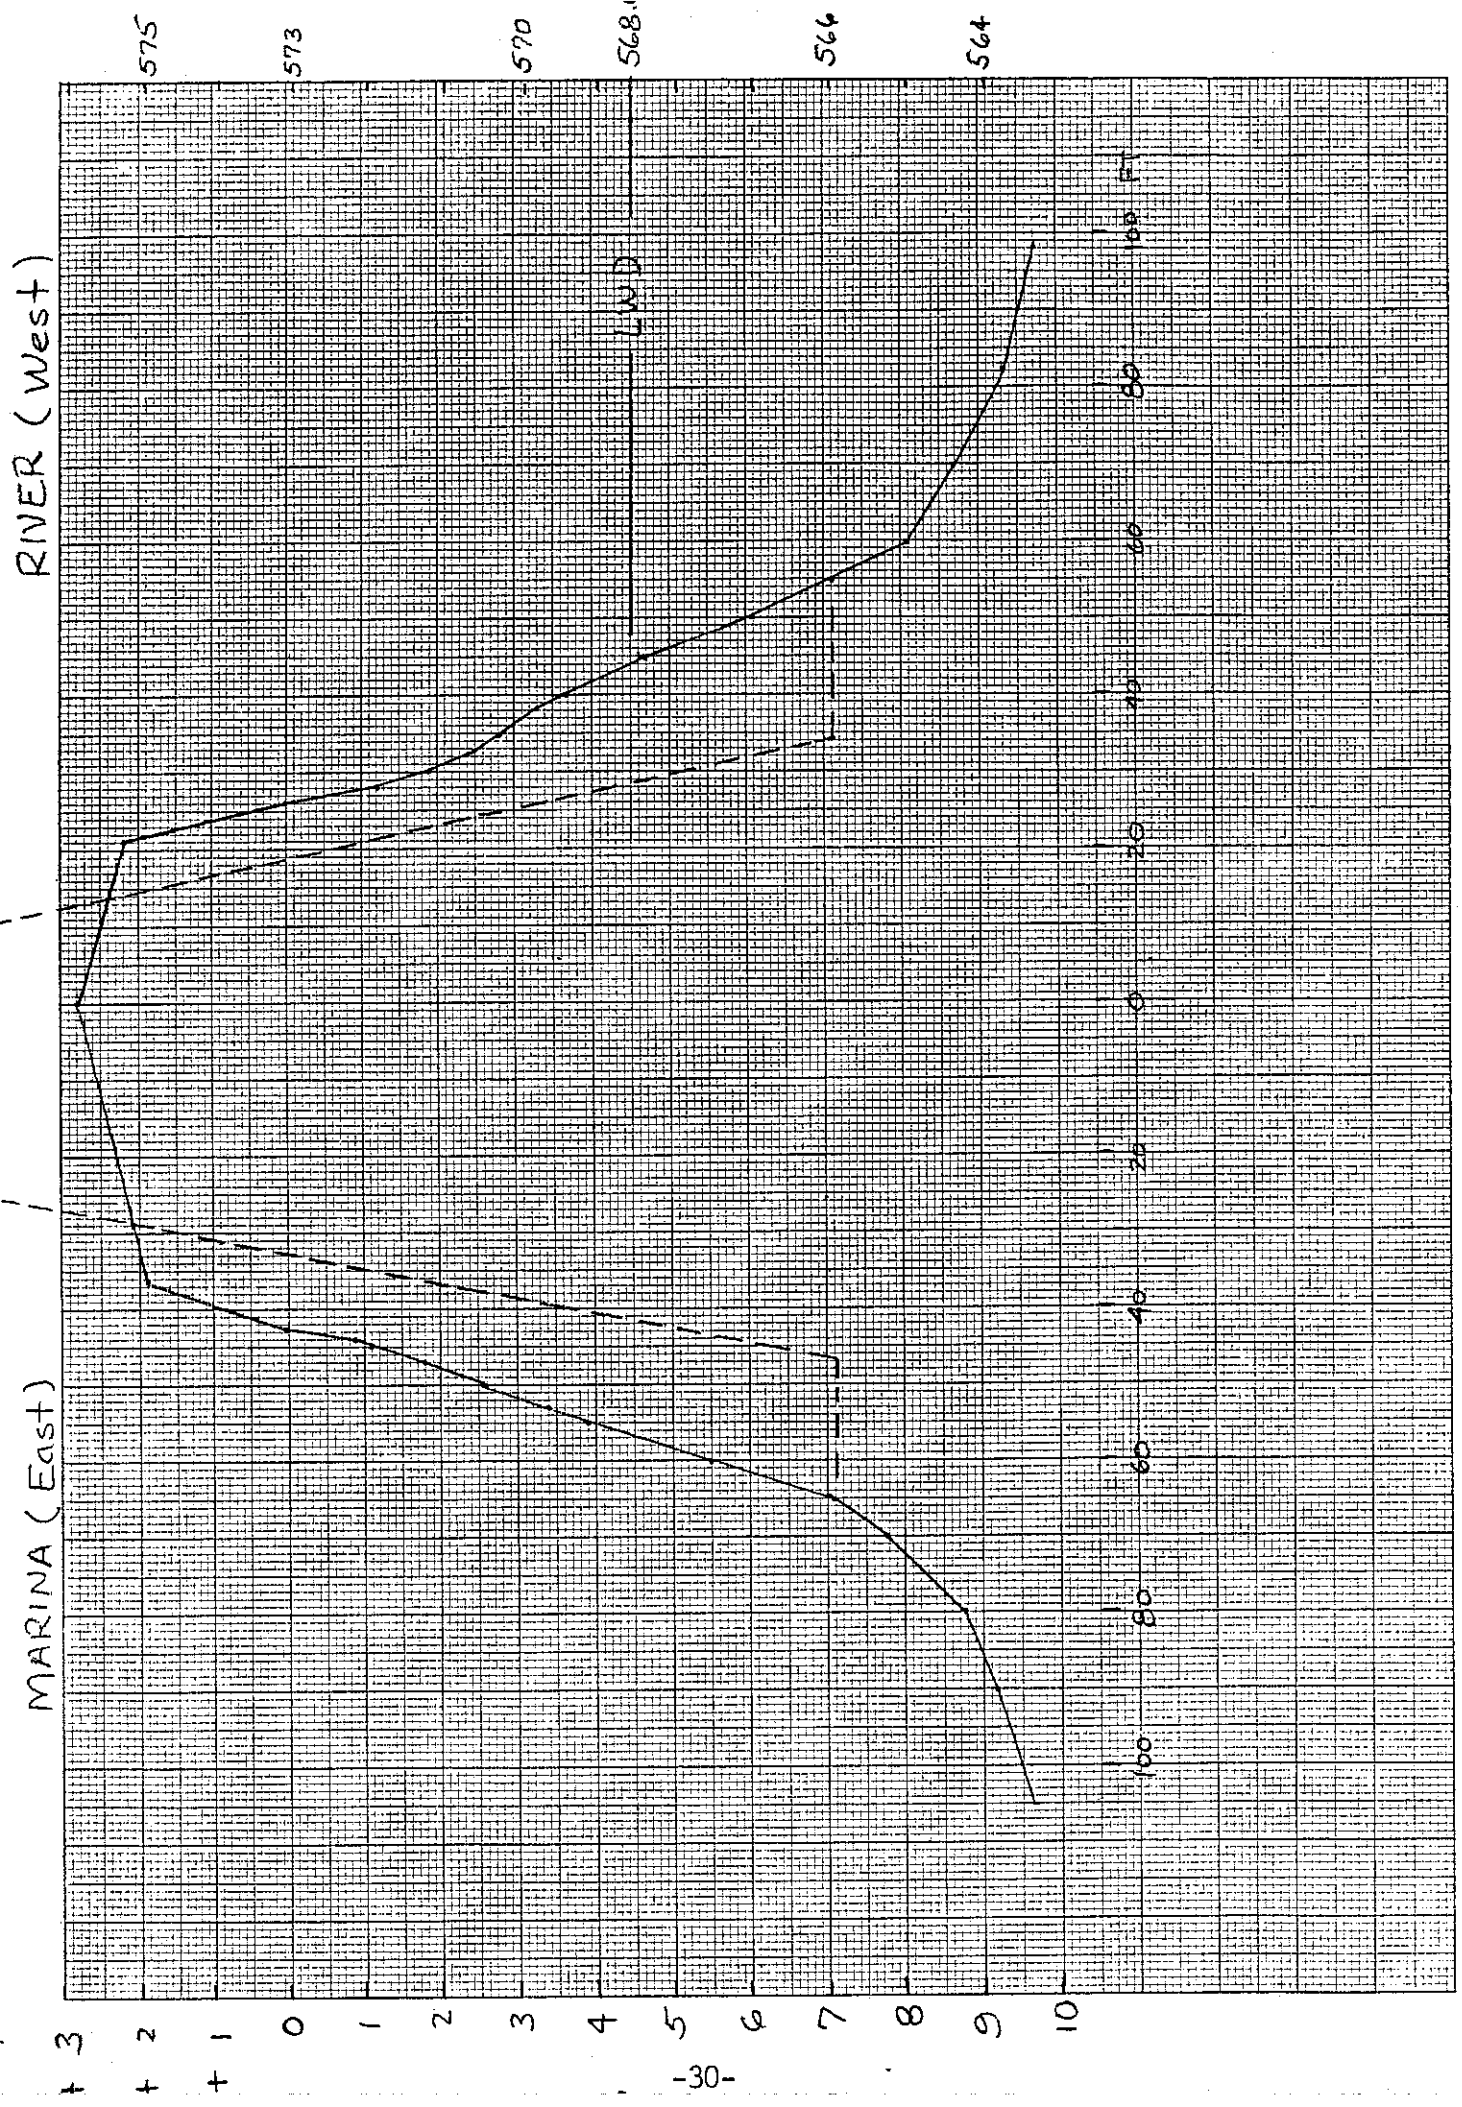
Figure 8. Depth Profile Line at Station 5.

Hydrographic surveys (Figures 8-9) show that the west breakwater is reasonably close to the profile of typical section C-C in terms of slope. At the water line, this structure is

approximately 18 ft wider than shown in the plan. Because of slumping at the toe of this structure, the base is about 31 ft wider than the plan. In terms of cross-sectional area, this structure exceeds the plan by about 19%.

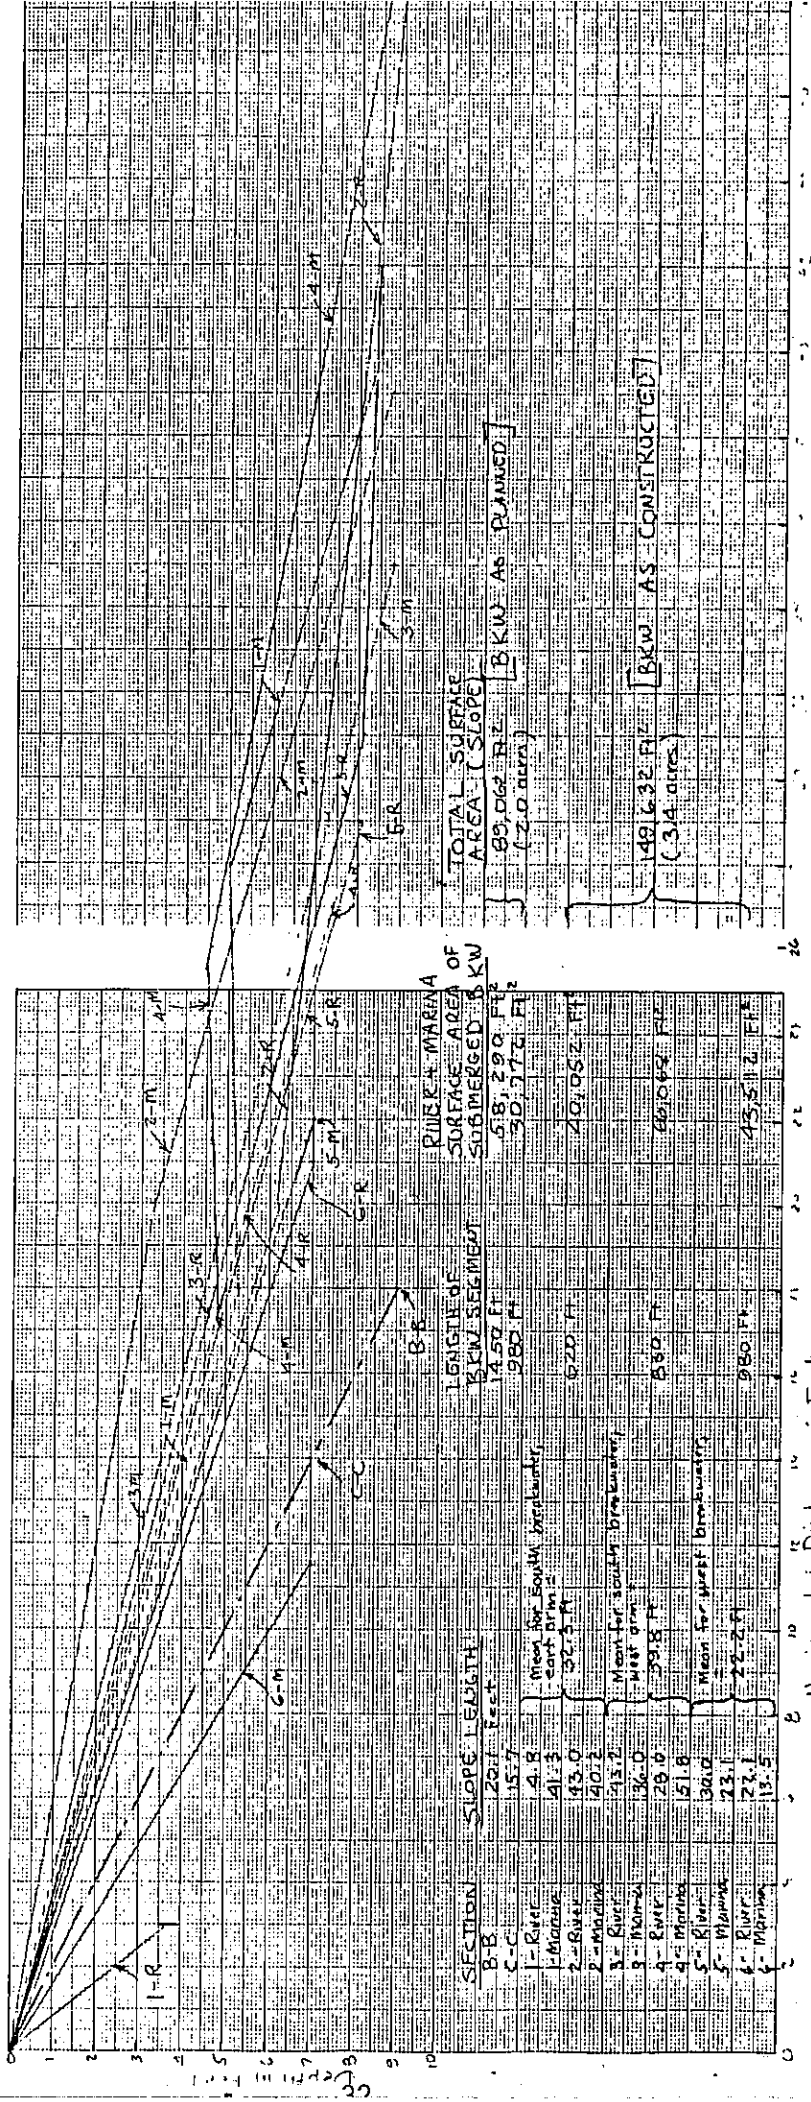
Due to the more gentle slopes the structure covers approximately 60% more mud, river bottom than called for in the plan. However, because of the gentle slope the surface area of submerged rip-rap habitat has also increased (Figure 10):

Figure 10. Comparison of slope distance and area between planned and constructed breakwaters at Clinton Reef Marina.
