Corrosion of Steel and Aluminum Scuba Tanks

Francis C. Cichy
Hilbert Schenck
John J. McAniff

Francis C. Cichy
Mechanical Design Engineer,
Beloit Corporation, Jones Division,
Dalton, Massachusetts

Hilbert Schenck
Professor of Mechanical Engineering,
University of Rhode Island

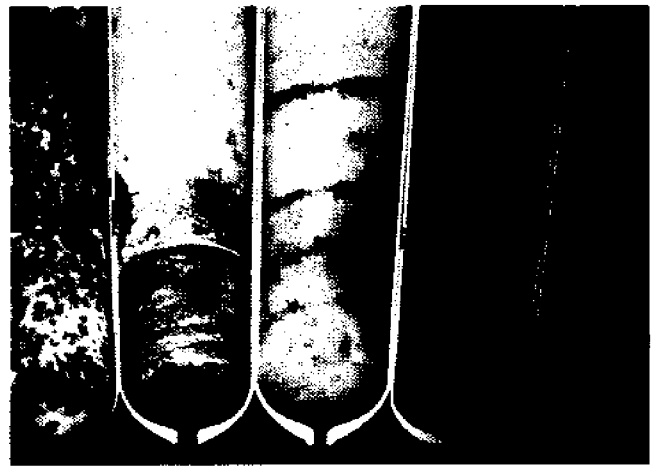
Figure 2. Sectioned halves of five condemned-in-service steel cylinders.

This cursory study of "cylinders of opportunity" suggests a similar picture to that presented by the accidents noted in the previous section. That is, some cylinders may suffer dangerous wall thinning but will tend to be spotted before they explode. The valve-blocking danger from large amounts of loose rust in the tank may well be the more serious accident possibility stemming from tank corrosion.

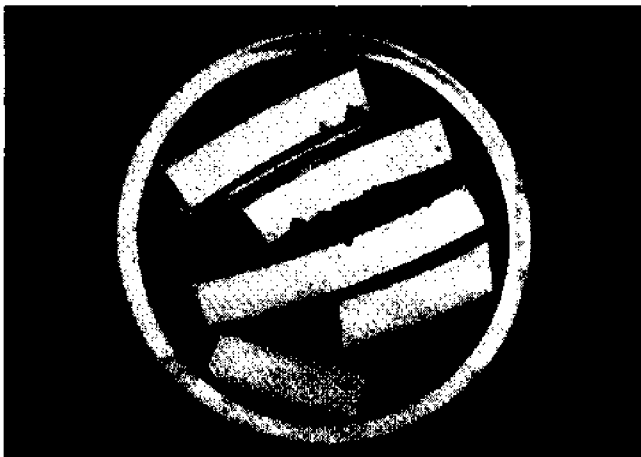
Figure 3. Various wall sections from a tank manufactured in 1961. Some of these pits extend one-third of the way into the wall.

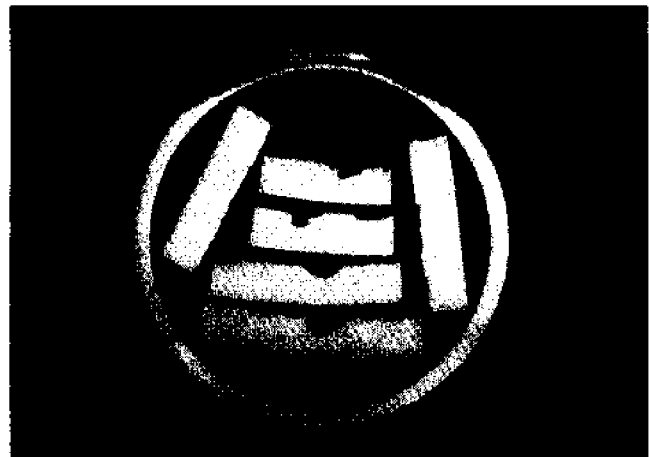
The wall sections in Figure 4 show the worst case of pitting in the 40 cylinders. This was an unevenly coated cylinder made in 1963, with corrosion damage heavy in the lower half. The detected thinning here was almost one-half the wall thickness, but deeper pits could have been present. Out of the eight sectioned cylinders, four had "large amounts" of rust, enough to plug or stop an air regulator if the diver maneuvered so as to bring the particles down over the regulator valve inlet extender.

Figure 4. Various wall sections from a tank manufactured in 1963 that was unevenly coated. These were the deepest and most serious pits found in the condemned-in-service cylinders.

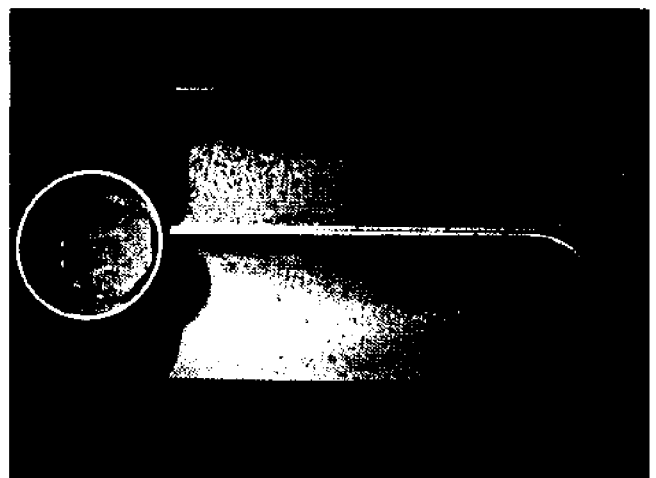
Figure 8. General view of Tank 8422. Corrosion is light except in bottom, where an extensive corrosion ring appeared.

Because water surface area obviously has a large effect in the rate at which this attack proceeds, Tank 8422, Figure 8, showed less wall thinning, although a complete and complex corrosion ring formed at the water surface to steel interface. The section, Figure 9, shows how the ring grows by depleting the parent metal beneath.

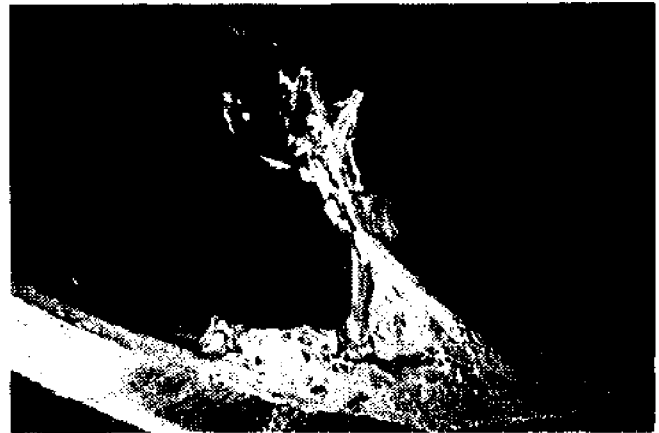
Figure 9. Close-up (1½ inches wide) of cross-section of corrosion ring in Tank 8422. Note that the ring grows by depleting the parent wall metal beneath it.

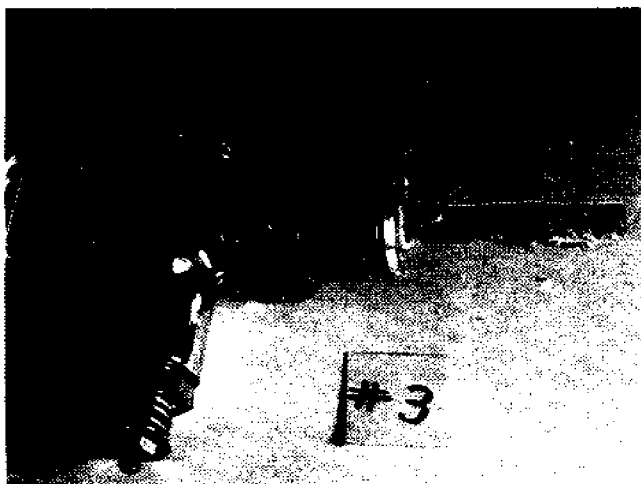
Figure 12. Valve of test cylinder 31365. Note the accumulation of corrosion products on the brass extender and within the threads.

Another accelerating effect in 31365 was the direct corrosion of the brass extender and the resulting continual introduction of copper ions into solution. The combination of anionic species contained within the salt water, such as chloride and bicarbonate ions (present as NaCl and NaHCO_3), dissolved oxygen, and copper ions, will have a synergistic effect, thus increasing the overall rate of attack (Becerra and Darby, 1974; Porter and Hadden, 1954; and Davies, 1959). Corrosion of the actual brass was verified by running X-ray fluorescent patterns on the corrosion products removed from the brass extender (see Figure 12). The results showed these products contained substantial quantities of both copper and zinc. In addition, copper depositions were found throughout the entire wetted surface area of 31365 as brown or reddish-brown stains, indicating areas where the copper had actually plated out on the aluminum (Figure 13).

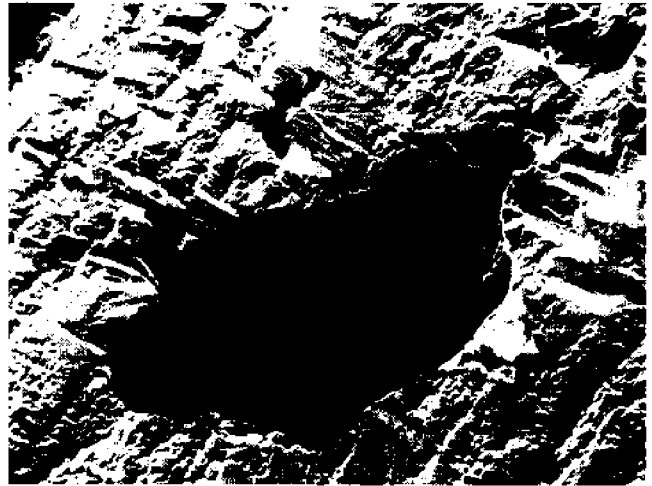
Figure 15. Overall view of pit in Tank 31365, using a scanning electron microscope at 50X. Note the initiation of pits at major flaws in the oxide film.

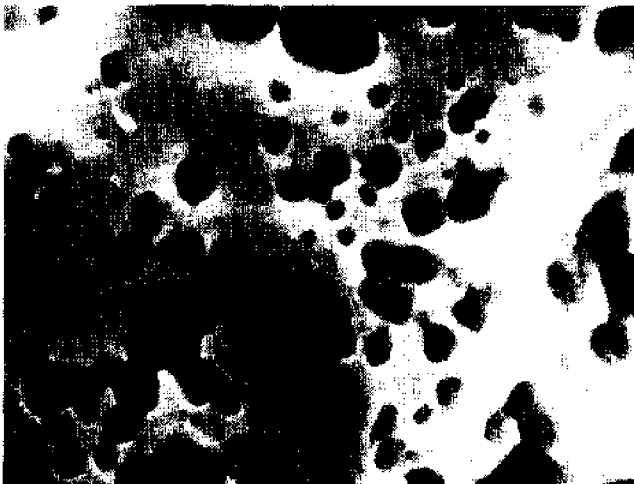
Figure 16. Characteristic bottom structure of the aluminum pits, taken with a scanning electron microscope at 5000X. The many small pits present at the very bottom of the pit appear to initiate and guide further growth. This pattern of attack was observed in all aluminum pits studied with the SEM, regardless of their location.

the high magnification of 5000X, tiny new pits, already joining to form crevices, could be seen (Figure 16), and this condition was found in all the pits so studied in cylinders 31365 and 31622.
