AIRPHOTO ANALYSIS OF THE IMPACT OF HURRICANE ALICIA ON GALVESTON ISLAND

Arthur R. Benton, Jr.
Jim M. Bolleter

Remote Sensing Center
Texas Engineering Experiment Station
Texas A&M University

TAMU-SG-85-201
September 1984
Technical Report RSC-6661

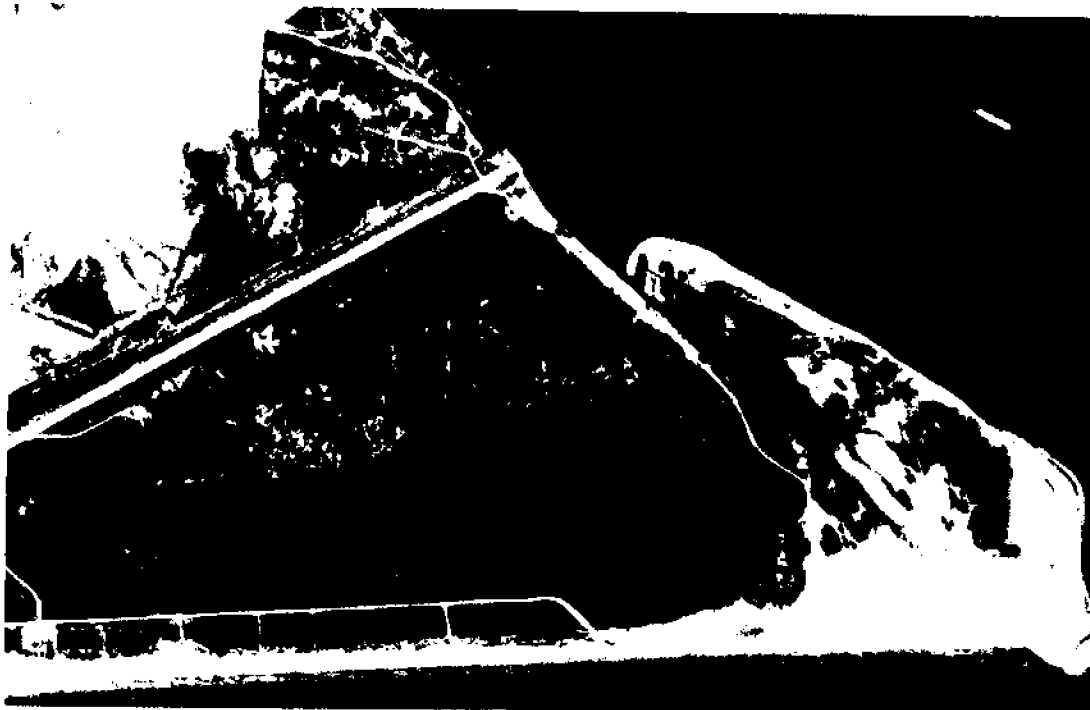
Figure 2. East Beach, September 1979. Remote Sensing Center CIR photo.

Figure 2 shows the northeastern three quarters of East Beach in September 1979. The beach area adjacent to the South Jetty had advanced some 4000 feet since the 1890's; almost all the land area in the photograph did not exist when jetty construction began. The South Jetty, running from top left to the lower

right corner of Figure 2, is met by the seawall just above photo center. The partially vegetated peninsula overlapping the channel at right is Big Reef, composed of sand washed over the South Jetty from East Beach, usually during winter storms.

shows an ongoing advance of the vegetation line. The left half of Figure 2, for example, shows a typical accretionary condition. There was little indication of this in the right half of the photo, but that is because of trail bike and dune buggy traffic on and across the dunes in that area. Along the beach area in the left half, the local government had erected barricades and posted signs in a partially successful attempt to restrict this practice and preserve the newly developed dune vegetation. Figure 3, however, shows that Alicia had removed almost all indication of recent advance.

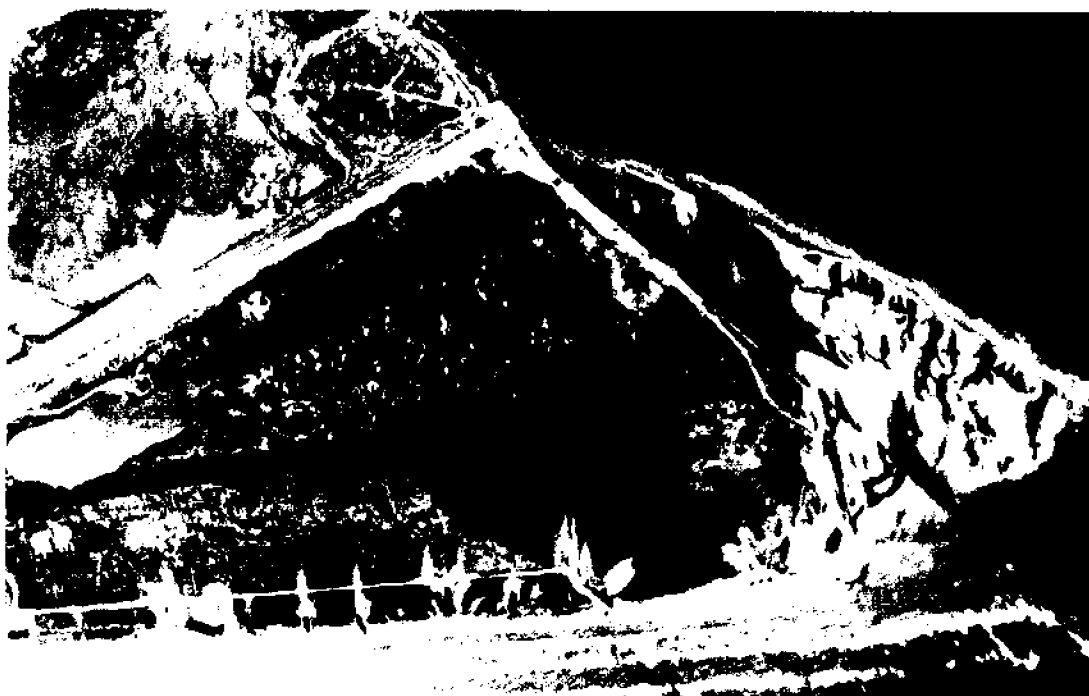
Figure 3. East Beach, September 1983. Remote Sensing Center CIR photo.

Note the sand plumes extending back behind the beach from the roads which ran perpendicular to the beach in the 1979 photo. Throughout East and West Beach, sand scour was greatest along this type of road, since there was no vegetation to maintain the backbeach dunes and bluffs against the forces of wind and sea. The long, narrow, dark patches centered on the beach side of each plume are water-filled ponds created by scour currents.

The new condominium at lower left is flanked by washover fans, the result of vegetation being stripped from adjacent dunes during construction. Compare with the minimal erosion around the older condominium at extreme lower left, where vegetation had been left reasonably intact prior to the storm. Note also the additional dredge spoil deposited at upper left since 1979.

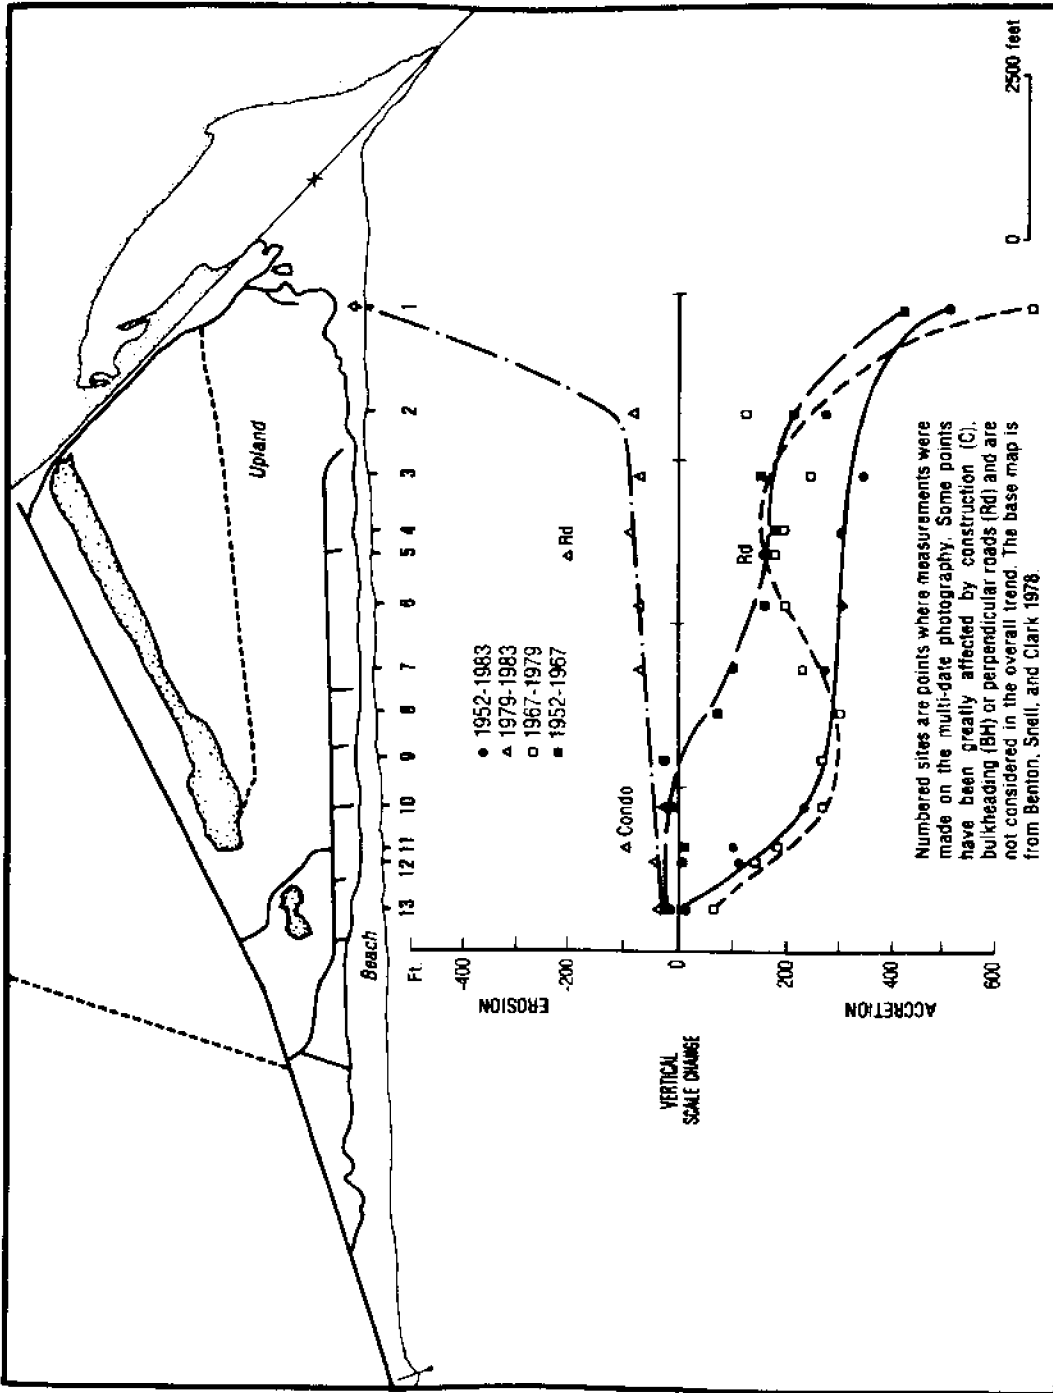
Figure 4. Shoreline Changes, East Beach, 1952-1983

The curves in Figure 4 show short- to mid-term erosion at East Beach since 1952. Points 1 through 13 are transects along which vegetation-line distances were measured on the 1952, 1967, 1979 and 1983 aerial photography. The curves show that East Beach was accreting during all periods except for 1979 to 1983. It remains to be seen whether East Beach will again recrete in the coming years.

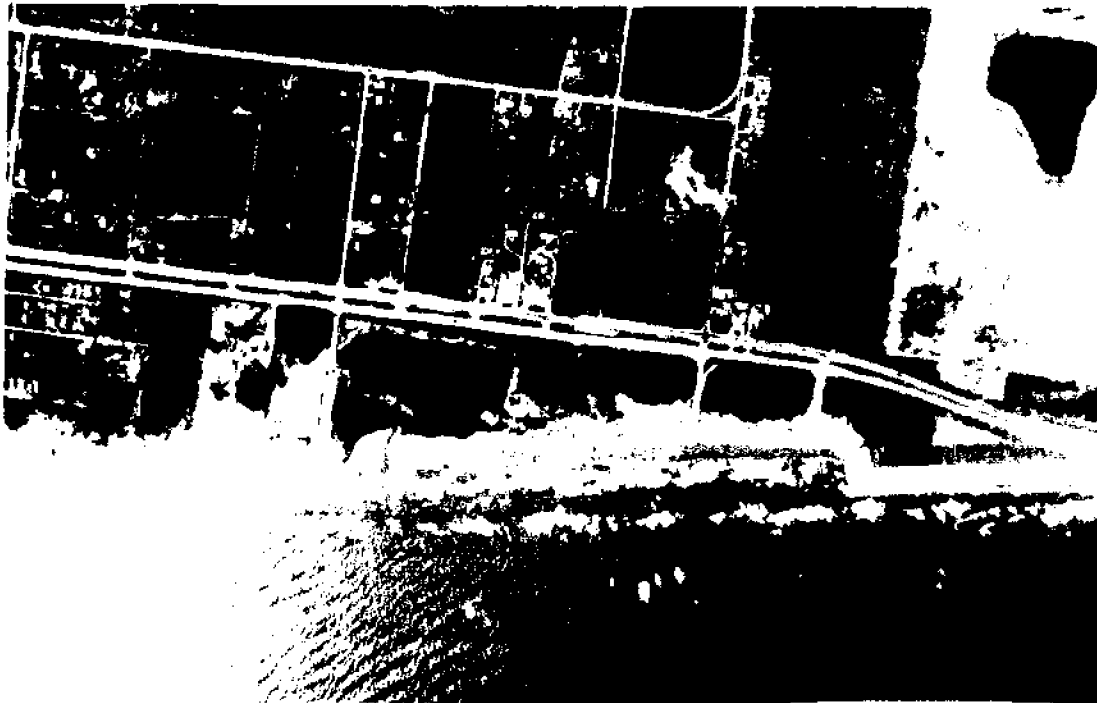
Figure 6. End of Seawall, 1983. Remote Sensing Center photo.

Figure 6 on the next page, taken in September 1983, shows the same beach area after Hurricane Alicia. This late-summer photo shows that the shoreline had retreated about 275 feet since 1967, a mean erosion rate of some 17 feet per year. Note that two of the borrow pits, well back from the shoreline in 1967, fronted on the Gulf after Alicia. Note also that four of the five beachfront houses in the 1967 photo were gone by 1983 and the fifth was standing out in the surf swash zone. As will be discussed further along, the erosion rate in this area has apparently accelerated since the mid-1970's.

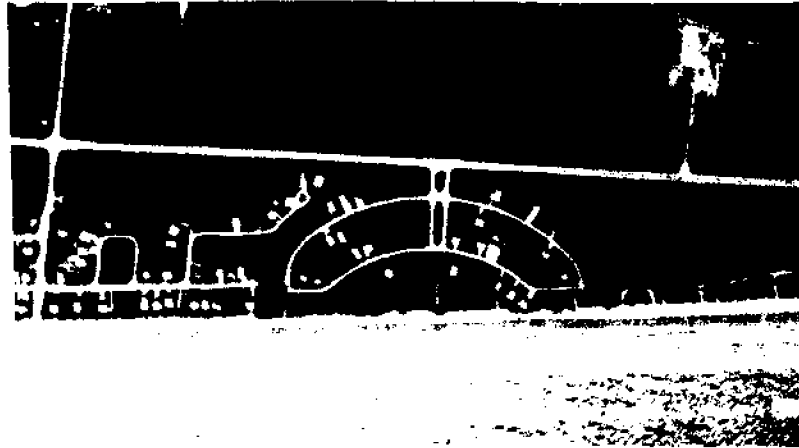
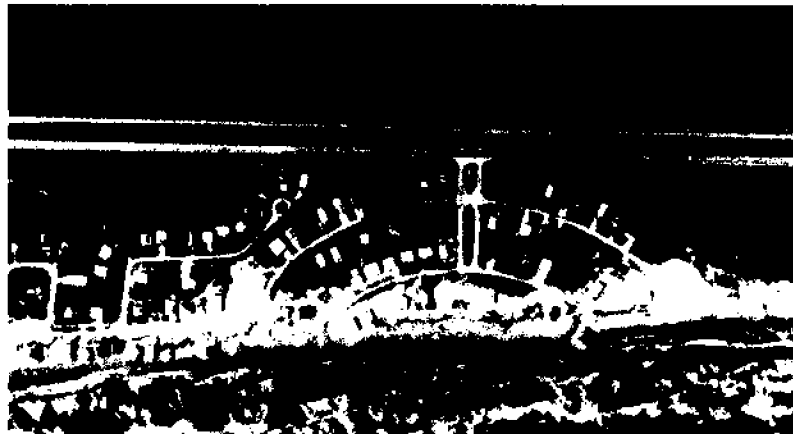
Figures 7 and 8 show Spanish Grant, the first beachfront subdivision beyond the seawall, in September 1977 and September 1983, respectively. The vegetated bluffline, quite distinct in Figure 7, is seen in Figure 8 as a thin, irregular dark line separating the beach from the sand lens washed onto the top of the bluff by the storm. In 1977 all beachfront homes were comfortably back from the edge of the bluff, although the yard of the one farthest on the right jutted onto the beach slightly, its edge protected by rip-rap (see Figure 9). After Alicia that house was standing in the surf swash zone. The homes at left have fared somewhat better, but they, too, found themselves on the public-beach side of the vegetated bluffline after passage of Alicia.

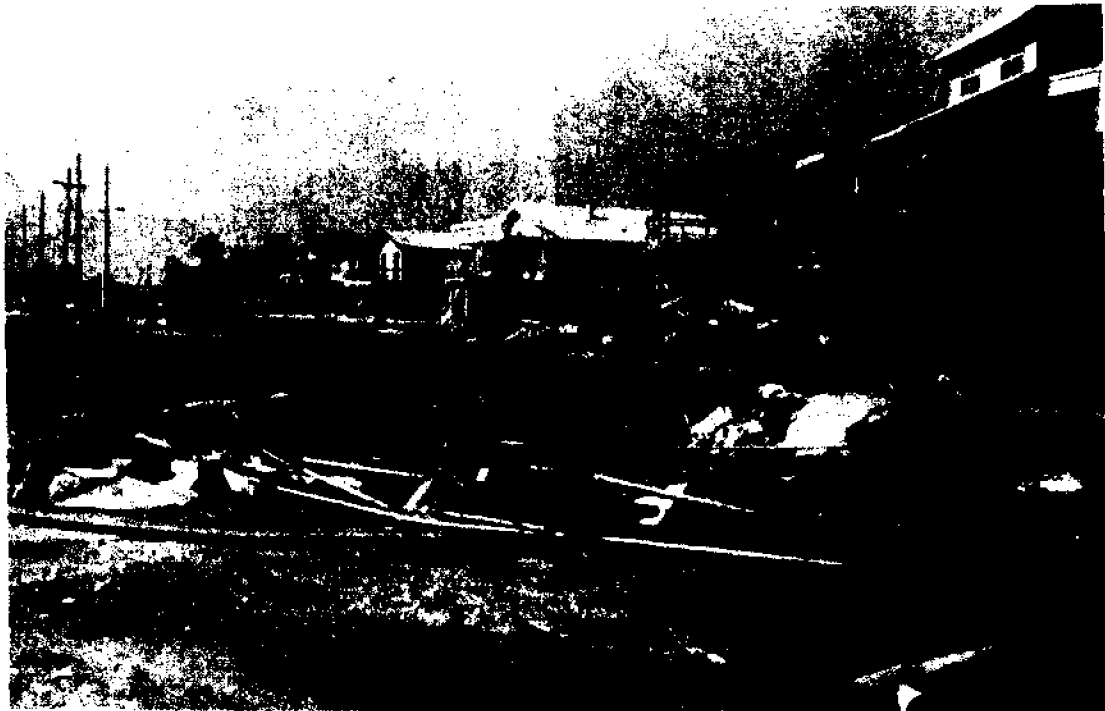
Figure 11 on the next page shows damage to underground utilities at the southwest edge of the Spanish Grant subdivision, about 1200 feet southwest of

Figure 11. Undermined Utilities at Spanish Grant, 1983. RSC photo.

the house in Figures 9 and 10. The homes on the left are actually in Bermuda Beach, the next development to the southwest. Although beachfront property tends to be snapped up rather quickly, what we see here is a case of developed frontage being eroded away before houses could be built on it.

Note that there is no evident structural damage to any of the homes in the photo despite the very extensive damage to the lightly paved street and to the utilities buried under it. Dwellings in these two relatively new subdivisions seem better built than those in older areas on West Galveston, and this could account for the modest amount of apparent damage in the immediate area.

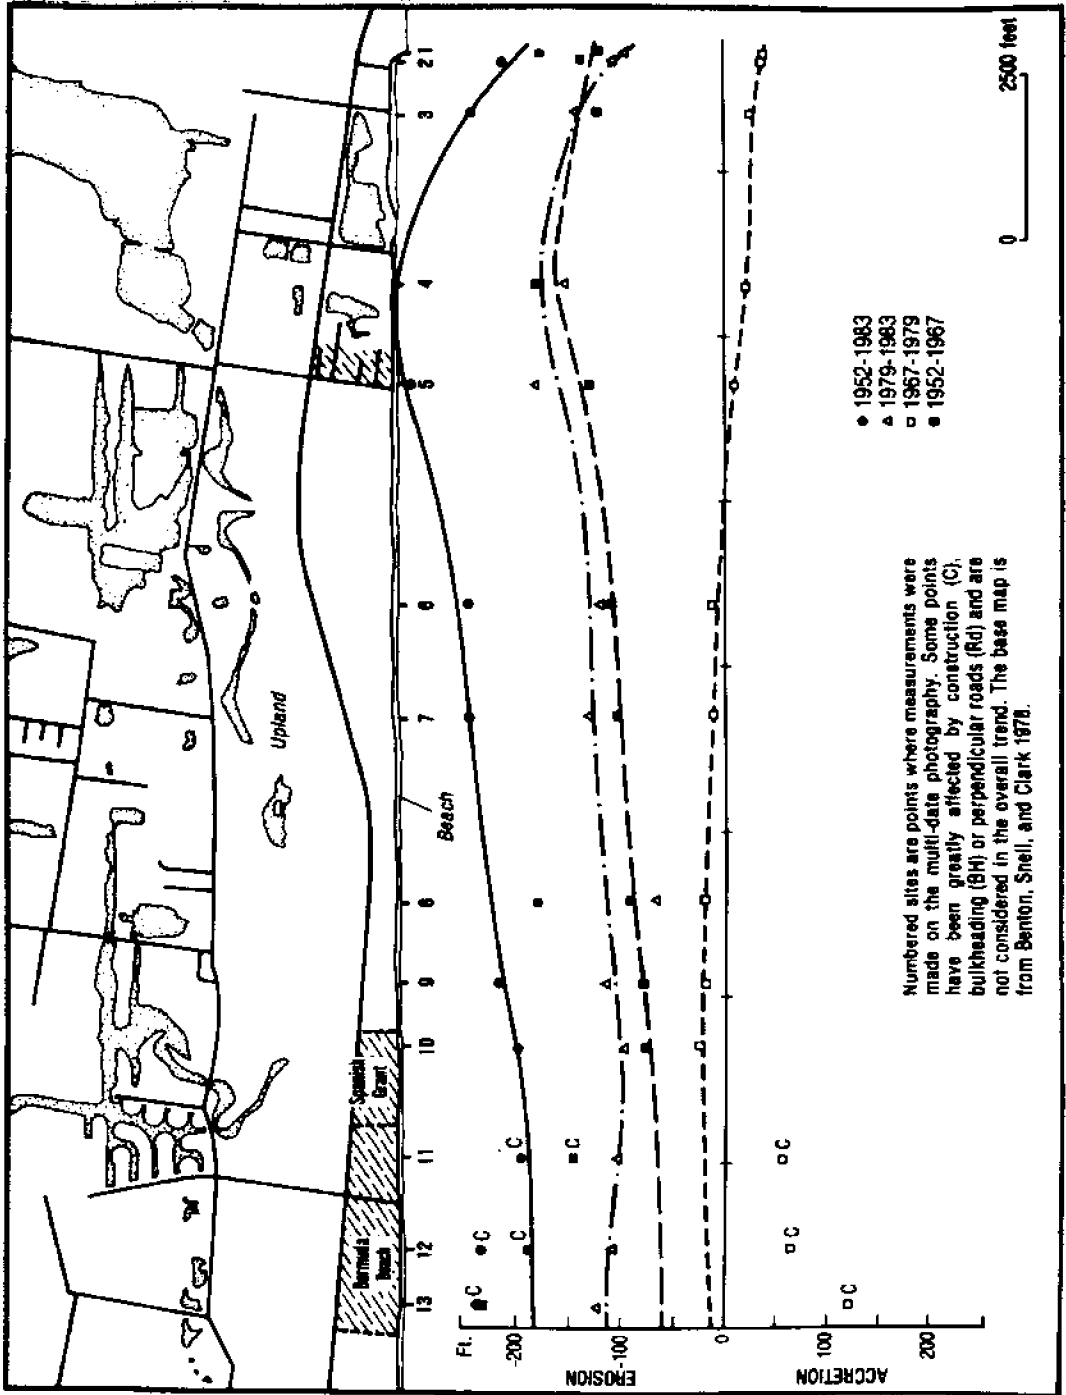
Figure 12. Shoreline changes, end of Seawall to Bermuda Beach, 1952-1983

Figure 12 is the set of curves showing erosion amounts over four different timespans for the area just discussed. Half a mile from the seawall the loss of beach from 1952 to 1983 was over 300 feet, a rate of about 10 feet per year. Of that 300 feet, just over half eroded away in the interval between 1979 and 1983,

the bulk of that accruing to Alicia. The 1979-1983 rate has thus been nearly 40 feet per year.

Further to the left (southwest) in Figure 12, erosion amounts diminish for all periods except the questionable 1967 to 1979 timeframe. This decrease is to be expected because southwest-moving longshore currents now come around the end of the seawall in a sediment-deficient state, resulting in rapid erosion of the shoreline just beyond. As that line has become deeply indented, the point of maximum erosion has moved to the southwest. This process will undoubtedly continue in the years to come, with the point of maximum erosion moving slightly southwestward with each erosional event. After the first three quarters of a mile or so from the end of the seawall, erosion rates decrease rapidly as the southwest-moving longshore currents approach their sand-carrying capacities.

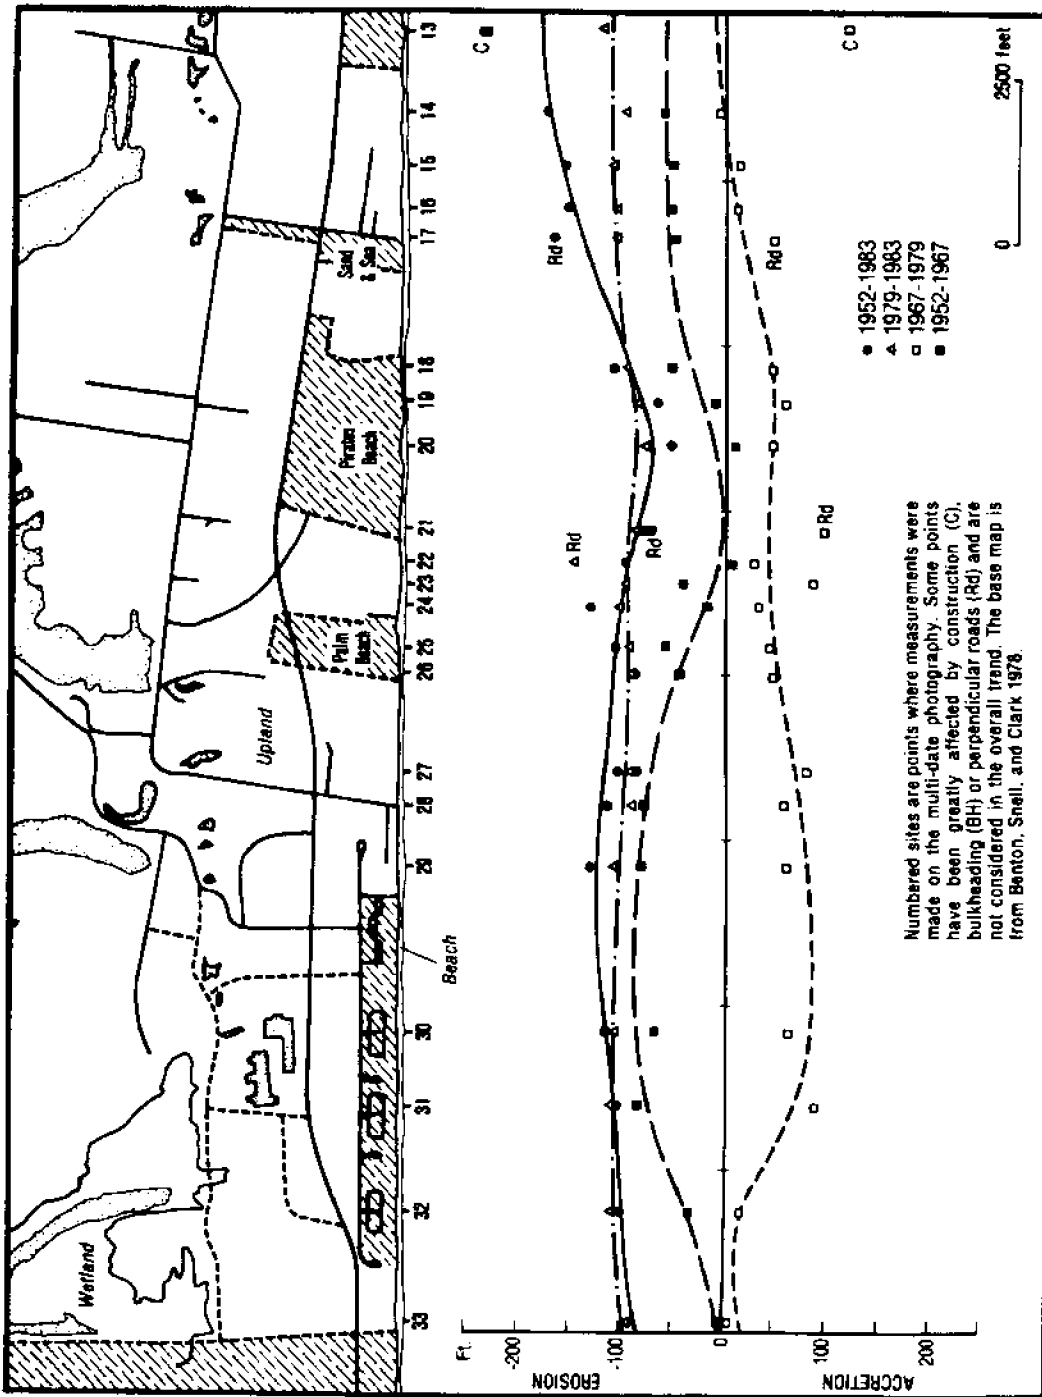
Figure 13. Shoreline Change, Bermuda Beach to Jamaica Beach, 1952-1983

Bermuda Beach to Jamaica Beach - Figure 13 (next page) is the set of shoreline-change curves for the next beach segment to the southwest, the beginning of a long stretch of West Beach shoreline where there was an accretionary trend between 1967 and 1979. Mid-term shoreline change during the 1952-to-1979 period was very near zero, erosion from 1952 to 1967 being generally balanced by accretion from 1967 to 1979. This is evident from comparing the 1952-to-1983 curve with the 1979-to-1983 curve: except for the slight divergence toward the right edge of the figure, 1952 to 1983 is closely matched with 1979 to 1983.

Note that for 1979 to 1983 there was a near-constant 100 feet of erosion. Comparison with post-Hurricane Allen photography shows that most of the 1979 to 1983 erosion was the result of Hurricane Alicia.

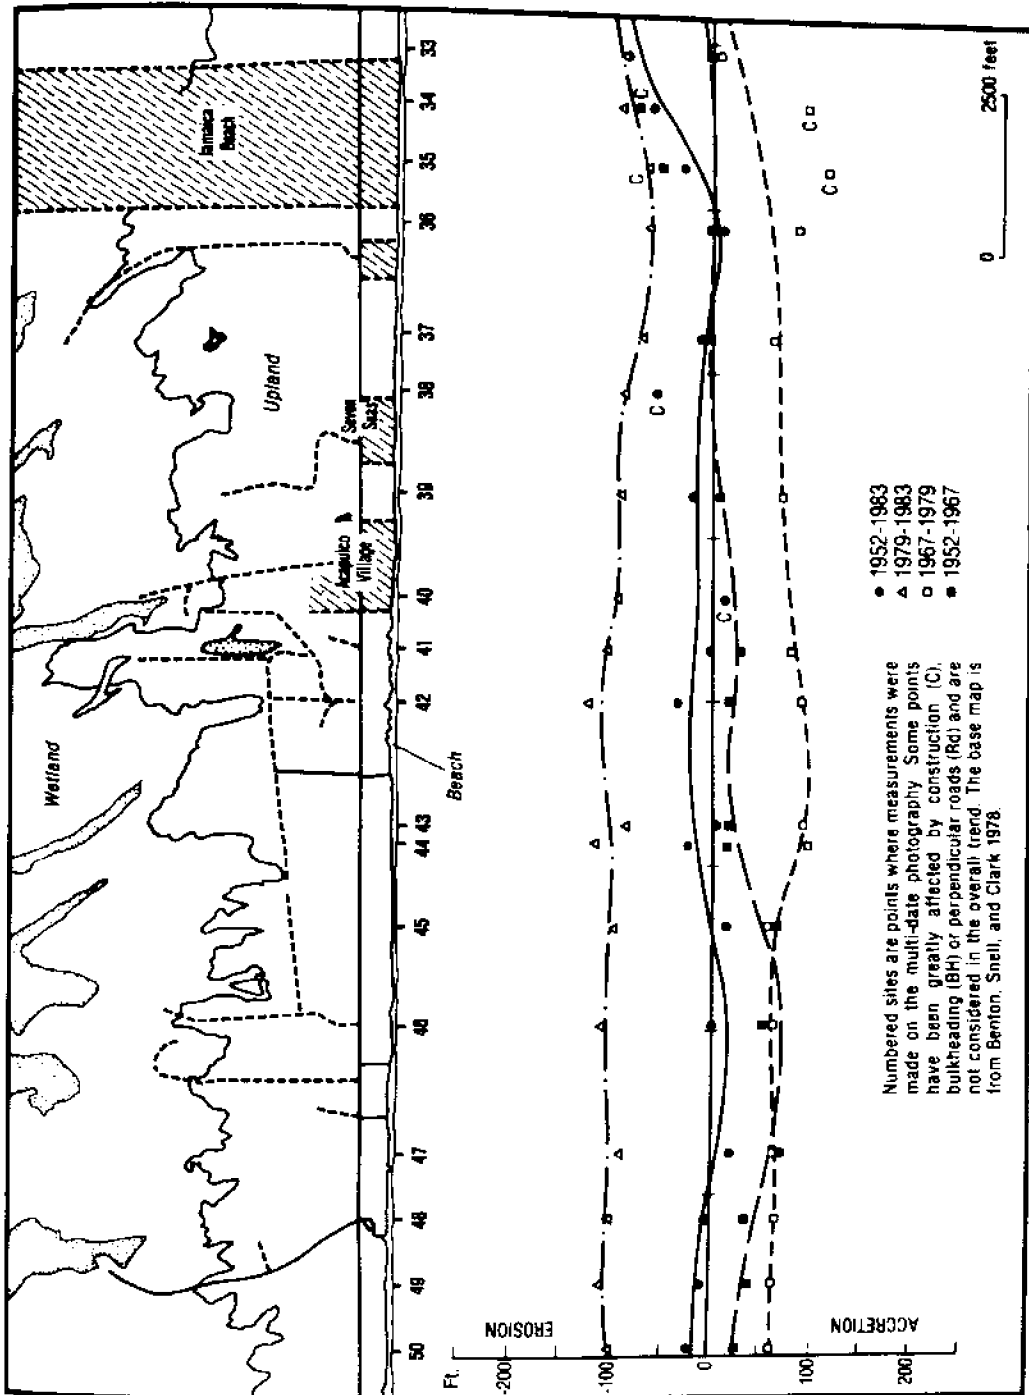
Figure 14. Shoreline Change, Acapulco Village Beachfront Area, 1952-1983

Vicinity of Acapulco Village - Figure 14 shows vegetation-line change values from Jamaica Beach southwestward (West Beach Transect Nos. 33 to 50). Here, for all time periods except 1979 to 1983, there was accretion rather than erosion. Accretion averaged about 10 feet per year over most of this stretch from 1967 to 1979 but less than 5 feet per year from 1952 to 1967. The 1979 to 1983 change was a fairly even 100 feet, the bulk of that due to Alicia, as is the case over most of West Beach.

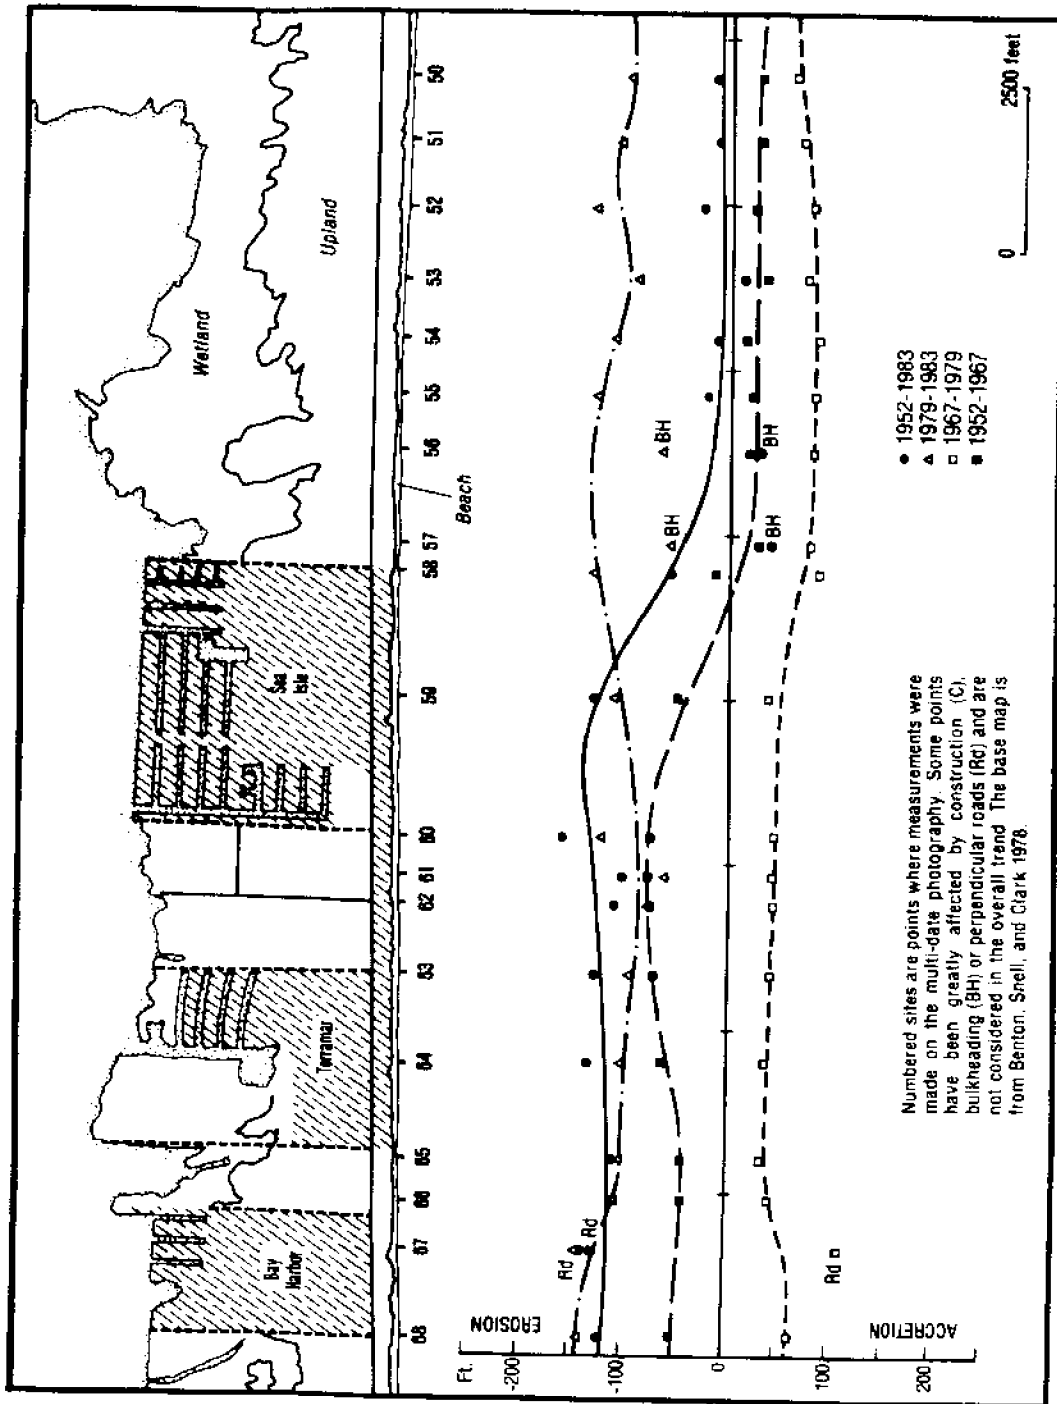
Figure 18. Shoreline Changes, Sea Isle Beachfront Area, 1952-1983

Figure 18 on the next page shows the vegetation-line change curves for this section of West Beach. The 1967 to 1979 plot still shows accretion, although less than occurred further northeast. The 1952 to 1967 curve, on the other

hand, changes rapidly from accretion to erosion at the northeast side of Sea Isle. The 1979 to 1983 curve, as before, continues to show erosion of 100 feet and more.

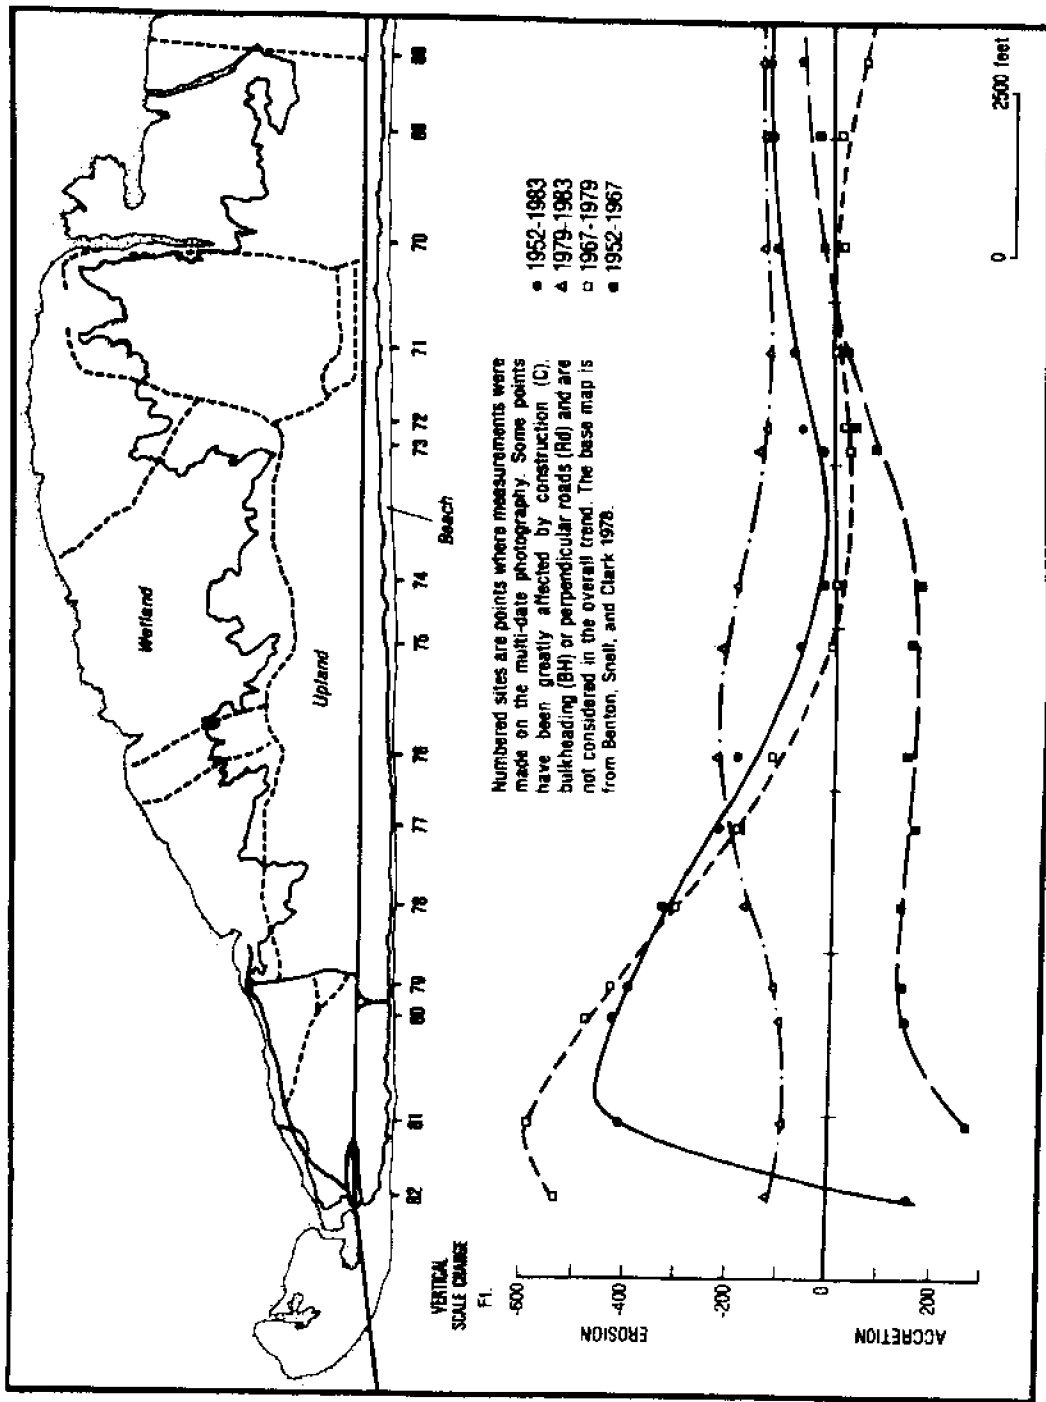
Figure 22. Shoreline Changes, Southwest End of Island, 1952-1983

There was a maximum vegetation-line retreat of nearly 600 feet at the tip of the island (Transect 81) from 1967 to 1979; but from 1952 to 1967 the vegetation line advanced some 270 feet at that point while the shoreline receded. This significant countermovement, illustrated by Figures 19 and 20, was apparently unique to the island tip. Other photos show that between nearby Transects 71 and 80 the vegetation line and shoreline advanced together from 1952 to 1967.

Examination of Figures 19 to 22 clearly shows the high rates of short- and mid-term erosion at the end of the island. From 1967 to 1979 the rate was 50 feet per year, while it was 25 feet per year from 1979 to 1983. Had Alicia crossed the coast a few miles further southwest, much greater scour would probably have occurred at the tip, with greater beach loss at the bridge.
