SURVEY OF SHORELINE STRUCTURES POPPONESSET BEACH, MA

M. R. Goud
and
D. G. Aubrey

May 1983

Technical Report

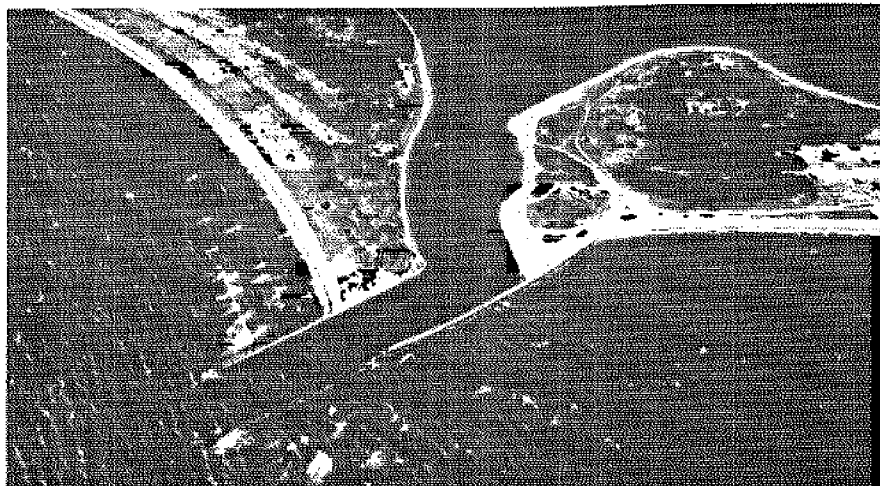
Photo #1. Sta. I. Waquoit Jetty aerial photograph; South Cape is on the right, Washburn's Island to left. Note gap in lower jetty approx. at midpoint.

Condition: good, although the eastern jetty is discontinuous for 10m, from 270 to 280m; for 200m beyond this point the jetty is constructed of jagged boulders, in less ordered patterns (see photos 1 and 4).

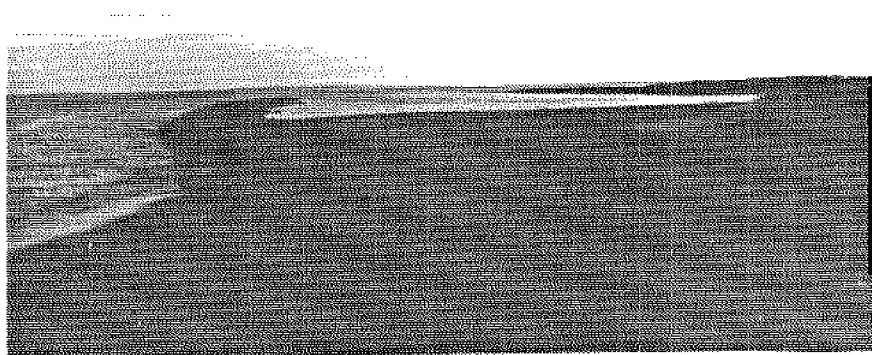
Photo #2. Sta. I. Waquoit jettys, western jetty in foreground.

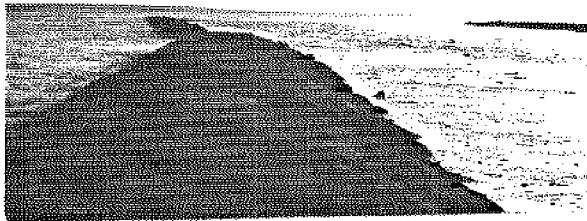
Photo #3. Sta. I. Waquoit jetty, end of eastern jetty in foreground, western to right.

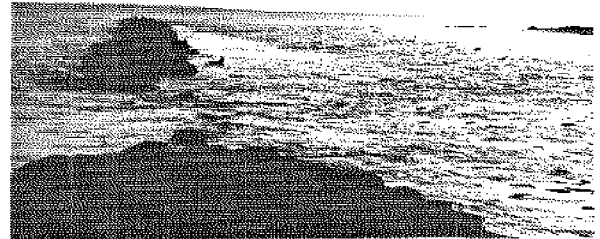
Photo #4. Sta. I. Waquoit eastern jetty gap at 280m.

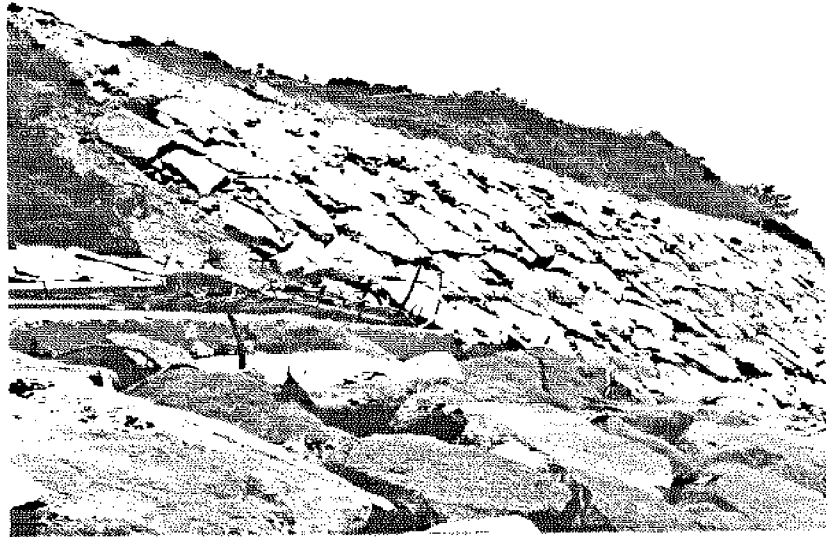
Photo #6. Sta. IIa-b. North end of IIa. Compare smooth riprap surface with photo 5.

Condition: fair to good; most of the small stones in the riprap apron have washed away, leaving only the boulders to act as reinforcement to the concrete blocks. The wall and apron made a smooth slope down to the beach when they were installed, and in the 4 years since then waves have left the blocks tilted and the rocks in disarray; this is shown in the first photograph, and can be contrasted with the second, where this seawall abuts structure IIb and the original smooth slope of the riprap is visible.

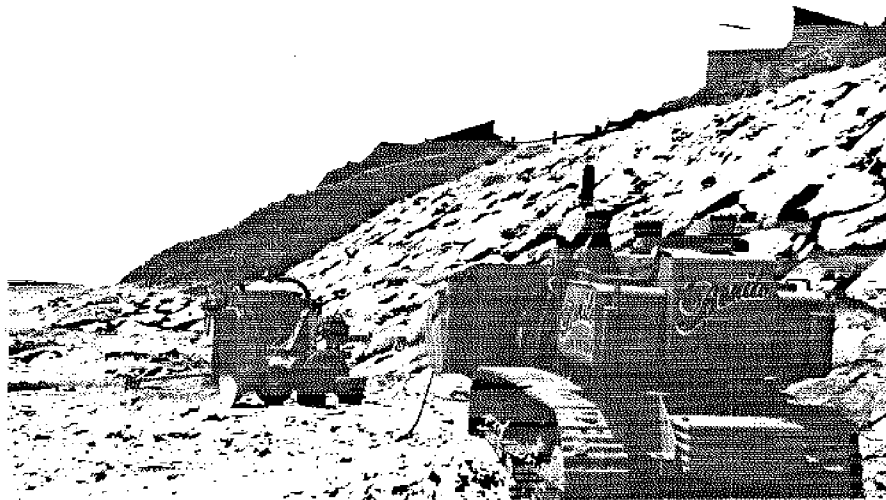
Effectiveness: very good; the shoreline has not retreated since the wall was built; there is no evidence of undercutting; and beach width is generally the same as that of the surrounding areas. Beach roses on slope above seawall provide additional stabilizing force (photo 7).

Photo #7. Sta. II, a-b. North end of IIa, South end of IIb, looking southwest. Note beach roses above wall in this photo and in photo 8.

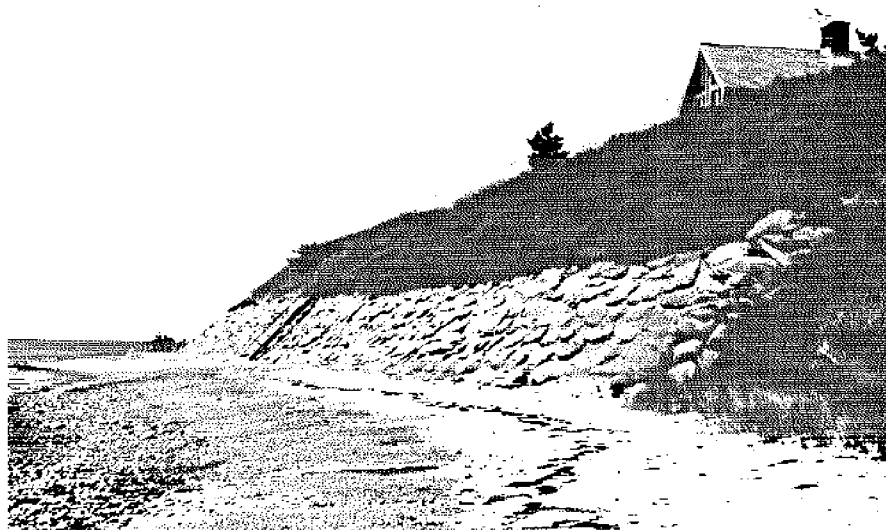
Condition: excellent; was being refurbished during this evaluation (June 1982)

Photo #8.
Sta. IIb.
Northern end
of seawall.

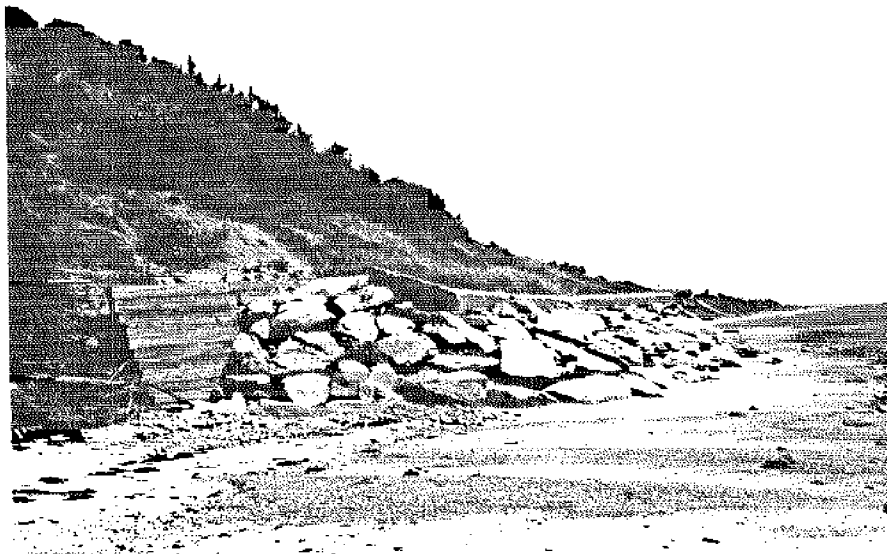
Photo #9. Sta. IIIa. Seawall with stone apron, looking northeast.

Condition: fair. Boulders in disarray; no matrix in riprap.

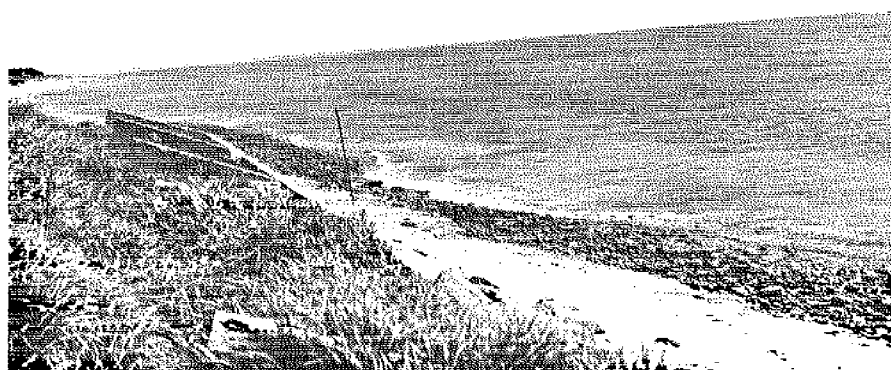
Effectiveness: fair. The grass on the slope appears to be essential for maintaining slope stability, and there is some undercutting of the wall (photo 10).

Photo #10. Sta. IIIa. Seawall, landward side. Undercutting is occurring where grass thins between farthest reinforcements.

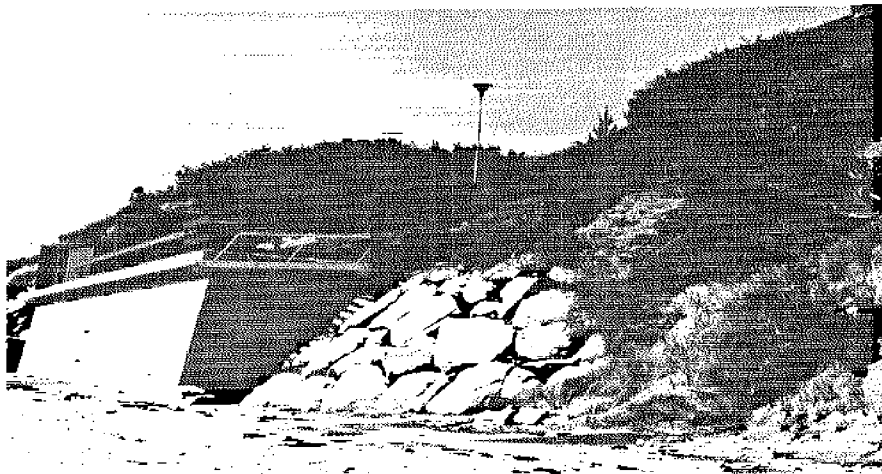
Photo #11. Sta. IIIb. Seawall and terraced deck, looking southwest.

Condition: excellent

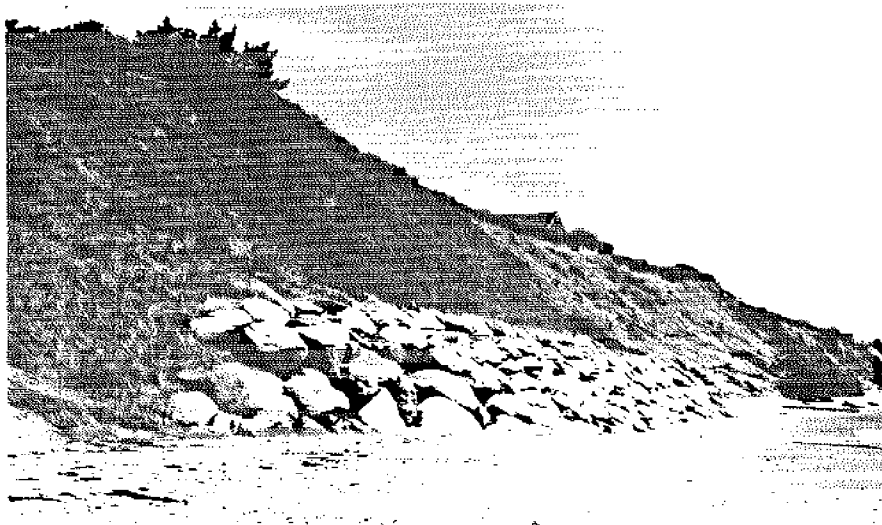
Condition: very good

Photo #12. Sta. IIIc. Concrete seawall with boulder apron & cliff vegetation for increased stability; looking northward. Note increased landward migration of cliff immediately north of seawall.

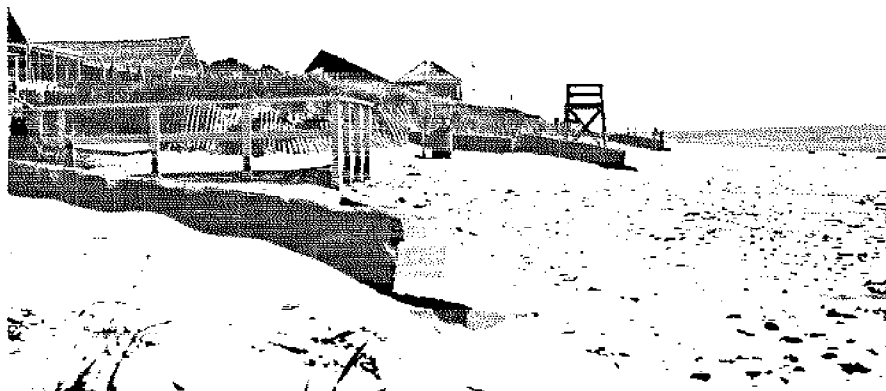
Photo #13. Sta. IV. Set of backshore groins in front of Popponesset Inn; looking northeast.

Condition: fair

Effectiveness: Popponesset Inn officials reported some initial sand accumulation, but said the groins no longer appear to have any effect in stabilizing the dunes.

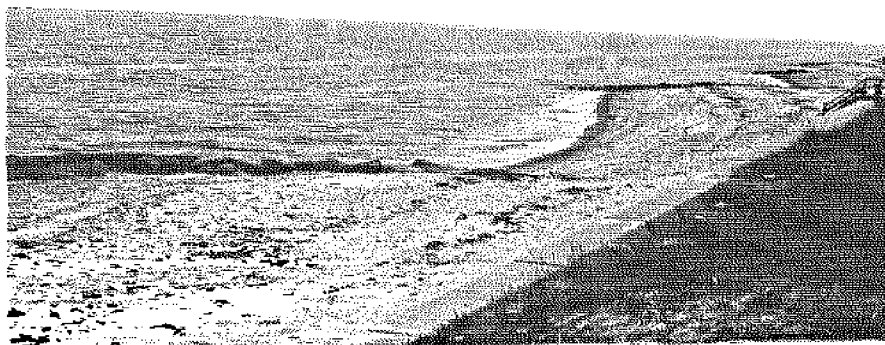
Photo #14. Sta. V. Southernmost 5 groins, looking south. Photo displays sand capture on northern side of groins in June 1982.

Condition: fair to good; very little cobble matrix

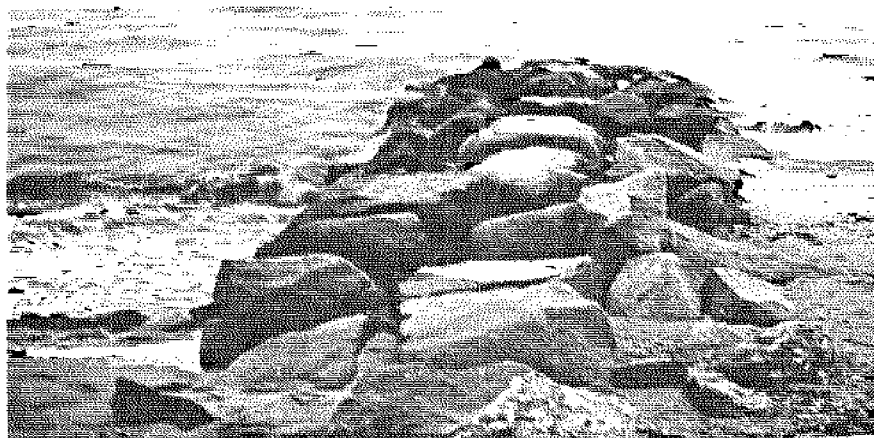
Photo #15. Sta. V. Groin displaying sand accumulation on southern side of structure in January, 1983.

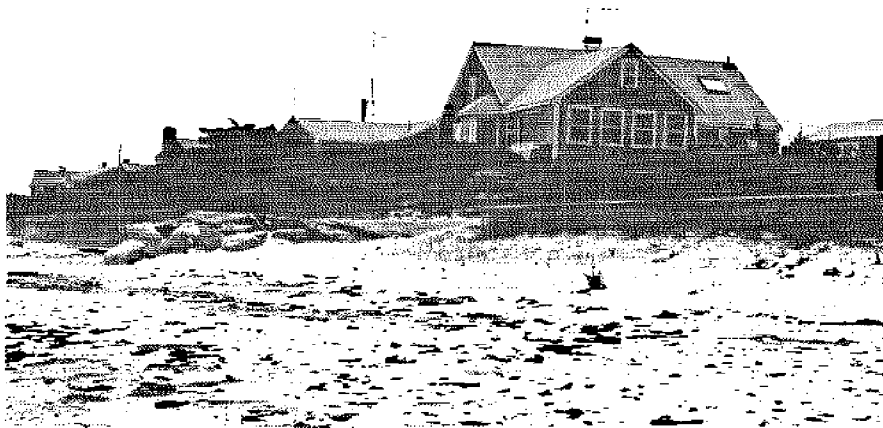
Photo #16. Sta. Va. Northern end of seawall between second and fifth groins. Extent of erosion of unreinforced bluff can be seen to the right of the boulders.

Effectiveness: good. On the single lot without a seawall, the dune has been noticeably eroded (see photo 16)

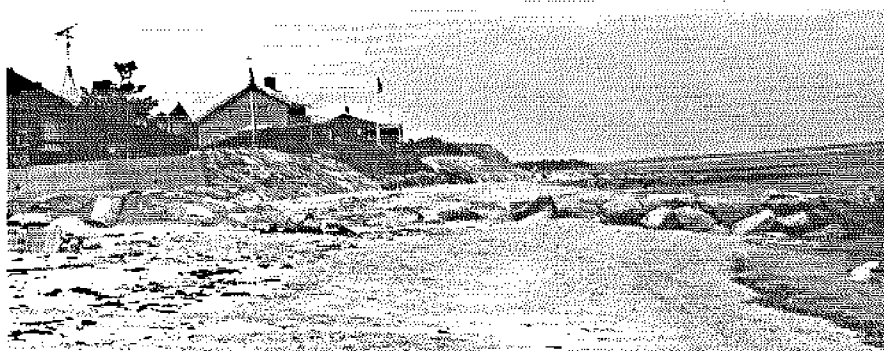
Photo #17. Sta. Vb. Groins 7-9 and seawall between them, looking north. Increasing height of seawall to north is visible.

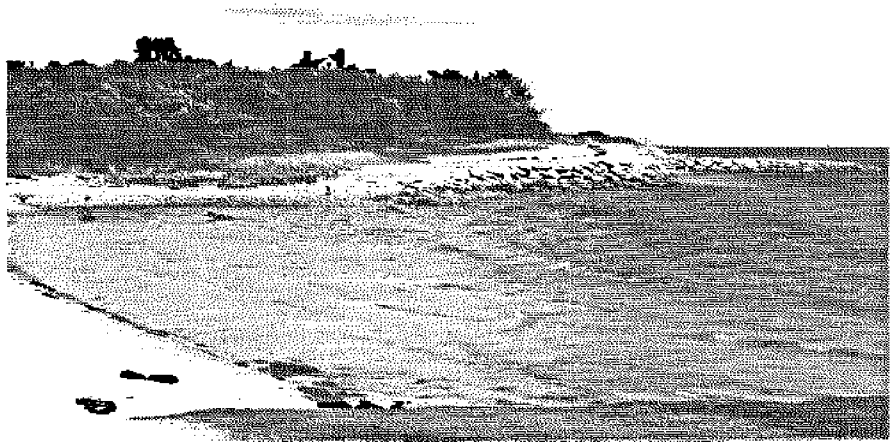
Photo #18. Sta. VI.
Southwest end of sta.;
note receding beach
beyond seawall.

Condition: fair to excellent. The most southerly groins were rebuilt in spring of 1982, so they are flat and all interstices are filled with small stones (see photo 18). Groin 11, by contrast, is in only fair condition, and is falling apart at its seaward end.

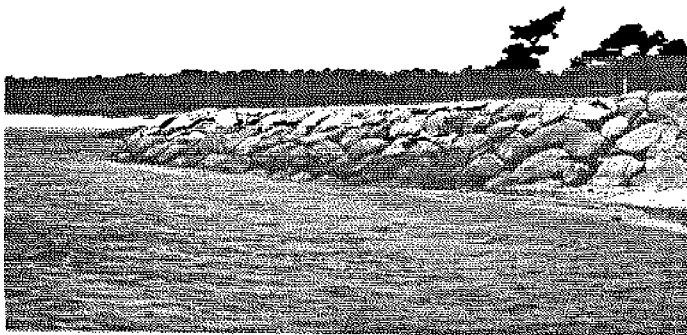
Photo #19. Sta. VI. Recently
refurbished seawall just
south of groin 1

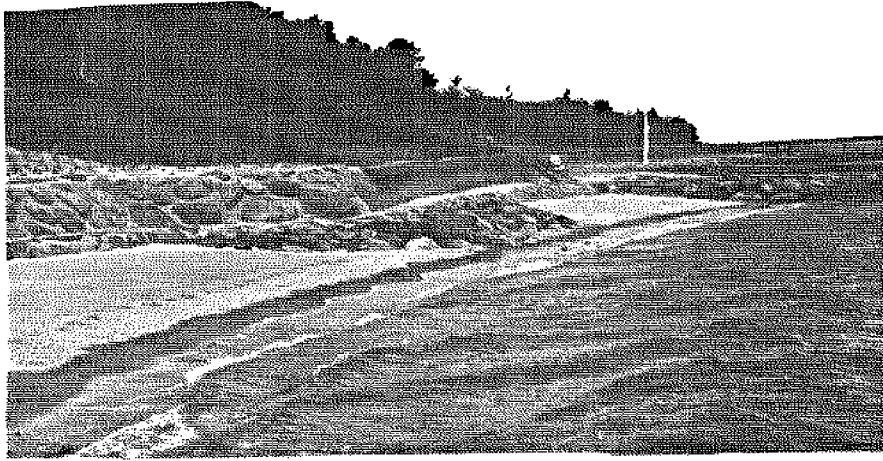
Photo #20. Sta. VI. Change in seawall construction at point C; groins 2-4.

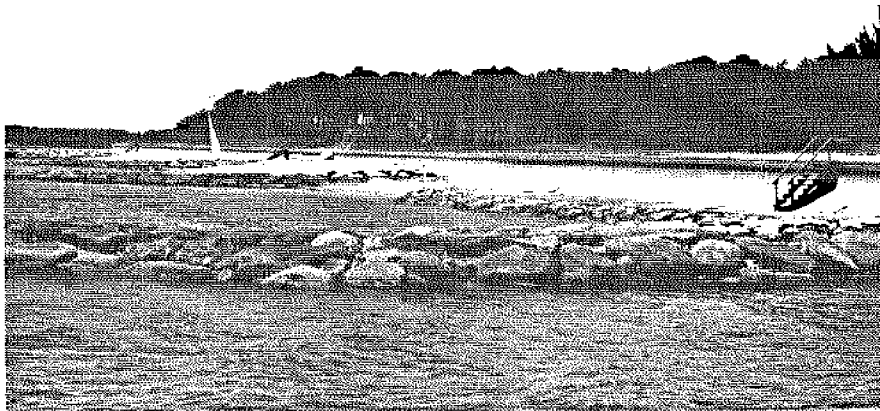
Photo #21. Sta. VI. Groins 5-2, looking southwest. Note widening of beaches south of groin 4.

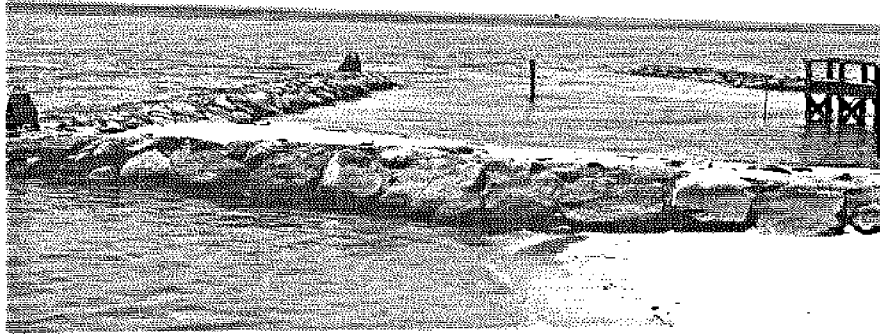
Effectiveness: variable. The 2 farthest north have been effective at capturing sand on their southern sides, made evident by the fact that north of groin 13 the shoreline is pebbly, while to the south it is sandy (see photo 29). The 3 most southerly, however, have captured sand to their north. The groins in between, exposed to Nantucket Sound, have been less effective and only the large, jointed groin number 6 has preserved a beach, and that only in a thin fillet immediately south of the groin (see photo 22).

Photo #22. Sta. VI. Groin 6, with its 4m wide fillet of trapped sand. End of pier and groin 7 visible on right.

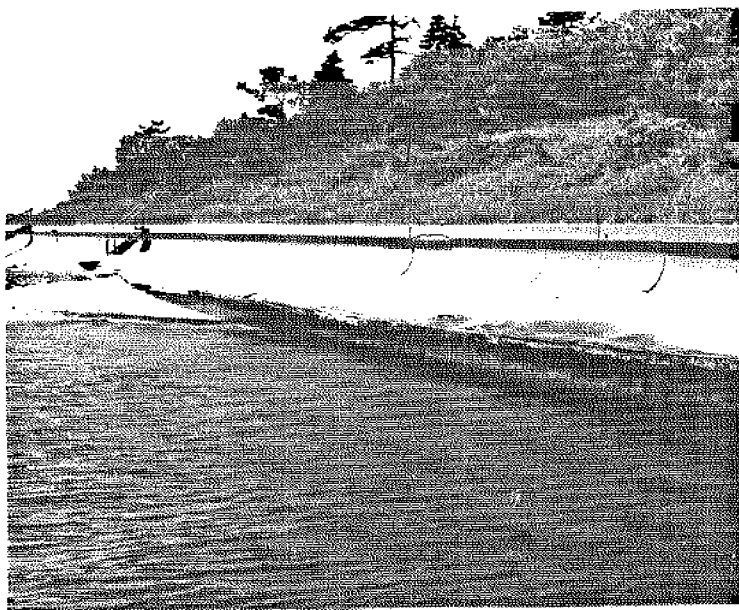
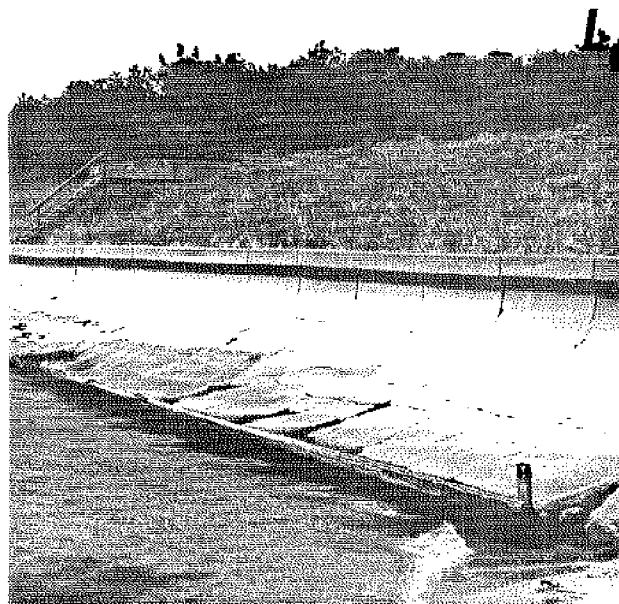
Photos 23 and 24. Sta. VI. Seawalls between groins 6&7 and 7&8, each looking to southwest. Note poor condition of revetment.

Construction: concrete wall of the same type as above; the revetment is concrete, slanted seaward 15-20 degrees from the horizontal. Between groins 4 and 5 is a 2m wide reinforcement of loose boulders (photo 21). From groins 5 to 8, the revetment is terminated by a vertical wooden fencing, .3-.5m high (photo 23).

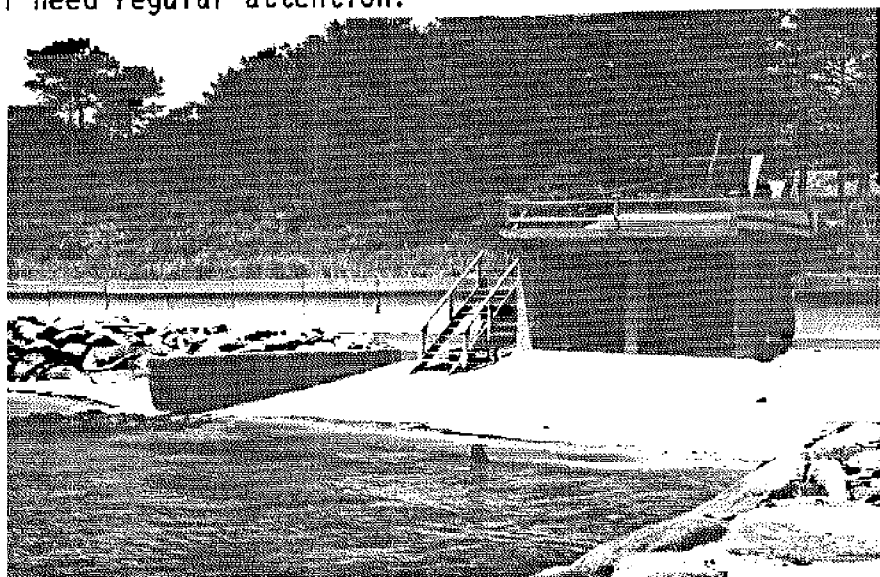
Photo #25. Sta.VI.
Seawall and boathouse
between groins 8&9.

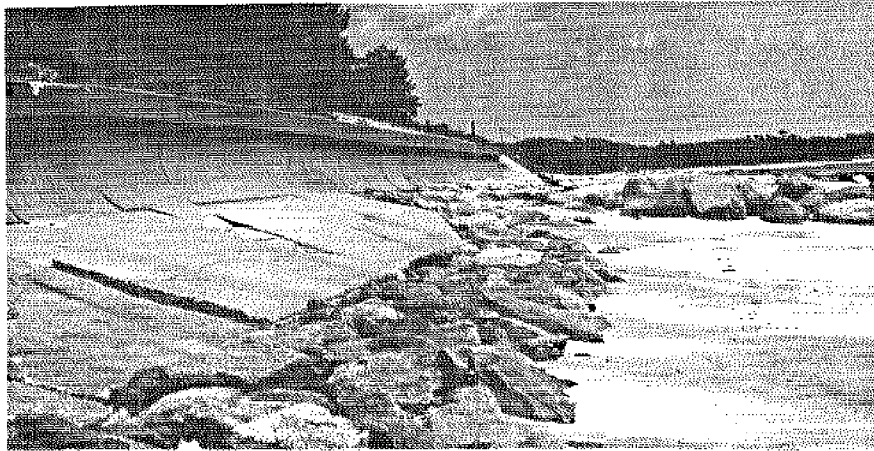
Photo #26. Sta. VI. Seawall and revetment with boulder apron, looking northeast, between groins 10&11.

Condition: wall condition generally good; revetment fair: it is cracked and broken in places

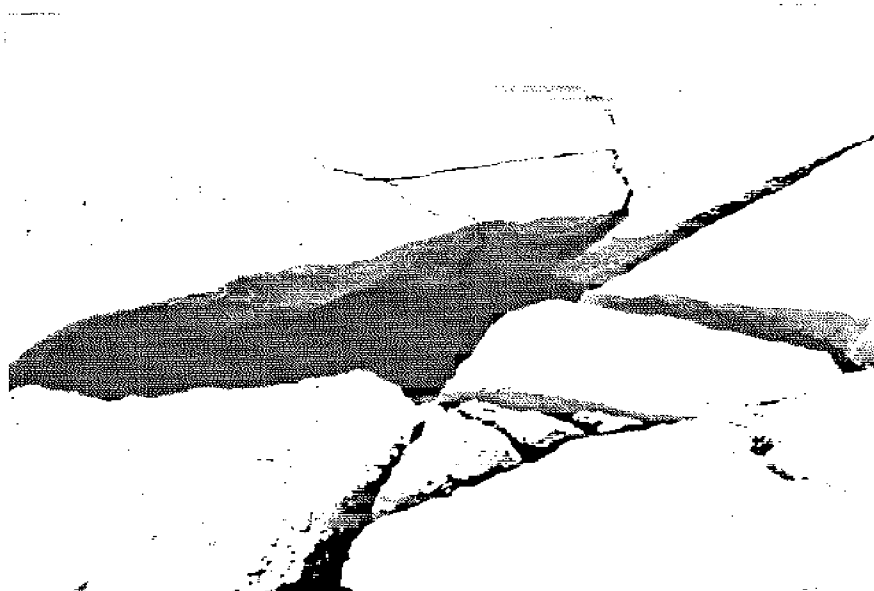
Effectiveness: wall effectively retards cliff retreat. The revetment seems ineffective in preventing scour beneath it, as can be seen in photo 27 where an airspace has been left under the concrete. The beach widens northward, shielding walls from wave stress.

Photo #27. Sta. VI. Cracked revetment between groins 10&11, showing space where sand has been eroded beneath the concrete.

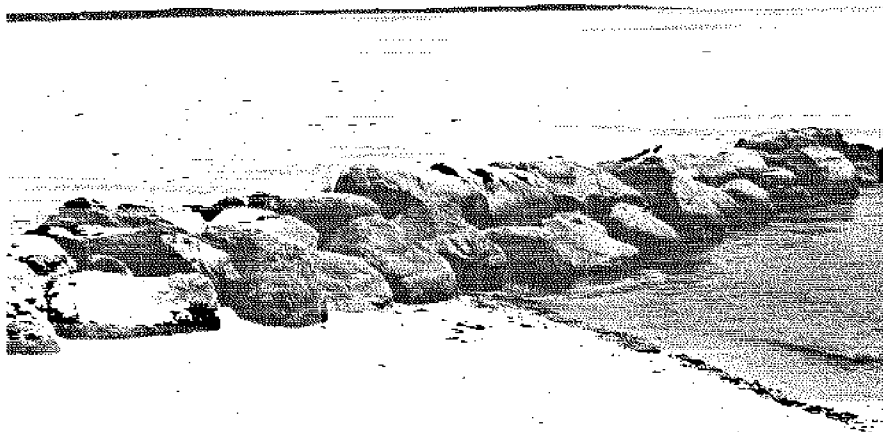
Photo #28. Sta. VI. Groin #11, showing part of wide beach.

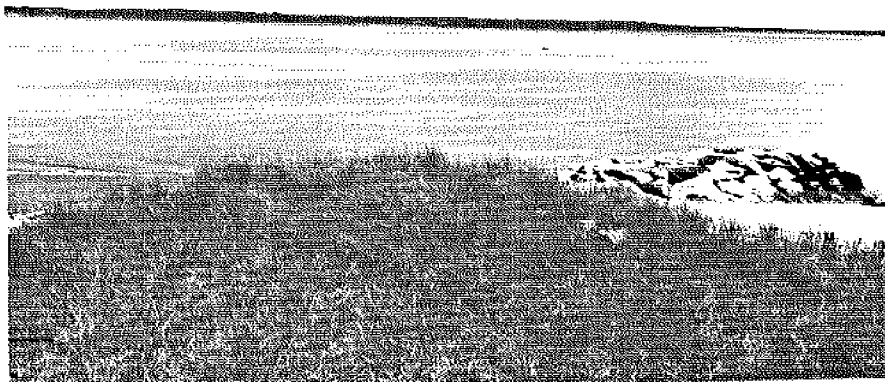
Photo #29. Sta. VI. Groin #13. Trapped sand on beach can be seen on southern side of groin (right), with pebble-covered shoreline on left where sand has been scoured away.

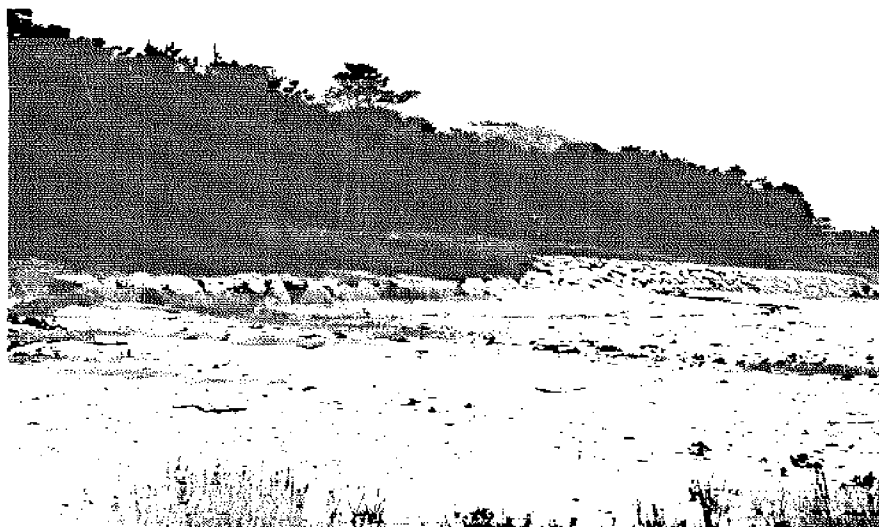
Photo #30. Sta. VII. Groin and seawall in area of onshore sand migration, looking northeast. Groin is visible in sand, extending from seawall at center left edge of photo. Embayment is visible at northern end of seawall, at center right edge of photo.

This groin is about 30m long, constructed of loose boulders. It has been made obsolete by the onshore migration of sand from the abandoned limb of the spit, so that it is now 100m from the water's edge.

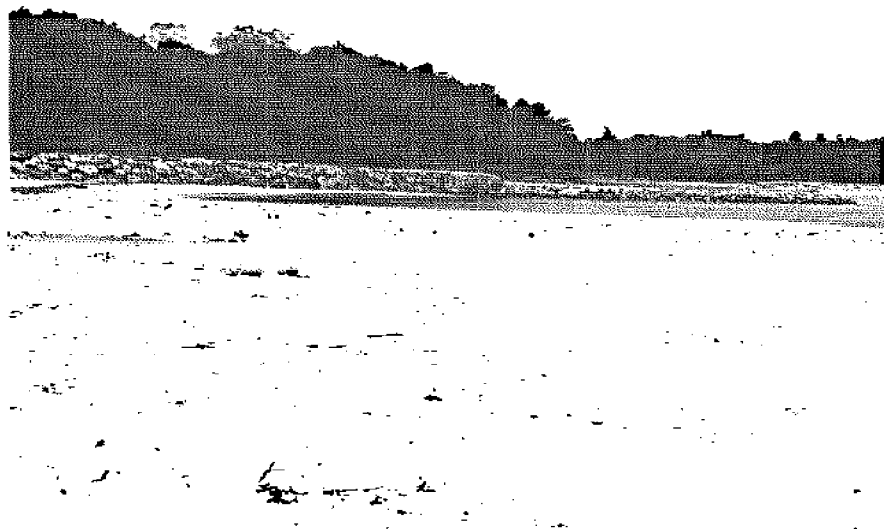
Photo #31. Sta. VII. Seawall beyond meter 130, showing embayment and exposed point. Note expanse of sand, all of which has migrated onshore from former NE limb of Popponesset Spit.

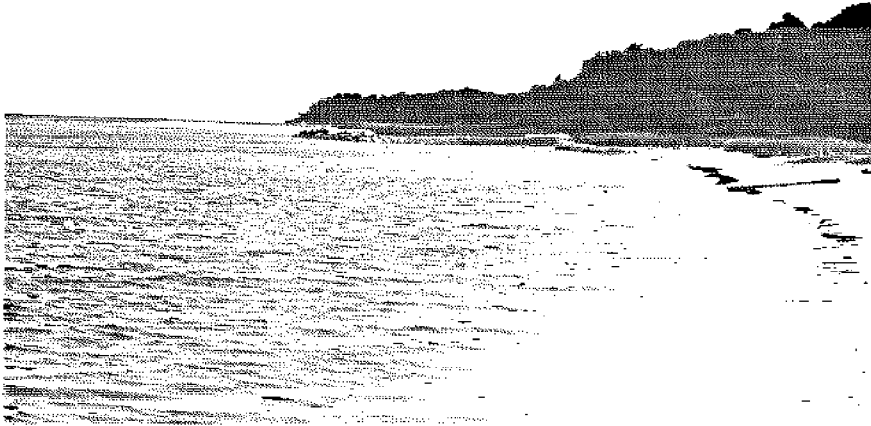
Photo #32.
Sta. VII.
Northern end
of seawall,
with sandbag
reinforcement
as it stood in
June, 1982.

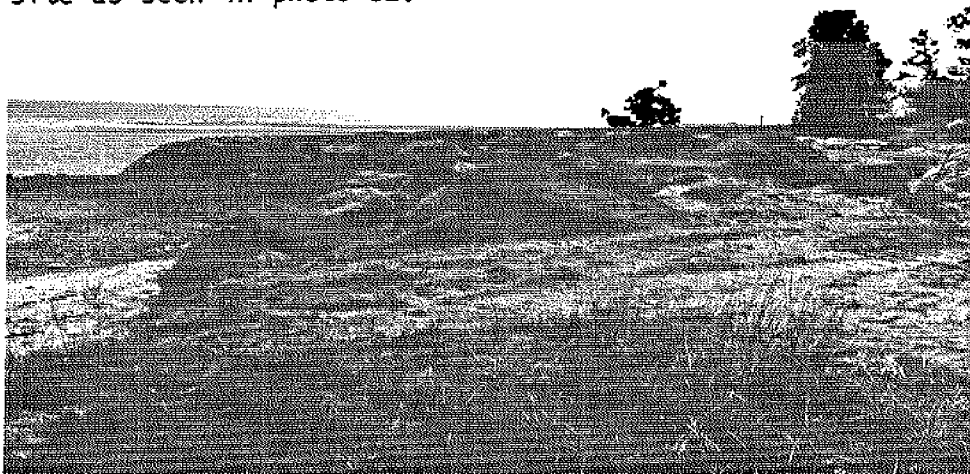
Photo #33. Sta. VII. Seawall extension in progress, slightly landward of sandbag site as seen in photo 32.

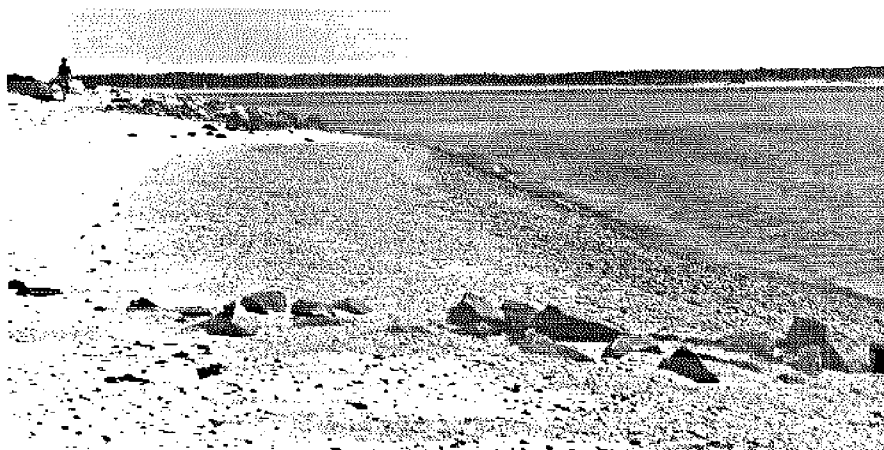
Photo #34 Sta. VIII
Groin 1, neglected
and nearly filled, in
area of onshore sand
migration.

Condition: poor; probably immersed at high tide

Effectiveness: almost none; onshore migration of sand from the northeast limb of Popponesset Spit has made the stabilizing structures unnecessary. A wall which formerly prevented bluff erosion (photo 35) is likewise a vestige of the previous shoreline configuration.

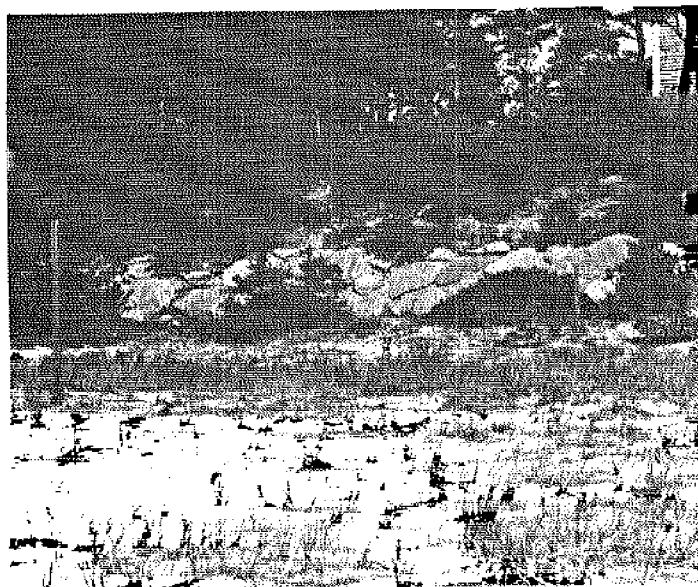
Photo #35. Sta. VIII.
Seawall near Rushy Marsh Pond
which has been isolated from
water by onshore migration of
sand.

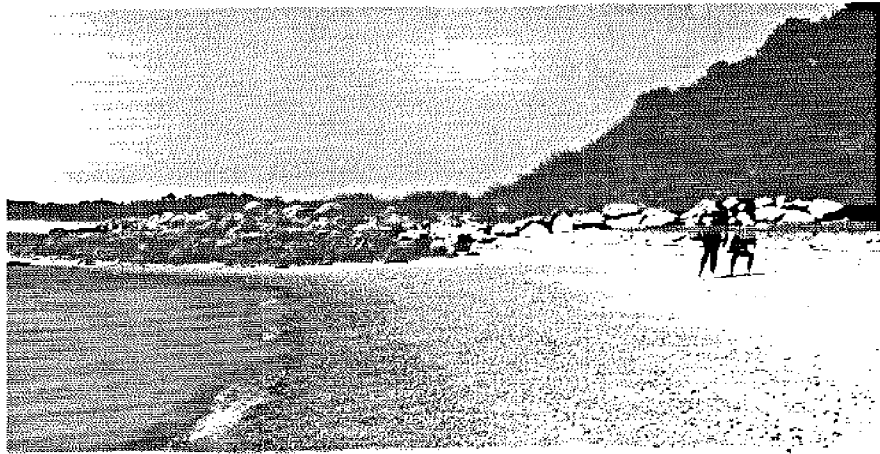
Photo #36. Sta. VIII. Groin 2, looking southwest, and the point of land it is protecting.

Construction: large pile of loose boulders, becoming a seawall about 1.5m high extending 15 m to the north along cliff (see photo)

Condition: fair

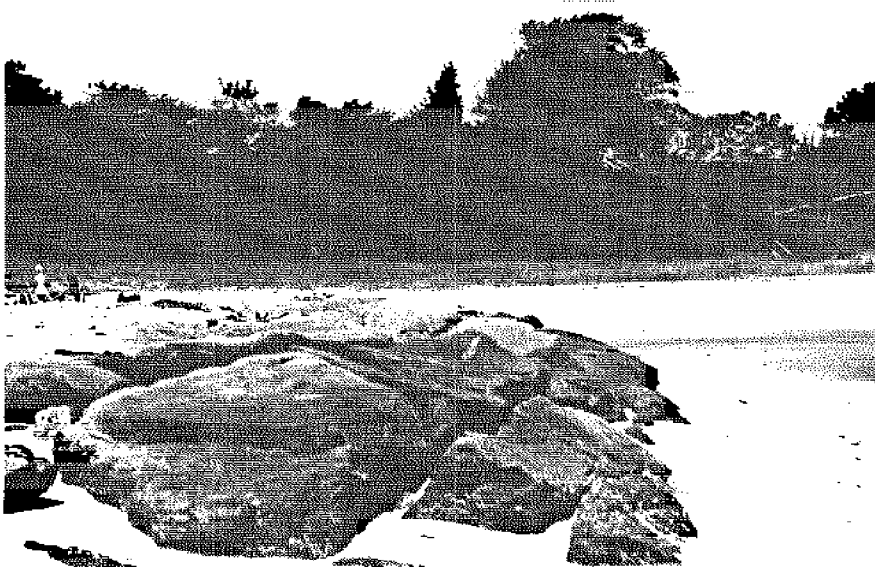
Photo #38.
Sta.VIII Groin 8,
looking shoreward,
displaying sand
accumulation on
southwest side of
groin, nearly
overtopping
structure.

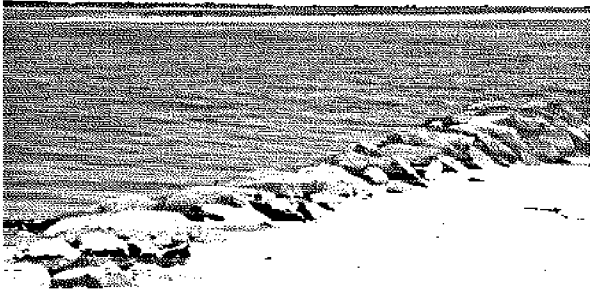
Photo #41. Sta. VIII. Groin 14, displaying sand accumulation on SW side of groin and erosion on NE.

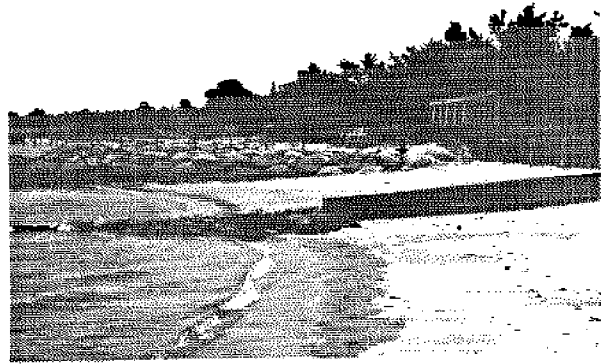
Photo #42. Sta. VIII. Groins 14 & 15, and seawall, looking southwest.

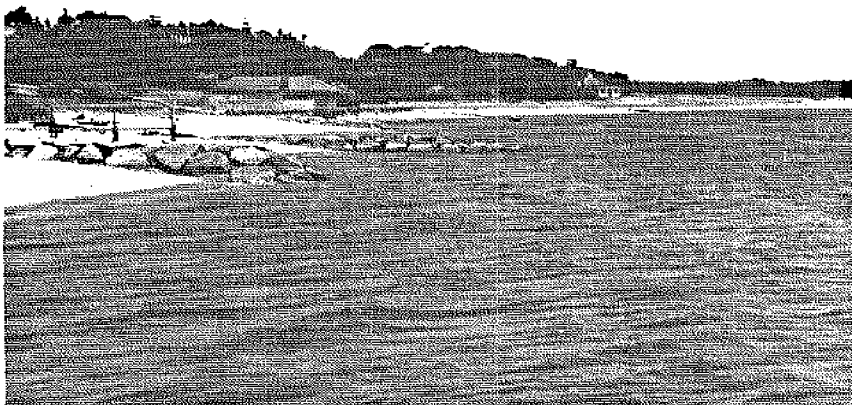
Photo #43. Sta. VIII Groin 13 through end of station, looking northward.

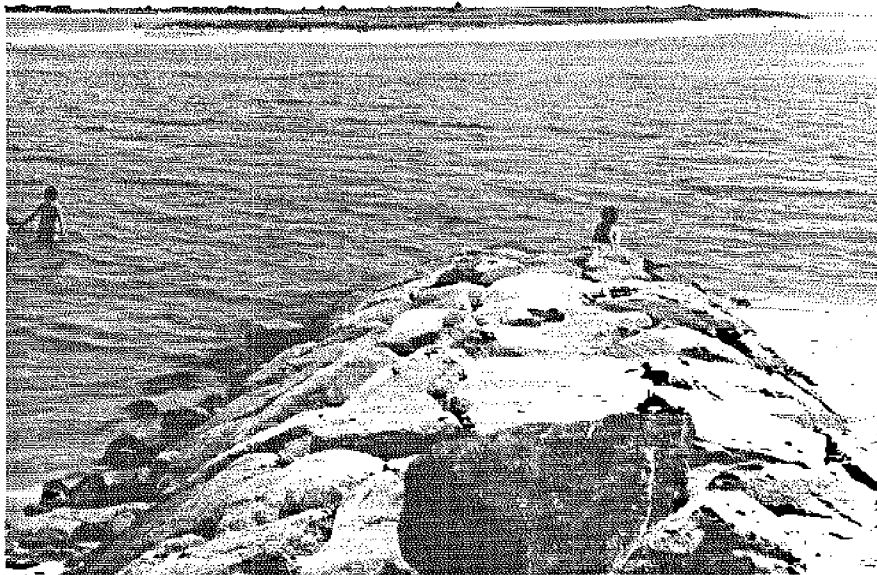
Photo #44. Station VIII. Groin 16. Note sand erosion from public beach on left.

Condition: very good

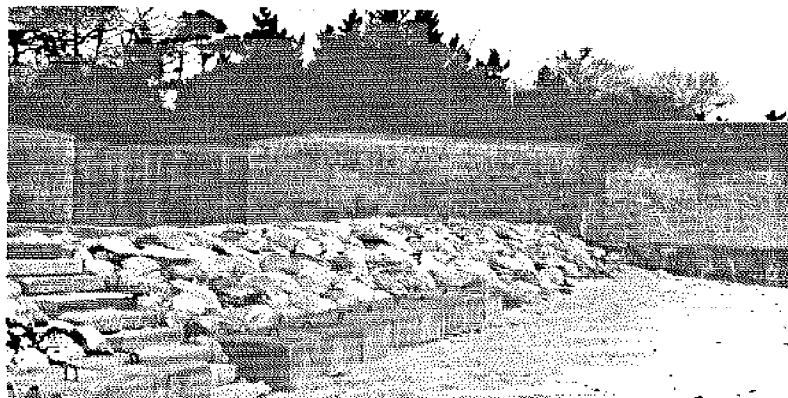
Condition: very good

Effectiveness: very good; the parking lot shows little sign of undercutting behind the wall.

Photo #45 Sta. VIII
Seawall between groins
16 & 17, slanting down
from public parking lot

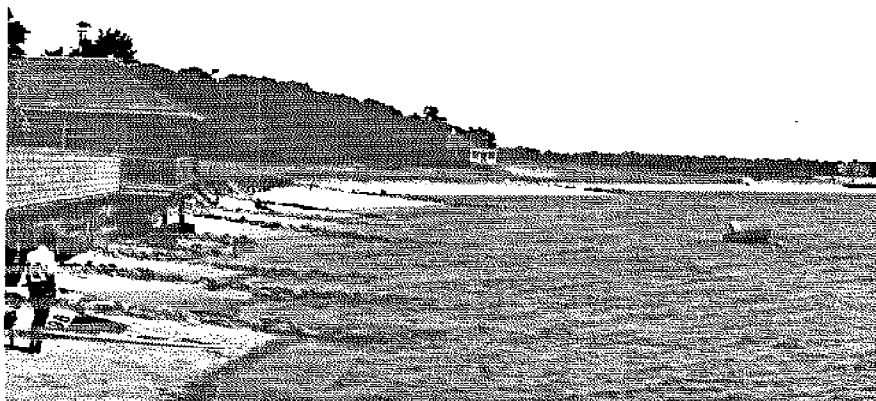
Photo #46. Sta. VIII. Groins 17-26, bath house, and seawall. The view is north, toward Bluff Point.

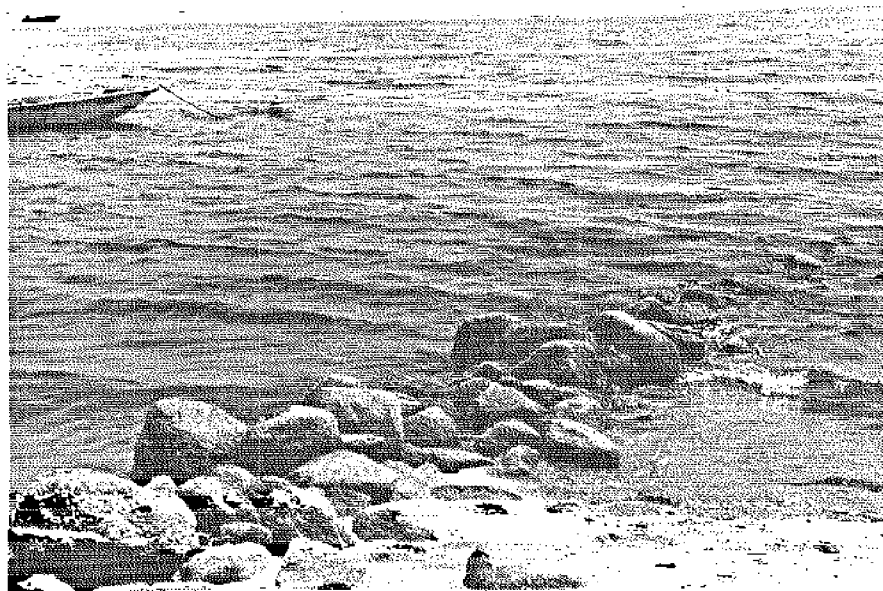
Condition: poor

Photo #47. Sta. VIII. Typical groin of group 17-24, in poor condition.

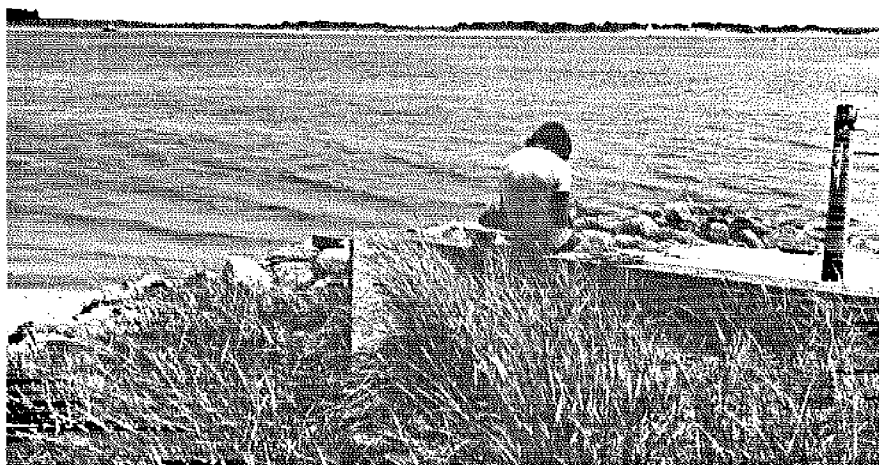
Photo #48. Sta. VIII. Groin 25 and end of wooden seawall. Note sand accumulation to southwest of groin.

Effectiveness: good; the beach is substantially wider to the south of the groins, and downdrift erosion can be seen in photos 48 & 49.
