EVALUATION OF EXISTING AND POTENTIAL HURRICANE SHELTERS

Byron D. Spangler
and
Christopher P. Jones

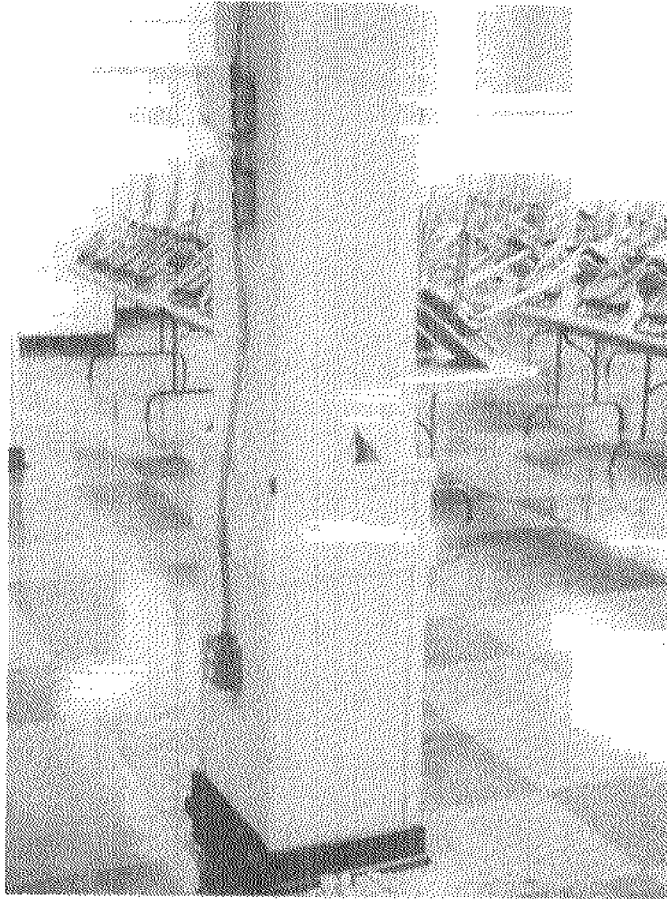
Figure 2. .Deterioration of Interior Column

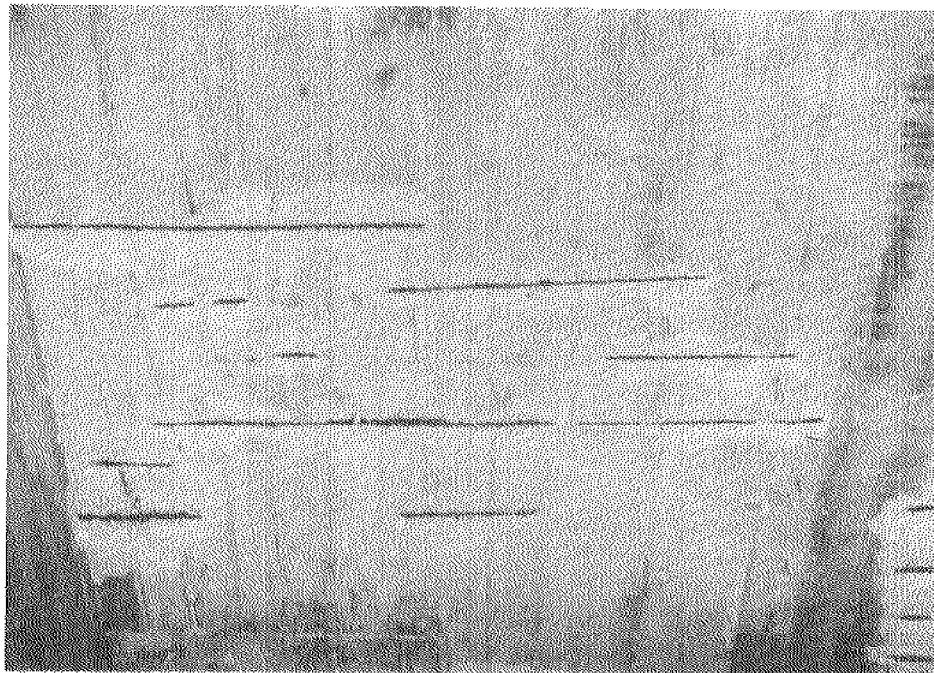
Figure 3. . Spalling on Underside of Slab

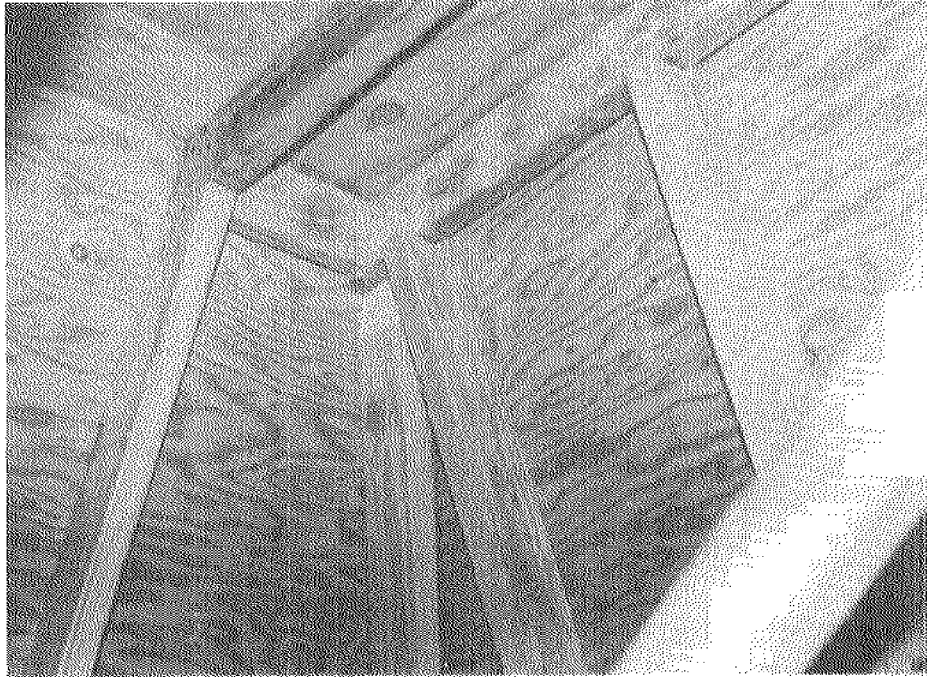
Figure 4. Timber Roof with Inadequate Fasteners

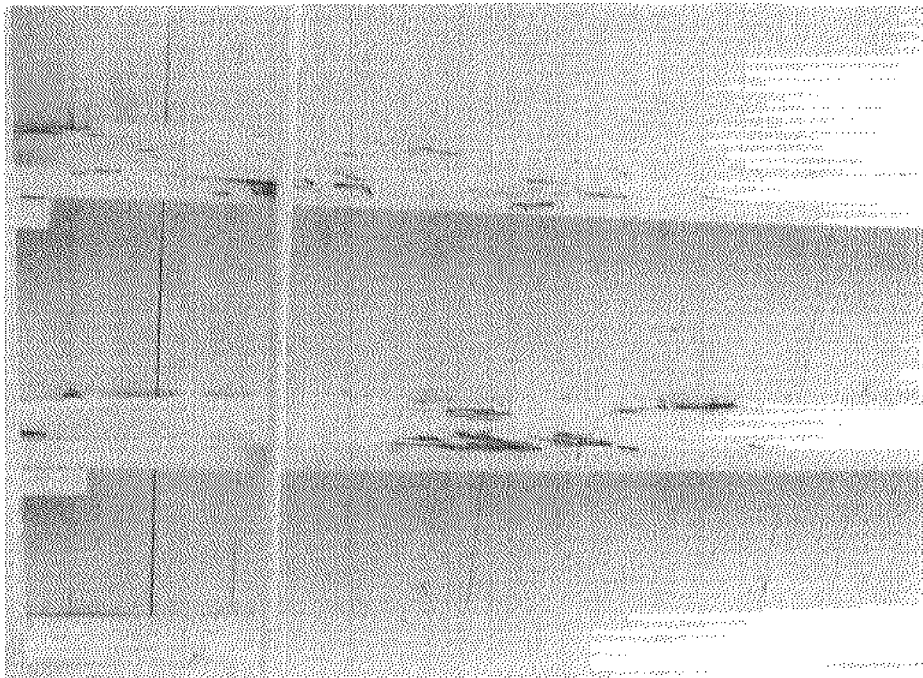
Figure 5. Deterioration on Underside of Timber Roof

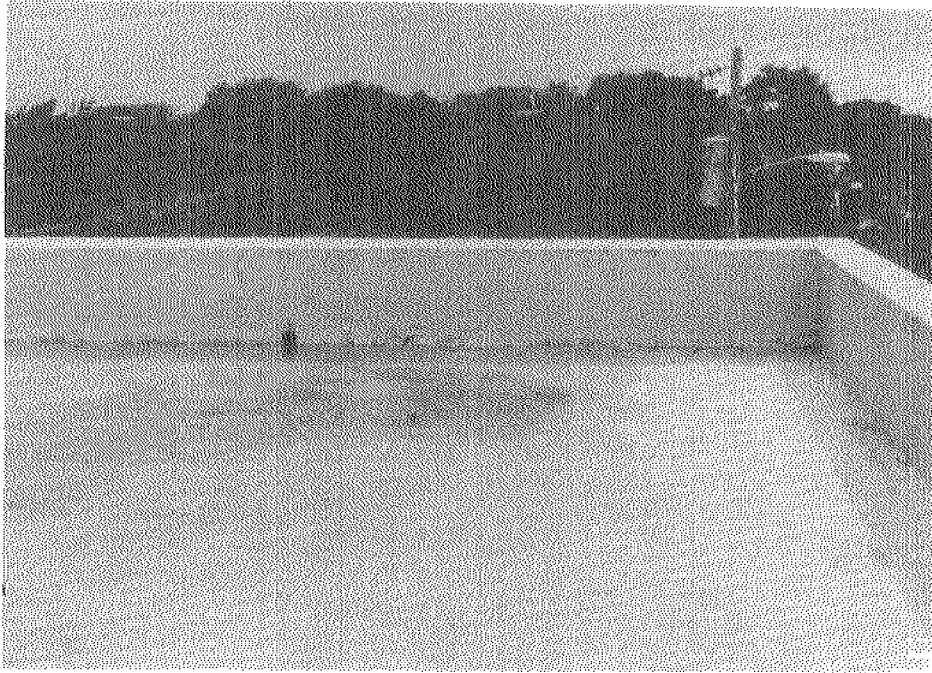
Figure 6. Parapet that Will Trap Water if Scuppers Clog

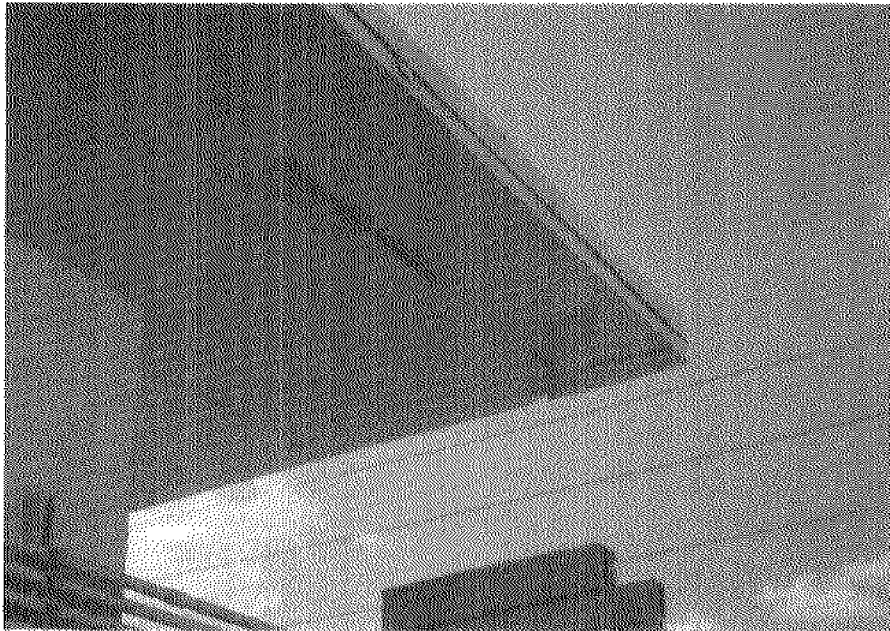
Figure 7. Deterioration on Underside of Roof Overhang

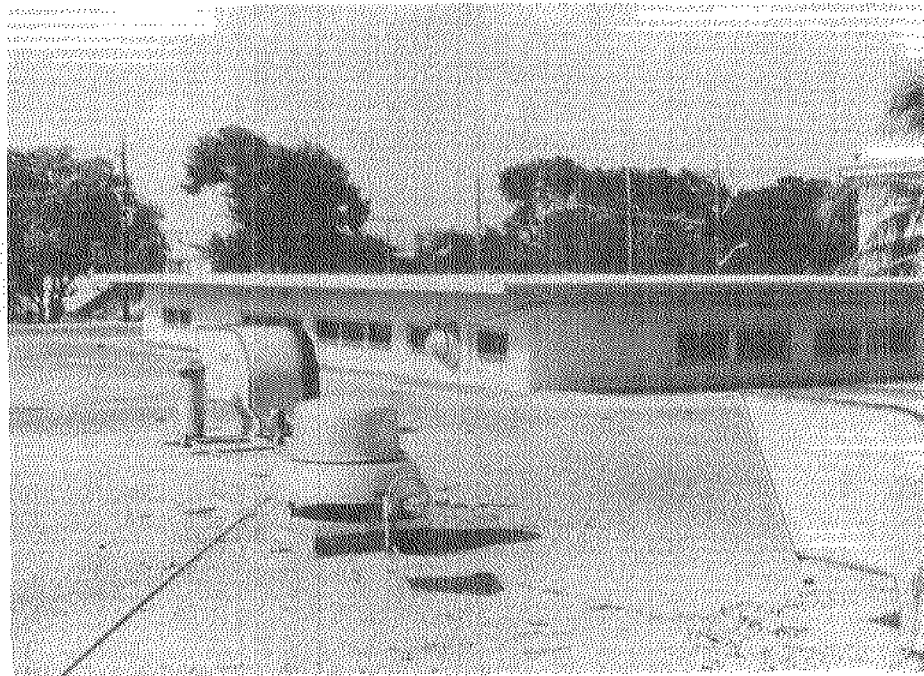
Figure 8. Mechanical Projections that Could Allow Rainfall to Enter Building and Could Damage Clerestory Windows if They Fail.

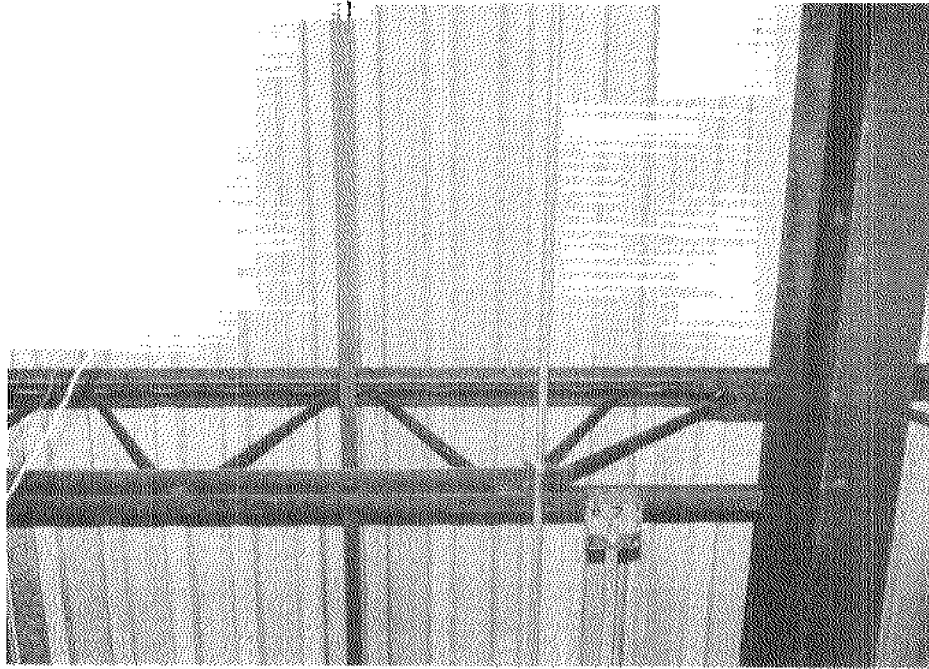
Figure 9. Check Welds Between Joists and Corrugated Forms

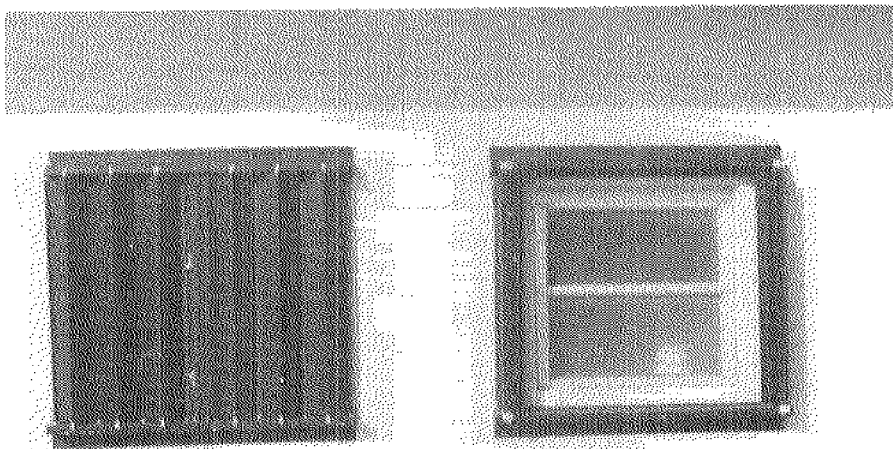
Figure 12. An Example of Shutters Properly Fastened to Structure

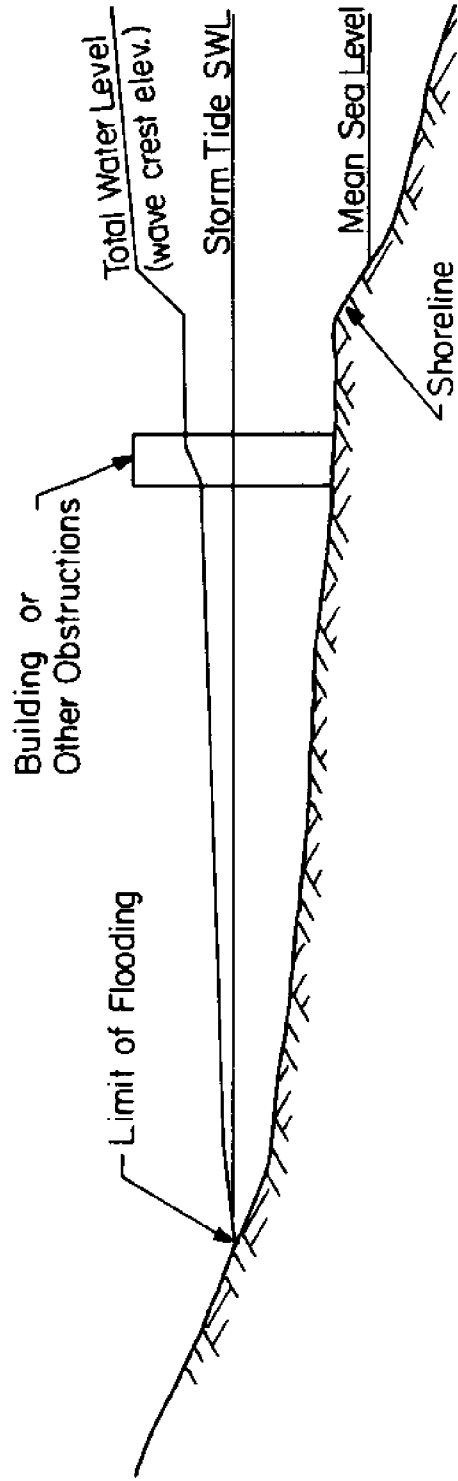
Figure 13. Variation in Total Water Level Along Transect

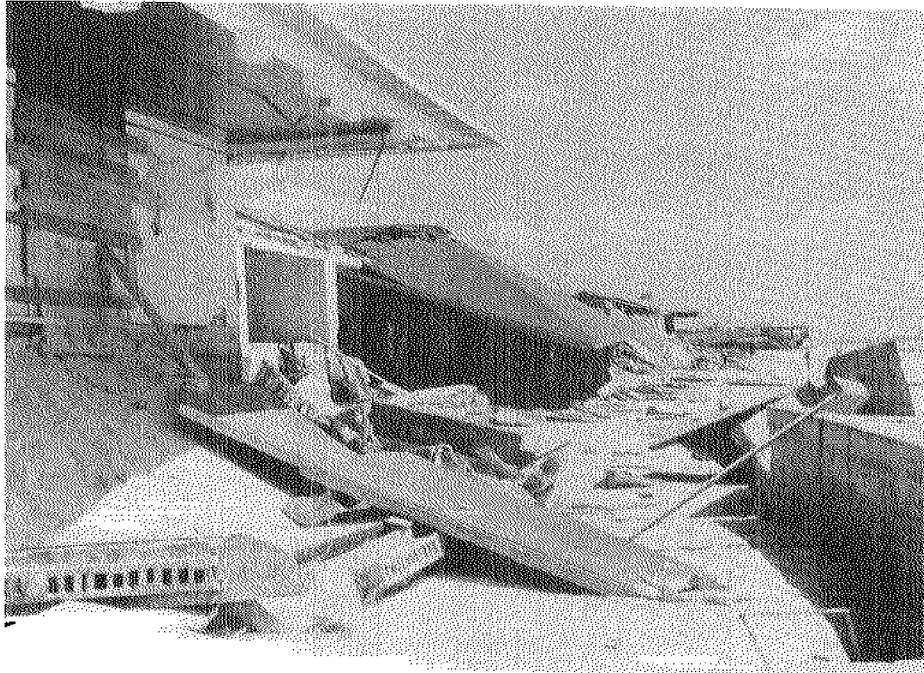
Figure 14. Structures with Spread Footings or Other Shallow Foundations Cannot Withstand Scour

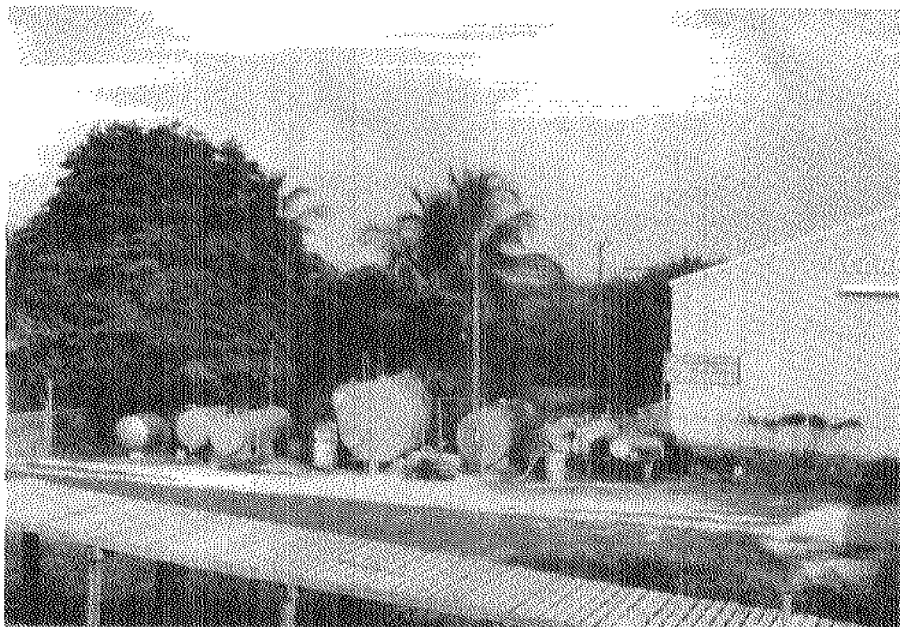
Figure 15. An Example of Debris that Could Strike a Shelter

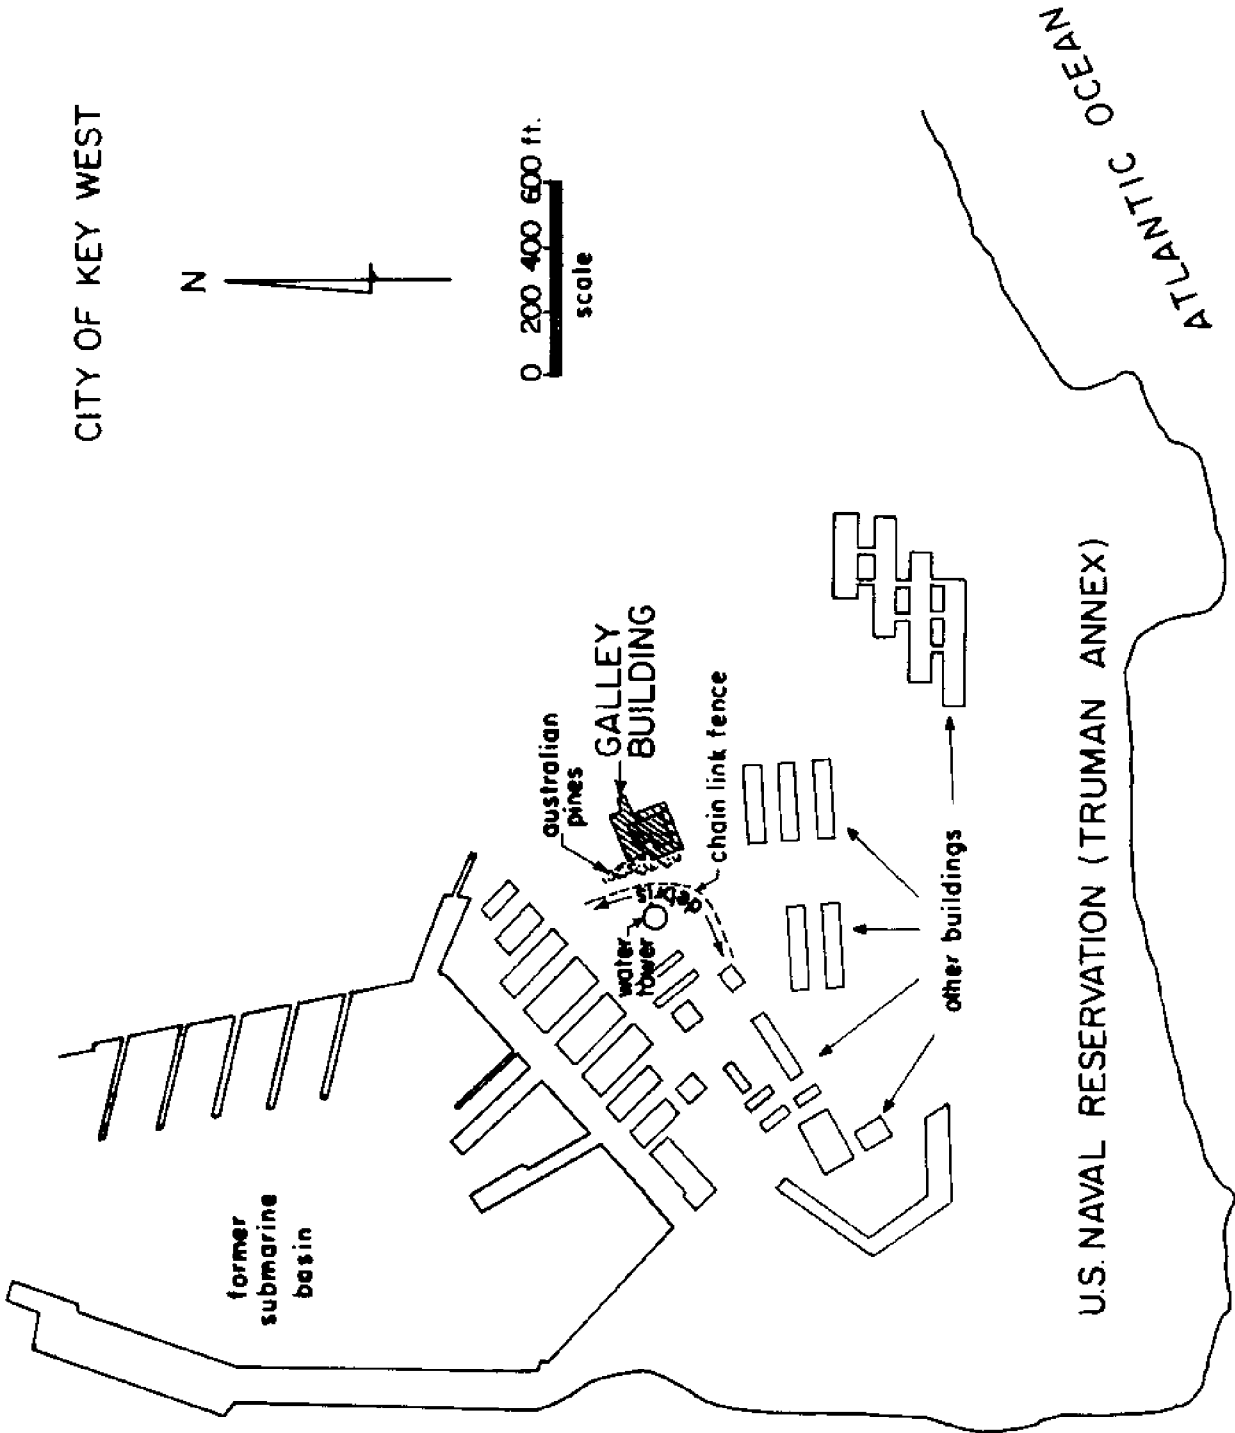
Figure 17. Location Map

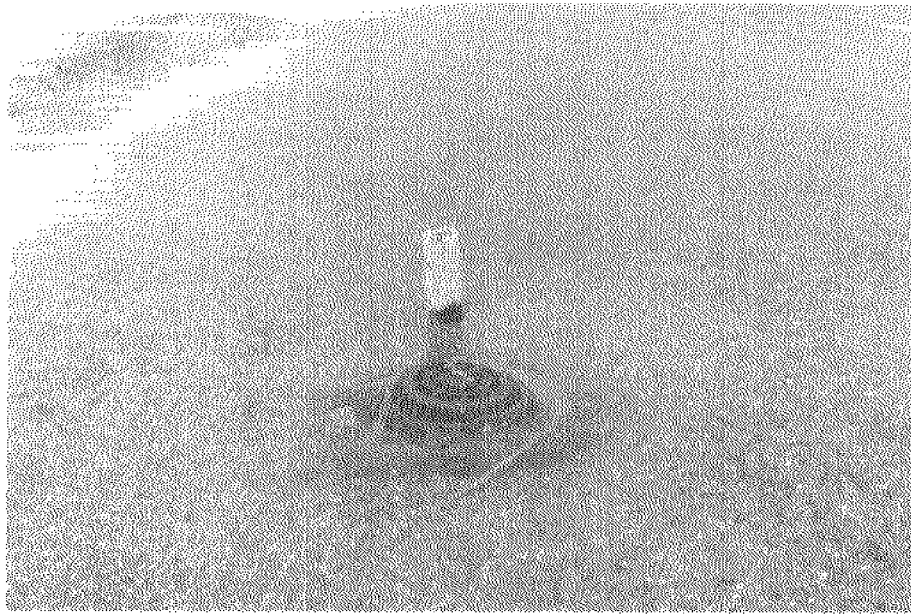
Figure 13. Clogged Roof Drain and Standing Water

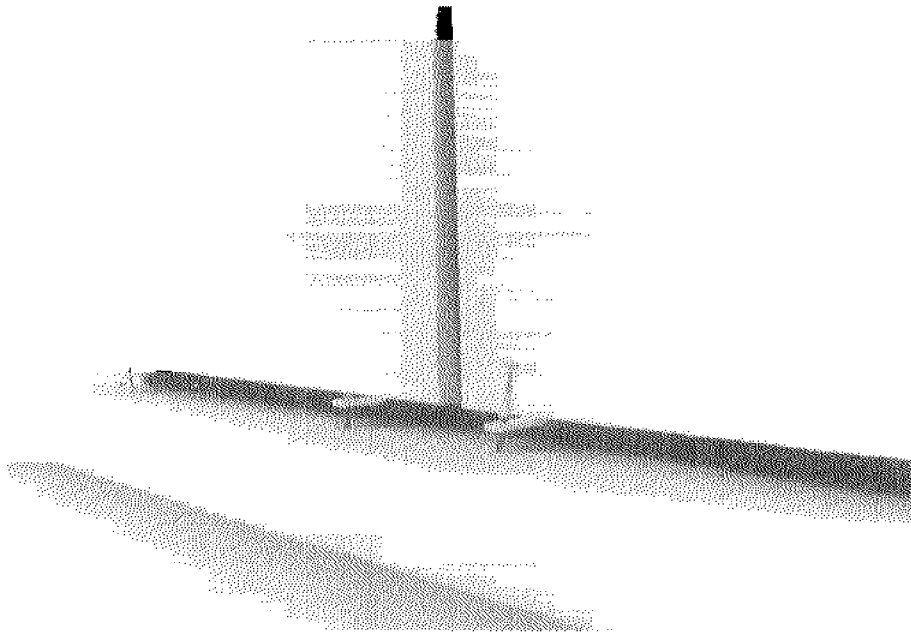
Figure 19. Bottom Shutter Fastener

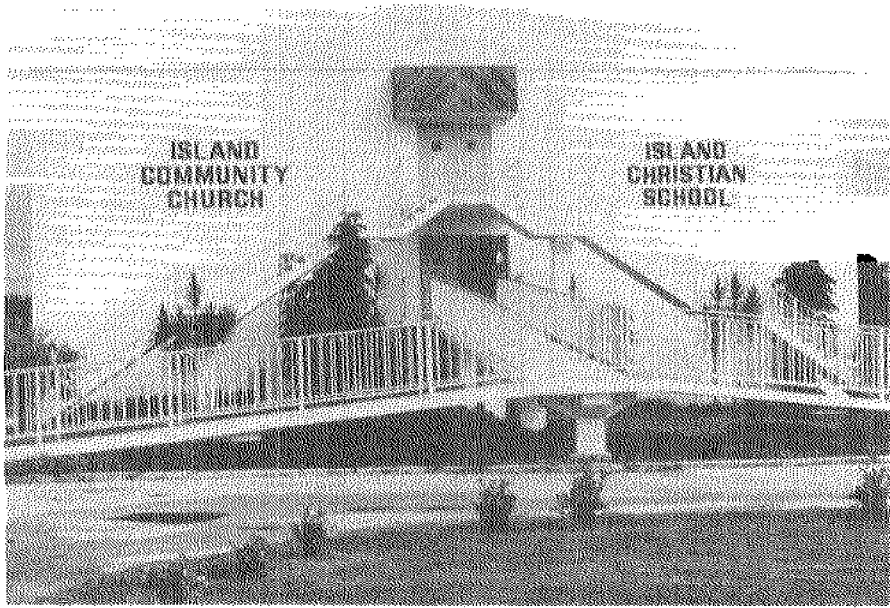
Figure 20. Front View of Island Christian School

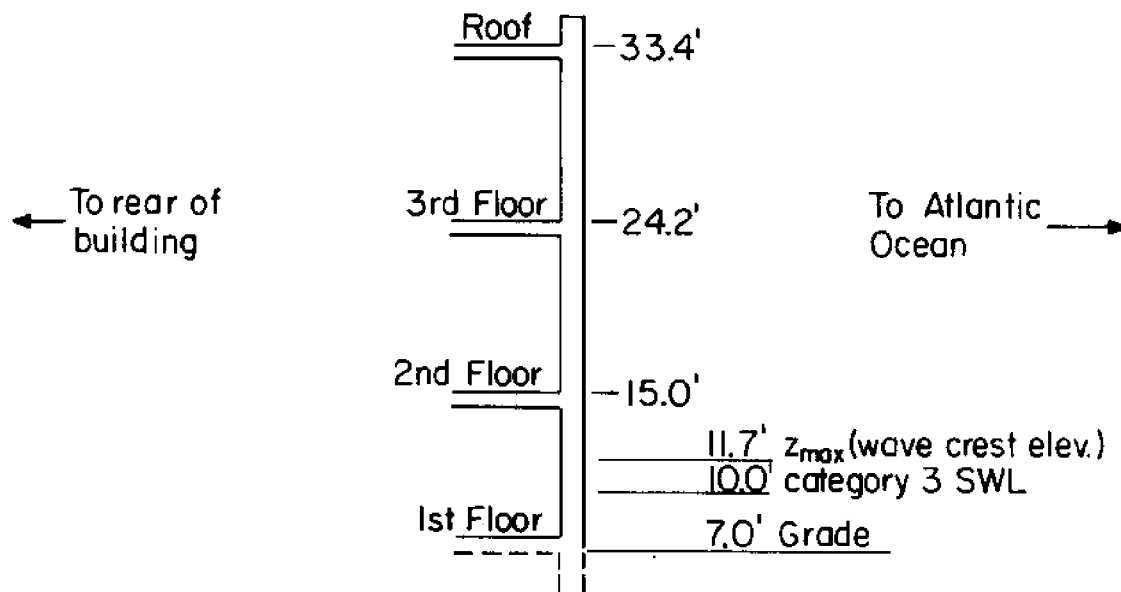
$$\begin{aligned}
 z_{max} &= SWL + 0.55 (SWL - \text{Grade}) \\
 &= 10.0' + 0.55 (10.0' - 7.0') \\
 &= 11.7'
 \end{aligned}$$

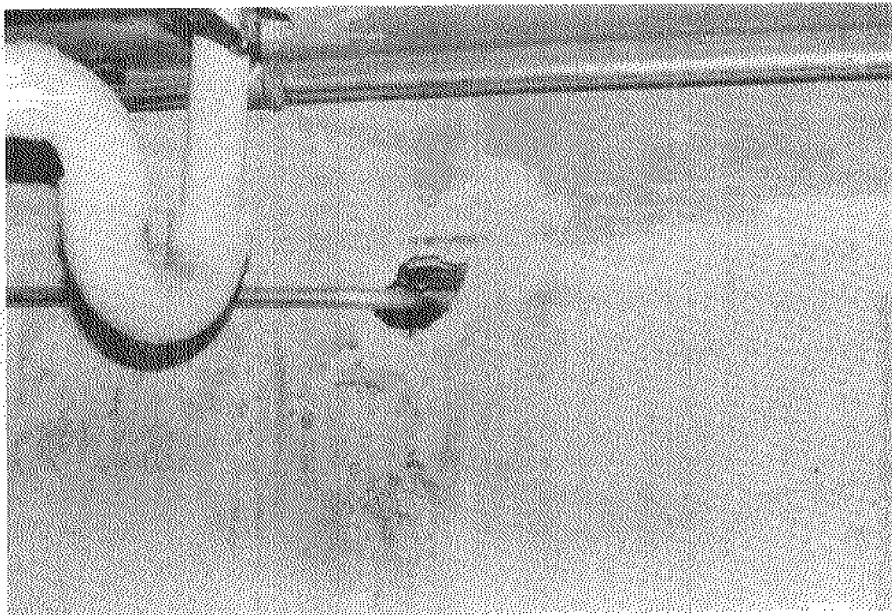
Figure 25. Bottom Steel I-beam is Exposed
