**THE MICHIGAN DEMONSTRATION EROSION CONTROL PROGRAM IN 1976**

**Prepared by the University of Michigan Coastal Zone Laboratory**

**Michigan Sea Grant Program  
Technical Report No. 55**

**February 1977**

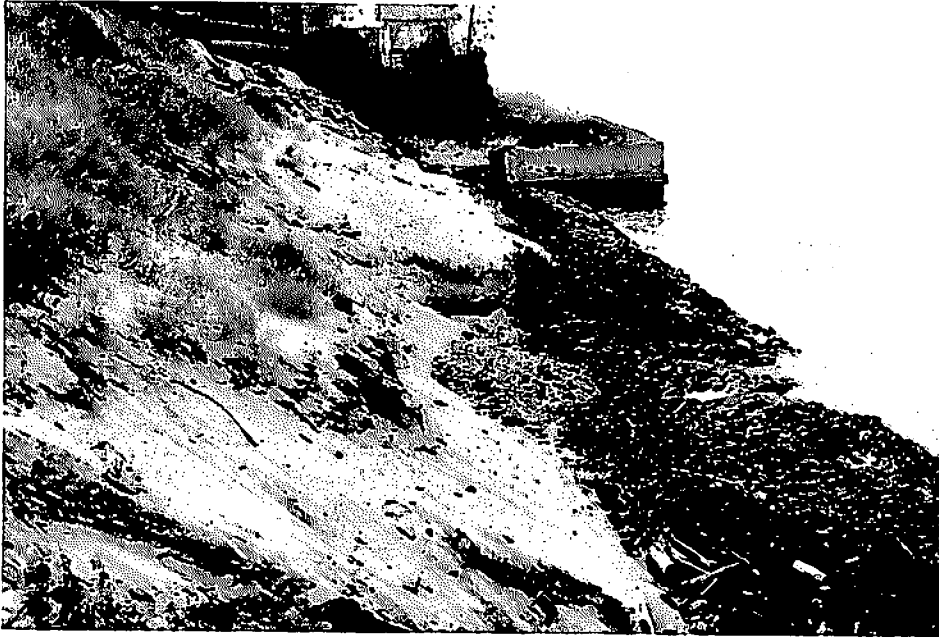
Figure 5. Michiana, September 16, 1975.

Conditions were so severe that the steel seawall at the north edge of the site was destroyed and the road at the top of the bluff was threatened. Damage to the revetment resulted in a change of its slope from 2 to 1 to 4 to 1. Figure 6 presents a typical profile of this site. The backside of the revetment was 3 feet (.9 m) lower after the storm. The underwater region immediately offshore had been severely eroded. Therefore, depths near the toe of the structure were greater than those before and during construction. This factor made the toe of the structure more vulnerable to erosion and probably increased the run-up. It is believed that the undermining was caused by the combination of scour at the toe and the backwash from the run-up. The rock mastic revetment was more effective than the adjacent seawall as it was able to provide protection for the bluff (and the road) even in its damaged condition.

This photograph shows the condition of the revetment after collapse. Some sections, however, have remained relatively unchanged. Notice the exposed foundation of the concrete seawall in the background; evidence of the higher lake level in this vicinity and the lowered beach profile.

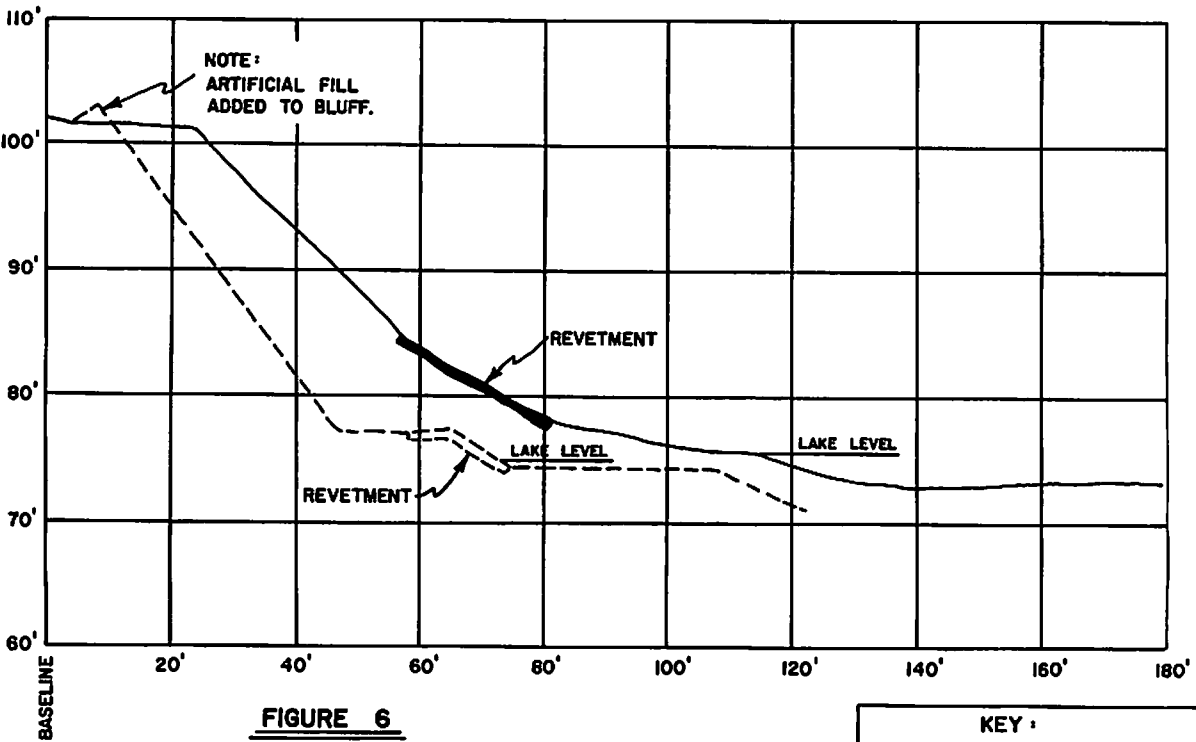
**FIGURE 6**  
**PROFILE OF ROCK MASTIC REVETMENT**  
**STATION 1+75 — MICHIANA, MICHIGAN**

unusually long storm also may have been caused by wave reflection off the steel wall at the north end. This is supported by the fact that 75 feet (22.9 m) of revetment closest to the wall suffered severe slumping whereas the next 75 feet (22.9 m) was hardly damaged. Even in its collapsed position, the revetment continues to provide some protection from minor storms.

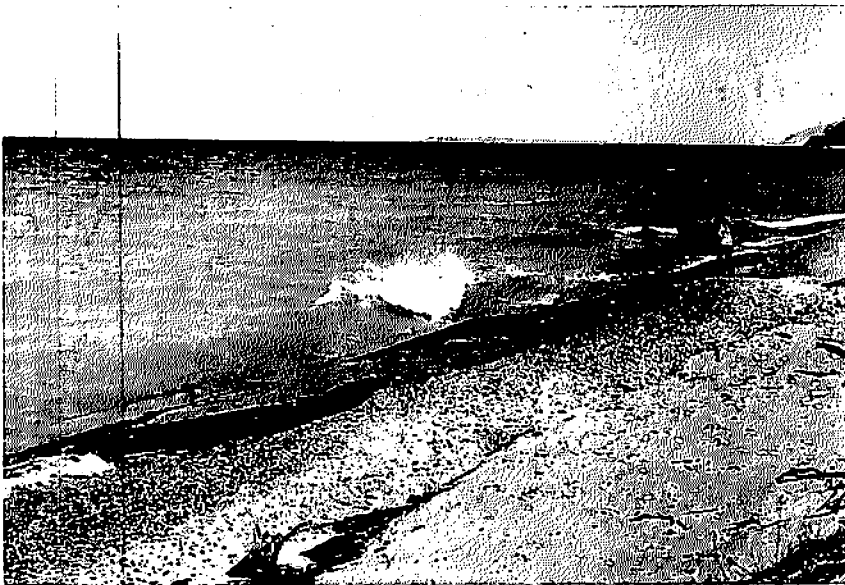
Figure 13. Empire, April 28, 1976.

This method of shore protection has proven ineffective at this exposed location. Modifications, such as tying the ends of the tube into the bluff or providing a foundation, may be expected to increase the effectiveness of a single 40-inch (101.6 cm) diameter Longard tube used as a seawall. At the Moran Township site a similar installation consisting of three tubes has been quite successful. At Sanilac-Section 11, a single 69-inch (175.3 cm) diameter Longard tube has been somewhat more effective.

The portion of tube which was exposed after substantial beach area was eroded can be seen. Some of the filter cloth foundation is also evident in the photograph. Most of the tube, which had begun to rip in 1974, was completely ripped and shredded at the time of this photograph.

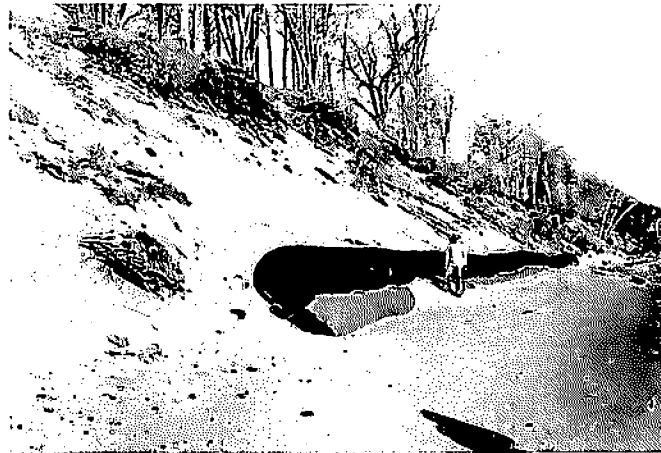
Figure 20. Moran Township, April 28, 1976.

The Moran Township site is seen in the spring of 1976. The Longard tubes are still in place after being shimmed up. Although a number of the shims (wedges) have been lost, many are still evident in this photo. It can be seen that the lower front tube is still a different color. This is because an experimental protective coating was applied to this tube during the first year of study. The sandbag structure is evident in the background. Many of the sandbags have been lost (largely, it is believed, due to vandalism). A number of trees have fallen immediately behind these structures as the top of the bluff has receded.

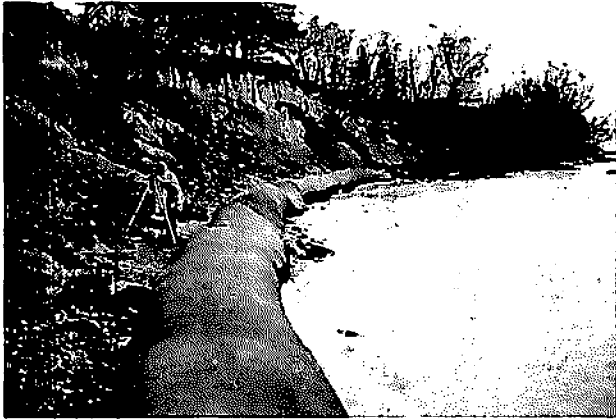
Figure 24 (above). Sanilac-Section 11, November 1, 1975.

The tubes performed well at this location through the fall of 1975. There was minor shifting and damage. Some sand had been lost at the center of the structure where the two tubes meet, and the north end had moved lakeward about 5 feet (1.5 m); see Figure 24.

At the time of this photograph the bluff had slumped (naturally) to some extent and portions of the tube were being pushed lakeward by the back pressure of the slumping bluff. One small portion in the center of the structure had lost sand. Generally, it can be seen that the tube withstood the forces of the environment to that point.

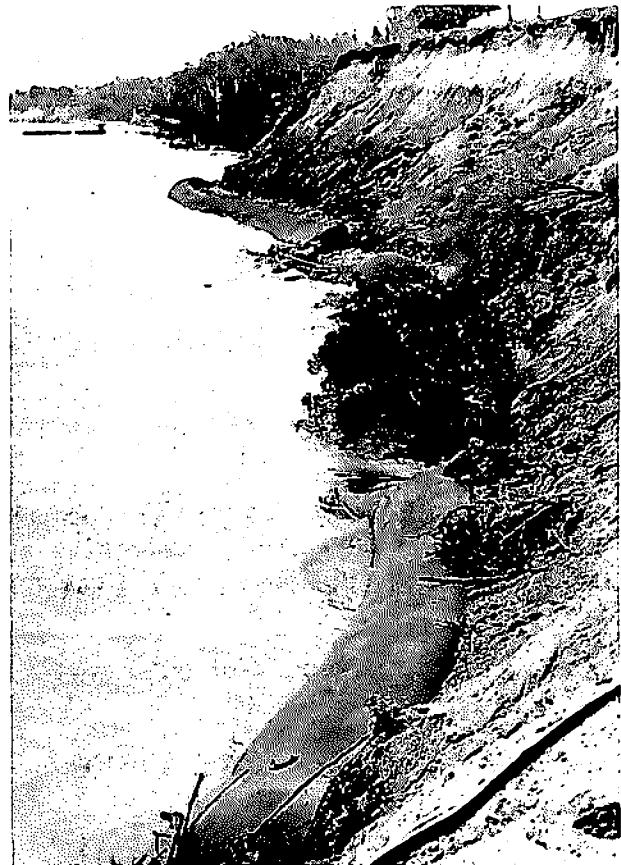
Figure 25 (right). Sanilac-Section 11, May 20, 1976.

The survey made in the spring of 1976 revealed that this structure had been severely damaged; see Figure 25. This damage probably occurred during a critical storm experienced in late April 1976. Portions of the tube have collapsed and the entire structure has rolled toward the lake. Photographic records show that during the past two years the bluff recession rates to the north and south have been greater than at the site of this installation. It appears that these tubes have reduced the erosion rate to the land area behind them. Figures 26 and 27 show the movement of the tube.

The damage to the tubes is evident in this photograph. The tubes have rolled toward the lake and sections of the tube have lost their sand. Bluff recession has been recorded behind the tubes.

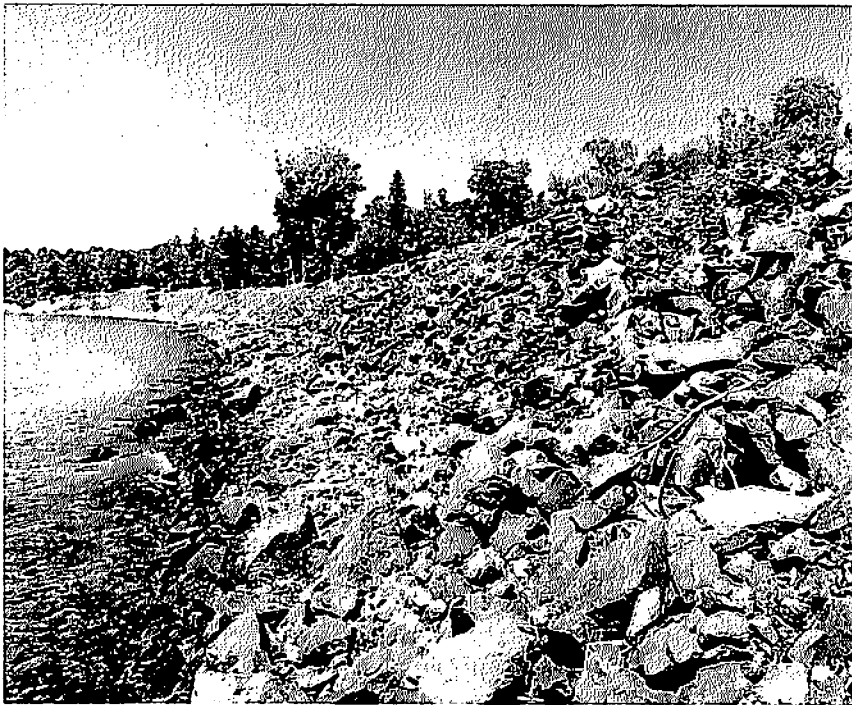
Figure 31. Keweenaw Peninsula, June 30, 1976.

This photograph of the revetment in the spring after the major storms illustrates the stable condition of the revetment.

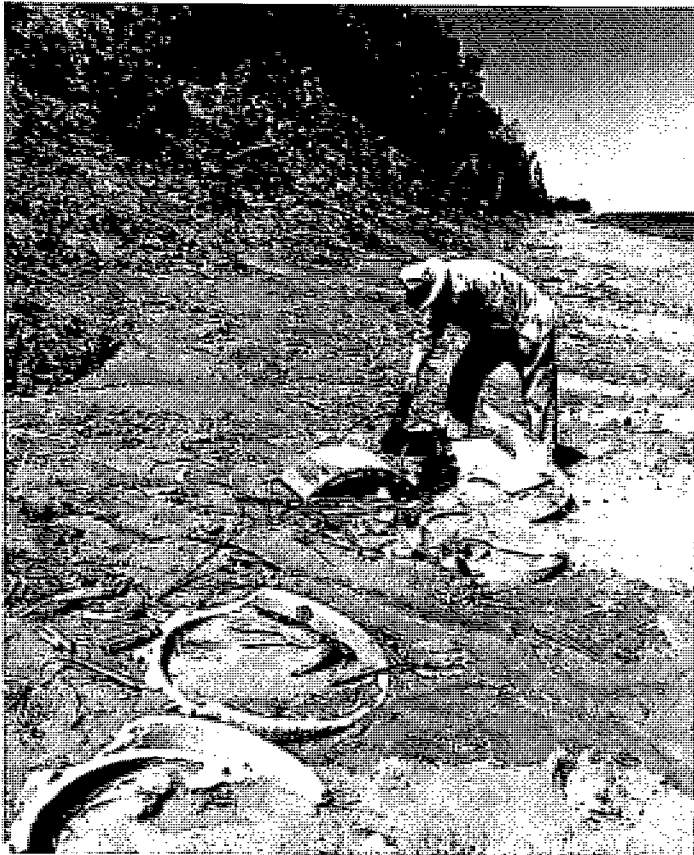
Figure 34. Little Girls Point,  
June 30, 1976.

The broken Nami rings and  
torn filter cloth foundation  
are clearly evident in this  
photo.

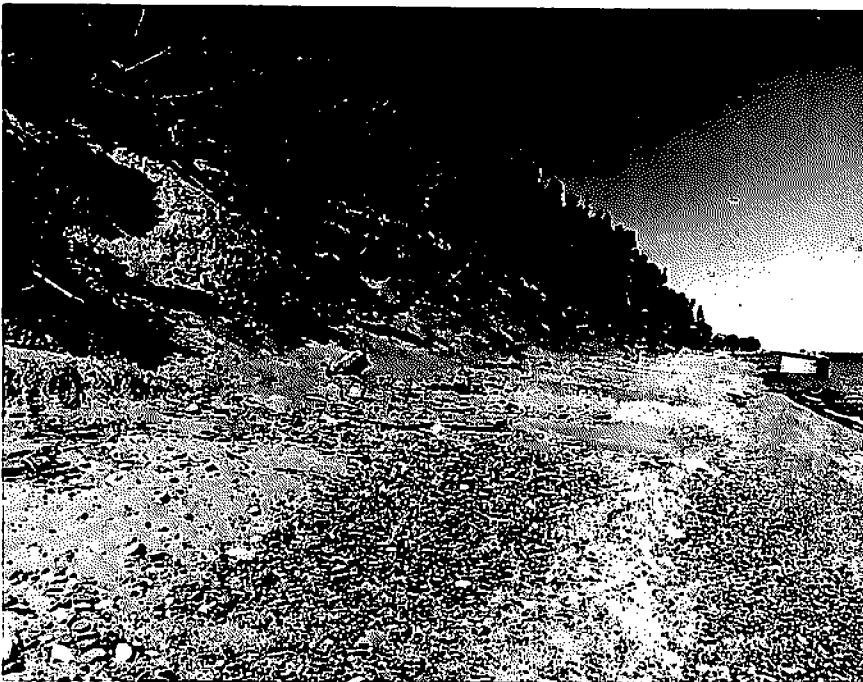
Figure 35. Little Girls Point, June 30, 1976.

This is the same view of the project site as Figure 32,  
only one year later. The large amount of damage to the  
revetment is readily apparent. Bluff recession behind the  
revetment is also obvious.

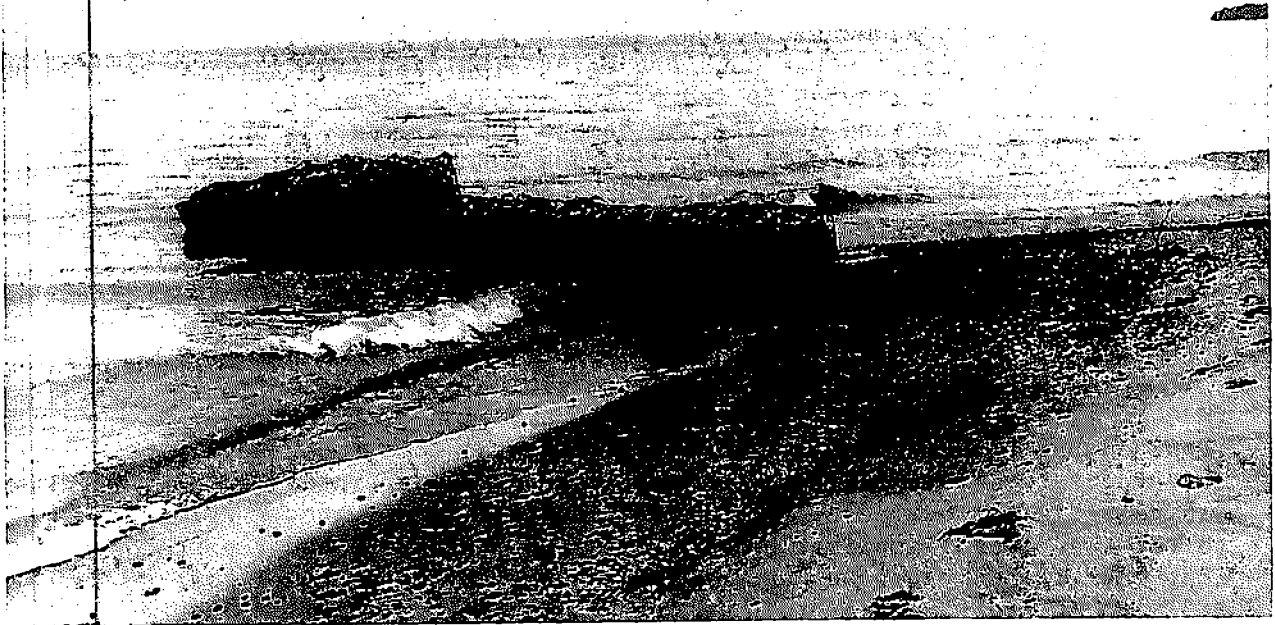
Figure 53. Sanilac-Section 26, May 19, 1976.

This view of the gabion groin, after one and a half years of service shows beach build-up and settling at the lake end of the groin.

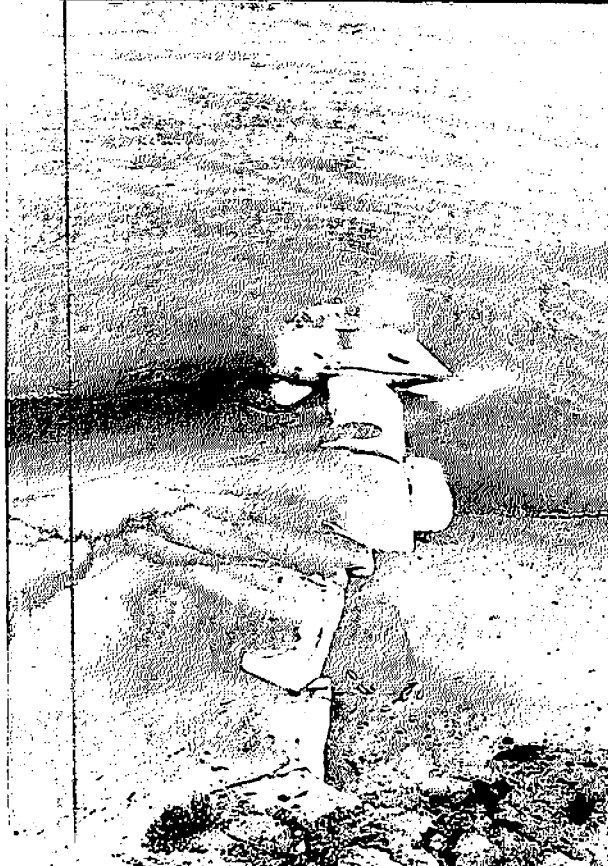
Figure 57. Sanilac-Section 26,  
May 19, 1976.

Giant Sandbag Groin. The giant sandbag groin was installed in the late fall of 1973 and suffered major damage in the first year. The length of the groin is 60 feet (18.2 m.) and it cost \$30 per foot (\$98 per meter) to install. Nearly 15 feet (4.6 m) of sandbags were lost at the lake end of the groin. Vandalism is probably not the cause since the missing bags were from the lakeward end of the structure which is submerged. Bags are continuing to deteriorate, rip open, and become lost; other bags are being displaced from their original positions; see Figures 56 and 57 for changes. The structure appears to be trapping some sand despite the damage (see Figures 58 and 59). Preliminary conclusions as to effectiveness and durability indicated that sandbag groins offer temporary protection. They do not seem as durable as other structures and should not be considered permanent protection. With annual replacement of damaged bags and protection against tearing, sandbag groins could function effectively for several years.

The condition of the groin is shown two years later (than Figure 56). Sand has been trapped by the groin but a large number of bags have been lost or have shifted. As is apparent, sandbags are not a permanent means of shore protection.

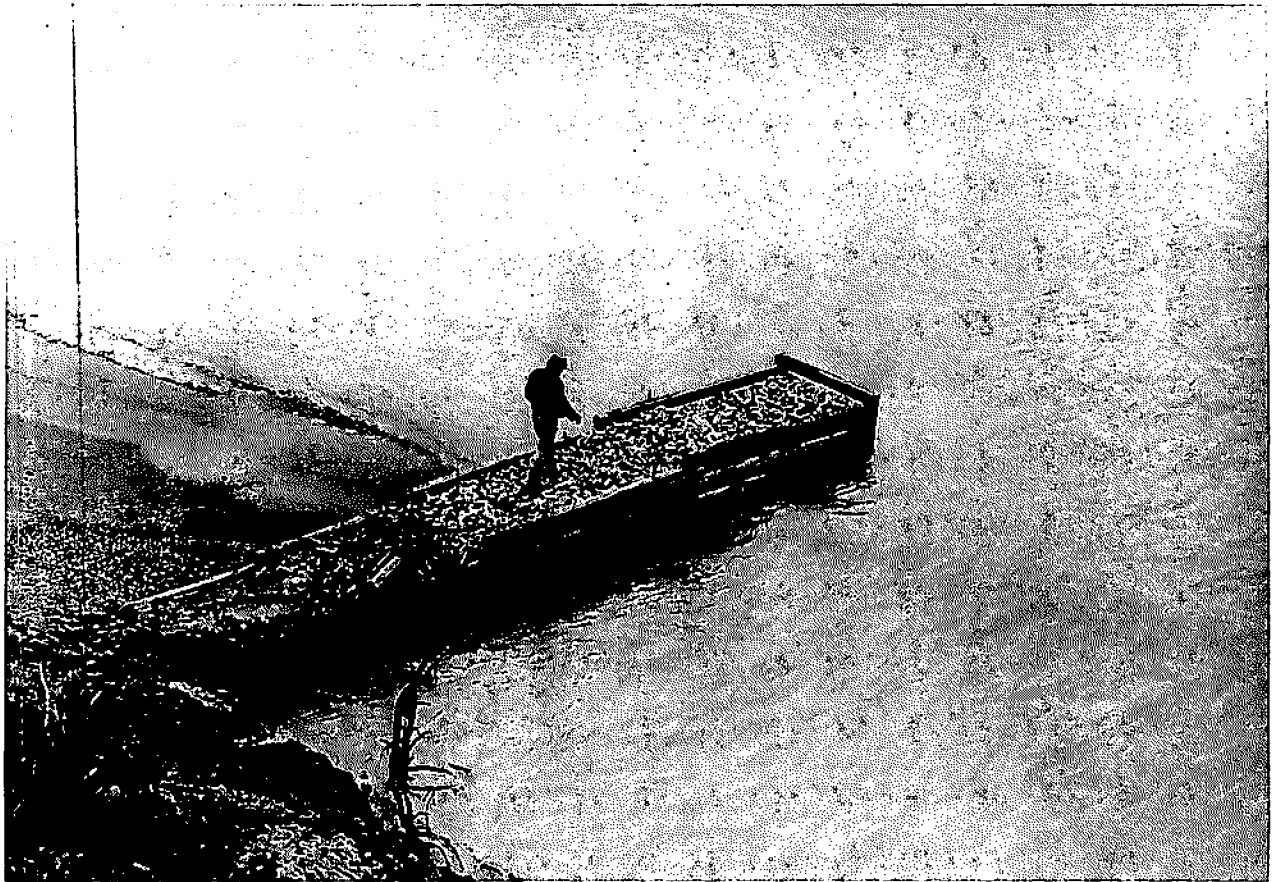
Figure 62. Sanilac-Section 26, May 19, 1976.

Timber Crib Groin. Very few data are available for the timber crib groin installed at the extreme south end of the site in the fall of 1975. It extends 50 feet (15.2 m) and cost \$30 per foot (\$98 per meter) to install. To date, it has remained in good condition (see Figures 62, 63, and 64).

Shown here is the timber crib groin. It had been installed the previous fall. Some beach build-up can be seen in this photo.
