Evaluation Of Tying Materials For Floating Tire Breakwaters

University of Rhode Island
Marine Technical Report 54

Marine Technical Report No. 54

April, 1977

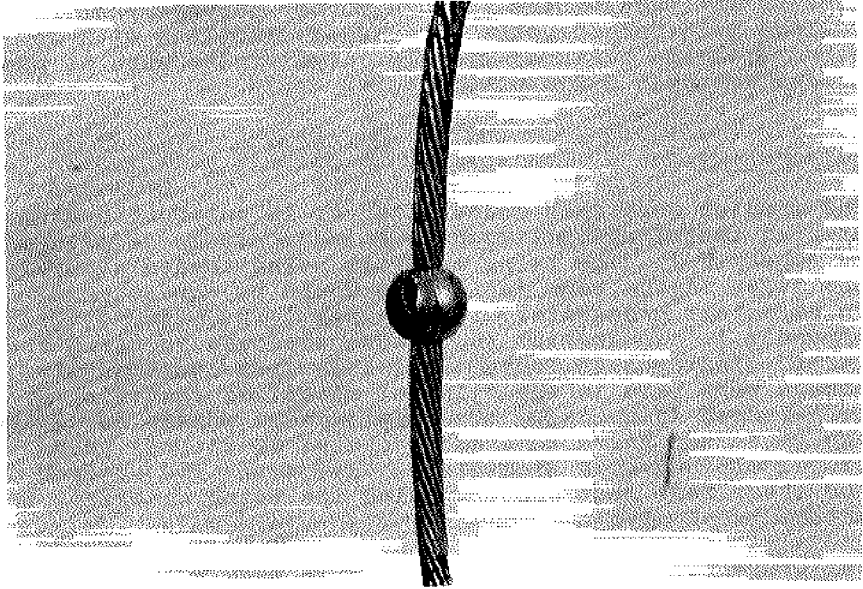
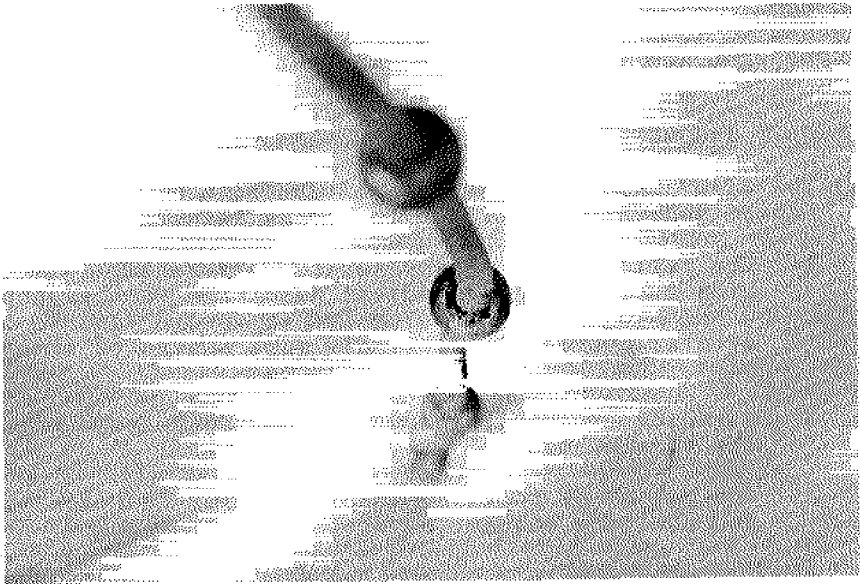
- a. The 3/16" 1x19 stainless steel wire with ball swedges proved undesirable for the following reasons:
 1. The ball swedges showed severe preferential corrosion along its longitudinal axis (see Photographs 1, 2 and 3). This corrosion led to swedge failure on several specimens after only five months of immersion.
 2. Evidence of crevice corrosion was noticeable within the wire bundle.
 3. The method of holding cables securely in place was not positive enough; several "jumped" swedges.
 4. The wire severely chafes the tire casing (see Photograph 2).

Photo #1 & #2. Severe corrosion on stainless steel ball swaged over stainless steel tying wire.

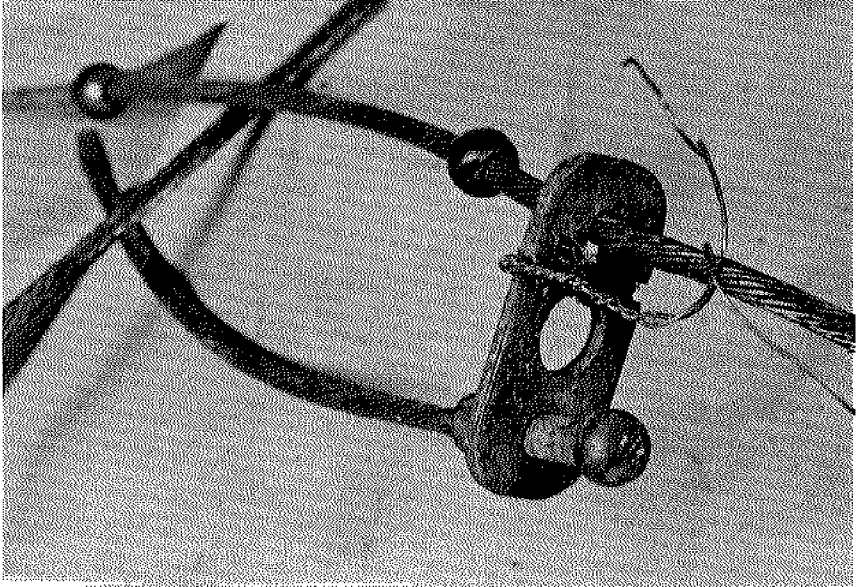
Photo #3. Positioning clamp showing function of stainless steel ball swedges on stainless steel tying wire.

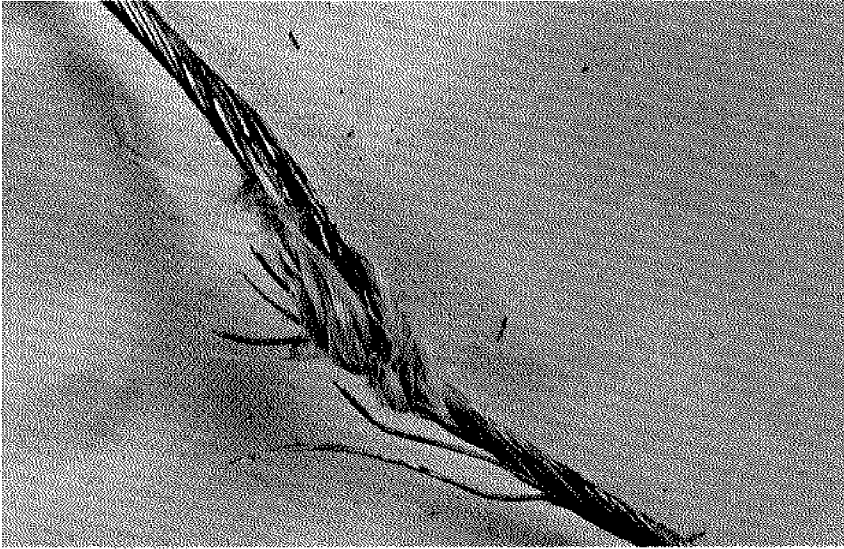
5. The life expectancy is poor because of corrosion accelerated fatigue.
- b. The 5/32" 1x12 stainless steel wire with Kevlar core is undesirable:
1. This material experienced multiple failures due to severe crevice corrosion and fatigue. Of all the wire ropes tested, this was the worst (see Photograph 4).

Photo #4. K-Core stainless steel wire showing typical failure. Wire has a central core of Kevlar fiber.

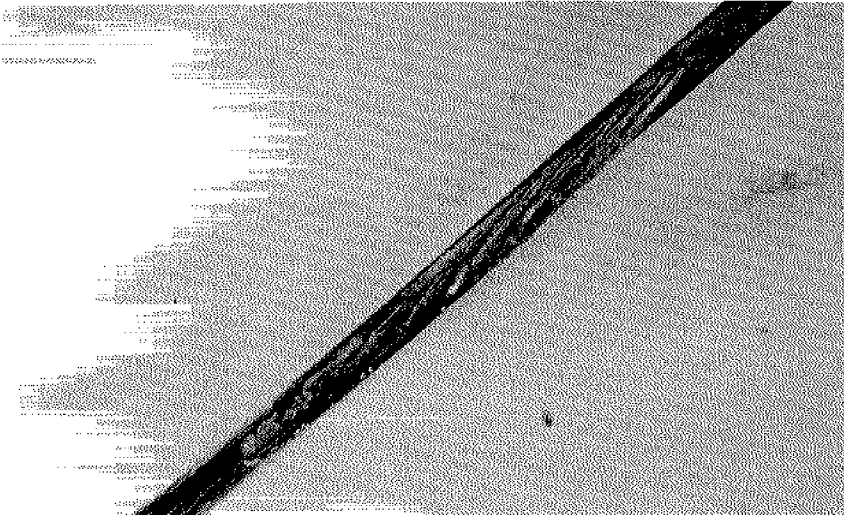
1. The polypropylene wears off after only two or three months of service because of chafing between the tires (see Photograph 5).
 2. Wire chafes the tire casing (see Photograph 6).

Photo #5. Polypropylene coated wire showing the exposed wire resulting from several months of abrasion against the tire casings.

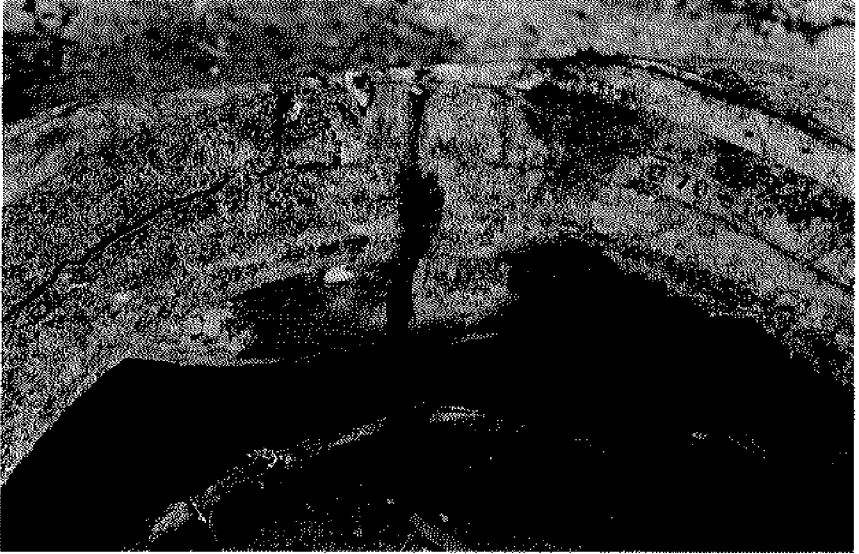
Photo #6. Tire casing depicting a typical cut due to wire chafe.

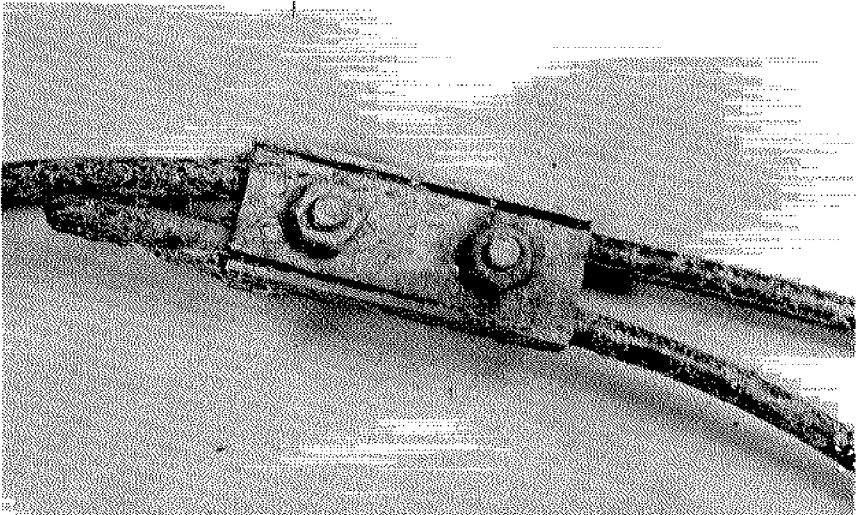
3. The method of fastening the wire causes damage to the protective coating and adds an additional metallic component to the system (see Photographs 7 and 8).

Photo #7. A stainless steel cable clamp holding polypropylene coated wire.

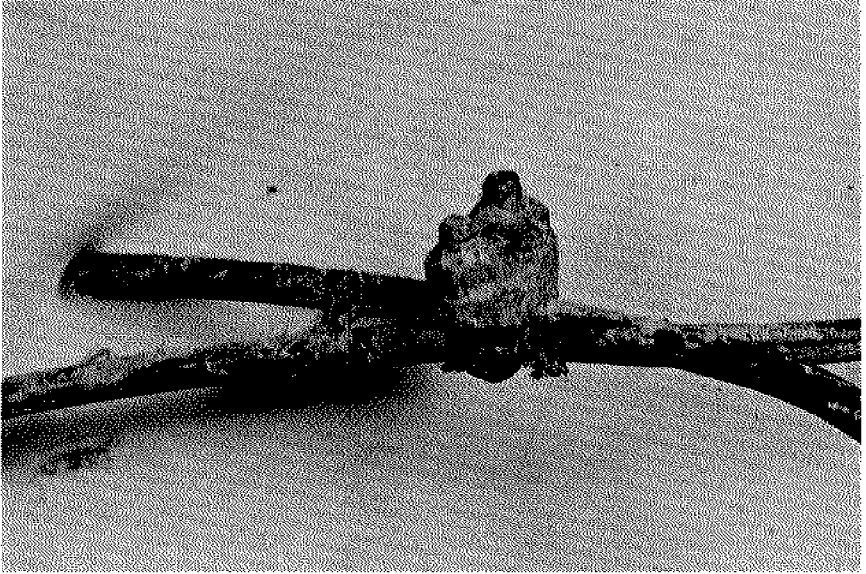
Photo #8. Steel cable clamp holding polypropylene coated wire.

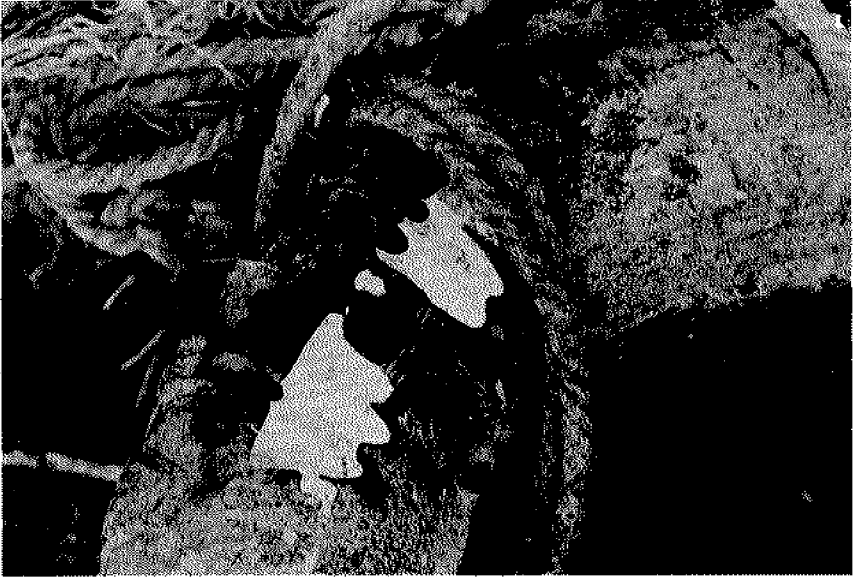
3. The line tends to chafe grooves into the tire casings (see Photograph 9).
- f. The 1/2" nylon rope is not recommended:
1. It demonstrated poor abrasion resistance. Several lengths had their breaking strength reduced by more than 75 percent as a result of abrasion during an eight-month period.

Photo #9. Tire casing chafe due to fiber rope abrasion.

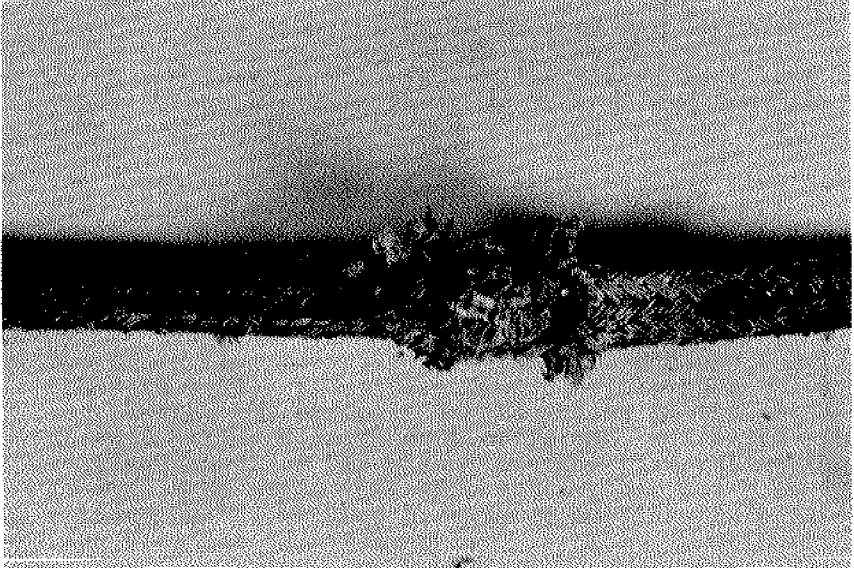
- g. The 1/2" Poly-D rope is not recommended for the same reasons as given for test material "f" above.
- h. The 1/2" Kevlar line is definitely not recommended. It demonstrated the worst fatigue characteristics of all the fiber materials tested. Total failures were noted after only four months of testing (see Photograph 10).

Photo #10. Kevlar rope showing beginning of fatigue-abrasion failure.

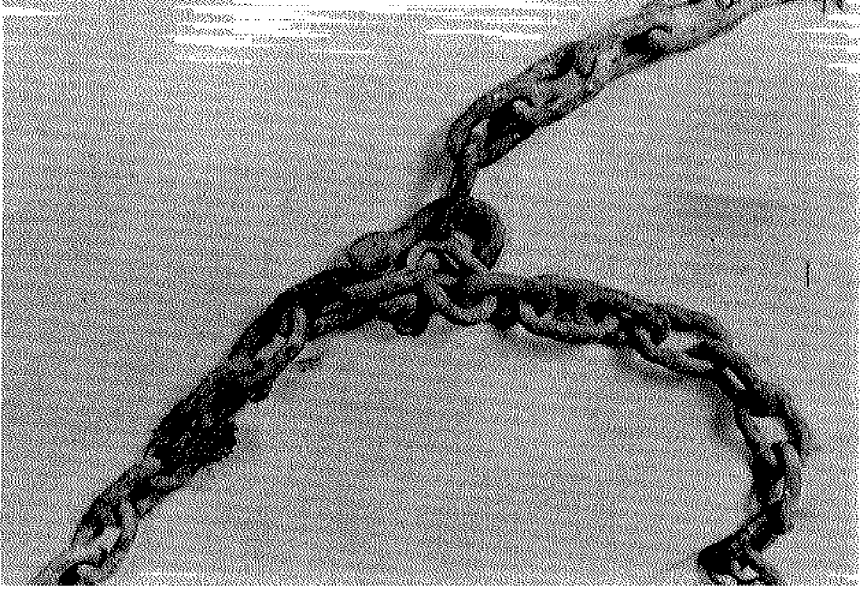
- j. The 3/16" welded, galvanized steel chain withstood the test in excellent condition (see Photograph 11). The chain connections were made with 3/16" galvanized steel shackles. Although this chain remained in good condition, it is not recommended for long-term breakwater installations. Once the zinc coating has corroded away (it acts as a sacrificial anode) the attack on the underlying steel is relatively rapid, causing multiple failures after several years of immersion. Heavier galvanized chain would last longer but eventually undergo the same corrosion.

Photo #11. 3/16-inch galvanized chain and shackle.

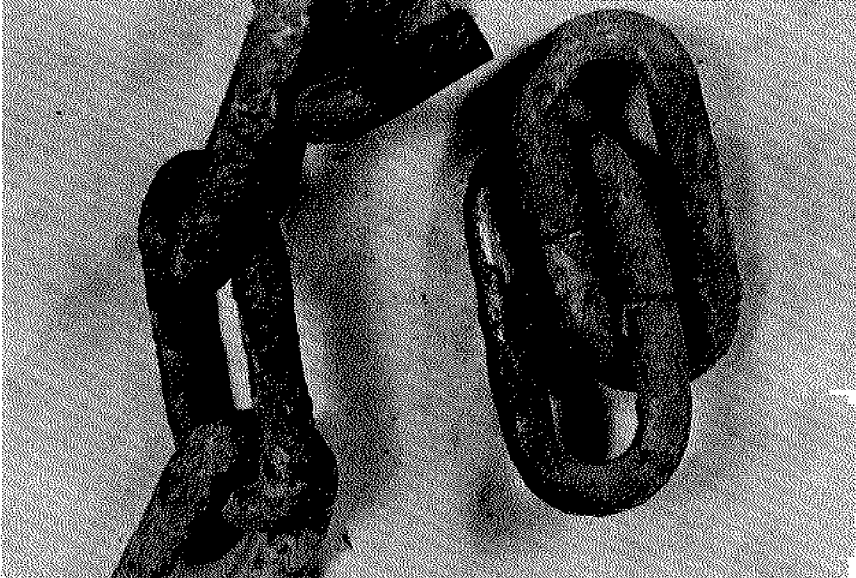
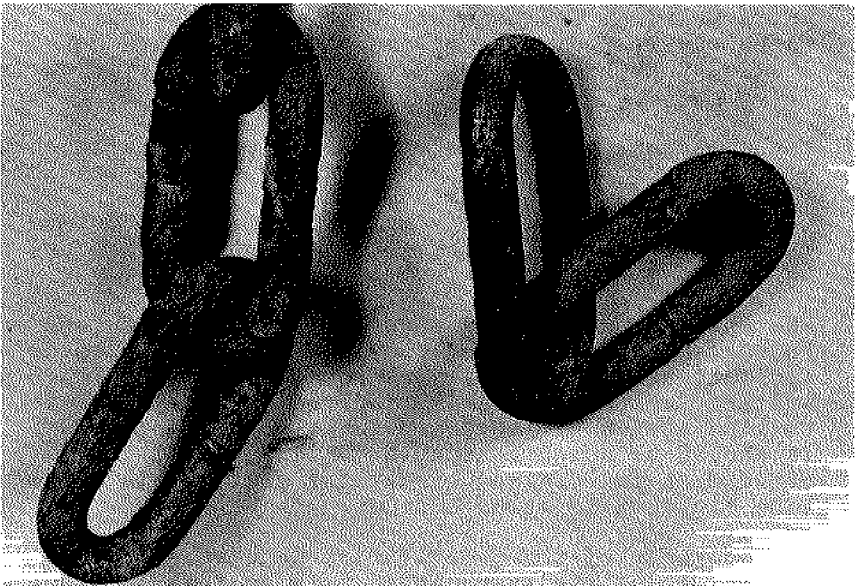
1. Approximately 30 percent of the test chain links showed 13 to 16 percent reduction in cross sectional area as a result of only 9.5 months immersion (see Photographs 12 and 13). The remaining 70% of test chain showed varying degrees of corrosive decay ranging from 3 to 10 percent reduction. This corrosion was primarily concentrated on the "solid" length of the chain link, i.e., the portion which bears the bending and tensile loads. The preferential corrosion in this area is probably due to the method of forming the chain links. In any case, the reduction of area because of corrosion results in an average decrease in chain strength of 14 percent.

Photo #12 & #13. Half-inch special chain, non-galvanized, showing the results of corrosion.

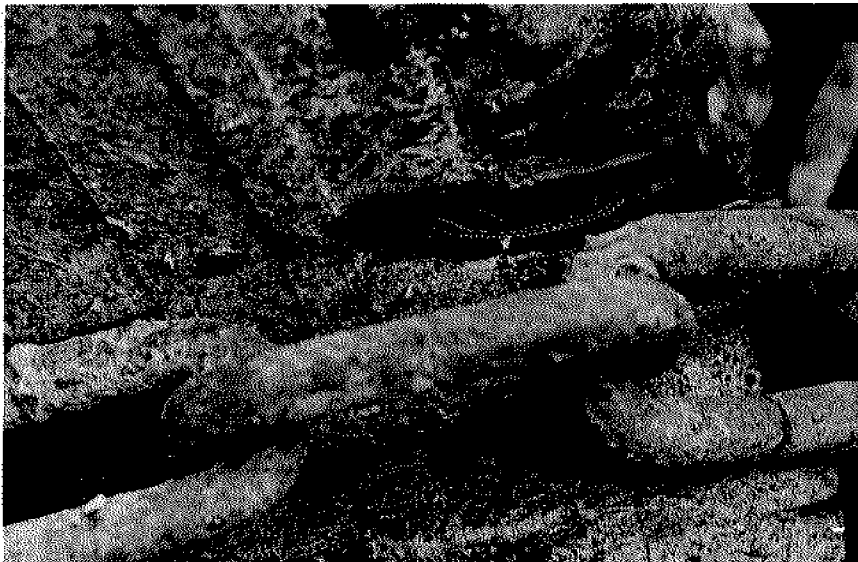
3. The chain cuts severely into the tire casings (see Photograph 14), reducing buoyancy by creating holes and letting air escape. The roughness of the chain's surface, which results from corrosion, increases the cutting action of the chain into the tire casings. It should be noted that this cutting has not been noticed on the chained breakwater sections in place on Lake Wingfoot in Akron, Ohio.

Photo #14. Cut into tire casing as a result of half-inch special chain abrasion.

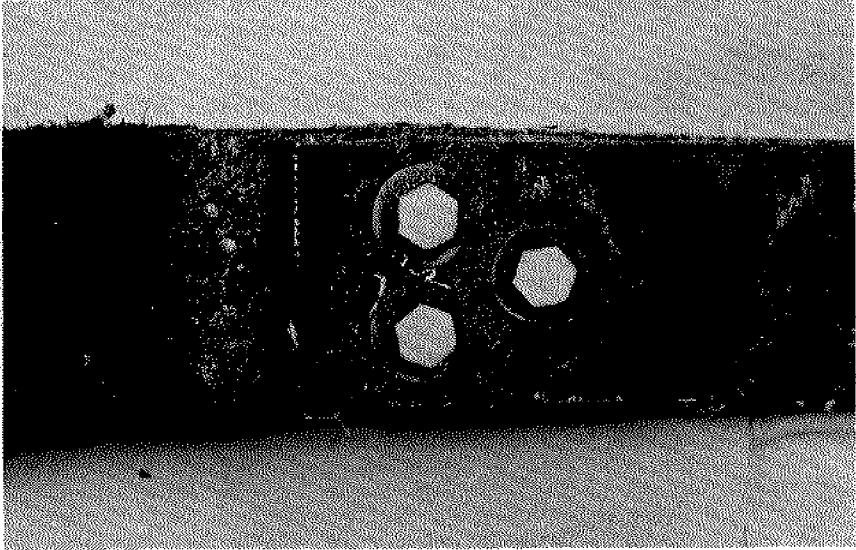
System 1. The use of three 3/8-16 bolts per tie, as shown in Photograph 15. The belt width used with this pattern should be no less than 2.00" in the bolt zone to prevent the belting from tearing through to the edges. This pattern can support an average load of 2,100 pounds before the bolts fail. Note that washers must be employed under the bolt head and nut to prevent them from pulling through the rubber. Voids in the center of these 3/8-16 injection-molded bolts cause the strength of these bolts to vary by several hundred pounds. For this reason, system number two is recommended over use of the 3/8-16 bolts. This is not meant to indicate that 3/8-16 bolts cannot hold a breakwater together; there are several such breakwaters in use at present that have been in the water for over nine months. One of these at Great Bay Marina, N.H., is 100 feet in length and positioned perpendicular to a daily tidal flow in excess of three knots.

Photo #15. Rubber conveyor belt edging showing 3/8-16 nylon bolt pattern with washers.

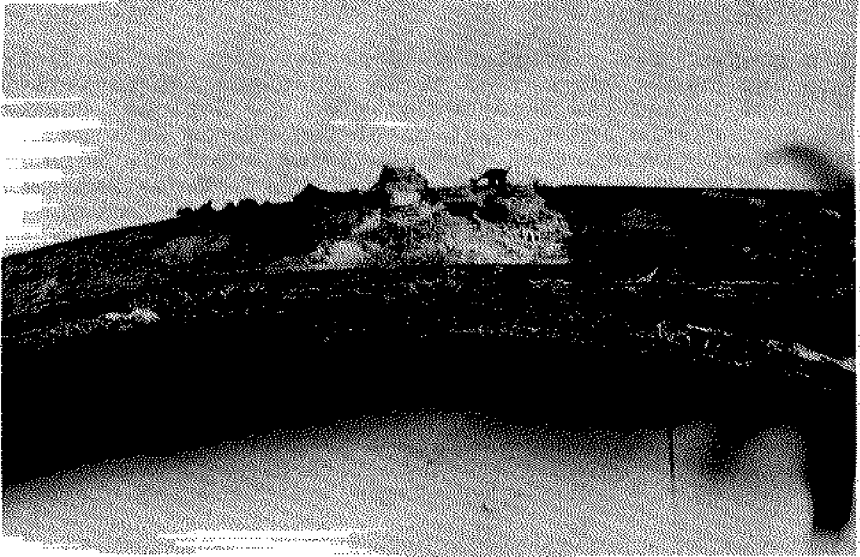
One-quarter inch of protruding thread allows a propane soldering tip to melt and distort a sufficient number of threads to prevent the nut from "backing off." Also, the growth of marine plants in the exposed threads greatly hampers the nut's working loose (see Photograph 16).

Photo #16. Edge view of rubber conveyor belt joint fastened with 3/8-16 nylon bolts.
