COASTAL LANDSLIDES IN SOUTHERN CALIFORNIA

**BY BERNARD W. PIPKIN
AND
MICHAEL PLOESSEL**

A USC SEA GRANT PUBLICATION

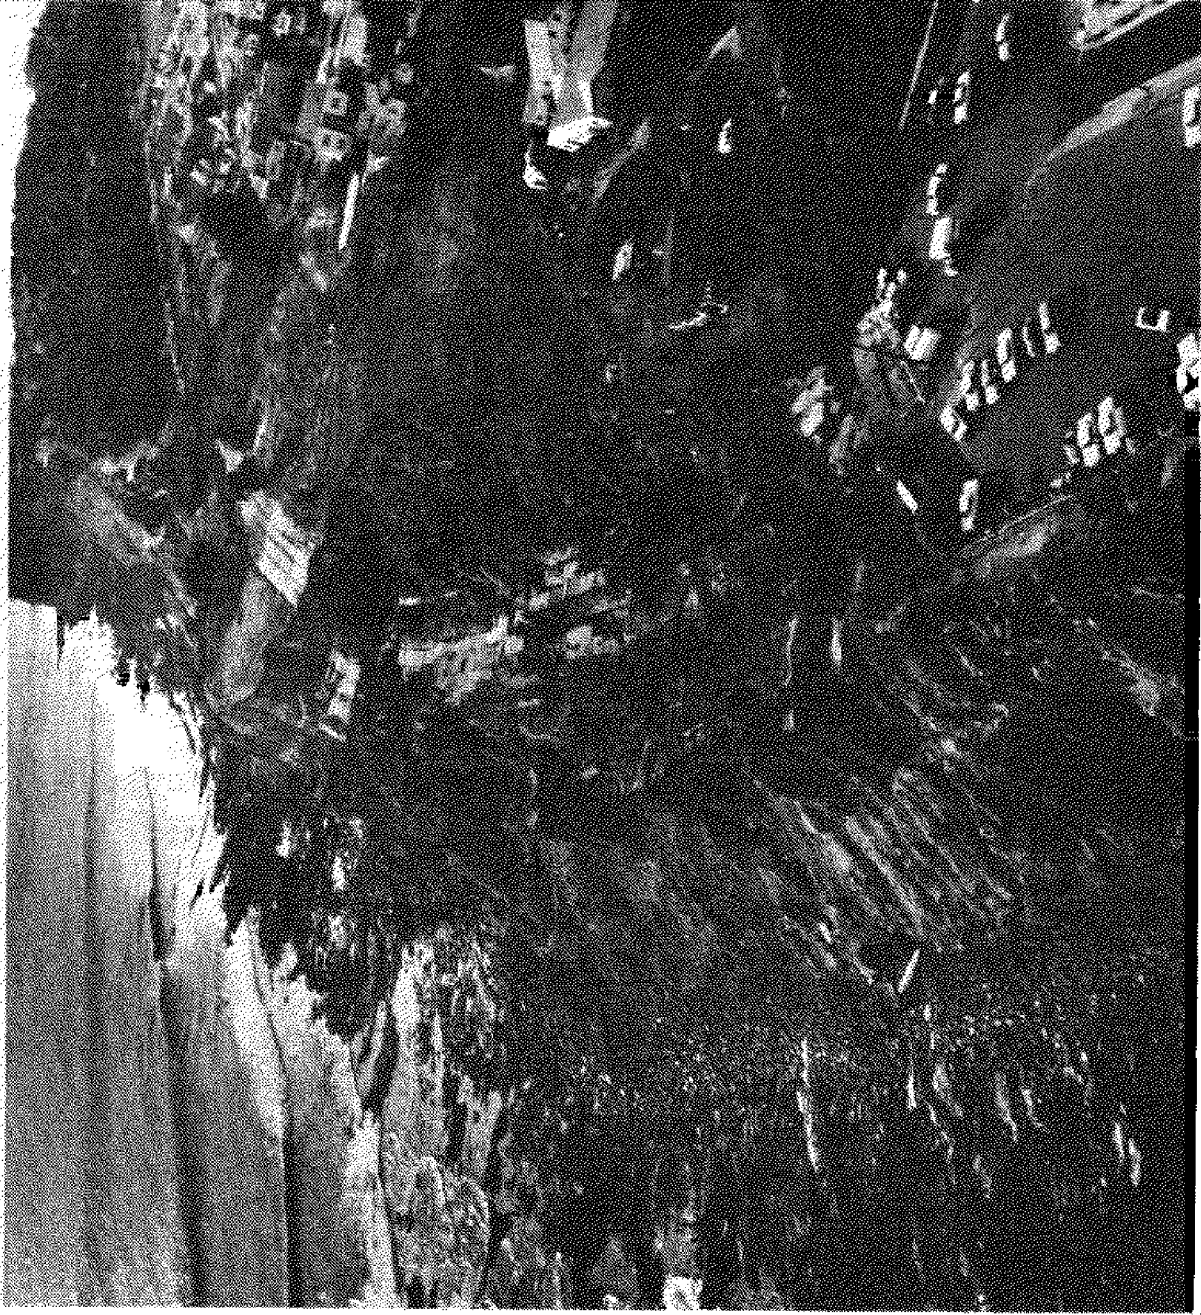
Figure 1. The Point Fermin landslide at the southern tip of the Palos Verdes Peninsula. The slide disrupts the nearly flat surface of a marine terrace in the right half of the picture. One can also barely discern the foundations of removed structures adjacent to the disrupted asphalt street across the slide. (Photo by John S. Shelton)

The Point Fermin slide (Figure 1) became active in 1929 and the photo shows the total displacement after 30 years. Many homes, and a quarter-mile section of road, were destroyed. Failure was caused by underground water weakening shale layers sloping toward the cliff face. Total movement on the slide has been about 200 feet, and recurrent movement takes place during heavy rains.

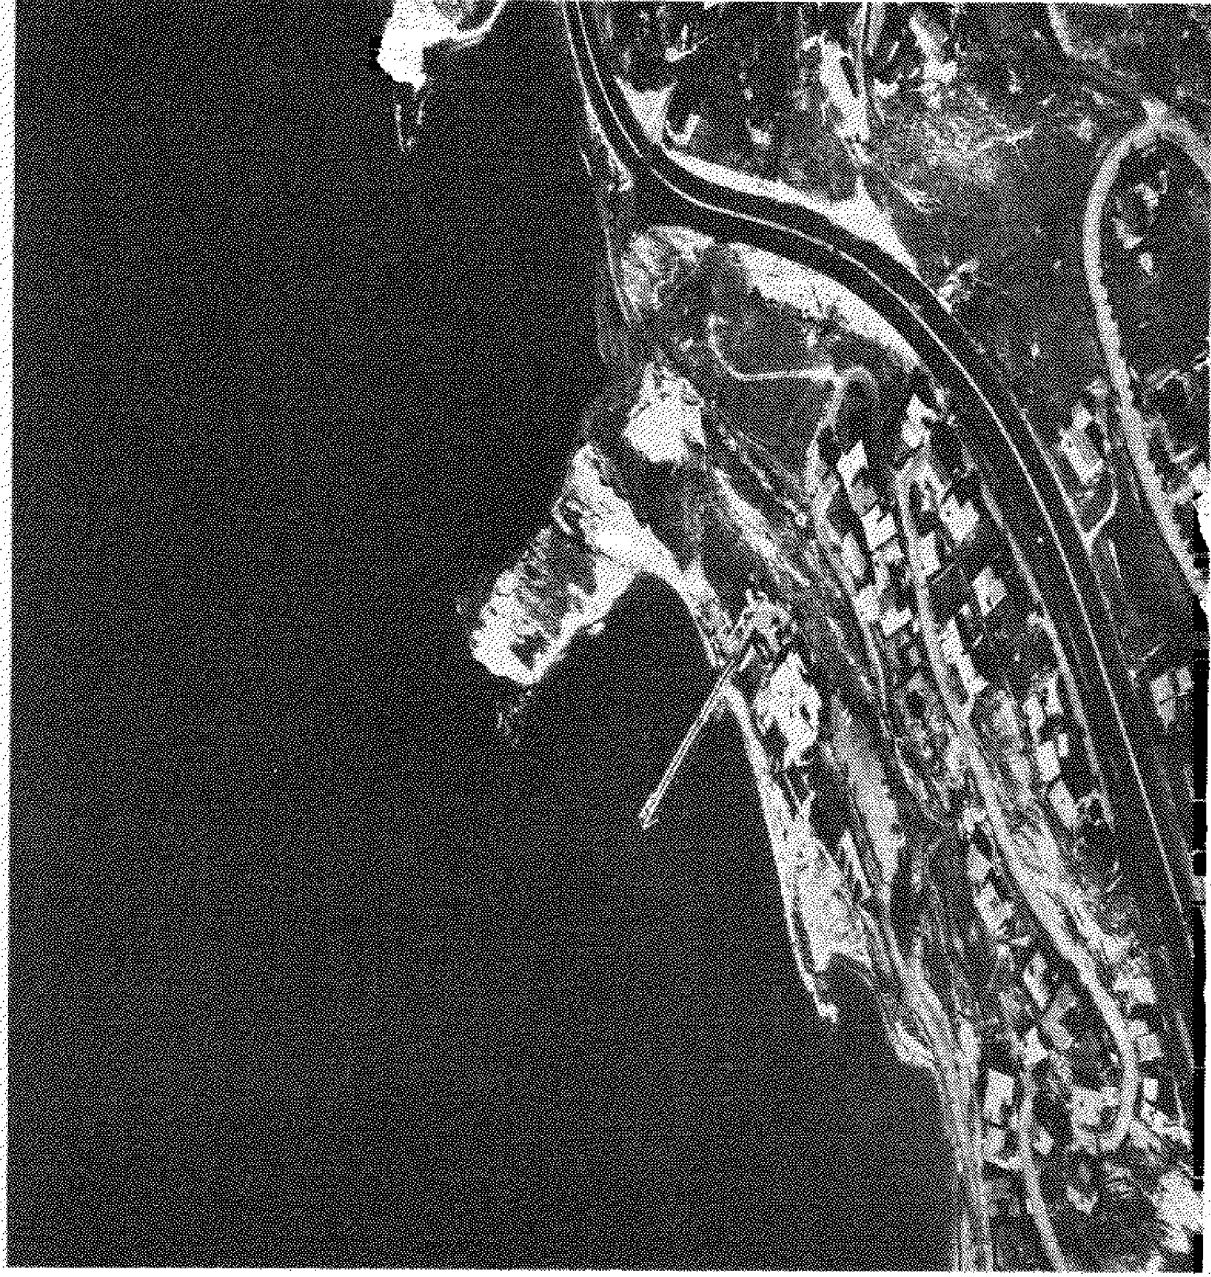
Figure 5. Lower portion of the Portuguese Bend landslide as of March 5, 1958, with Inspiration Point at right center and Portuguese Point at the extreme right of the photo. Signs of distress are the buckle in the pier that marks the slide plane and fissuring of the ground between the highway and Inspiration Point. In fact, many homes suffered severe distress at this stage and were rendered uninhabitable. Compare with Figure 6. (Photo by John S. Shelton)

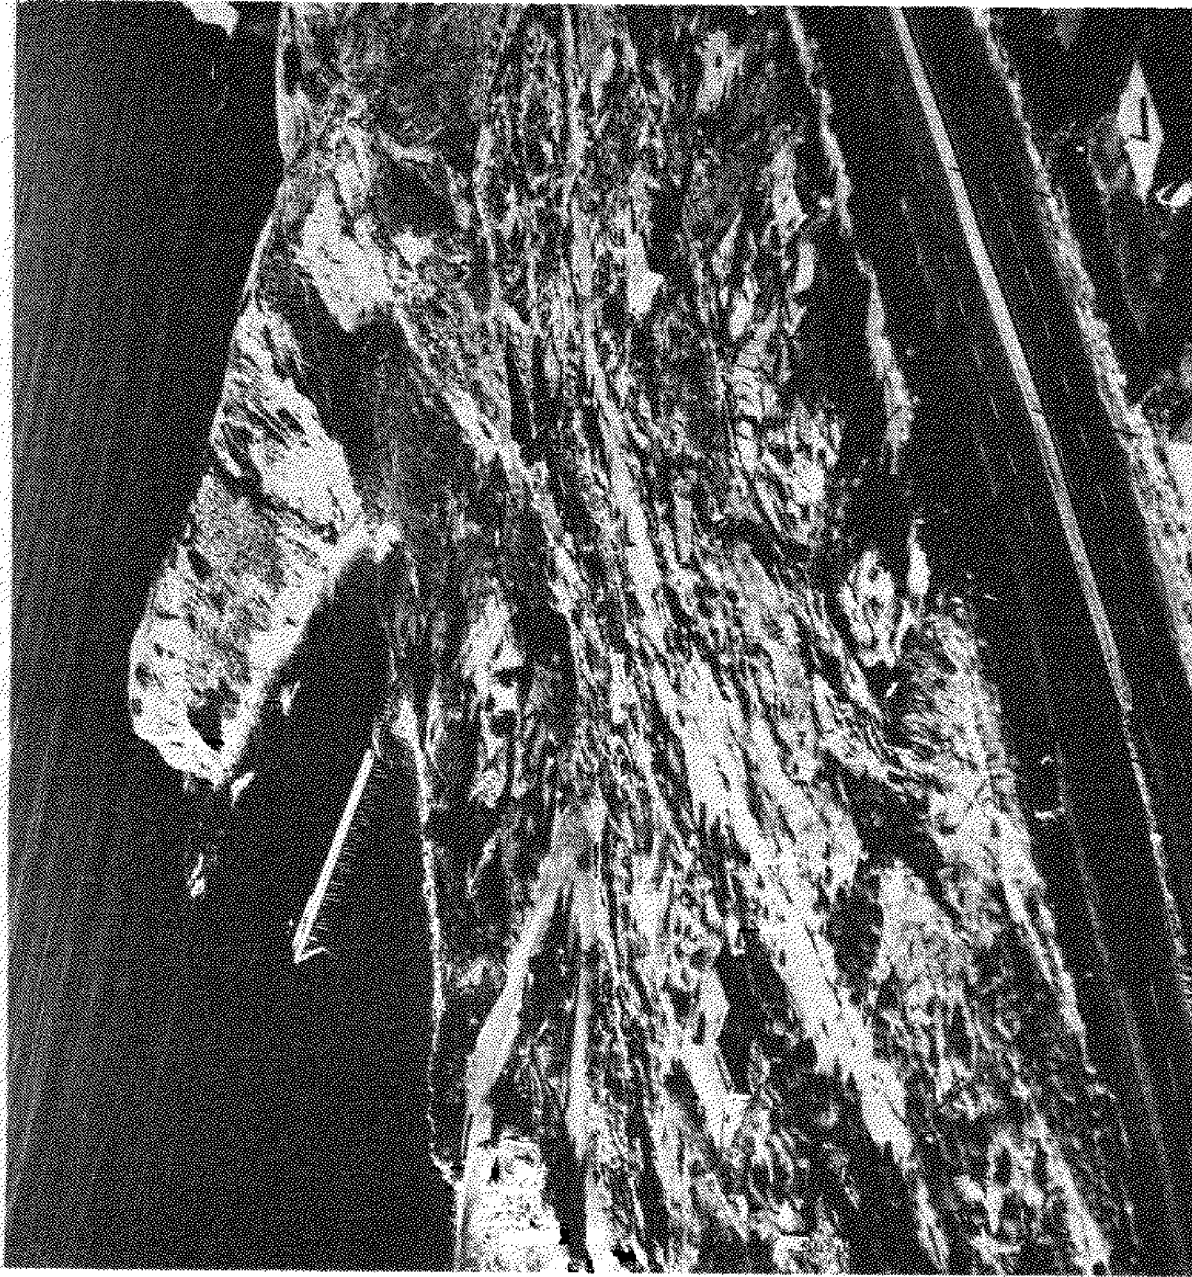
Figure 6. Lower portion of the Portuguese Bend landslide taken November 24, 1959. Inspiration Point is in the upper middle part of the photo. Note the break in the pier that marks the slide plane, the disrupted and fissured ground, and the wavy center divider on the highway. The slide is still moving, as of 1972, at an average rate of about .25 inches per day. The center divider has been removed and the area covered by asphalt. (Photo by John S. Shelton)

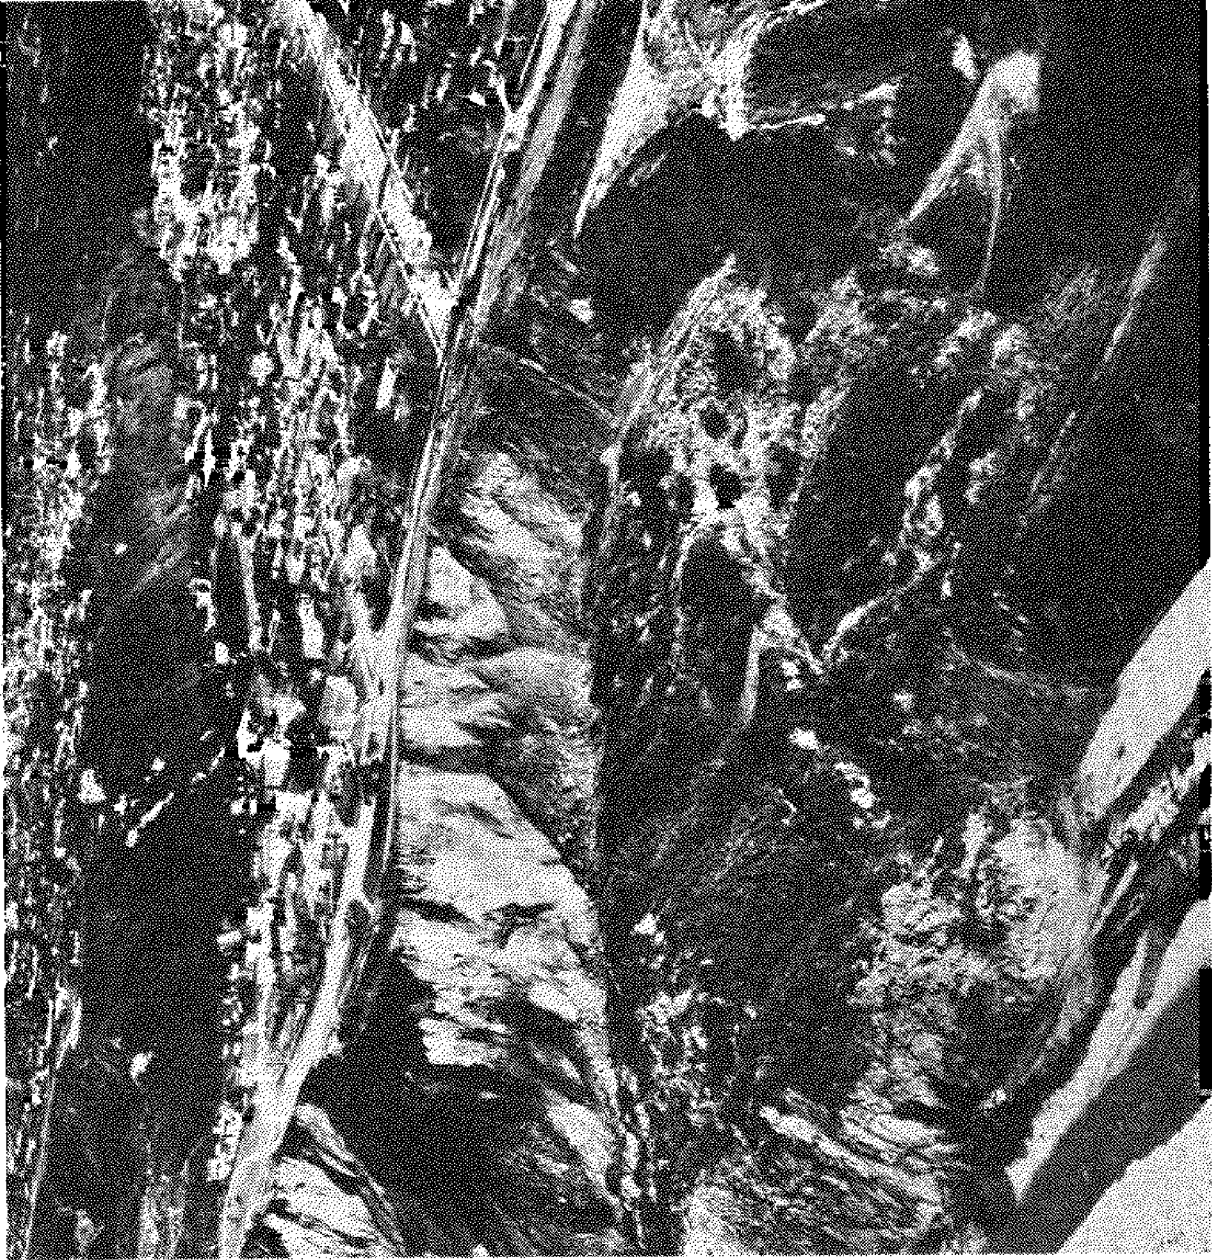
Figure 7. Pacific Palisades landslide the day after it occurred, April 4, 1958. Note the slide to the north that had taken place only a month earlier. Because the slide was so large, the highway had to be relocated around the toe. An ancient slide is to be seen at the low terrace in the lower-right portion of the picture. (Photo by John S. Shelton)

The Pacific Palisades are a cliffed segment of the coastal zone north of Santa Monica. The palisades themselves present a scalloped appearance from ancient and active slumps and rock-falls. On April 4, 1958, a slide involving 90,000 cubic yards of material plunged down on the Pacific Coast Highway (Figure 7). The movement took place so suddenly that an engineer was killed and several pieces of equipment were buried. The real irony, however, is that the men and equipment had just finished removing the last of the debris from a slide which had taken place a month earlier just to the west. Rather than risk another slide during removal, it was decided to build the highway around the toe of the slump.

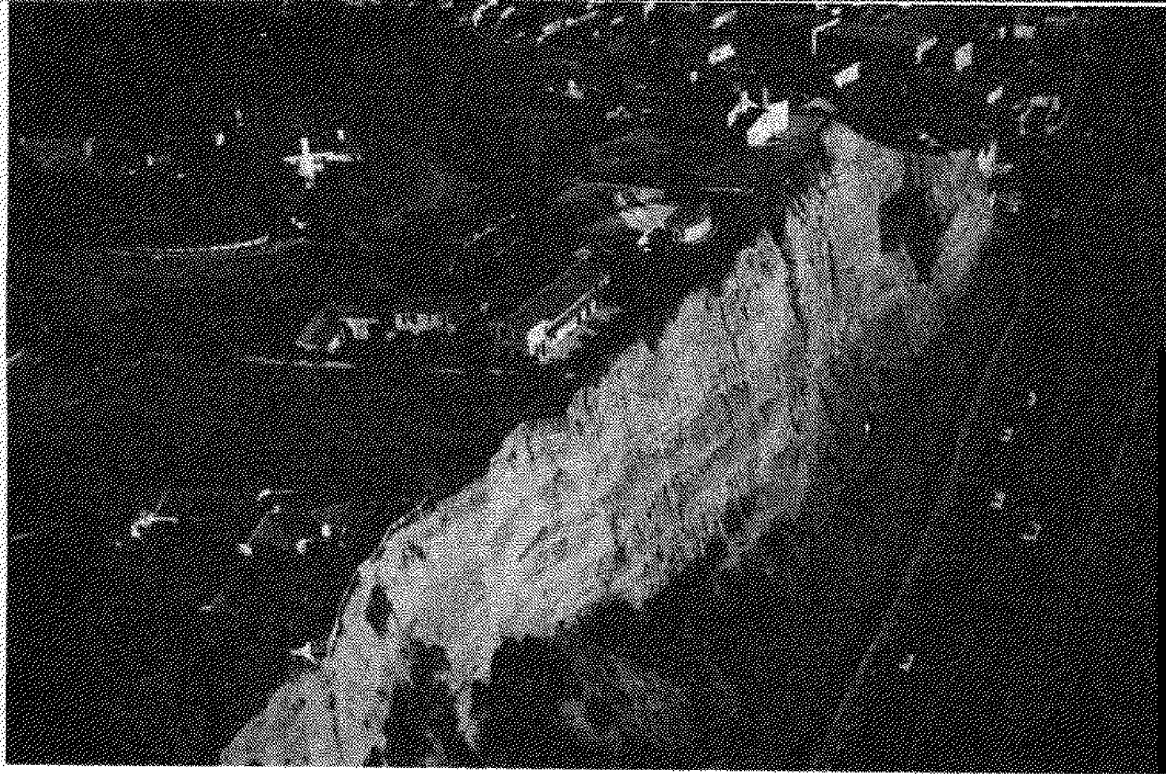
Figure 8. Portion of the Huntington (Pacific) Palisades looking east prior to 1968. Cliffs are composed of poorly consolidated sands and gravels and are 160 feet high.

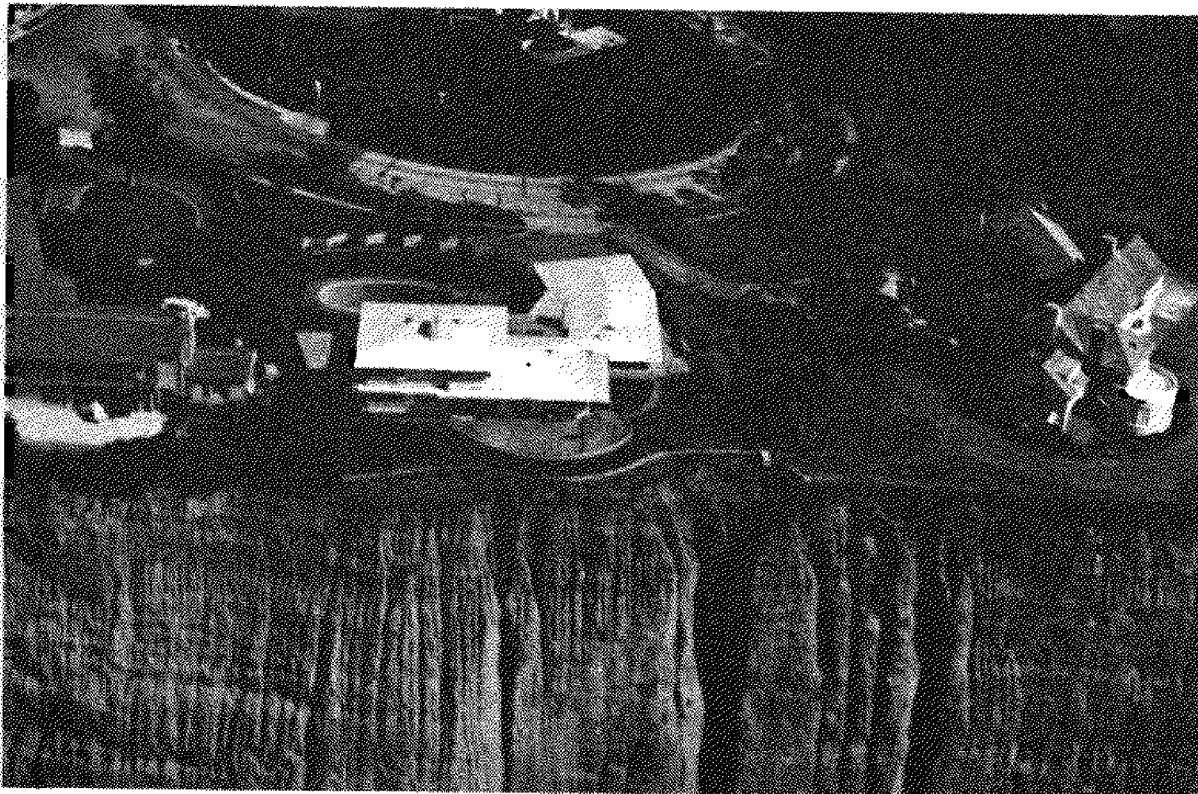
Figure 9. Closeup of cliff face shown in Figure 8 below dwelling valued in excess of \$100,000. Note vertical cracks (joints) that have become enlarged due to poor surface drainage and precipitation.

4. Follow the grading ordinance and consultant's recommendations on lot drainage. Poor surface drainage can cause severe sloughing and speed recession of the edge of sea cliffs.

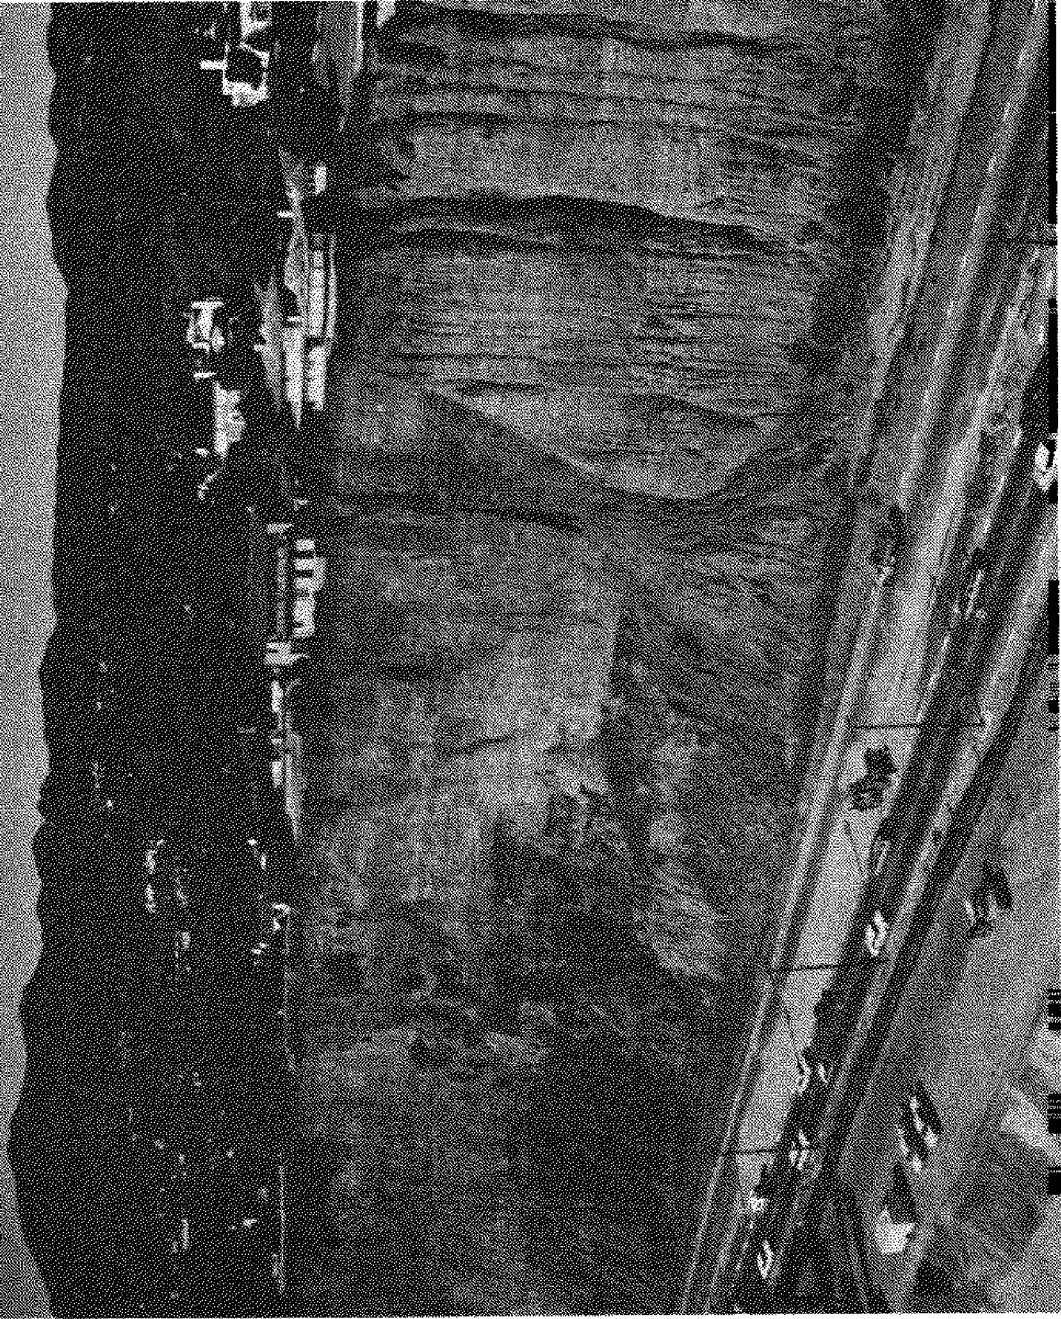
Figure 10. Same area shown in preceding figures after failure (rockfall) along joints shown in closeup of Figure 9. The fall took place in the upper part of the cliff and resulted in the loss of about 15 feet of property at the top.
