1 **Unpacking Tornado Disasters: Illustrating the Southeast U.S. Tornado-Mobile and Manufactured**
2 **Housing Problem Using the March 3, 2019 Beauregard-Smith Station, Alabama Tornado Event**

3 Stephen M. Strader^{1*}, David B. Roueche², and Brett M. Davis²

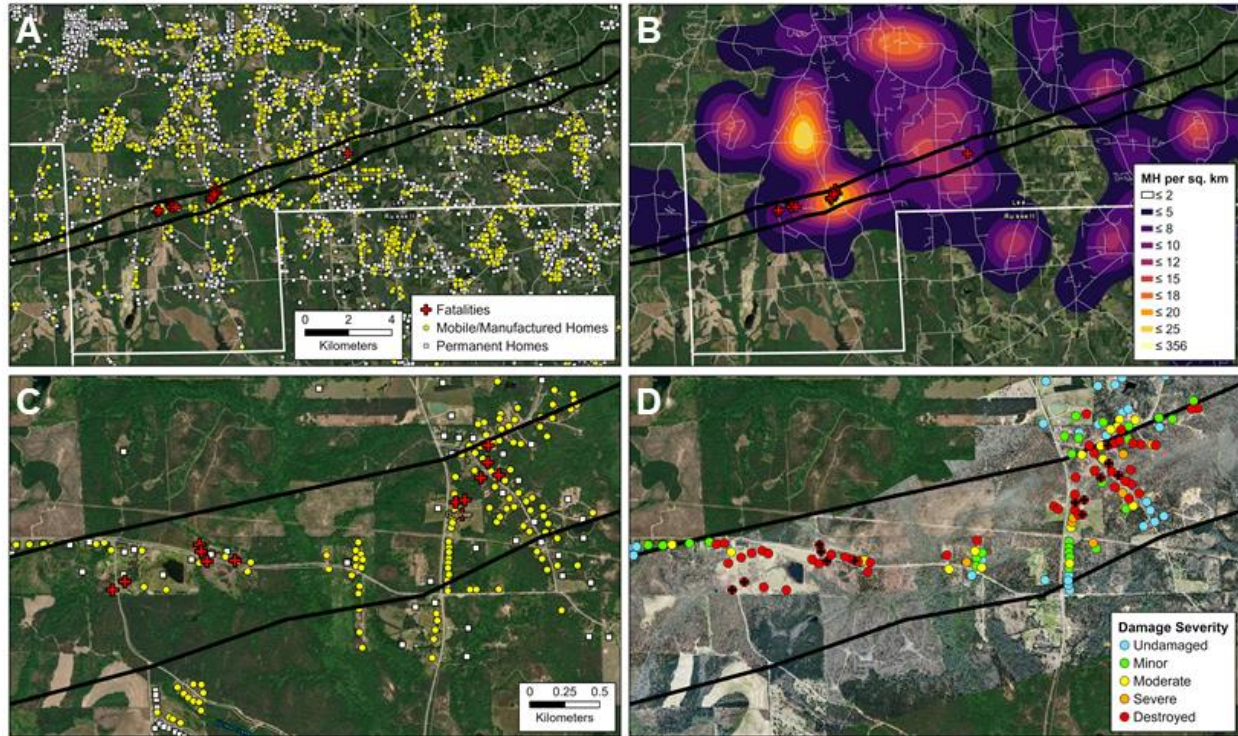
773
 774 **Fig. 4.** Beauregard-Smith Station, AL surveyed National Weather Service (NWS) tornado damage path
 775 (black outlined polygon). (A) indicates mobile/manufactured home (MH), permanent home (PH), and
 776 fatality locations (red cross); (B) illustrates MH density (MHs per km²); (C) is a zoomed in area of the
 777 Route 36 to Route 38 in Lee County, AL region where most fatalities occurred; (D) highlights the damage
 778 severity based on the post-event damage assessment.

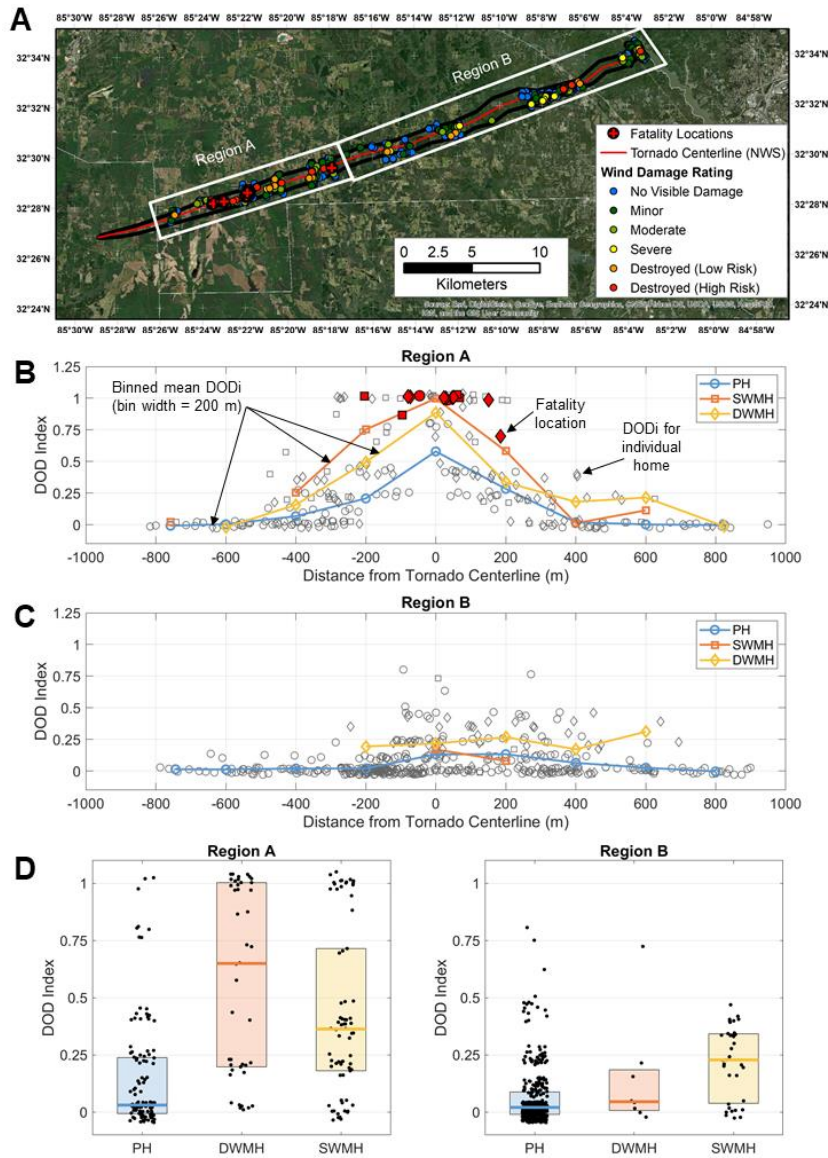
339 Of the 380 structures affected by the tornado, 328 were single-family homes (DIs 2, 3 and 4 in the
340 EF Scale). To better assess tornado impact severity to these structures, the tornado damage path was split
341 into two primary geographic components, Region A and Region B (**Figure 5**). The tornado path was split
342 into these two regions based on damage severity and potential changes in tornado intensity as discussed
343 previously. Damage was more severe within the first 20 km (12 miles) of the tornado path (designated
344 Region A) than in the remainder of the path (designated Region B). Within Region A, complete structural
345 failure in both PHs and MHs was most common within an approximately 250 m buffer on each side of the
346 tornado centerline. Within this region, and in general across the entire tornado width in Region A,
347 SWMHs sustained the highest damage on average, with PHs sustaining the lowest damage on average

348 (**Figure 5B, D**). In Region B, extending from the edge of Region A to the Alabama-Georgia border,
349 complete structural failure rarely occurred, despite similar building typologies, indicating the reduction in
350 tornado intensity (**Figure 5C, D**). In both regions, SWMHs were the most likely to exhibit complete or
351 catastrophic failure (**Figure 6**), with 54% in region A, and 13% in Region B, exhibiting damage with a
352 high risk to life-safety. This corresponded to 22 of the 41 damaged SWMHs in Region A, and one of the

353 eight damaged in Region B, that experienced DOD6 or higher (i.e., the unit rolled, lofted, and/or
354 experienced the destruction of the roof and all walls). DWMHs and PHs demonstrated better
355 performance, with 29% (20 out of 70) of DWMHs and 16% (8 out of 50) of PHs with failures deemed
356 high risk to life-safety in Region A, and 0% (0 out of 35) and 2% (2 out of 124) respectively in Region B.
357 The two high risk PH failures in Region B occurred in a section of poorly constructed, low-income homes
358 in Smith Station.

780 **Fig. 5.** Wind damage assessments for all structures in the tornado path. (A) Spatial overview of entire
 781 tornado path using categorical damage ratings; (B) and (C) DODi for single-wide MHs (SWMHs),
 782 double-wide MHs (DWMHs), and permanent homes (PHs) in Region A and Region B of the tornado with
 783 respect to the center of the tornado. Lines indicate average DODi over 200 m bins. Negative distances
 784 indicate homes located on the north side of the centerline. Jitter has been added to the y-coordinates to
 785 facilitate better visualization. Red filled markers in plots (B) and (C) indicate fatality locations. (D) Box
 786 plot indicating the median, 25th and 75th percentiles of DODi for all PHs, SWMHs, and DWMHs in
 787 Regions A and B.

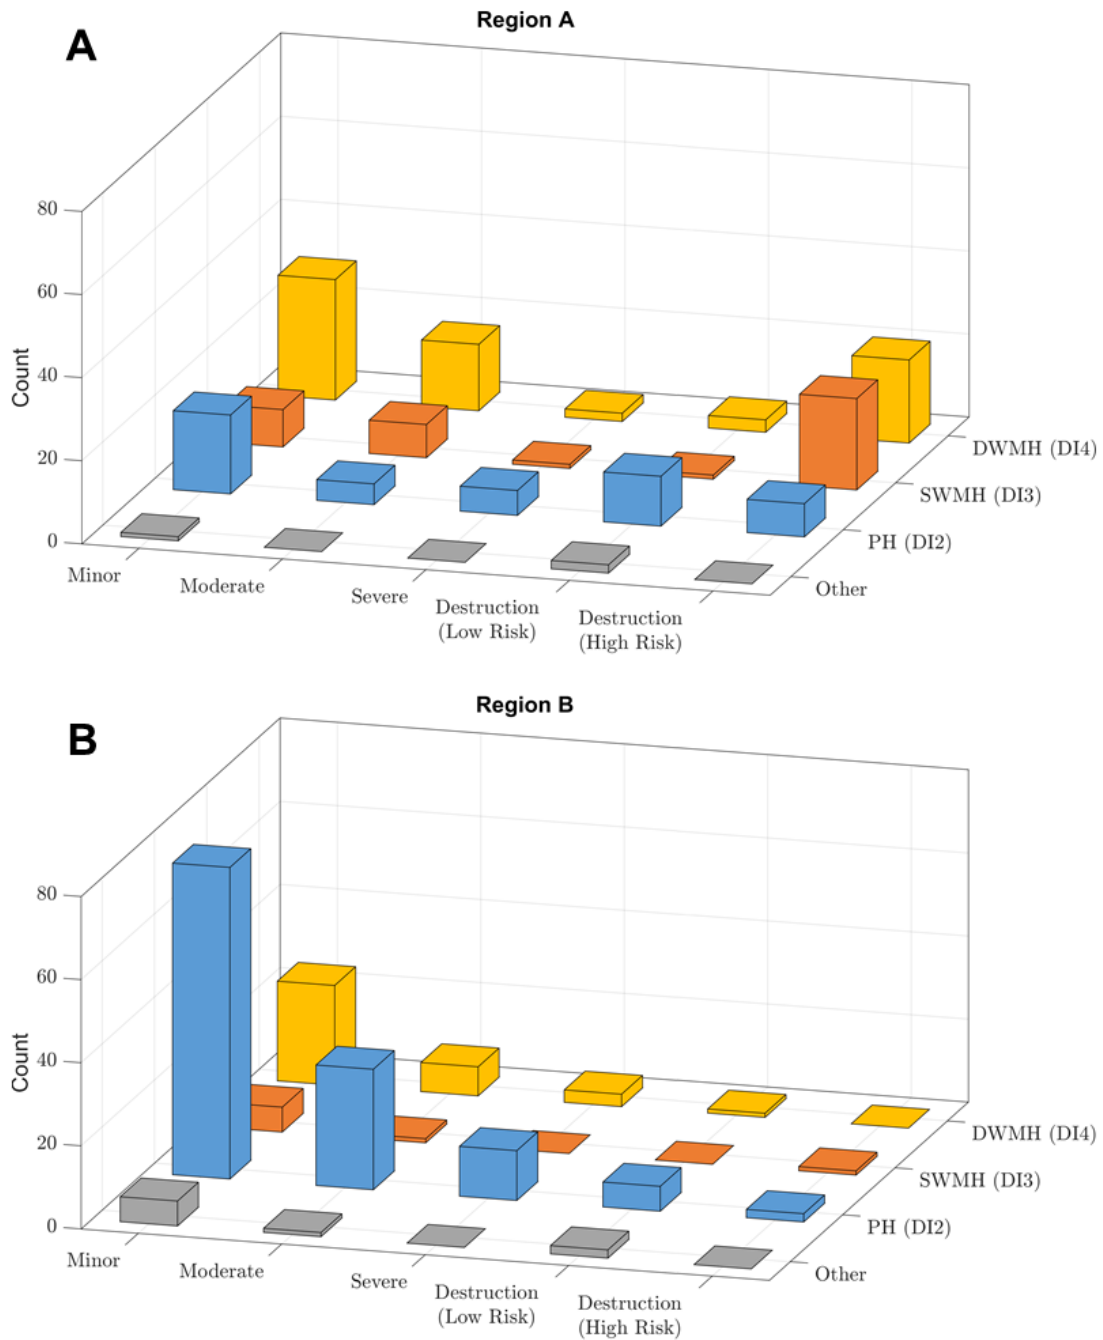
789 **Fig. 6.** Wind damage states of the affected buildings in (A) Region A and (B) Region B using Vickery et
 790 al. (2006) but modified to separate economic destruction from destruction posing a high risk to life-
 791 safety.

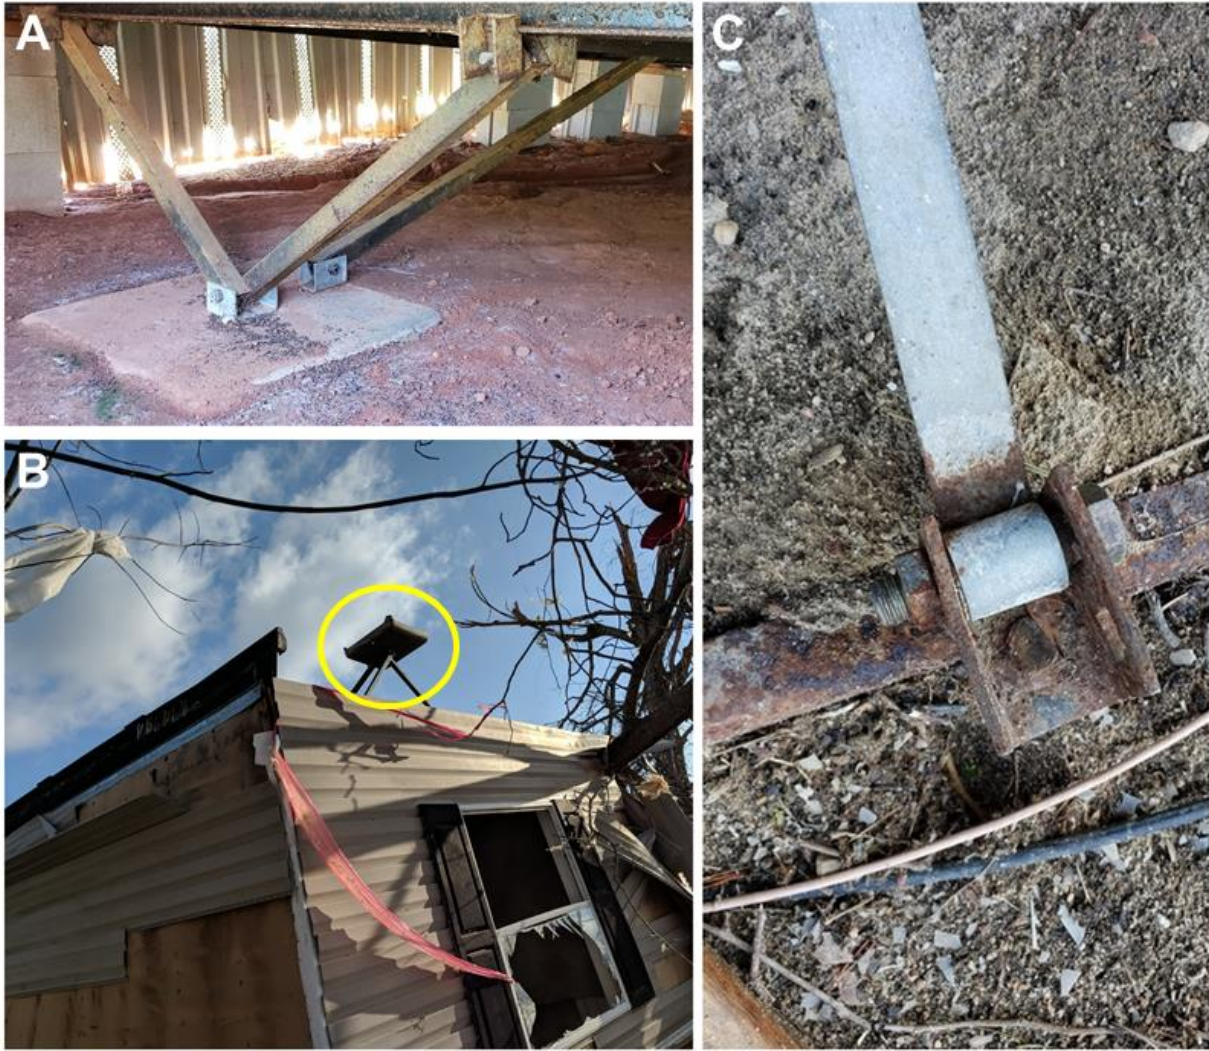
359 The *key failure mechanism* that led to the destruction of several PHs and many MHs *was the*
360 *lack of any positive anchorage to the ground*. Many PHs were simply resting on unreinforced masonry
361 stem walls that offered no resistance to the uplift forces induced by a tornado, a weakness recognized in
362 past studies also (e.g., Marshall 1993; Prevatt et al. 2012a). Where PHs were constructed on concrete
363 slabs, with anchor bolts to the slab through the sill plates, at a minimum some walls were always left
364 standing even with complete destruction of surrounding buildings. In MHs, previous studies have linked
365 destruction with the lack of anchorage altogether (e.g., Kensler 1985; Sparks 1985), but in this study, all
366 observed MHs appeared to have some anchorage/stabilizing system present at time of tornado impact.
367 However, the use of alternative pan anchorage systems, which rely upon the self-weight of the structure to

368 resist any uplift forces, and the frequent corrosion of ground anchors and diagonal straps where used,
369 compromised the wind resistance of these homes, potentially allowing catastrophic failures to occur at
370 relatively low wind speeds (**Figure 7**). For example, in several cases, the debris from a MH revealed that
371 the home failed due to the radial inflow of the oncoming tornado, pulling the structure towards the
372 tornado as it was destroyed. This complete destruction therefore occurred prior to when the tornado's
373 most intense winds could impact the MH.

793 **Fig. 7.** Common anchorage problems encountered in the Beauregard, AL tornado included frequent use of

795 corrosion of diagonal ties and ground anchors. Panel B is an overturned MH with a pan anchorage system

796 illustrated (yellow circle).

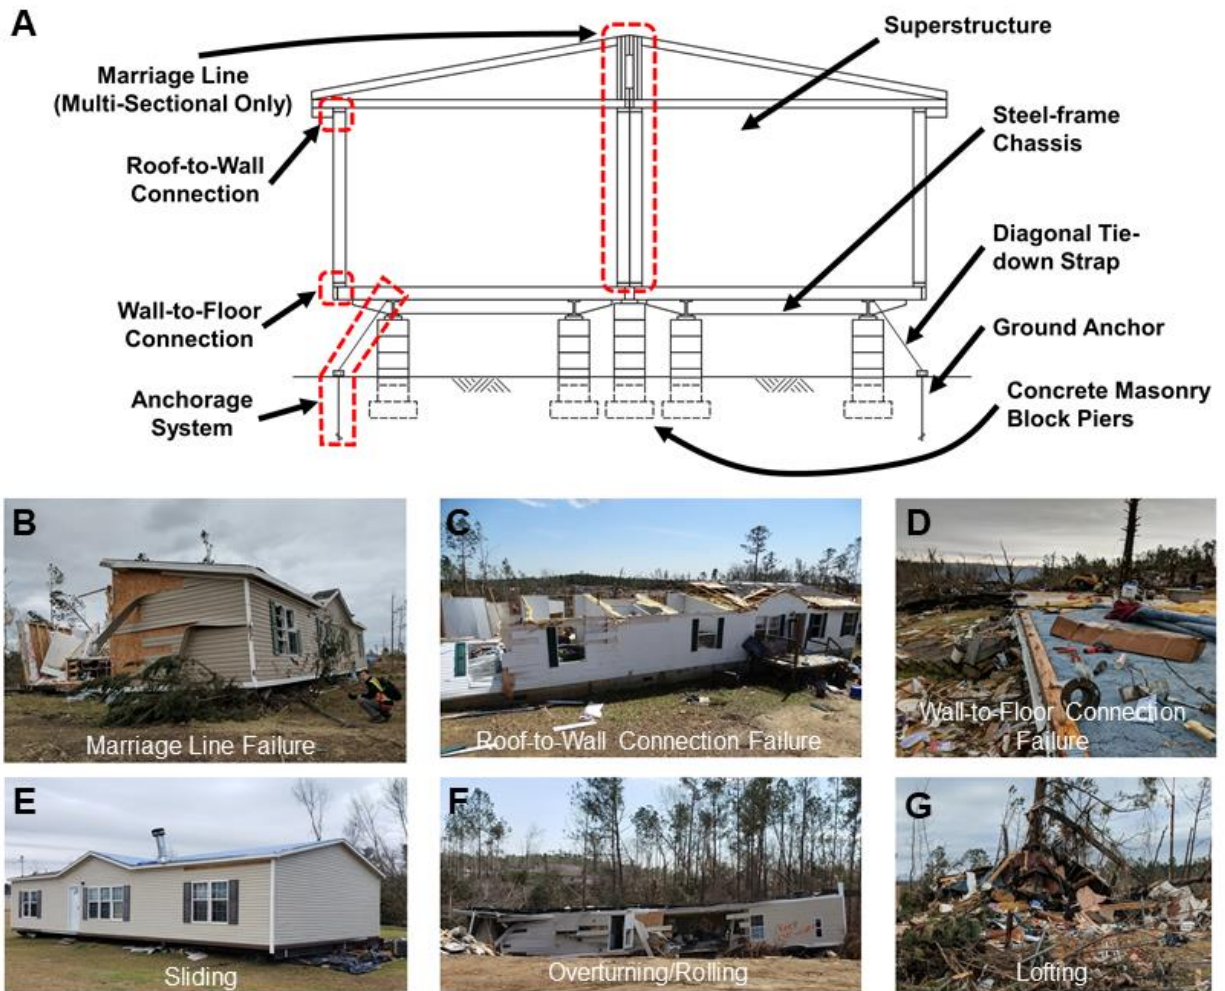
374 A considerable trend in the MH failures was the overall lack of an optimum damage progression.
375 While damage generally initiated with loss of roof cover and cladding elements, very rarely was the loss
376 of roof sheathing or roof structure observed with the anchorage system intact. The four primary
377 mechanisms of structural failures observed in MHs consisted of the following: 1) separation at the
378 marriage line (DWMHs only), 2) roof-to-wall connection, 3) wall-to-floor connections, and 4) failure of

379 the anchorage system resulting in either sliding, overturning, or lofting (**Figure 8**). Of these potential
380 mechanisms, the anchorage system was nearly universally the first element of the structural load path to
381 fail during the tornado, compromising the entire structure and the safety of the occupants. This lack of
382 “safe” failures in both SWMHs and DWMHs relative to PHs is exemplified in **Figure 6**. Specifically, 12
383 of the 20 destroyed PHs in Region A were deemed low risk failures in that at the very least some walls
384 were left standing although the home was a total loss. In contrast, only 1 of the 23 destroyed SWMHs and
385 3 of the 23 destroyed DWMHs could be considered low risk failures. Conversely, the remaining 19 MHs
386 were destroyed with nothing left in their original locations as determined by the combination of the debris
387 swaths, MH location data, and local parcel or tax records. The implications of this finding within the

442 wall-to-floor connection, anchoring system), subjecting the occupants to wind-blown debris and blunt-
443 force trauma (**Figure 8**). The fatality rate in MHs was 12 fatalities per 100 MHs damaged (11.3 and 14.0
444 for DWMHs and SWMHs). This fatality rate is 5.3 times higher compared to the number of fatalities per
445 100 PHs damaged in the Beaugard-Smith Station tornado.

798 **Fig. 8.** Double-wide MH (DWMH) construction diagram with critical components and their locations
 799 labeled. Red dash lines highlight those areas where common failure mechanisms occur during tornado
 800 events and relate to the below damage survey photos (Panels B-G). Failure mechanisms in MHs included
 801 (B) separation at the marriage line in DWMHs; (C) roof-to-wall connection failures; (D) wall-to-floor
 802 connection failures; and (E)-(F) failures of the anchorage system, specifically (E) sliding; (F)
 803 overturning/rolling; and (G) lofting.
