NOAA ARRA USVI Watershed Stabilization Project

Fish Bay, St. John Drainage Improvements

March 31, 2012

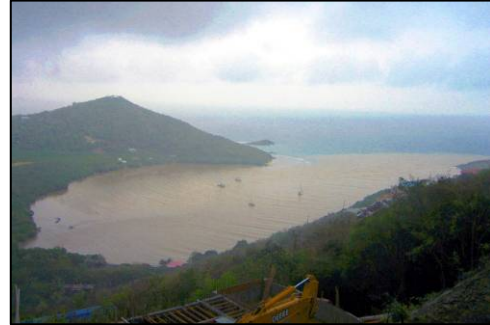
Photo 3: Sediment plume in Fish Bay.

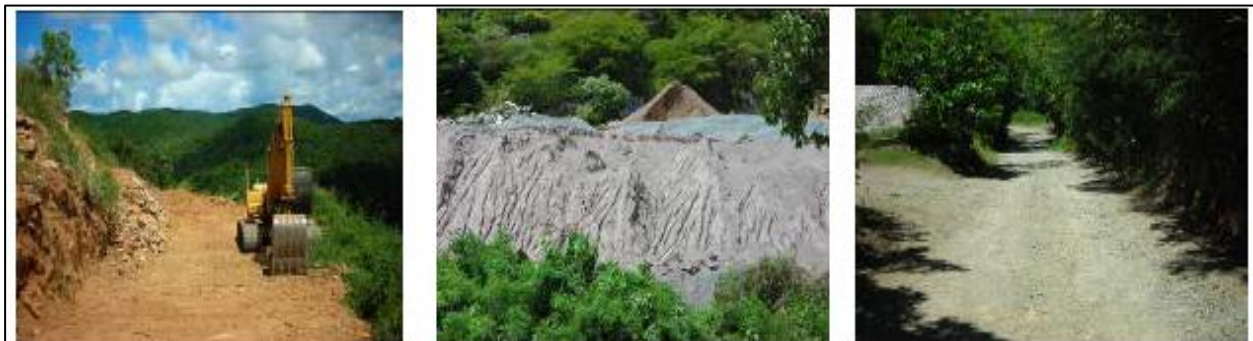
Photo 4: Sediment sources in Fish Bay including land clearing, construction materials storage, and unpaved roads.

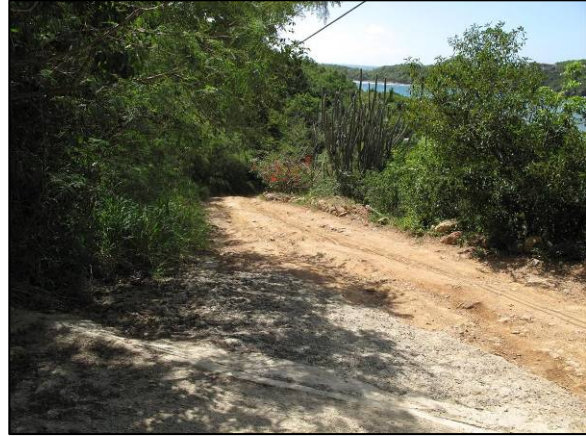
Previous research on St. John has shown that unpaved roads (Photo 5) can erode at rates that are up to 10,000 times higher than erosion rates on undisturbed hillslopes (Ramos-Scharrón and MacDonald 2007a), and that they are currently a dominant source of the terrestrial sediment entering Fish Bay (Anderson and MacDonald 1998; Ramos-Scharrón 2004). The application of a GIS-based erosion model (Ramos-Scharrón and MacDonald 2007b) estimated that the average sediment load into Fish Bay, based on the condition of the unpaved road network in 1999, was about 275 tons per year, and this was seven times higher than rates observed from natural, undeveloped sites. Unpaved roads accounted for 85% of the total estimated sediment yield (234 tons per year).

Photo 5: Unpaved road in Estate Fish Bay.

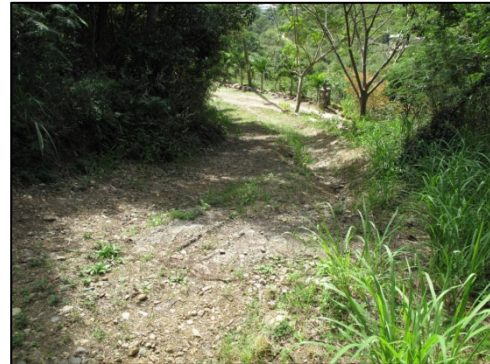
Photo 6: Z Road before construction.

- **Z-Road (Photo 6):** Work at this site included paving 777 feet of road surface, and improving road drainage with a 492-foot long paved ditch and a concrete swale.
- **Caribe Lane:** Work at this site included paving 130 feet of road surface.
- **Cocoloba Trail West:** Work at this site included paving 541 feet of road surface, and improving road drainage with a 541-foot long paved ditch and incorporating it with two already installed cemented swales and a broad-based swale at the bottom of the segment.
- **Marina Drive End-West:** Work at this site included paving of road surface, and improving road drainage with a 302-foot long paved ditch and a trench drain.
- **Marina Drive End-East (Photo 7):** Work at this site included paving 328 feet of road surface, and improving road drainage with a 328-foot long paved ditch and a new cemented swale.

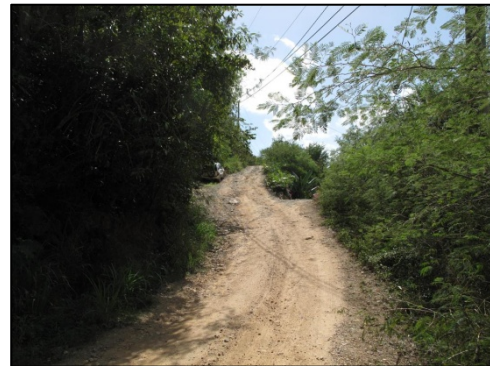
Photo 7: Marina Drive before construction.

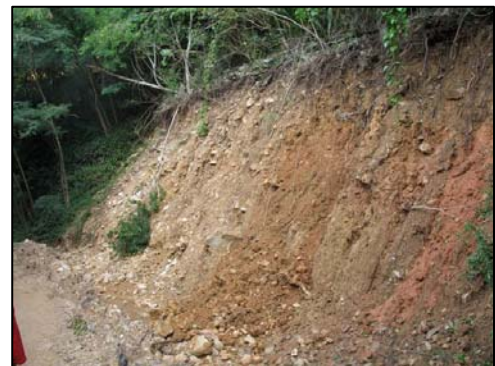
Photo 8: Road cut-slope needing stabilization.

- **Fish Bay Lane East:** Work at this site included paving 197 feet of road surface, and improving road drainage with a 197-foot long paved ditch and a new swale and culvert. A 98-foot long portion of the road cut-slope (Photo 8) was also secured with gabion baskets.
- **Hilltop Road:** Work at this site included paving 628 feet of road surface, and improving road drainage with 528 feet of paved ditch.
- **Cocoloba Trail East:** Work at this site included paving 850 feet of road surface, and improving road drainage with an 800-foot long paved ditch and three swales plus a riprap swale outlet.

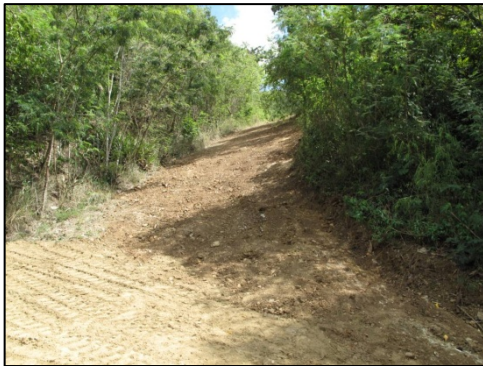
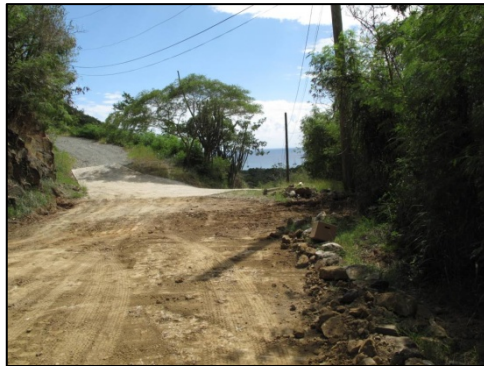
Photo 9: Z-Road during grading.

Photo 10: Z-Road during grading.

Hard surfacing of the roadbed consisted of grading (Photos 9 & 10) then 5-inch concrete pavement reinforced with woven wire fabric, known locally as “roadmesh” (Photos 11-14). Twelve-inch stone was used to protect swale outfalls from eroding and to dissipate the energy of the falling water. Larger stones were used if available and equipment operators could position them properly.

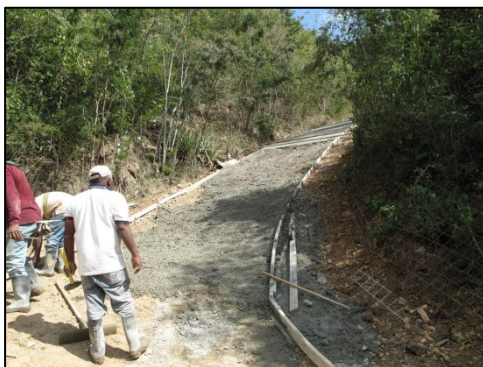
Photo 11: Z-Road during forming and paving.

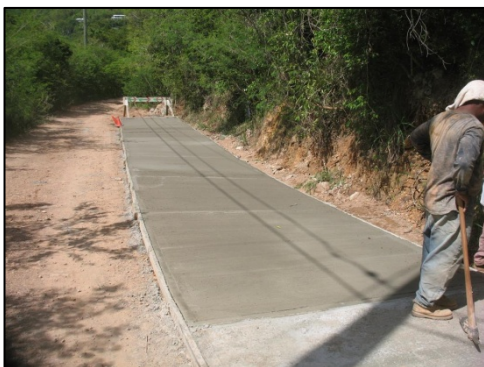
Photo 12: Marina Drive during paving.

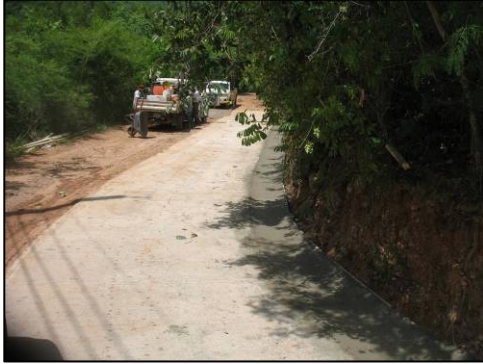
Photo 13: Marina Drive ditch paving.

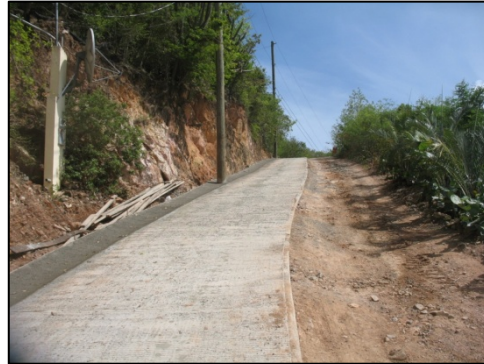
Photo 14: Marina Drive during paving.

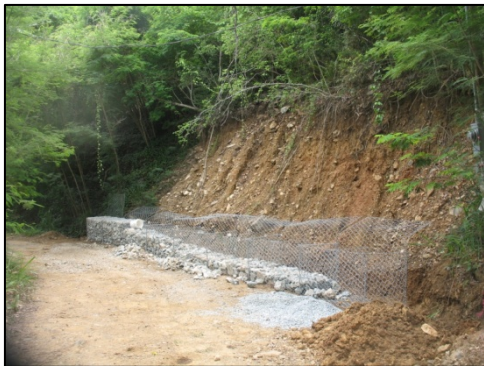
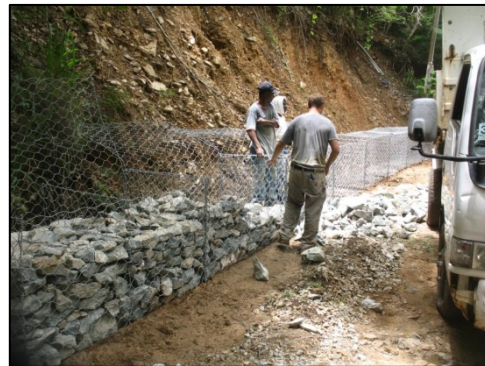
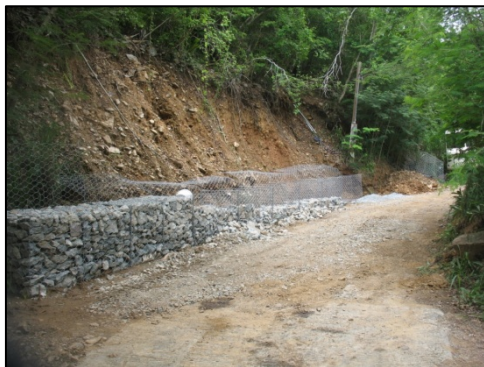
Photo 15: Cut-slope stabilization gabion basket installation.

Photo 16: Cut-slope stabilization gabion basket stone installation.

Photo 17: Cut-slope stabilization gabion basket installation.

Gabion basket cut-slope stabilization utilized two rows of 3'x3'x6' and/or 3'x3'x9' baskets to prevent slope failure. This part of the project required the first row of baskets to be keyed into the trench and slope (Photos 15-17). The second row of baskets was placed on top of the first row, so that the contractor could gradually fill in with earth behind them (Photo 18).

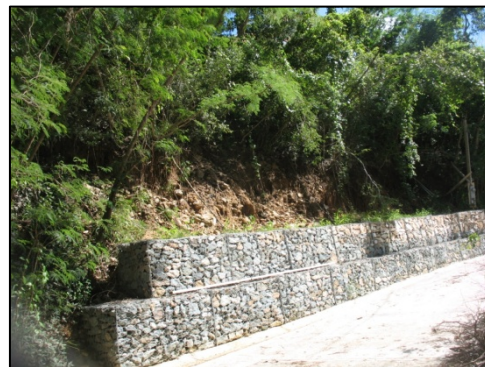
Photo 18: Completed cut-slope stabilization gabion basket installation.

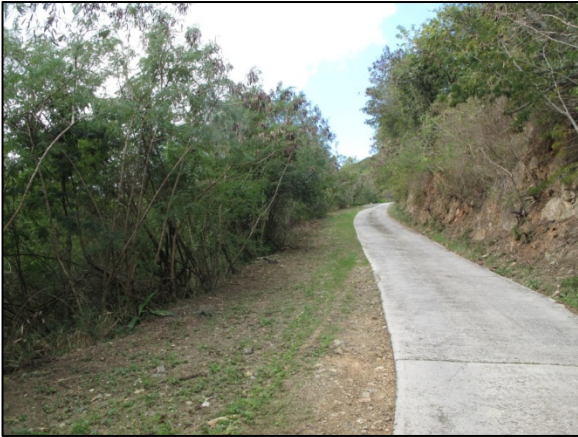
Photo 19: Completed Z-Road paving.

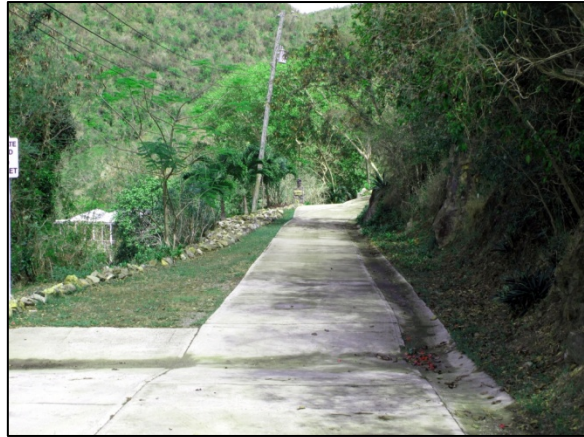
Photo 20: Completed Z-Road paving and concrete ditch and swale.

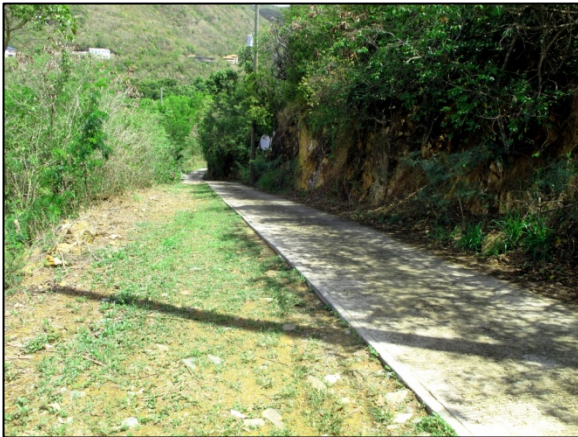
Photo 21: Completed Marina Drive paving.

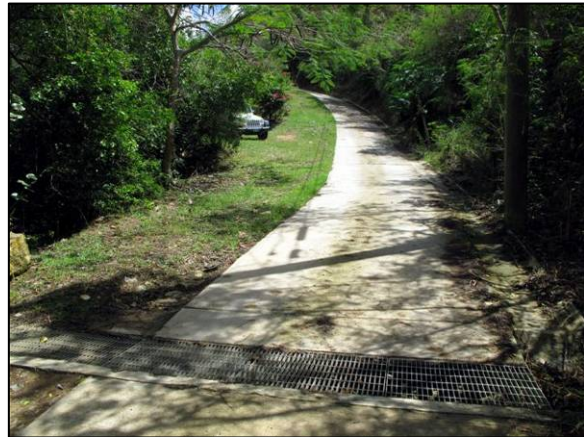
Photo 22: Completed Marina Drive paving and trench drain.
