**Calvert Cliffs Slope Erosion Project  
Phase I Final Report**

**Processes and Controls  
of Coastal Slope Erosion**

January 31, 1992

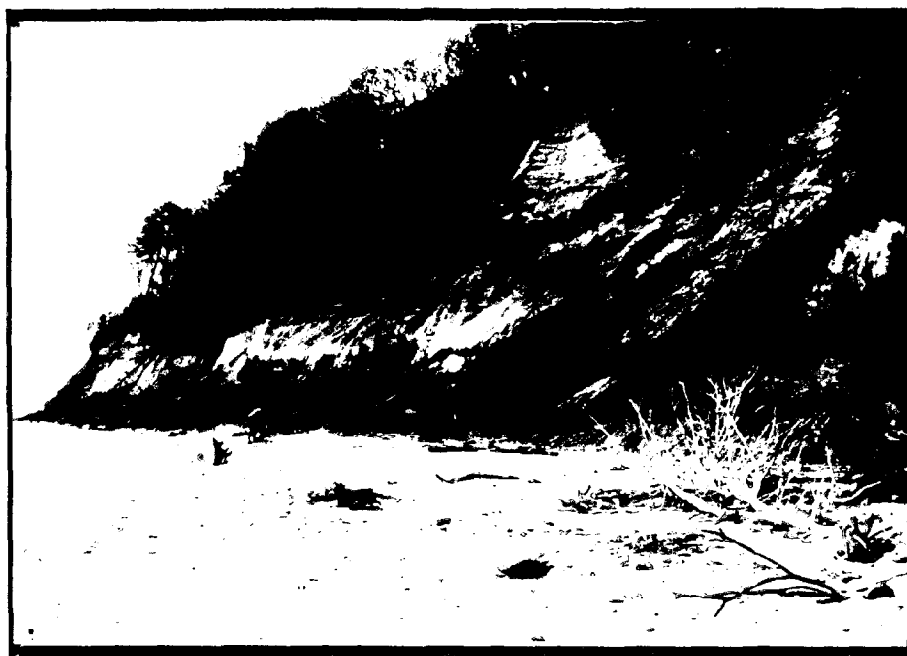
## Plate 2

Top photograph - Scientists' Cliffs North  
Bottom photograph - Chesapeake Ranch Estates, Little Cove Point

Both slopes are Type II slopes in that the dominant erosion mechanisms from slope toe to bluff top are hydrologically dominated. Note the lack of wave undercutting at each site.

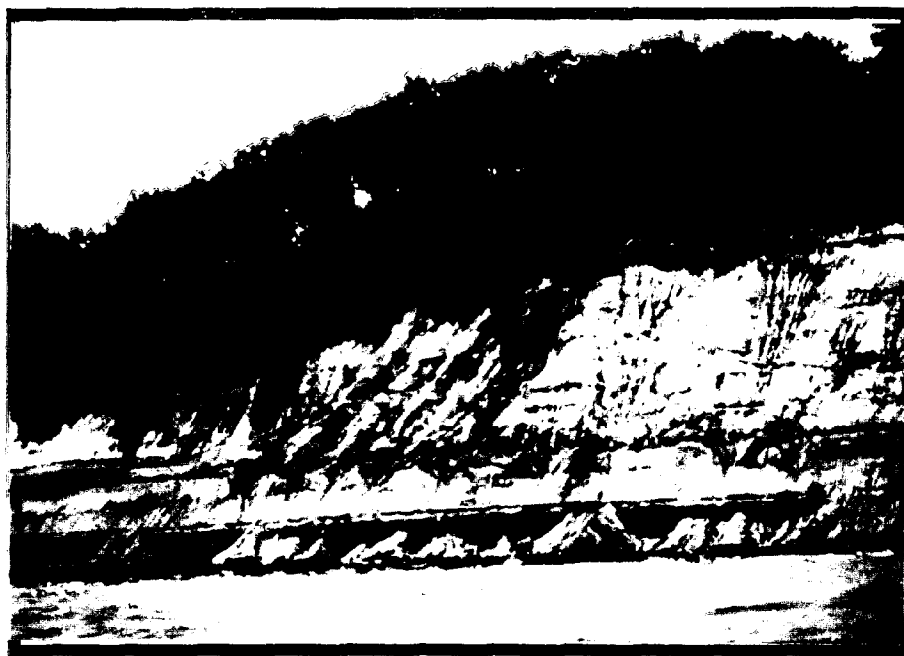
## Plate 3

Top photograph - Calvert Cliffs State Park, Grays Creek South  
Bottom photograph - Calvert Cliffs State Park, Rocky Point

Both slopes are Type III slopes. Here, hydrologic processes control the rate of erosion in the midslope and wave undercutting controls the rate of erosion in the toe zone. The contrast between the midslope and lower slope is clear in this photo; it occurs at the change from dark to light material. Ironstone blocks can be seen in the foreground.

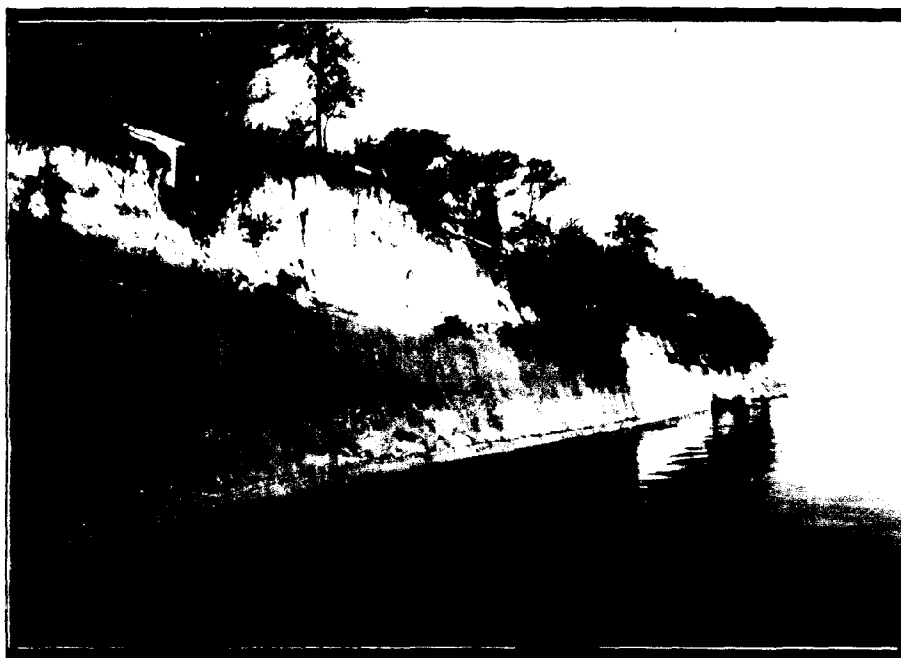
## Plate 4

Top photograph - Calvert Cliffs State Park, Grover Creek South  
Bottom photograph - Naval Research Laboratory, Randle Cliffs

Both slopes are Type IV slopes. Here, wave erosion oversteepens the toe zone causing sliding which retrogresses upslope until it reaches the bluff top. Hydrologic processes are still active, but the dominant mechanism of erosion is shallow sliding. Note that at Randle Cliffs, debris cannot accumulate at the slope base because of the water level.

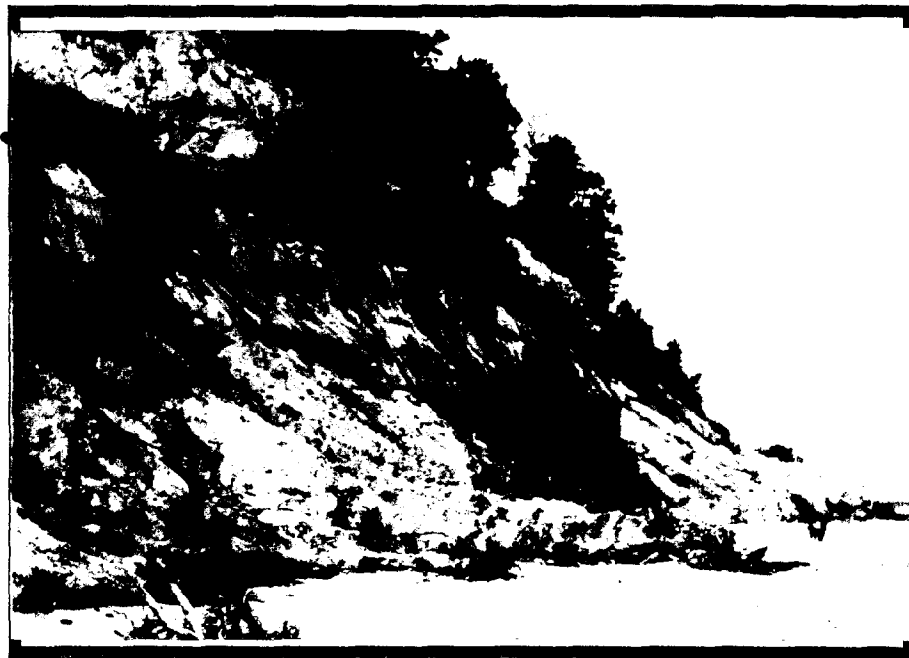
## Plate 5

Top photograph - Scientists' Cliffs, Parker Creek South  
Bottom photograph - Chesapeake Ranch Estates, Laramie Lane

Both slopes are Type IV slopes. Spalling due to oversteepening by wave undercutting is evident in the lower slope at Parker Creek. At Laramie Lane, large rotational slides which initiate on a saturated, weak clay in the midslope deliver large debris piles to the slope toe.
