# GREEN CAY GUT HEADCUT STABILIZATION PROJECT Final Report

114-H Green Cay  
St. Croix East End, USVI

August 2017

## Purpose

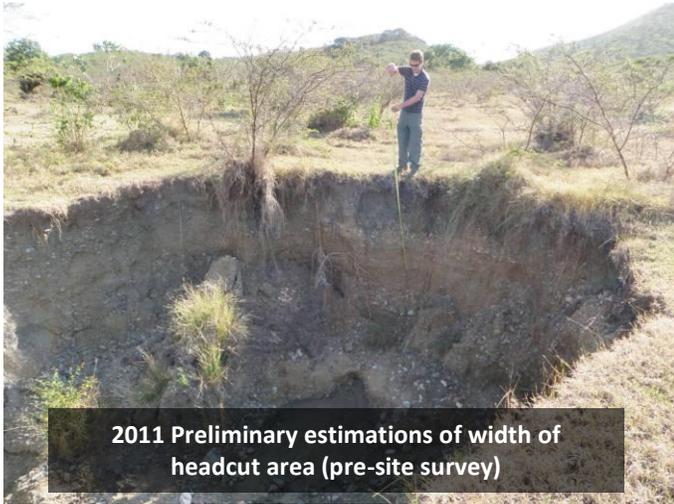
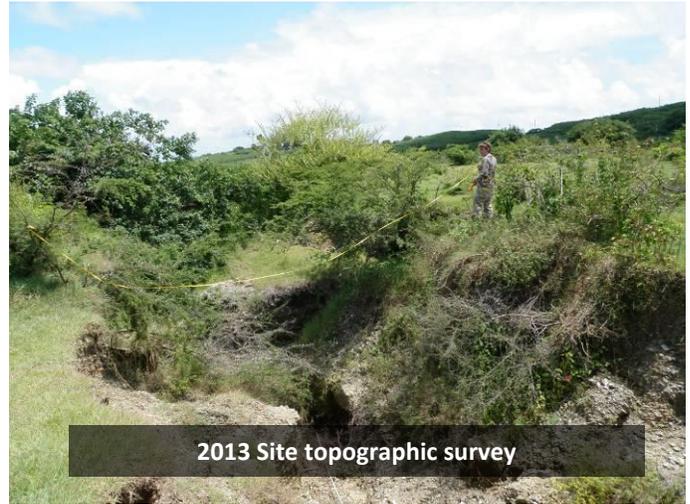
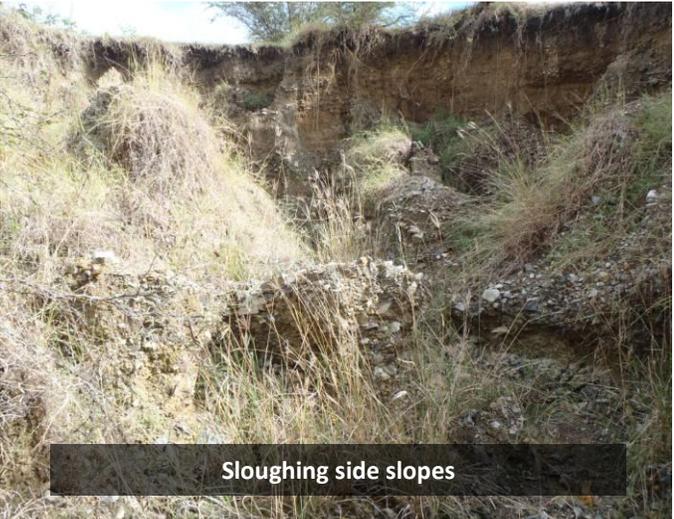
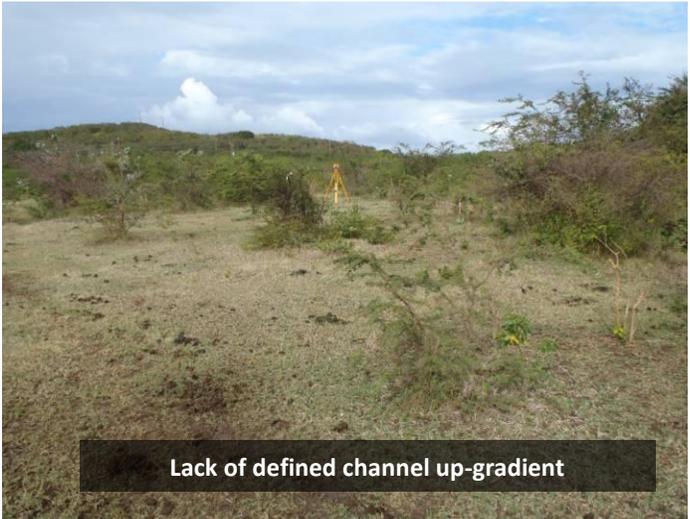
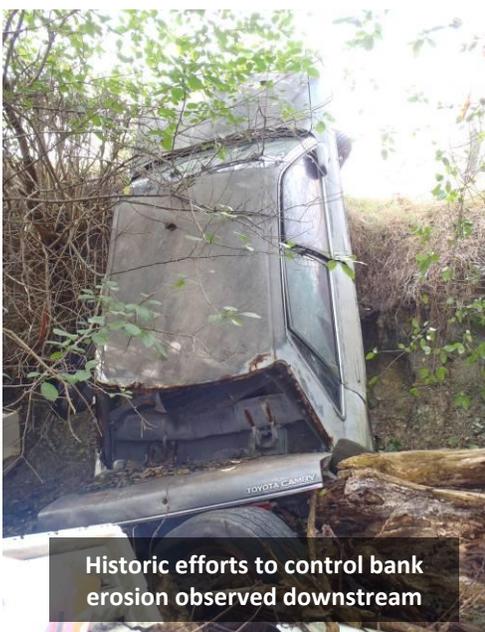
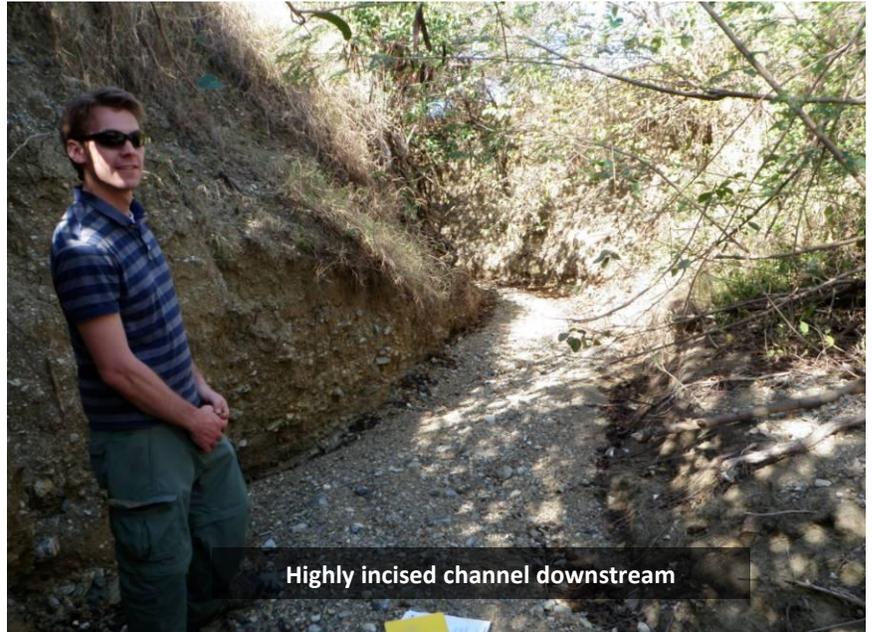
**Figure 2. Green Cay Headcut Before Stabilization Project**

In 2011 the St. Croix East End Watershed Management Plan (WMP) was created to identify and develop a plan for reducing land-based sources of pollution to the East End Marine Park. Watershed evaluations suggested that the Southgate watershed contributed nearly 20 percent of the total sediment load to the East End Marine Park. As such, the Southgate watershed was identified as a priority area, with the most significant source of sediment originating from erosion of an active headcut on the East Gut, locally and herein referred to as Green Cay Gut.

Green Cay Gut (also known locally as the East Gut) flows east to west and discharges into Chenay Bay, which is part of the East End Marine Park and is included in the island's 303(d) list of impaired waters for turbidity and other water quality parameters. The upper reaches of the gut are located on Green Cay Farm, LLC property and were highly incised with active bank erosion, down cutting, and bed scour. There was a severely-eroded, three-lobed headcut approximately 20-40 feet wide and up to 25 feet deep (**Figure 1**). An additional, smaller headcut was located to the south of the main headcut. The landowners estimated the rate of headcut migration at approximately 10-15 feet per year, which was been confirmed by HW through analysis of aerial imagery. Below this headcut (approximately 1,200 ft) the channel is extremely incised, as evidenced by past attempts to stabilize banks with cars and other debris. There is no clearly defined channel between the headcut and the up-gradient farm pond, except for a low point where overflow crosses the unpaved road.

The repair area under this project was limited to the immediate headcut and adjacent uplands (total disturbed area approximately 10,500 SF or 0.24 acre; approximately 180 ft long by 30-75 ft wide and did not include any stream restoration activities downstream). This repair project did not alter existing hydrologic conditions at the site or create changes in runoff patterns in the contributing drainage area. The conveyance channel was designed to convey storm flows produced during the 1.5-year recurrence interval event, as recommended by NRCS. This event approximates what is commonly referred to as the "channel forming discharge" event or the "bankfull" event. Boulder step-pool structures were sized based on stability requirements for the 100-year storm event flows of approximately 700 cubic feet per second.

The emergency repair approach was to excavate back from the edge of the headcut and establish a non-erodible channel with boulder step-pools mimicking steep, intermittent channels in the USVI. "Hard" stabilization consisted of large boulders used to establish a series of step pools to reduce velocities of storm flows. "Soft" engineering practices (e.g., erosion control blankets, and native shrubs, trees, and grasses) were used to stabilize side slopes and recreate a vegetated buffer. Fencing was installed to restrict livestock access.

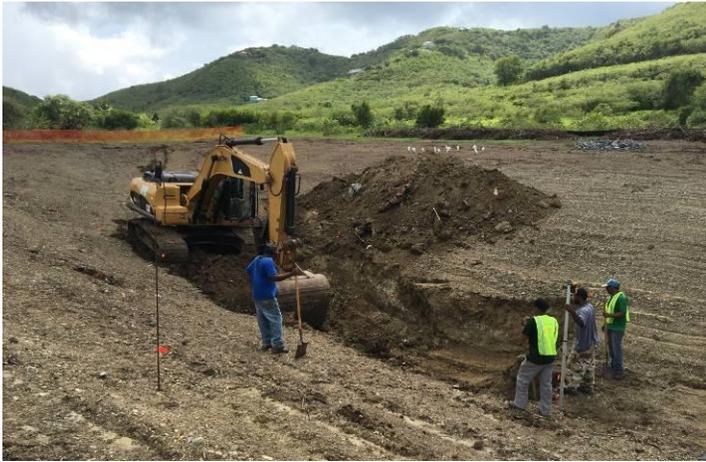
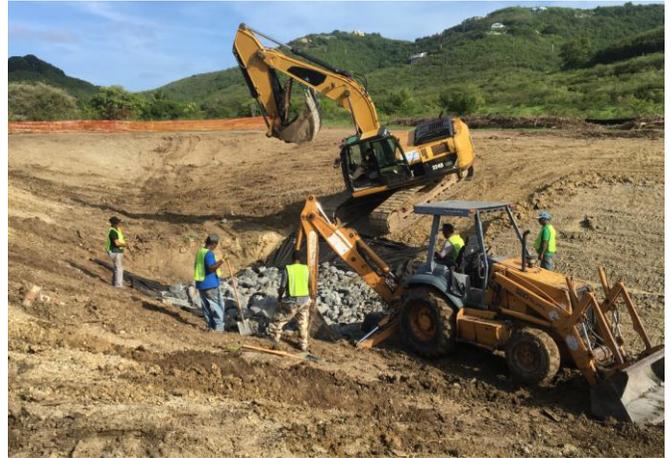
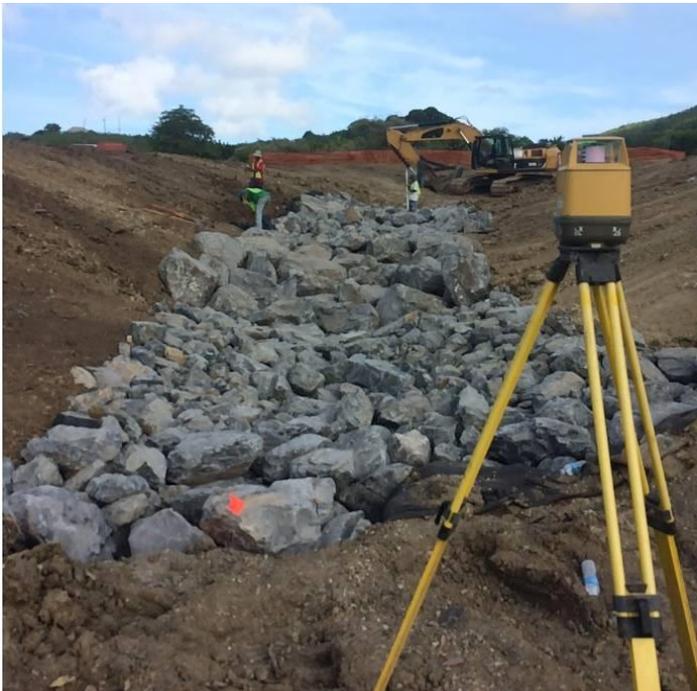
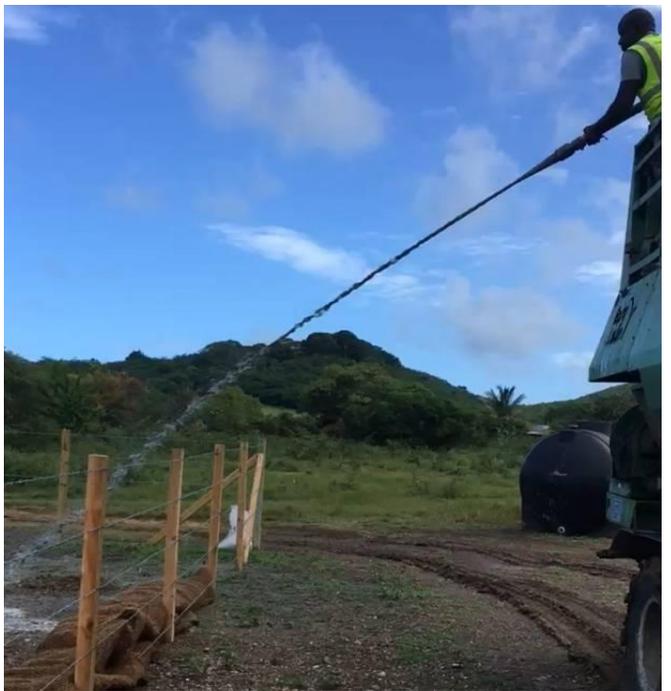
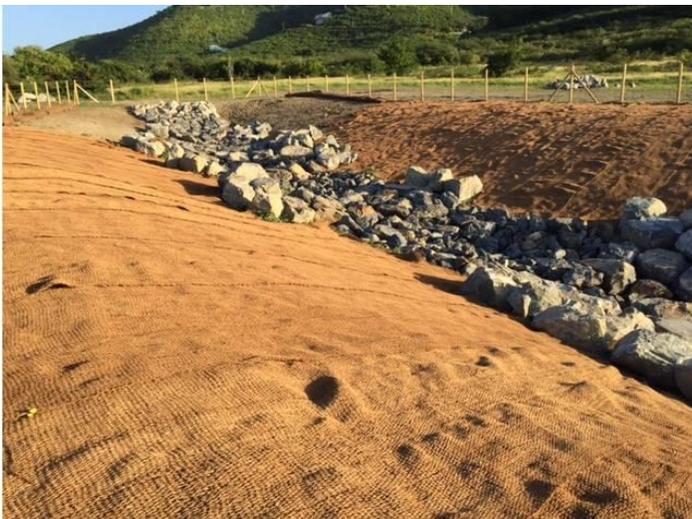
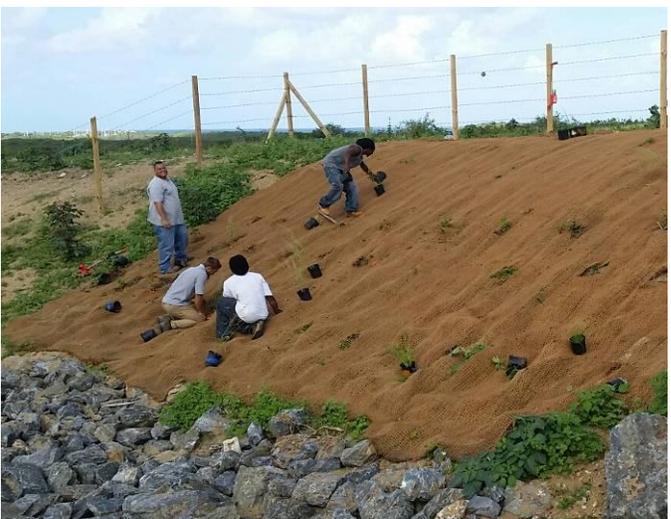
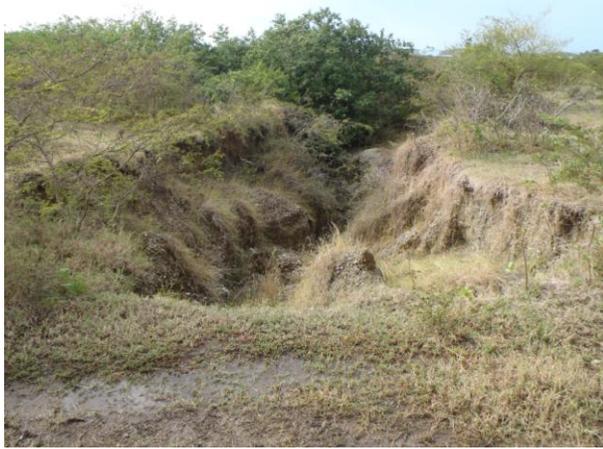
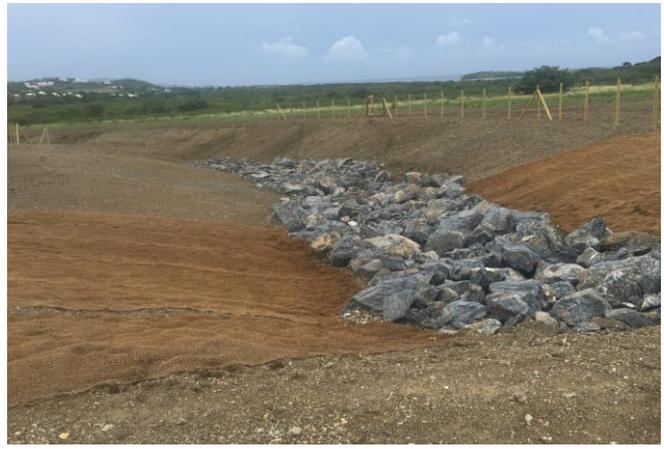
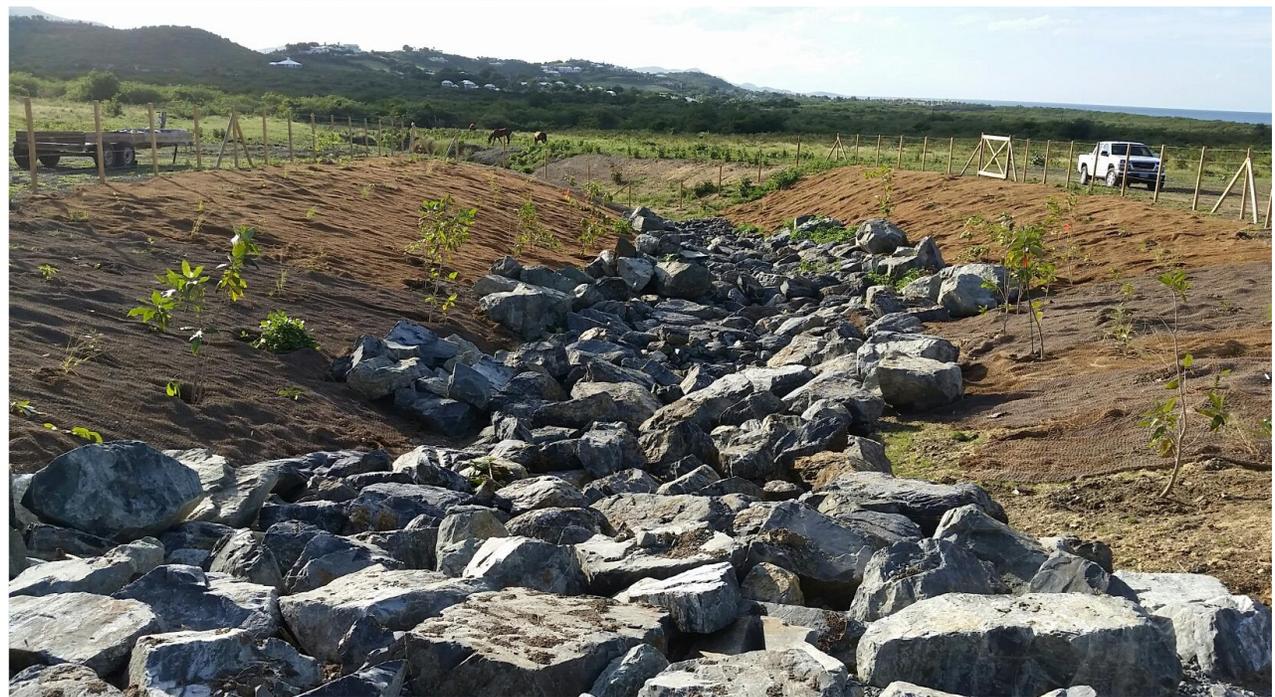
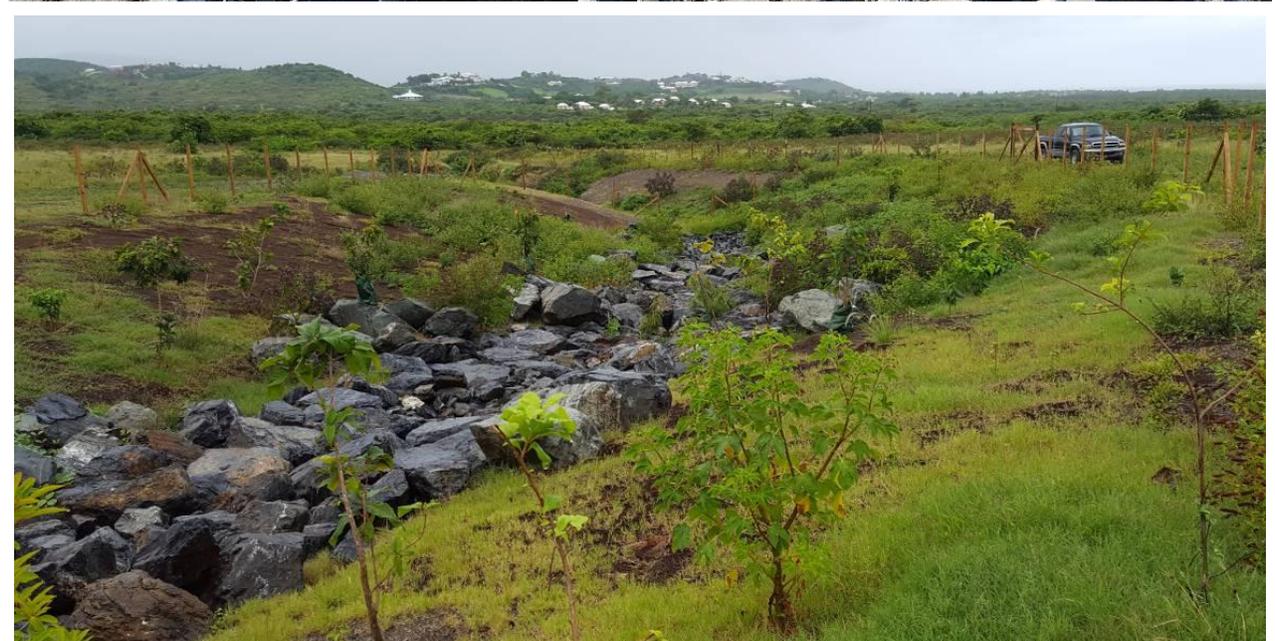
Figure 3. Construction of the stabilization project

The project team put the project out to bid in July, 2016 and held a pre-bid meeting on site February 27, 2016 to answer contractor's questions. Marco St. Croix, Inc. was selected as the contractor and construction began in early September, 2016. Due to rain delays, construction was not substantially completed until January, 2017. During the construction period, SEA provided routine construction oversight. HW and NRCS performed site inspections at key times during the construction process, such as during the installation of first step pool. Regular construction reports were submitted by HW to the contractor, owners, and members of the project team throughout the duration of the project. Due to unanticipated buried debris and some improvised grading, HW slightly revised the layout and number of step pools. This was issued as a revised site plan in October, 2016.

A final punchlist was provided by HW after a site walk was completed in January, 2016. A certification of completion was provided to the property owner on March 14, 2017 by HW certifying that the project was in substantial compliance with the approved "GREEN CAY GUT HEADCUT REPAIR EAST END, ST. CROIX, VI, CONSTRUCTION PLANS" dated June 2016 and REVISED SITE PLAN dated 10/10/16. An AS-BUILT MARKUP dated 1/4/17 provided adequate representation of the extent of stonework and fencing.

- Make sure limits of disturbance (LOD) are clearly marked in the field prior to clearing and grading activities. A section of the LOD was placed in an incorrect location, which led to additional grading and required stabilization.

- Hydroseeding was not overly successful given the poor soils on site. We recommend required soil amendments in these situations for better grass growth. Bare areas remain where soils were excessively clayey (covered with erosion control blanket).

- The 12” stone was in short supply, making it difficult to shape the step pools correctly.
- The contractor had difficulty installing the erosion control matting and in many places it did not have proper contact with the ground surface due to weeds, large chunks of clay/rock, etc.

Geographic Consulting Inc (GCI) was separately contracted to finalize a landscape plan for the site based on local expertise and plant availability. Planting started shortly after approved installation of step pools, and final installation of erosion control blankets and fencing. Native trees, shrubs and vines were planted along with fast-growing grasses on the banks of the Green Cay Head Cut Repair Project during the week of December 26-30, 2016. A wide variety of native plant material was established to: control soil erosion, stabilize banks and enhance the buffer forest habitat on site. All plants for this project were grown on St. Croix in GCI's native plant nursery. A total of 377 plants were established on the banks including 114 trees and shrubs in 1 gallon pots, 214 4" grass plugs, 36 trees and shrubs in 3-gallon pots and 13 native vines. Additional details of the species, quantities and sizes of all plants appear in **Attachment B**. GCI watered and replaced dead plants during a 6-month plant warranty period.
