AN INVESTIGATION OF POSSIBLE CAUSES OF THE SO-CALLED

"SNEAKER WAVE" AT TOMALES BAY, CALIFORNIA

Report No. HEL 28-1

Hydraulic Engineering Laboratory
Department of Civil Engineering
University of California
Berkeley, California

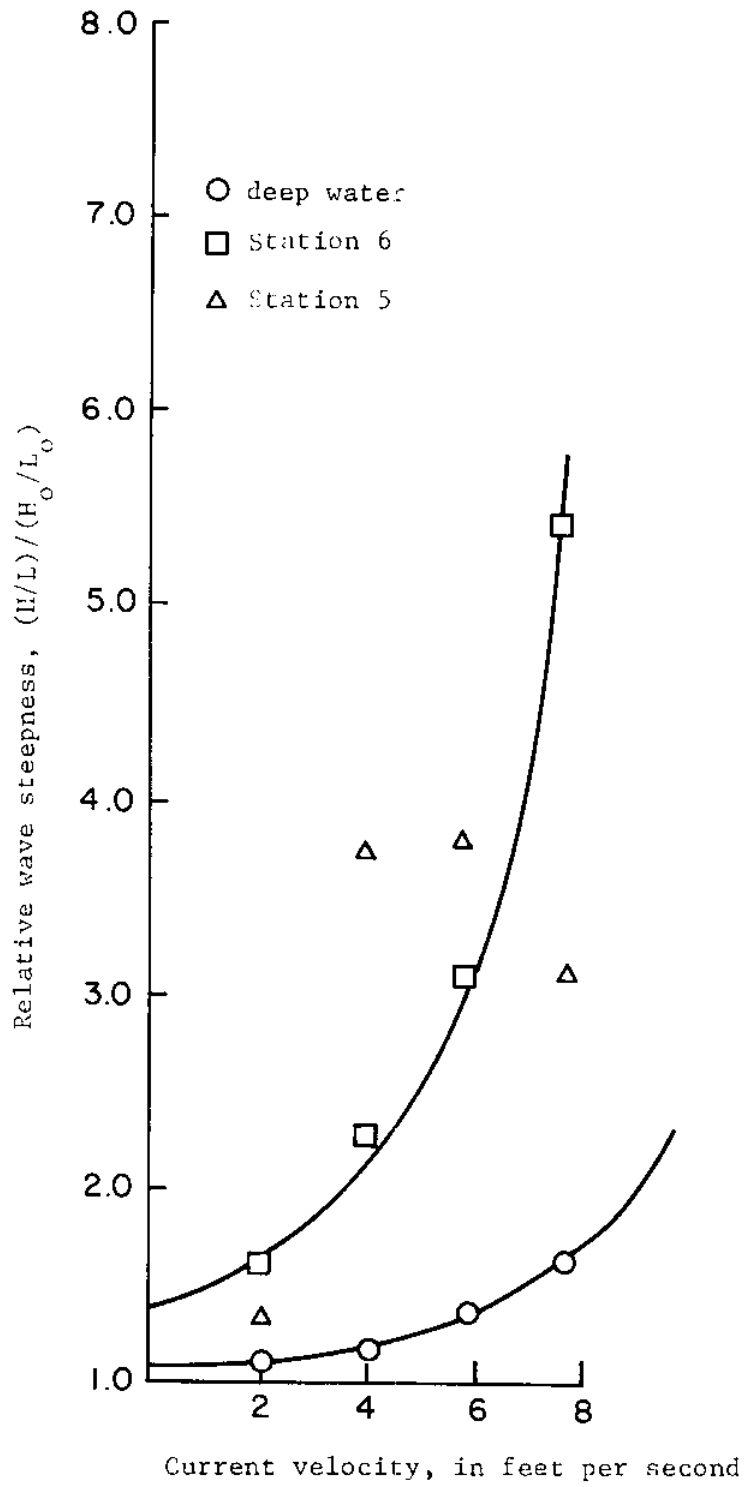
To get some idea of the effect of wave steepening, a model of the constricted section of the mouth of the bay was made in which the ebb current and the approaching waves could be simulated. An undistorted model at a scale ratio of 300:1 was constructed using the bathymetry obtained during the June 1974 field survey (see the following section, "Field Observations"). The extent of the model was approximately from station 4 to station 6 of the survey, as described in the next section. The model was constructed inside a recirculating flume so that any desired current could be maintained, and a paddle board wave generator was installed in one end of the flume. Four wave gages were installed: one in "deep water" near the paddle board, and one each at stations 6, 5 and 4 of the survey. Continuous gage readings were recorded on a four channel strip chart recorder. Recordings were made for prototype wave heights of 0, 6, 8, 10, and 12 feet, with each size wave subject to prototype currents of 0, 2, 4, 6, and 8 ft/sec. A typical set of results, for a prototype wave height of 8 ft., is shown in figure 3. The ebb current causes substantial wave steepening; for instance, an 8 ft/sec outflow causes approximately a four-fold steepening of the wave at station 6.

Figure 3 Increase of wave steepness as a function of outflow current velocity, for 8-foot waves

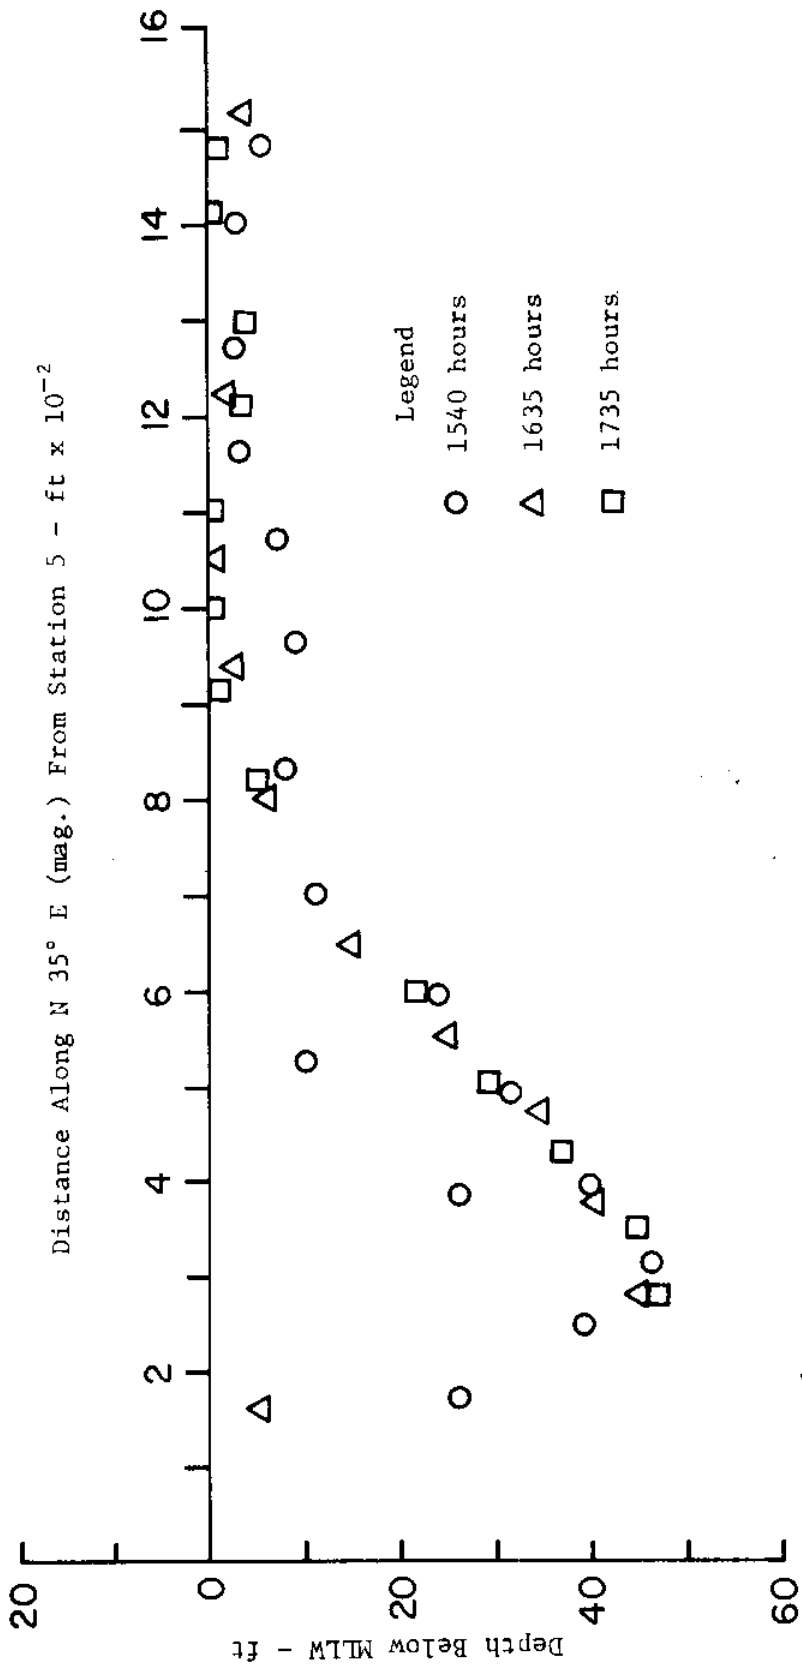
The depths observed at station 5 are shown in figures 6 through 8. The purpose of taking a number of observations throughout the tidal cycle was to see if there might be large movements of sand and short term changes in bathymetry. None were observed. Comparison of data at all the stations between June and September also showed

Figure 6 Variation of Depth with Time at Station 5, Flood Tide, June 26, 1974

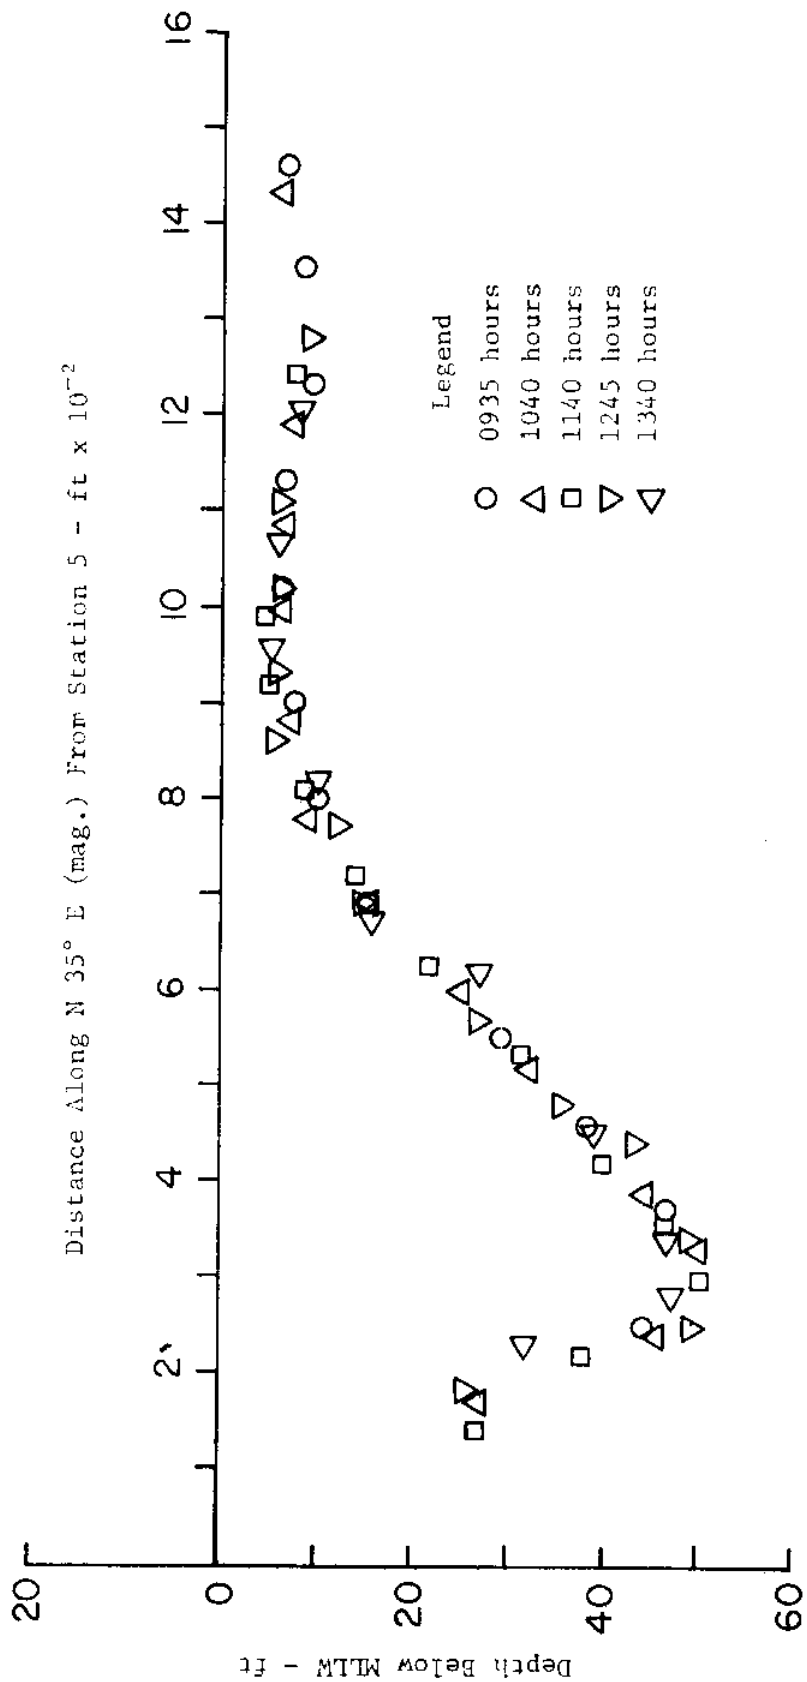
Figure 7 Variation of Depth with Time at Station 5, Ebb Tide, June 28, 1974

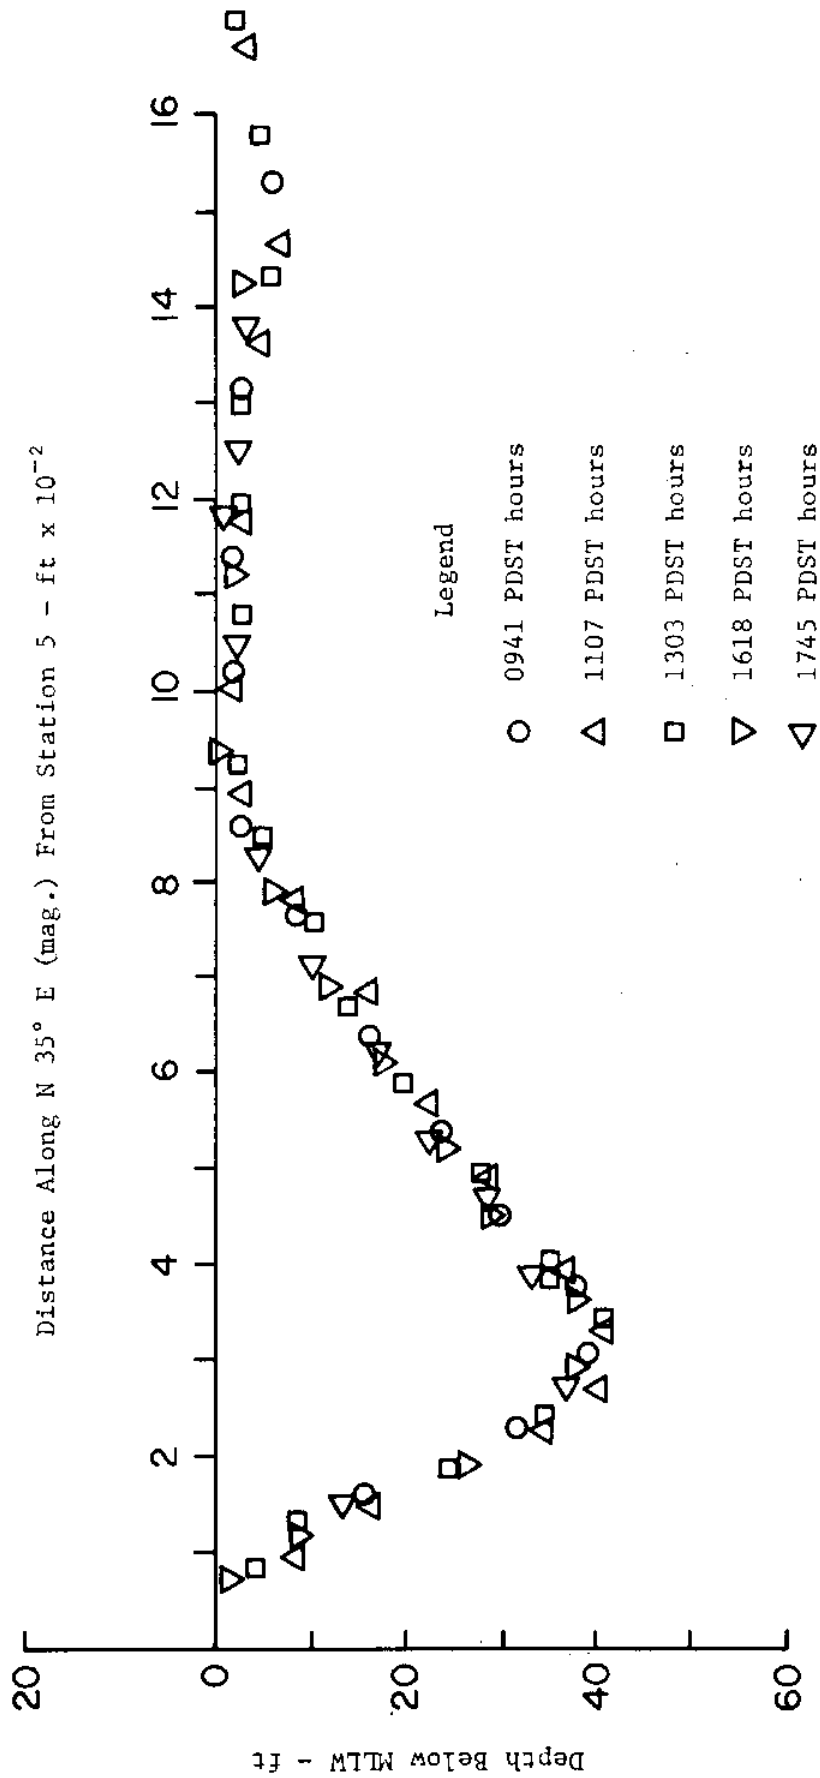
Figure 8 Variation of Depth with Time Flood and Ebb Tide, September 18, 1974

very little change. We conclude that tidal motion alone is not capable of moving large amounts of sediment near the mouth of the bay, since the bathymetry was similar in a period of weak tides in June and a period of strong tides in September. This observation probably explains the lack of formation of antidunes (sand waves; see Kennedy, 1963); antidunes can form when the Froude Number of the flow exceeds 0.8, as it often does at the mouth of the bay, but they require a large amount of sediment transport.

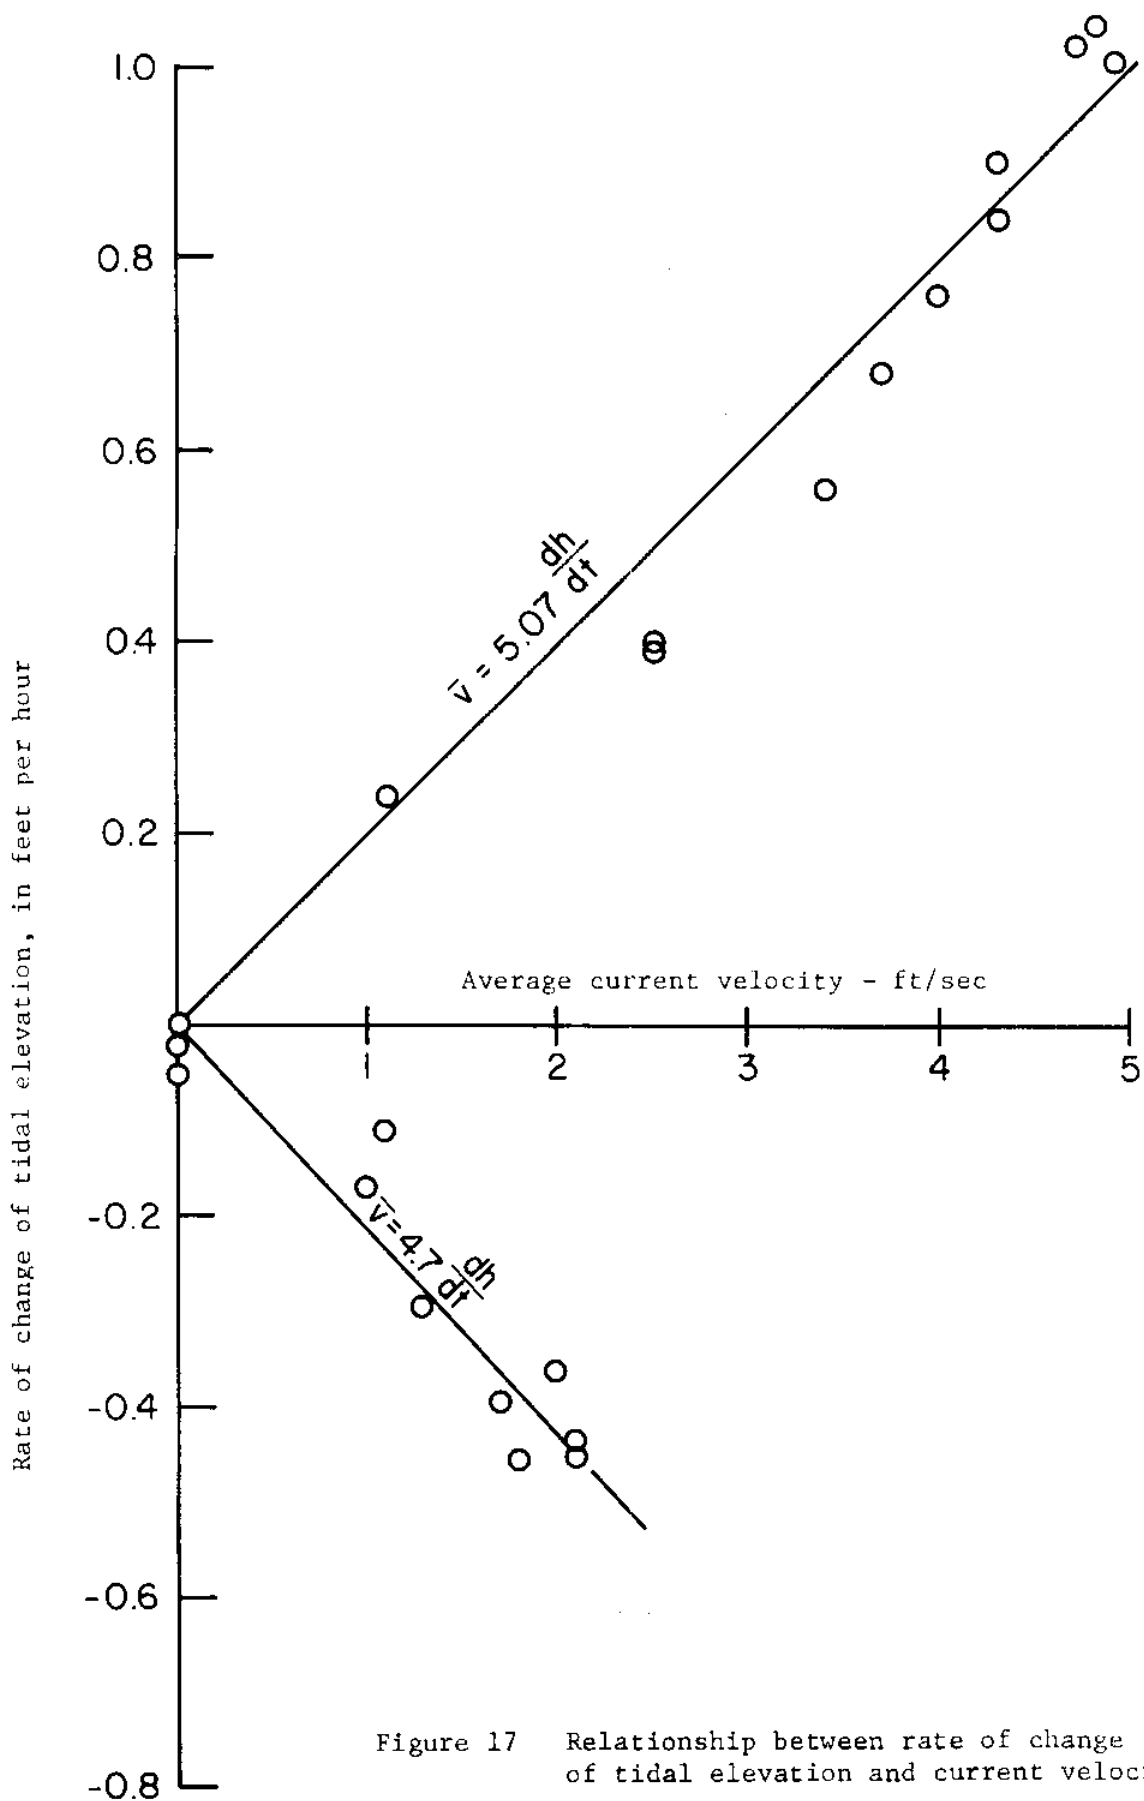
Observed velocities under a number of tidal conditions are shown in figures 11 through 16. Analysis of the data (figure 17) showed that the average velocity can be expressed as a linear function of the rate of change of tidal elevation.

Figure 17 Relationship between rate of change of tidal elevation and current velocity
