OREGON SEA GRANT  
ORES-U-T-95-002  
M/A-2

# Hyogo-Ken Nanbu Earthquake of January 17, 1995:

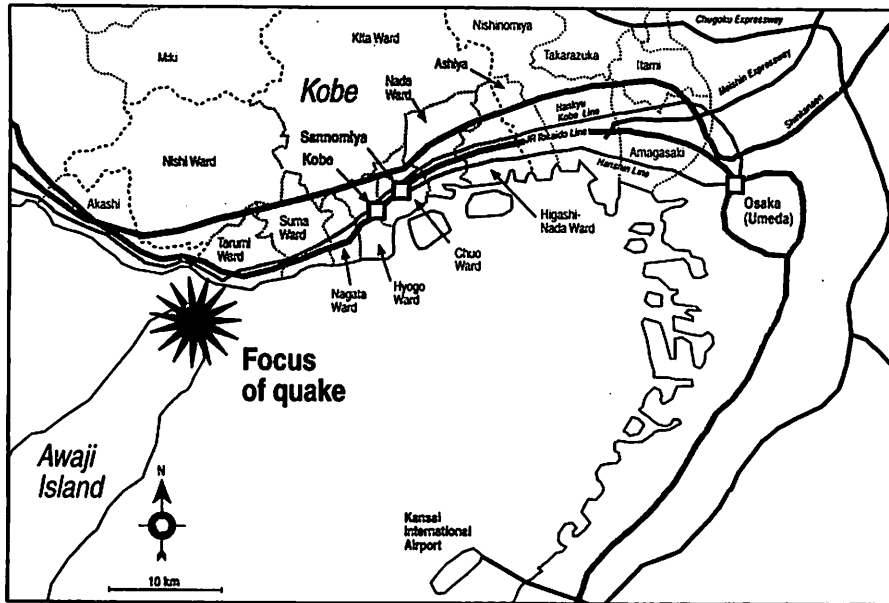
a) Main Shock on January 17, 1995 at 5:45 am (JTL, 1995)

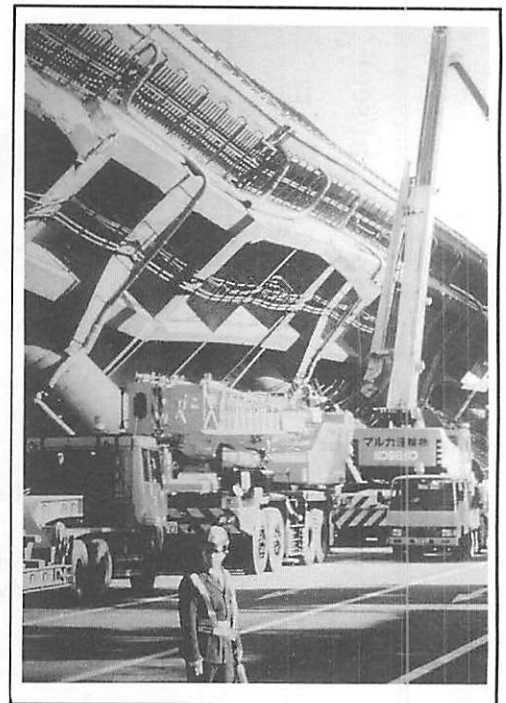
**e) Highway Bridge Collapse**

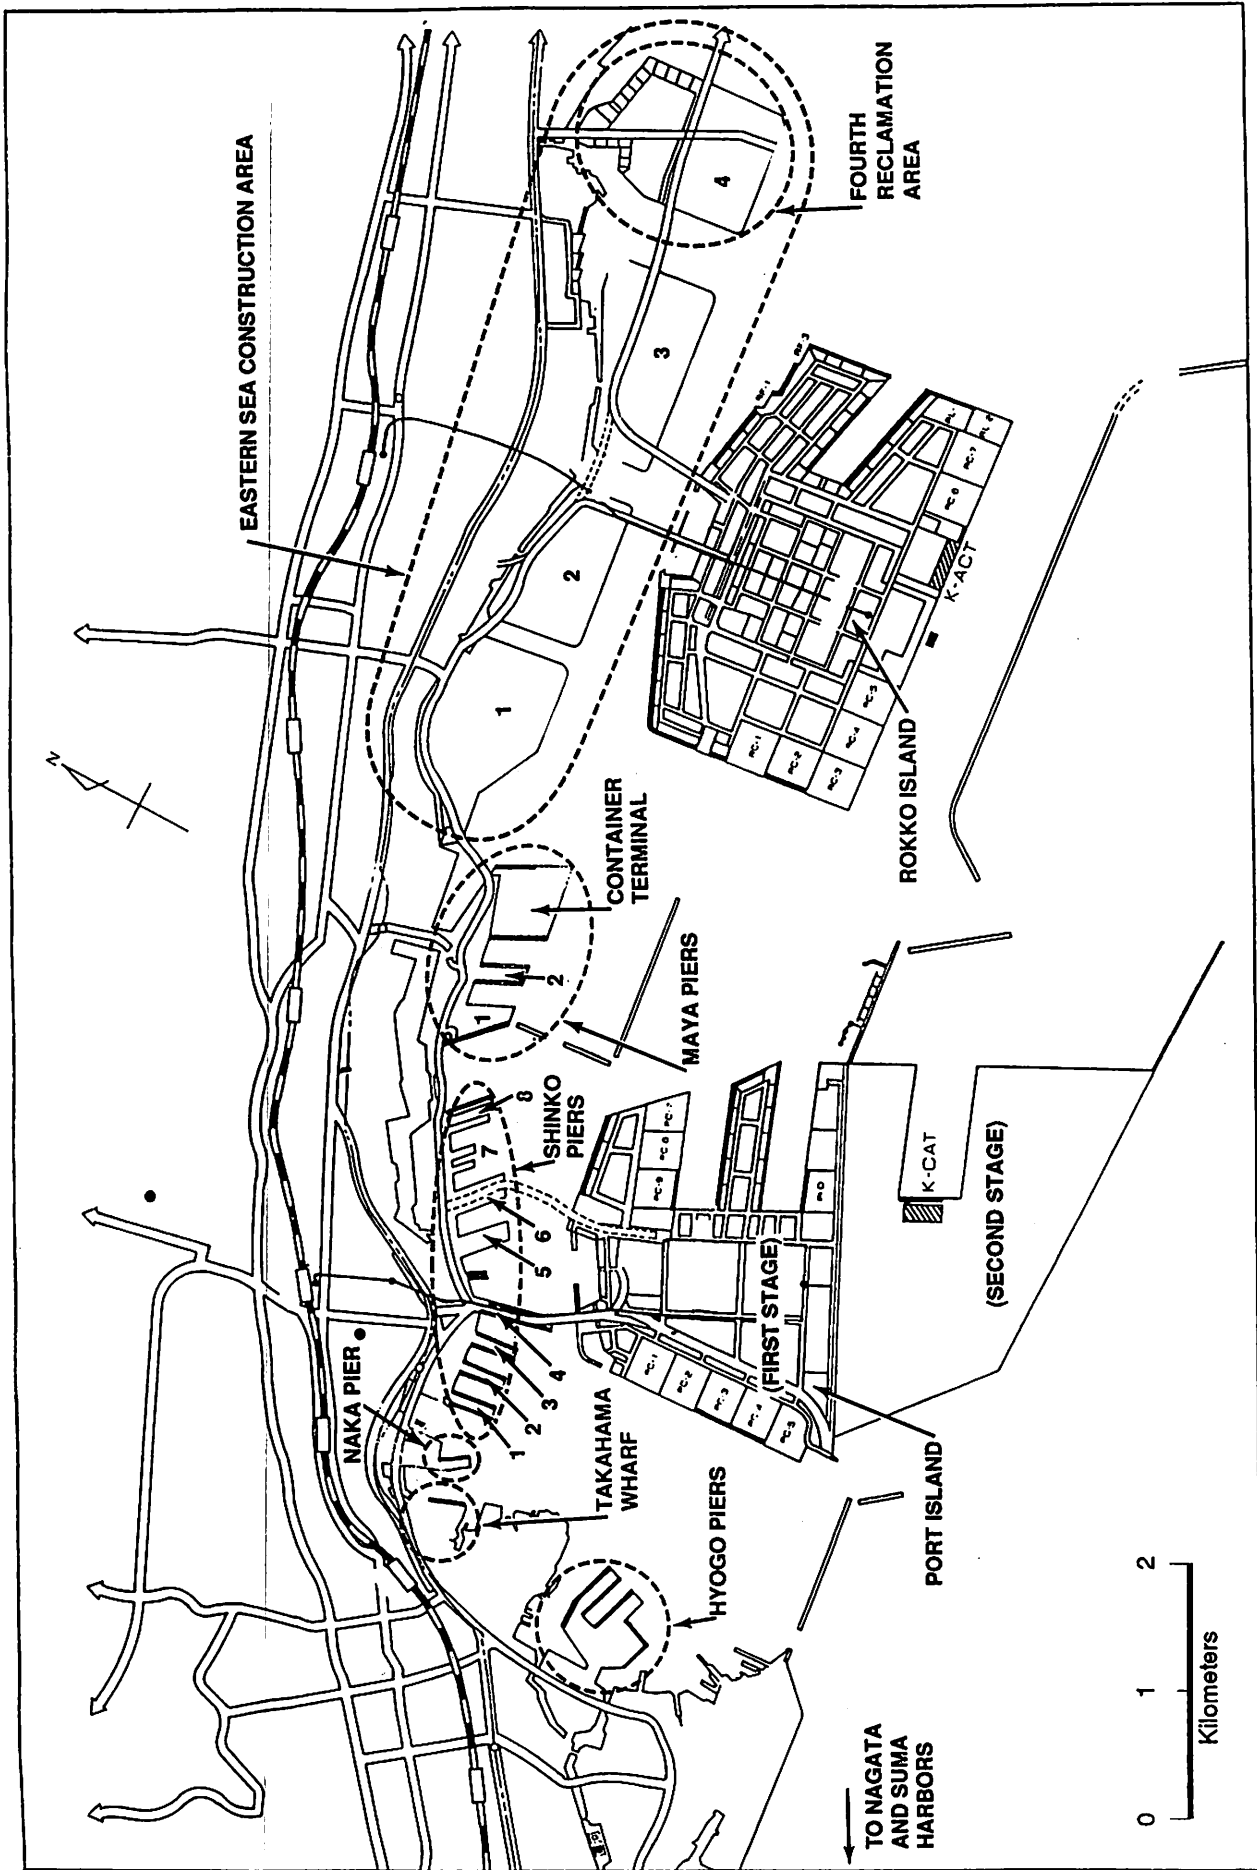
**FIGURE 3-1  
KOBÉ PORT**

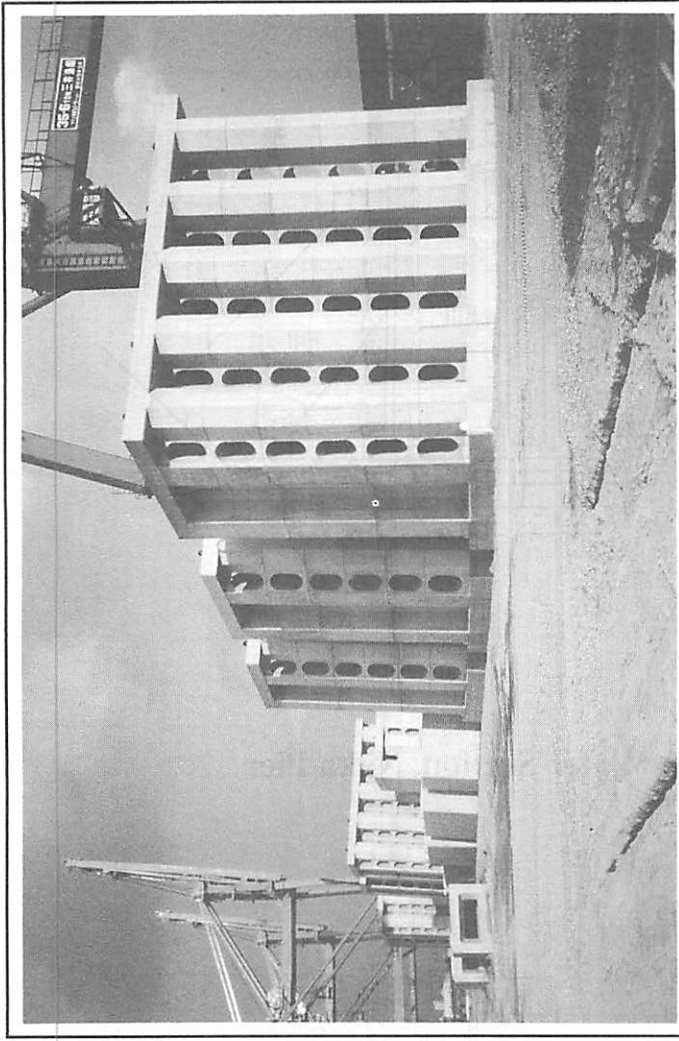
c) Replacement Caisson on Port Island (Similar to Originals)

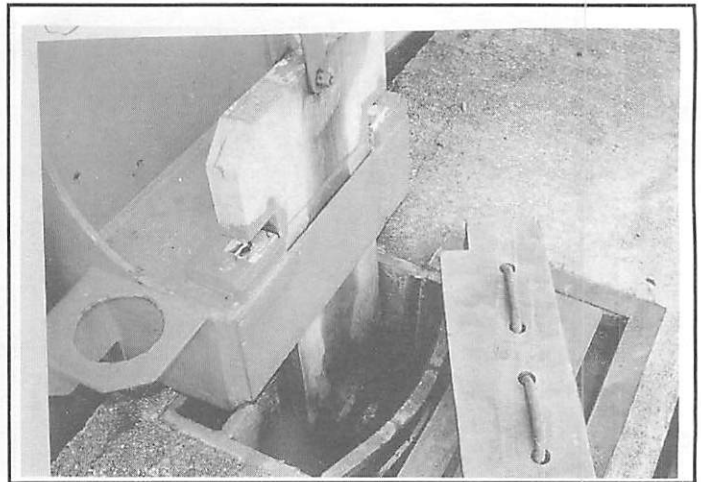
b) Damaged Locking Mechanism, Port Island  
(Photo by Dr. H.Tsuchida)

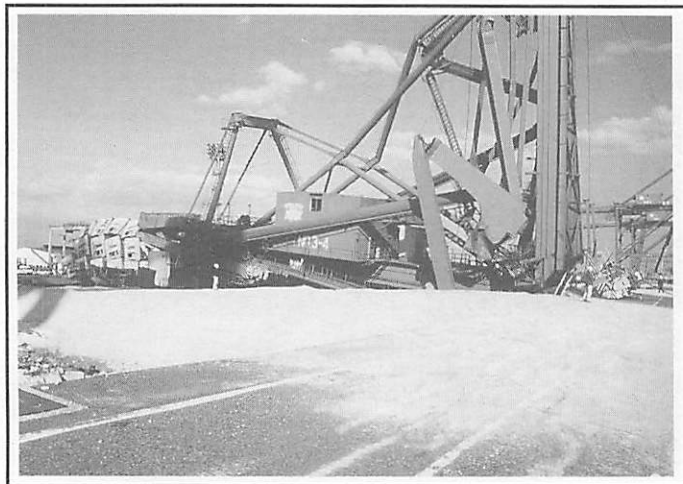
c) Collapsed Legs, Rokko Island

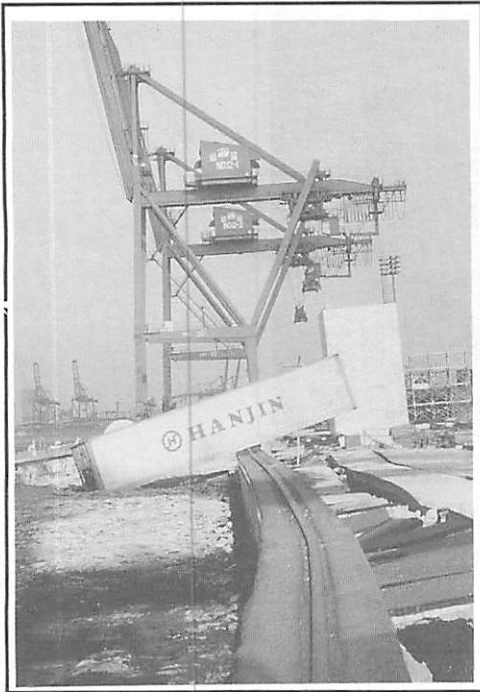
**e) Damaged Crane Rail at  
Minami Wharf, Port Island**

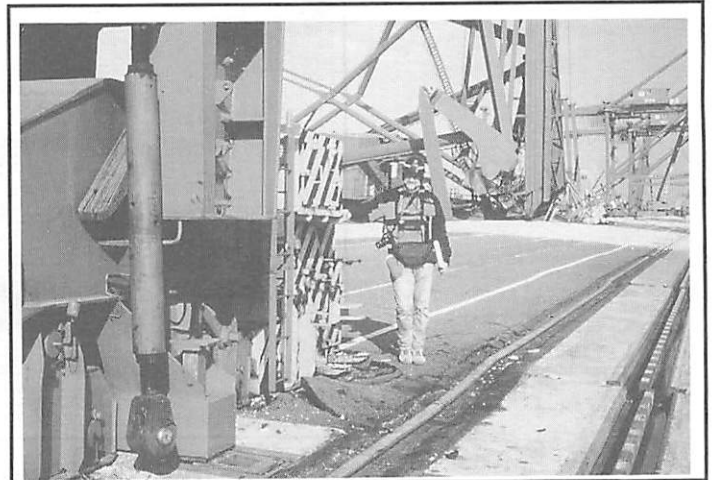
**f) Movement of Crane off of Rail,  
Rokko Island**

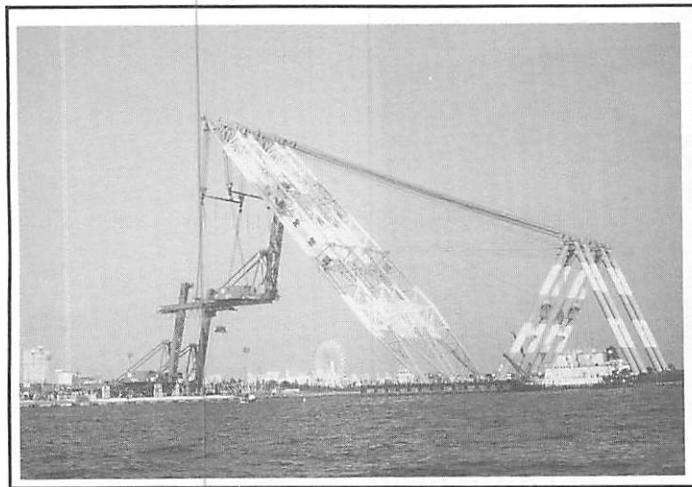
**g) Crane Repair, Rokko Island**

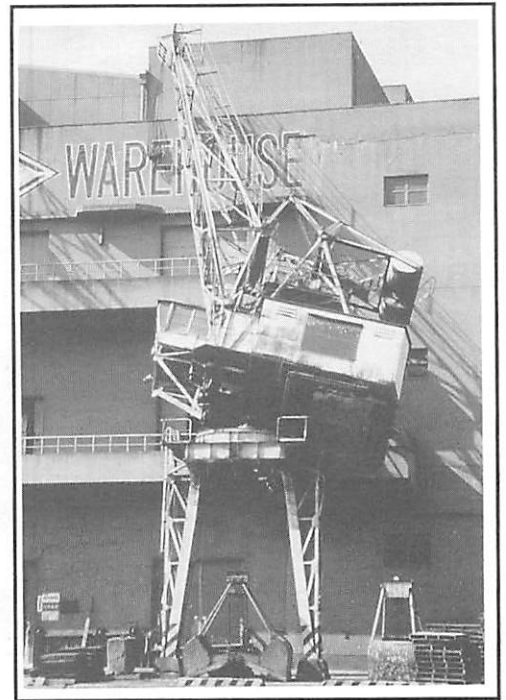
**h) Collapsed Support at  
Pier 7, Shinko Piers**

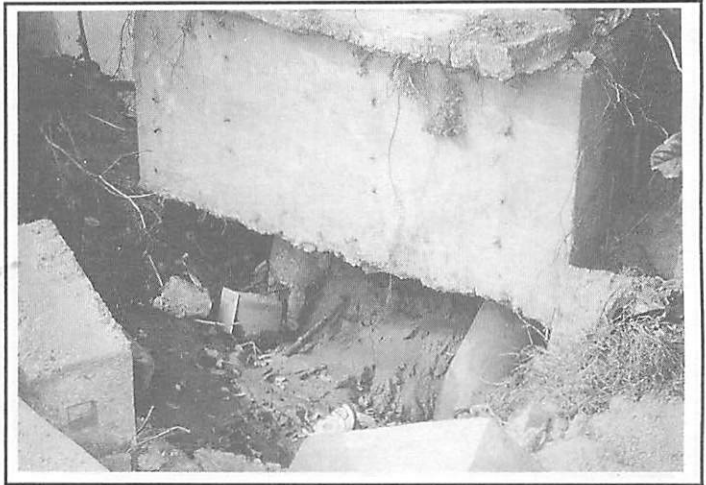
**b) Damage to Lightly Reinforced Concrete Cylinder Piles Beneath Building in Foreground of a).**

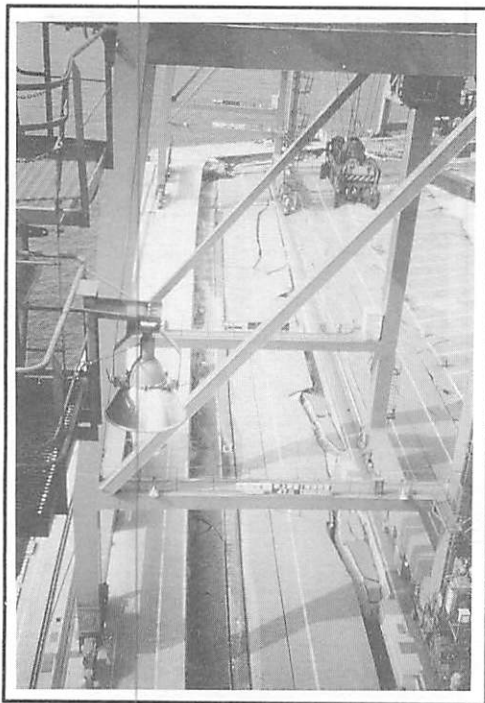
**c) Lateral Movement of Caissons at Berth O.**

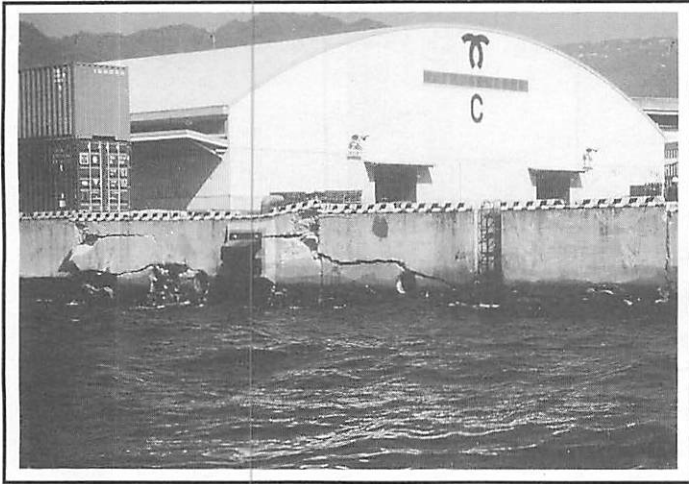
**i) Minor Quay Wall Damage between Berths B and C**

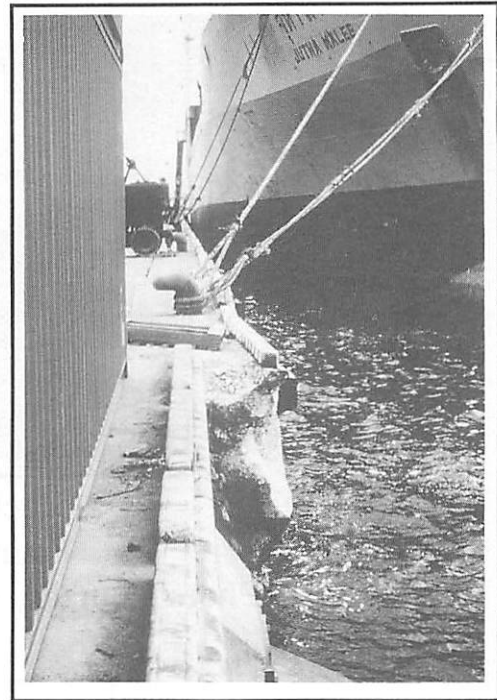
**j) Relative Seaward Movement between Berth B (background) and Berth C (foreground)**

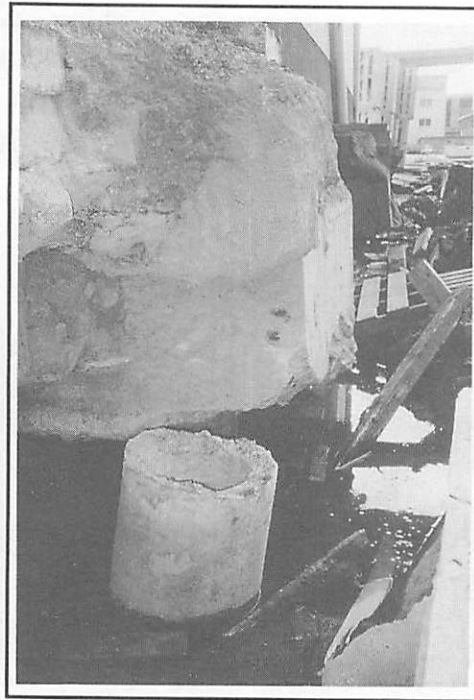
**b) Fracture of Hollow Concrete  
Cylinder Pile at Pile Cap -  
Port Island, Pier 1**

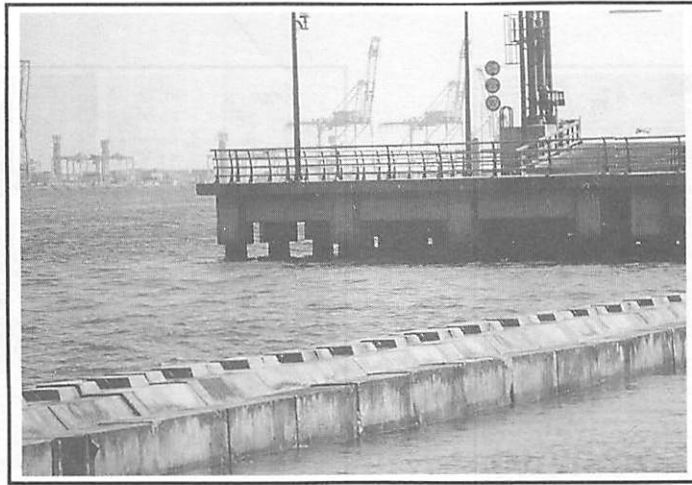
**a) View of Wharf Looking South**

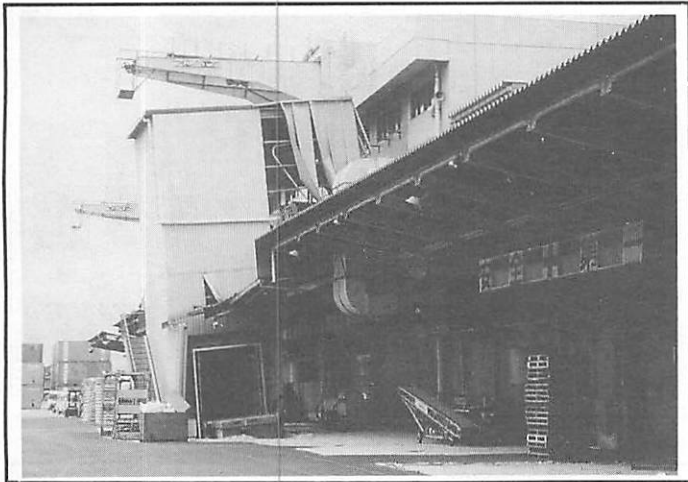
**a) Connection Failure of Braced Corrugated Metal Warehouse at Naka Wharf, Port Island**

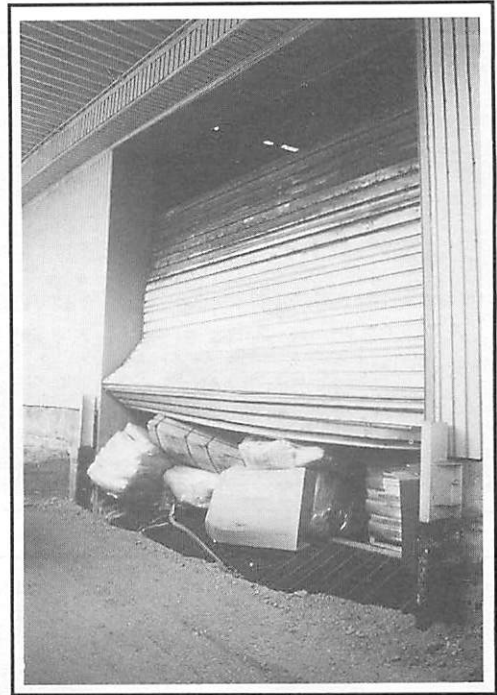
**b) Door Damage at Building in a)**

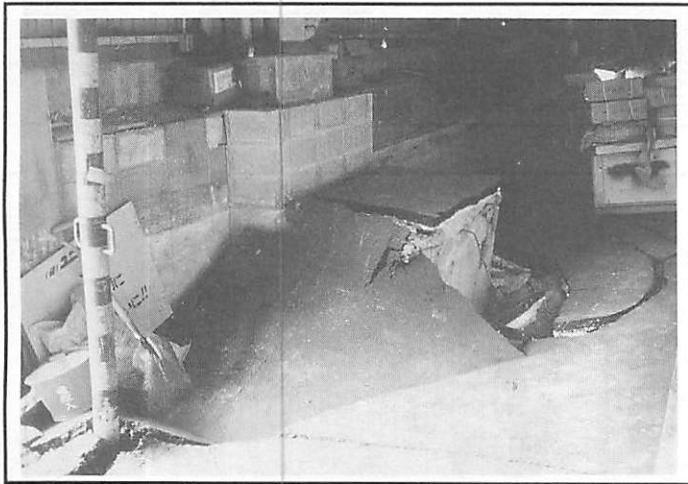
**c) Floor Settlement at Building in a)**

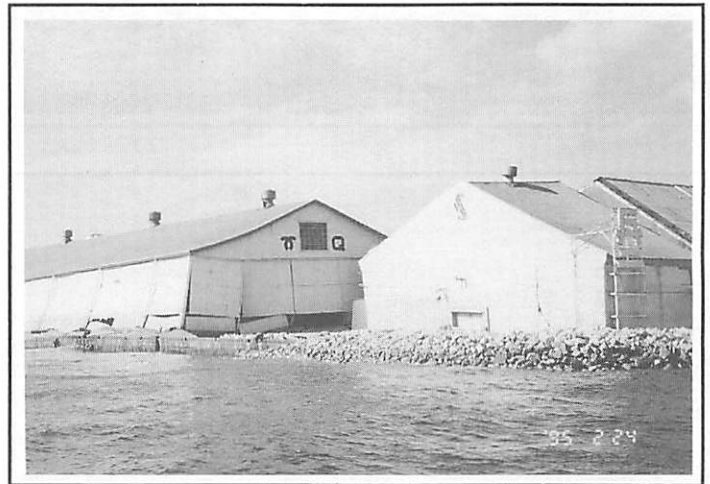
**d) Damage to Wooden Warehouse, Hyogo Pier**

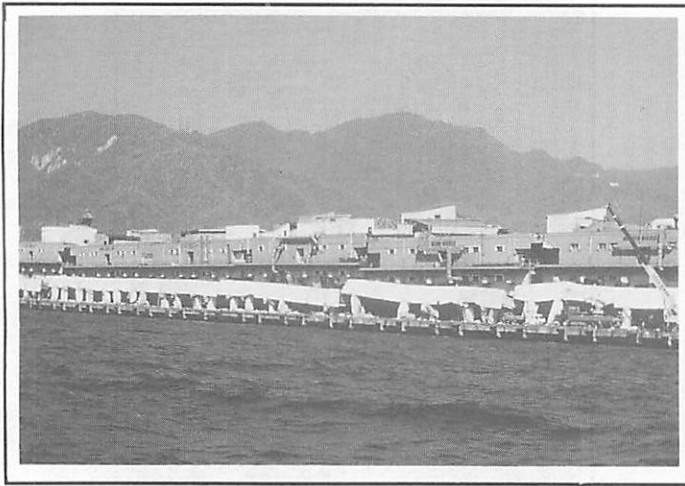
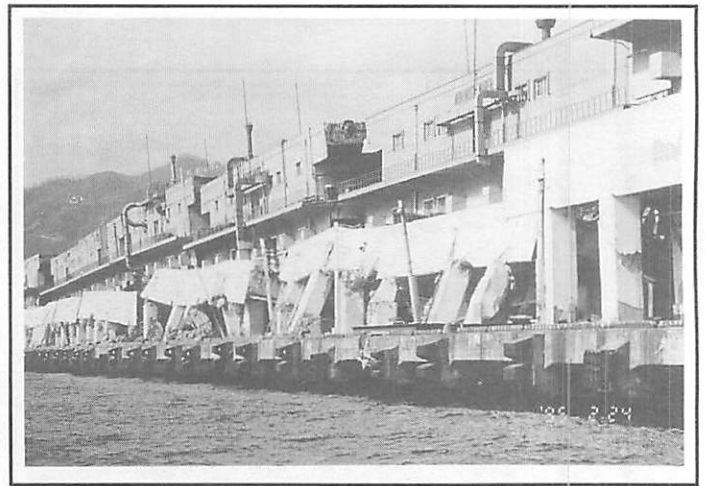
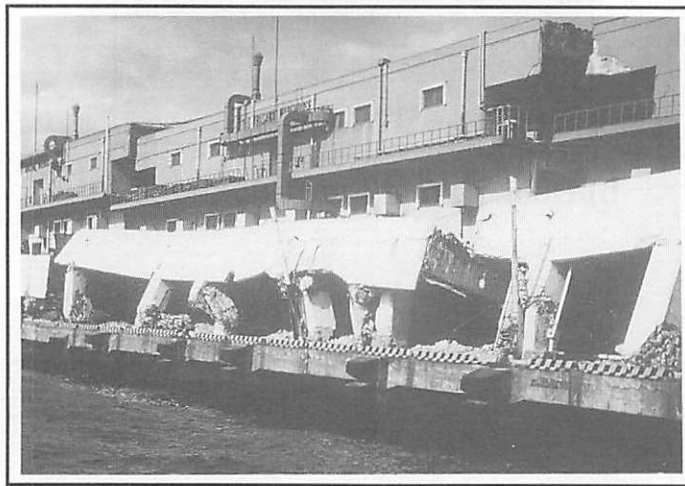
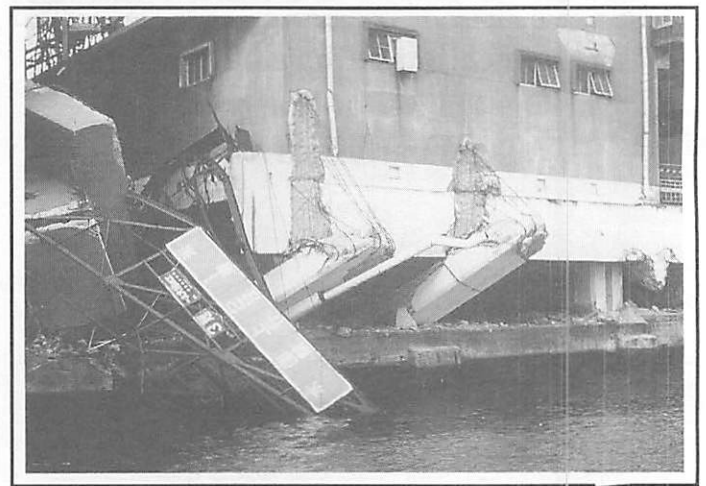
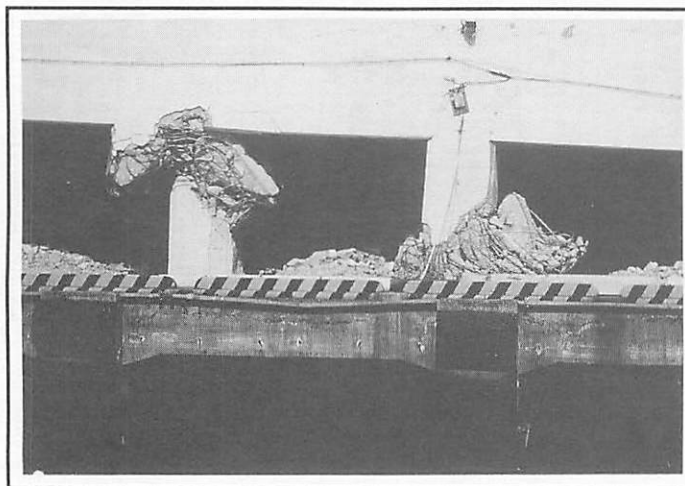
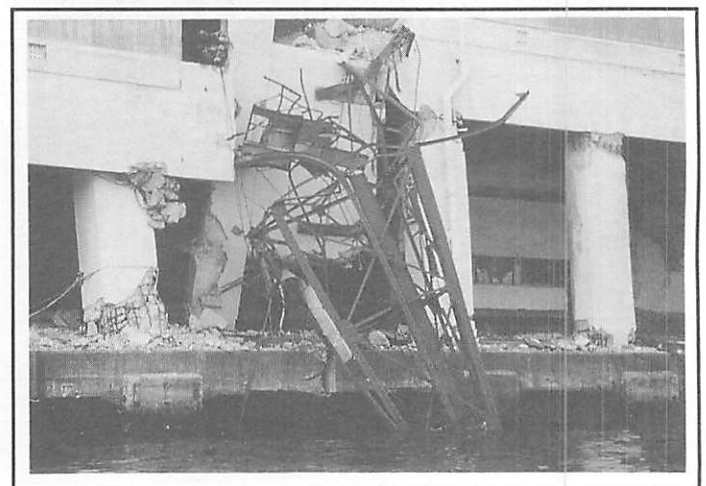
**FIGURE 3-25**  
**POOR PERFORMANCE OF NON-DUCTILE CONCRETE**  
**FRAME WAREHOUSE STRUCTURE AT**  
**PIERS 8A AND 8B, SHINKO PIERS**

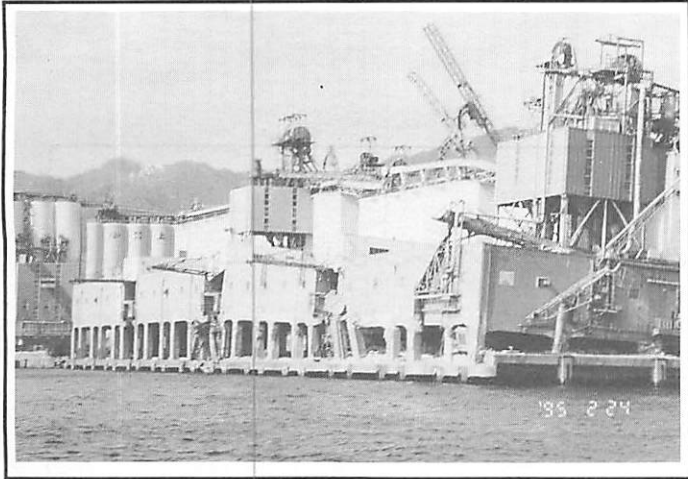
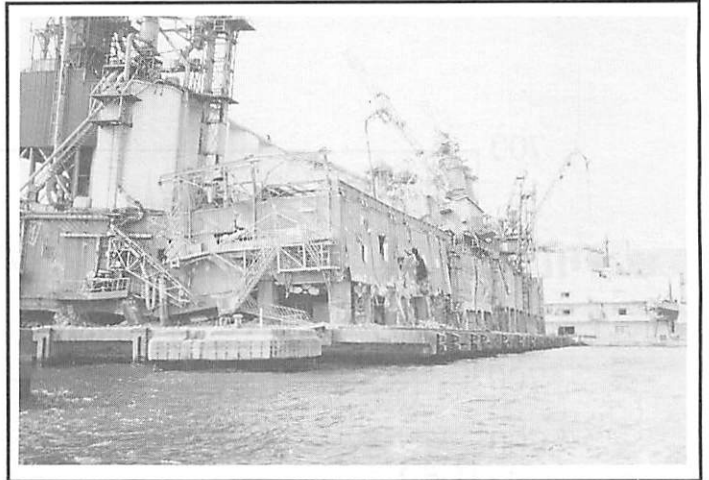
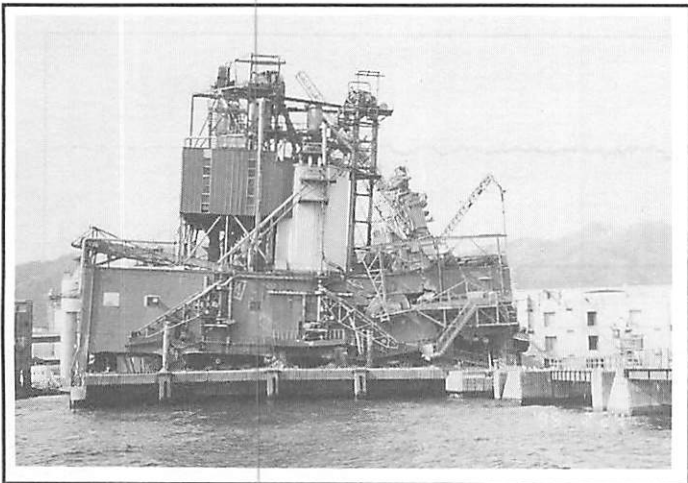
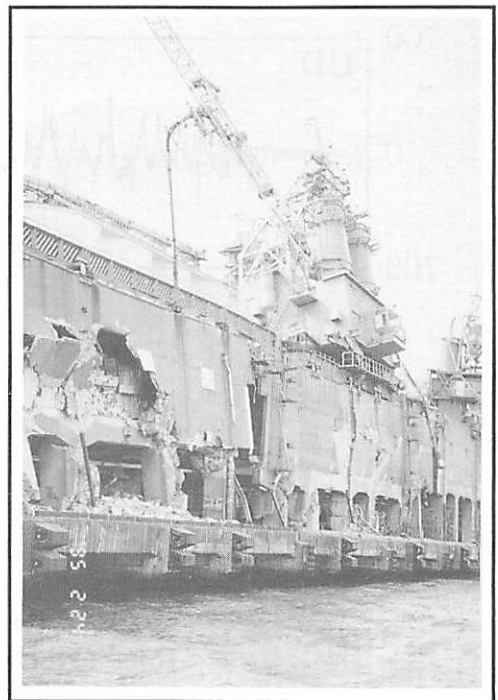
**FIGURE 3-26**  
**DAMAGE TO NON-DUCTILE CONCRETE FRAME WAREHOUSE**  
**STRUCTURE AT PIER 7, SHINKO PIERS**

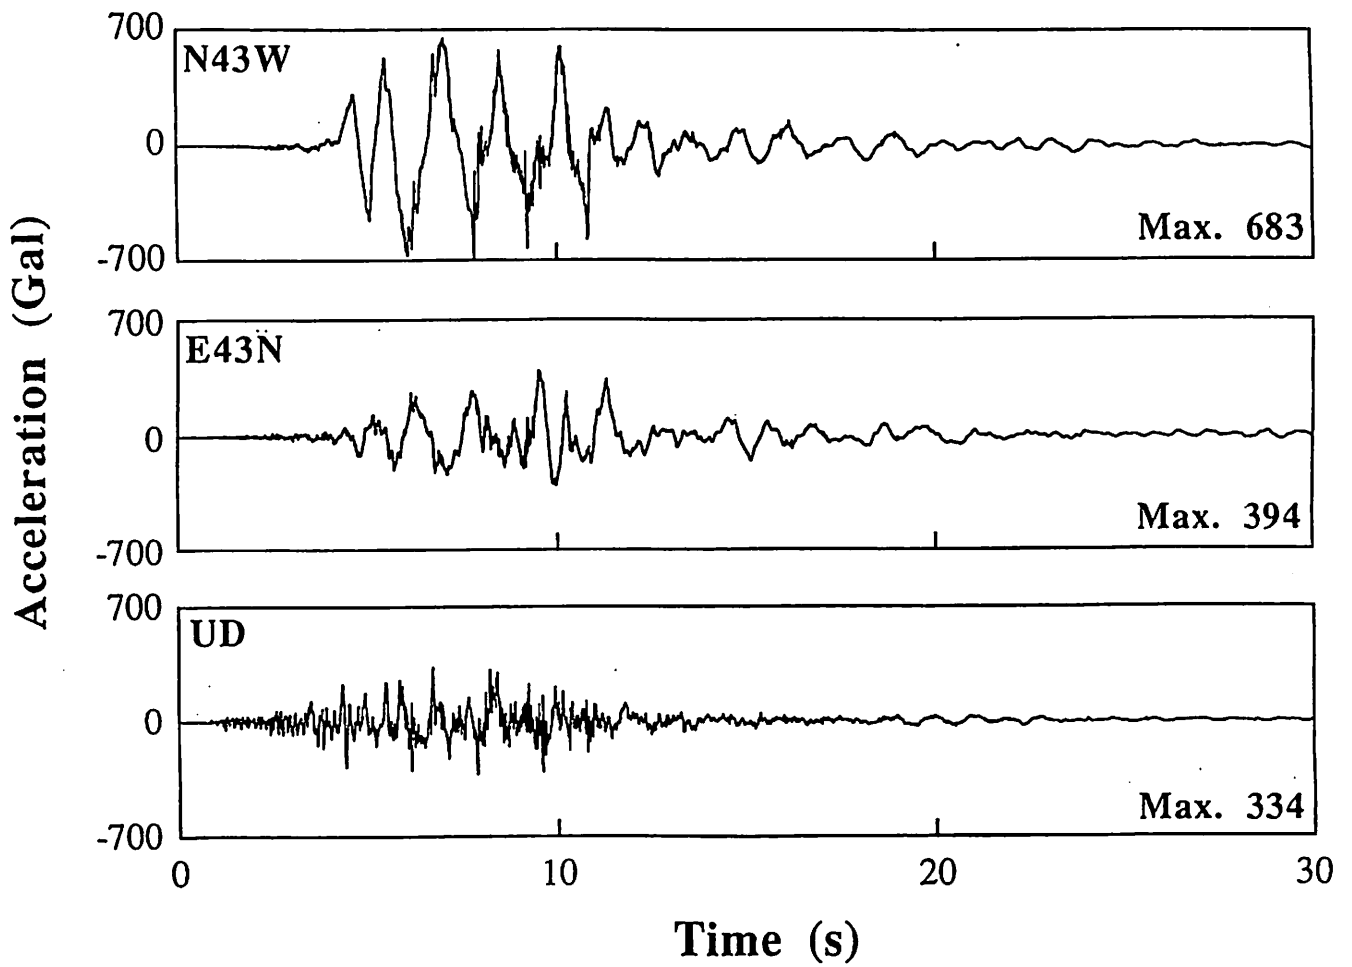
**FIGURE 3-27**  
**STRONG MOTION ACCELEROGRAM**  
**RECORDED AT PIER 8, SHINKO PIERS**  
**(DPRI, 1995b)**

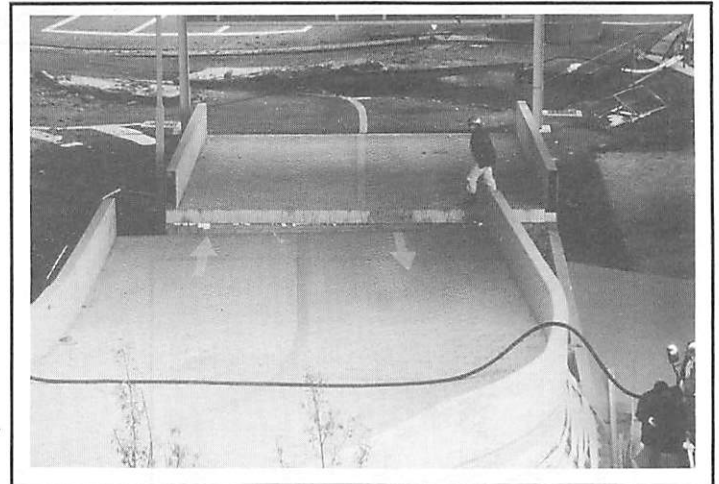
**c) Fill Settlement**

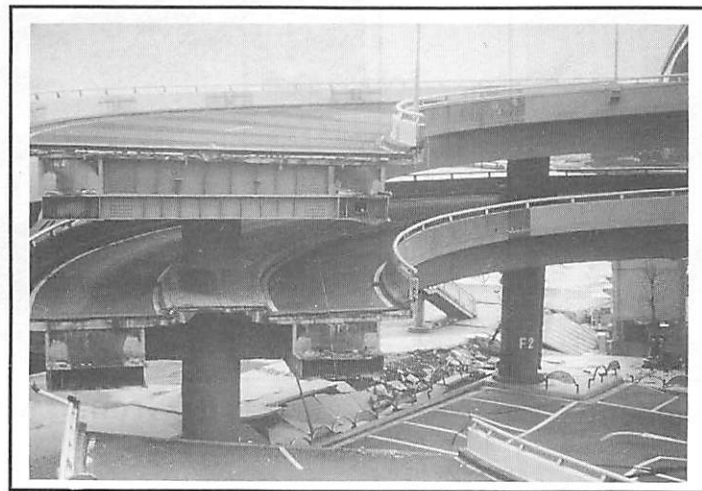
**e) Collapsed Ramp**

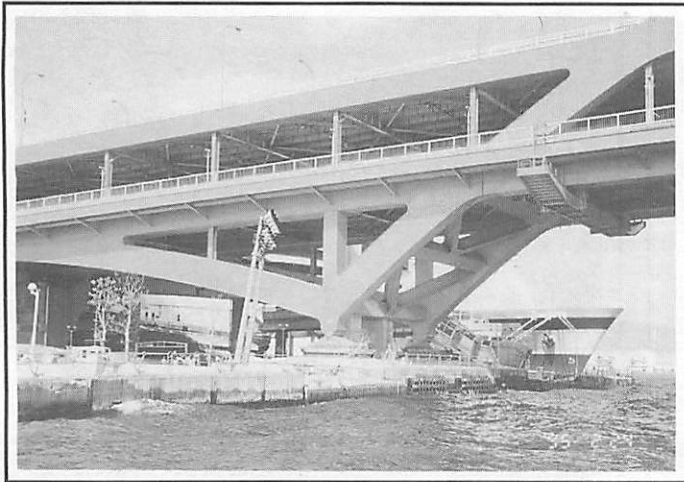
**a) Quay Wall Damage**

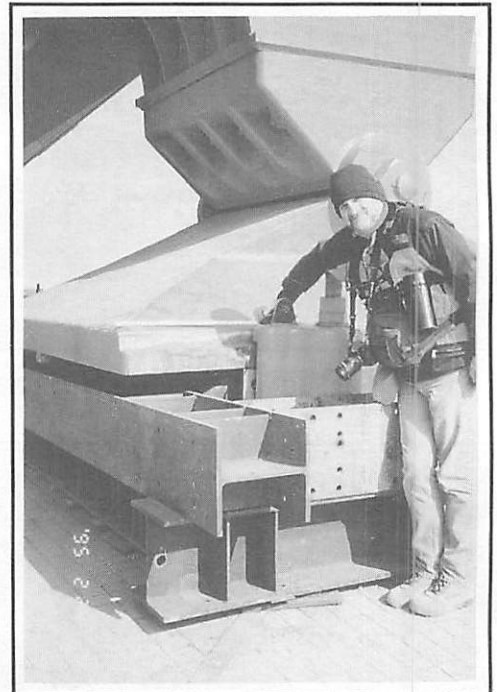
**b) Movement of North Support  
2ft (0.7m) to North**

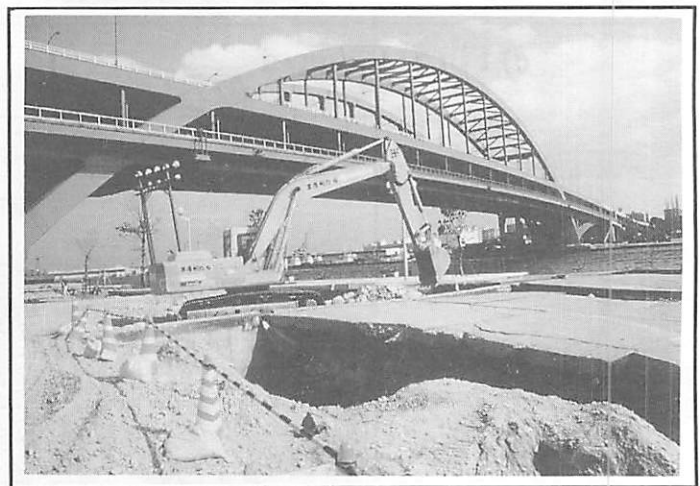
**d) Ground Movement**

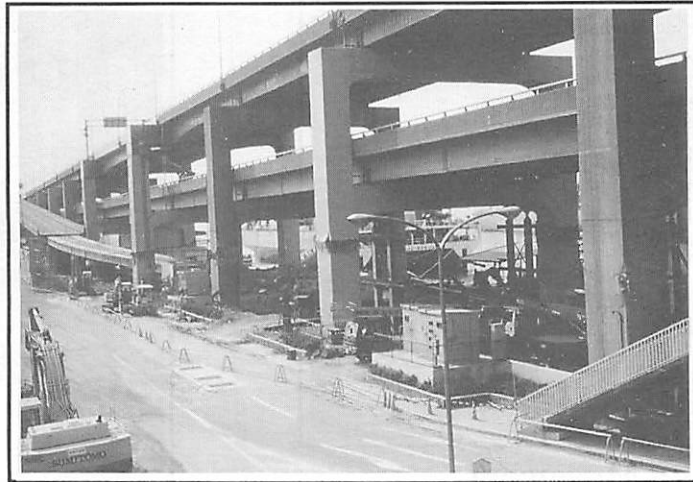
**a) Looking South Toward Port Island**

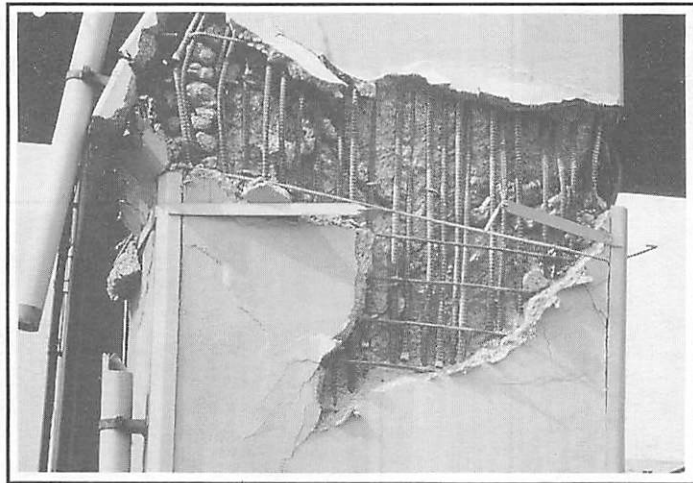
**b) Column Damage - Inadequate  
Transverse Reinforcement**

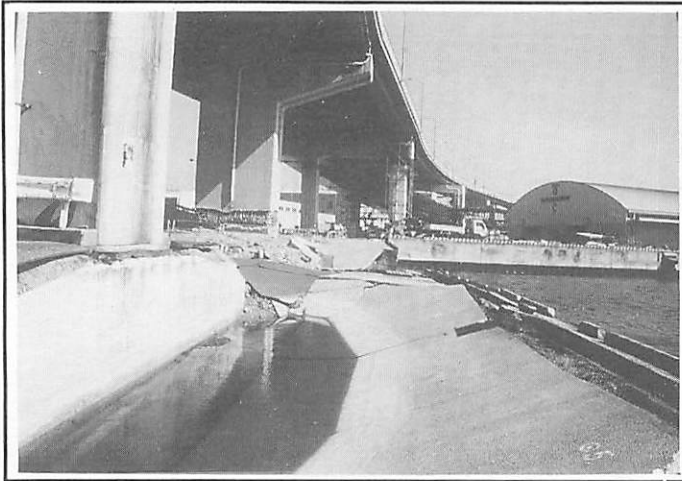
**a) Ground Movement**

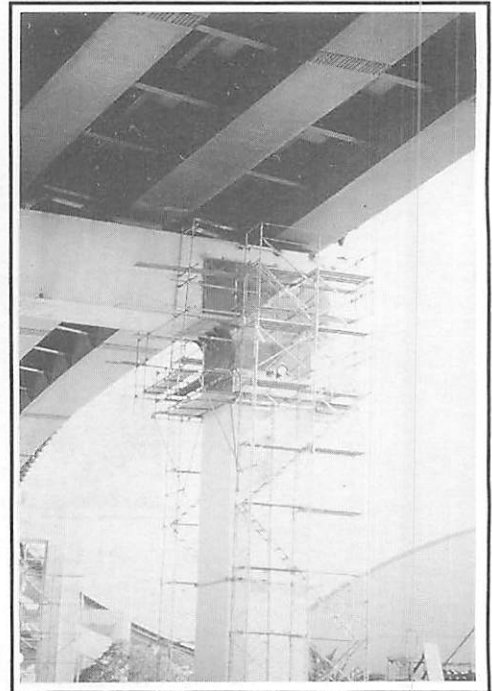
**b) Repair to Damage  
at Beam-Column Joint**

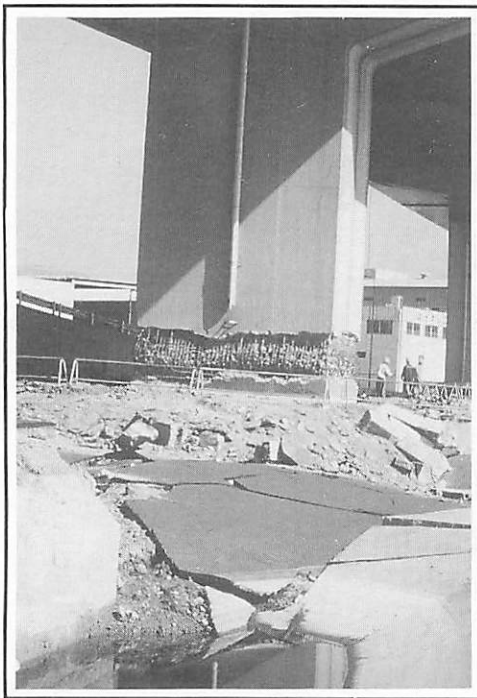
**c) Column Damage**

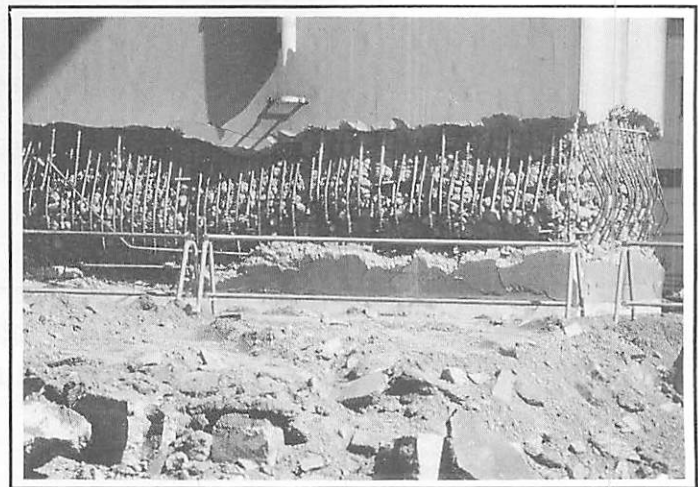
**d) Close-up of Column Damage from c)**

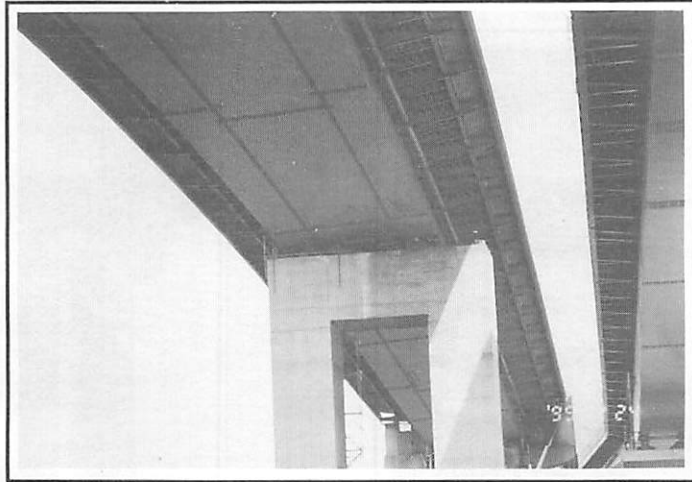
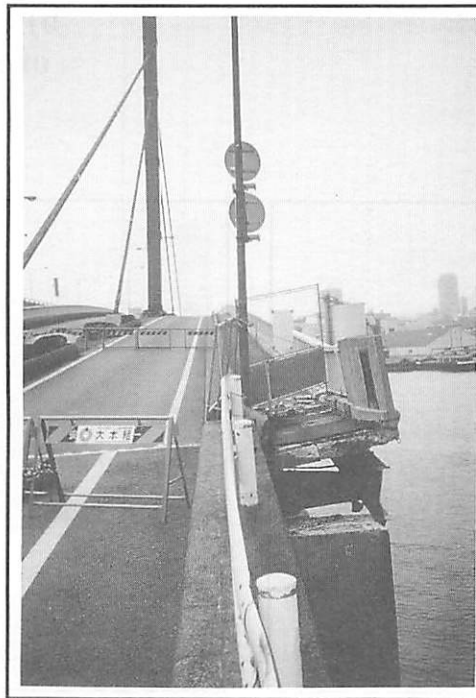
**FIGURE 3-34**  
**DAMAGE TO MAYA-OHASHI BRIDGE -**  
**LATERAL MOVEMENT OF DECK OFF OF BEARING SUPPORTS**  
**(BETWEEN MAYA PIERS AND SHINKO PIERS)**

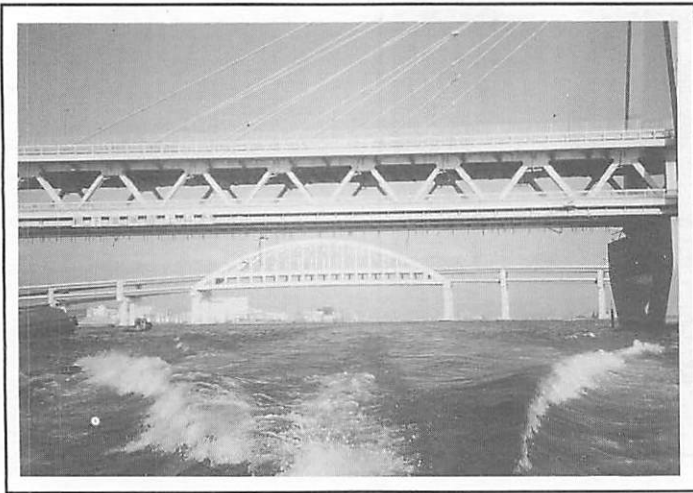
**a) View Looking East (Hanshin Expressway Bridge in Background, Rokko Ohashi Bridge in Foreground)**

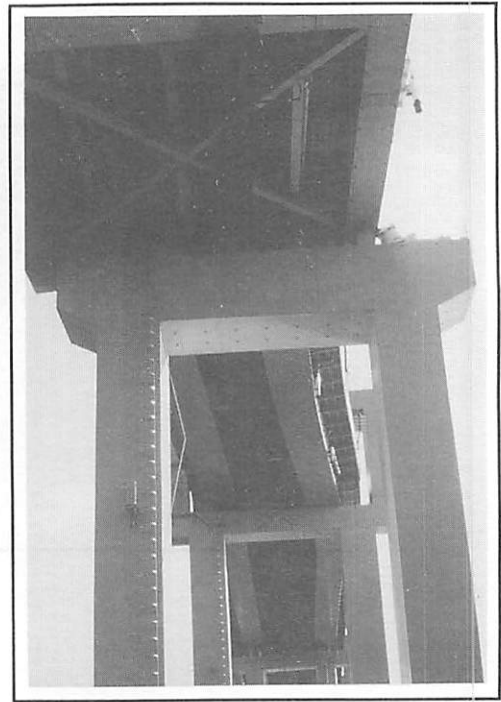
**b) Lateral Deformation of Superstructure and Bearing Failure**

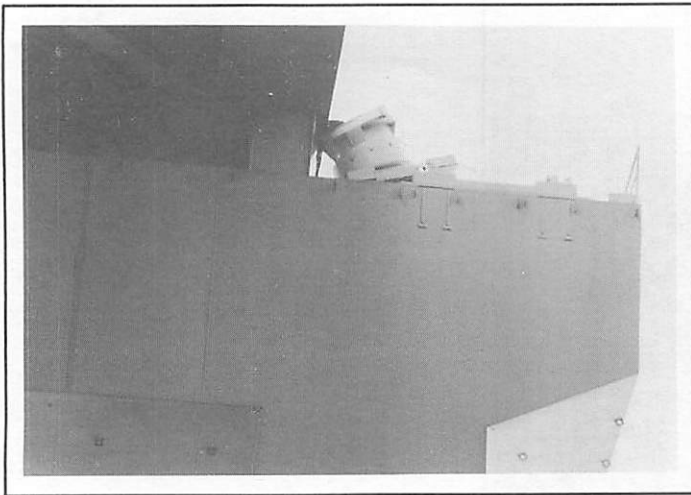
**c) Closeup of Bearing Failure from b)**

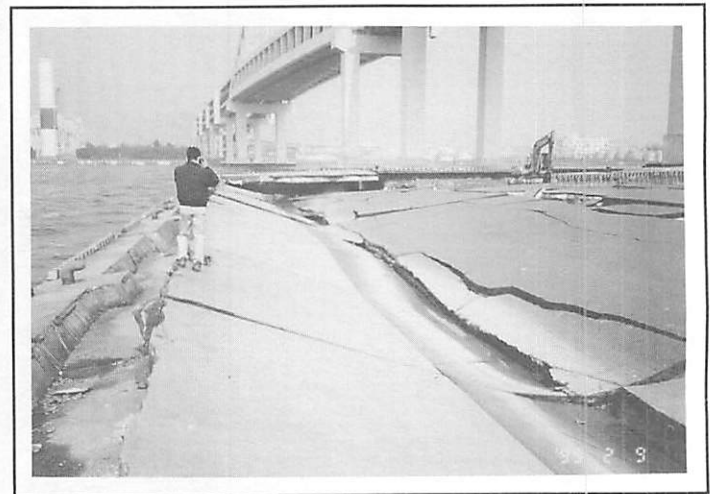
**d) Ground Deformation at South End of Bridge (on Rokko Island)**

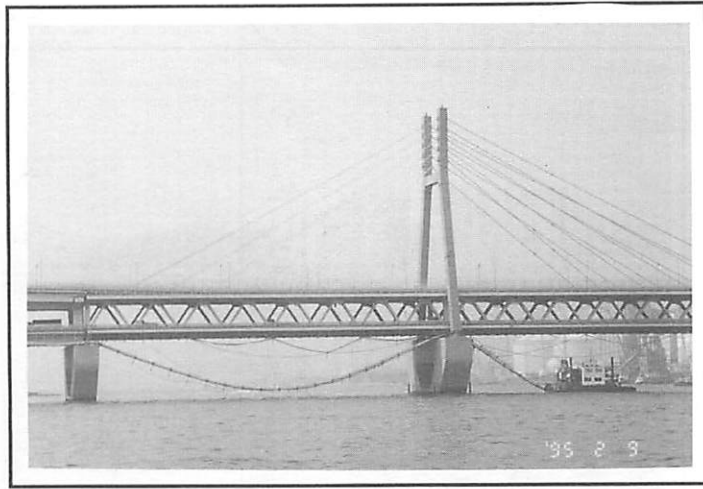
**a) Potable Water Line to Rokko Island**

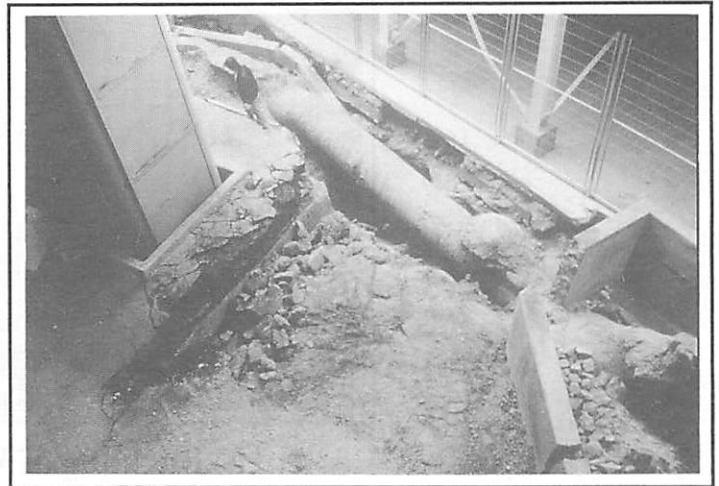
**c) Pier 4, Shinko Piers**

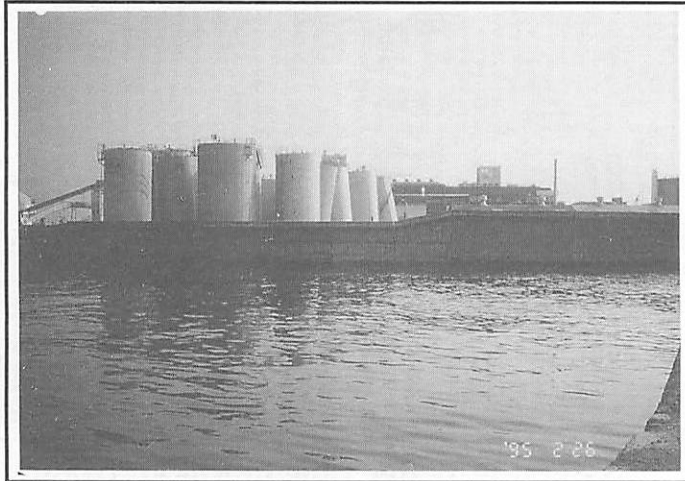
**a) Tank Tilting, Nagata Harbor**

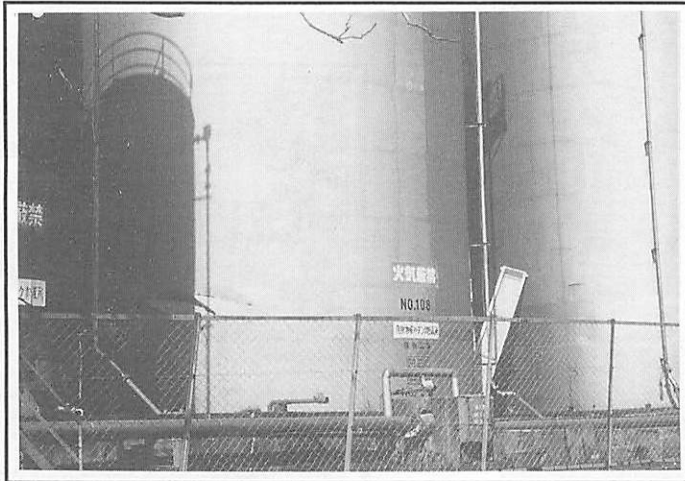
**b) Buckling of Walls, Fourth Reclamation Area**
