OREGON SEA GRANT  
ORES-U-T-95-002  
M/A-2

# Hyogo-Ken Nanbu Earthquake of January 17, 1995:

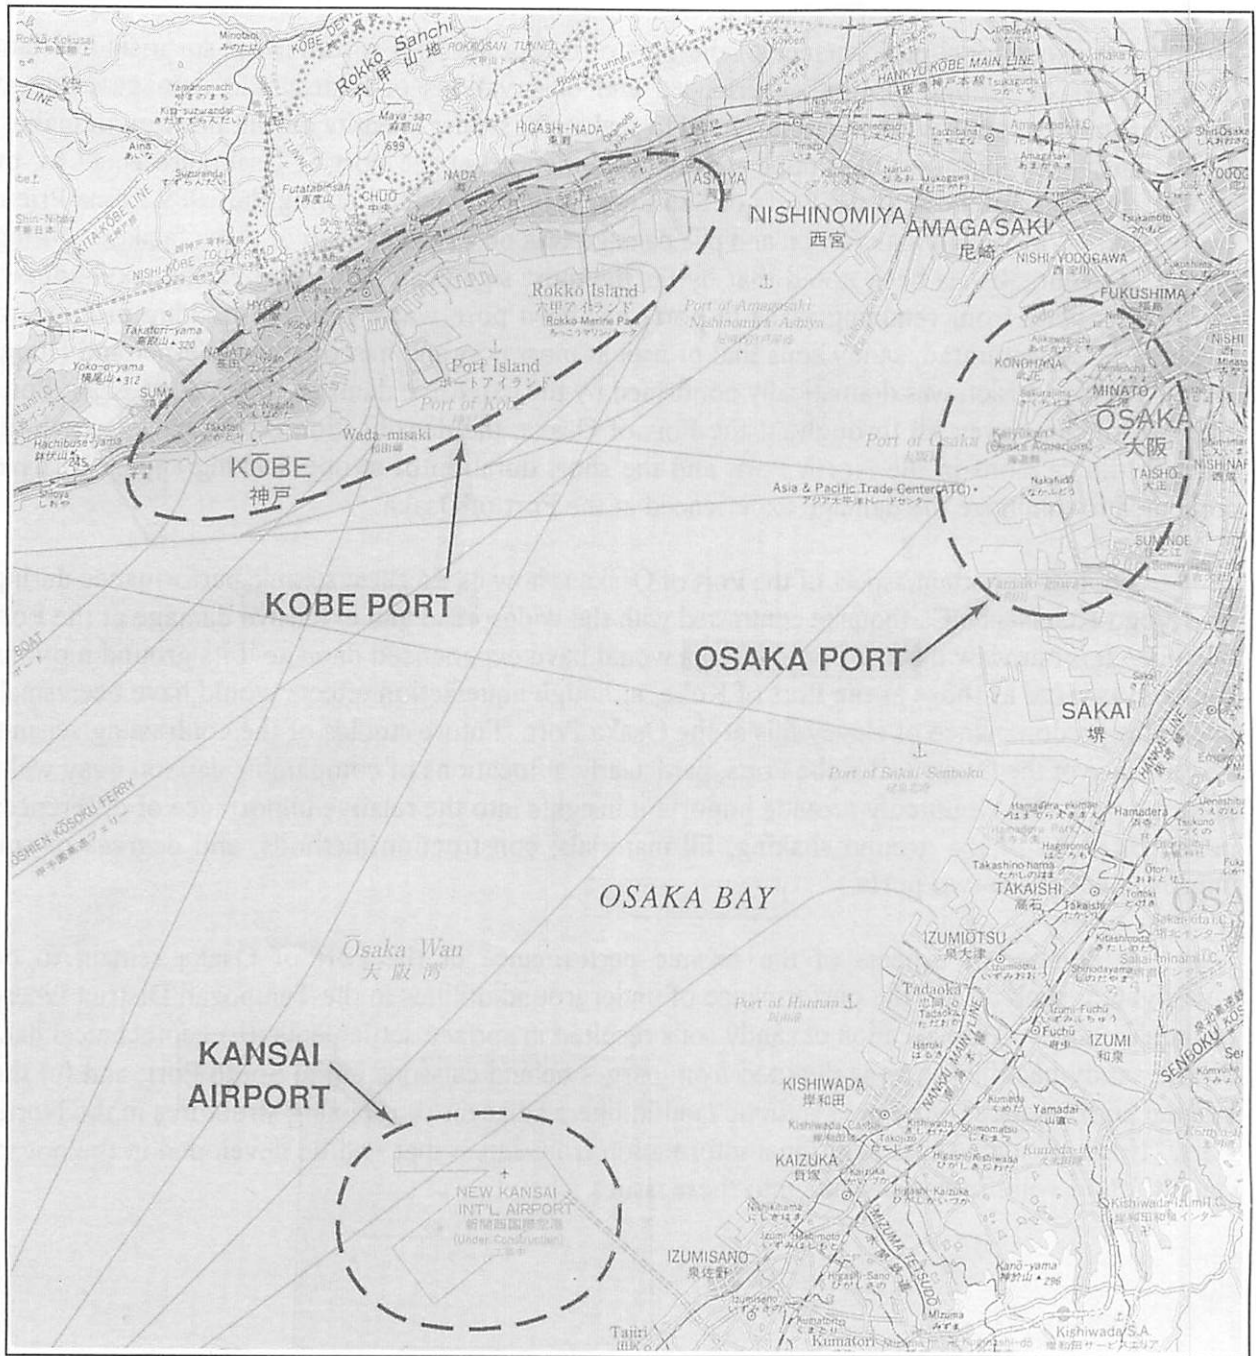
**FIGURE 4-1**  
**OSAKA BAY REGION**  
**(EERI, 1995b)**

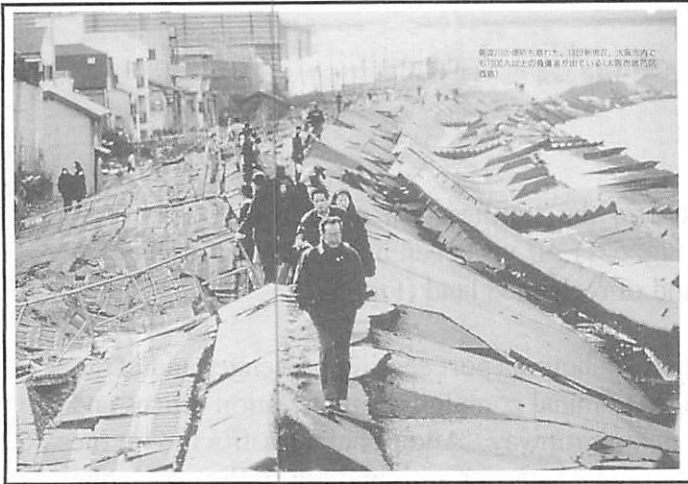
**a) Liquefaction-induced Ground Failure along Yodo River  
(Asahi Newspaper Co., 1995a)**

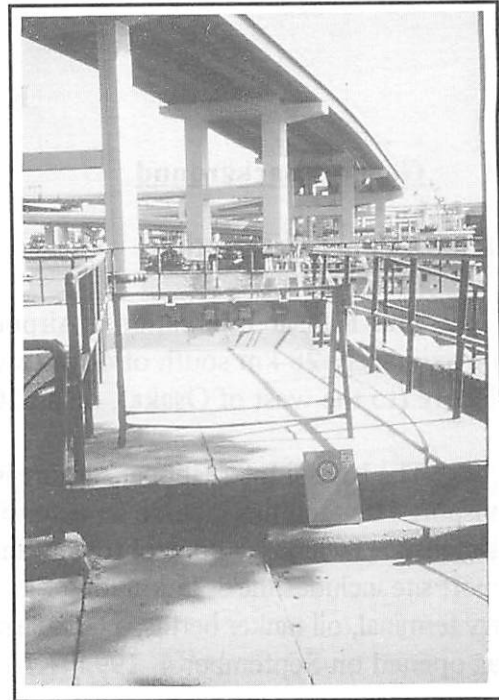
**b) Evidence of Ground Subsidence Adjacent to a Seawall**

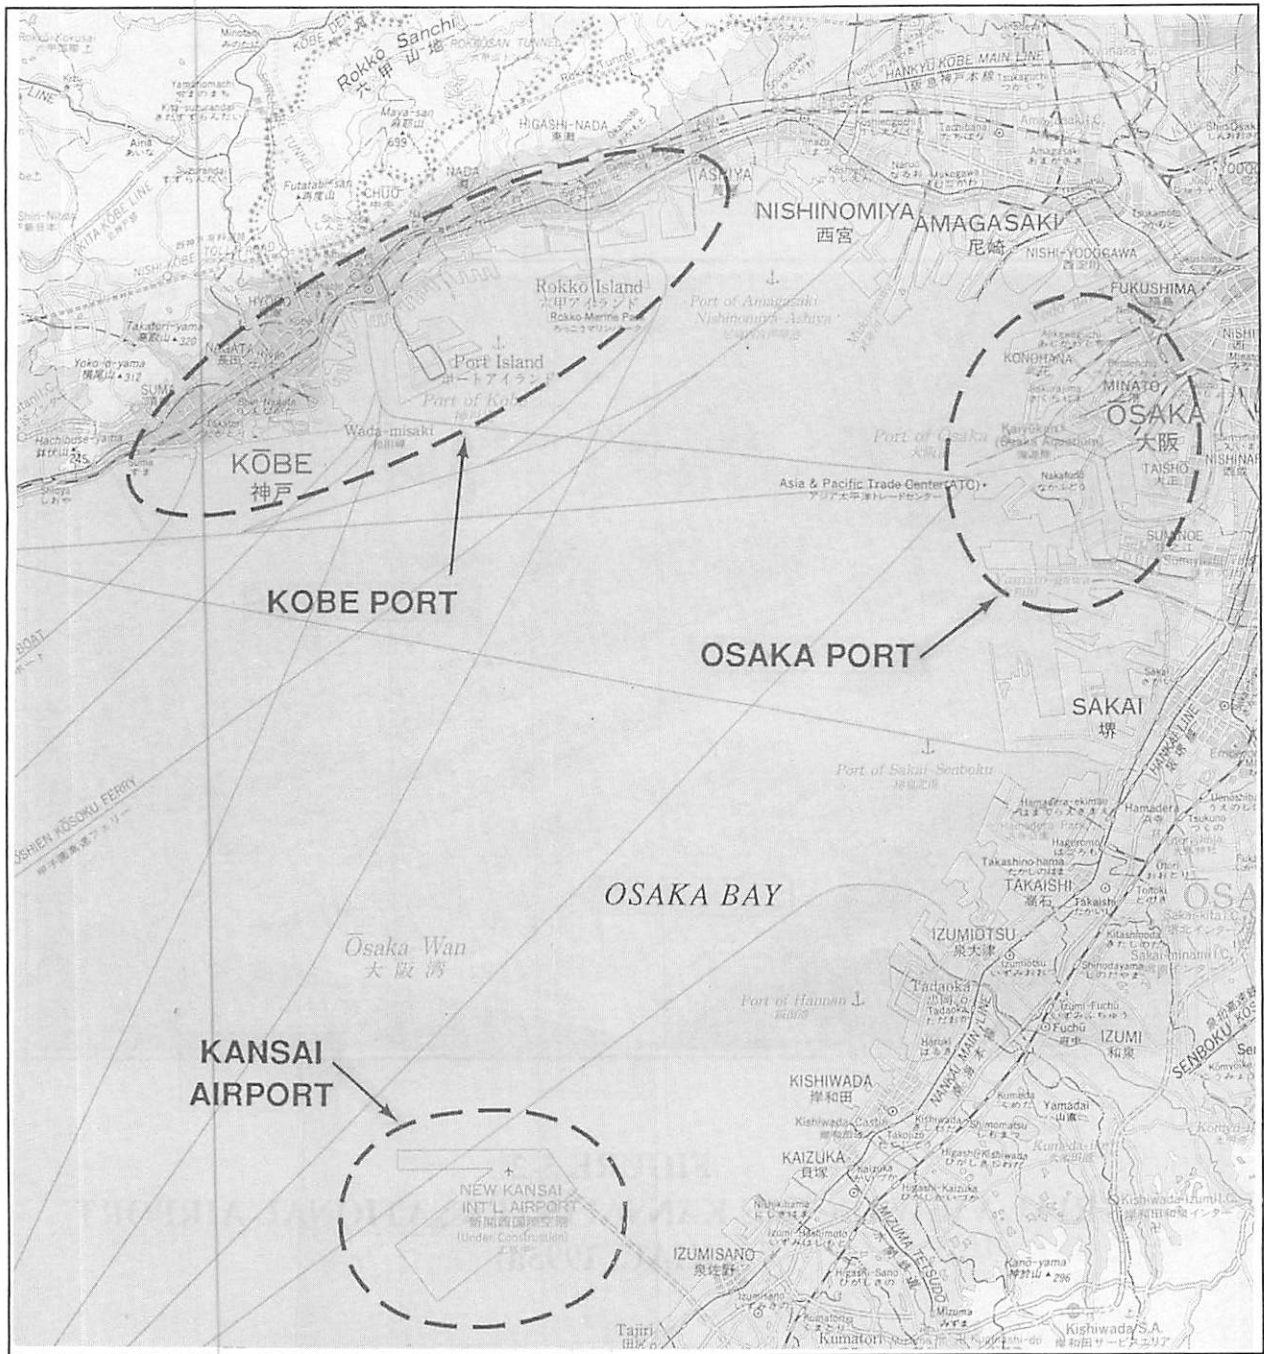
**FIGURE 5-1**  
**OSAKA BAY REGION**  
**(EERI, 1995b)**

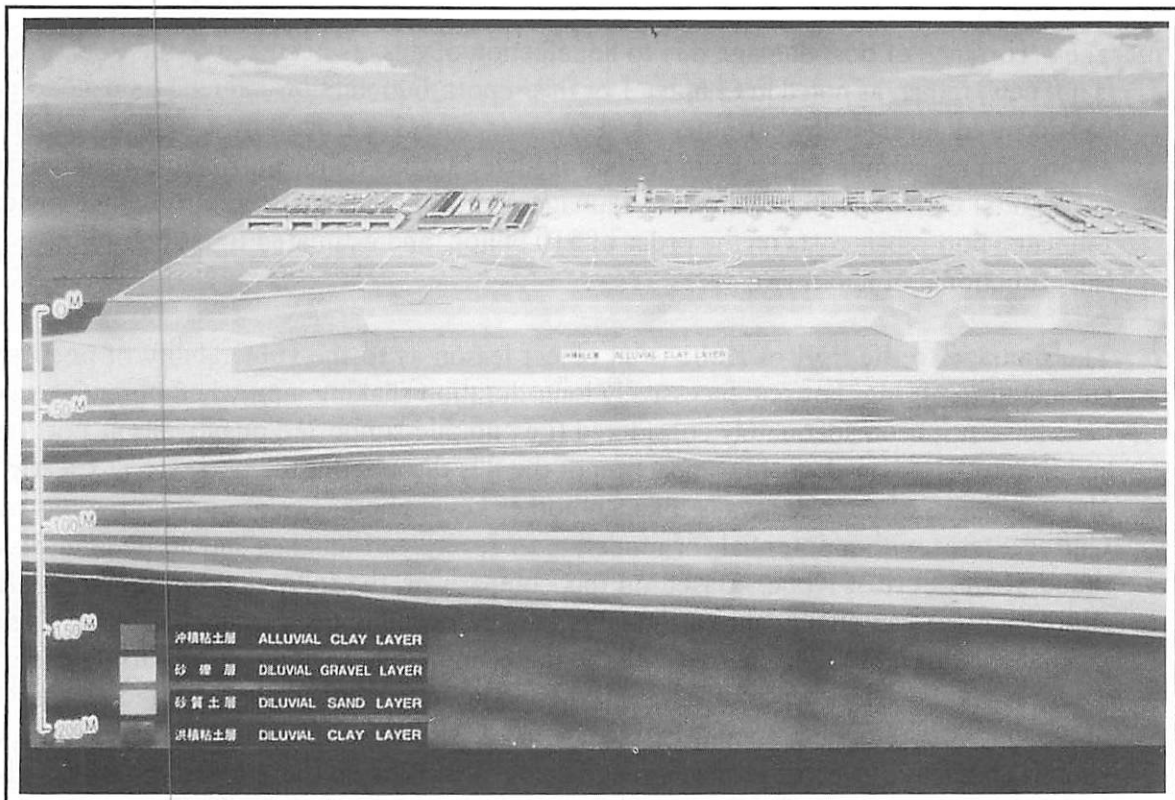
**FIGURE 5-3**  
**ILLUSTRATION OF SOIL CONDITIONS AT**  
**THE KANSAI INTERNATIONAL AIRPORT**  
**(KIAC, 1995a)**
