# Benthic Morphology and Marine Life Assessment for the Siting of Ocean Outfalls on South Tarawa

The South Tarawa Sanitation Improvement Sector Project, Tarawa Atoll, Kiribati

March 2015

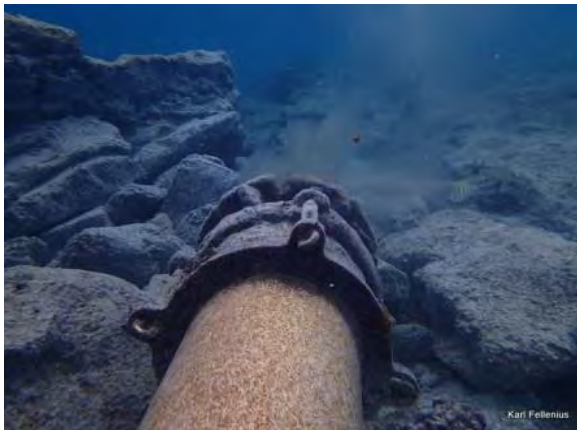
The existing end of the outfall pipe at Betio is shown in figures 4.1.72 and 4.1.73. The pipe itself appears in good condition except the portion that was attached from this point south has broken off. The broken pipe was not located on the reef flat, crest, or slope. The presence of dozens of concrete anchor blocks (CABs) strewn across the subtidal reef flat suggests that it has completely broken up into pieces and has washed away in recent years.

Fig. 4.1.72 From Betio end of existing pipe, looking South, corrected height +0.8m

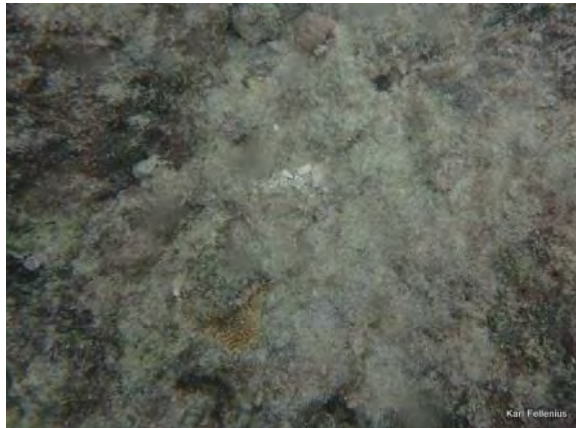
Only one palm-sized patch of encrusting coral and one cowrie were found on the intertidal reef flat in proximity to the existing and proposed outfall route (figs. 4.1.78 & 4.1.79).

Fig. 4.1.78 Betio reef flat proposed route, 15m Northeast of point 01, only coral patch found

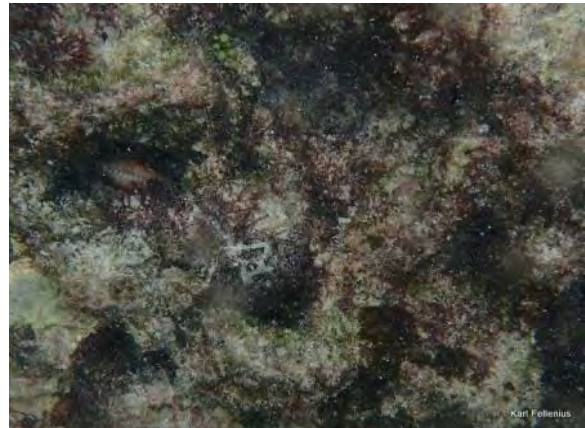
Fig. 4.1.79 Betio reef flat proposed route, 30m Northeast of point 01, only cowrie shell found

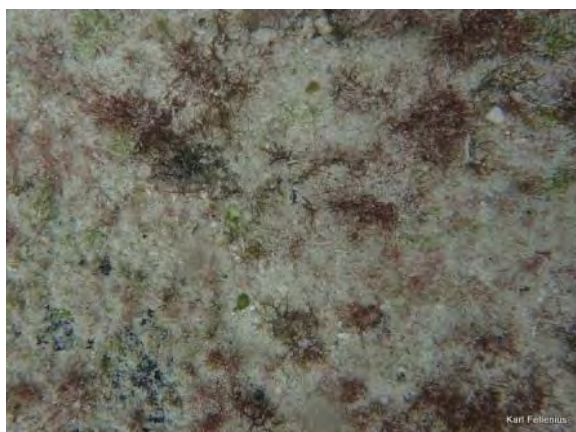
Cyanobacteria algae cover on the outermost part of the intertidal reef flat is largely present as mat-like or filamentous blue-green macroalgae (15% brownish-red patches in fig. 4.1.79) or within the fuzz of turf microalgae (30% fine reds in fig. 4.1.80). The green fleshy macroalgae sea grape (*Caulerpa* sp.) at the top of figure 4.1.79 can be associated with nutrient loading, but is generally healthy in moderation on the reef.

Fig. 4.1.80 Betio reef flat proposed route, half-way (51m) between points 27 (BETCOLD) & 01, typical algae cover

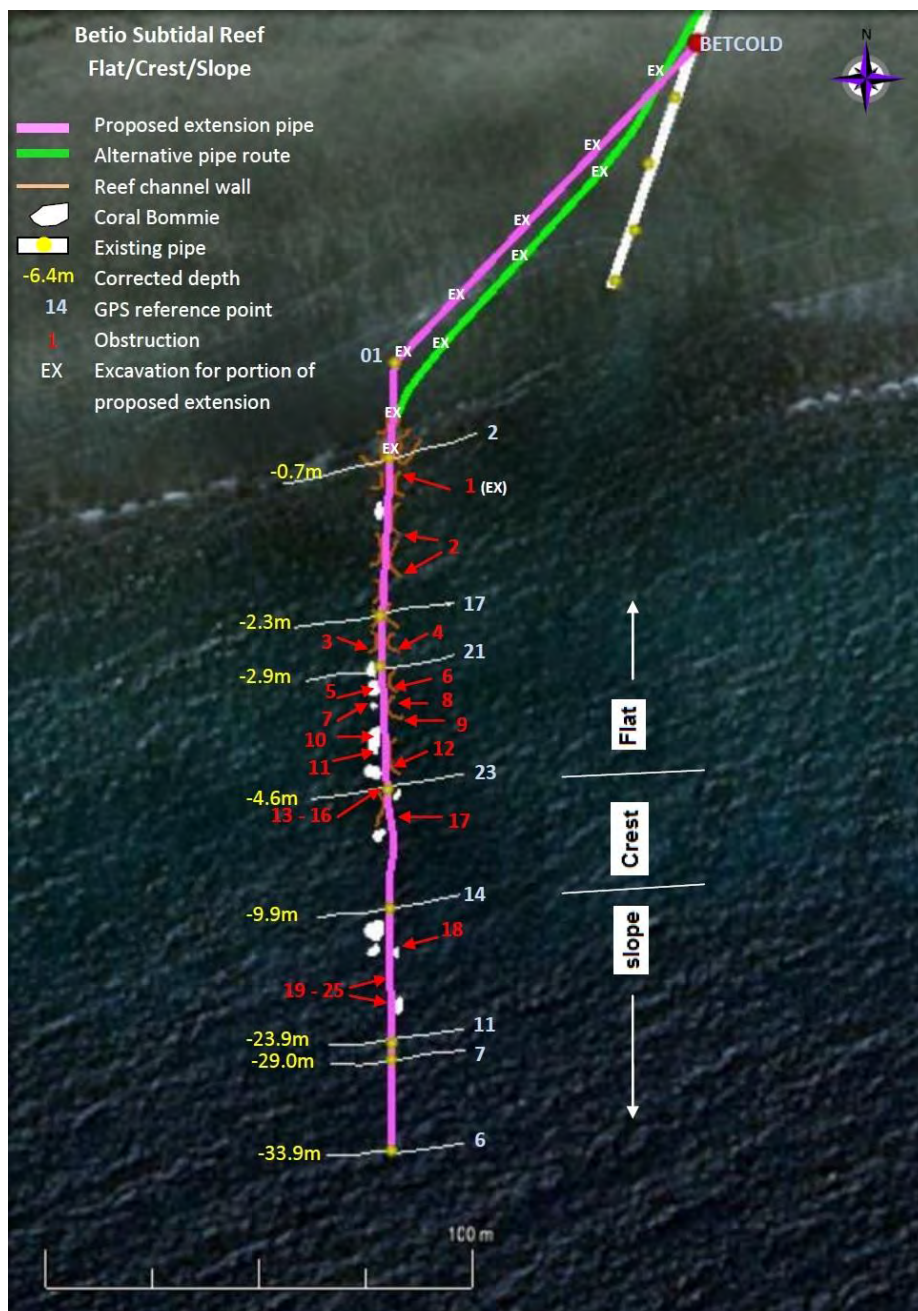
Fig. 4.1.97 Features and Obstructions along the Existing and Proposed Betio Outfall Route (digitized by SMEC)

Figure 4.1.97 shows the proposed outfall route and the various features and obstructions found along the length of the proposed extension. The trench from BETCOLD and the channel north of point 2 are not noted as obstructions as they are features that need to be excavated rather than removed from the proposed outfall pipe route.

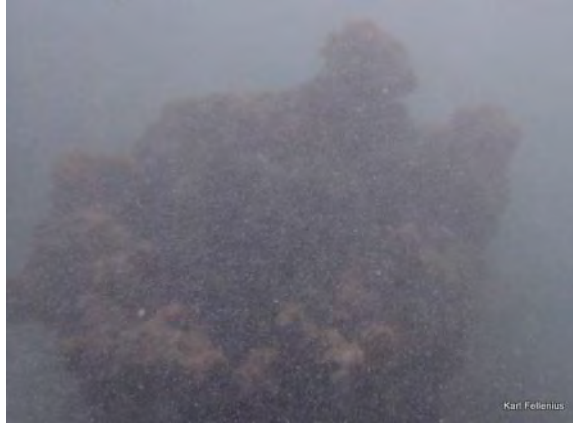
Obstruction 1: Beyond the channel 1-3m south of point 2 are two adjacent rocks obstructing the route that are each 0.75m in diameter for a total of 0.5m<sup>3</sup> that need to be removed. They are separate from the channel spur and are therefore not as solid. They are listed as an obstruction but it may be possible for the excavator to reach from the channel area. The reference is Betio video 5 at 1:27 and one rock is shown in figure 4.1.98. Each rock has about 10% cover of the same zooanthid noted for the channel. For most of the 33m route between point 2 and 17 the bottom is unobstructed and typical of figure 4.1.99. [dive team estimate 6 hrs.]

Fig. 4.1.98 Betio obstruction South of point 2, corrected depth 1.4m

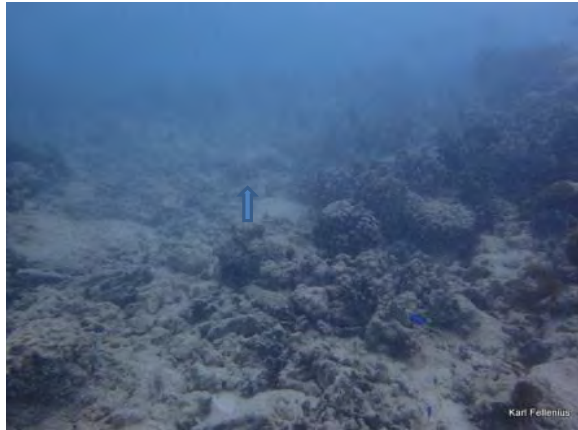
The 26m of substrate between points 23 and 14 is silt, rubble, debris, and coral at a slope of 11° (figures 4.114 and 4.115, reference at 02:32 and 02:26 respectively in Betio video 6). There is 10% coral cover across similar genus and growth forms identified closer to point 23, although colonies are in a more degraded state due to heavy siltation and about 45% cover of turf algae. There is no obstruction along this part of the outfall route, although there is significant rubble and debris present.

Fig. 4.1.114 Betio 10m South of point 23 looking South, route passes along ↑ corrected depth 6.3m

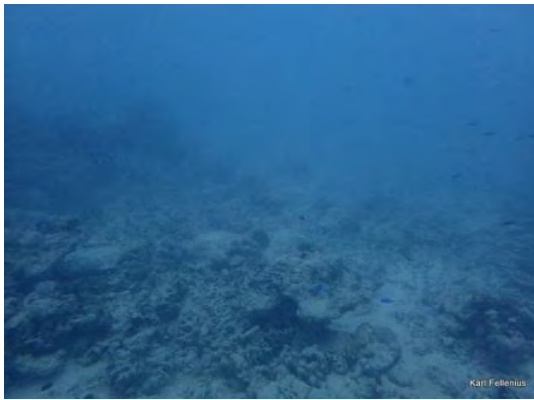
summary provided in the table. Coral cover on the outer reef crest is less than 5% to the east and about 15% to the west of point 14 (figs. 4.1.126 and 4.1.127). It is mainly *H. coerulea* with some encrusting varieties. There is less silt than was observed on the subtidal reef flat. There are slightly less turf algae at 50% cover, consistent with lower energy on the crest than on the subtidal reef flat yet with a significant nutrient load. Fleshy coralline algae are present at 15%. Crustose coralline algae are absent.

Fig. 4.1.126 From Betio point 14 looking East, corrected depth 9.9m

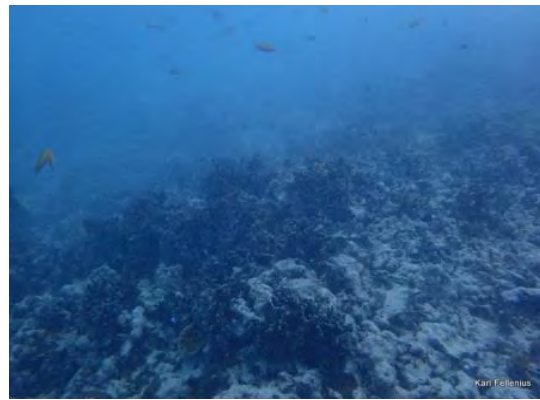
Fig. 4.1.127 From Betio point 14 looking West, corrected depth 9.9m

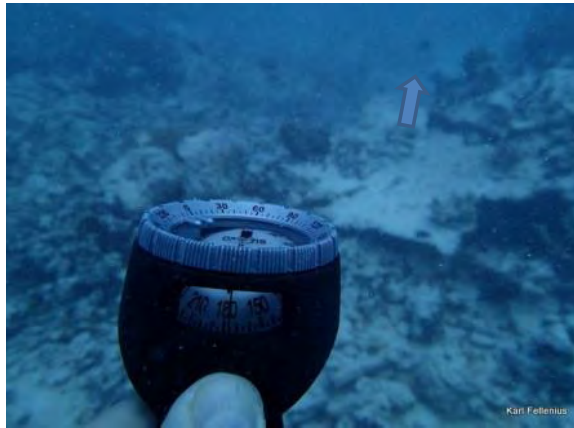
**Obstruction 18:** There is a collapsed dead table coral structure 1.5m wide and 2.5m long that is loose and needs to be removed from the outfall route (figure 4.1.129). There is some minor adjacent debris as well. The route is relatively clear for about 6m beyond that point as shown in figure 4.1.130. The reference is from 0:35 to 0:42 in Betio video 7. The corresponding reference is from 1:58 to 2:05 in Betio video 8. Note however that there are issues with both video segments. Video 7 stays right after heading south from point 14 from 0:20 to 0:35, when it should have stayed left. Video 7 (descending) at 0:35 is to the right of the arrow in figure 4.1.129, and video 8 (ascending) is to the left of the coral bommie noted in figure 4.1.130. [dive team estimate 1 hr. at 14m depth]

Fig. 4.1.129 Betio 7m South of point 14 looking South, route passes along ↑ corrected depth 12.7m

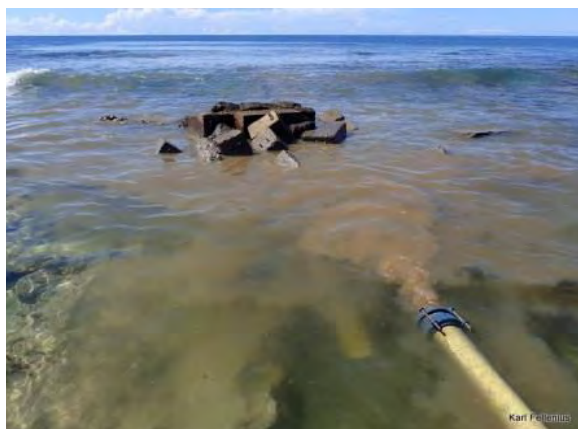
The end of existing pipe during active pumping is shown in figures 4.2.32 and 4.2.33. The pipe itself appears in good condition except the portion that was attached from this point south has broken off. There is a significant pile of CABs immediately south of the end of existing pipe, and these are discussed along with excavations and obstructions in section 4.2.3.

Fig. 4.2.32 Bairiki reef flat at point 25, end of existing pipe, looking South

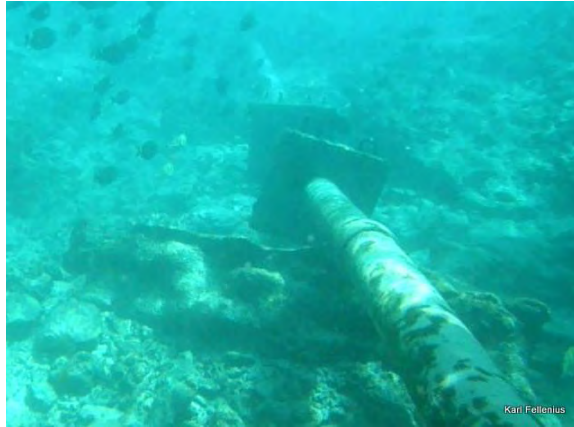
Obstruction 2: One rock 3m long, 1m wide, and 0.5m high obstructs the route 9m south of point 18 (video capture fig. 4.2.45 and reference at 3:34 in video). It is solid reef foundation and at best can be shaved down as needed as it would be very difficult to remove. A trench 0.5m wide is sufficient for the pipe, but this means that the position of adjacent CABs may need to be adjusted. [dive team estimate 1.5hrs.]

Fig. 4.2.45 Bairiki 9m south of point 18, looking South, corrected depth 0.9m

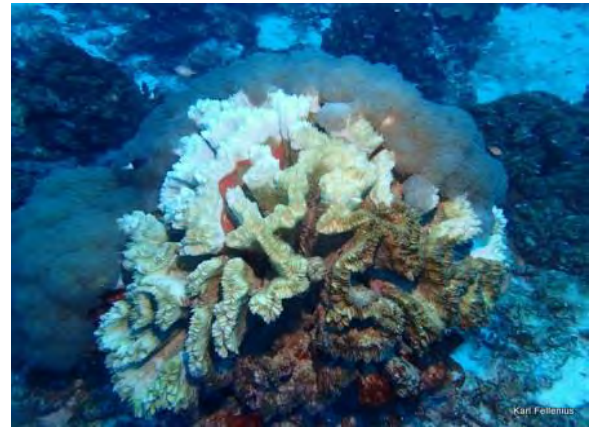
Fig. 4.2.100 From Bairiki 15m South of point 21, recent COTs feeding scar, corrected depth 16.5m

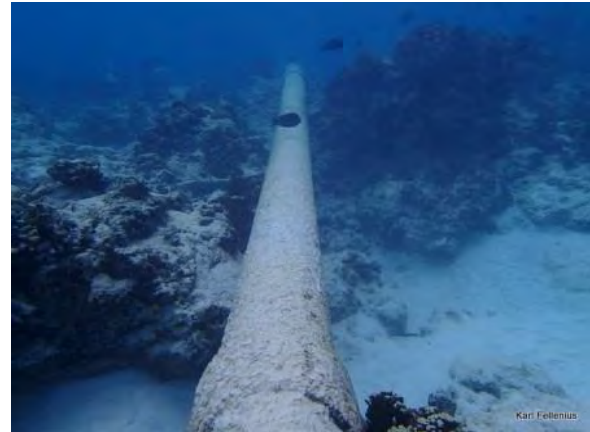
Fig. 4.3.47 From Bikenibeu 25m North of point 14, looking South, route along broken pipe, corrected depth 1.3m
