U. S. DEPARTMENT OF COMMERCE . NATIONAL OCEANIC AND ATMOSPHERIC ADMINISTRATION

# NATIONAL OCEAN SURVEY NATIONAL DATA BUOY CENTER

## EXAMINATION OF SEA LANES MOORING E AFTER TWO YEARS ON STATION

NATIONAL DATA BUOY CENTER JULY 1972 MISSISSIPPI TEST FACILITY BAY ST. LOUIS, MISS. 39520

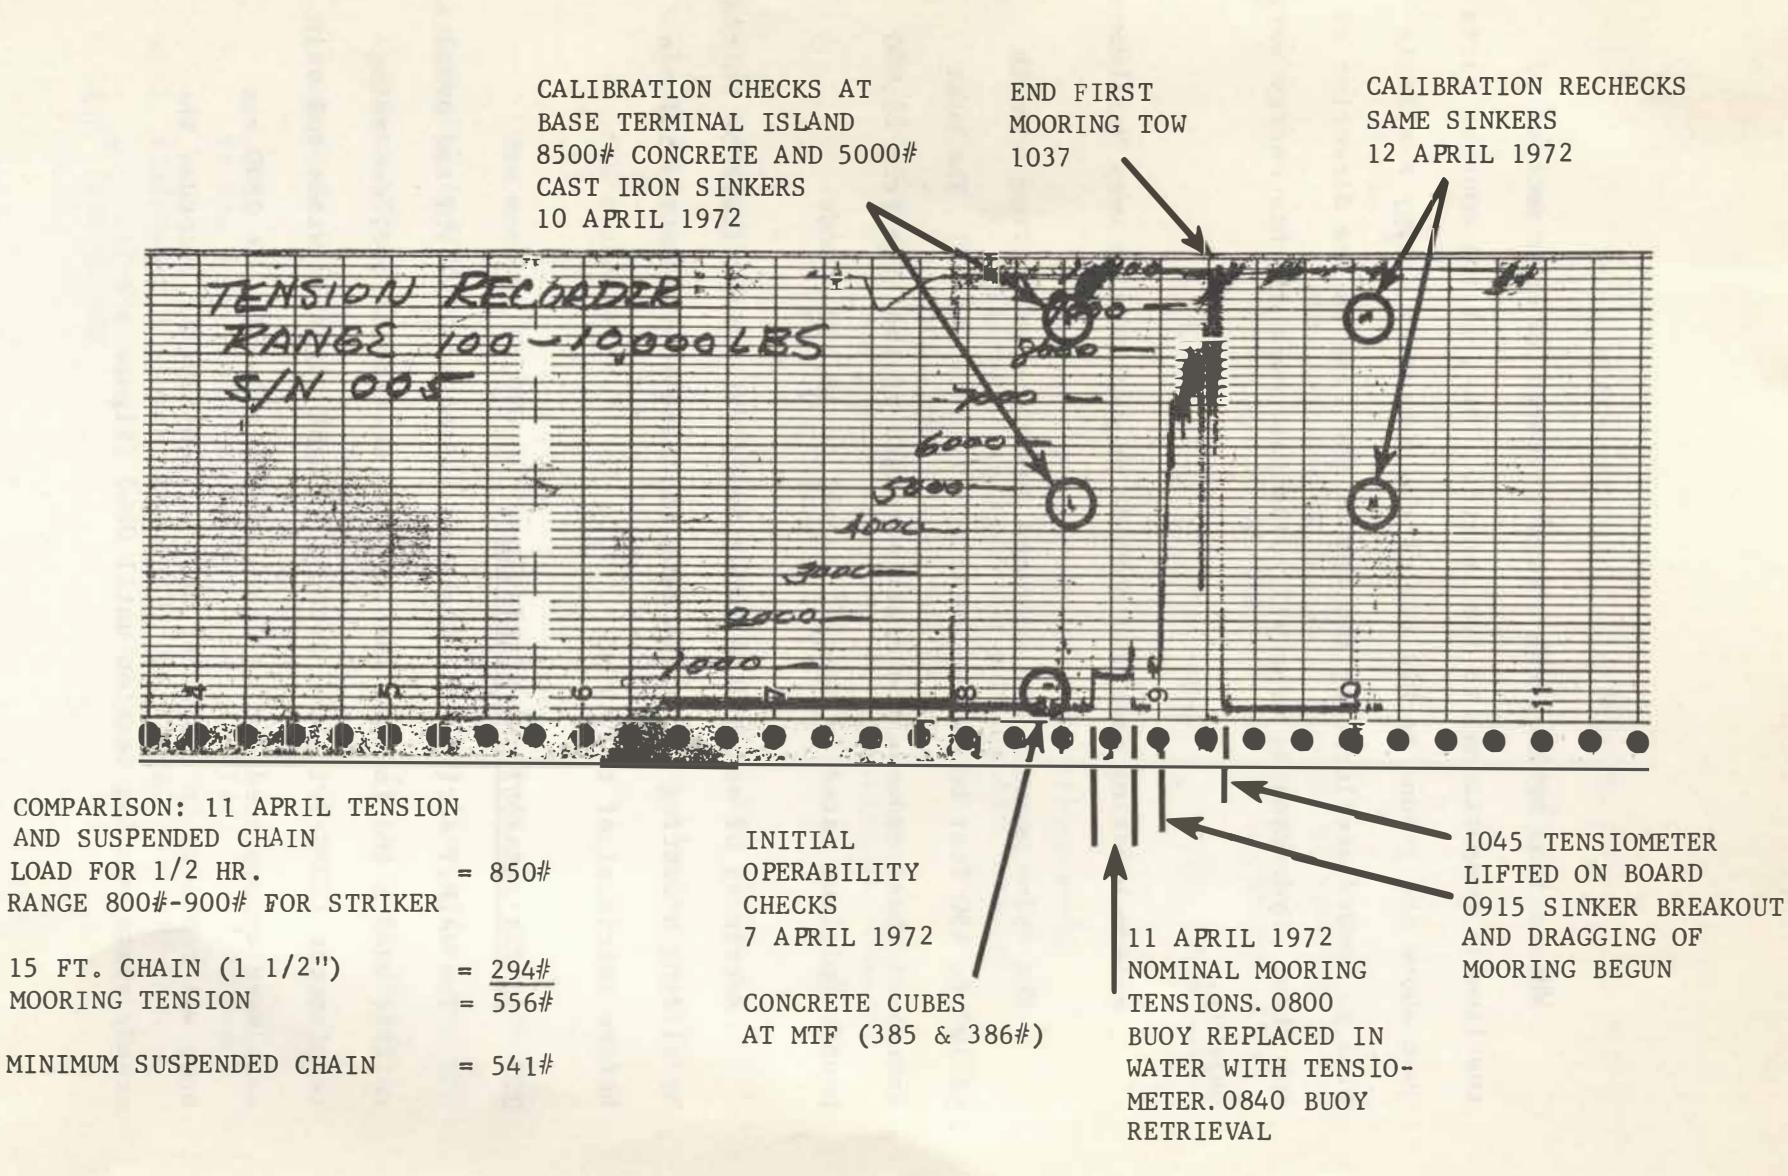
FIGURE 3.2-1 TENSION TRACES FROM BUOY E RETRIEVAL

The WALNUT arrived San Clemente Island at 0710 PDT and prepared to lift buoy E and install the in-line, self-contained, recording tensiometer (NDBC-Swift Co. S/NO05). Light variable winds and calm seas were encountered during the entire retrieval. At 0800 the buoy was replaced in the water and the tensiometer recorded the steady state mooring tension until 0840 (Figure 3.2-1).

Sinker breakout began at 0915 by backing on the mooring with the top 15 feet of chain in the ship's chain stopper. The WALNUT dragged the mooring and sinker toward shore until 1035. The tensiometer was then lifted aboard and retrieval of the first part of the mooring (Figure 4.1-2) began at 1115 using the hydraulic winch installed on the ship. This converted oceanographic winch consisted of a Vickers hydraulic motor on a Wheeler Manufacturing Company gear box. The towing and winching operations continued until the bottom chain and sinker were on board at 1655 PDT.

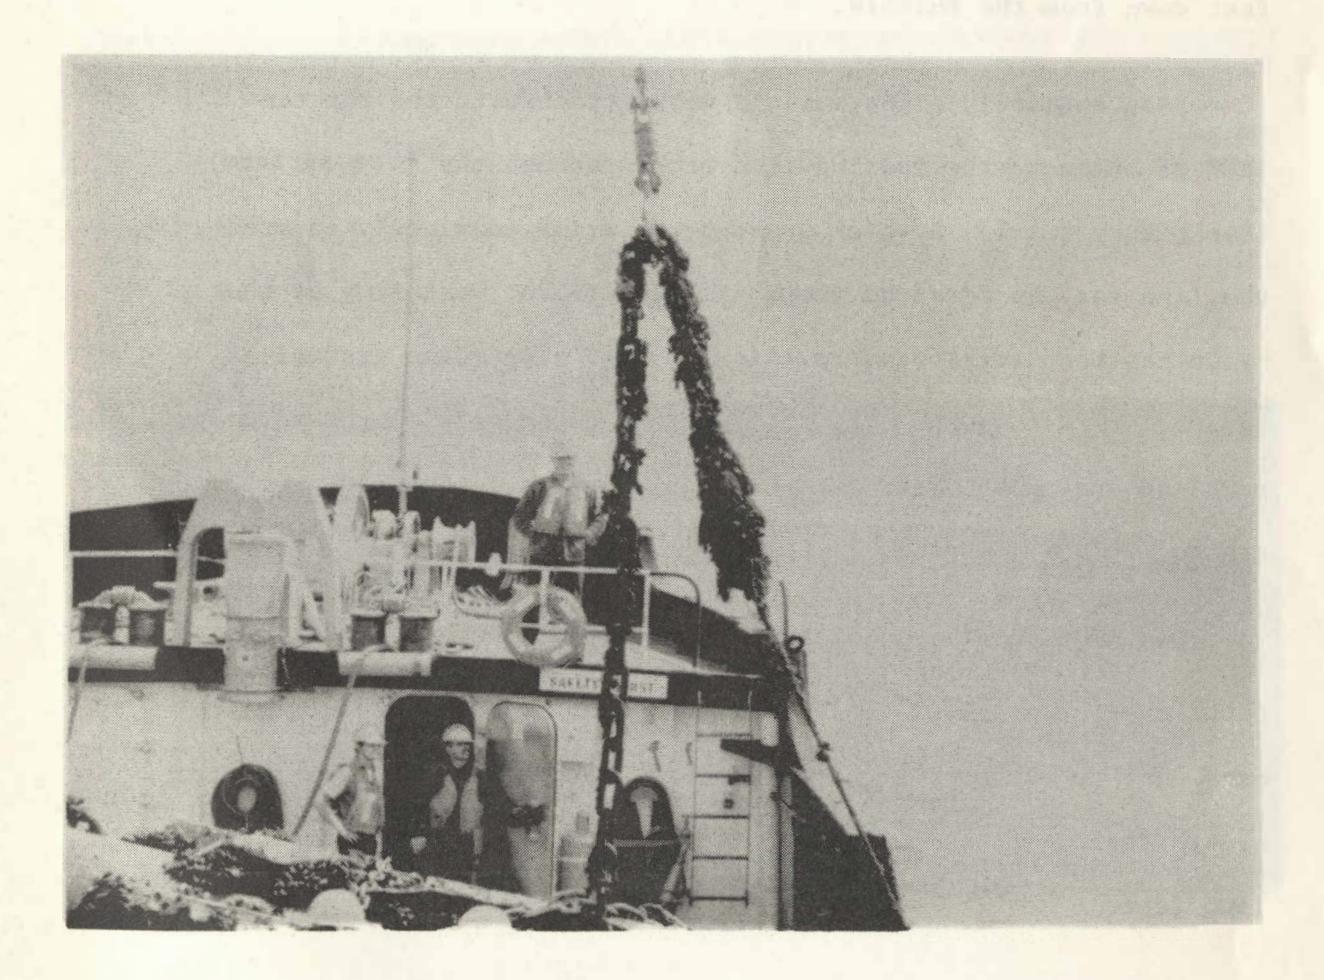
FIGURE 4.1-2 Two years of marine fouling on chain, shackle and captive thimble at top of the nylon line. for a protective covering around the nylon and captive thimble. A dipped or painted on coating of urethane 1/8 to 1/4 inch thick would eliminate these hazards. This coating should extend ten feet down from the thimble.

Approximately eight mussels were attached to the top ten feet of nylon as the mooring line broke through the sea surface (See Figure 4.1-2). A thick green-brown slime completely covered the line for the first 60 feet. No significant weakening of the nylon has been attributed to this fouling. The slime gradually became less with depth. At the 200 foot depth only slight coverage remained and at 350 feet (end of light penetration zone) the fouling ceased.

The swivel and shackle at the top of the mooring were covered with marine organisms and some red rust. Black corrosion deposits and red rust were found on the top captive bronze thimble. The bottom thimble had red rust, green copper corrosion and no fouling. None of these items had significant damage or wear.

- 2. Possible damage from the heavy barnacle and mussel growth at the top thimble and first few feet of nylon line may be protected against through the use of a coating of urethane.
