Pennsylvania  
Coastal Zone  
Management Program

SHORELINE EROSION  
AND FLOODING

ERIE COUNTY

THE GREAT LAKES RESEARCH INSTITUTE

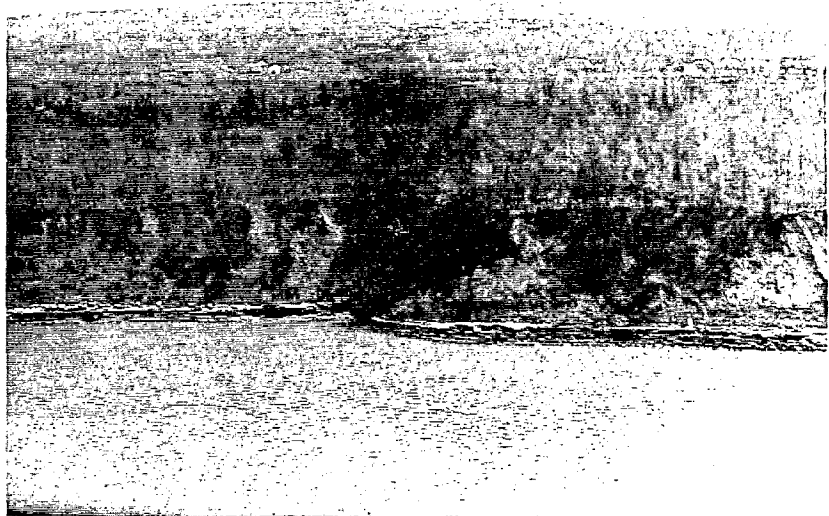
Above: Typical hummocky appearance produced by landslide activity

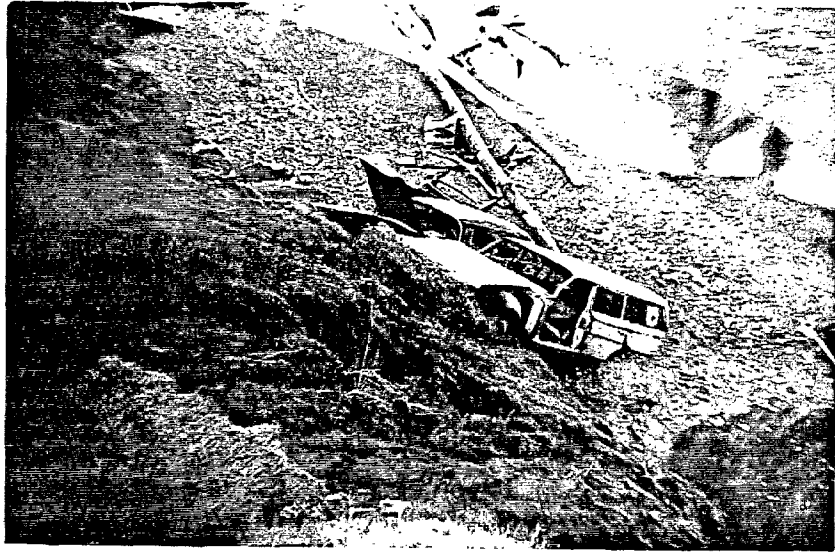
Above: Junked cars at base of bluff, Elk Creek; an attempt to retard slope failure

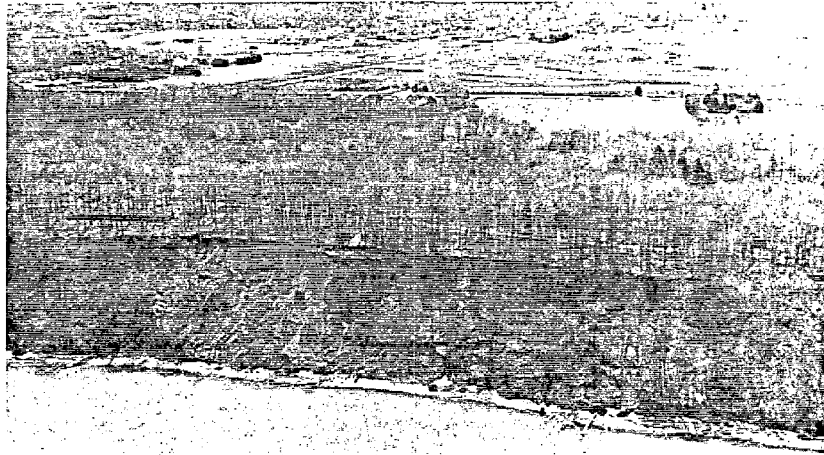
Above: Vegetation as an indication of movement - slump  
block in center with trees upright

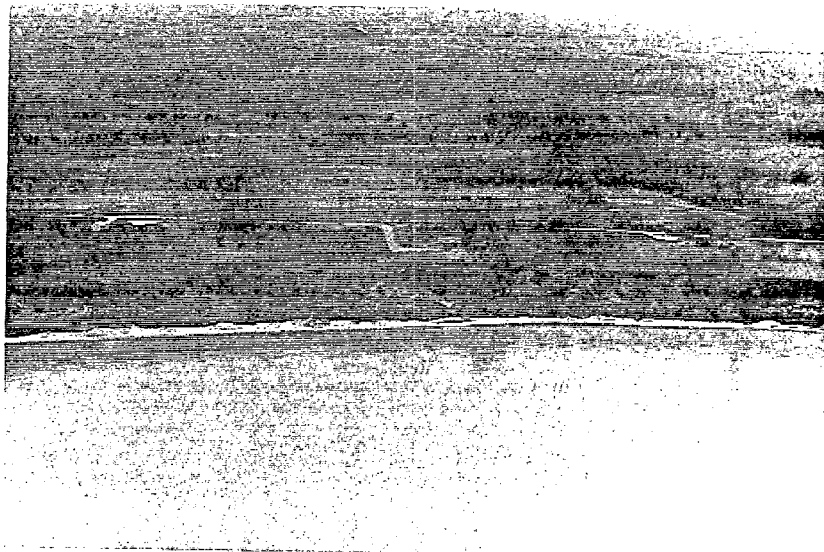
Above: Area of rapid recession: land cover beyond bluff  
is a contributory cause of recession

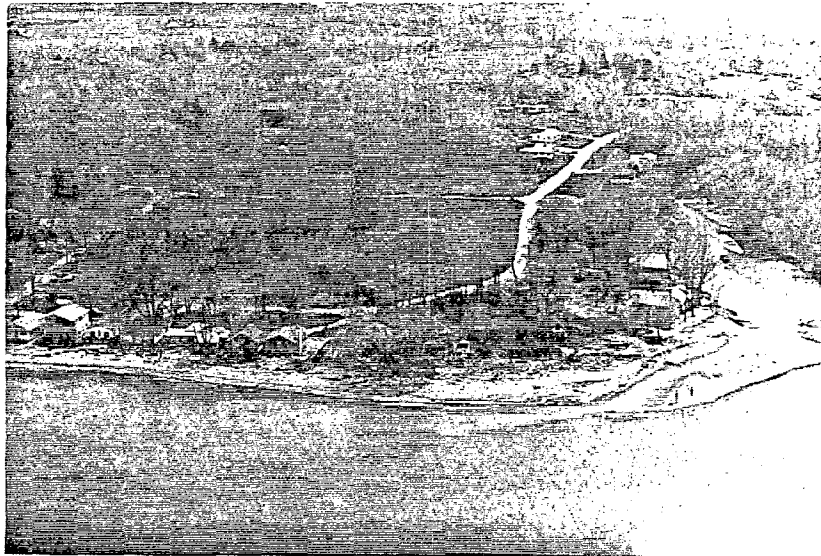
Above: Sunset Beach, Sixteen Mile Creek, North East Township; showing flood potential behind bay mouth bar

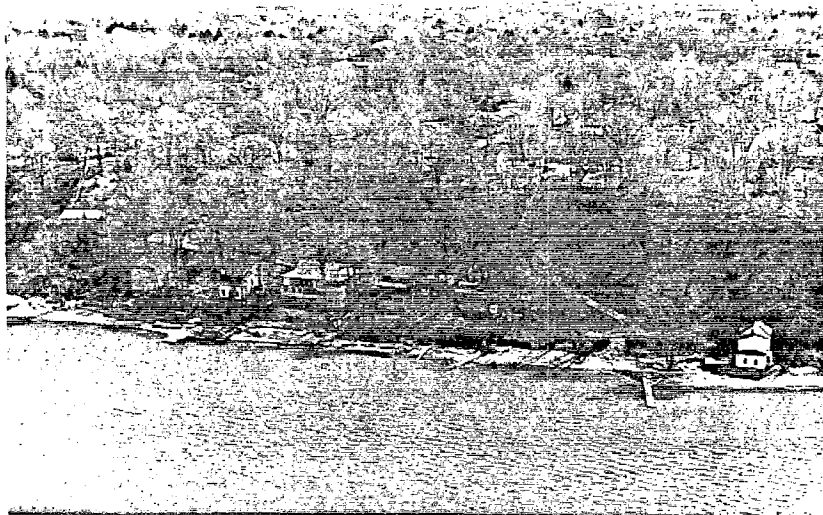
destroyed as a result of storm. The cottages remain-  
ing have suffered varying degrees of damage from  
slight to extensive. There has been significant beach  
erosion. Makeshift breakwalls and groins have also  
been subject to storm damage. The Kelso Beach cottages  
have been relatively free from damage because of  
extensive beaches built by a groin. The Beachcomber  
cottages are somewhat protected by a beach ridge stabi-  
lized by a now-buried breakwall and the beginnings of  
the Presque Isle beach system. However, this area is  
subject to flooding during storms.

Above: Hartt Estates, Montpelier Avenue, Millcreek Township;  
showing cottages at base of bluff
