Nantucket Shoreline Survey

An Analysis of
Nantucket Shoreline Erosion
and Accretion Trends
Since 1846

MIT Sea Grant College Report
MITSG 79-7

August, 1979

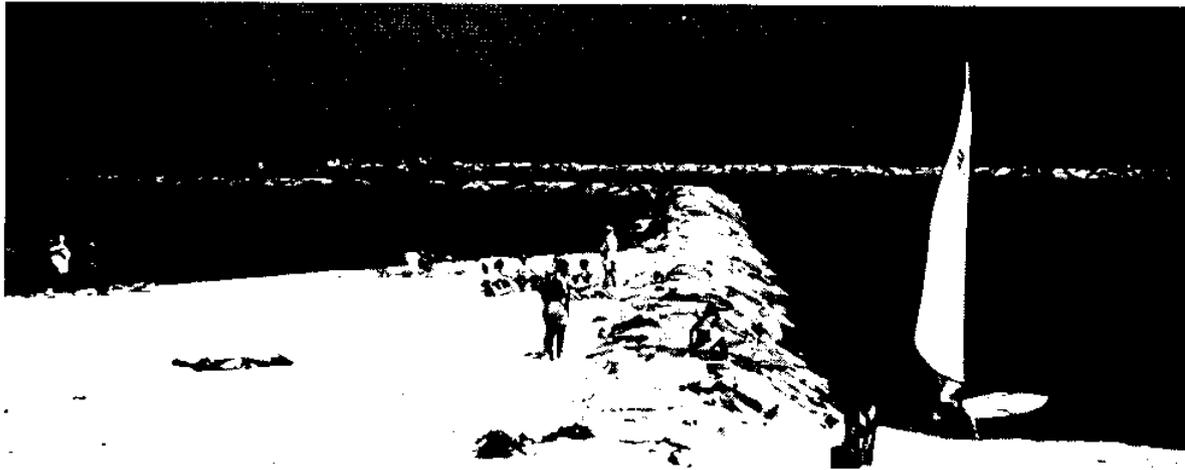
Figure 10. Photograph showing the effect of a groin on a beach.
Net littoral drift is from the left to right.

Littoral drift is extremely important in the balance and equilibrium of the shoreline. Sand transported parallel to the beach partially renourishes downdrift beaches which have been eroded by storm waves. Without this partial renourishment, erosion of the shoreline is accelerated. Obstructions, such as groins that are poorly placed (figure 10) can interfere with the littoral drift and consequently

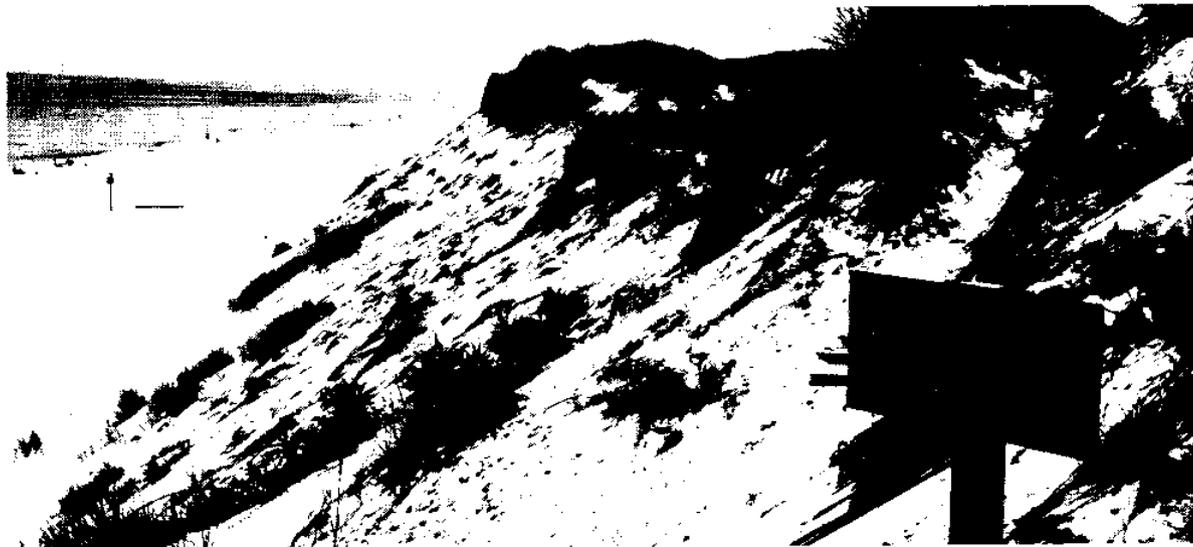
This study used three different methods to document dune and bluff erosion such as that shown in this photograph.

Perhaps the simplest method for documenting shoreline trends is to periodically measure the distance between a reference marker and the shoreline. Approximately 20 sites on Nantucket, representing critical areas of erosion or management concern, were selected for field measurements. At each site a reference marker -- concrete post, telephone post, house corner -- was selected and a profile perpendicular to the shoreline was run using standard surveying techniques (transit and tape method). For a number of years, measurements will be taken at most sites at the end of each winter and summer; though a few locations will be observed more frequently. Each year the newly compiled data will be made available as an appendix to this report.

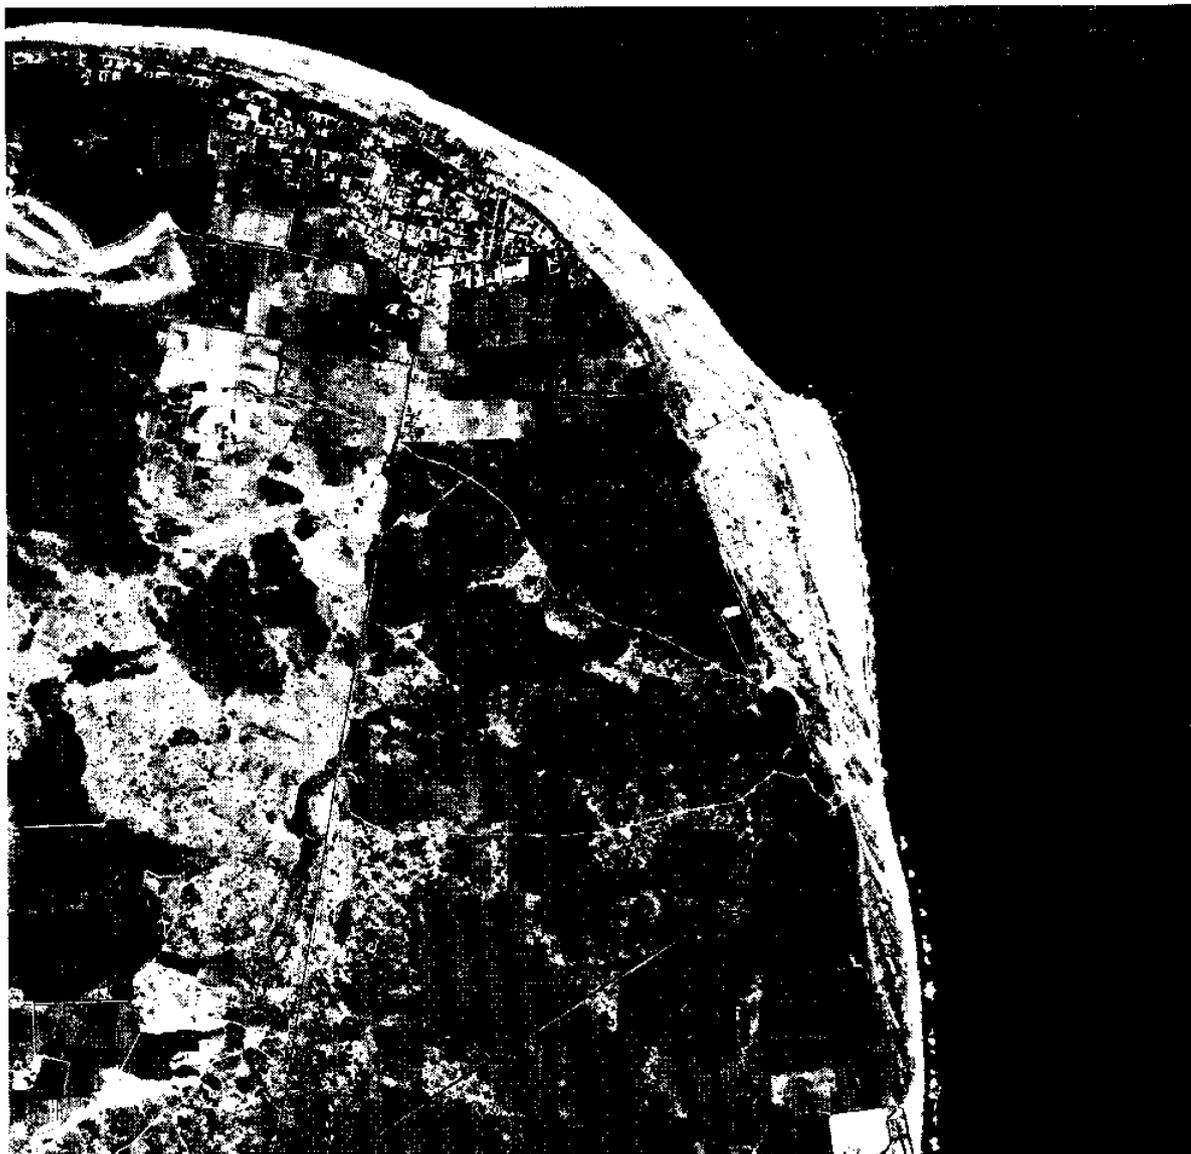
Figure 11. Example of one vertical aerial photograph (April, 1961) used in this study to measure shoreline changes. This particular photograph covers the area around Siasconset.

Vertical aerial photographs (figure 11) taken from specially equipped aircraft can be used to make shoreline comparisons, if pictures of the same locations are taken over a period of time. Although considerably less accurate than field measurements, aerial photographs are valuable for studying long stretches of shoreline. On Nantucket, photographs have been taken at intervals of 13 years or less since 1938, and the second of the three parts of this shoreline study makes use of this information. At the University of Rhode Island, Mike Goetz, under the supervision of Dr. John Fisher, conducted an historical photogrammetric survey of the patterns and rates of shoreline change on the island from 1938 to 1970 for his Master's thesis.

The aerial photographs used in this study were of differing scales ranging from 1:20,000 to 1:40,000. An instrument known as a Zoom Transfer Scope was used to produce a precise scale match from this different imagery. The base map was derived from the largest scale photographs. Cliffs, dunes and high tide lines shown in other aerial photographs were traced on overlays and compared with the base map. The shoreline of Nantucket was then divided into 1,000 foot segments (figure 12). Changes in the shoreline were measured along each segment

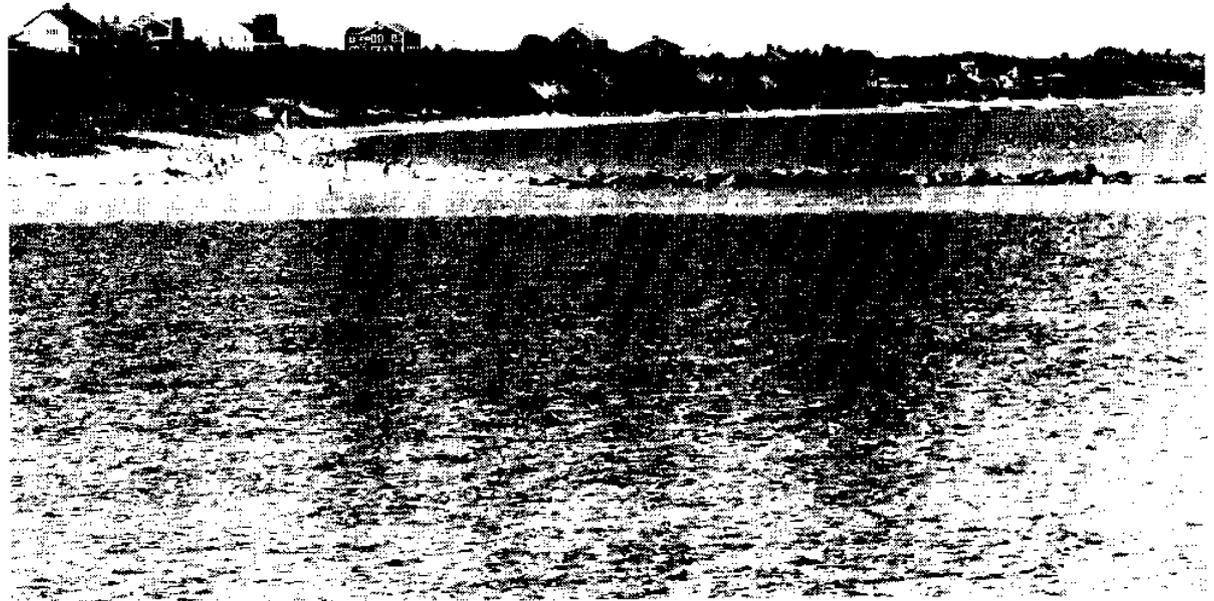
Photograph of the West Jetty and Jetties Beach.

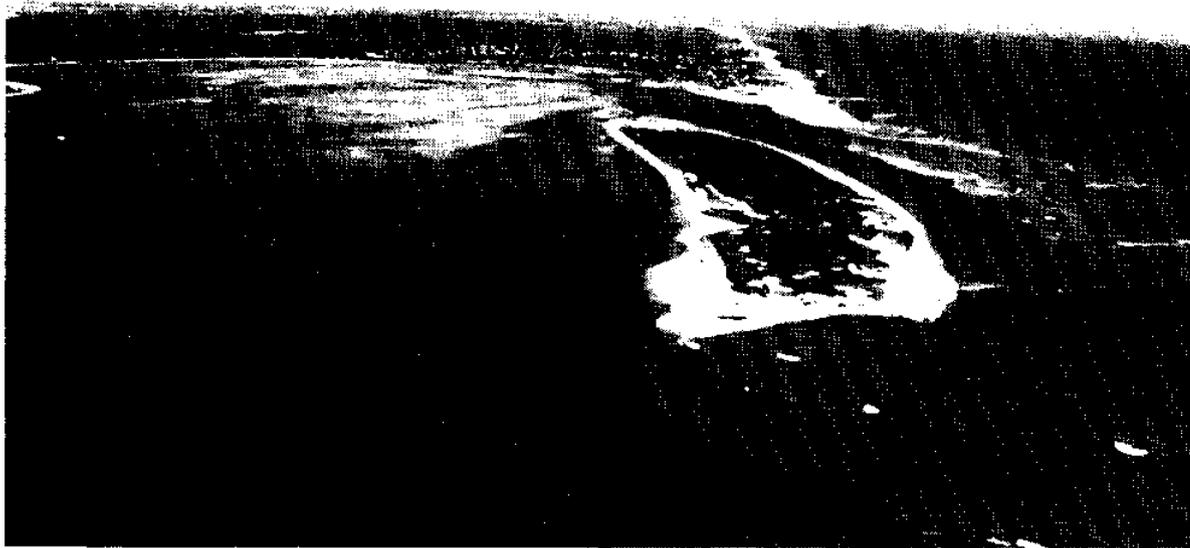
Photograph looking southeast over Smith Point and South Shore.

Prior to the breaching of the shoreline west of Madaket in December of 1962, Esther Island and Nantucket formed one continuous stretch of shoreline. At present however, the breached area is submerged by 15-18 feet of water. Between 1846 and 1887 erosion averaged about 19 feet/year, and though this rate appears to have slowed to about 11 feet/year during the 1900's, this area is still unstable and unsuitable for development. Besides exhibiting high rates of erosion on its southern flank, Esther Island changed dramatically between 1887 and 1955 through a westward accretion of 1100 feet at Smith Point. This indicates a net westerly direction of littoral drift along the south shore.

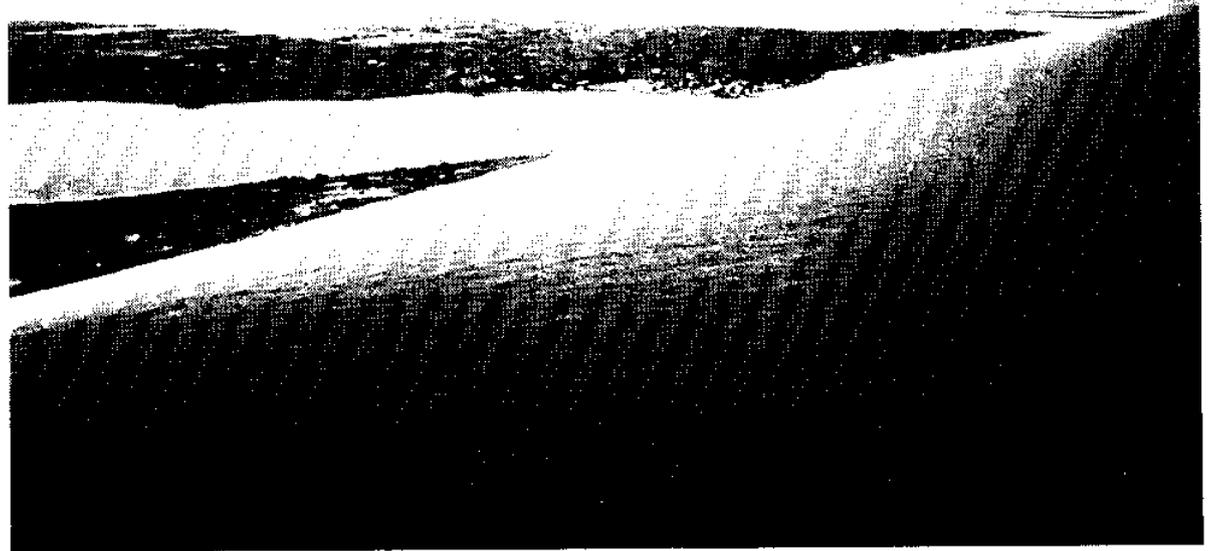
Photograph looking north from Sankaty Head to Great Point.

This section of the Nantucket shoreline faces directly into the northeast and the reader might assume the section would be eroding rapidly. This assumption would be reasonable considering that the most severe storm conditions in New England occur during a "noreaster" when winds and waves come from the northeast. Surprisingly however, much of this section of shoreline has been relatively stable with the exception of the area near Great Point. Between 1846 and 1887, erosion was less than 1 foot/year and between 1887 and 1955, the rate was less than 2 feet/year. It should be noted that these rates cannot be considered statistically significant since they are less than the level of accuracy of the charts themselves. Between 1938 and 1951, erosion ranged from near 0 to about 3 feet/year, but between 1951-1961, the vast majority of the beach, over 24,000 feet, remained unchanged. Between 1961-1970, erosion rates were generally less than 3 feet/year and averaged about half this rate.

The only exception to this general trend of very low erosion rates has been the area in the immediate vicinity of Great Point. From Great Point south about 4,000 feet, erosion rates have ranged between 4-20 feet/year since 1938. Some of this material eroding from the dunes and glacial cliffs at Great Point was transported around the spit and deposited to the west causing accretion of the shoreline and formation of sandbars parallel to Coatue Beach. Although most of the littoral drift moves to the north along the eastern shore, a portion of the sand eroding from Great Point was probably also transported to the south and contributed to the fairly stable shoreline in this area.
