# The Tucson, Arizona, Flood of October 1983

Committee on Natural Disasters  
Commission on Engineering and Technical Systems  
National Research Council

Thomas F. Saarinen (Team Leader), Department of Geography, University of  
Arizona, Tucson

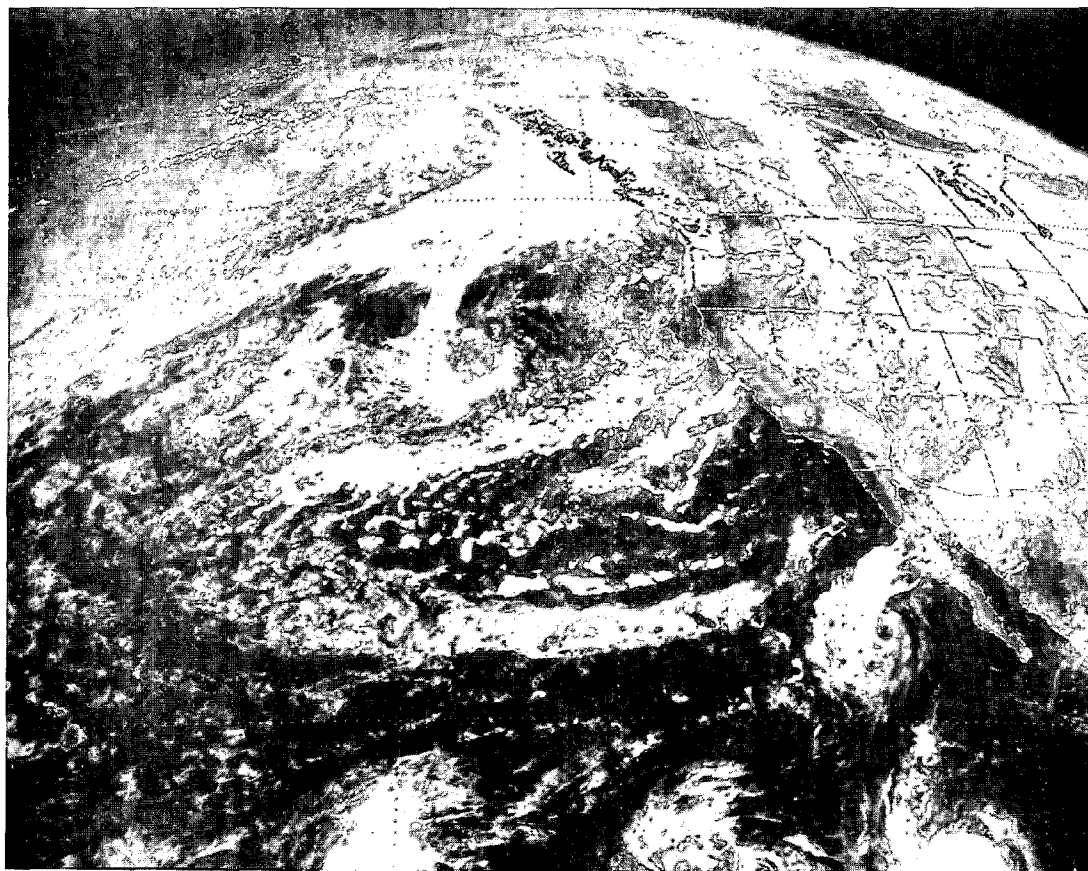
FIGURE 1 Moisture from tropical storm Octave, located off the west coast of Baja California, may be observed in the band of clouds extending across northwest Mexico, Arizona, and New Mexico. This photograph was taken at 6:15 p.m. GMT on October 2, 1983.

By Friday afternoon there were clues appearing that more heavy precipitation was due. Moisture, in the form of clouds, could be seen streaming northward from tropical storm Octave (Figure 1), and meteorologists at the Phoenix NWS Office marked the location of several embedded, precipitation-enhancing short waves rotating around the major upper-level trough (Figure 2). As a consequence, the hydrologists with the Joint Federal-State Flood Warning Office issued a statement:

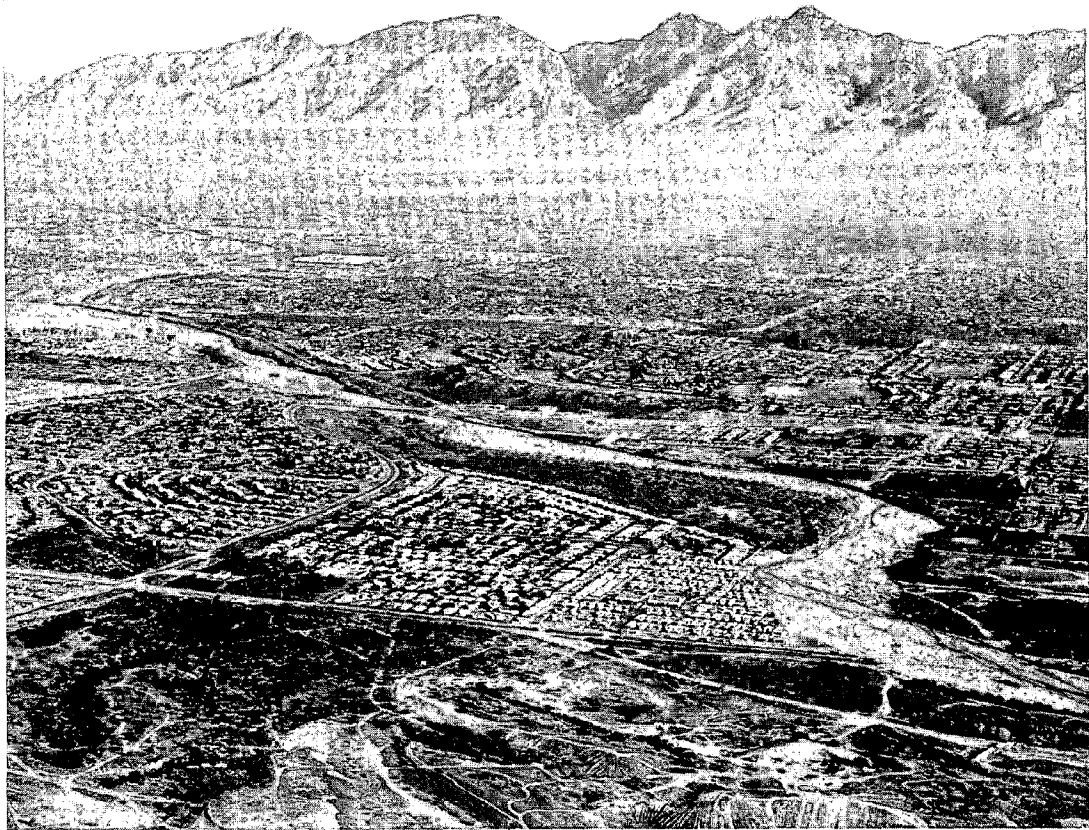
FIGURE 10 Aerial view of the eastern Tucson Basin on October 9, 1983, showing Pantano Wash in the foreground and the Santa Catalina Mountains on the skyline. Flood damage to the Rincon Country mobile home development (bottom center) is shown in Figures 26 and 38. Photograph by Peter Kresan.

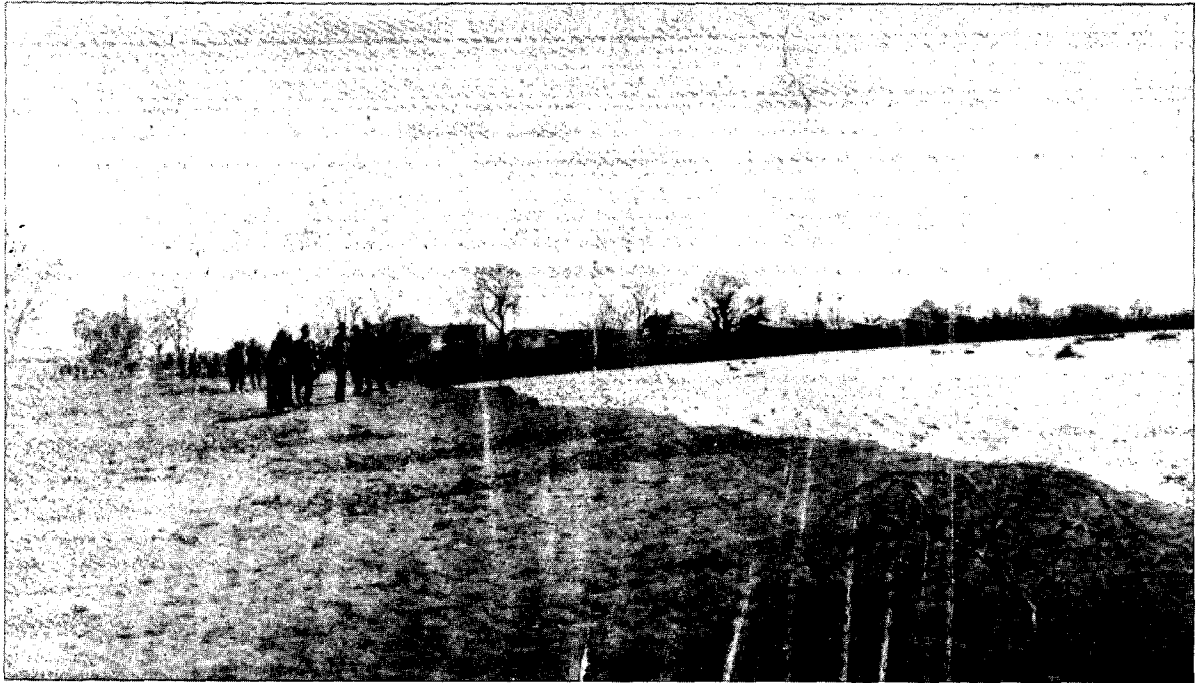
FIGURE 12 Erosion damage to the east abutment of the Congress Street bridge on February 1, 1915. The view is upstream (south), and Sentinel Peak ("A" Mountain) is visible at right. The gap of 60 m from the bridge to the east bank (left in picture) resulted from the downstream migration of a meander bend on that bank. This meander bend was visible in a 1902 photograph (Betancourt and Turner, in press). Source: Arizona Historical Society, Tucson.

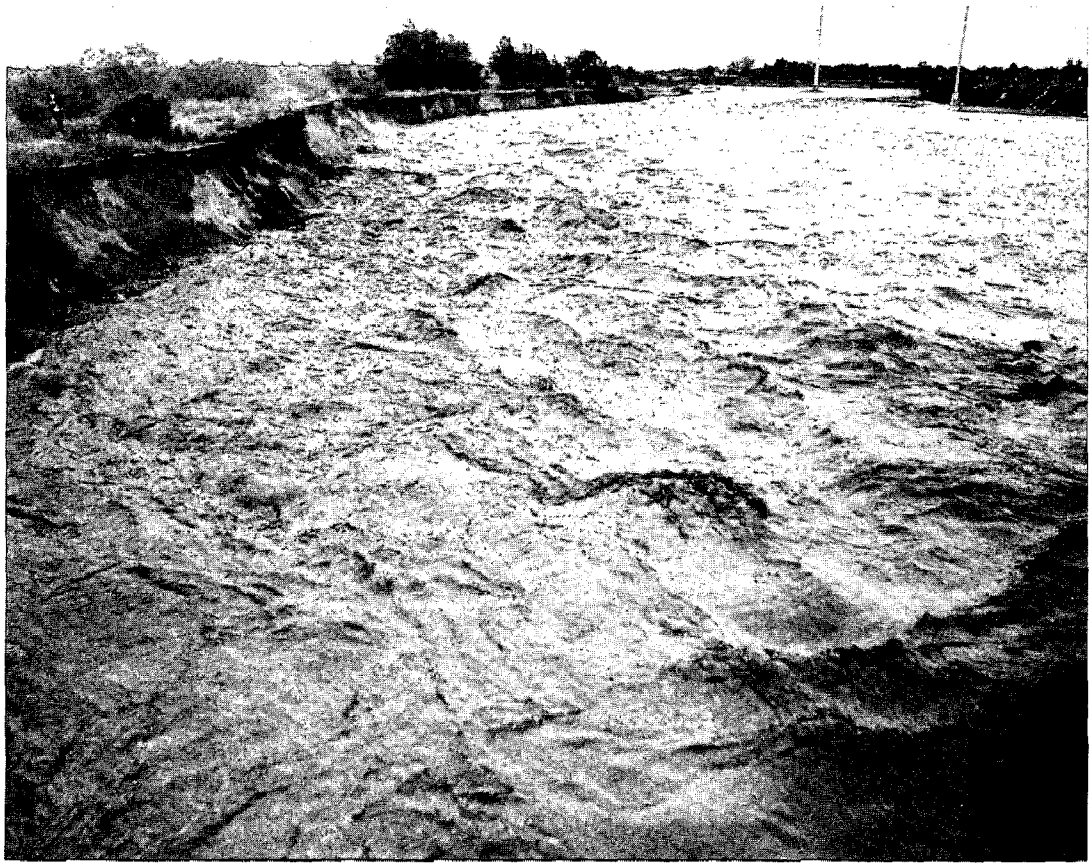
FIGURE 13 View upstream (east) from the Campbell Avenue bridge on October 1, 1983, showing erosion of the north (left) bank by meander flow. Note the dark thread of high-velocity water following the meander thalweg from the next bend upstream. Also note the utility lines in the stream channel. Photograph by Peter Kresan.

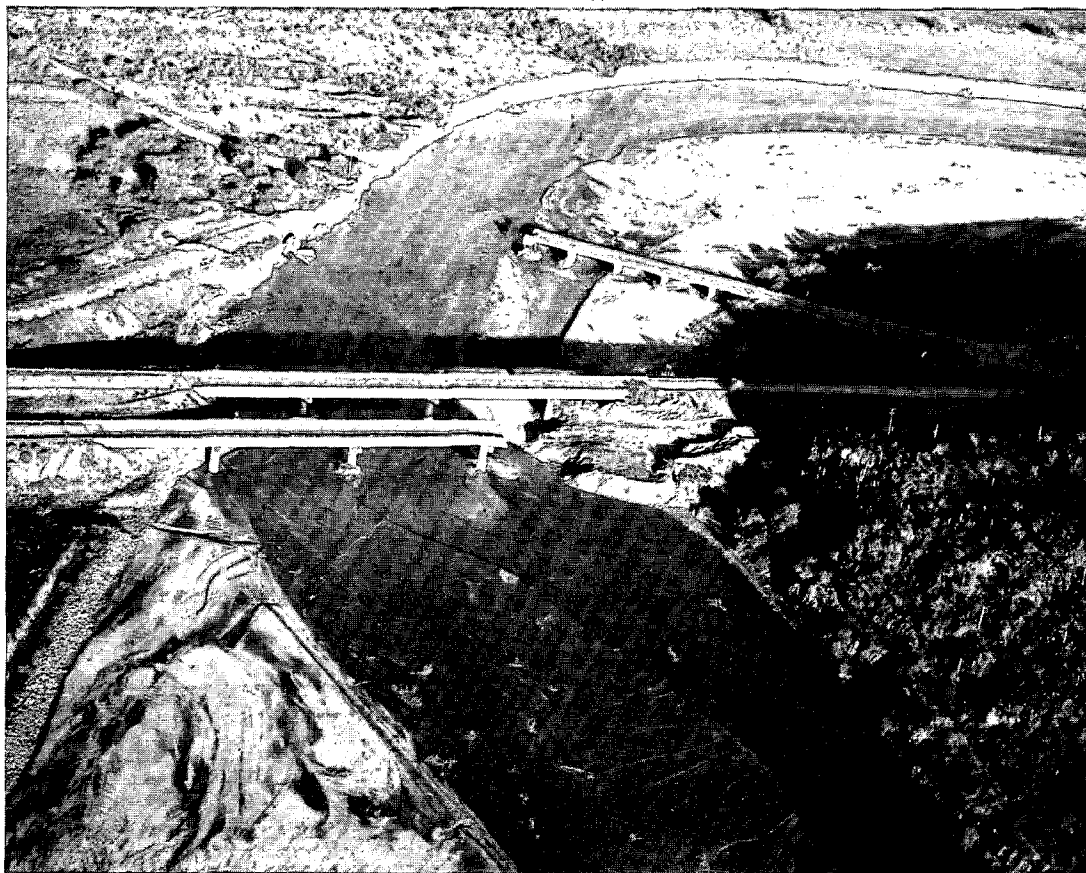
FIGURE 17 The Santa Cruz River at Martinez Hill (lower right) on October 9, 1983. Damage to the north abutment of the north-bound lane bridge of Interstate 19 is visible at center. As the flow meandered to the west bank, it eroded the west abutment of the San Xavier Road bridge (top center). Bank erosion extended through the former intersection of San Xavier Road and the access road to Interstate 19 at left center. Note the blocks of collapsed bank material on this bank. Riprap placed along this bank failed to prevent meander migration in the 1983 flood. Photograph by Peter Kresan.

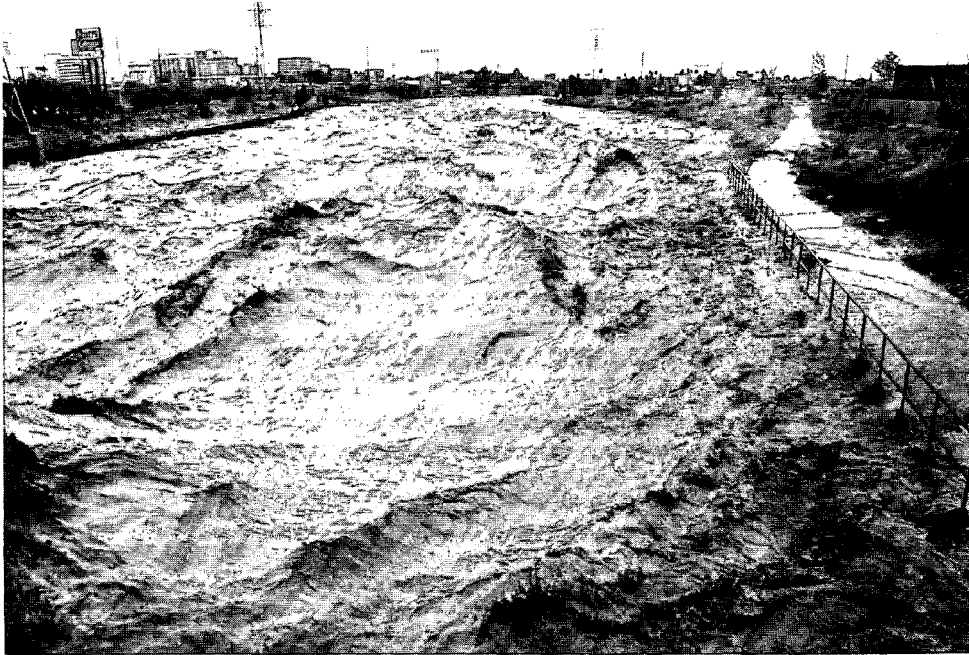
FIGURE 19A View of Santa Cruz River upstream (south) from St. Mary's Road bridge on October 2, 1983. Note confinement of flow within artificial banks composed of soil cement. Photograph by Peter Kresan.

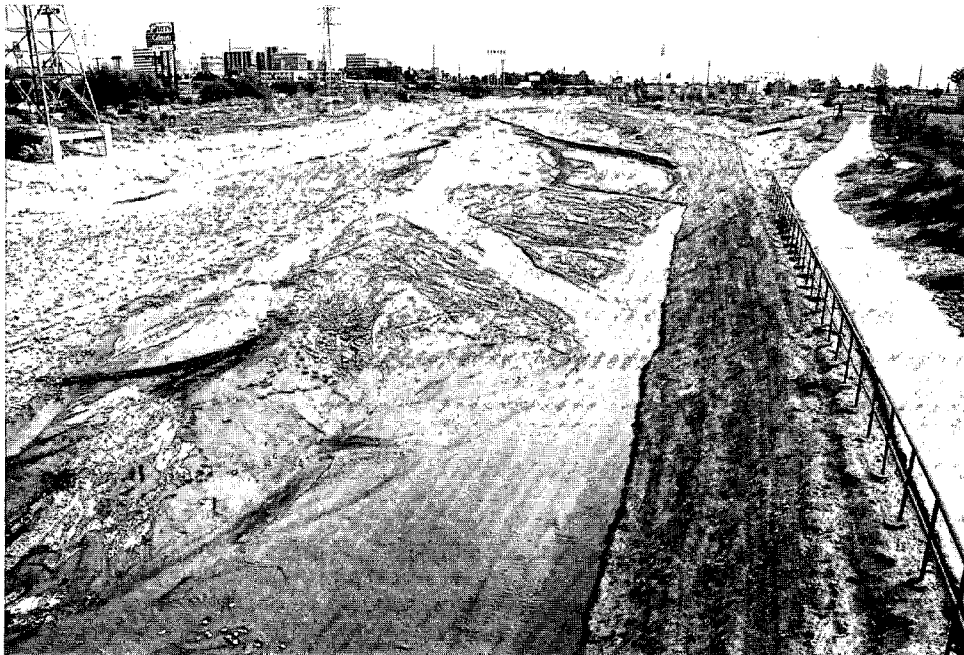
FIGURE 19B View from approximately the same position in late October 1983. Note incision at base of soil-cement slope and meandering thalweg of low-flow channel that developed during waning flow. Photograph by Peter Kresan.

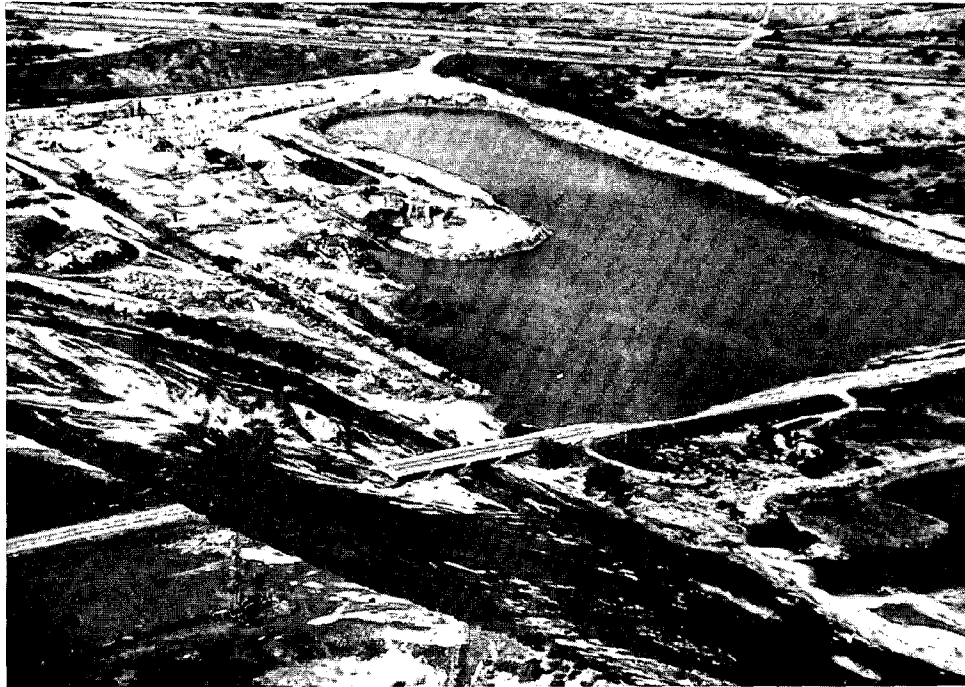
FIGURE 21 The Ina Road bridge over the Santa Cruz River on October 8, 1983, showing extensive erosion of its west abutment. Channel shifting to the west resulted in deposition at the former bridge cross section. Water spilling into the flooded gravel pit (right center) eroded large sections of the eastern approach road. Photograph by V. R. Baker.

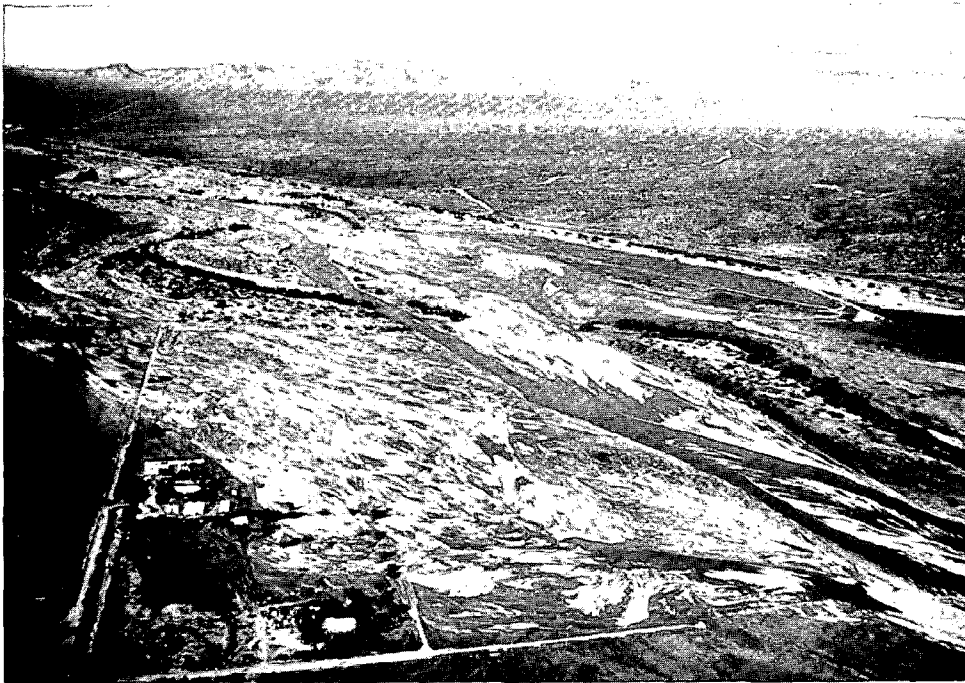
FIGURE 22 View downstream (north) along the Santa Cruz River north of Pima Farms Road (foreground) on October 8, 1983. The sinuous bends lined with riparian vegetation developed from relatively continuous low discharges from a sewage treatment plant located approximately 5 km upstream of this point. The flood discharge carved a straighter course along the center of the low-flow meander trend. Also note the extensive sedimentation in splay patterns to either side of the central flood channel. Interstate 10 runs diagonally across the top half of the photo, and the Tortolita Mountains are visible on the skyline. Photograph by V. R. Baker.

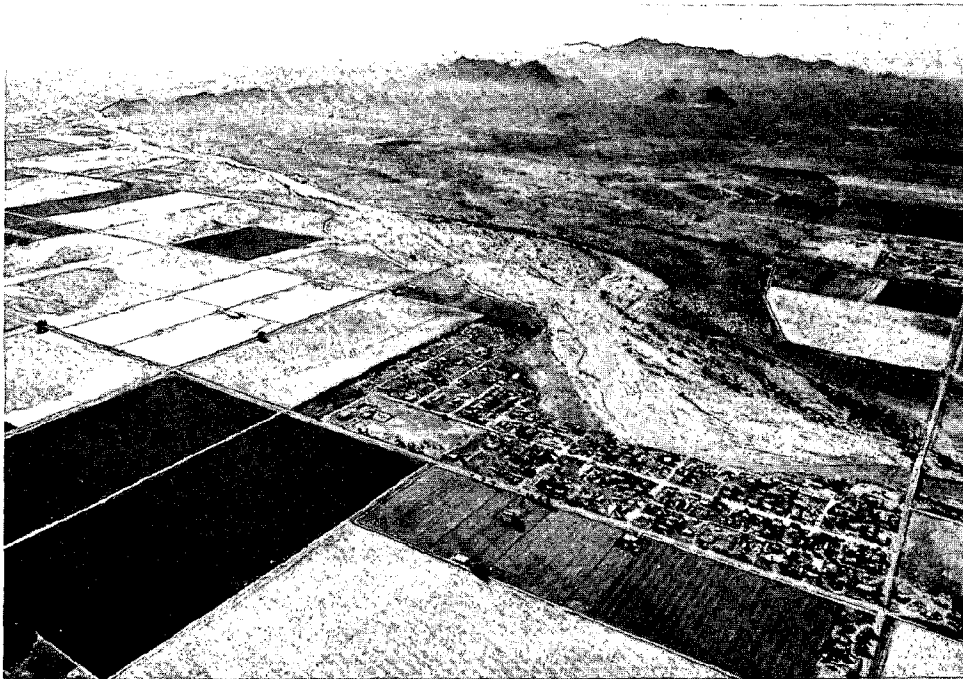
FIGURE 23 View of Marana (center) looking south toward the Tucson Mountains on October 9, 1983. Floodflows in this area spread over extensive agricultural land and caused considerable damage. The prominent meander bend at Marana experienced severe erosion during the prolonged winter flood of 1978. In contrast, the much larger 1983 flood peak resulted in relatively little erosion on this bend. Photograph by Peter Kresan.

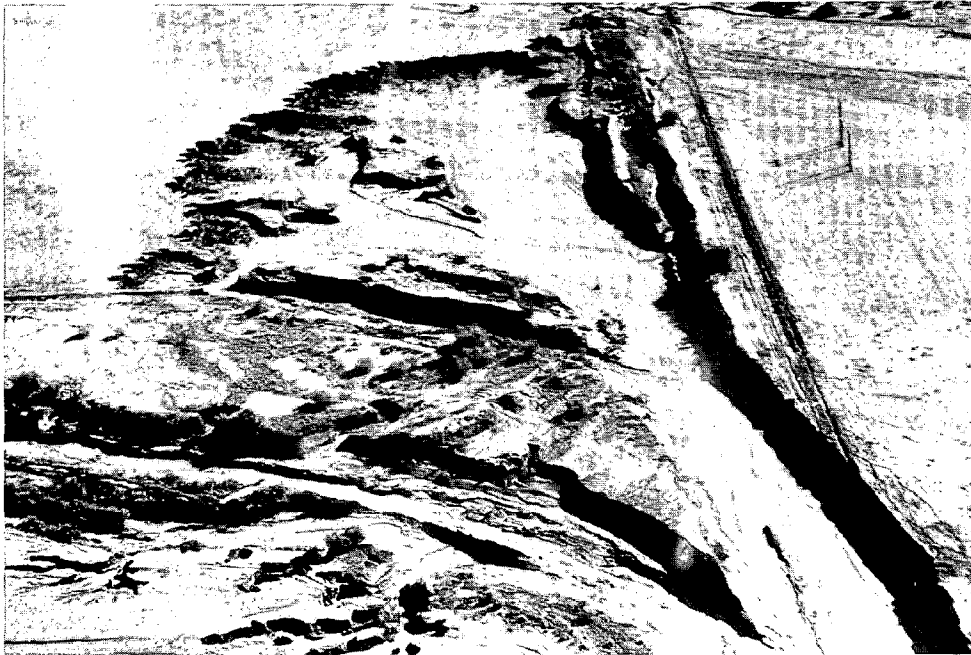
FIGURE 25 Headcut on the Santa Cruz valley floor immediately south of Picacho Peak, 15 km northwest of Marana, on October 8, 1983. Photograph by V. R. Baker.

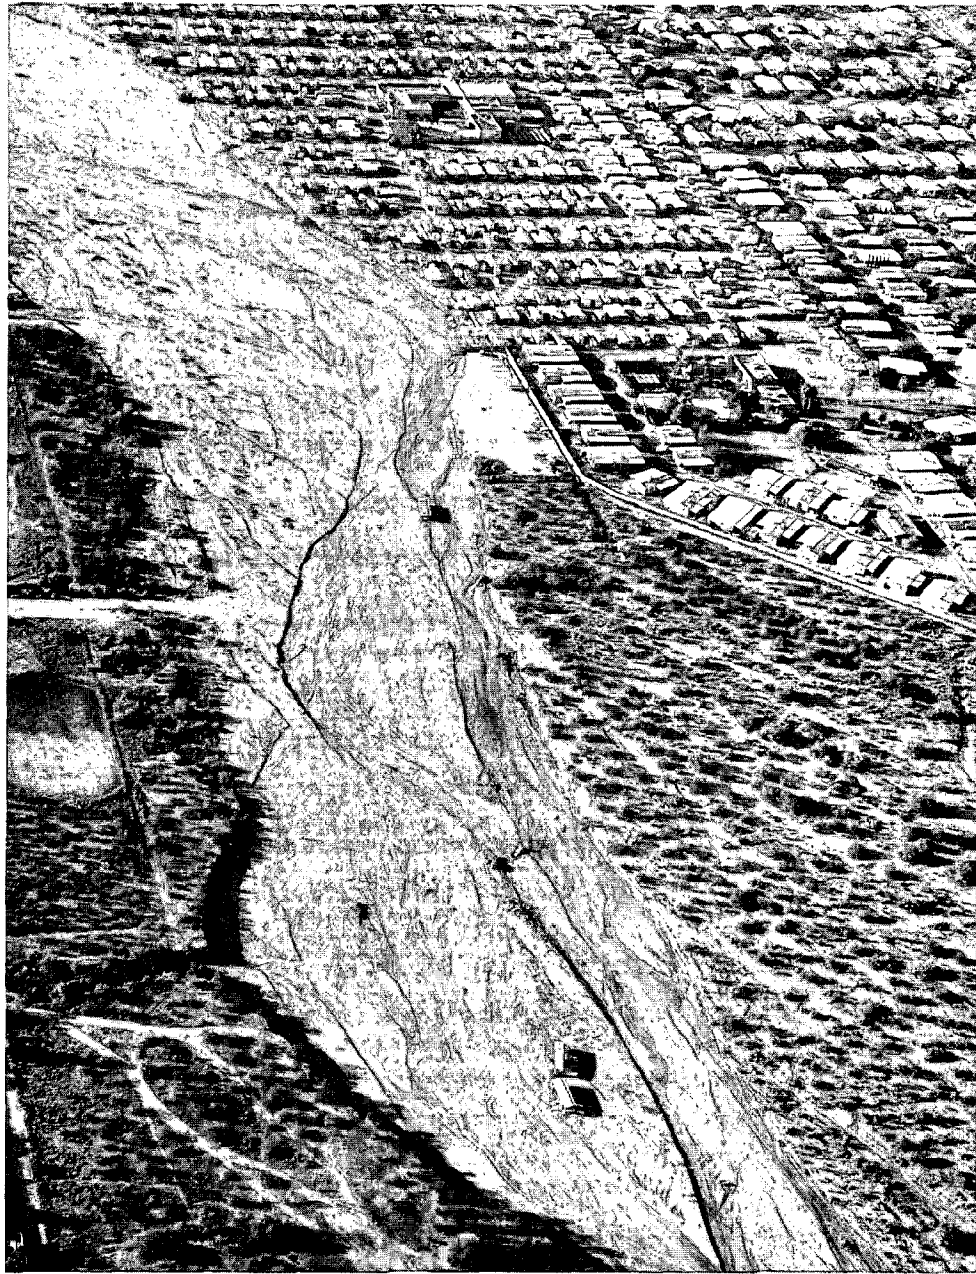
FIGURE 26 Pantano Wash at the Rincon Country mobile home development (upper right) on October 9, 1983. Escalante Road runs along the top (south) end of the photograph. The prominent bend of Pantano Wash at the top center undermined several mobile homes, which can be seen in the channel at the center and bottom of the photograph. Several automobiles were also incorporated into the northward flow of Pantano Wash. A ground view of the channel at this location is shown in Figure 38. Photograph by Peter Kresan.

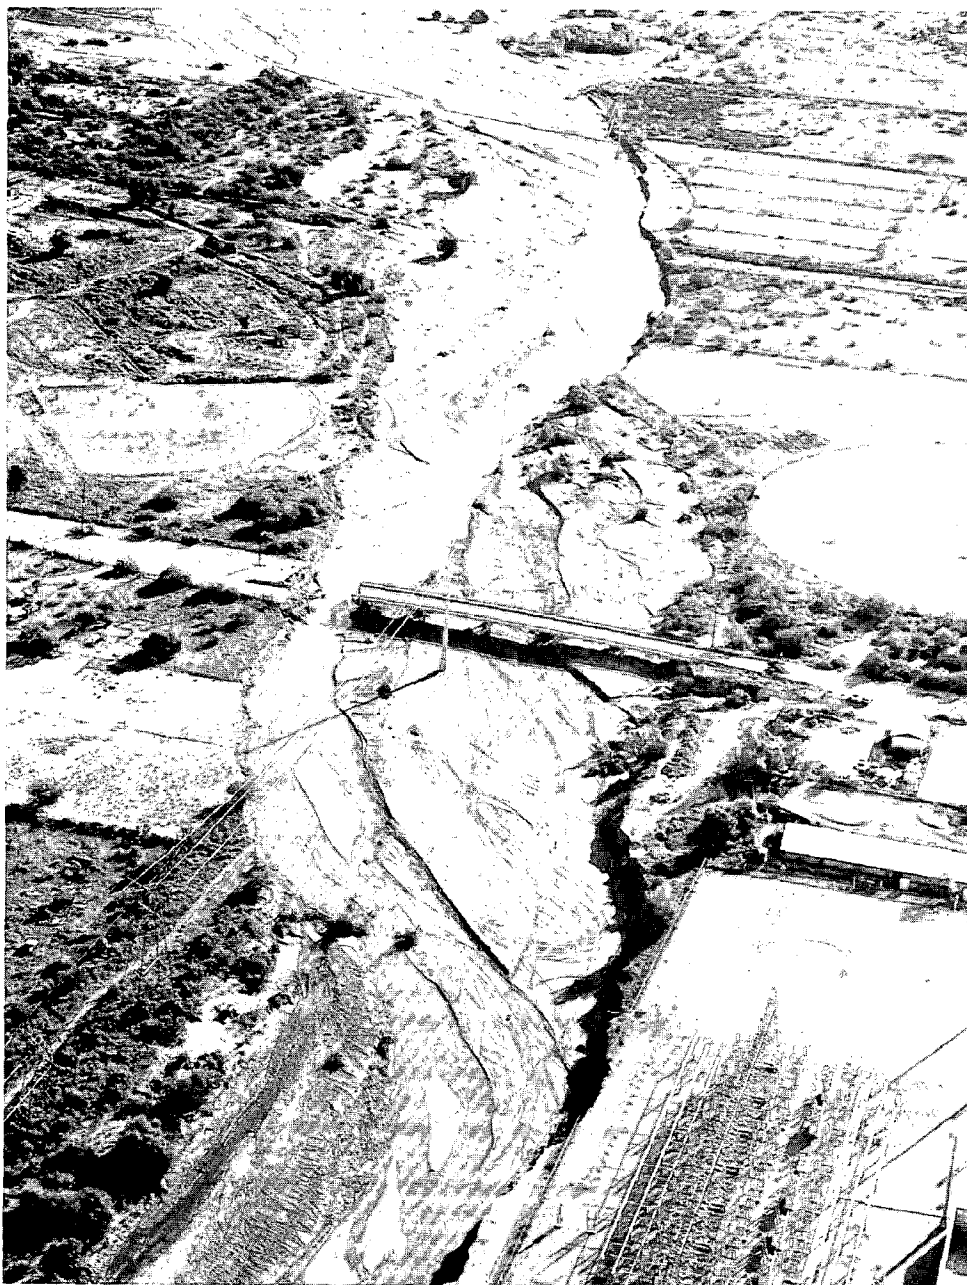
FIGURE 27 The Dodge Road bridge over the Rillito on October 9, 1983. Damage to the north (left) abutment was caused by meander migration. Note the prominent cutbank on the north side and corresponding point bar on the south (right) side of the stream. The meander bend immediately downstream (bottom right) is threatening an electric utility station. The anomalously wide section of channel at the top center was the site of a preflood channel sand-mining operation. Photograph by Peter Kresan.

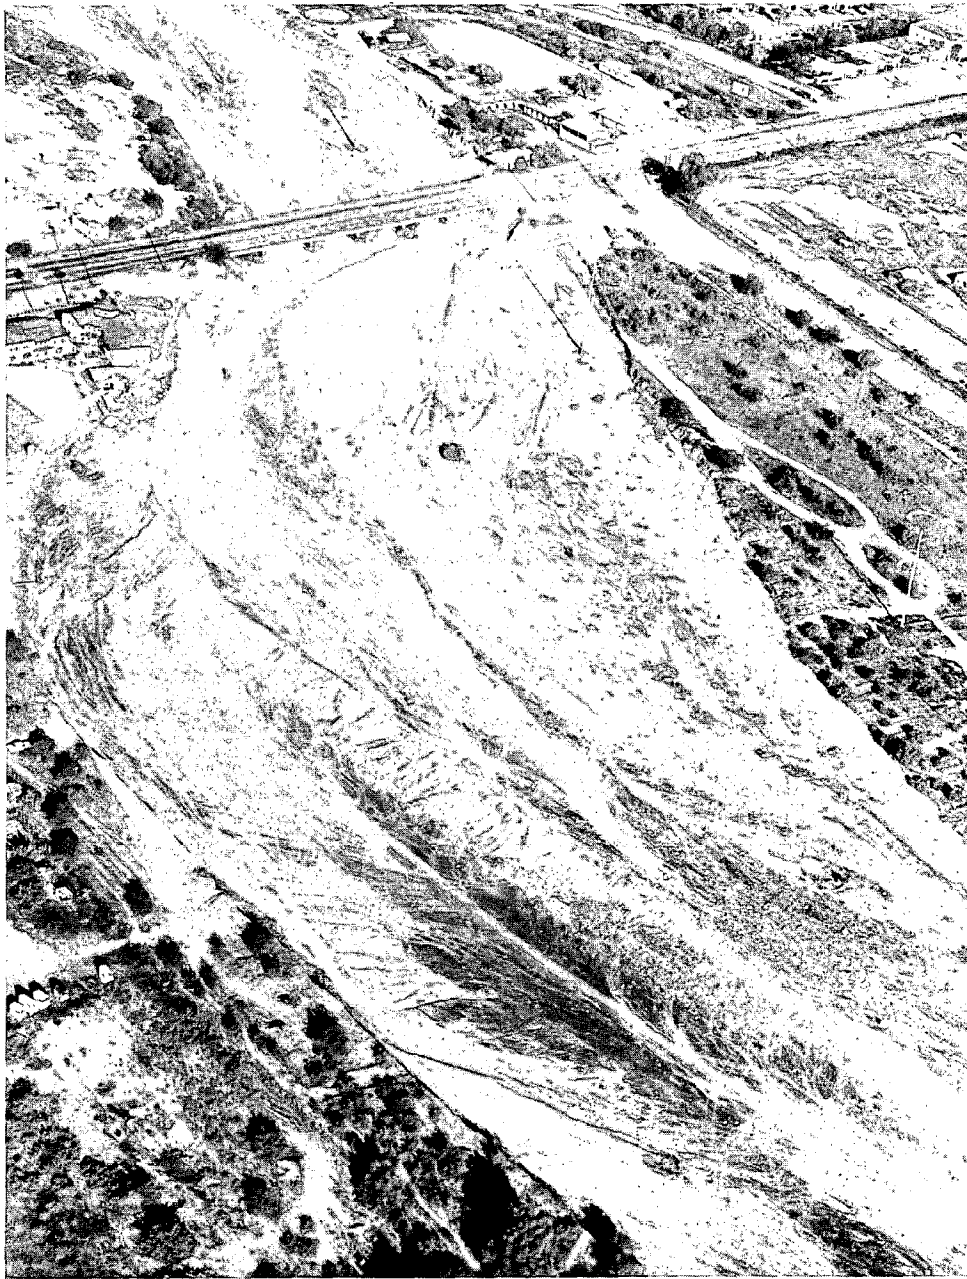
FIGURE 28 The Rillito at the First Avenue bridge on October 9, 1983, showing meander migration on the south (left) bank, which undermined the office building complex in the upper left of the photograph. The return flow to the opposite bank at the upper right damaged the north (right) abutment of the bridge. Temporary repair had been effected at the time of this photograph. Figures 35 and 36 show damage to the office buildings. Photograph by Peter Kresan.

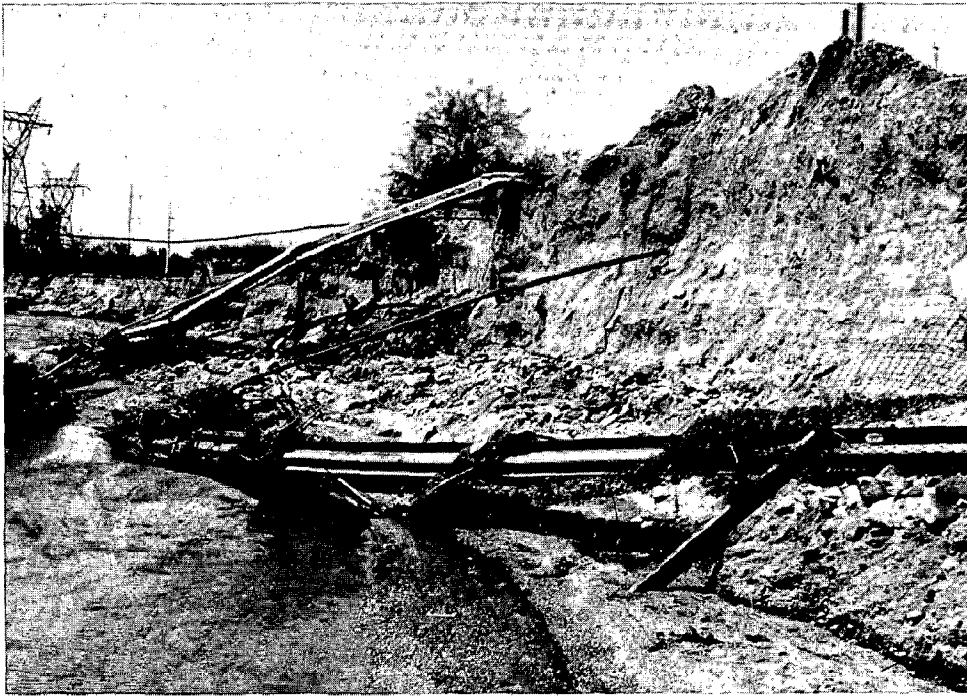
FIGURE 29 Bank erosion along the Rillito at the Dodge Road bridge on October 10, 1983. Photograph by Thomas F. Saarinen.

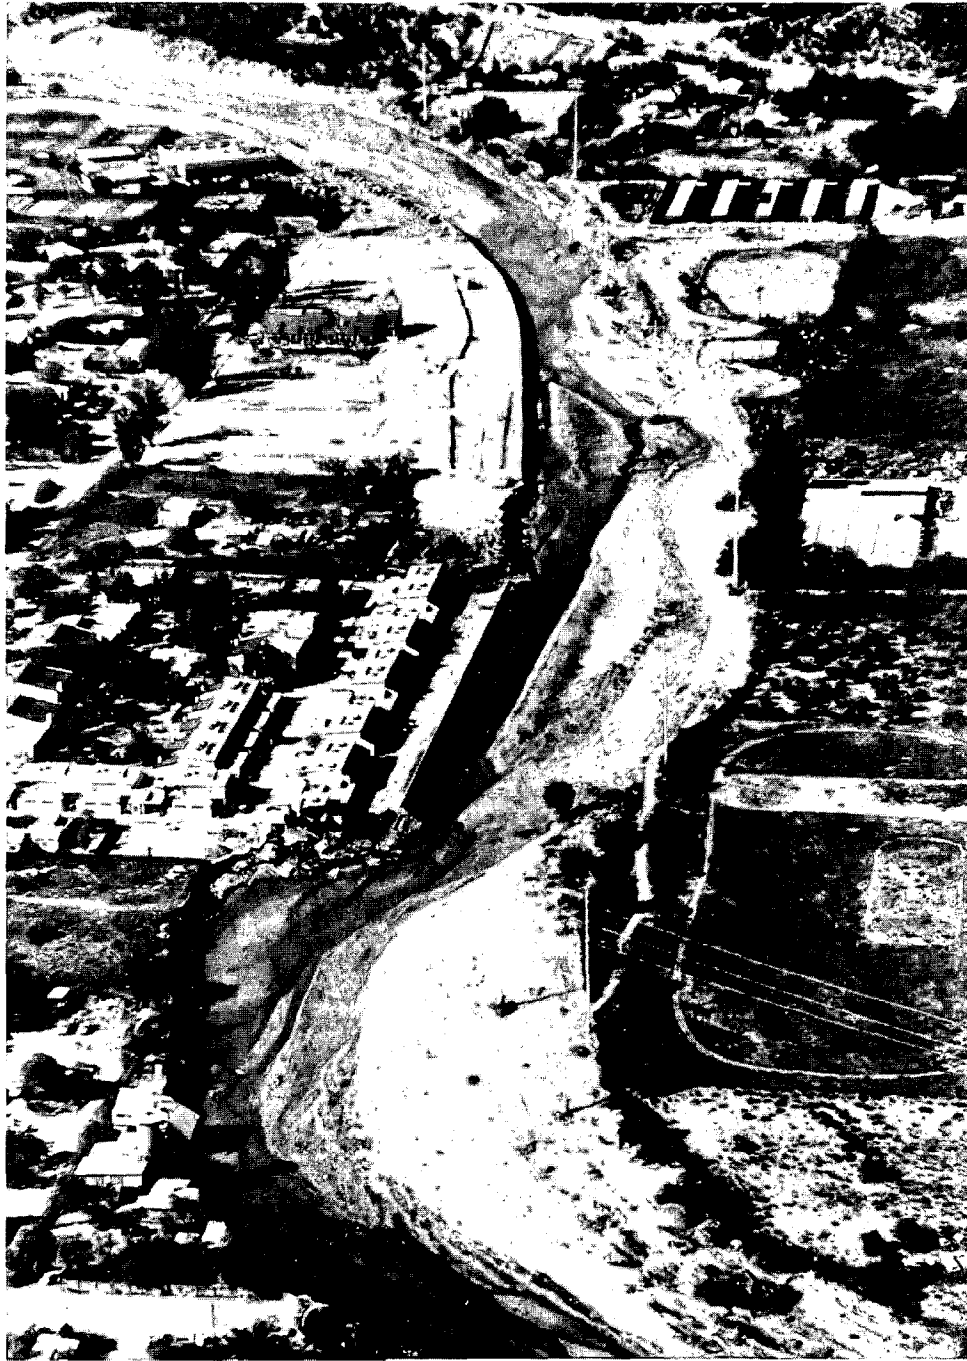
FIGURE 31 The Rillito near Prince Road (lower left) on October 8, 1983. Damage to the Pima Park Townhomes (center) occurred when the prominent meander bend at the bottom center migrated west (left) into the vacant property immediately upstream of the townhouses. This allowed erosion to occur behind the soil-cement bank protection lining the stream at the townhome property. The prominent point bar at the bottom center developed as the meander migrated westward. Photograph by V. R. Baker.

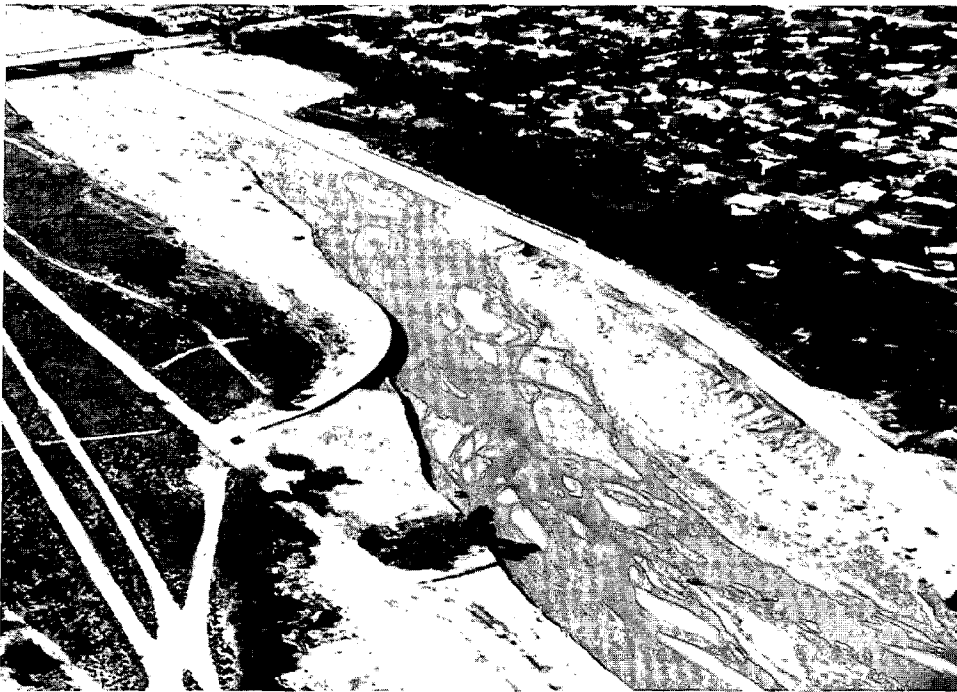
FIGURE 32 Soil-cement revetment works lining both banks of the Tanque Verde Creek immediately east of the Sabino Canyon Road bridge (top left) on October 8, 1983. Photograph by V. R. Baker.

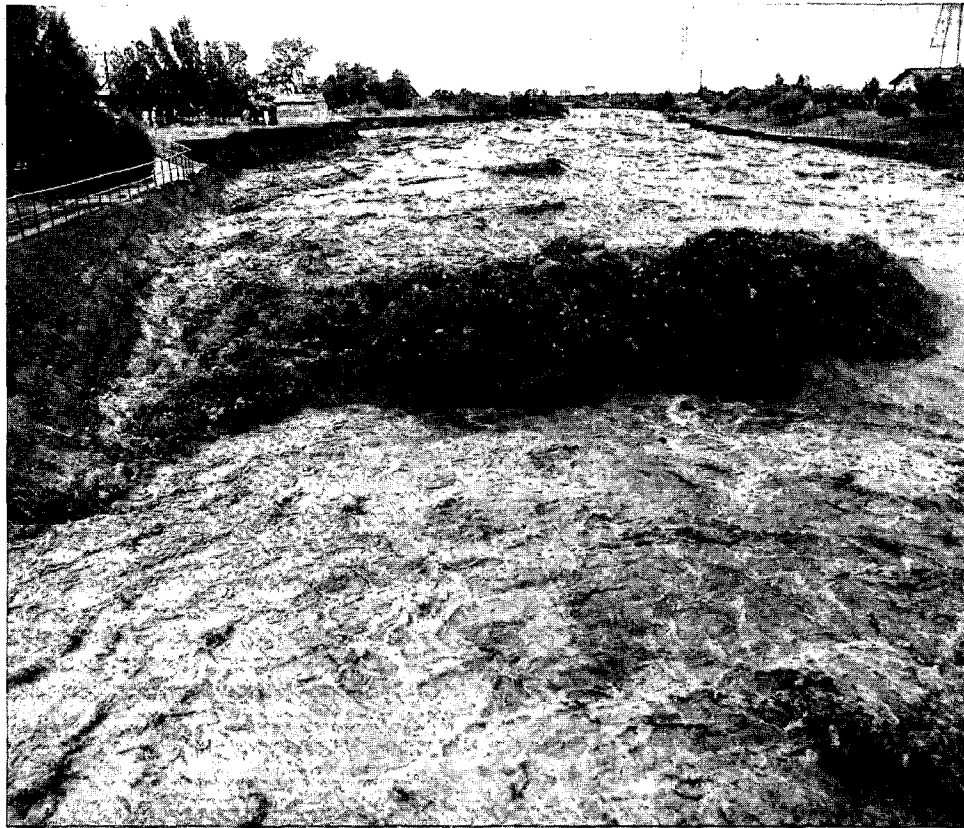
FIGURE 33A View downstream (north) along the Santa Cruz River from the St. Mary's Road bridge on October 2, 1983. Note that the soil-cement banks confine the flow for approximately 100 m beyond the bridge. Pronounced bank erosion occurs at the distal end of this protection, especially on the west (left) bank, toward which the flow is directed. The high-velocity thread of the flow is marked by antidunes and standing waves. Photograph by Peter Kresan.

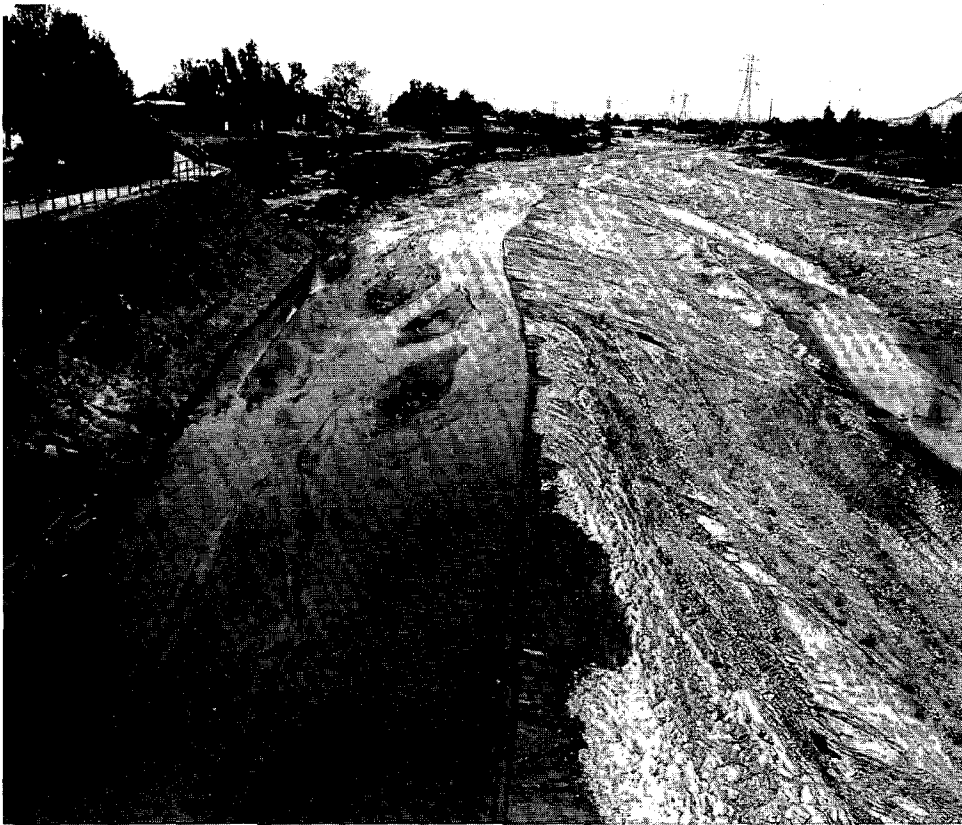
FIGURE 33B View from approximately the same position on October 16, 1983. Note that the west bank has receded further from its position on October 2. Damage to the distal end of the soil-cement bank protection on the east (right) bank is shown in more detail in Figure 34. Photograph by Peter Kresan.

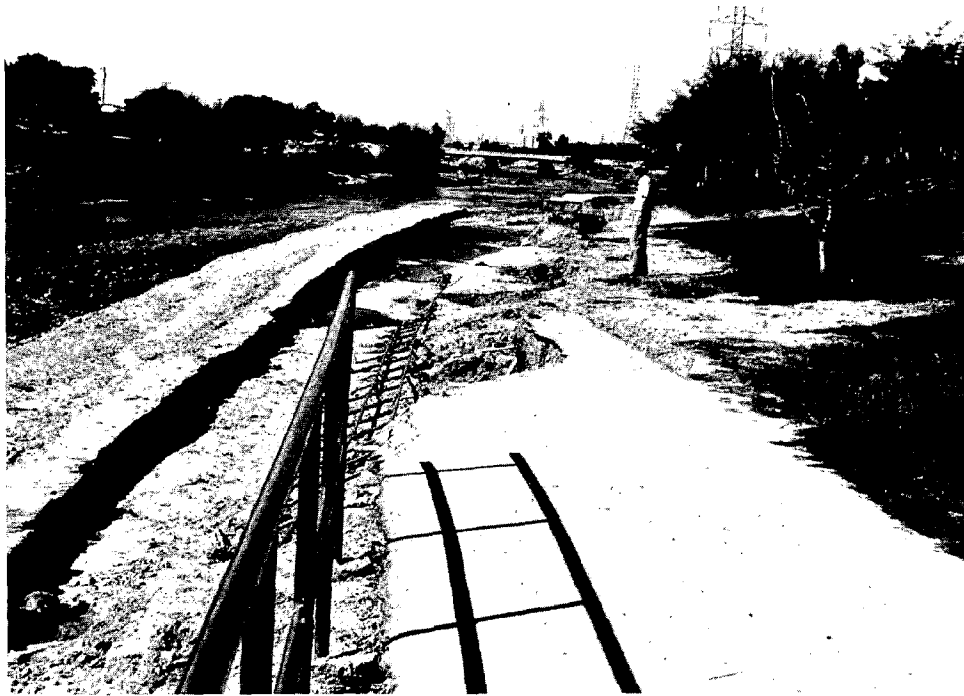
FIGURE 34 View downstream (north) along the Santa Cruz River between the St. Mary's Road bridge and the Speedway Boulevard bridge (visible at top center) on October 10, 1983. The distal terminus of the soil-cement bank protection has been eroded by the flows shown in Figure 33A. Photograph by Thomas F. Saarinen.

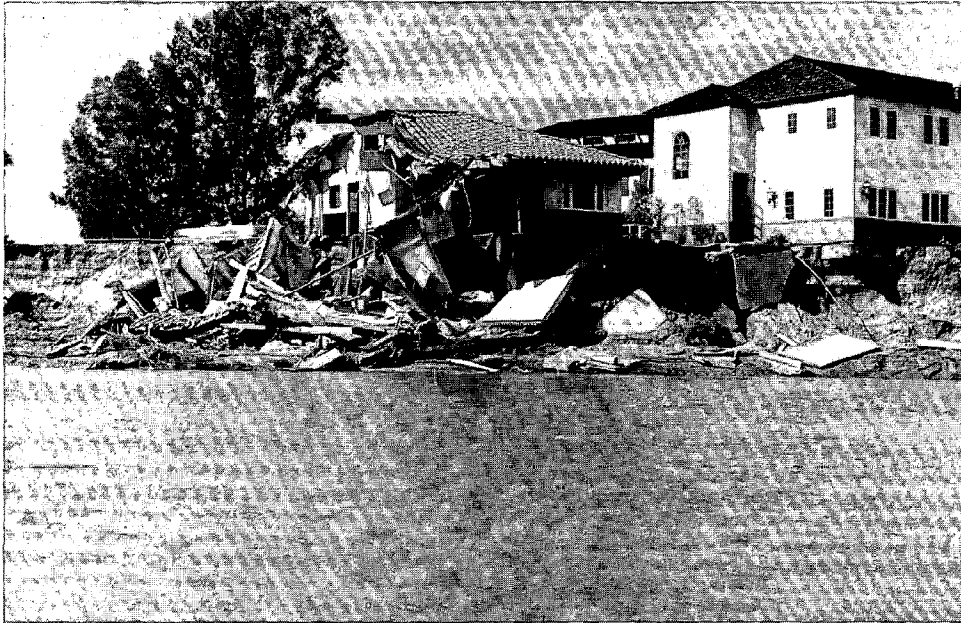
FIGURE 35 Damage to an office building complex caused by the undermining of the bank of the Rillito at First Avenue. An aerial view of this site is provided in Figure 28. Photograph by Tad Nichols.

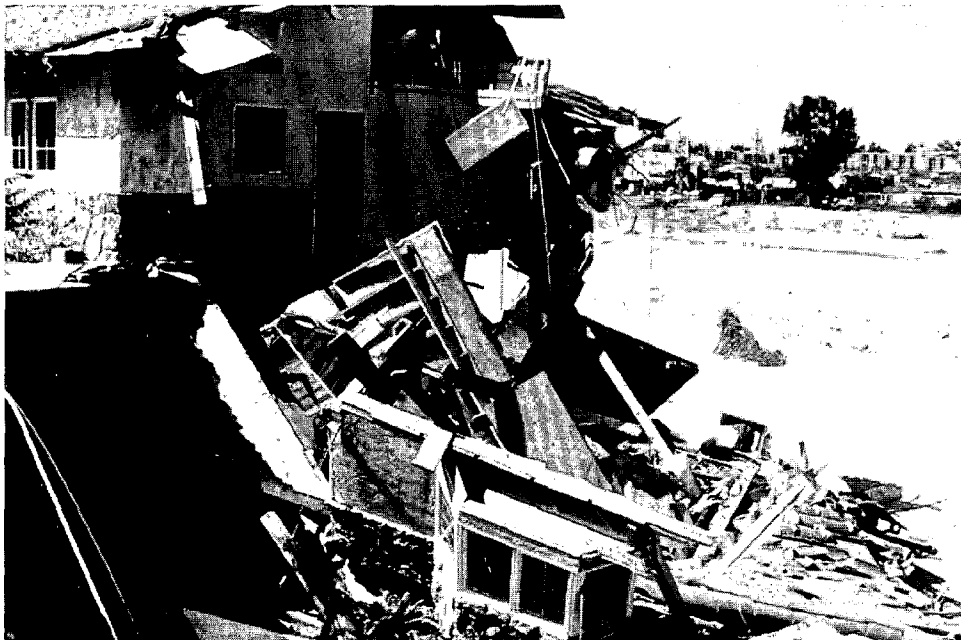
FIGURE 36 Damage to an office building adjacent to unprotected channel banks along the Rillito immediately upstream (east) of the First Avenue bridge. Photograph by Thomas F. Saarinen.

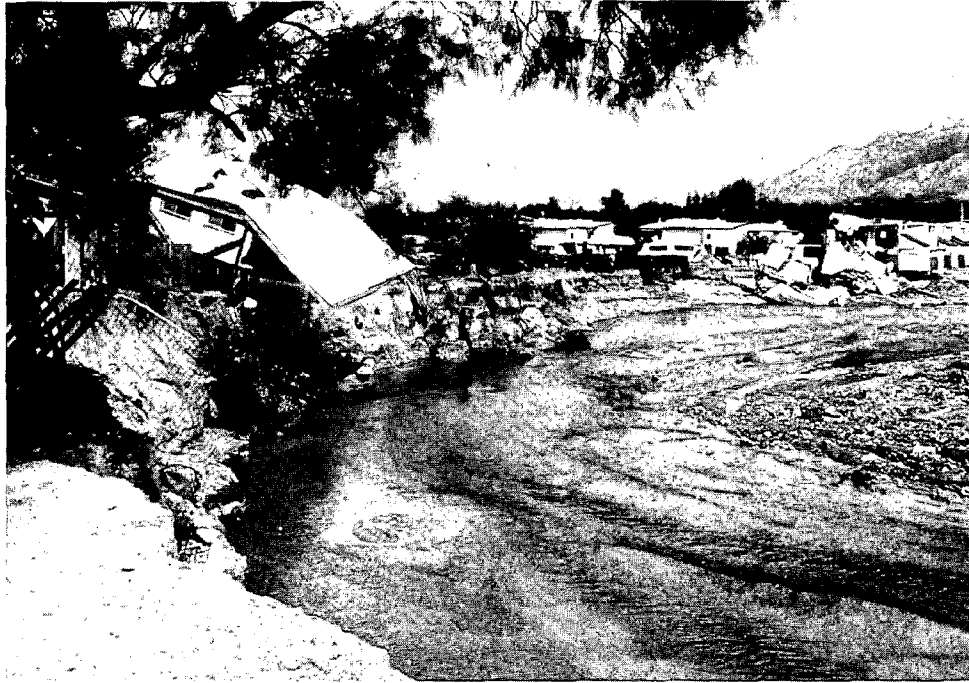
FIGURE 37 View downstream (northwest) along the Rillito from the terminus of Prince Road (lower left) on October 8, 1983. Compare this picture with the aerial view that includes the same reach (Figure 31). The house in the left foreground has toppled into the active meander cut slope. Damage to the Pima Park Townhomes is visible in the right background. Photograph by Thomas F. Saarinen.

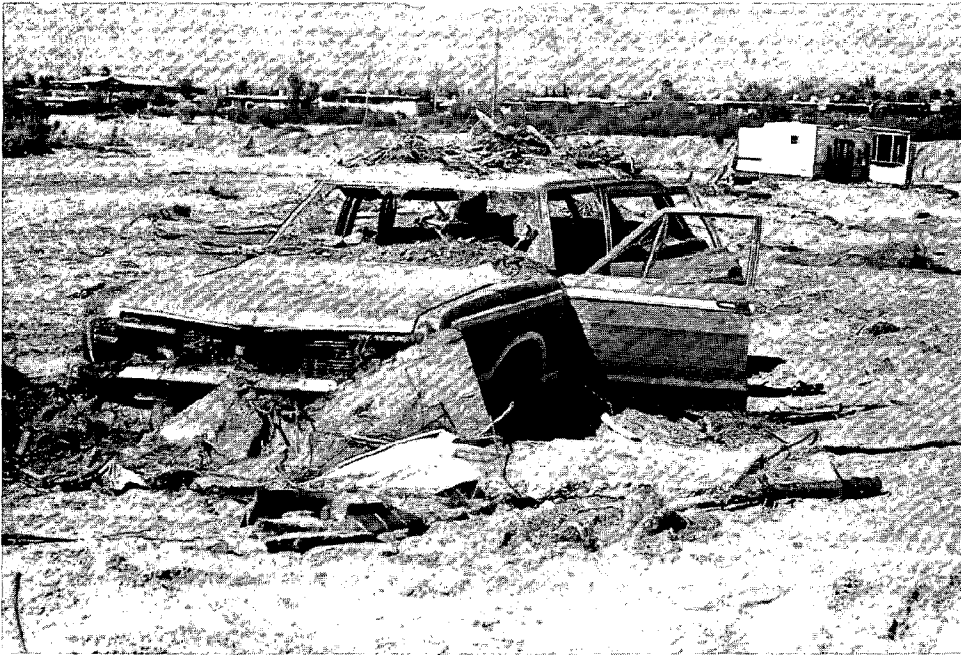
FIGURE 38 Flood debris in the channel of Pantano Wash from the Rincon Country mobile home development (see Figure 26) in late October 1983. The view is downstream (north). Photograph by Peter Kresan.

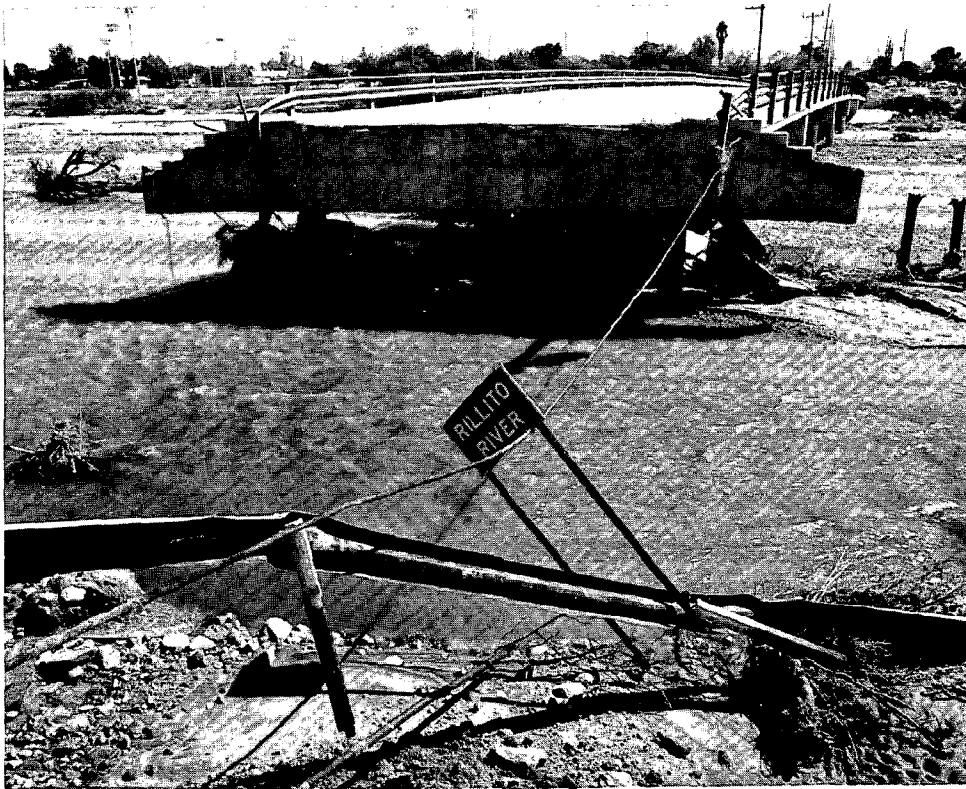
FIGURE 40 The Rillito at Dodge Road on October 5, 1983, showing the erosion of the north abutment. Photograph by Peter Kresan.
