# The Tucson, Arizona, Flood of October 1983

Committee on Natural Disasters  
Commission on Engineering and Technical Systems  
National Research Council

Thomas F. Saarinen (Team Leader), Department of Geography, University of  
Arizona, Tucson

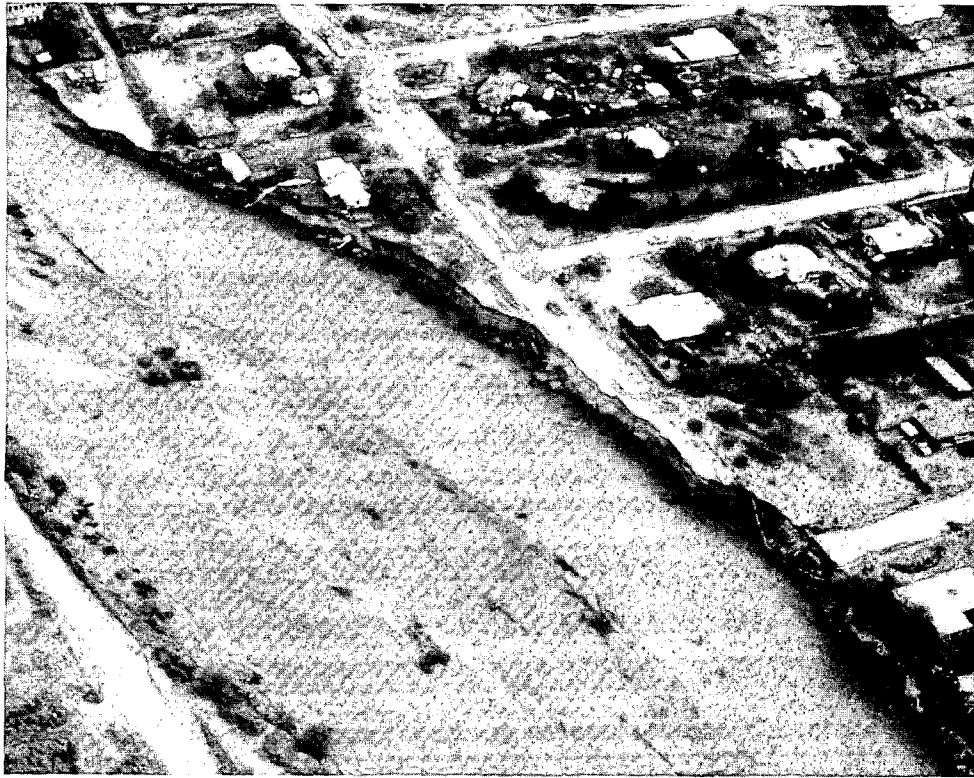
FIGURE 42 Aerial view of Lamar Heights on October 2, 1983. Notice that the junction of Michigan and Koster avenues has been eroded away along with several houses. Photograph by Peter Kresan.

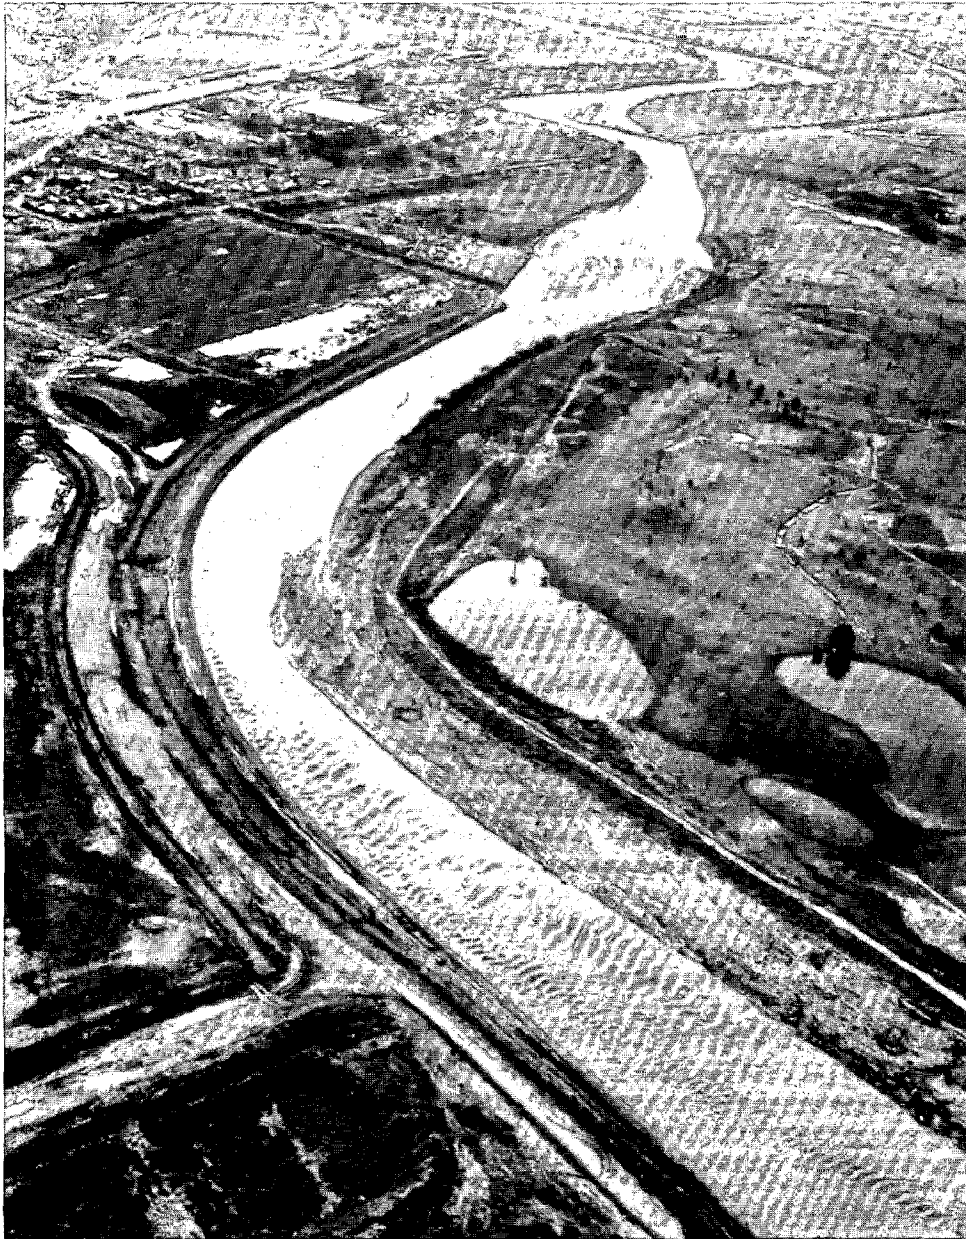
FIGURE 43 Aerial view of Santa Cruz River showing the sudden widening of the stream banks at a point with no bank protection. Photograph by Peter Kresan.

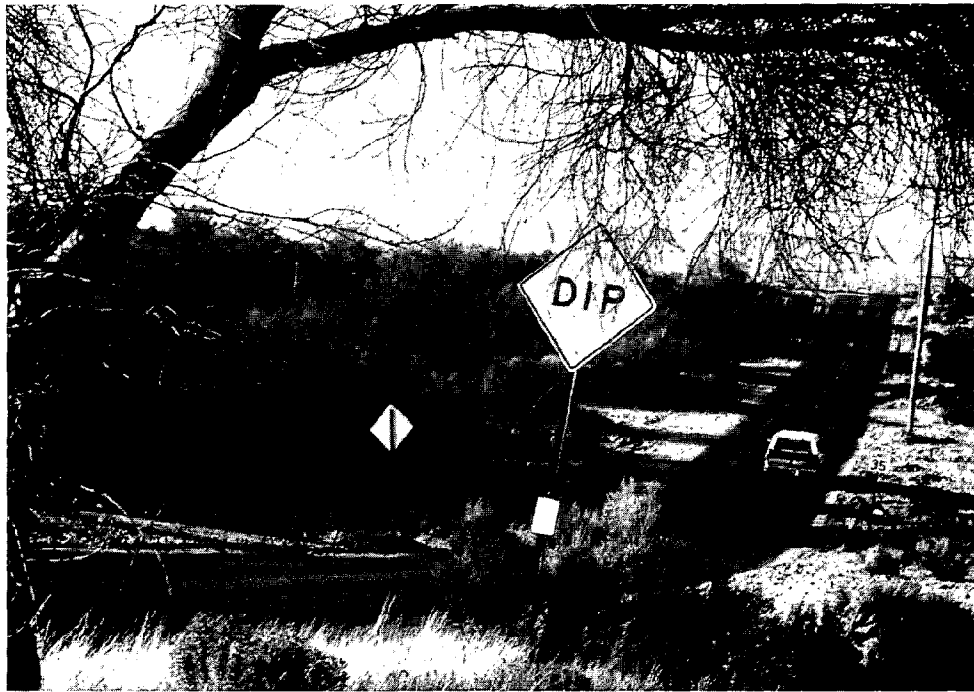
FIGURE 44 Dip crossing showing common practice of roads crossing at streambed level. Photograph by Thomas F. Saarinen.

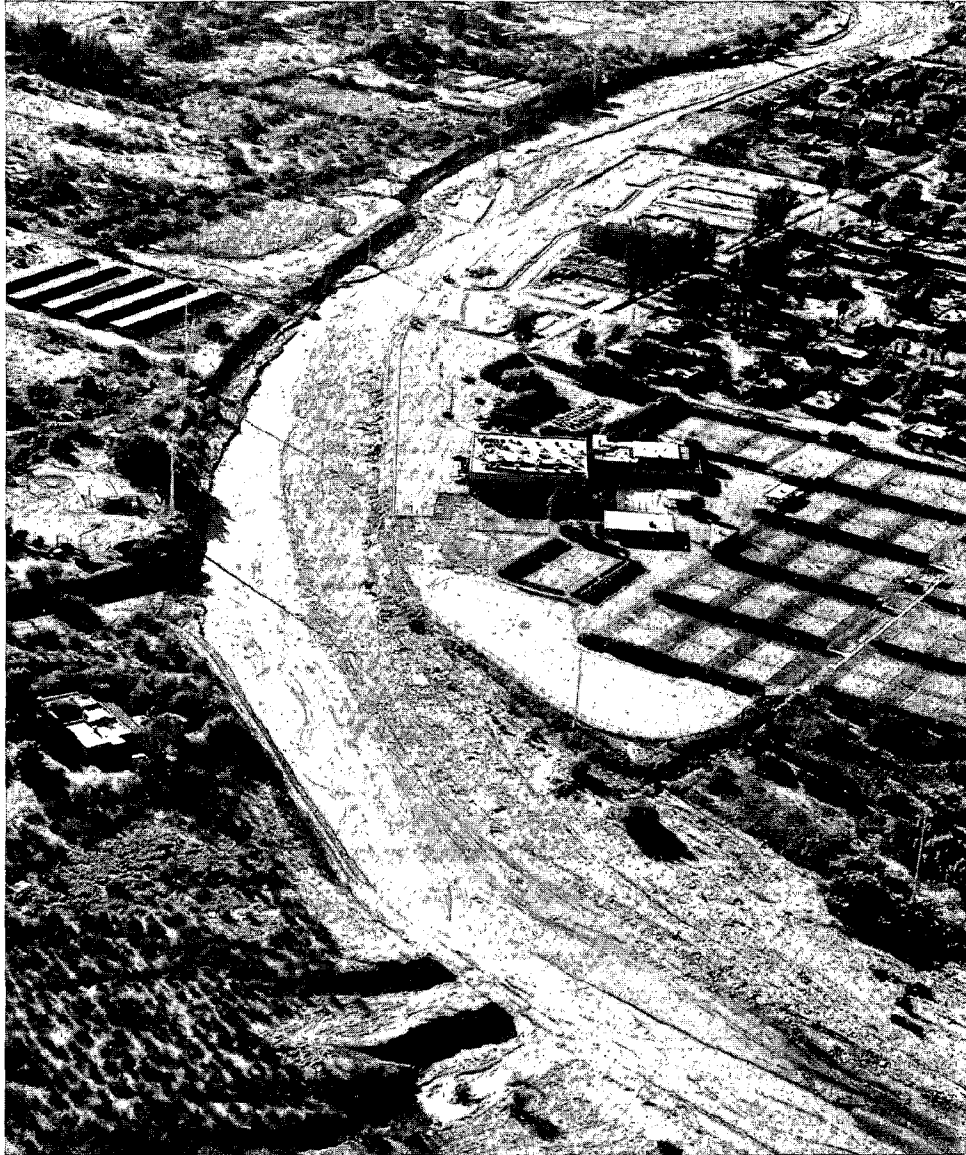
FIGURE 46 Low-density rural ambiance formerly characteristic of the entire Rillito corridor. On the left are homes, stables, and open fields. On the right is a tennis club; in the upper right background are the Pima Park Townhouses (see Figure 37). Photograph by Peter Kresan.

High land costs lead to high-density use. So the Rillito corridor, formerly notable for its rural ambience with stables, ranches, the Rillito Race Track, and winding River Road (Figure 46), is now being transformed by high-density residential development (Figure 47). Over a thousand building units have been platted, and many would probably be under construction were it not for the moratorium. Locations adjacent to the river are reflected in such names as Haciendas de Rios, Rio Cancion, Riverside Apartments, River Grove Estates, Rio Vista, and Lazy Creek. Obviously the potential for flood damage will be much greater in the future as these and other projects are completed.

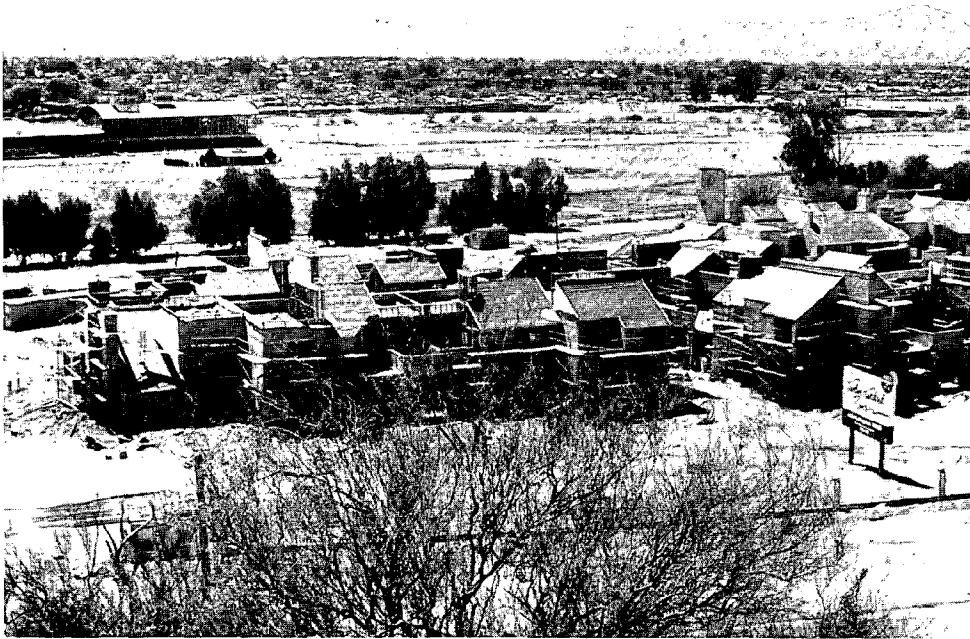
FIGURE 47 New construction now characteristic of many portions of the Rillito corridor. Notice the Rillito Race Track in the background. Photograph by Thomas F. Saarinen.

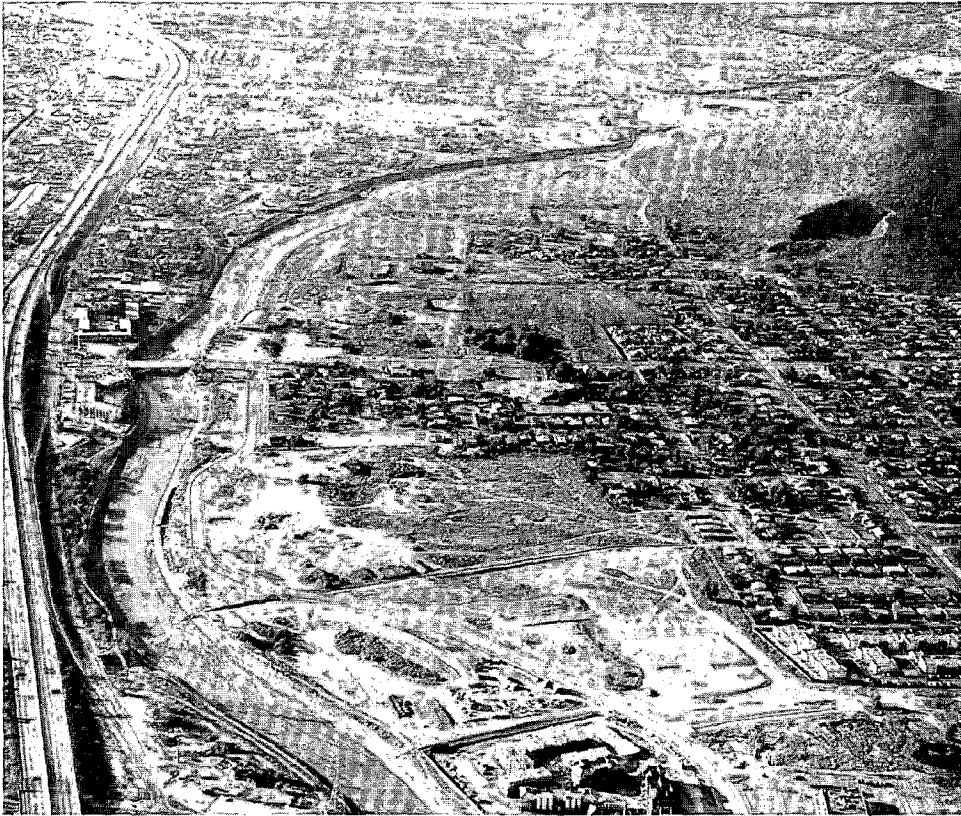
FIGURE 49 View looking south along the Santa Cruz with Interstate 10 on the left. The open, yet-to-be developed lands of the Rio Nuevo project are west of the Santa Cruz between the neighborhood of Menlo Park and the river. In the middle background is the Congress Street bridge. South of Congress is a large area of sanitary landfill. Just above the bottom edge of the photograph may be seen new construction of the first stage of the Rio Nuevo project at St. Mary's Road (also see Figure 50). Photograph by Peter Kresan.

The success of soil-cement bank protection has been praised and seen by some as a solution to future flood erosion problems in Tucson (Cornelius, 1983). The most notable use of soil-cement bank protection was in the Rio Nuevo project west of downtown Tucson on the Santa Cruz River, where close to 2 miles of bank protection were in place prior to the October flood. But the cost of this project could be justified on a benefit-cost ratio because of its special character. It is a very large, long-term project designed to dovetail with downtown redevelopment and the Santa Cruz River Park (Figure 48). Major important bridges were already in place, and former landfill areas posed potential problems without adequate protection (Figure 49). Most projects would not have as compelling a set of reasons for such substantial public and private investment in bank protection and grade control structures. The Rio Nuevo project was also designed to meet FEMA design standards for the 100-year flood ( $850 \text{ m}^3/\text{s}$  or 30,000 cfs). During the October flood the limits of its capacity were strained (Figure 50) and areas immediately downstream were severely eroded (Figure 51). To build protective works beyond this standard is enormously expensive.

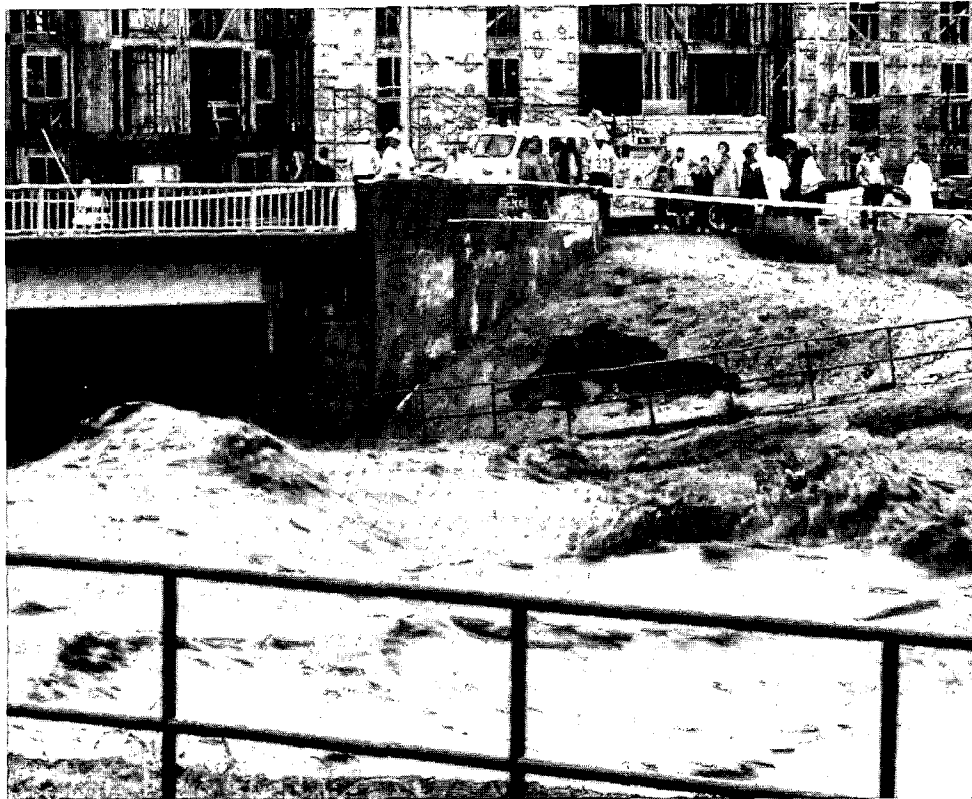
FIGURE 50 The St. Mary's bridge during the flood of the Santa Cruz on October 2, 1983. Notice the waves above the level of the riverside walk. The new construction in the background is the first residential portion of the Rio Nuevo project. Photograph by Peter Kresan.

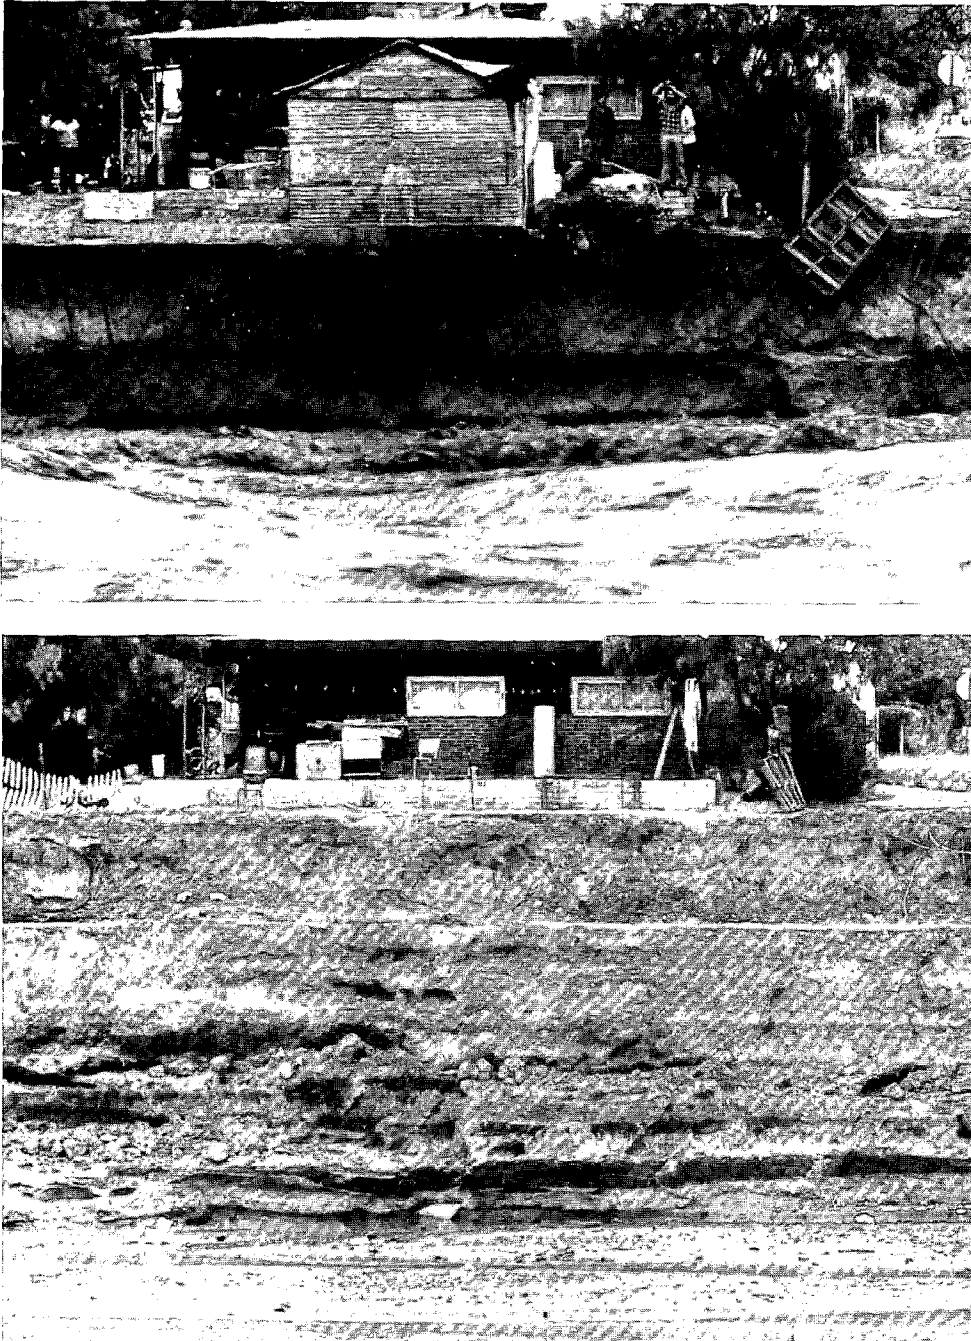
FIGURE 51 Point on the west bank of the Santa Cruz just beyond the bank protection of the Rio Nuevo project. The top photograph, taken during the flood on October 2, 1983, shows people watching the undermining of the bank below the shed. The bottom photograph, taken later in the month, shows that the portion of the bank on which the shed stood is no longer present. The view of the house is no longer obscured by the shed and the roots of the tree at right are exposed. Photograph by Peter Kresan.
