# BEACH EROSION IN SOUTH CAROLINA

Miles O. Hayes, Thomas F. Moslow  
and  
Dennis K. Hubbard

*South Carolina Coastal Council*

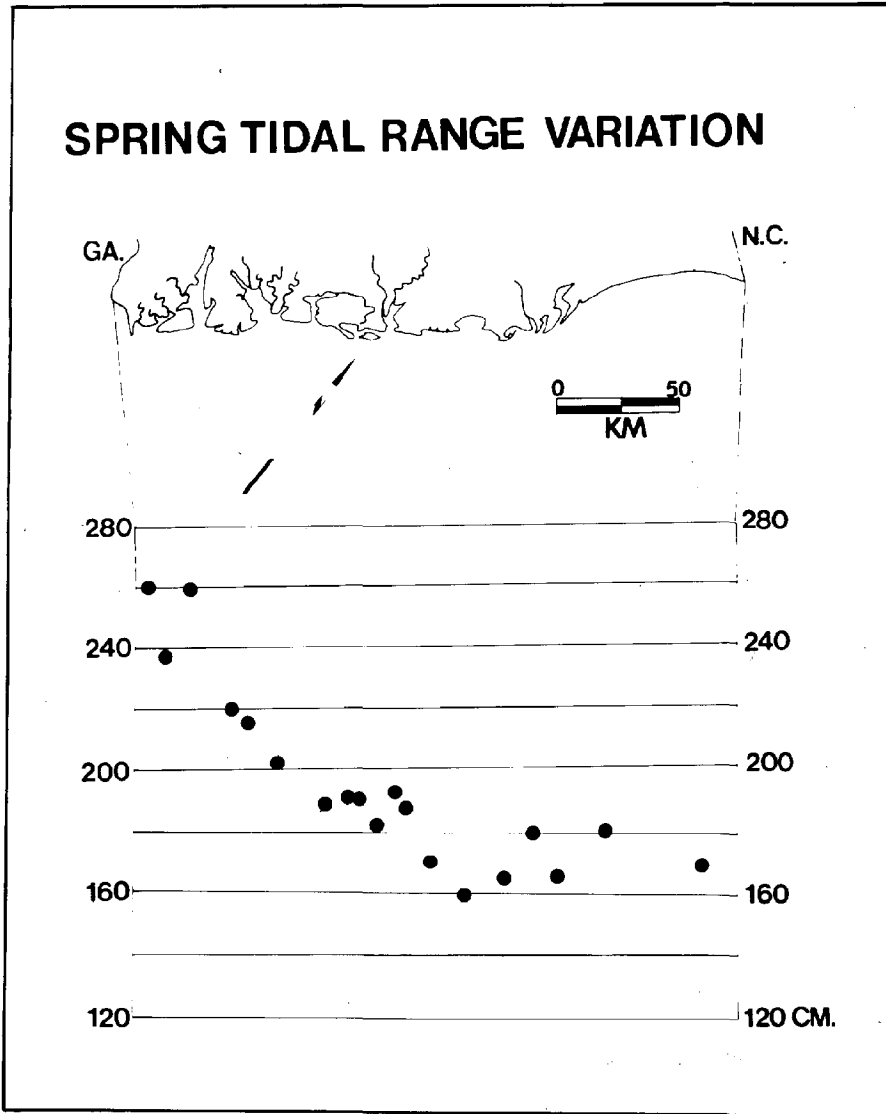
Figure 5. Spring tidal range variation along the shoreline of South Carolina. Note increase in southerly direction. (from Brown, 1977).

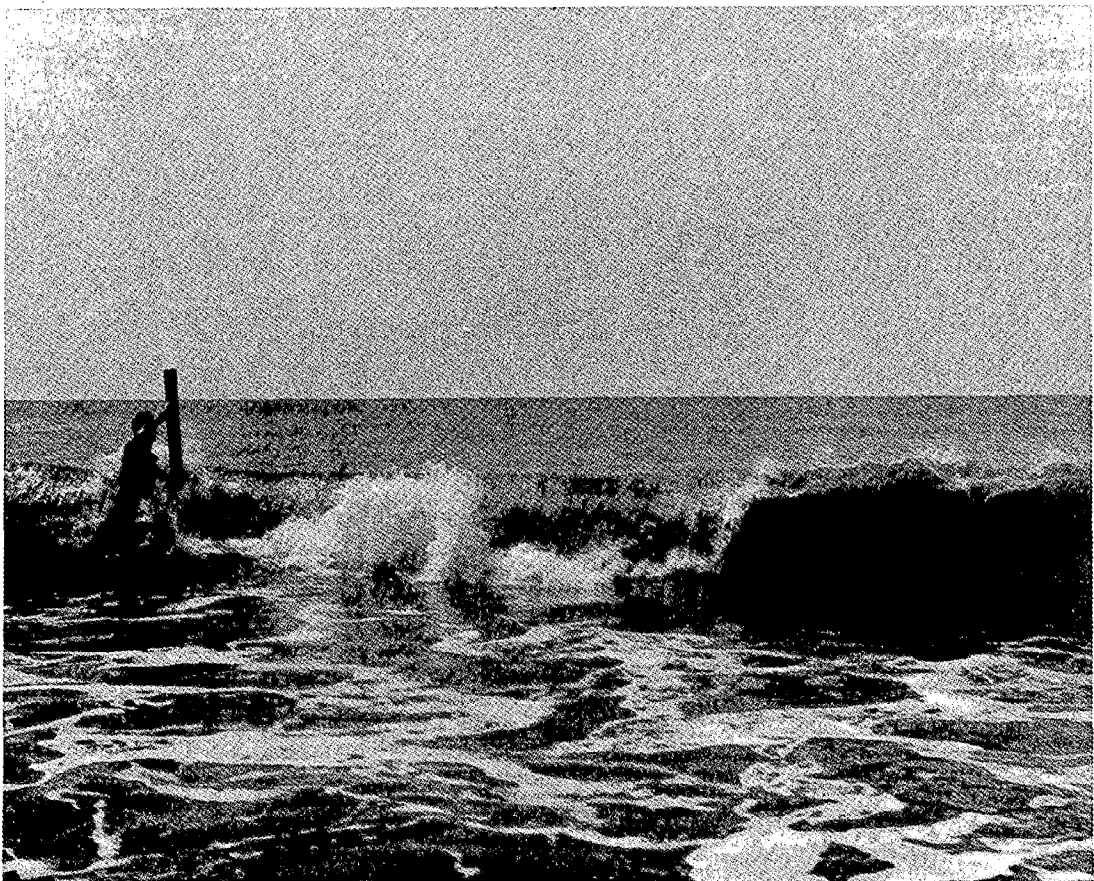
Figure 14. Plunging breaking wave.

Research into what type of waves cause coastal changes has found that, in general, short, steep waves tend to erode the beach while longer, lower profile waves cause sand to be added to the beach. Four types of waves shown in Figs. 13-16 occur on the S. C. coast. These are:

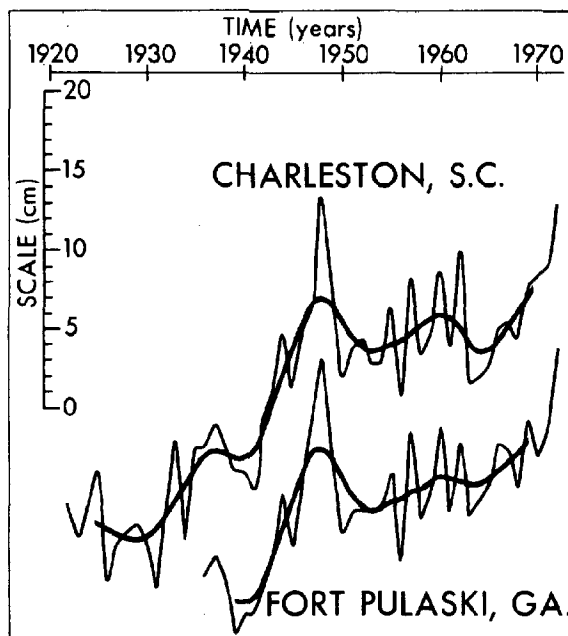
Figure 20. Changes in sea level with respect to the adjacent land at Charleston, S. C. and Fort Pulaski, Ga. (from Hicks and Crosby, 1974).

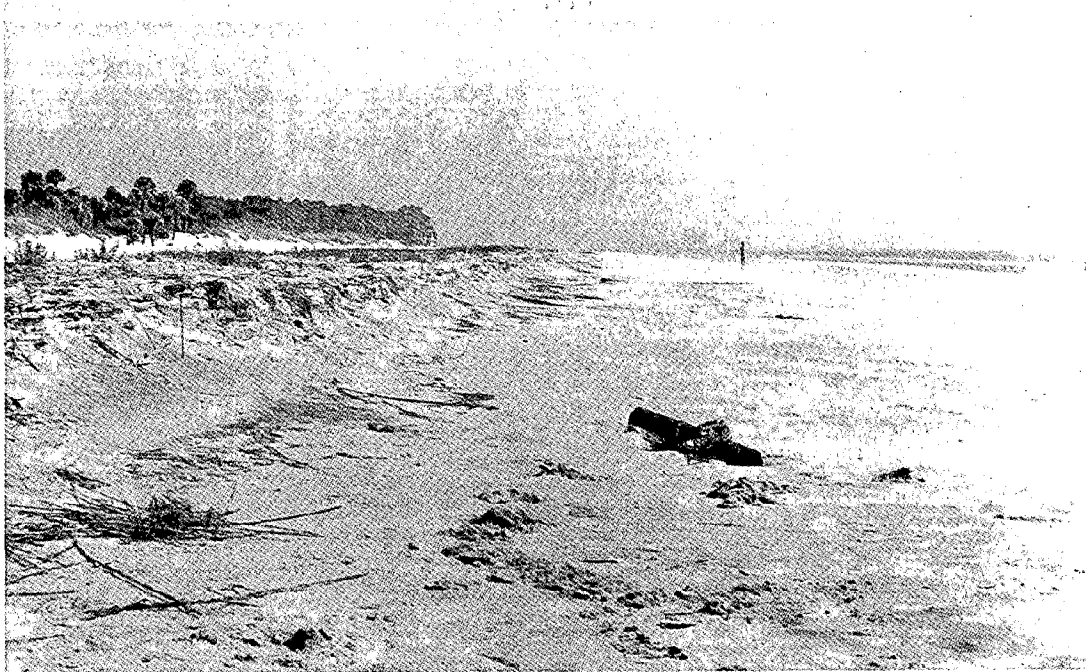
Figure 21. Typical post-storm (1 day) beach profile displaying a wide, flat beach backed by a scarp.

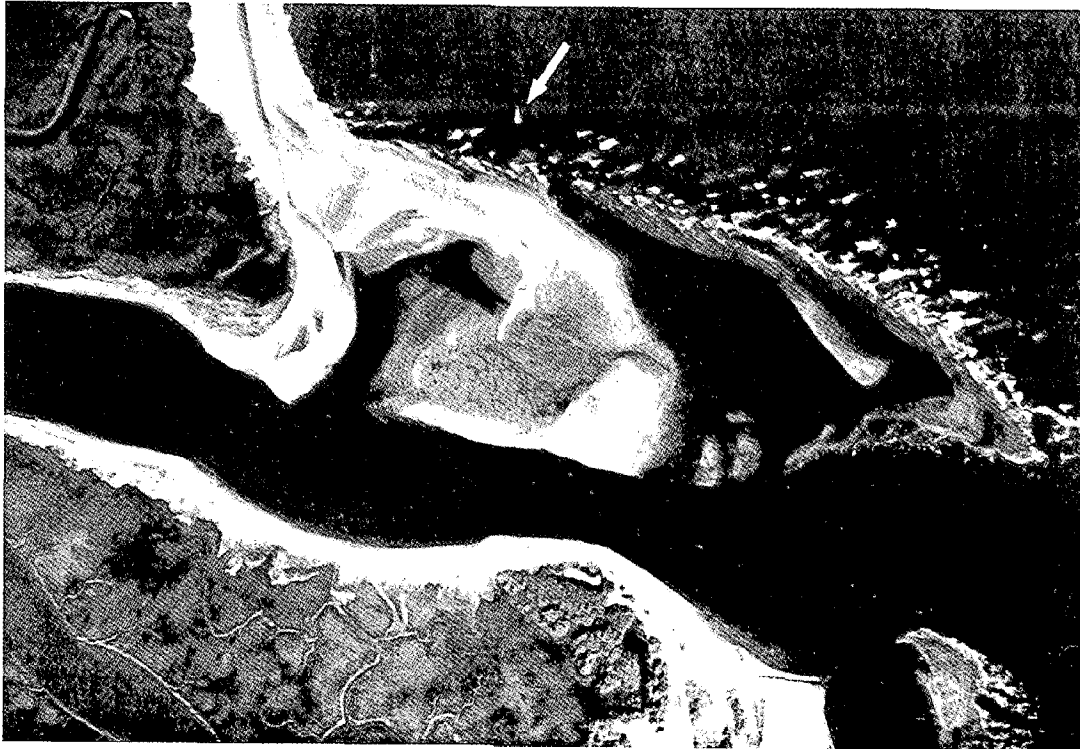
Figure 25. Morris Island light. The lighthouse was located on the beach at the south end of Morris Island in 1939. Over 1600 feet of erosion has occurred since that date. This erosion is in part related to the construction of jetties at Charleston Harbor to the north, as well as its proximity to a tidal inlet. Photo taken January 7, 1975.

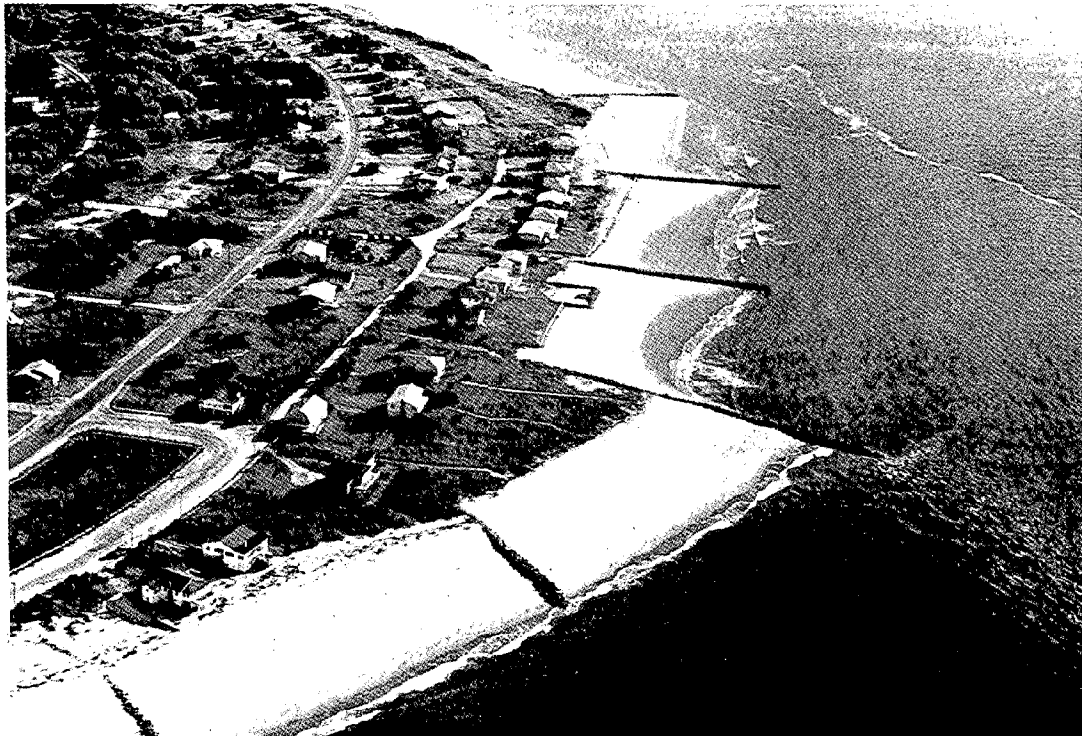
Figure 26. Oblique aerial photograph of a series of groins constructed along Edisto Island beach. Note the accumulation of sand along the updrift (eastern) margin of each groin.

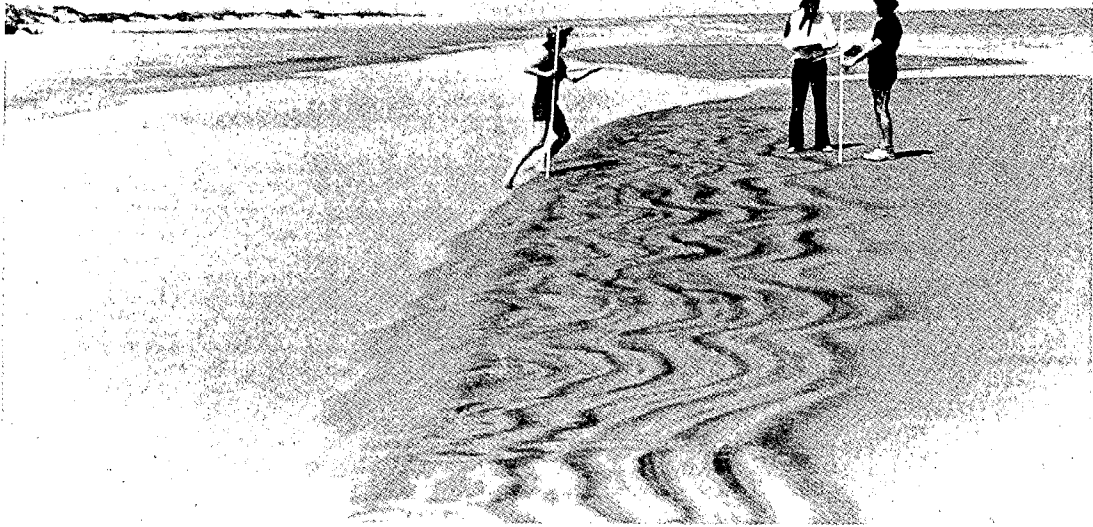
Figure 28. Photograph illustrating the survey technique of Emery (1961) used to determine beach profiles.

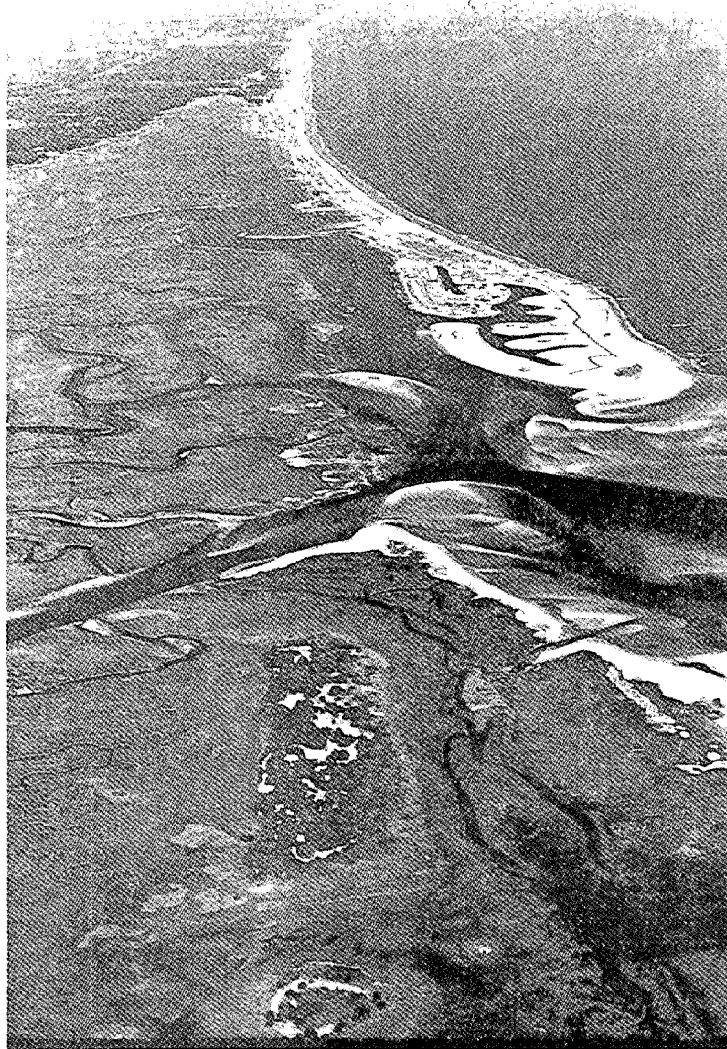
Figure 30. Oblique aerial view of the arcuate strand looking north from Murrells Inlet.(from Brown, 1977).

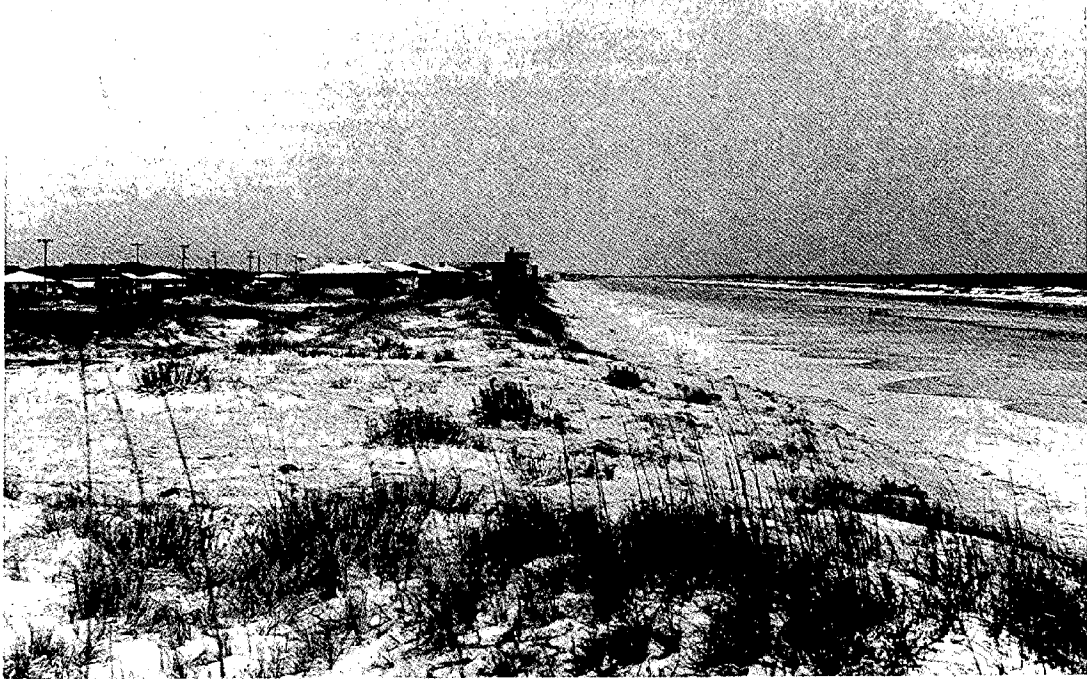
Figure 31. Well-developed dune system in front of the first row of houses at station CGB-1, Garden City beach. These dunes provide protection from storm-produced wave attack.

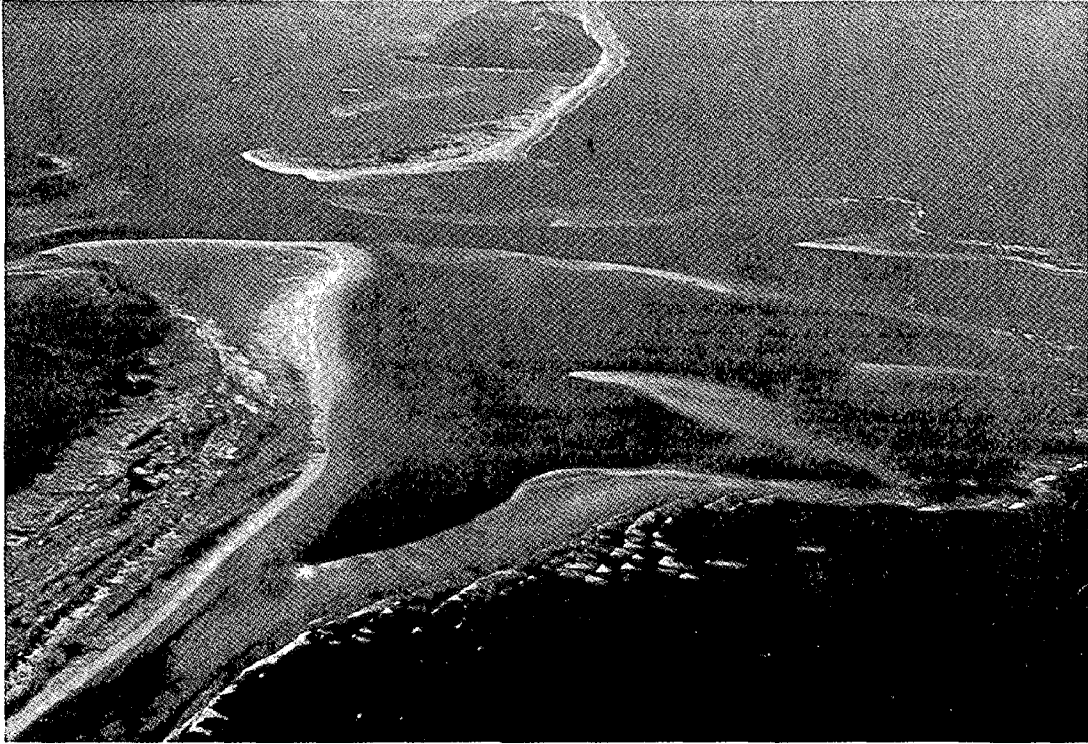
Figure 33. Oblique aerial view of North Inlet that separates Debidue (to the north) and North Islands.

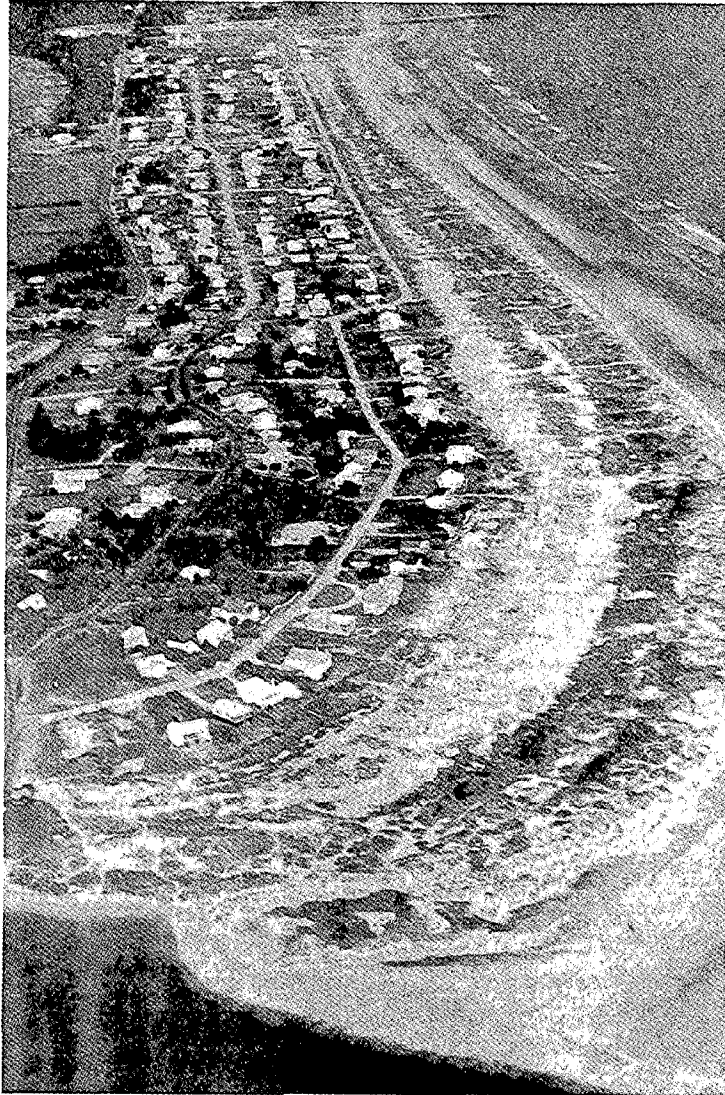
Figure 37. South end of Isle of Palms. Southerly migration of Breach Inlet has allowed the deposition of a recurved spit at the south end of the Isle of Palms. Note houses built on older recurves. Large open area is where a developer has flattened the sand dunes in the location of profile stations IP-03 and IP-04. View looks north.

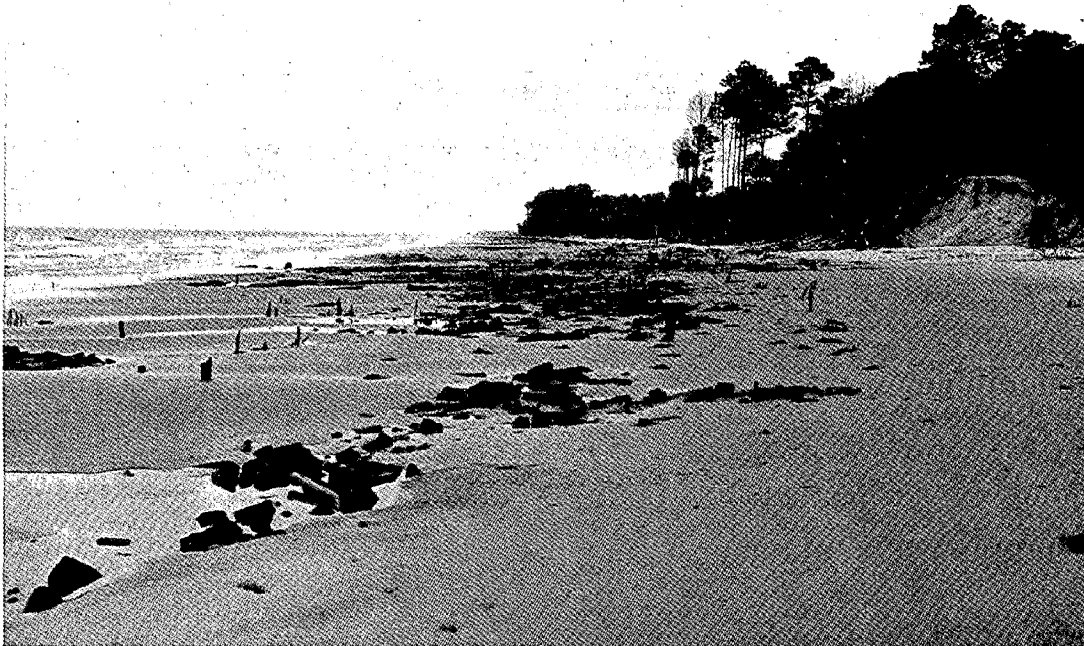
Figure 41. Tree remains exposed on the present beachface in the locality of station HI-02 at Hunting Island.

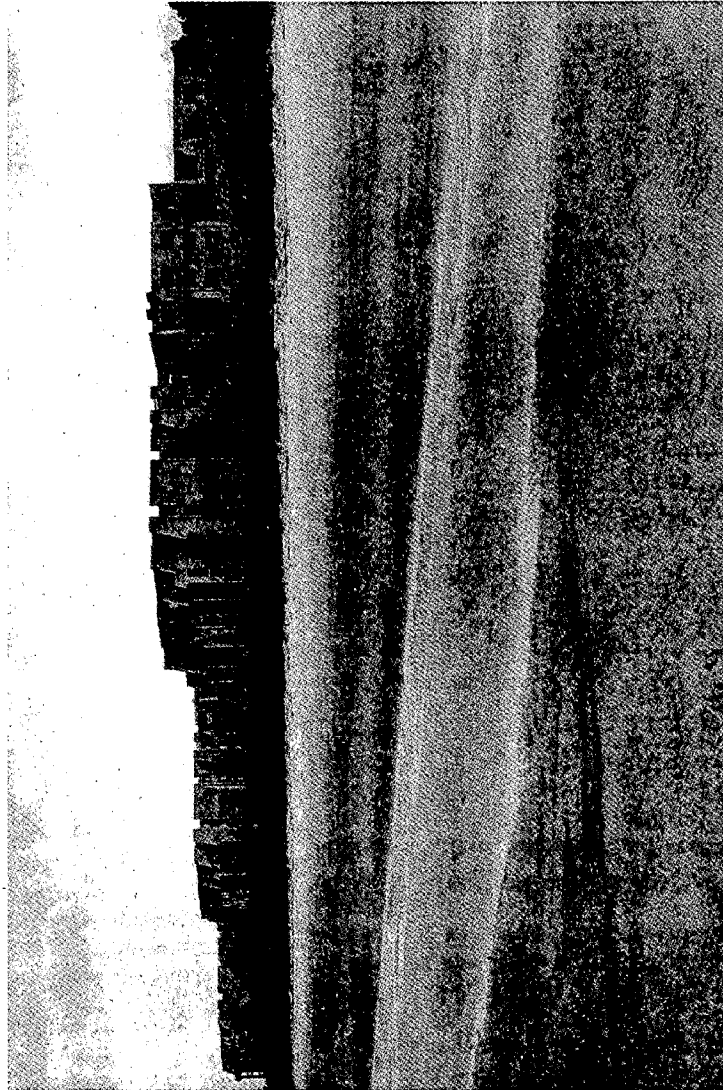
Figure 43. Ground view of profile station HHI-2 at Hilton Head Island. The beach in this location is backed by a low planted ridge covered by Uniola (sea oats).
