HISTORICAL CHANGES AND RELATED COASTAL PROCESSES, GULF AND MAINLAND SHORELINES, MATAGORDA BAY AREA, TEXAS

J. H. McGowen and J. L. Brewton

BUREAU OF ECONOMIC GEOLOGY
The University of Texas at Austin
Austin, Texas 78712
W. L. Fisher, Director

THE GENERAL LAND OFFICE OF TEXAS
Bob Armstrong, Commissioner

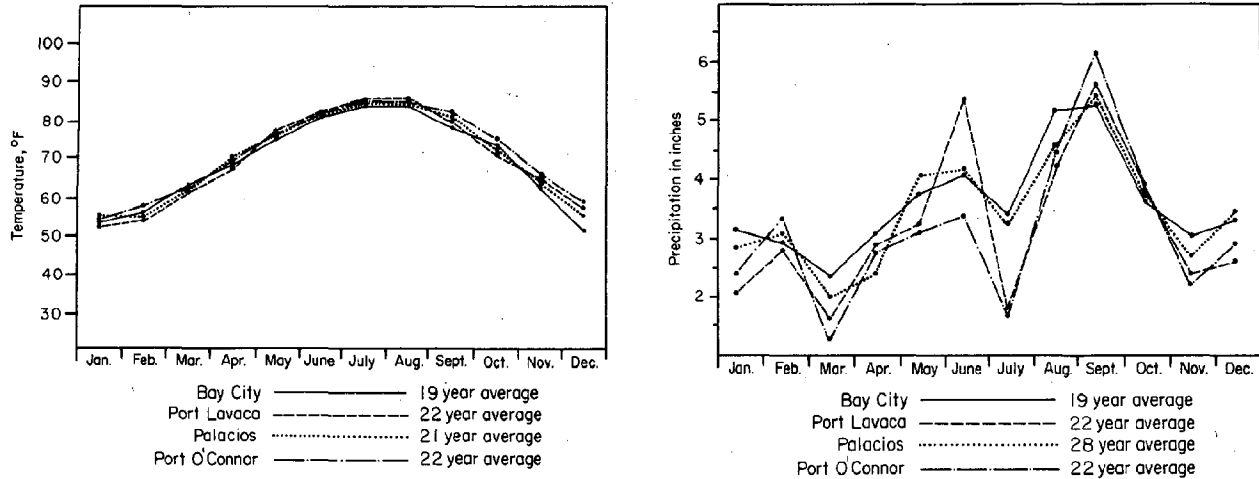
Figure 4. Temperature and rainfall distribution for Bay City, Port Lavaca, Palacios, and Port O'Connor. (A) Mean monthly temperature. (B) Mean monthly precipitation. Data from U. S. Dept. Commerce, Climatological summary, Bay City, 1943-1961, and from Env. Sci. Serv. Adm., U. S. Dept. Commerce, Palacios 1941-1968, Port Lavaca 1947-1968, and Port O'Connor, 1948-1969.

Climate of the Matagorda Bay area is humid subtropical (U. S. Department of Commerce, 1958-1969). Rainfall and temperature data (fig. 4) are almost identical for four weather stations in the vicinity of Matagorda Bay (fig. 5). Rainfall distribution graphs show two peaks, one in June and the other in September, which coincide with thunderstorm and hurricane occurrences, respectively.

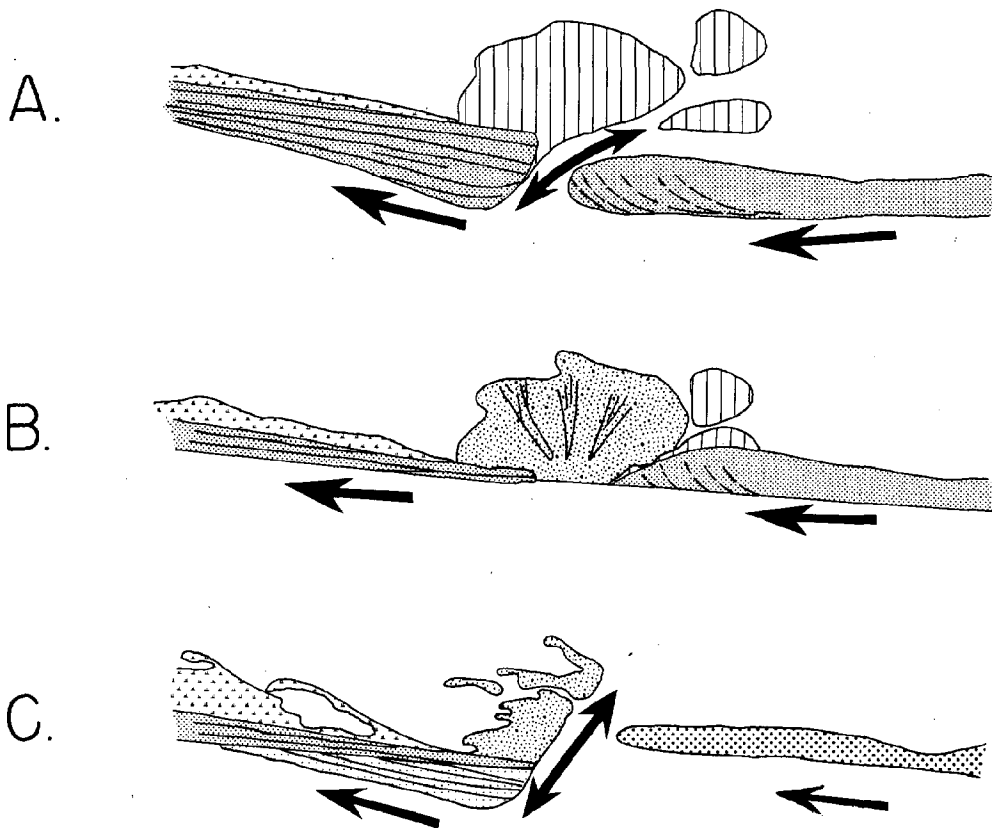
- A. CLOSING OF TIDAL PASS
 B. TIDAL PASS CLOSED, DELTA BECOMES A WASHOVER, BEACH EROSION
 C. TIDAL PASS OPENED, TIDAL DELTA ERODED, BEACH ACCRETION

Figure 14. Postulated sequence of events leading to the development of an erosional unconformity on Matagorda Island. Sequence C is the present configuration of Matagorda Peninsula and Matagorda Island in the vicinity of Pass Cavallo.
