SHORELINE EROSION IN VIRGINIA

A Sea Grant Advisory Service of the
College of William and Mary

Educational Series No. 31

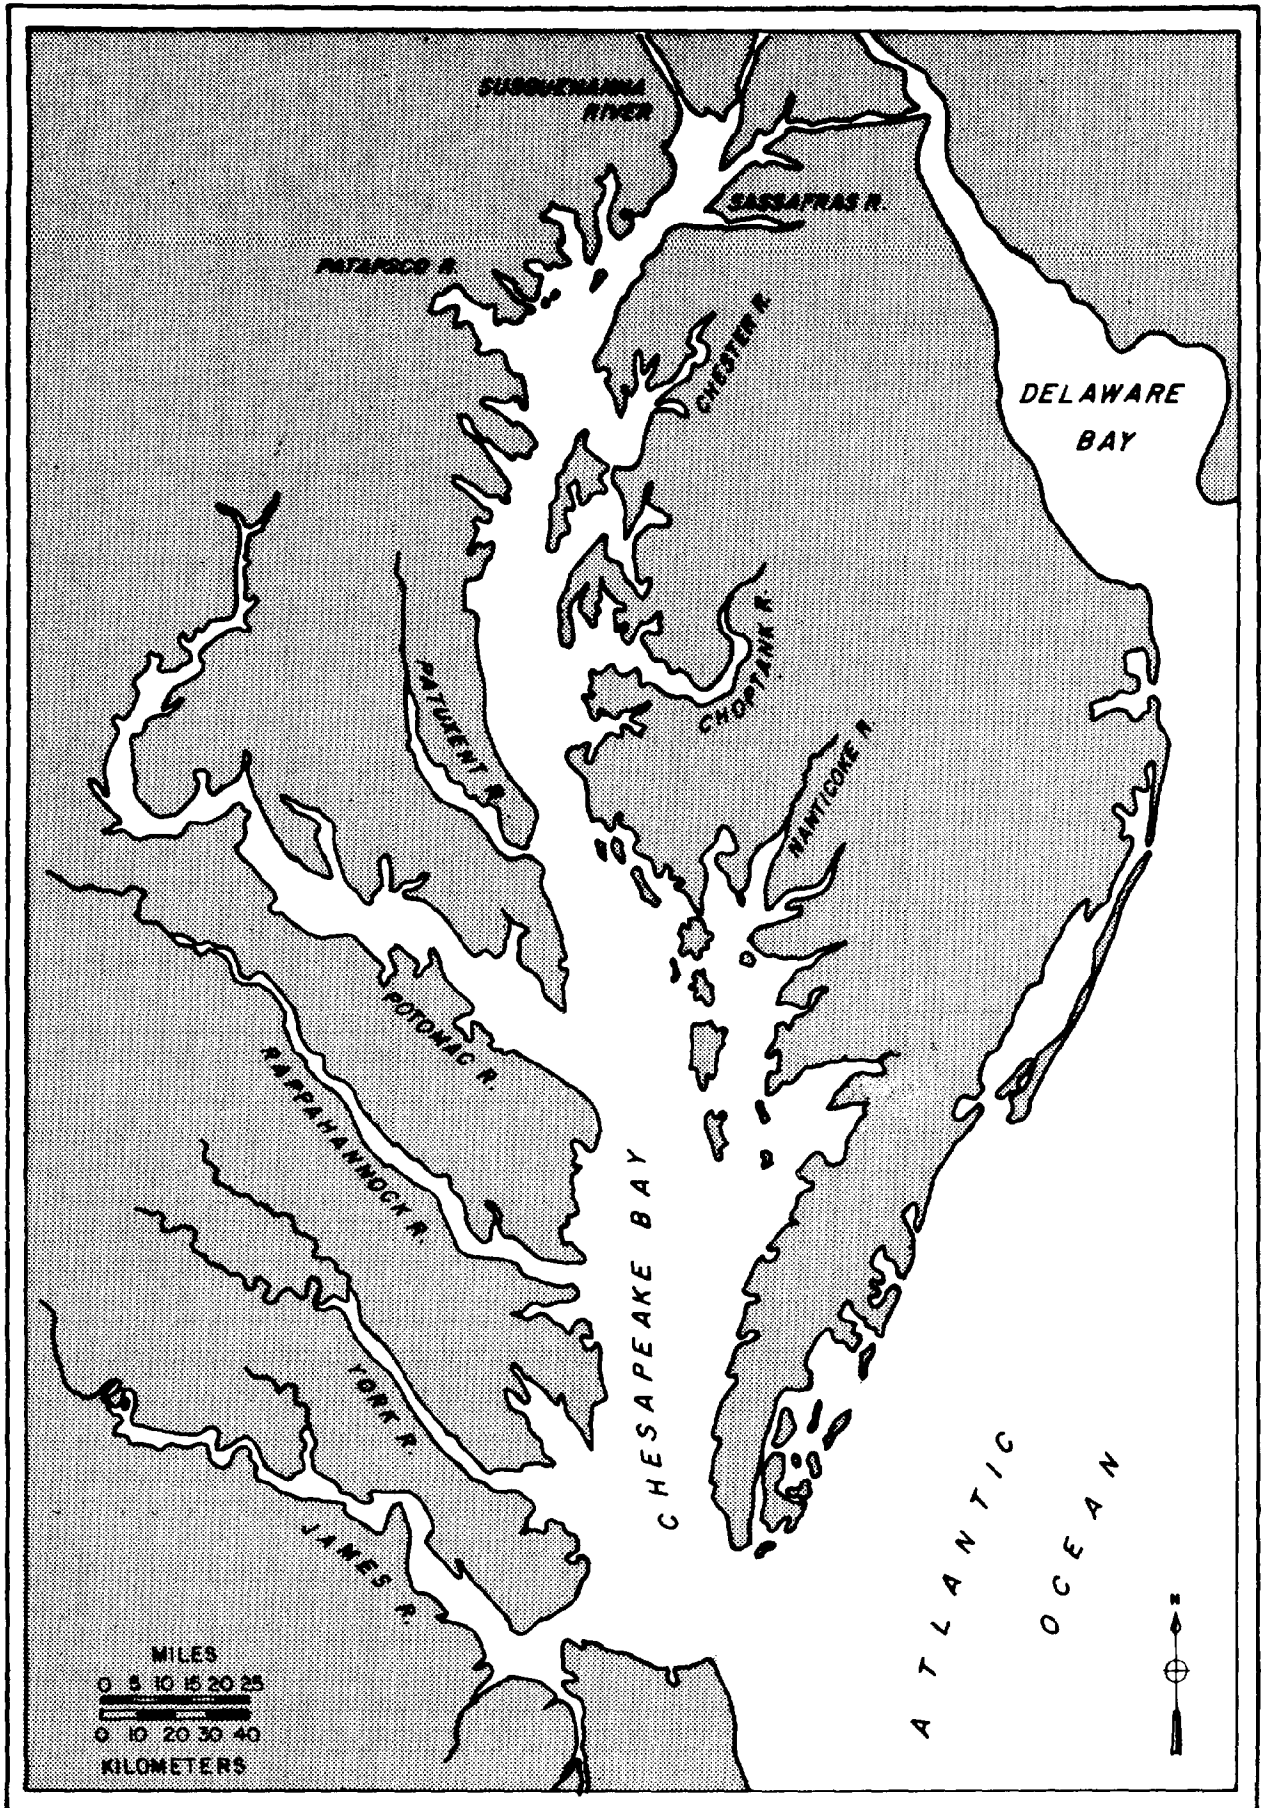
Figure 1 — Chesapeake Bay and its tributaries.

The Chesapeake Bay and its tributaries are drowned river valleys of the ancestral Susquehanna River system (Figure 1). Drowned river valleys where seawater from the ocean and freshwater from upland rivers mix freely are called estuaries. The circulation in the estuaries is influenced by the astronomical tidal conditions, the amount of fresh water run-off and the shape of the basin.

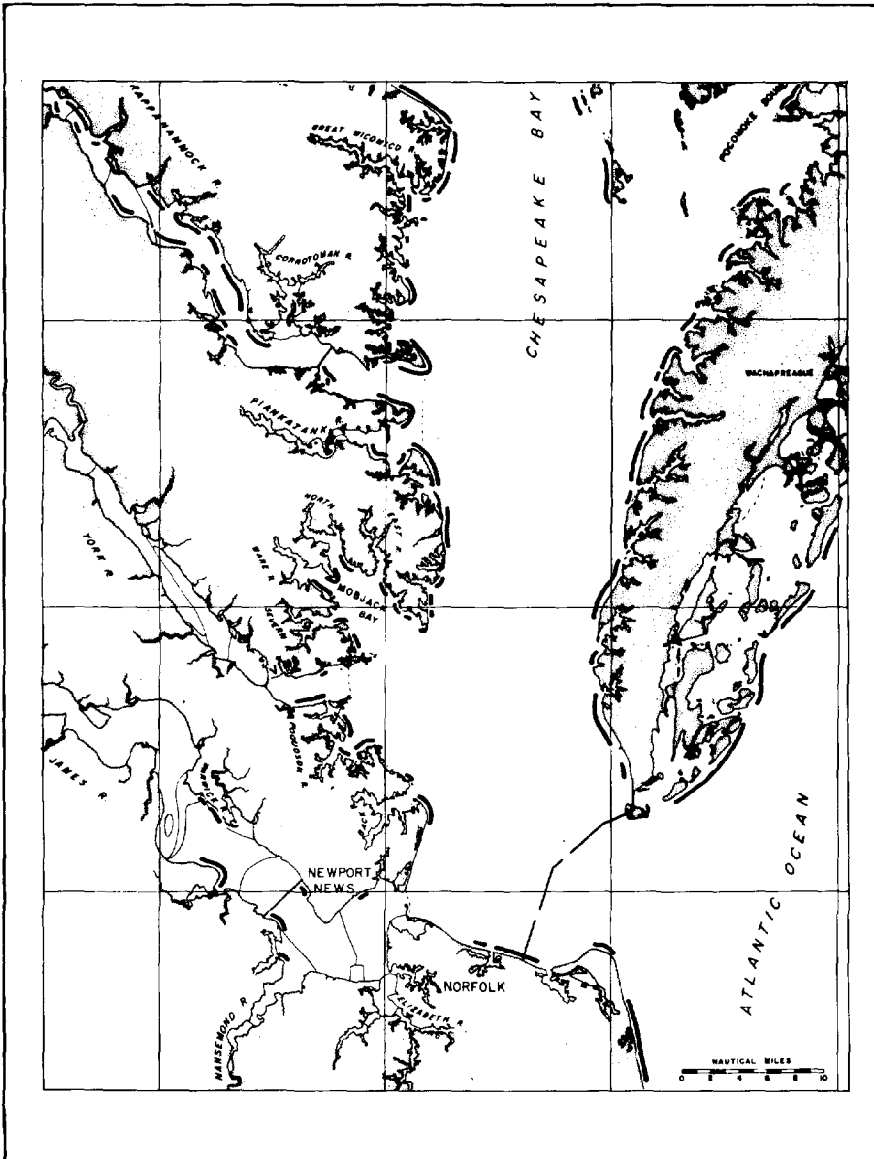
Figure 2 – Green lines indicate erosion rates of two or more feet per year.

line exposure to the northwest, north and northeast directions from where the severest seasonal winds originate. Individual segments of shoreline have experienced erosion rates of more than seven feet per year. However, one or two feet per year is more common. For the 2,365 miles of estuarine shoreline measured, the average rate of erosion is about 0.7 feet per year (Byrne, et al., 1979). The Virginia Institute of Marine Science defines severe erosion as any shoreline segment with a rate of two or more feet

per year (Figure 2). Shoreline erosion becomes a problem when coastal property with improvements (house, cottage, etc.) are threatened by a rapidly receding shore bank.

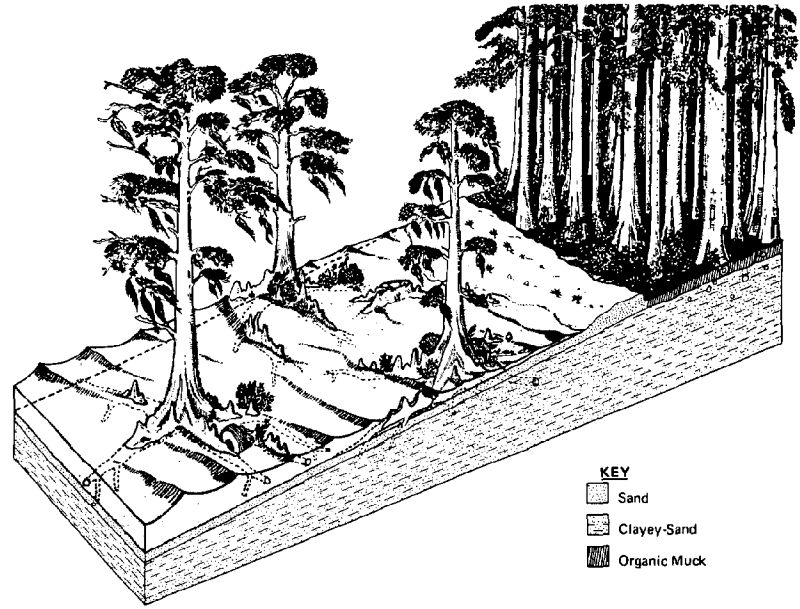
Figure 4 — The cypress fringe damping erosion wave forces and trapping sediments is illustrated in this figure. The cypress trees can form a natural bulkhead which dissipates wave energy and traps sand.

Swamp forests occur as rivers flood plain vegetation (Figure 4). As sea level rises and floods the upland river basins, the flood plains become the receding shoreline. In Virginia, extensive reaches of swamp forest shorelines occur in the upper portions of the tributary estuaries and their lateral creeks.

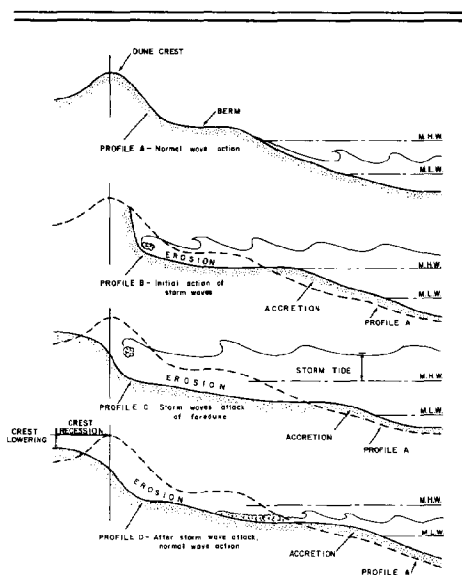
Figure 3 — Creation of nearshore bar during a storm.

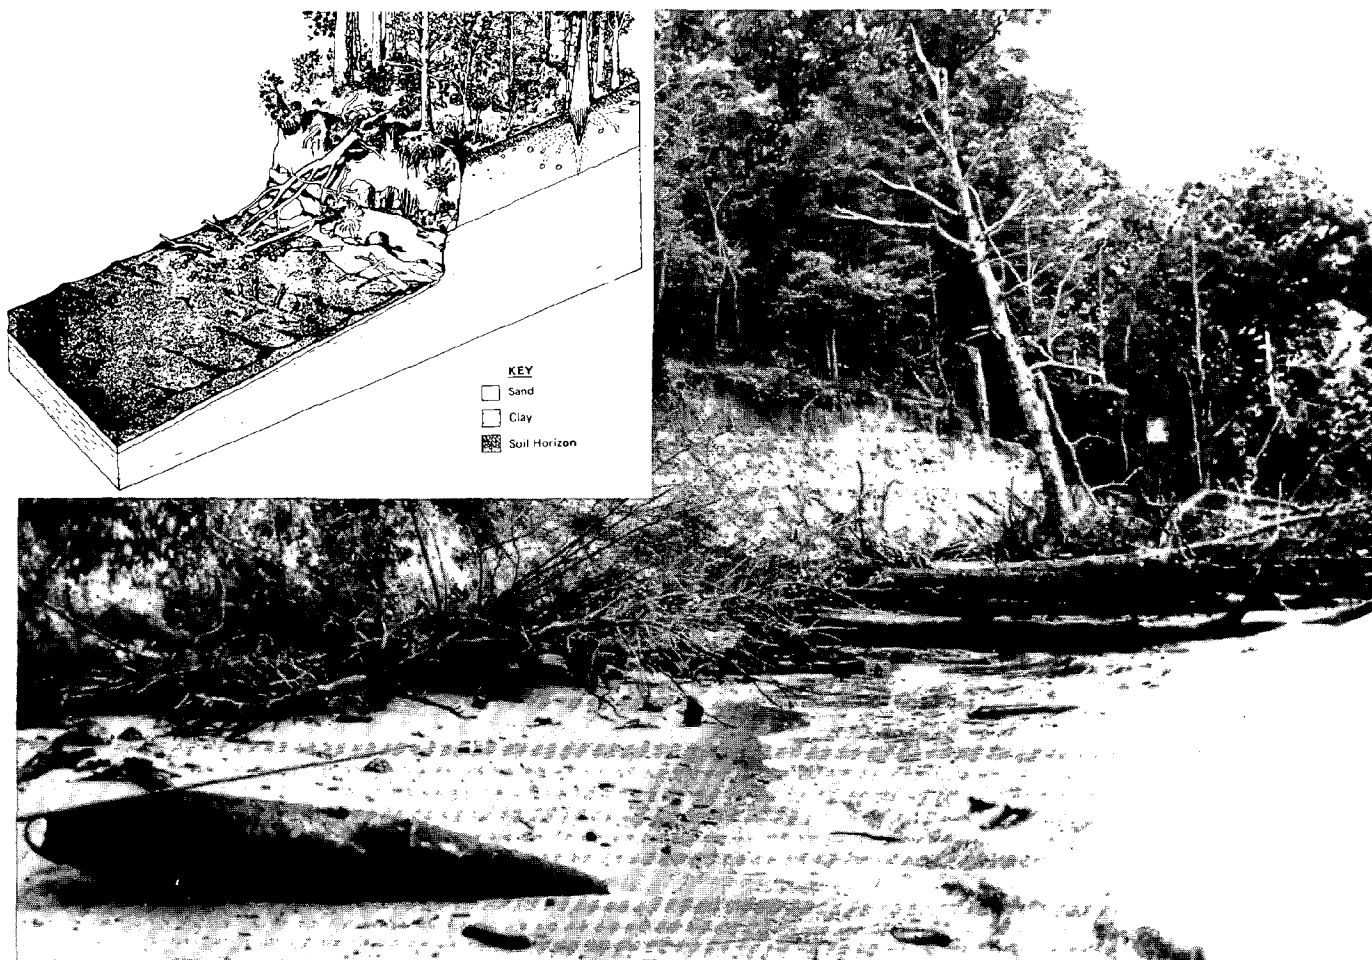
Figure 5 — Erosion of sediment banks is the primary source of material for the beaches along the estuarine shoreline. (Upper right) storm waves undercut the high bank causing slump blocks, along with the vegetative cover, to slide onto the beach. In this illustration, the slump blocks are reduced by further wave action, leaving behind debris of fallen timber.

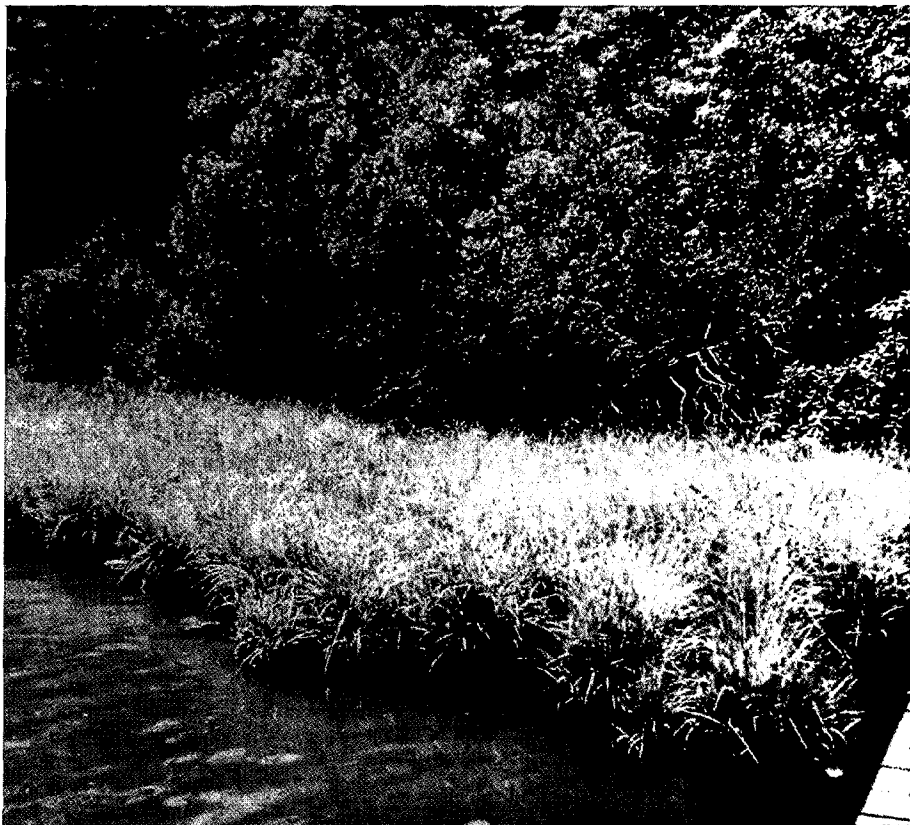
Figure 6 — Fringe marshes offer excellent natural buffers to erosion. The marsh grass greatly reduces wave energy acting on the shoreline.

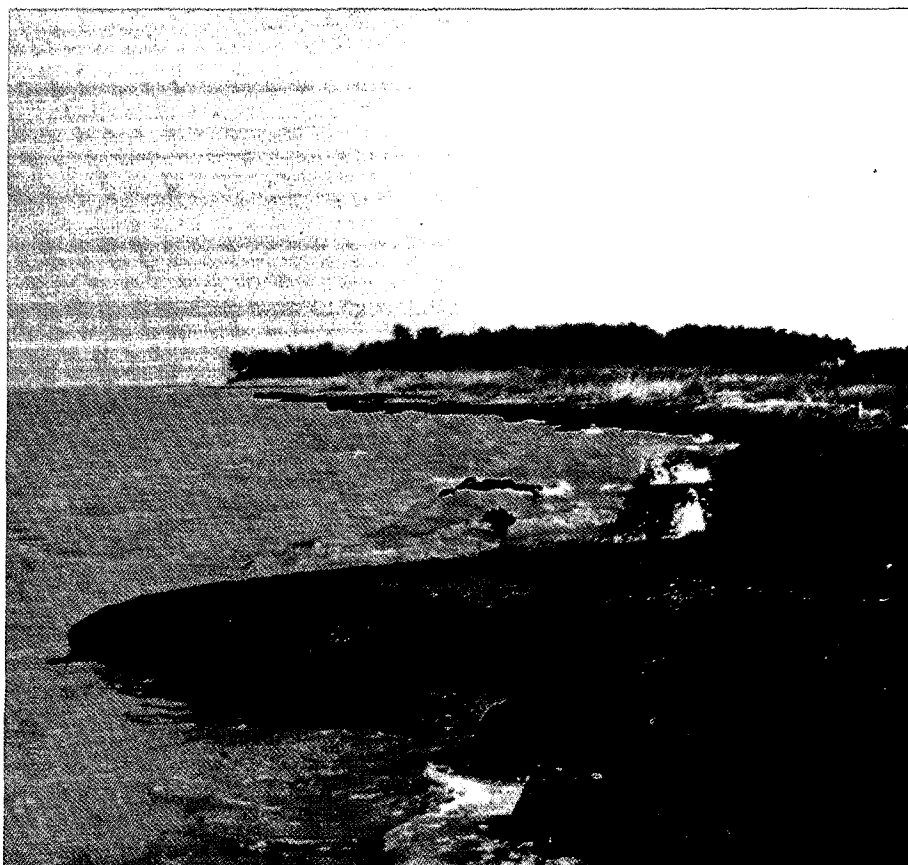
Figure 7 — Extensive marsh plains occur along many low lying areas bordering the Chesapeake Bay.

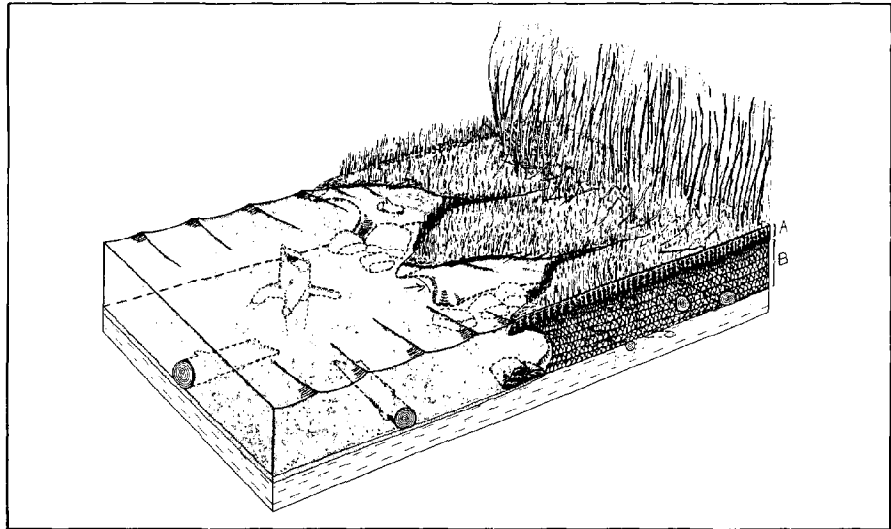
Figure 9 - The factors involved in erosion of the brackish marsh shoreline are illustrated. During low tide, wave action erodes the softer underlying peat (B), undercutting the firm surface layer (A). The peat shelf breaks into blocks that fall into the water, leaving U-shaped notches along the bank.

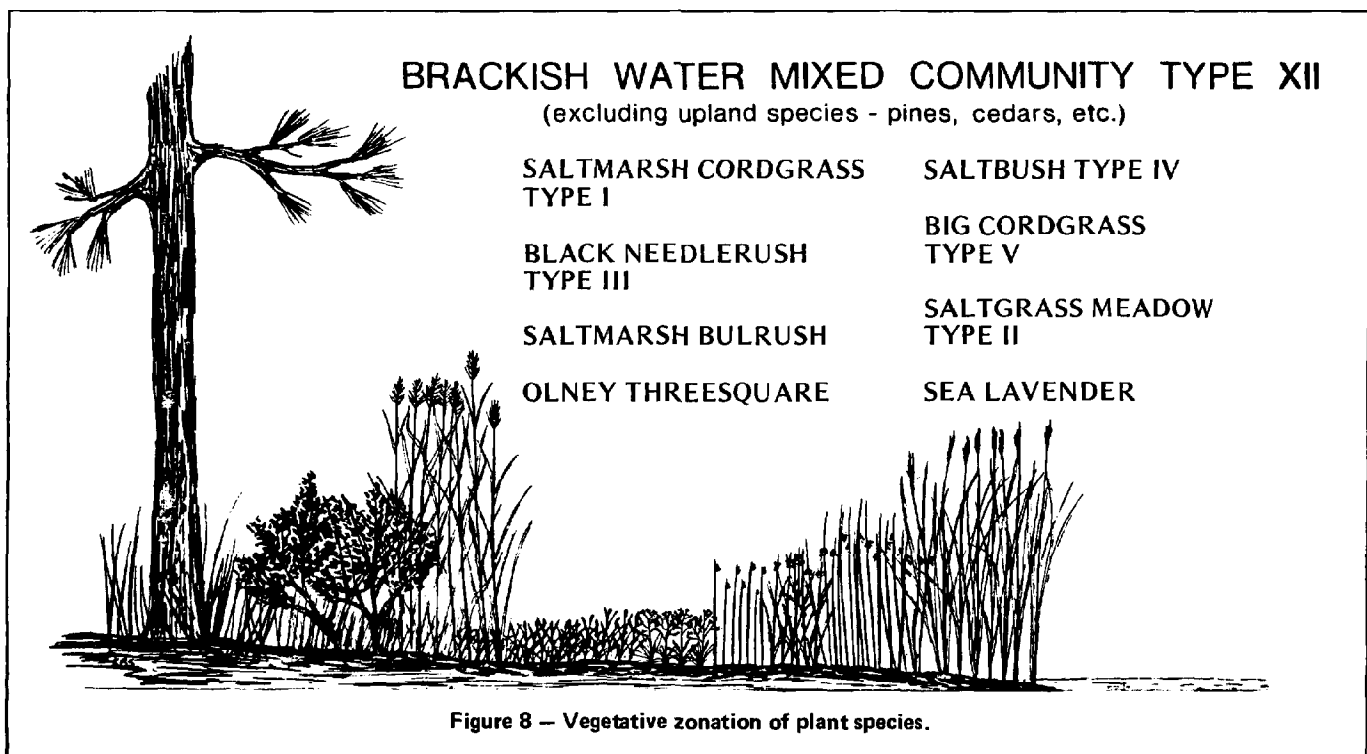
Figure 8 - Vegetative zonation of plant species.

Figure 8 depicts tidal wetlands of Virginia and the vegetative zonation of plant species. There are 212,000-225,000 acres of tidal marshes in Virginia. In addition to their value as an essential link in the estuarine food chain, marshes also act as effective buffers to erosion of the fastland. Their low elevation and matted root system make marshes more resistant to wave erosion than sediment banks exposed to the same fetch conditions.

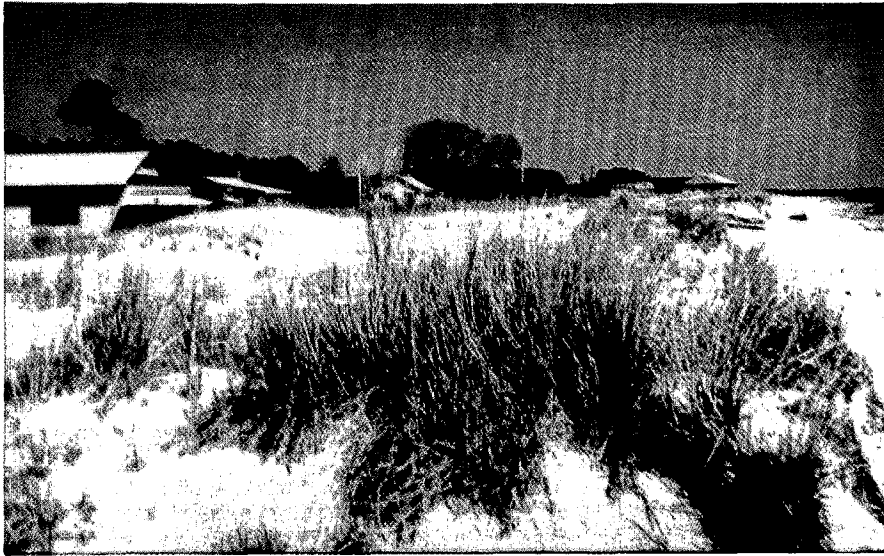
Figure 10 — Extensive low-lying dune shorelines occur along bay shores in Hampton, Mathews County and Northumberland County.

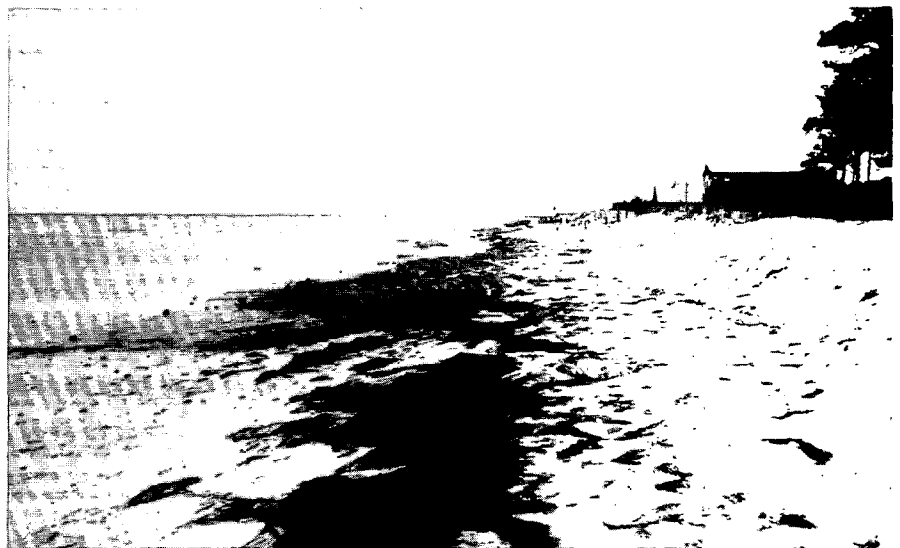
Figure 11 — The dune shorelines recede by washovers during storms. This often exposes a peat horizon which was once a living marsh behind the dune system bayward of its current position.

active beach, forcing the beach to react to a reduced sand supply by retreating. In many instances this retreat exposes the surface of marsh peat covered by previous washovers (*Figure 11*).

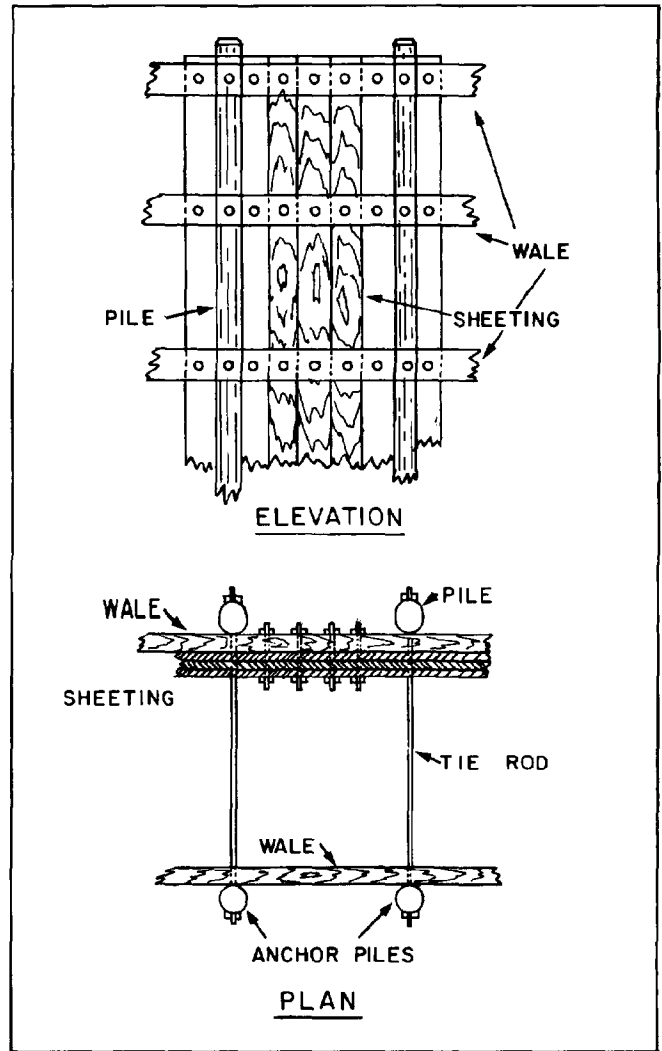
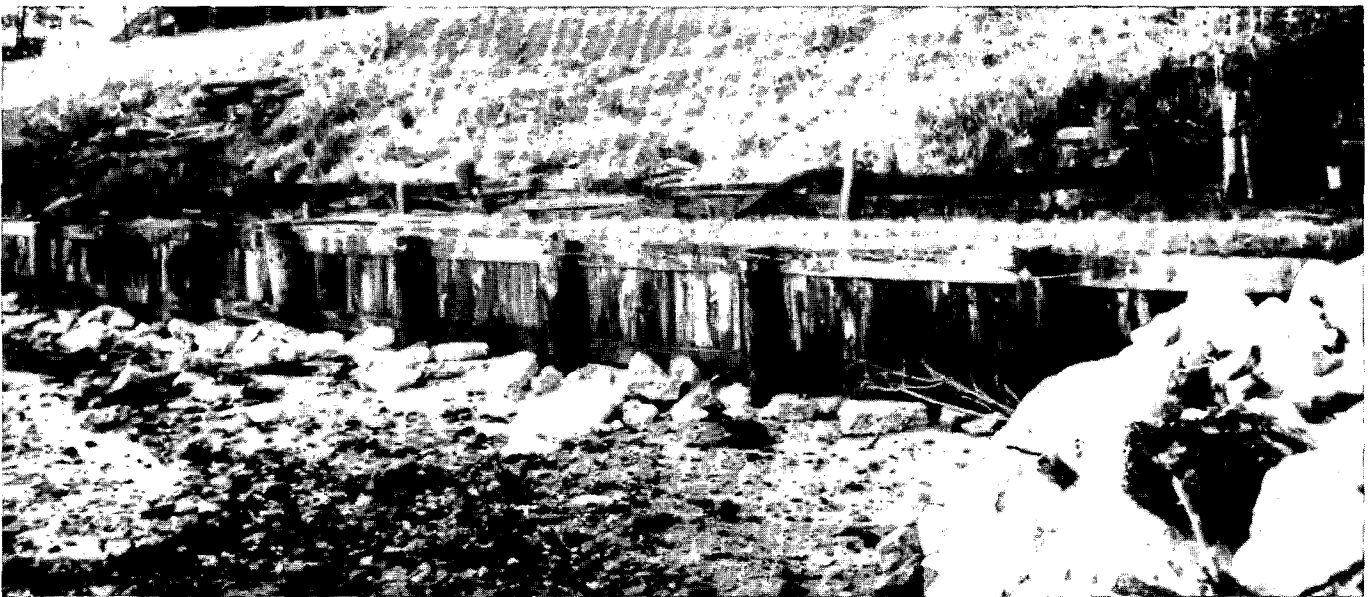
Figure 14A — Wooden bulkhead. Figure 14B (top right) timber sheet - pile bulkhead.

The respective definitions of these structures vary little although different construction materials are sometimes associated with each structure (Figures 14A & B, 15, 16A & B). Vertical structures act to retain the fastland material and to prevent wave induced erosion. In one way, they can be thought of as defensive structures. However, in many situations, vertical structures lead to the loss of the beach which may front them.

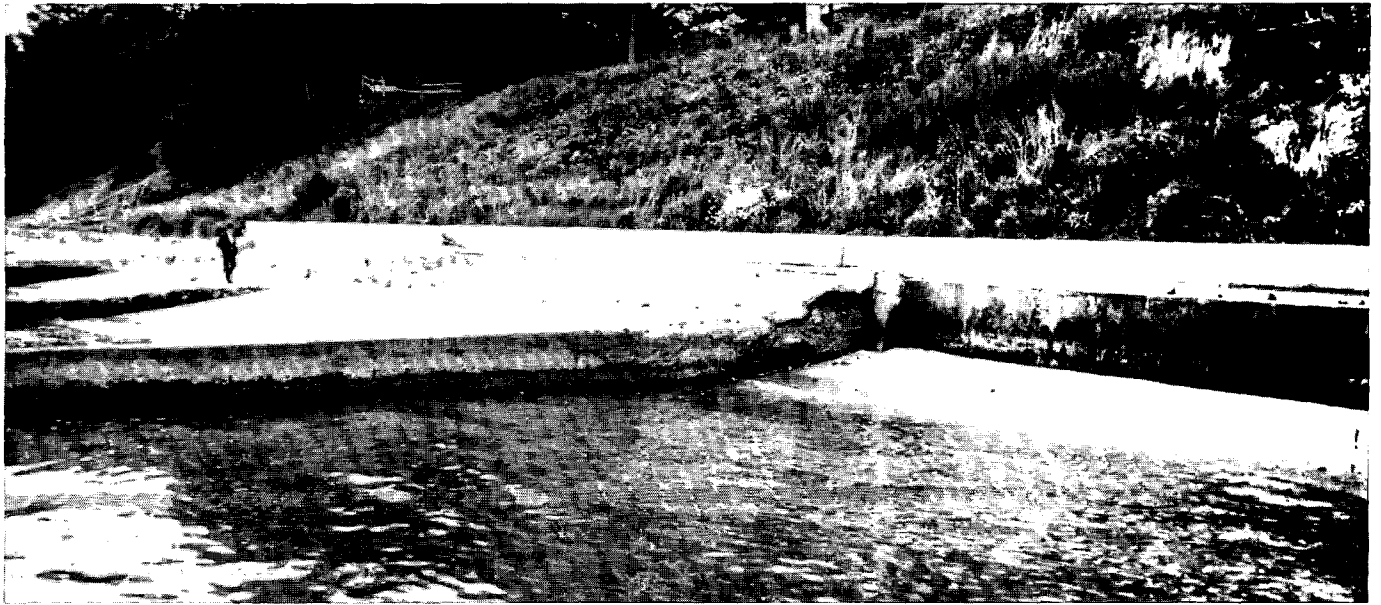
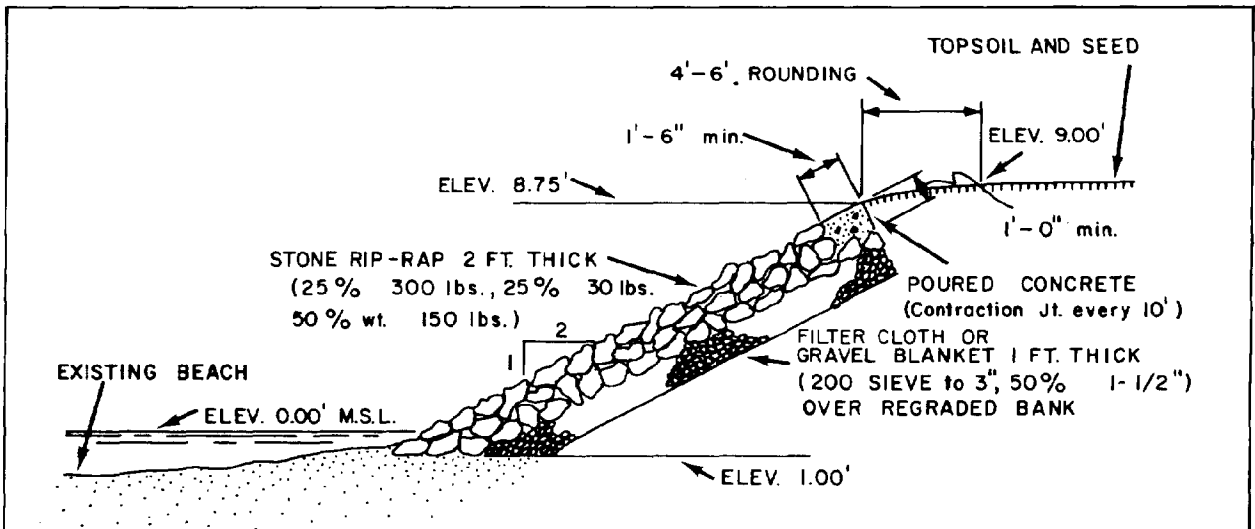
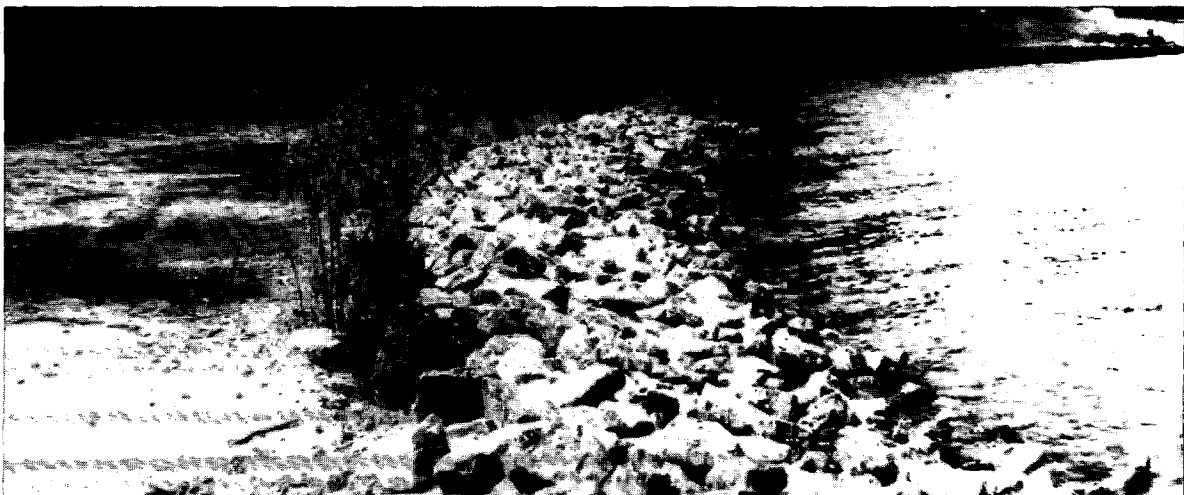
Figure 15 — Concrete seawall (top). Figure 16B (bottom) small riprap revetment. Figure 16A (middle) riprap revetment.

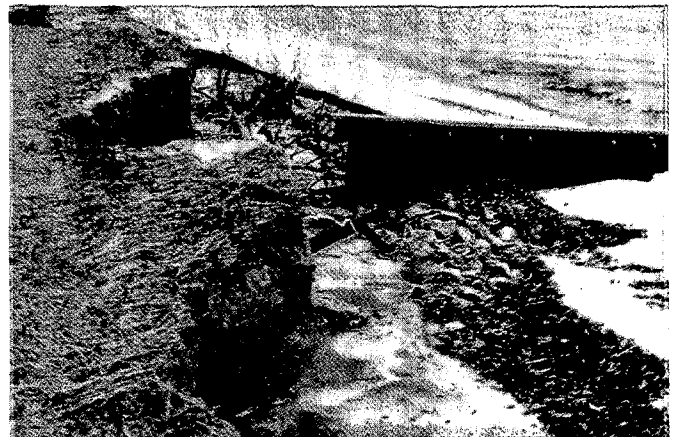
Figure 18 – Groin which has been flanked by severe erosion.

Imperative in the success of groins is an adequate supply of sand to quickly fill the groins and then begin bypassing sand. An inadequate supply of sand can lead to accelerated erosion downdrift of the groin. In some cases, this accelerated erosion can flank the groin rendering it totally useless (see Figure 18).

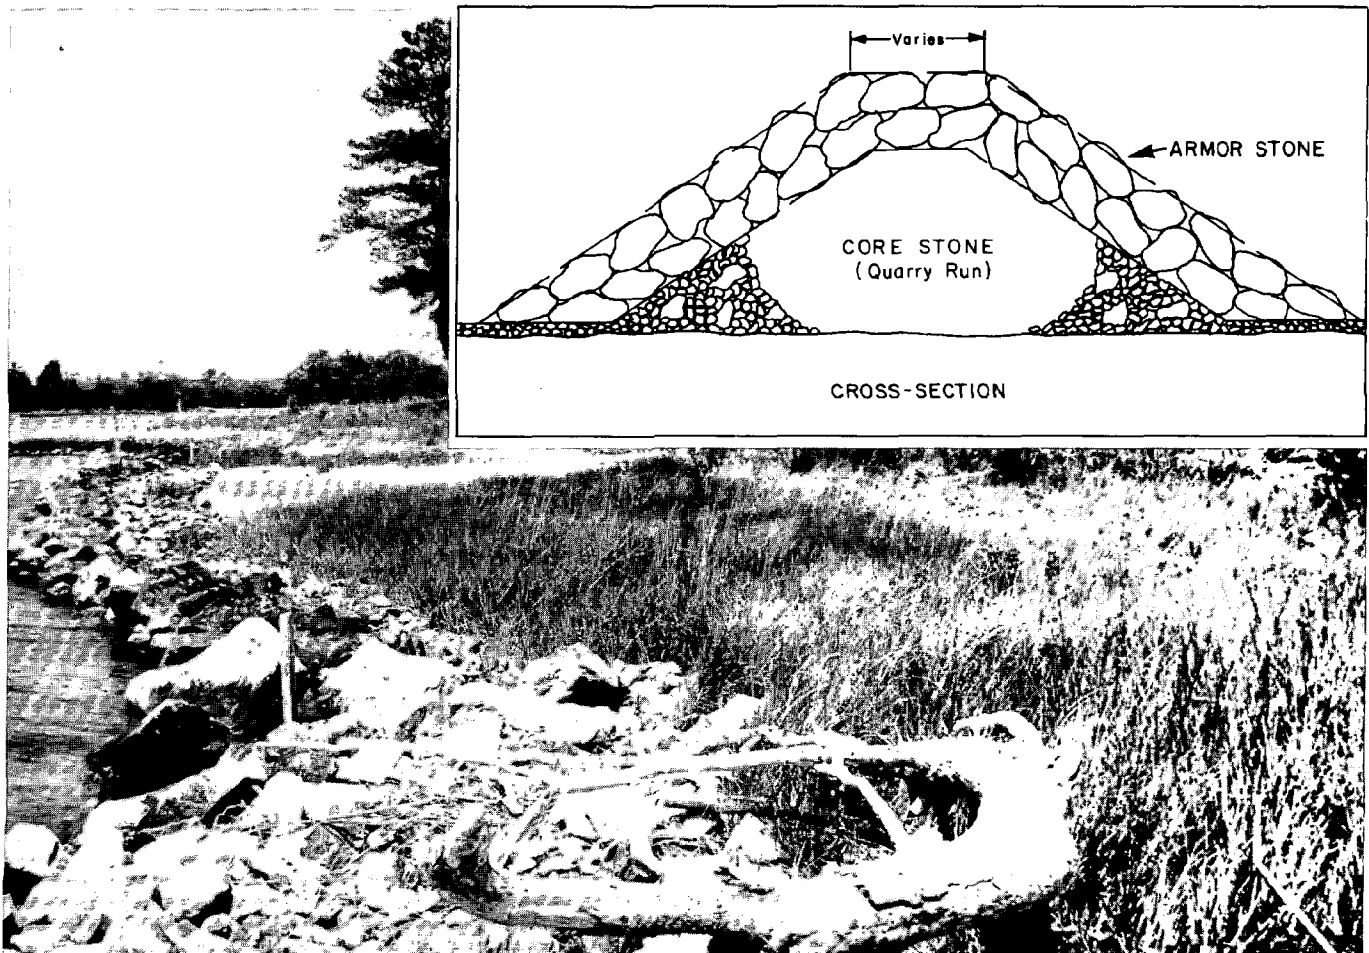
Figure 19A – Small stone breakwater. Figure 19B (upper right) generalized cross section of a large stone breakwater.

A solid breakwater is a structure usually constructed of stone, which serves to reduce wave height (Figures 19A & B). This reduction of wave height reduces the erosive power of the waves striking the beach or entering a harbor. As solid breakwaters work to resist the full power of the incoming waves, the structure must be massive. If not designed and placed properly, they can lead to accelerated nearshore currents which can cause erosion. Used incorrectly, they can halt the parallel littoral sand transport leading to accelerated erosion downdrift.

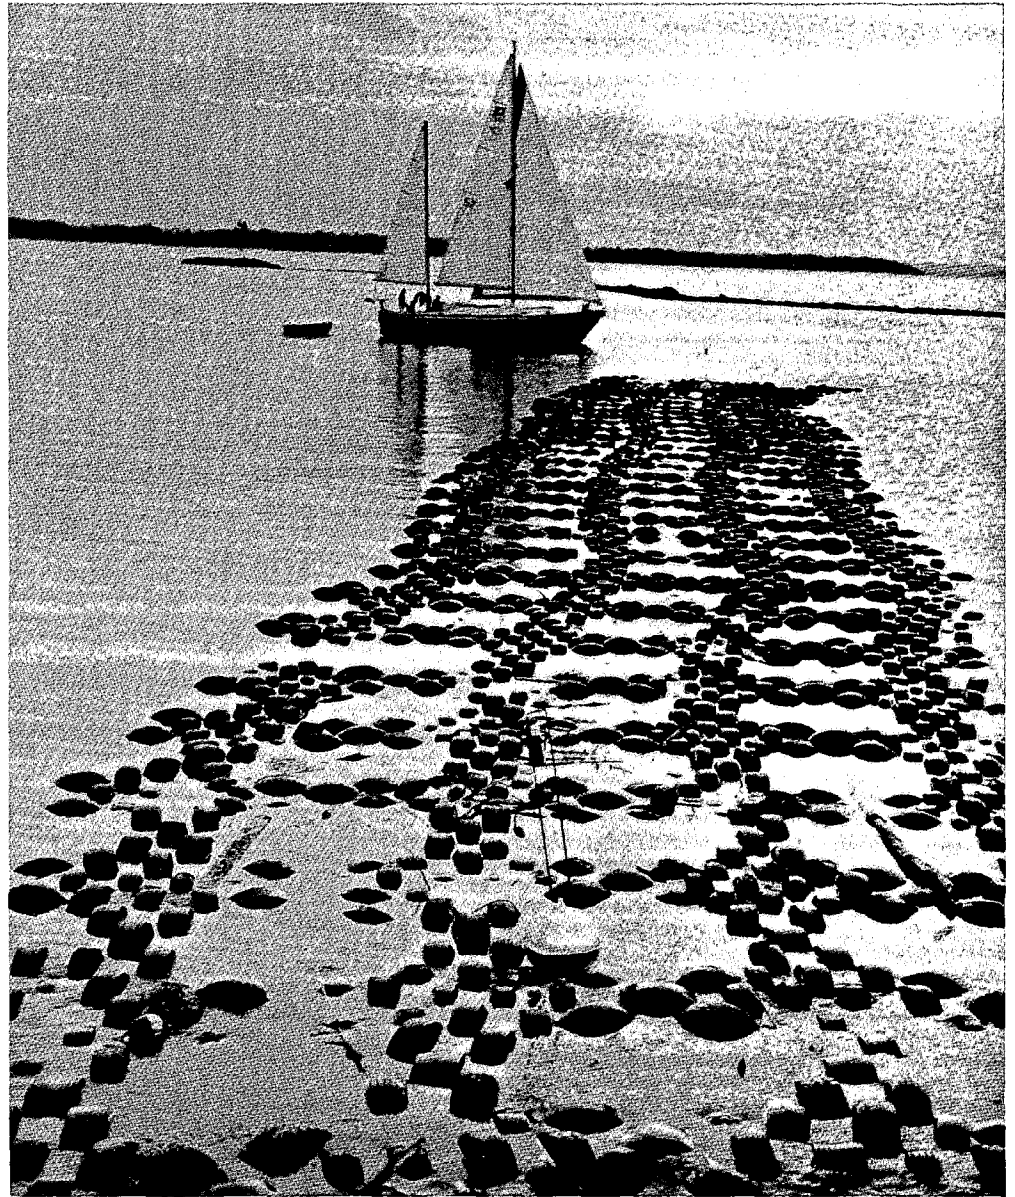
Figure 20 — Floating
tire breakwater.

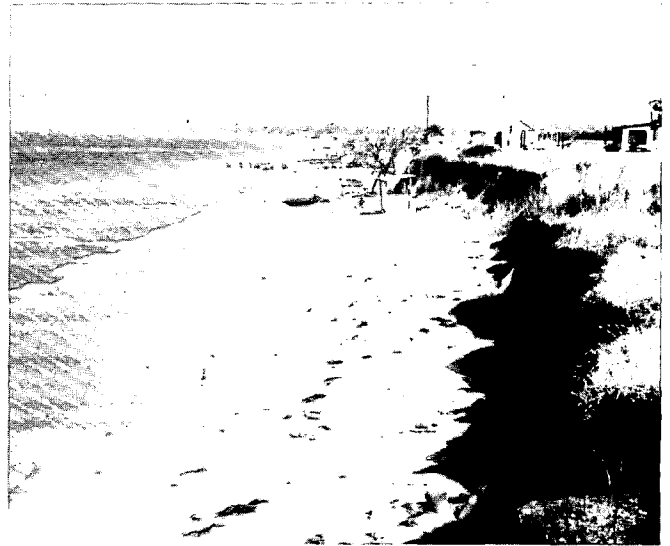
Figure 21A — Sandbag sill.

The principle involved is known as a perched beach. As illustrated (Figures 21A & B) the desired effect is to elevate the profile of the beach. If successful, a protective layer of sand exists at the base of a cliff or bulkhead. Because this layer is significantly higher than the unprotected backshore height, additional protection is afforded during storm elevated water levels. This system offers protection from all wave angles and at higher water levels. In essence, it resembles a "permanent" bar situated at the step of the beach.

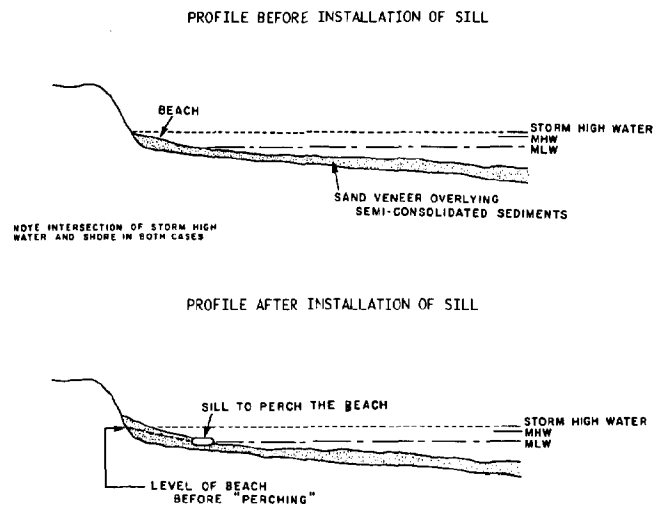
Figure 21B — Perched beach concept.

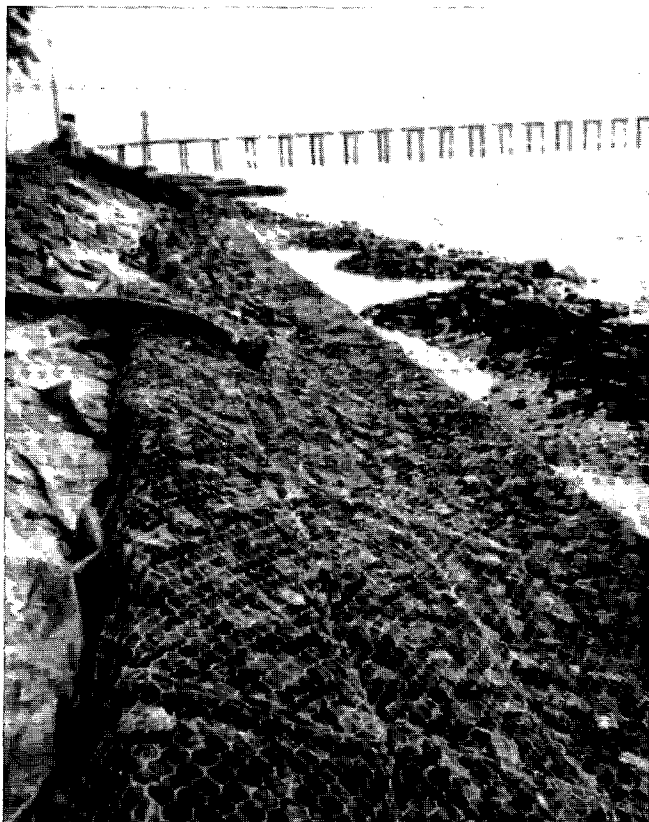
Figure 22 – Gabion revetment.

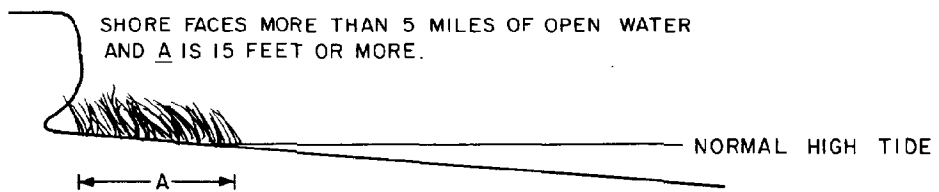
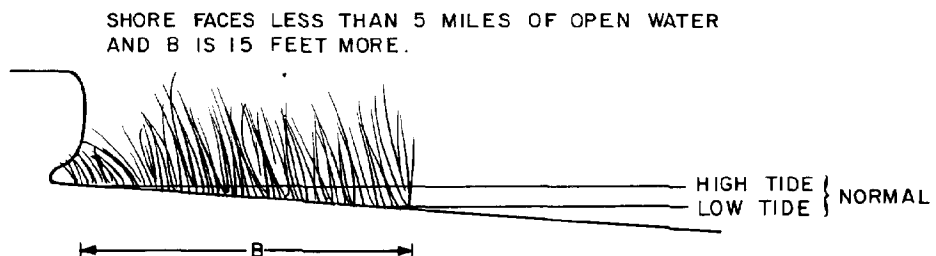
Figure 23 — Marsh site suitability scheme.
