<b>Project Period</b>	8/01/2013 - 8/30/2015
<b>Project Location</b>	Napili Kahawai carries storm runoff down Napili 4-5 watershed onto the beach & bay at Napili, Maui.
<b>Description (from Proposal)</b>	Napili is on northwest coast of Maui, HI.
<b>Project Summary (from Proposal)</b>	Finalize streambed remediation to complete planned flora restoration, and expand Napili Bay health monitoring efforts to include assessment of nutrient pollutants in runoff.
<b>Summary of Accomplishments</b>	<p>Napili Bay and Beach Foundation hired a contractor to successfully clean out and replant the ephemeral streambed we have named Napili Kahawai (Napili stream). This was done in accordance with the plans from the consulting firm Sustainable Resources Group International, Inc. (srgii), to mitigate further erosion damage causing deposition of sediment into Napili Bay.</p> <p>Water quality monitoring and visual observations have demonstrated no sedimented runoff events from this watershed since this project was completed in Spring, 2014.</p> <p>An expanded water quality monitoring program that conforms to data needed by Hawaii Department of Health, Clean Water Board was initiated in Summer, 2015. Data

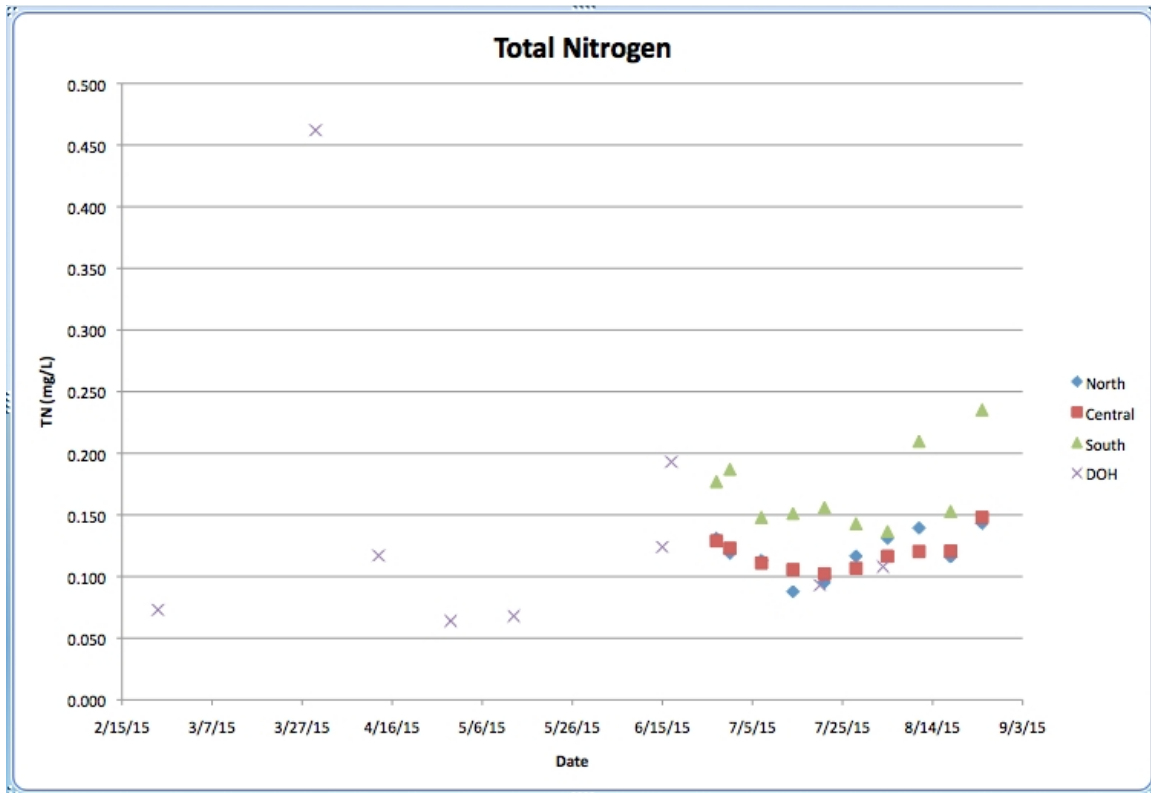
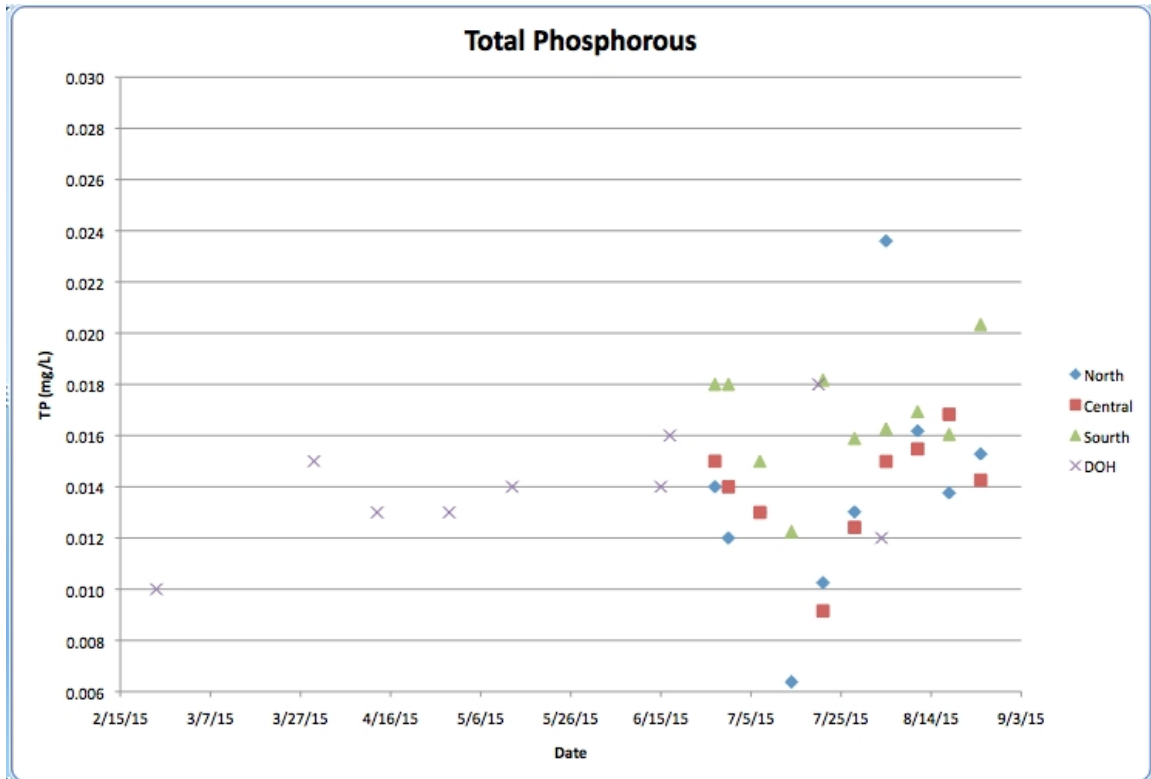
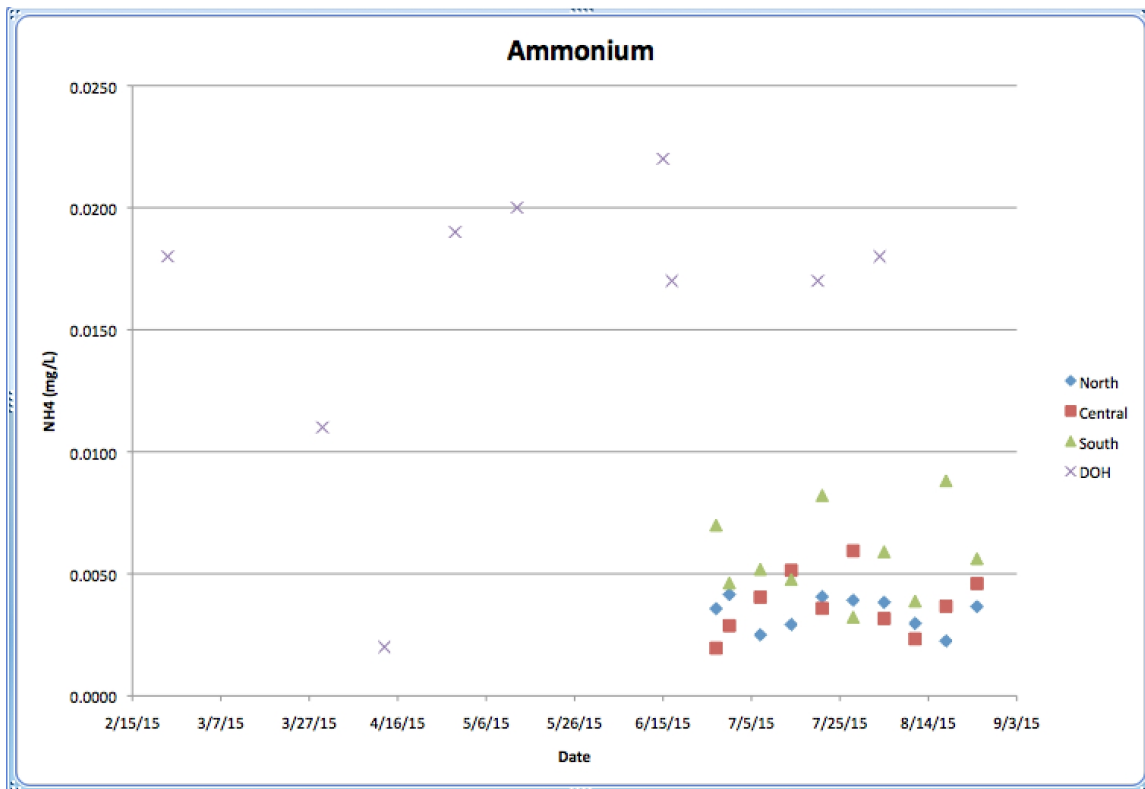
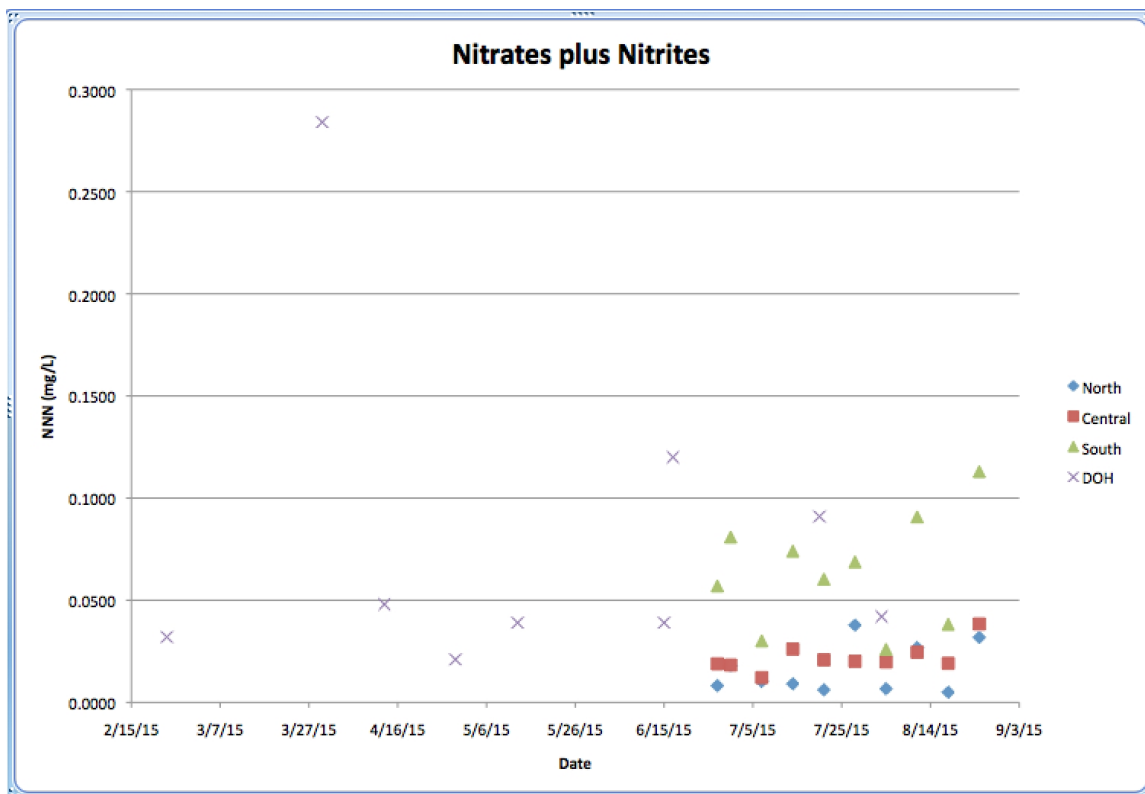
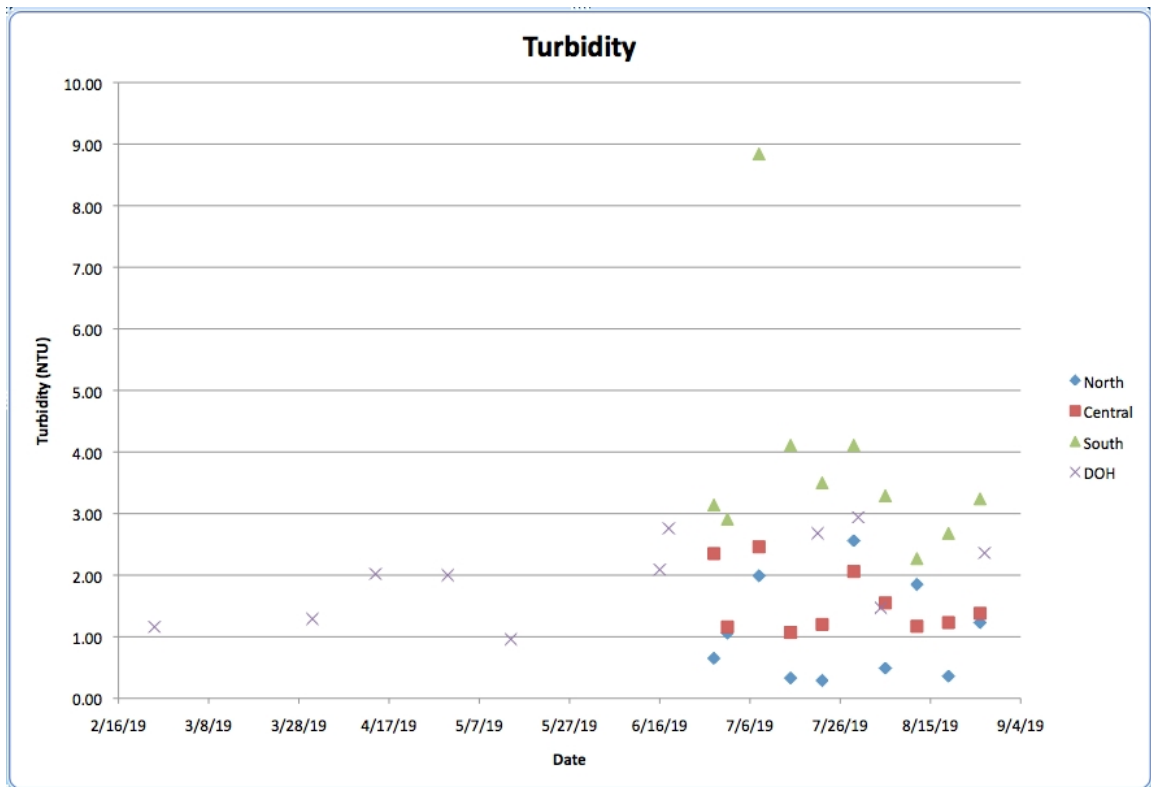
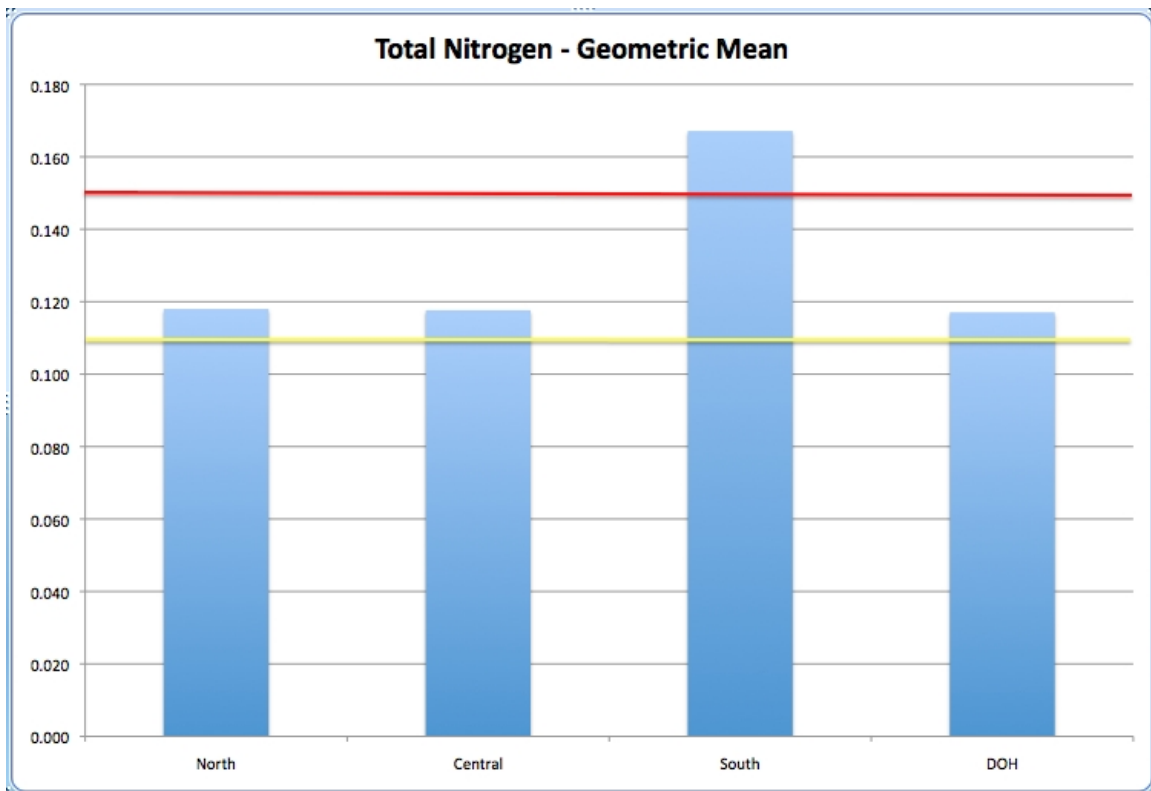
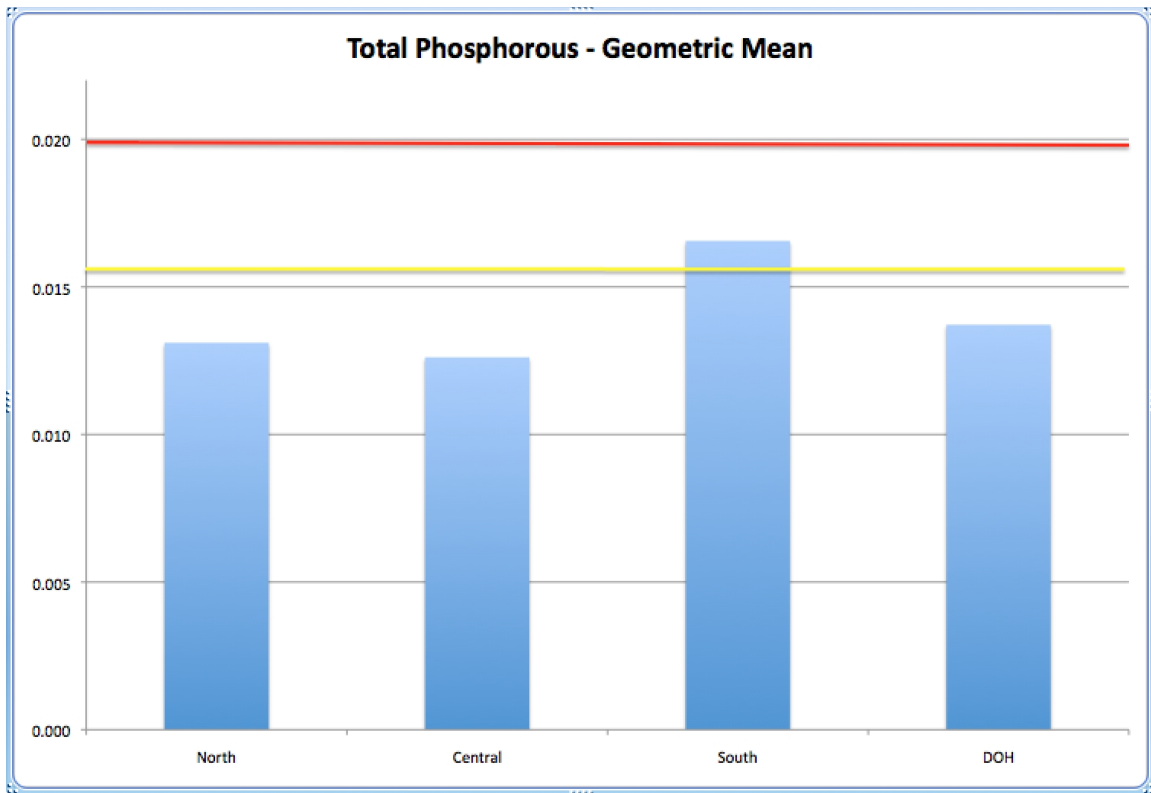
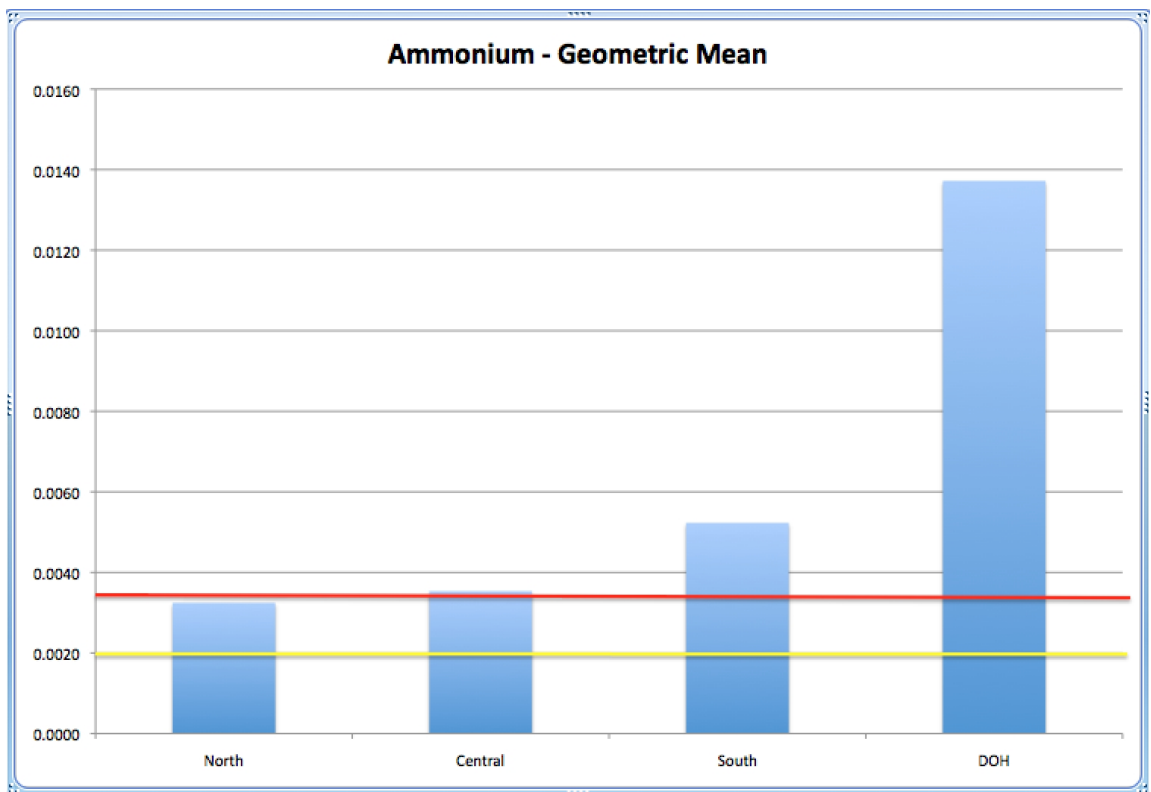
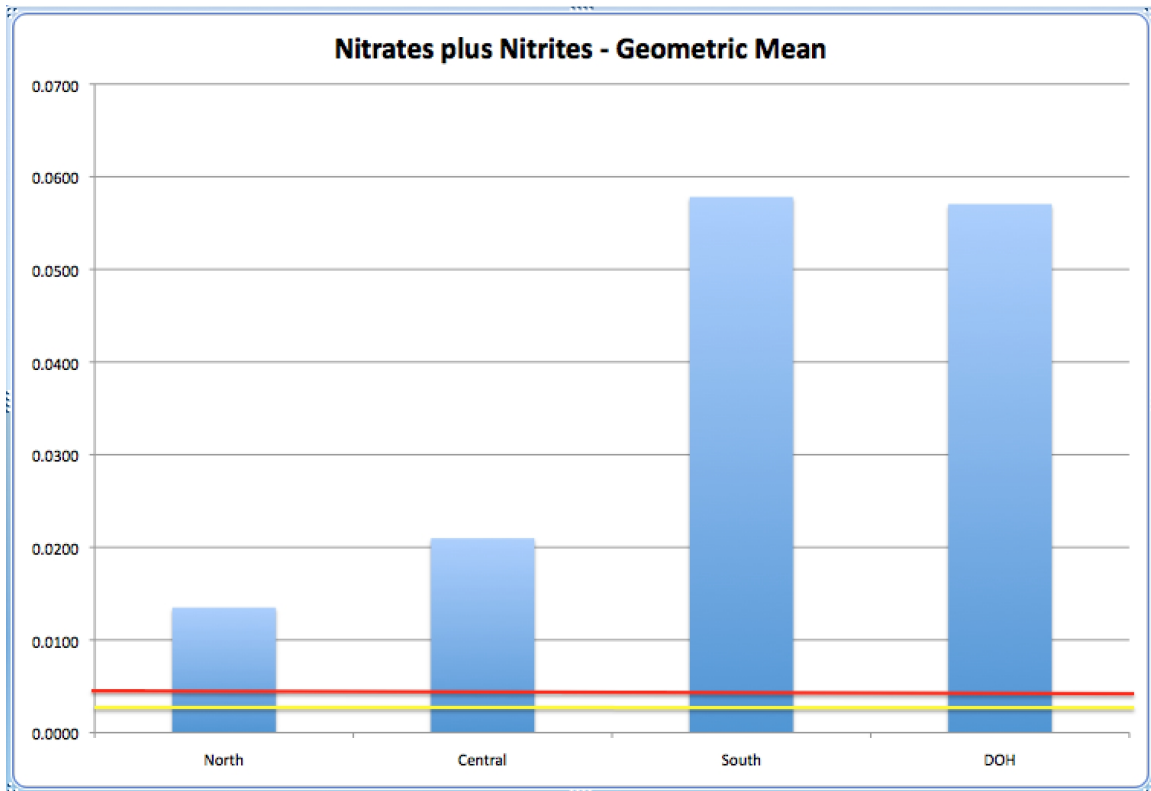
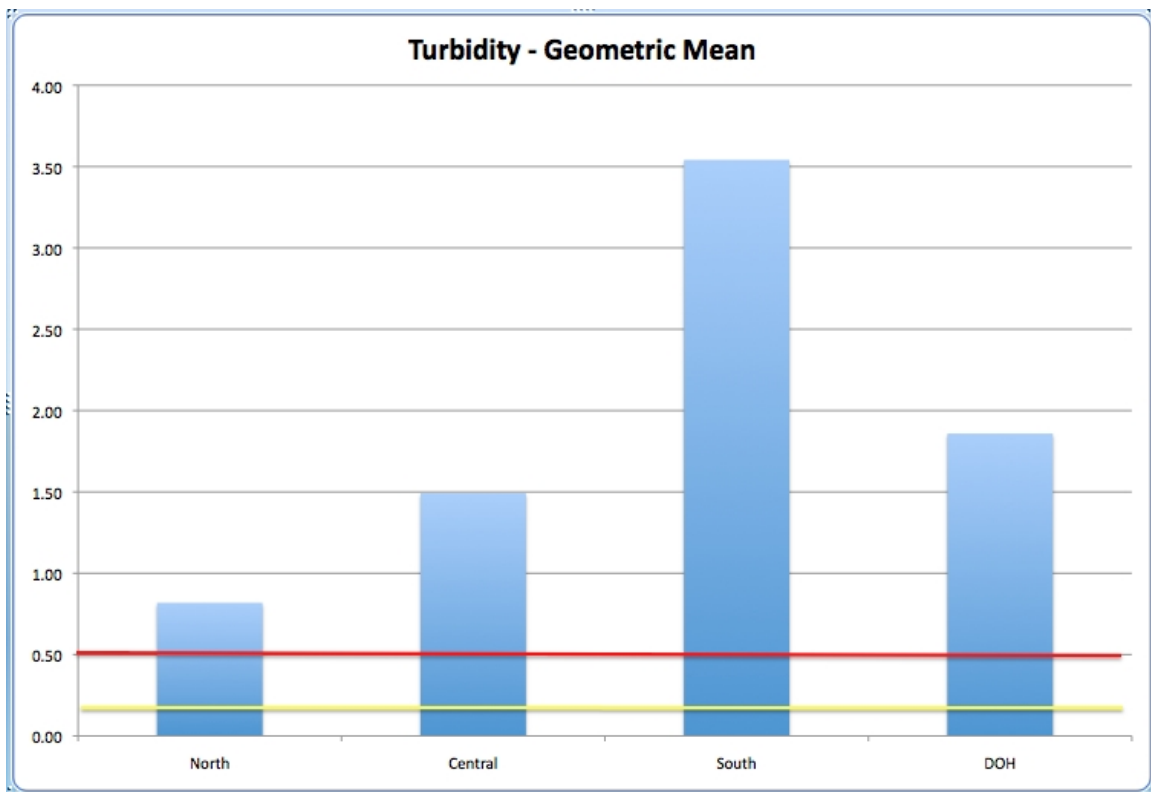
Data is presented in two different ways. The first set of plots shows all points plotted against the collection dates and colored by the sample site location or DOH. The second set of charts presents the geometric mean of all data points plotted by location (and DOH) and compared to the state water quality standards. Both the dry and wet criteria standards are plotted on the charts (dry is designated by the yellow line and wet is designated by the red line). The state DOH uses the dry criteria standard for Napili bay.

It is clear from the second set of plots that Napili Bay exceeds the state water quality standards for every parameter except for total phosphorous. The water quality on the south side of the bay is generally not as good as on the north side of the bay. Fish and algae surveys done by snorkeling the bay confirm the poor turbidity readings on the south side of the day. It is generally very difficult to see marine life on the south side of the bay due to poor visibility. The north side is generally much clearer and speculation is that the circulation is better on the north side of the bay. Additionally, an ephemeral stream occasionally enters the bay on the south side and historically has brought a great deal of sediment into the bay on the south side. In 2011, NBBF repaired a defective outlet valve on the sedimentation basin between the stream and the bay which has significantly improved conditions on the south side.

“ It is clear from the second set of plots that Napili Bay exceeds the state water quality standards for every parameter except for total phosphorous. The water quality on the south side of the bay is generally not as good as on the north side of the bay. Fish and algae surveys done by snorkeling the bay confirm the poor turbidity readings on the south side of the bay. It is generally very difficult to see marine life on the south side of the bay due to poor visibility. The north side is generally much clearer and speculation is that the circulation is better on the north side of the bay. Additionally, an ephemeral stream occasionally enters the bay on the south side and historically has brought a great deal of sediment into the bay on the south side. In 2011, NBBF repaired a defective outlet valve on the sedimentation basin above the stream and the bay, which has significantly improved conditions on the south side.”
