MAINTENANCE DREDGING EFFECTS ON VEGETATION ADJACENT TO
THE GULF INTRACOASTAL WATERWAY - CEDAR LAKES SECTION

Randy Vaughan and Clarissa Kimber
Geography Department, Texas A&M University

June 1977

TAMU-SG-77-207

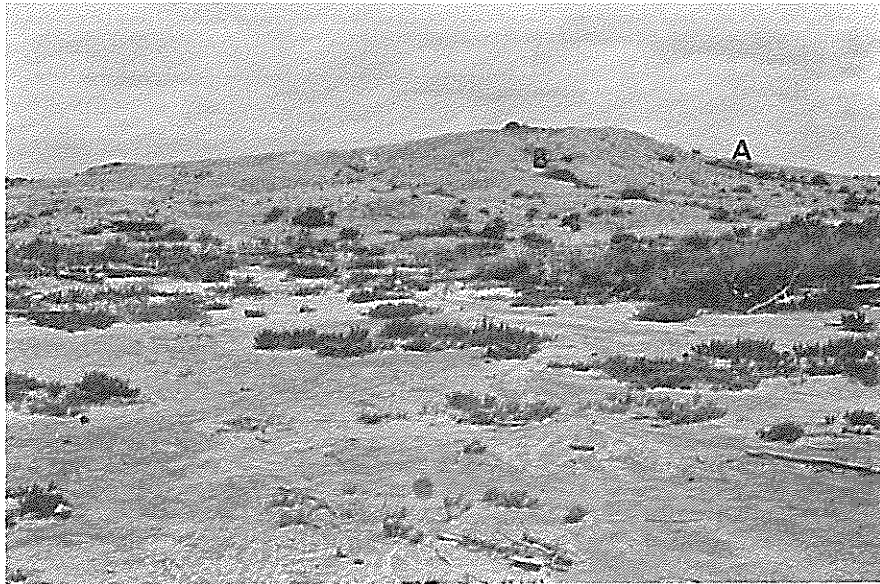
Photo 1. View of spoil mound from the base of site D. The mound is composed of heavy, yellow clay with increasing percentages of sand at the base. Clumps of Salicornia sp. occupy the sandy substrate at the base of the mound. The effects of storm surges are evidenced by the drift wood (A) located at approximately three meters elevation on the mound. Gulleying is also taking place on the mound (B).

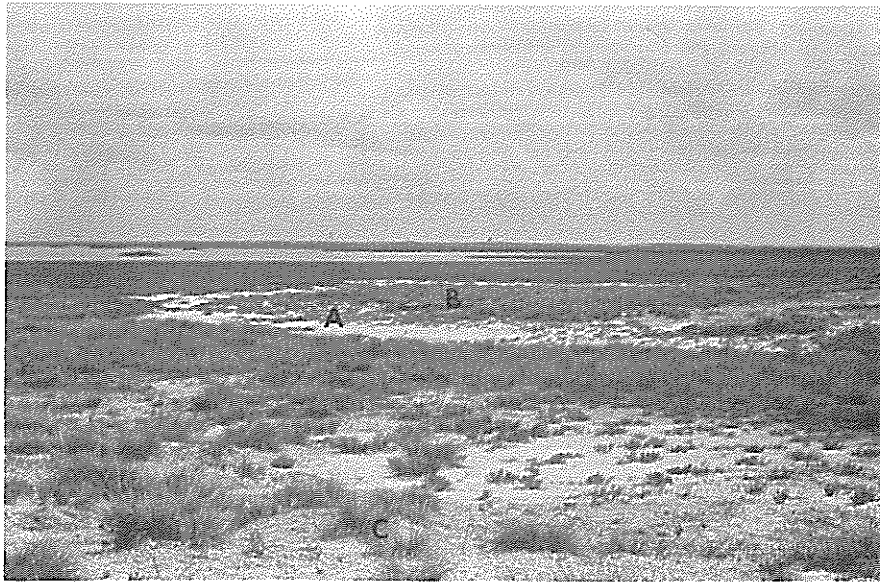
Photo 2. Typical sand ring at the base of a spoil mound adjacent to site D with Cowtrap Lake in the background. Salicornia sp. (A) is the first inner ring of vegetation on the sand followed by S. patens (B). S. patens (C) is in the foreground with an accumulation of clay nodules from the mound at site D. Patches of bare ground are frequent in the area.

alluvial fans and pockets are found in the gullies and rills and there is a general accumulation of sand ringing the base of the mounds (Photo 2). Clay nodules from 1 cm to 3 cm in diameter are scattered across the mounds and are also found accumulated in depressions and piled up against obstructions such as grass clumps.

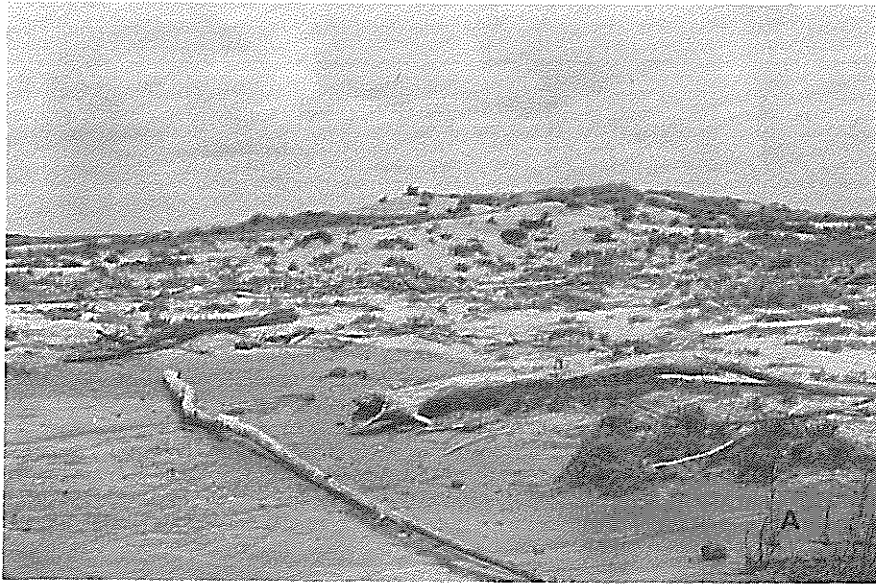
Photo 4. Spoil located near the edge of the canal in the vicinity of site D. Spoil material and vegetation are visibly eroding and are being carried into the canal. The vegetation cover is primarily Salicornia sp. and S. patens. In the lower right of the photograph is a small, possibly emerging colony of S. alterniflora (A). Drift wood from the canal is scattered over the area.
