Grantee Organization: University of Guam

Project Title: Talakhaya Watershed Soil Loss Assessment (CNMI)

Talakhaya Watershed Soil Loss Assessment Project
Status as of November 2014

Mohammad H. Golabi, Soil Scientist
and Sydonia Manibusan, Research Associate II

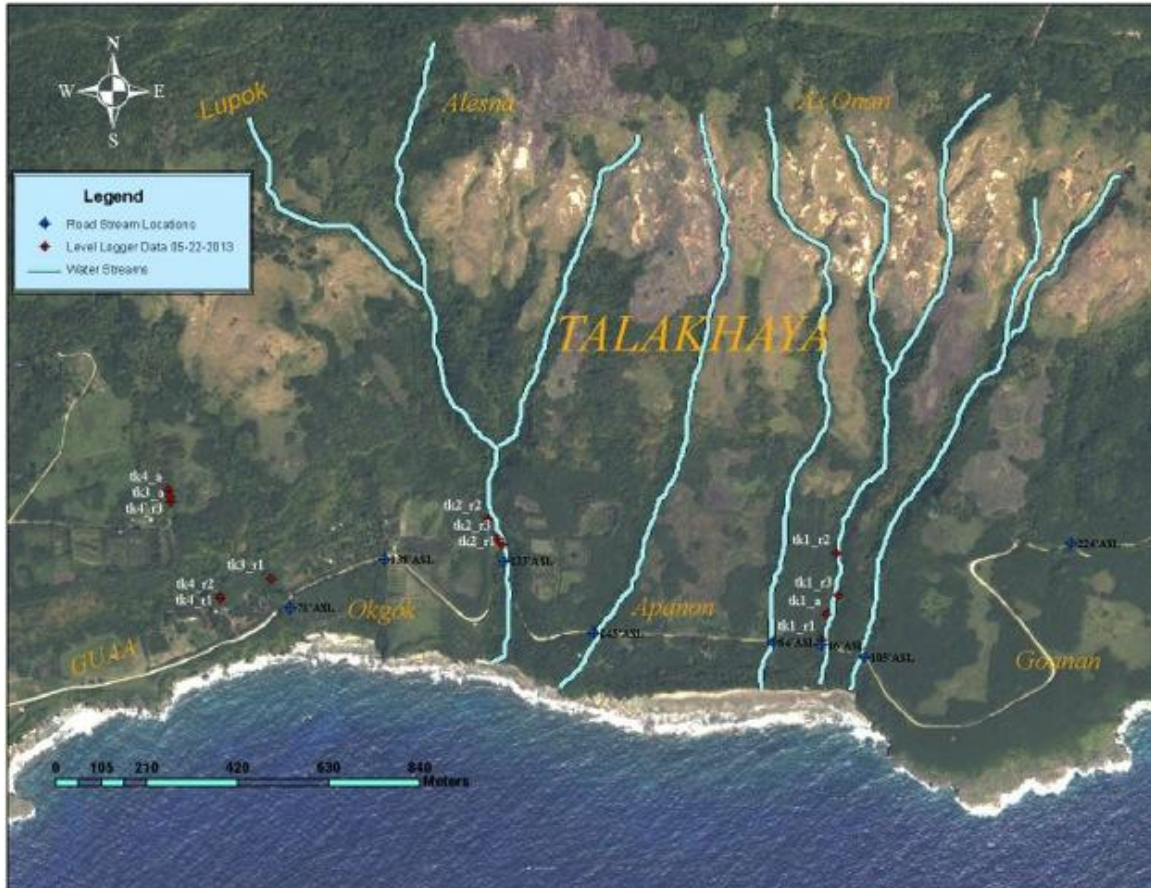
Figure 1: Talakhaya watershed working Map (courtesy of Bill Pendergrass of the Rota BECQ office) shows the ‘major’ streams and the location of the level loggers that are used for monitoring the effect of re-vegetation of the watershed.

The Talakhaya watershed in Rota (Fig. 1) is identified as a Coral Reef Management Priority site for the Commonwealth of the Northern Marianas Islands (CNMI). Since 2006, CNMI resource management agencies including Division of Forestry, Division of Environmental Quality, Department of Lands and Natural Resources, and the Luta (Rota) Soil and Water Conservation District have collaborated on restoring the Talakhaya watershed badlands in Rota. These agencies have worked with USDA Natural Resources Conservation Service in identifying Best Management Practices (BMPs) and restoration projects. Beginning in 2007, NOAA Coral Reef Initiative (CRI) funds were awarded to CNMI to begin re-vegetation efforts of the badlands areas in Talakhaya in Rota. These efforts endured mixed success, with successful re-vegetation followed by human-induced burning of the area. In 2010, federal and jurisdictional partners came together to develop a Conservation Action Plan (CAP) for the Talakhaya watershed. The CAP highlights the need for continued re-vegetation (include the Vetiver grass) for the eroding areas, assessing rate of soil loss in the watershed, addressing intentional burnings with education and fire prevention campaigns, surveys of community attitudes, and the hiring of seasonal field agents for increased surveillance, among other objectives (Bickel, 2012).

Upon determining the measurement parameters and types of devices to be used to best collect data, the supplies and devices needed were ordered beginning December 2012. Devices ordered for the use of the project included: 16 OnSet Hoboware level loggers, 4 Hoboware rain gauges, 1 Hach portable flow meter, and 1 Horiba multi-parameter meter (temperature, pH, dissolved oxygen, turbidity, electrical conductivity, and total dissolved solids measurements). Data collected from such instruments were used to determine the hydrology of the watershed and the level of sediment that is travelling through the streams (Fig. 1) to be deposited in the nearby Bays. Installation of the level

In addition to the fixed device data collection, the collection of data from the flow meter and multi-parameter meter also begun in the fixed stream sites as shown in Figure 1, where level loggers have been installed (Fig. 1). The collection of data from these devices was conducted during monthly site visits and installation trips to Rota.

GIS mapping (Fig. 1) of the level logger locations also was conducted with the assistance of Mr. Bill Pendergrass of the Rota BECQ office, one of the partner agencies working on the Talakhaya Project.

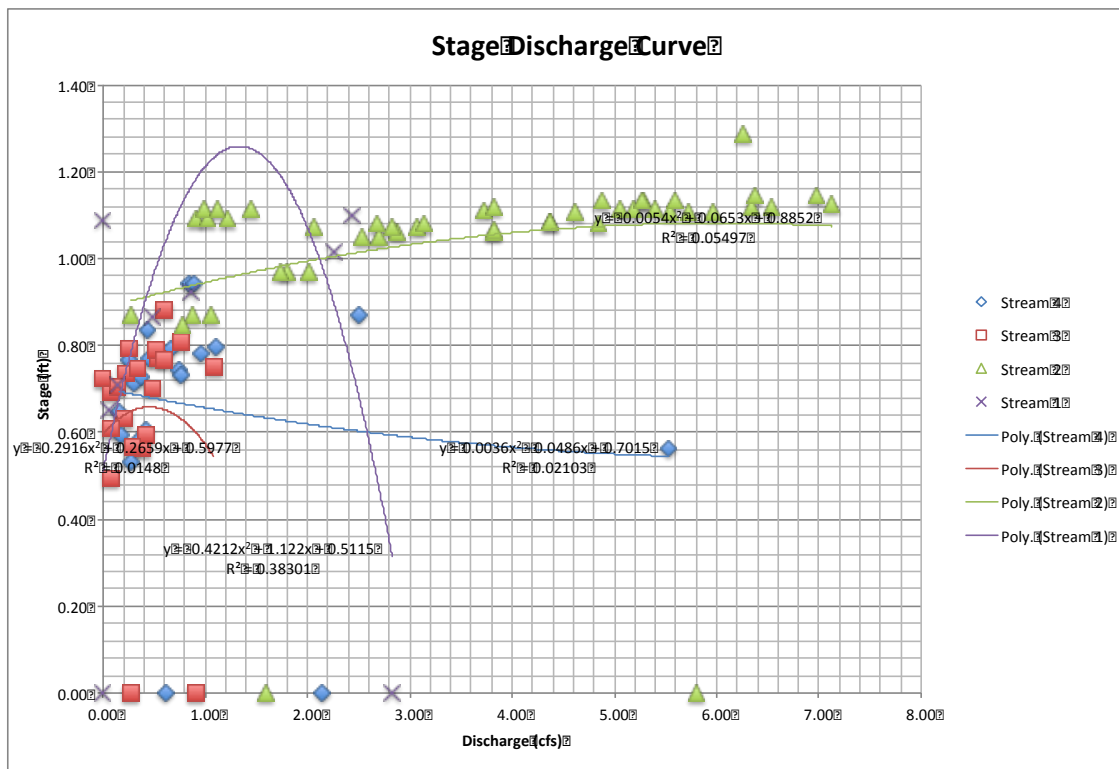
Figure 16: Stage Discharge Curve for Talakhaya Gauged Streams

A preliminary stage discharge curve (Fig. 16) was developed for the four streams measured in the study. The stage discharge curve was developed from the stream flow measurements conducted and the stream level measured by the installed level loggers.

The stage discharge curves developed for this study utilized only one-year of data collected (Fig. 16). Therefore, this does not provide a fully accurate estimate of the flow and water level relationship of the streams. However, the

stage discharge curve developed can serve as the basis for future hydrologic studies within the Talakhaya Watershed. It is recommended that flow and level recordings of the streams continue to be measured (at least for one full El Nino and/or LaNino cycle) in order to obtain a more accurate estimate of the watershed behavior for future studies.
