WORKSHOP SUMMARY

TO: Fran Castro, Kaitlin Mattos, and Clarissa Bearden, CNMI BECQ
FROM: Anne Kitchell, HW
DATE: July 29, 2015
RE: Summary of Pacific Island Watershed Institute II: Managing Your Drainage Infrastructure

This memorandum provides a summary of the second Pacific Islands Watershed Institute (PIWI2) held May 20-22, 2015 at the Susupe Multi-Purpose Center on Saipan, CNMI. The PIWI2 was a three-day training workshop sponsored by the CNMI Bureau of Environmental and Coastal Quality (BECQ) and NOAA and conducted by Horsley Witten Group (HW) and the Center for Watershed Protection (CWP), with support from CUC. PIWI2 included hands-on training focused on illicit discharge detection and elimination (IDDE), stormwater BMP tracking and maintenance, and drainage improvements for unpaved roads. Most of the course was spent in the field.

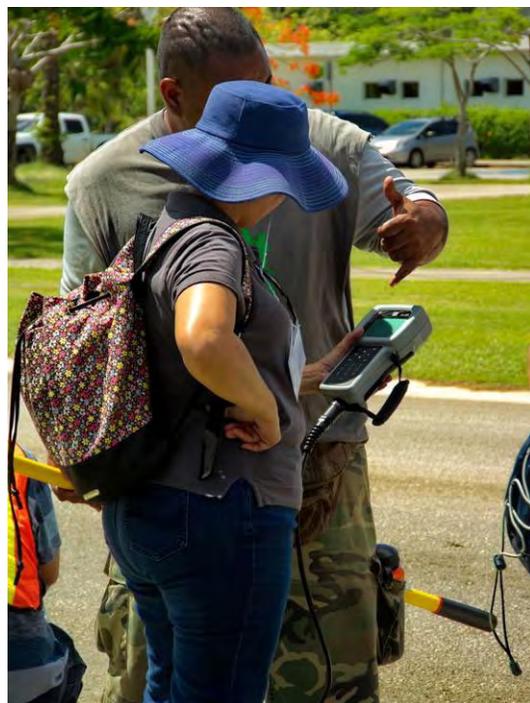
PIWI2 offered opportunities for inter-island sharing, such as BECQ staff explaining to Guam CMP staff how to use this Conductivity/PH meter (photo: John Fraser).

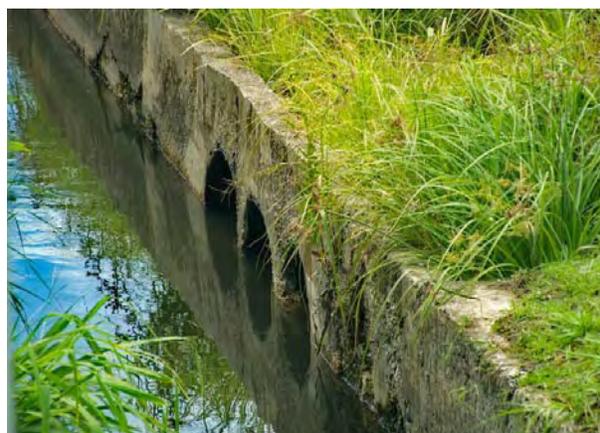
Outfalls were sampled using the field equipment, however submerged and clogged conditions make detecting the sources of discharges challenging (Photo: John Fraser).

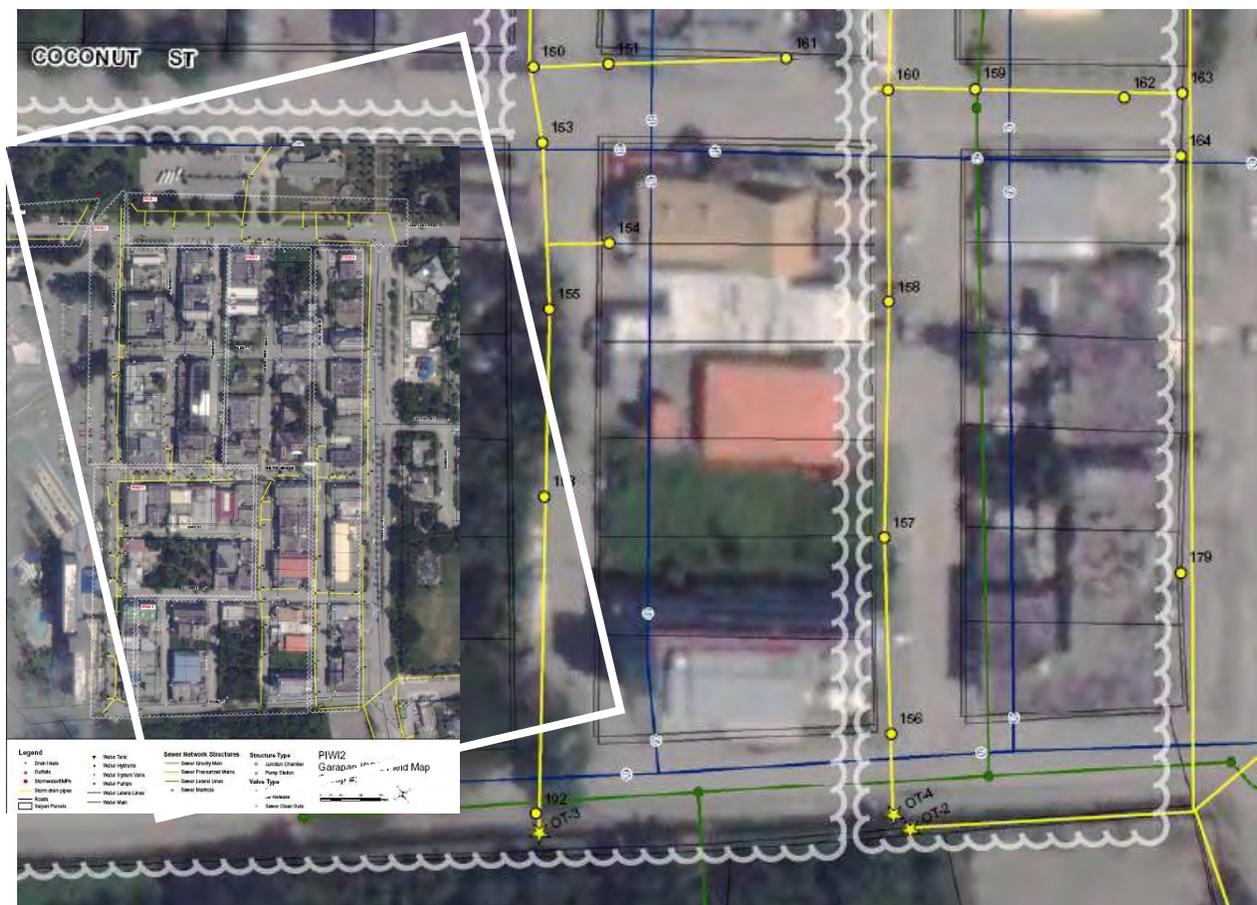
Figure 1. Field maps with preliminary drainage infrastructure were used to pre-select areas for investigation and to provide ID #s for outfalls and drain inlets. CUC and BECQ provided most of the basemap layers. Drain inlets were previously mapped by BECQ as part of the stormdrain marking campaign. The preliminary pipe network was based on a review of Winzler and Kelly stormwater assessment plans.

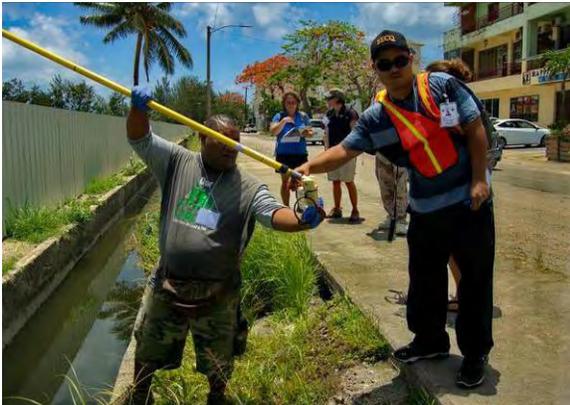
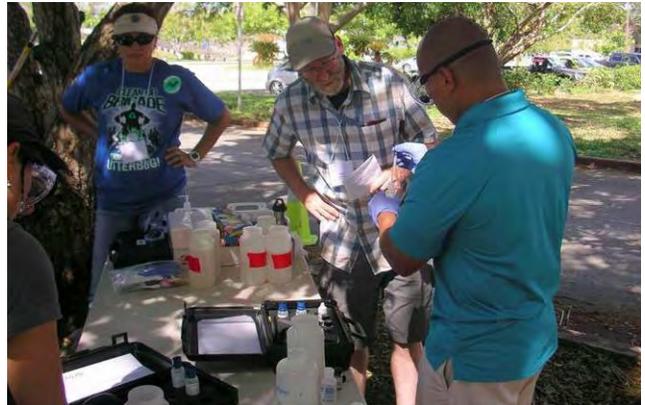
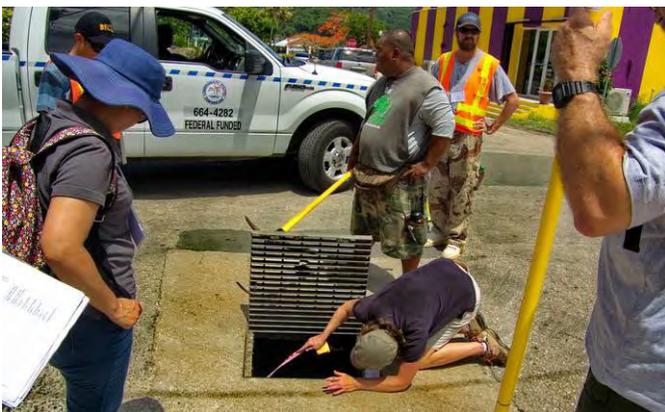
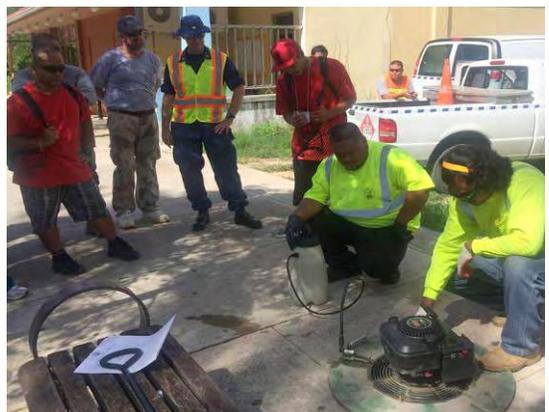
Figure 2. Participants were divided into three groups to collect water quality samples, complete data sheets, measure pipe inverts, obtain results at the mobile lab, and observe smoke test demonstrations.

Teams walked the streets, opened manholes and inlet grates, where feasible, and collected water samples at outfalls, drain inlets, open water features for the following parameters: ammonia, bacteria, conductivity, temperature, and pH (Figure 2). Information on pipe sizes, elevations, and condition was also collected for structures. Potential stormwater hotspots were identified and mapped.

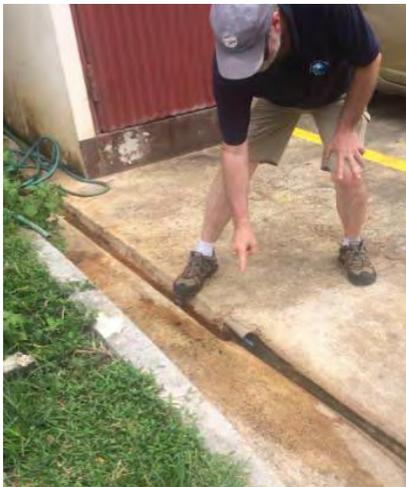
(Left) location of sample at Kinpachi on Plumeria Ave that required three dilutions in order to be read by the Ammonia Kit.

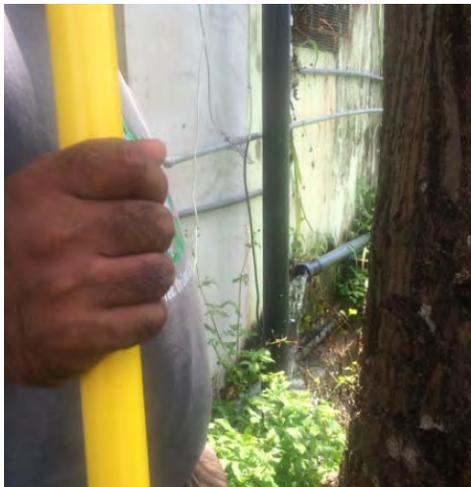
(Right) An active illicit discharge was identified during the field training, it was called in and repaired by the end of the day.

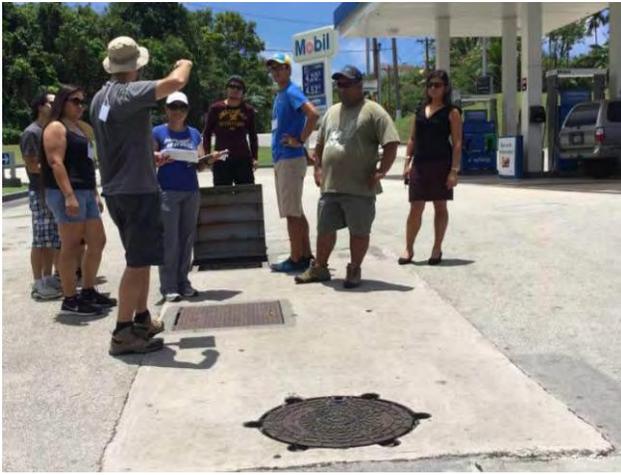
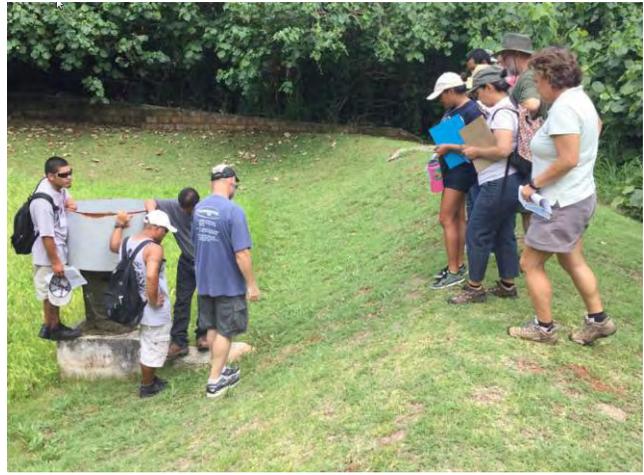
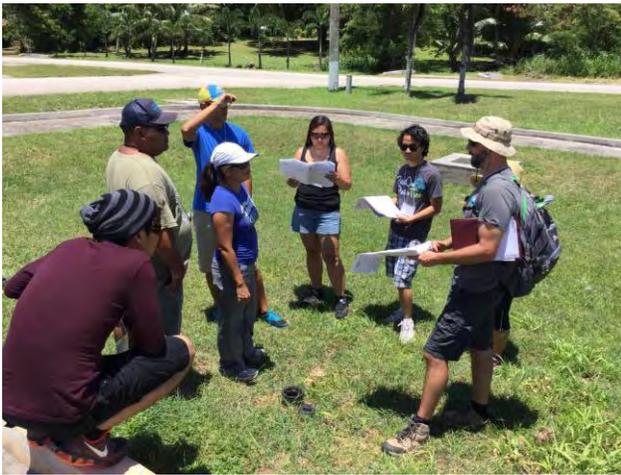
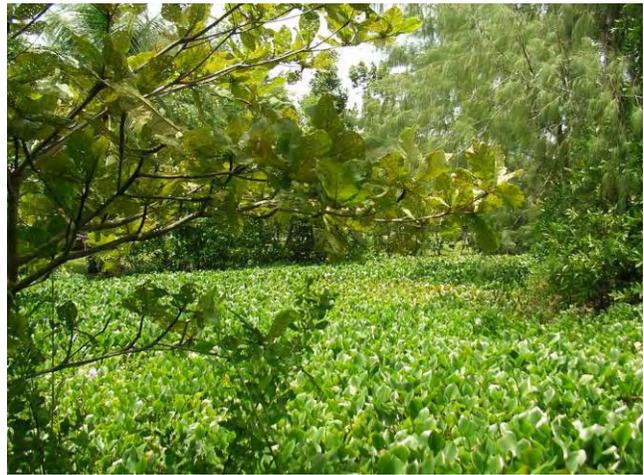
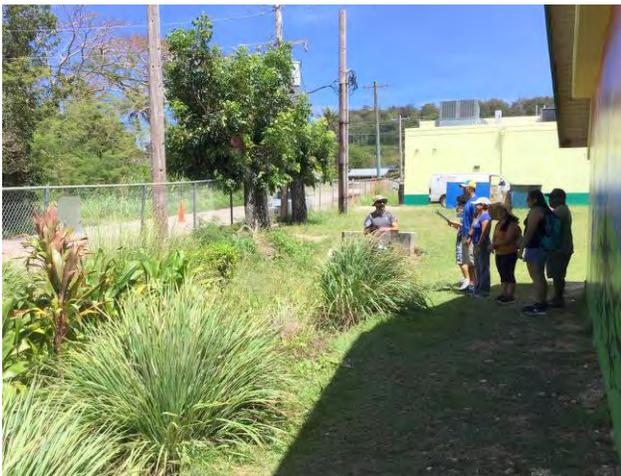
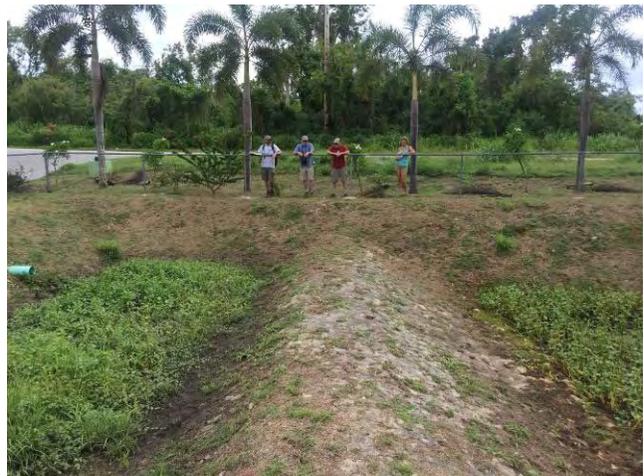
Figure 4. (From top left to bottom right). Mobil Kagman pretreatment and ponding basin, Organic filter at Kagman Joeten, Constructed wetland at American Memorial Park, rain garden at San Vicente Elementary School, and multi-celled ponding basin at Micronesians Brokers.

BMP	Maintenance Issues	Priority for Action
Organic filter at the Kagman Joeten	Some erosion at pipe inlet carrying roof runoff into main filter area. Use stone to stabilize. There is some sediment accumulation. Keep an eye on this site as Phase II develops and ponding basin the rear comes on-line. The underdrain system was not built according to plans and may be challenging to inspect and clean.	Low
Multi-celled ponding basin at the Micronesian Brokers	Don't need to mow/bushcut as frequently as they appear to be doing. Want to allow vegetation to establish on the side slopes (2:1 slopes are very steep and have bare spots).	Low
Ponding basin at the Kagman Mobil	Outlet pipe showing signs of piping under embankment, which will ultimately lead to embankment failure.	High
Rain garden at San Vicente Elementary School	Clean inlet and overflow outlet. Keep an eye on the embankment near the outlet because it appears that the facility is a little undersized	Low

Constructed Wetland at AMP	<ul style="list-style-type: none"> Dredge the basin. Cleaning out sediment accumulation upstream of at weir wall may not be important since the weir elevation is set on tides; Install containment system in grass area or in parking lot for drying of dredged materials. Dewater, for example in a truck container with silt sock around it. Dispose of dry material as cover at landfill. The Park service concerned about stockpiling on site, maybe access by the pump stations More revegetation of stream. Removing invasives and replant for stabilization Redesign with sediment forebays, concrete boxes for easy maintenance 	Medium

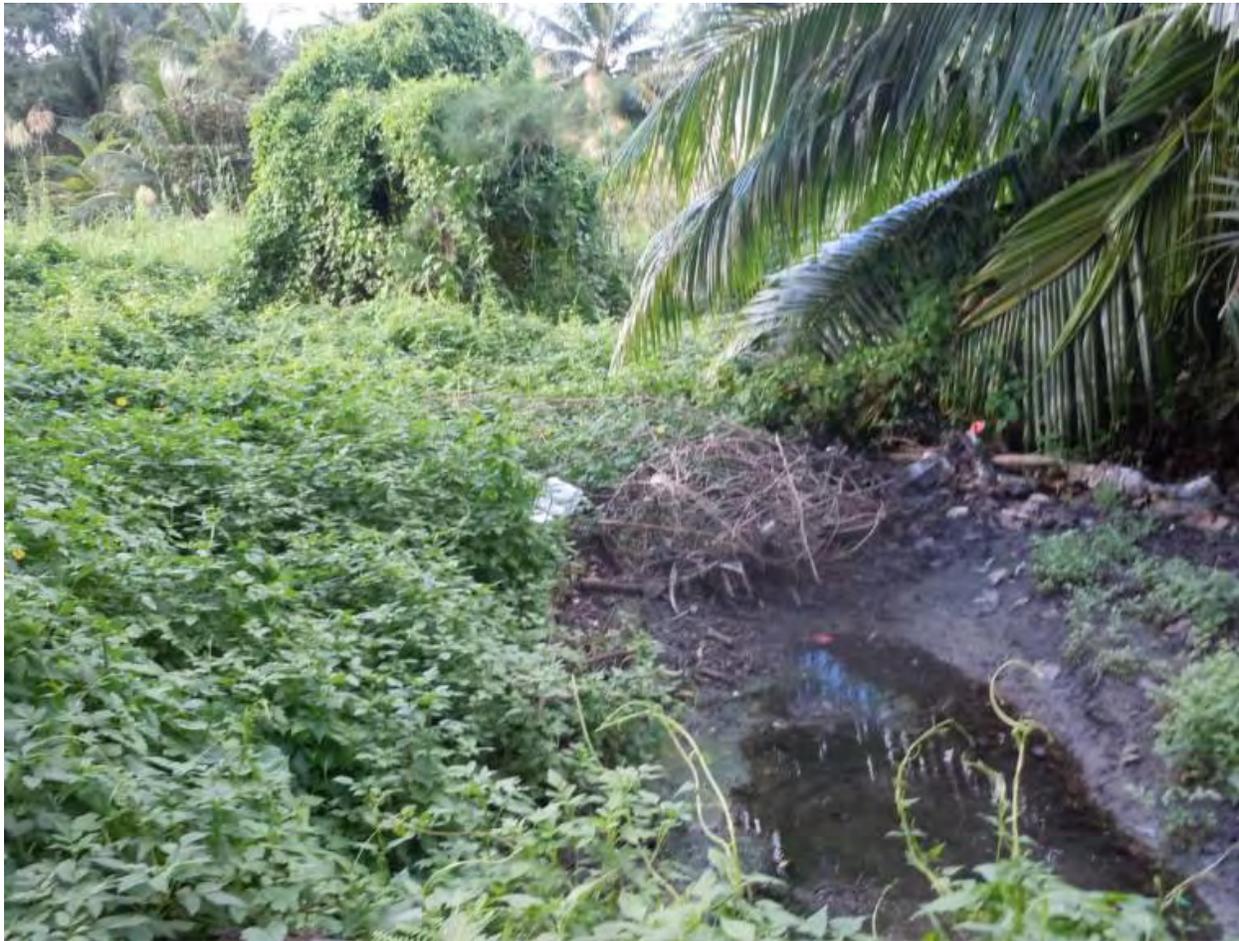
Figure 6. A redesign of the constructed wetland is recommended to include concrete-box sediment forebays at the two primary inlet locations to ease maintenance burden.

Additional questions arose at the AMP wetland regarding endangered species habitat and health issues (Figure 6). Maintenance activities are temporary, so time them around when the endangered birds are not utilizing the BMPs for nesting or foraging. Health issues with maintenance activities can be addressed by wearing proper protective gear, and disposing of material at the landfill. This is a good example of why operations and maintenance plans should be established for each BMP. For future retrofit efforts, it will be critical to obtain an MOA between parties that spells out ownership, liability issues, and addressed operation considerations.

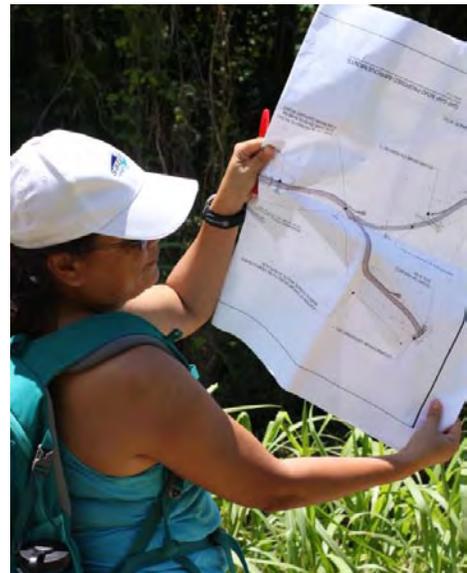
Each group was provided a plan set to mark up in the field showing existing conditions as well as the proposed paved option for Gap Gap Rd.

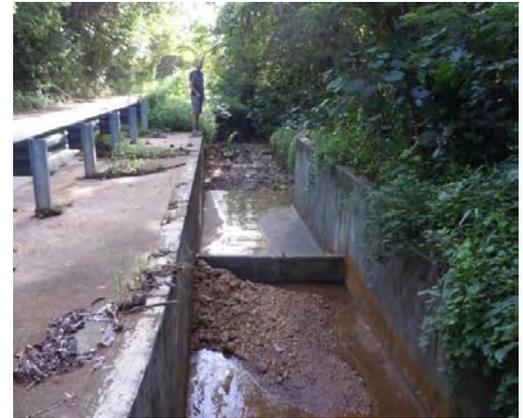
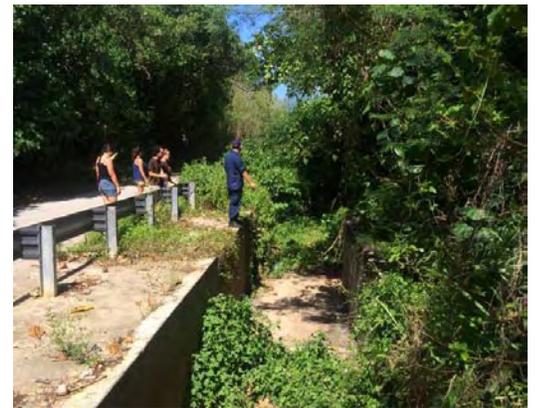
Sediment traps in November (recon visit) vs in May (training).

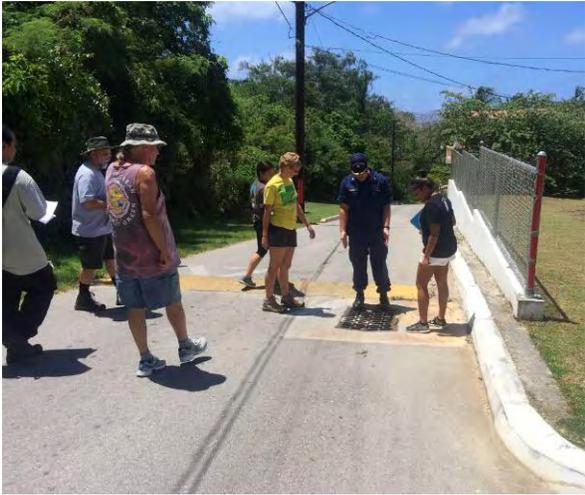
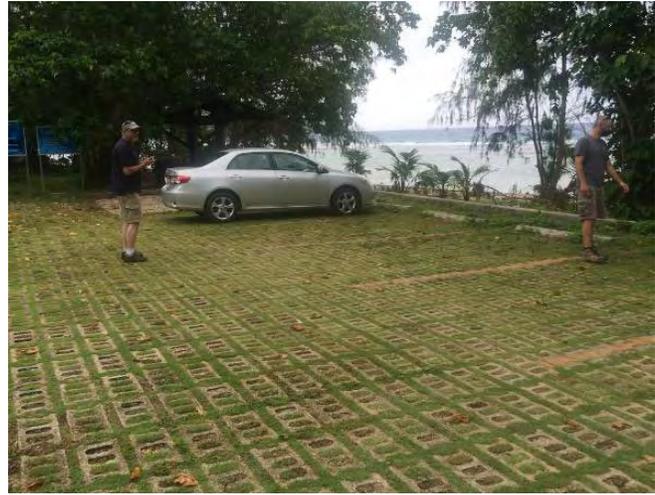
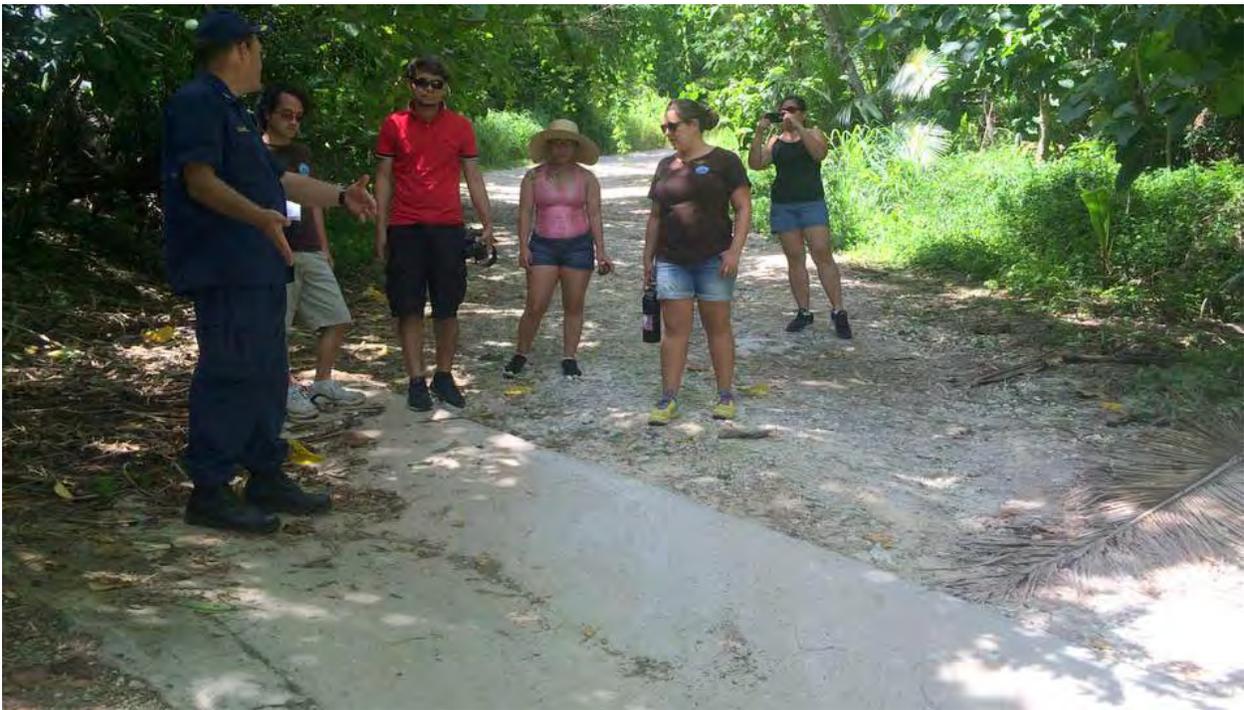
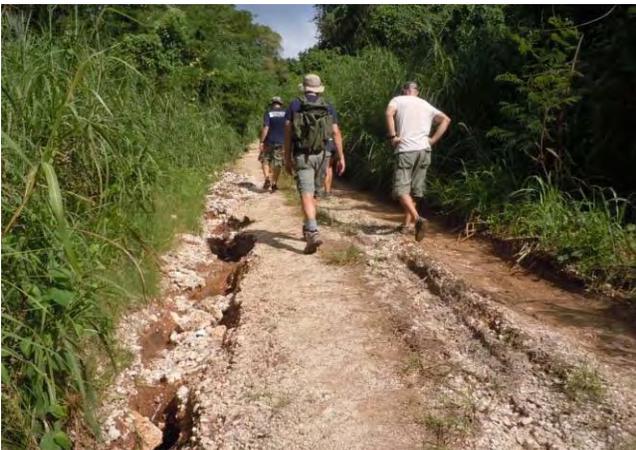
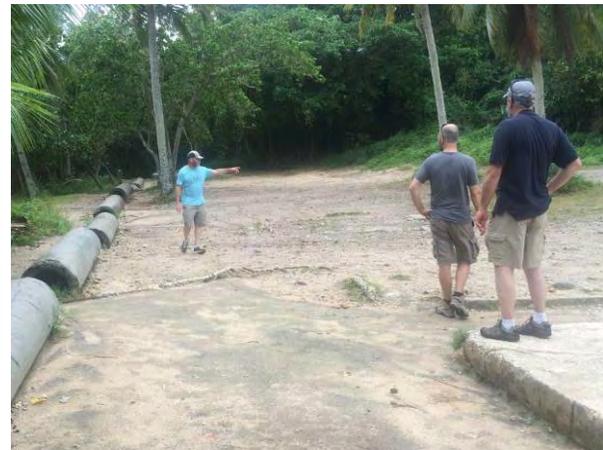
Figure 8. (From top left to bottom right). Participants observed upper Lao Lao Bay Rd. improvements and discussed lessons learned; saw how the beach access lot was stabilized with permeable pavers; walked Gap Gap Rd., and generated design ideas for stabilizing the Dive Site parking lot.

Recommendations discussed by groups for restoration and stabilization of the dive site include (see Attachment C):

- Catching offsite runoff from LaoLao Rd. and conveying into a rain garden adjacent to the parking area
- Formalizing the traffic flow by creating one entrance, establishing vegetated islands, and revegetating some non-traffic areas
- Revegetation of area between parking lot and beach with native plants, using boulders or other bollards to designate 2-3 trails to beach
- Installing pervious pavers (like at other beach access area) in parking stalls, potentially pitching parking area to a common discharge location
- Installing a gazebo/covered picnic table and grill at existing concrete pad in back.
- One-way driveway at divesite with angled parking spaces

Recommendations for retaining an unpaved Gap Gap Rd. include (see Attachment C):

- Diversion at the top of road (e.g., depressed gutter line or speed bump) to prevent water from paved road from coming down Gap Gap Rd.
- Maintain ditch on the paved road to continue to convey flows down paved road.
- Install diversion structure near top of hill to reduce off-site runoff issues.
- Use waterbars and dips at strategic locations, regrading of road, and with a lined drainage ditch on inslope or changing the cross slope to direct water into existing gulch
- Use an intercepting drainage ditch to prevent off-site runoff from coming down hill
- Continue using proposed road alternate due to property issue constraints.

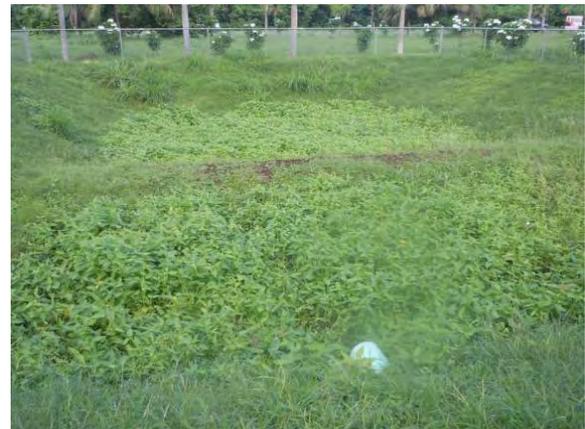
Micronesia brokers. Two-celled ponding basin with underground O/W separator.

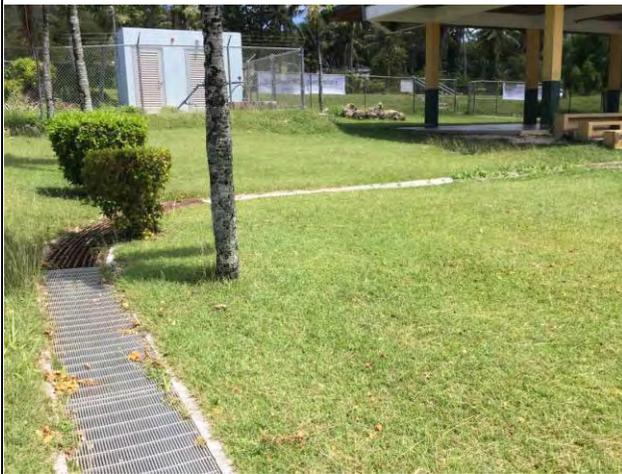
Large drainage area to practice ratio, and practice may be slightly undersized. DA includes basketball court.

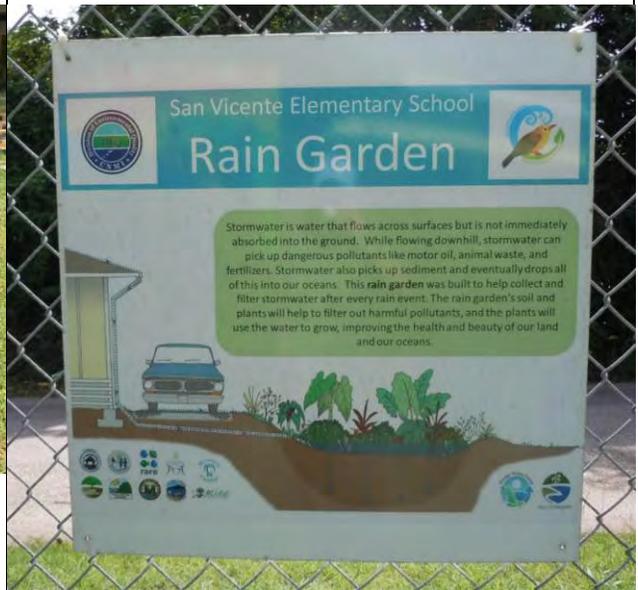
Educational signage posted along fence to show how the rain garden functions.

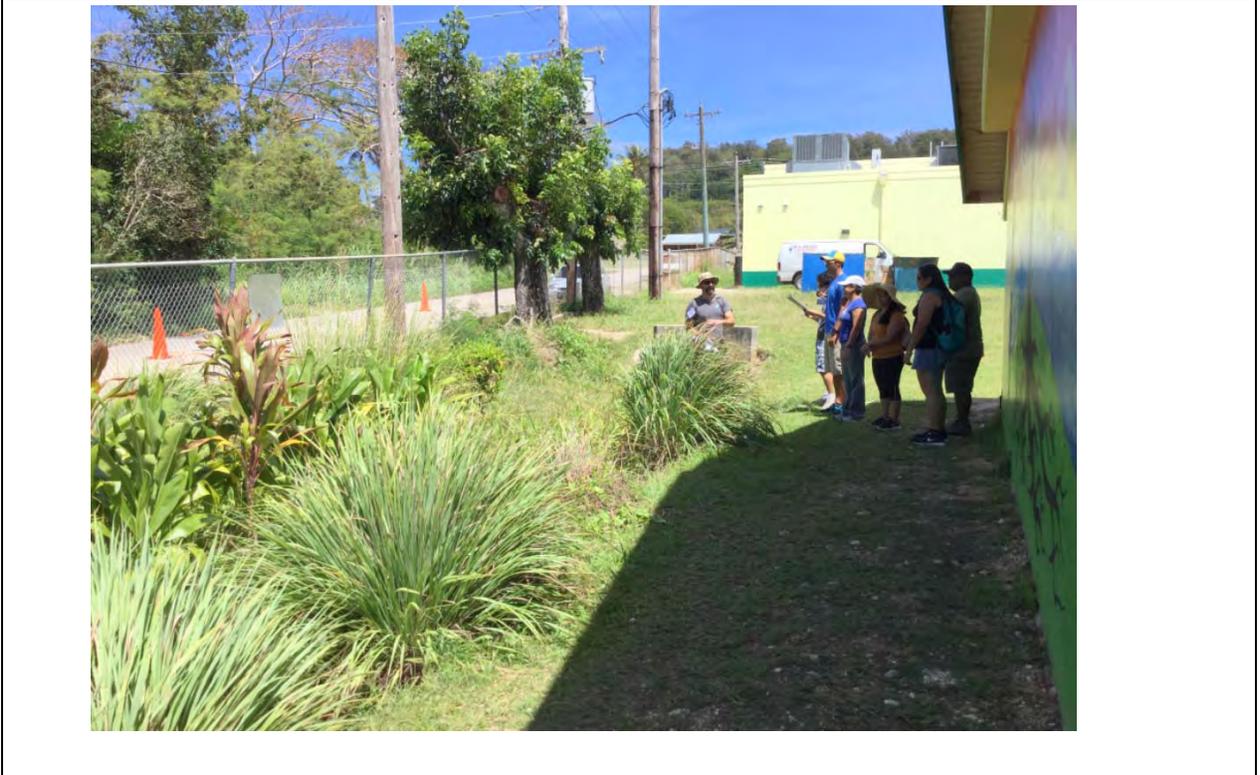
Plants look good, keep up the weeding as needed.

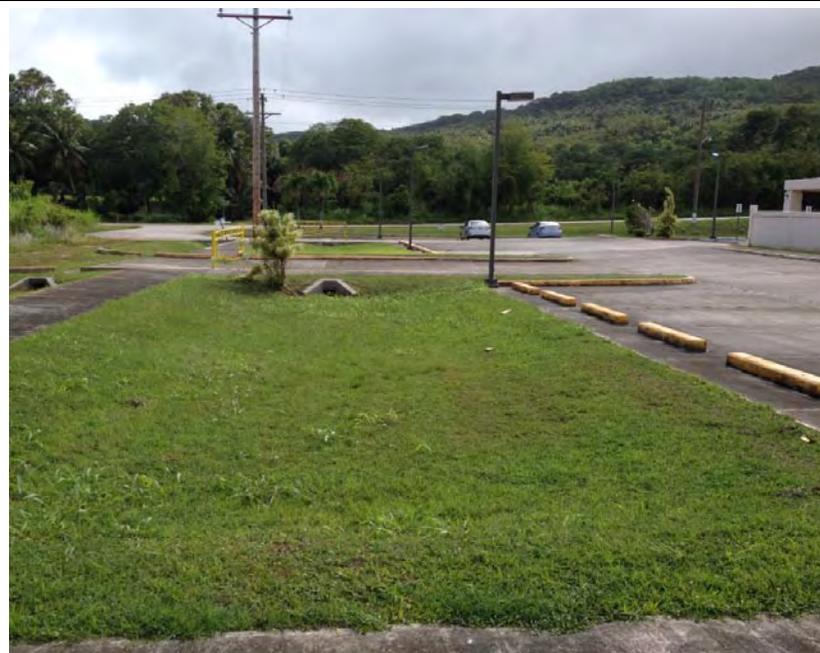
Grass system is easy to maintain; however consider adding trees that could also provide shade for parking spaces and increase evapotranspiration rates.

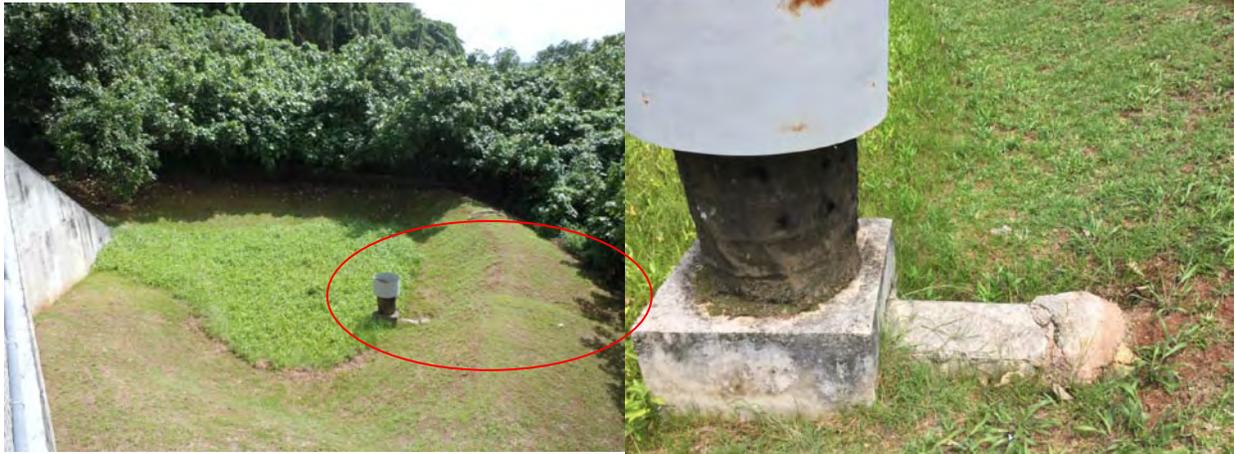
Piping is visible on the embankment. Holes are visible where the base of the pipe enters the embankment.

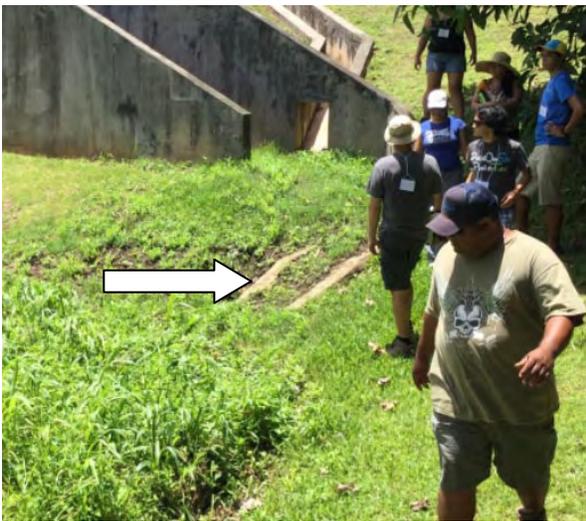
Clean sediment from concrete inlet flume

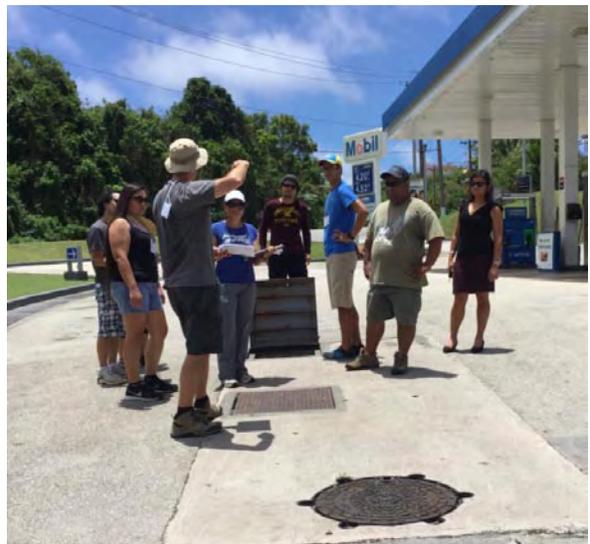
Access to O/W separator was maintained.

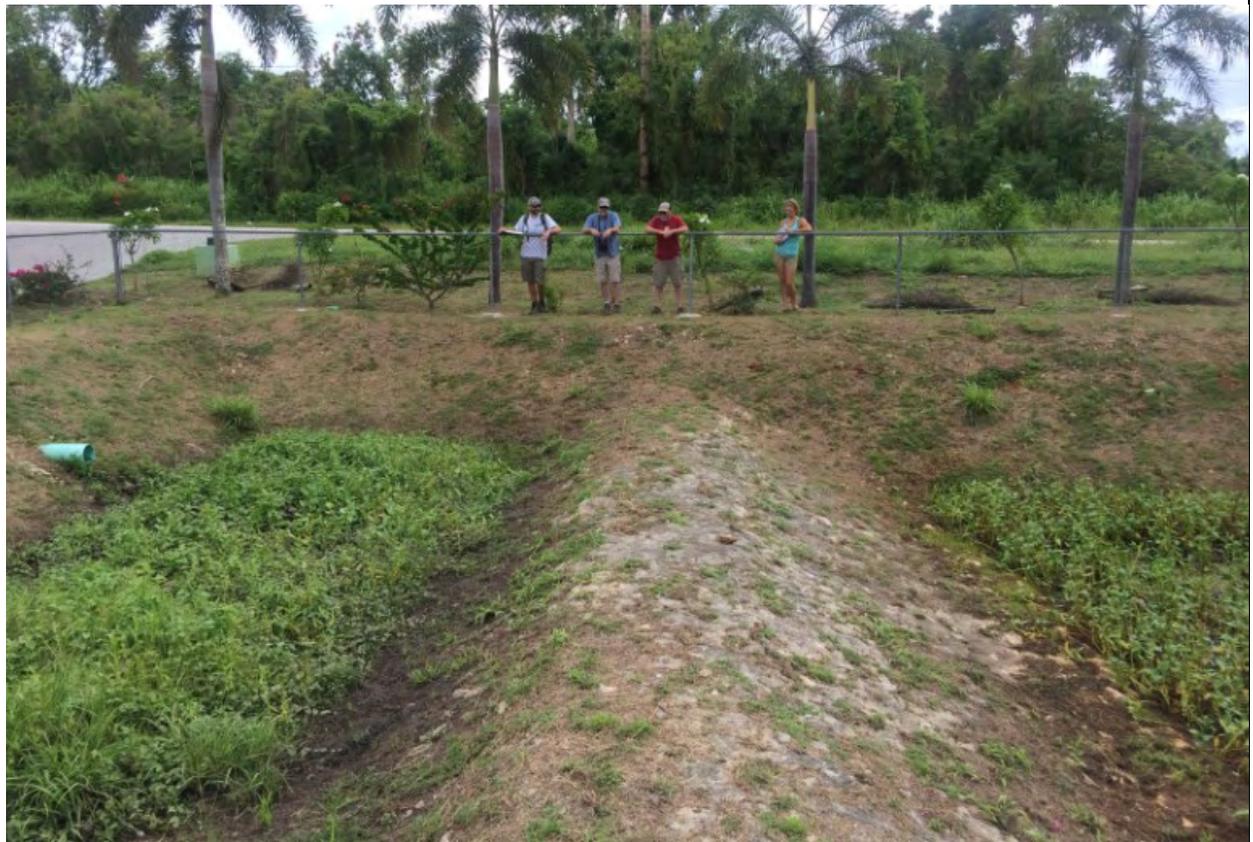
Bare spots on steep side slopes and in weir. Try to keep vegetated to improve stability.

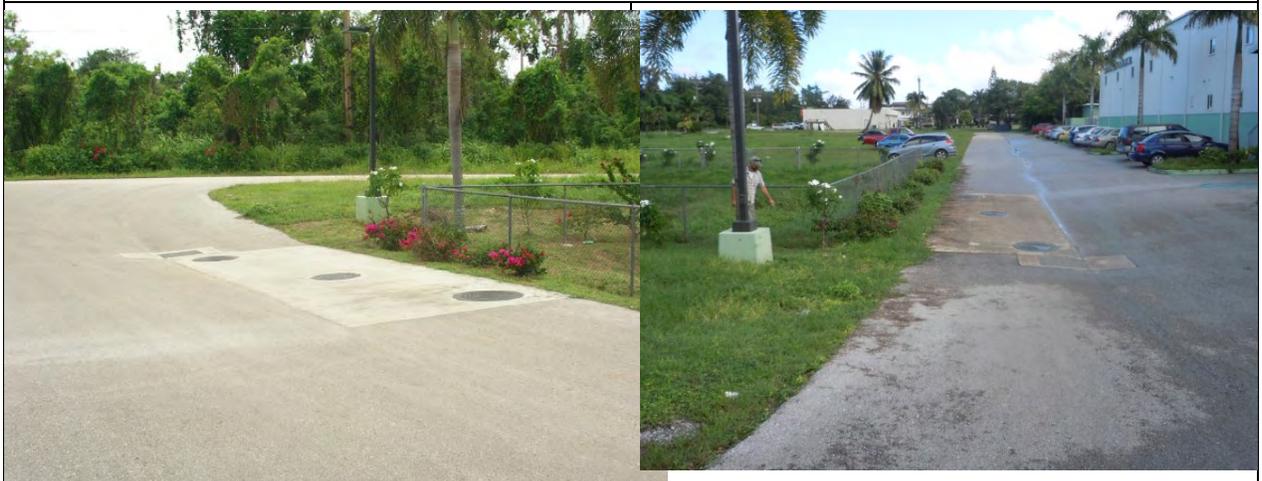
Oil/Grit separator provides additional pretreatment for BMP.

Drainage area to BMP collects sediment and other materials which are conveyed into O/G separator.

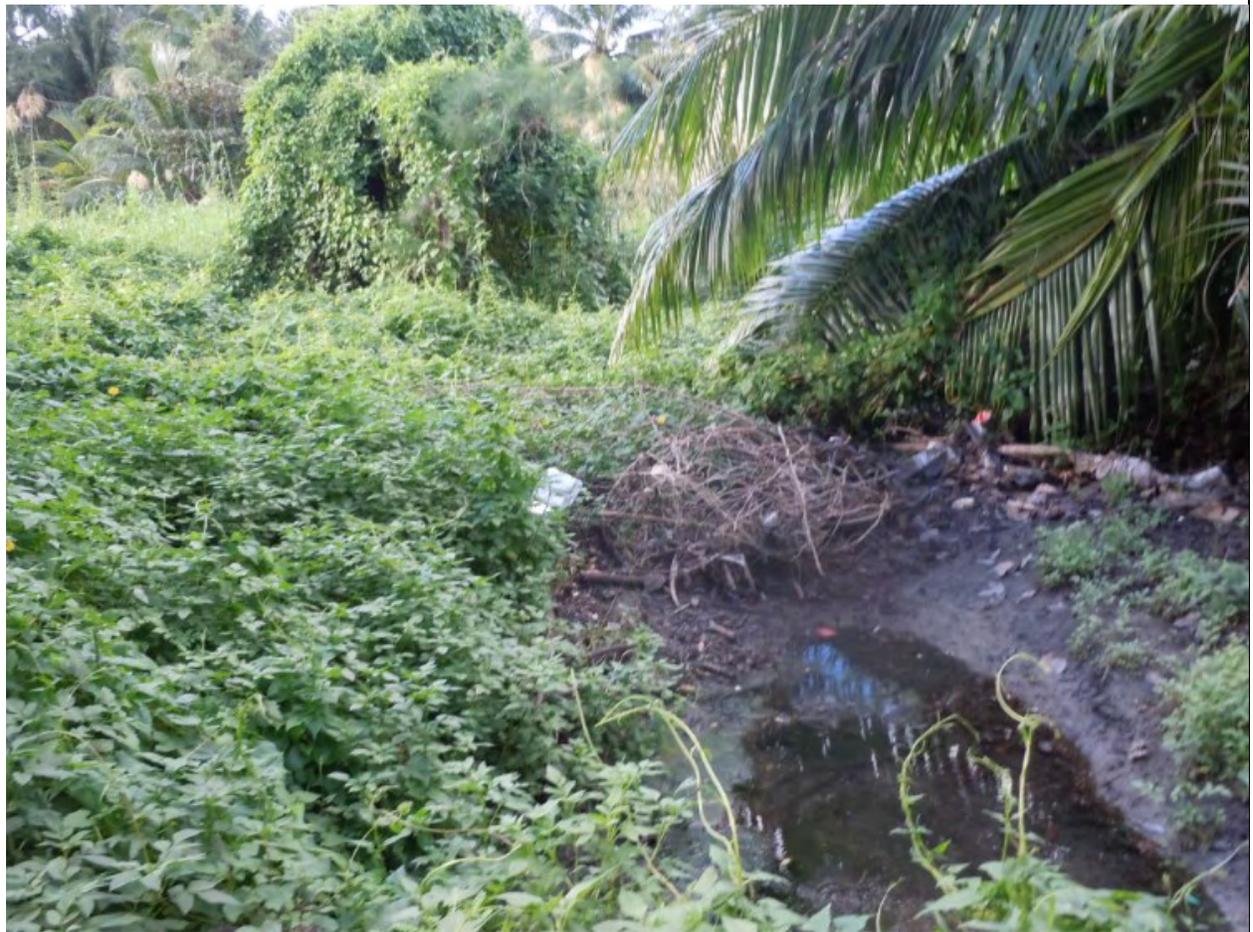
Sediment and debris deposition at one of the inlet pipes. This is a location where a concrete box/forebay structure would help ease future maintenance burden.

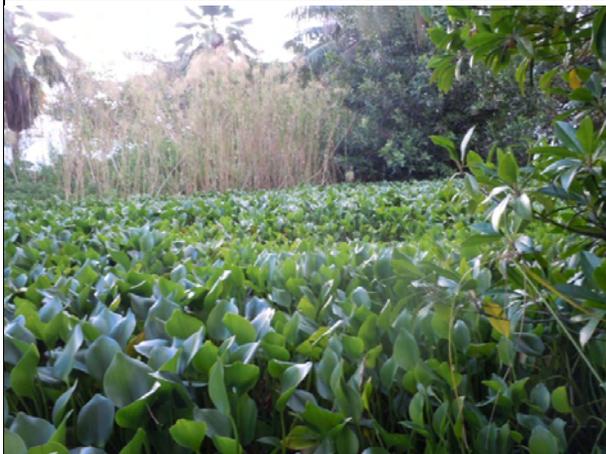
Remove invasives and re-establish open water system.

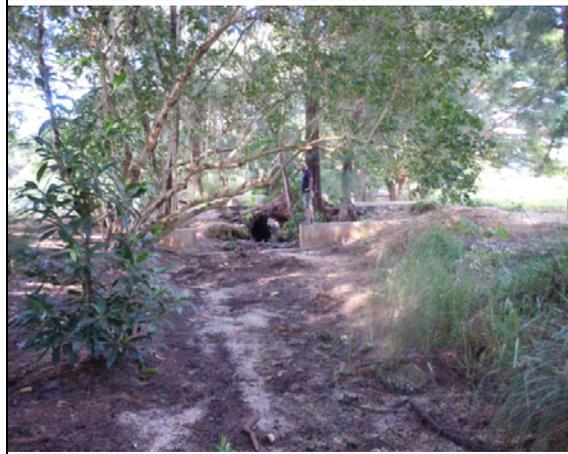
Replant along the stream corridor.
