# Shoreline Situation Report ESSEX COUNTY, VIRGINIA

Special Report In Applied Marine Science and Oceanic Engineering Number 135 of the

VIRGINIA INSTITUTE OF MARINE SCIENCE  
Gloucester Point, Virginia 23062

1976

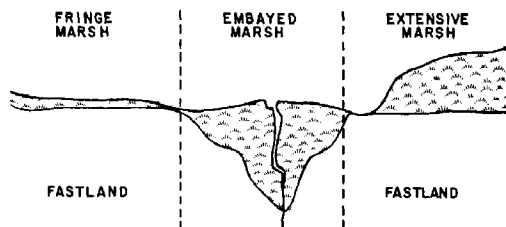
Figure 1

A profile of the three shorelands types.

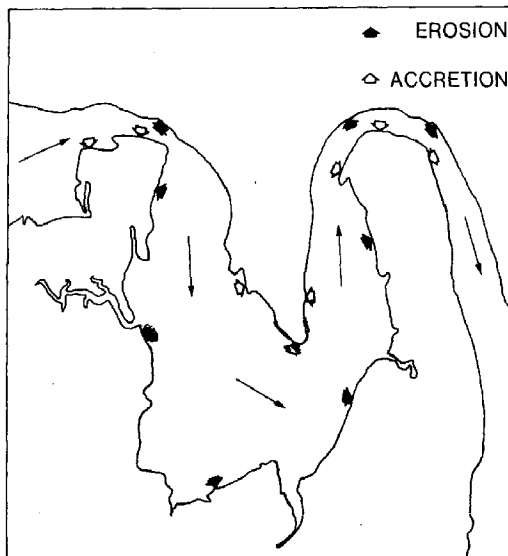
FIGURE 3. TYPICAL RIVER MEANDER

Most of the erosion and accretion found along the upper Rappahannock River (above Beverly Marsh) occurs at the bends in the river. The river current is fastest on the outside of the meanders and is much less on the inside. As a result, the outside bends erode while the inside bends accrete. The amount and rate of erosion depends upon both the composition of the land in the bends and the speed of the current there (see Figure 3).

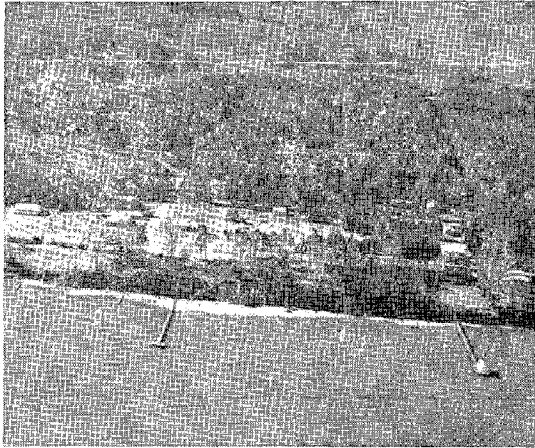
FIGURE 4

FIGURE 4: View of Mark Haven Beach, Subsegment 1A. Like much of the county's shorelands, a thin strip of land adjacent to the shore has been developed for residential use while the remaining lands are undeveloped. Notice the erosion of the bluffs in this section.

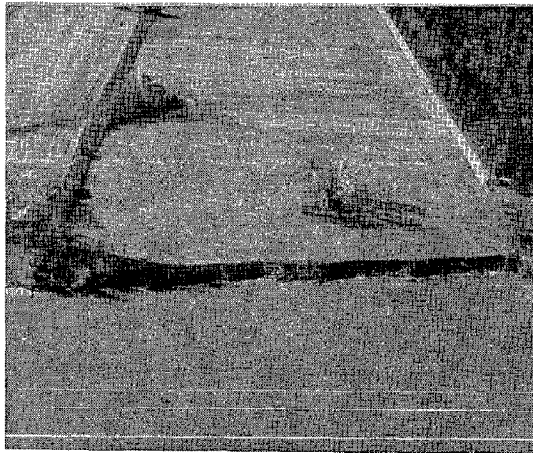
FIGURE 6

FIGURE 6: View between Browns Point and Wares Wharf, Subsegment 1B. Erosion of the bluffs in this area, besides causing the loss of valuable farmlands, is also a cause of non-point source pollution to the Rappahannock River. Rain runoff carries a variety of fertilizers and pesticides into the river. In order to reduce erosion of such farmlands, a "green zone" (an area that is planted in grasses, bordering the shoreline) should be established. Along the Essex County shoreline, a green zone fifty feet wide should be sufficient.

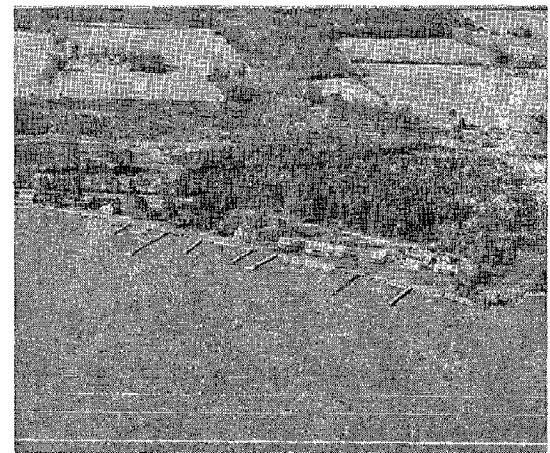
FIGURE 7

FIGURE 7: South of Lowery Point, Subsegment 1B. The numerous groins have not been successful in creating beaches in front of the bulkhead in this area.

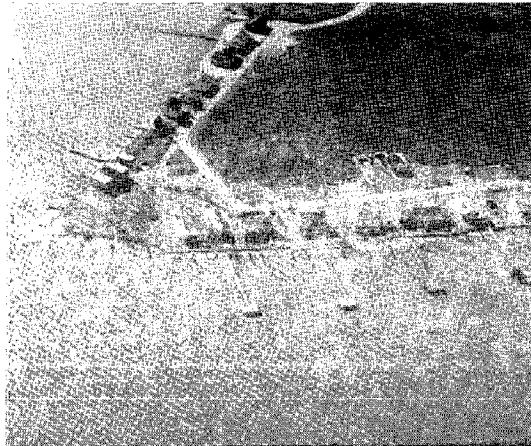
FIGURE 8

FIGURE 8: Lowery Point, Subsegment 1C. These residences were built on artificial fill dumped on the marsh. The groins of cement bags have not been effective in building up a buffer beach in front of the bulkhead,

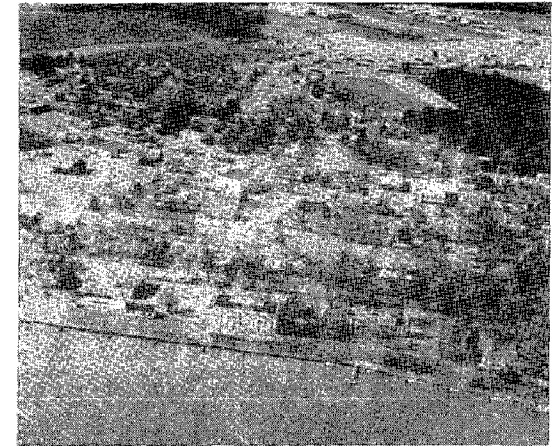
FIGURE 9

FIGURE 9: Tappahannock, Subsegment 4A. Tappahannock is the only town located along the shorelands in Essex County. The entire shoreline has been artificially stabilized in this area. Again, the groins have not been effective in trapping a buffer beach.

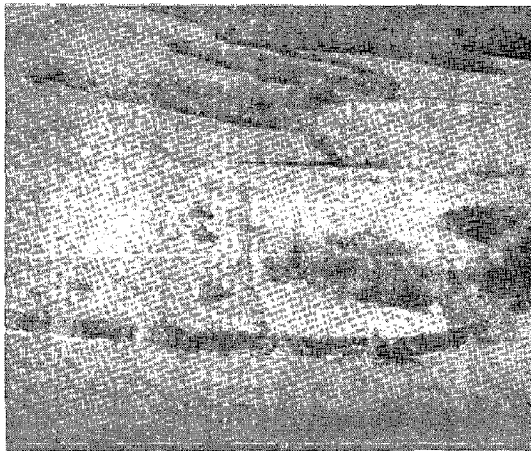
FIGURE 10

FIGURE 10: East of Mount Landing Creek, Subsegment 4A. Erosion is a problem for the shoreline in this area. As can be seen from the photo, a small housing development is being constructed in this section.

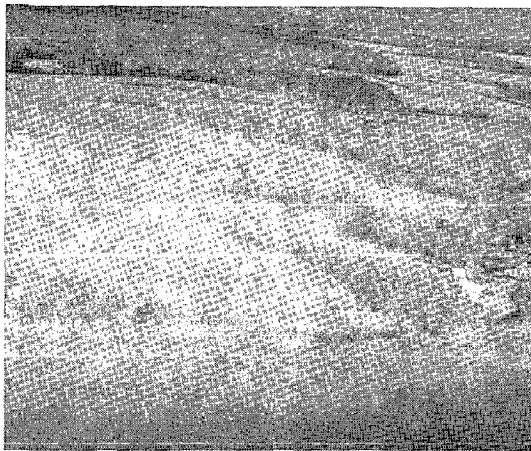
FIGURE 11

It was observed that several agricultural areas have been plowed perpendicularly to the shoreline (see Figure 11). Such plowing encourages rain runoff erosion and is a prime contributor to non-point source pollution. The sediments suspended in the rain runoff contain large amounts of fertilizers and pesticides which contribute to seasonal water quality problems. Most runoff erosion and the ensuing pollution from agricultural areas could be eliminated by; 1) plowing parallel to the shoreline, and 2) leaving a "green zone" along the shoreline (A "green zone" is a buffer area planted with grasses between the field and the shore. In Essex County, a buffer of fifty feet should be sufficient). Proper use of the shorelands would do much to control runoff erosion of the agricultural lands and the pollution of the river. The other two types of erosion are dependent upon the location of the area, the type of nearshore zone, and many other variables.

FIGURE 11: Daingerfield Landing, Subsegment 6A. The agricultural fields have been plowed perpendicular to the shoreline, which encourages rain runoff erosion. Plowing should be parallel to the shore with a fifty foot buffer zone along the shoreline.
