Western Washington University

Project Completion Report

Puget Sound Shore Erosion Protection Study

SHORE PROCESSES AND EROSION
ABATEMENT ALTERNATIVES FOR
PUGET SOUND

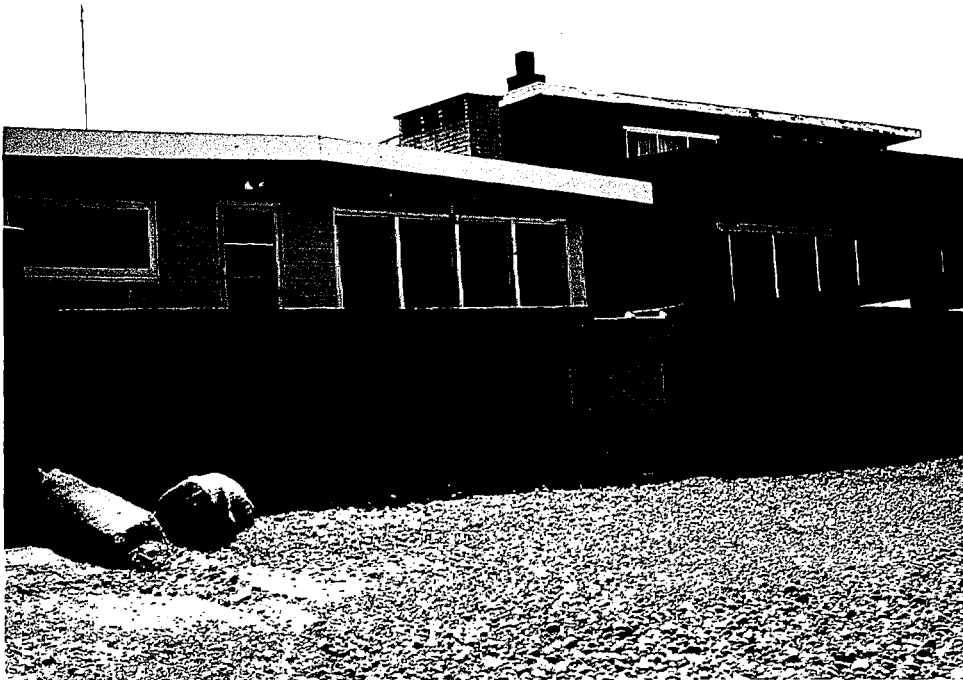
1. Structure Number: 1
2. Structure Type: Concrete - vertical/recurved bulkhead
3. Location: Birch Bay, Whatcom County

This bulkhead appears adequately strong to resist the level of wave attack experienced at this site. There are no weepholes to provide drainage along the base of the structure, but since the backshore is impervious (concrete patio), none are needed. No tiebacks were incorporated in the bulkhead, a factor which could hasten overturning, should the beach lower more than 12 inches.

A 3-foot wide blanket of 20-50 pound rock at the toe would help to protect the footing from wave scour and reduce the possibility of bulkhead failure during a severe storm. Periodic placement of a fairly large quantity of sandy gravel at the bulkhead toe would also be a possible alternative should the beach lower more than 6 inches.

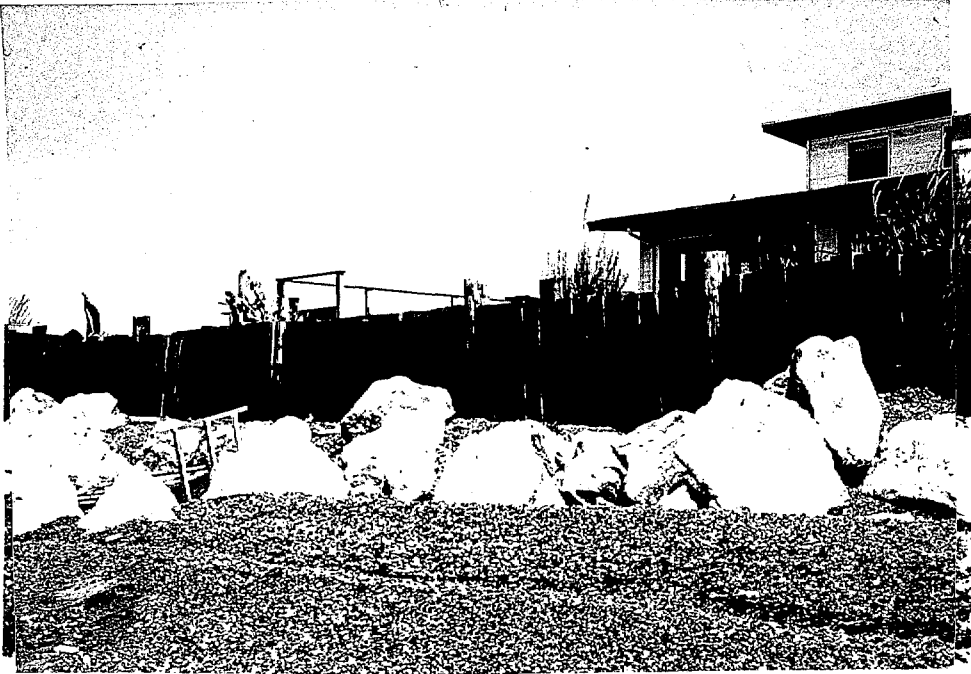
1. Structure Number: 2
2. Structure Type: Vertical railroad tie bulkhead
3. Location: Sandy Point, Whatcom County

This bulkhead appears adequately strong to resist the normal level of wave attack experienced at this site. The riprap toe protection fronting the structure is adequate in size, but is subsiding because of a lack of proper bedding material. A horizontal cable which connects the railroad ties, probably lends little strength to the structure. Had tiebacks been attached to the cable every several feet, its usefulness would have been much improved. The bulkhead top elevation is sufficient to provide protection from wave overtopping and debris damage, except in the rare event of an exceptionally high tide occurring simultaneously with high winds from the northwest.

The structure could be improved by removing the existing riprap, placing an 18 inch thick by 8-foot wide blanket of quarry spalls (20-200

pounds) in front of the bulkhead, and then replacing the riprap on the blanket as close to the bulkhead as possible. This procedure would significantly reduce the rate of subsidence of the riprap. However, it should be noted that the recreational and scenic value of the beach has been lessened by the use of riprap.

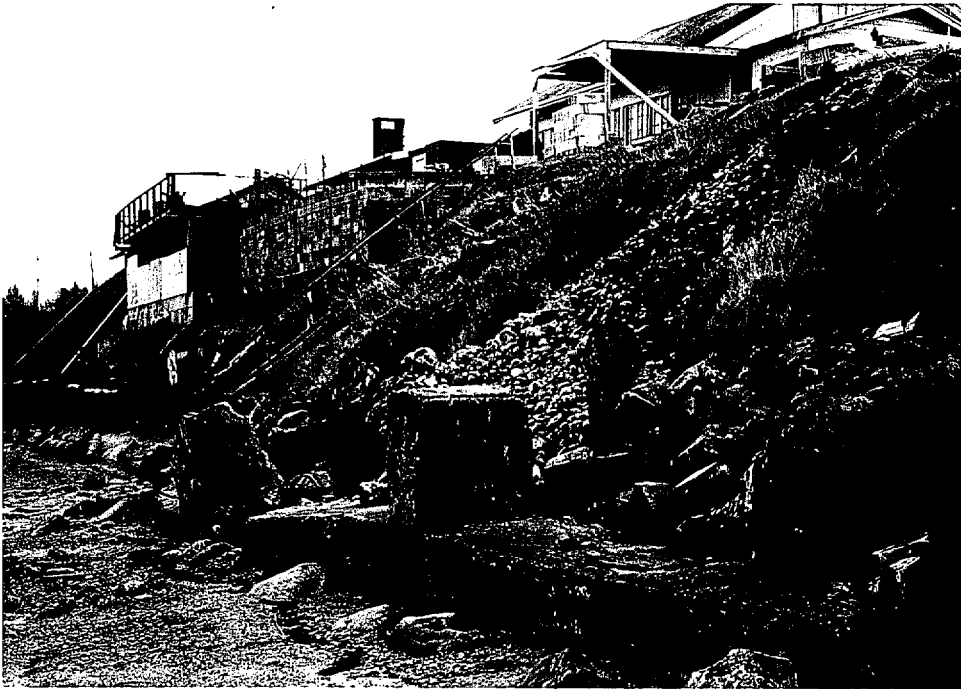
1. Structure Number: 3
2. Structure Type: Concrete - vertical bulkhead (failed)
3. Location: Samish Island, Skagit County

This bulkhead, as originally constructed was adequately strong to resist the wave attack experienced at this site. However, the bulkhead was not a satisfactory bank retaining device. Lack of weep holes for drainage along the base of the bulkhead, compounded the bluff saturation problem. No tie-backs were incorporated in the original structure and the bulkhead had no rock toe protection. If toe protection or beach nourishment had been incorporated in the bulkhead maintenance, the 1-1/2-foot of toe scour which had occurred over the last 20 years could have been reduced. However, as discussed previously, toe scour is probably only a partial contributor to the problem. As constructed, the top elevation of this bulkhead was marginal. During extreme tides, there

was virtually no freeboard and any additional wave action probably caused overtopping, adding to the bluff saturation problem.

In this case, the lack of bank stabilization appears to be the primary cause of the bulkhead failure. If no solution is found for the bank foundation problem, the undestroyed portions of the bulkhead will probably fail in the near future. With no toe protection, the bank would be exposed to wave action, and the erosion rate could increase dramatically.

Solving the bank foundation problem could help to slow the rate of erosion at this site. Bank stabilization procedures could include resloping to a more stable angle, dewatering, and revegetation. In addition, a new means of protecting the bank toe should be provided. This could be a new bulkhead, either timber or concrete, or a revetment of some sort. In the event of further bank slumping, a "nonrigid" revetment of rock or gabions might prove less prone to catastrophic failure than a vertical bulkhead of wood or concrete.

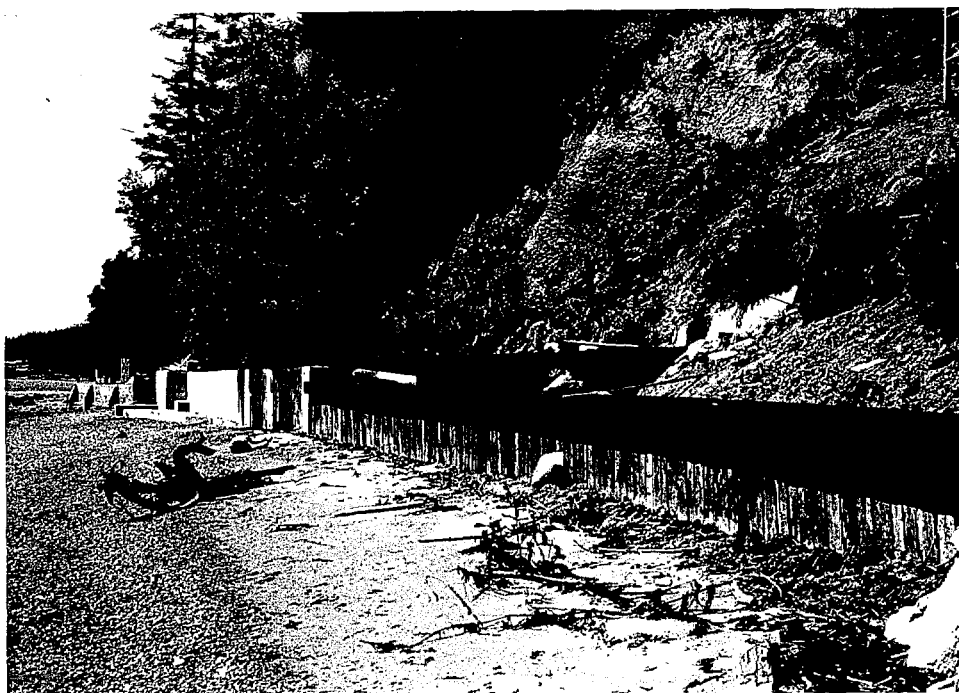
1. Structure Number: 4
2. Structure Type: Railroad Tie - vertical bulkhead
3. Location: Fidalgo Island, Skagit County

This bulkhead is adequately strong to resist the level of wave attack experienced at this site, but the structure is not designed to retain the high bluff behind it. The structure top elevation appears to be adequate, but high tides accompanied by moderate wave action may produce some overtopping. Since no filter material was provided behind the structure, fine material eroding from the bluff may continue to pass through the bulkhead. As of the inspection date, toe protection rock has only been provided along the eastern 25 percent of the structure. This rock is adequately sized but protection of the entire toe should be completed promptly. No tiebacks were included in this design, but the structure is only four feet high and, may be adequately strong to support the back fill behind it. However, a major bluff failure would overturn the bulkhead whether or not tiebacks were used.

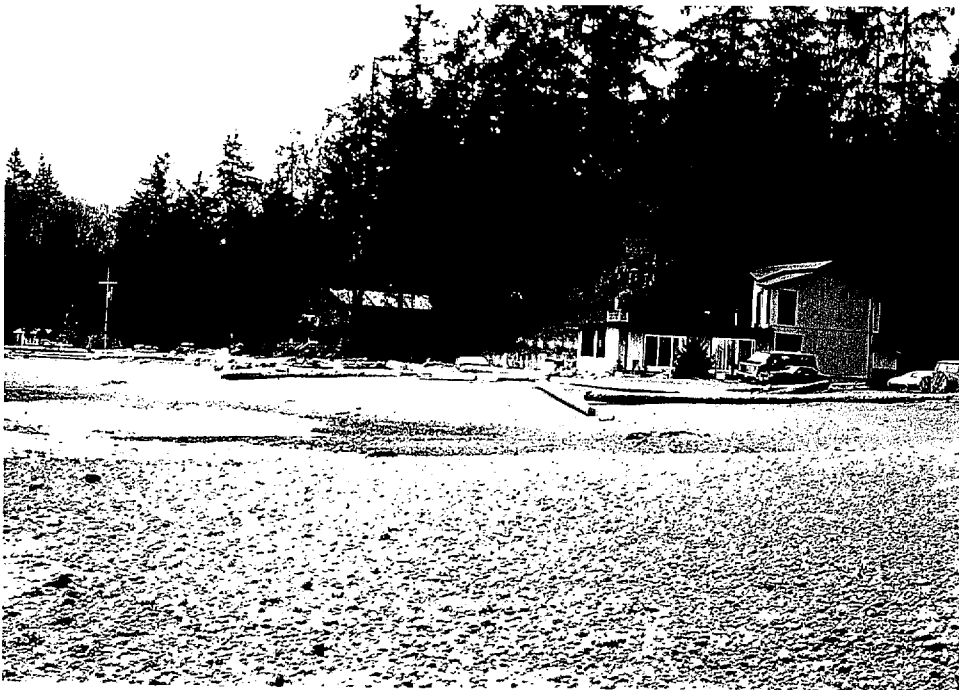
Bulkhead Site

1. Structure Number: 5
2. Proposed Structure Type: Concrete - vertical/recurved bulkhead (proposed)
3. Location: Nisqually Reach, Thurston County

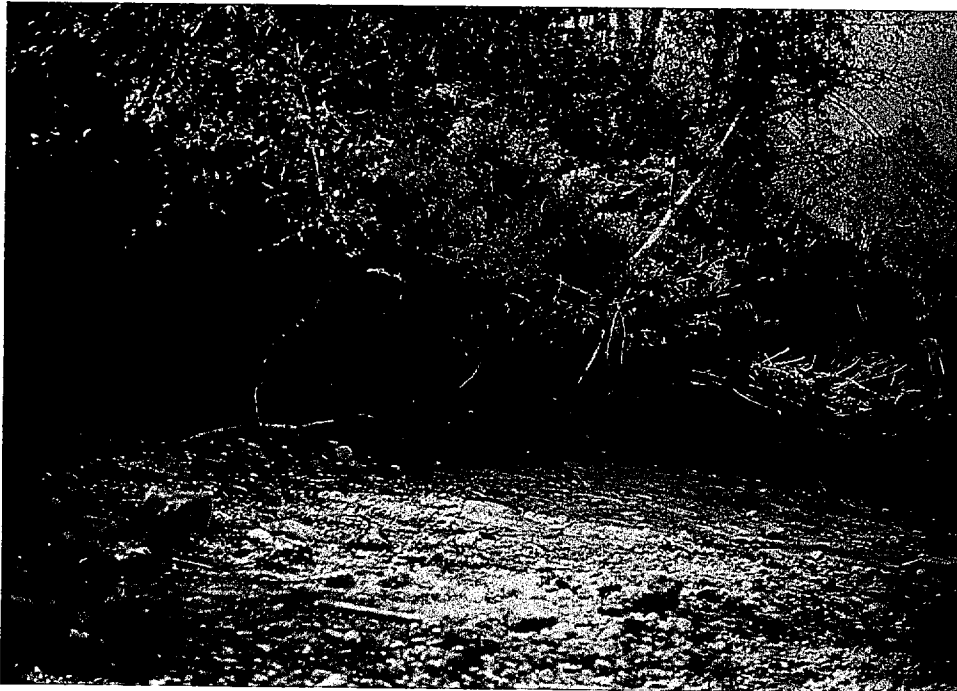
Bulkhead Site

1. Structure Number: 6
2. Structure Type: Concrete - vertical/recurved bulkhead (proposed)
3. Location: Dana Passage, Thurston County

- e. Bluff Geology: The material at this site ranges from clayey silt exposed on the upper beach to 10 feet of silty sand in the lower bank, grading into a more silt free sand above. The lower bank has been severely undercut by wave action in places. The bank is failing both as relatively small scale debris slides and as caving slabs of cohesive sand

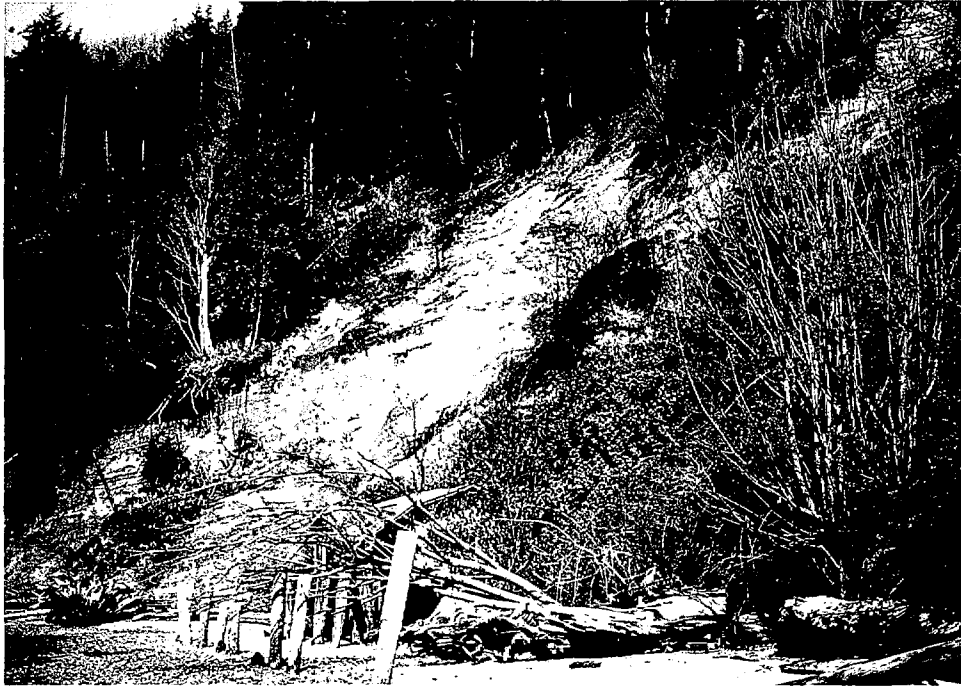
Erosion Site

1. Structure Number: 7
2. Structure Type: None proposed as yet
3. Location: Tulalip Shores, Snohomish County

This site is exposed to heavy wave attack from the south. An effective fetch of about 6 miles allows the generation of waves in excess of 5 feet high. The relatively shallow beach probably causes the highest waves to break offshore, and waves striking the bluff toe should be limited to 3 to 4 feet under most conditions. The predominance of southerly waves causes the net transport of littoral material to be toward the northwest. Erosion problems at this site appear to be serious and seem to result from ground water activity in the bluff combined with wave action attacking the bluff toe. The bluff is over 100 feet high and appears to be composed of silt, clay, and sand. Material from the bluff is deposited at the bluff toe, then removed by wave action.

A bulkhead at this site may need special attention to its foundation design as the disturbed slide materials may well extend into the upper beach. As ancient landslides may reactivate, every effort should be made to prevent groundwater buildup within the slide mass as well as the bank. Prevention of reactivation through drainage control will probably be much more effective and cheaper than a retaining structure.
