Land and Water Interactions—Activity 1 of Two

Shoreline and bluff erosion has been identified by shoreline residents as a critical problem along some parts of the Great Lakes. Land losses of up to 10 feet per year have been estimated for some areas. Property damage totals millions of dollars. Land loss and property damage are caused by the conflict between natural forces and human activity along the shoreline.

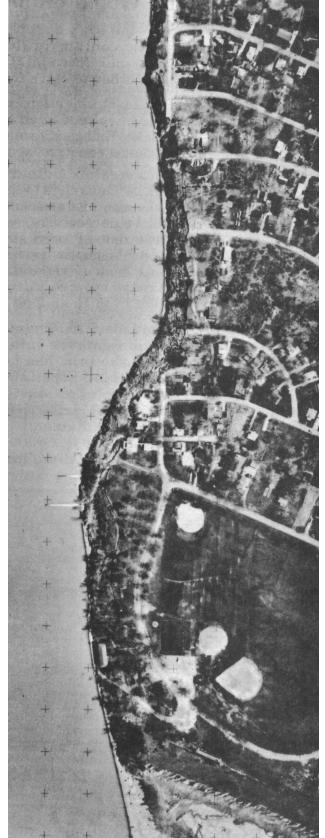
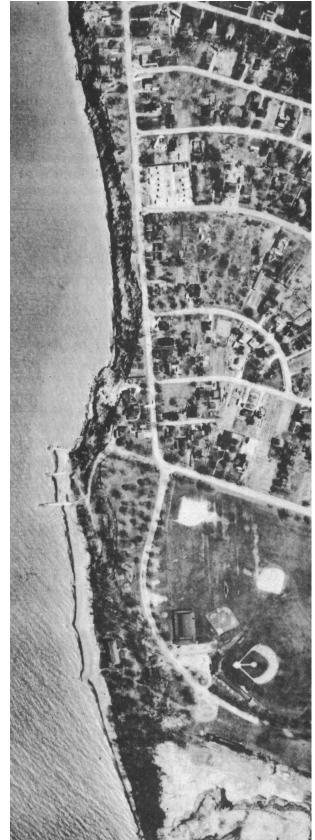
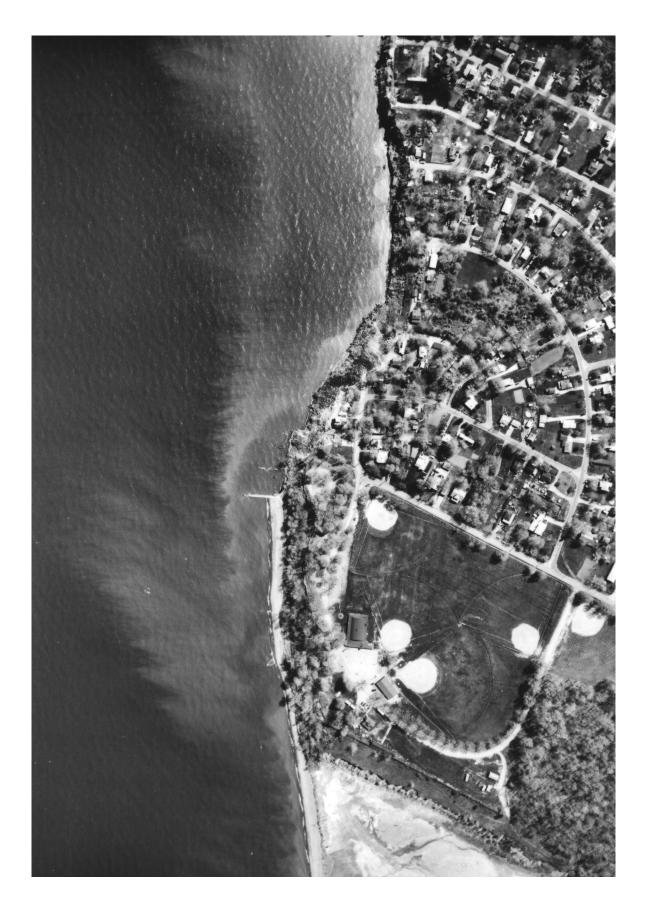
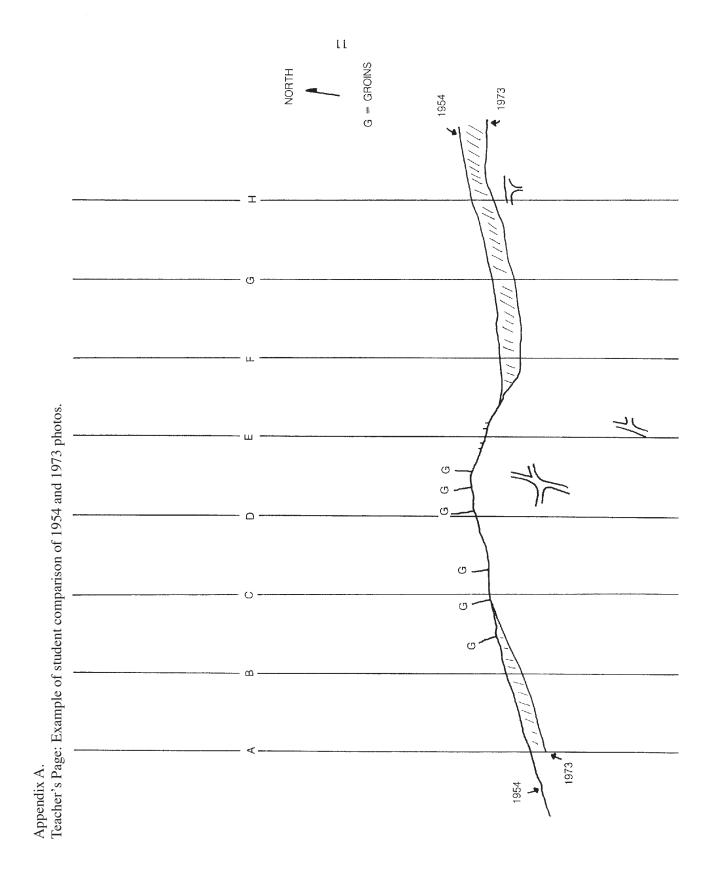
- 1. Students should observe the groins at the center of the photo, the sand beaches to the west, and the slumping bluffs to the east of the groins.
- 2. In the second photo, the beach has largely disappeared, and the bluffs have retreated southward. A part of the highway has been removed as well as several buildings.

- 3. Additional erosion has taken place, as noticed for example in the area to the east of the groins.
- 4. There are six rather prominent groins. In the 1954 photo, students may see several other small structures built out from the beach. These may be small groins or perhaps piers. Of the three largest groins, one has become very faint in the 1973 photo. Other groins seem to have disappeared. They have been submerged by the higher lake level. The general level of the lake increased over the decade from 1960 to when the 1973 photo was taken. This is the major reason that the beach is not as wide and that the groins seem less prominent. In the 1981 photo, two groins are recognizable with the other appearing faint.

- 13. The two shorelines are the result of erosion processes and the consequent retreat of the shoreline to the south. ONE CAUTION; LINE A WILL CROSS A CLAY PIT. On the 1973 photo, clay has been removed to the beach. Therefore, there is a broad white stretch on the photo. Students may interpret this as cliff recession.

- 14. The shaded area represents land removed by erosion.
- 15. A greater amount of erosion has taken place to the east. Because of the presence of the clay pit, students may not arrive at this conclusion. You should discuss this with them.

- 16. The groins protected the portion of the shoreline they were connected to. The new beaches, once formed, provide a place for waves to expend their energy. This energy is not used to erode the upland areas; consequently, the recession rate of the shoreline is considerably reduced. Beyond the groins on the downcurrent side, currents will pick up a new load of sediment, and there will be more erosion than occurring upstream of the groins.

You should have noticed some straight objects jutting out into the water in the west central part of the photos. These are **groins**. They are structures designed to protect the shoreline by trapping sand.

Groins will cause deposition on their upcurrent side, and increased erosion on the downcurrent side. Therefore, it appears that the predominant direction of the longshore currents is from west to east.
