**REVISED
DRAINAGE
MANAGEMENT
PLAN HOMER, ALASKA**

**drainage investigations for
the west hill, sterling south,
and beluga lake areas**

February 1982

QUADRA
ENGINEERING, INC.

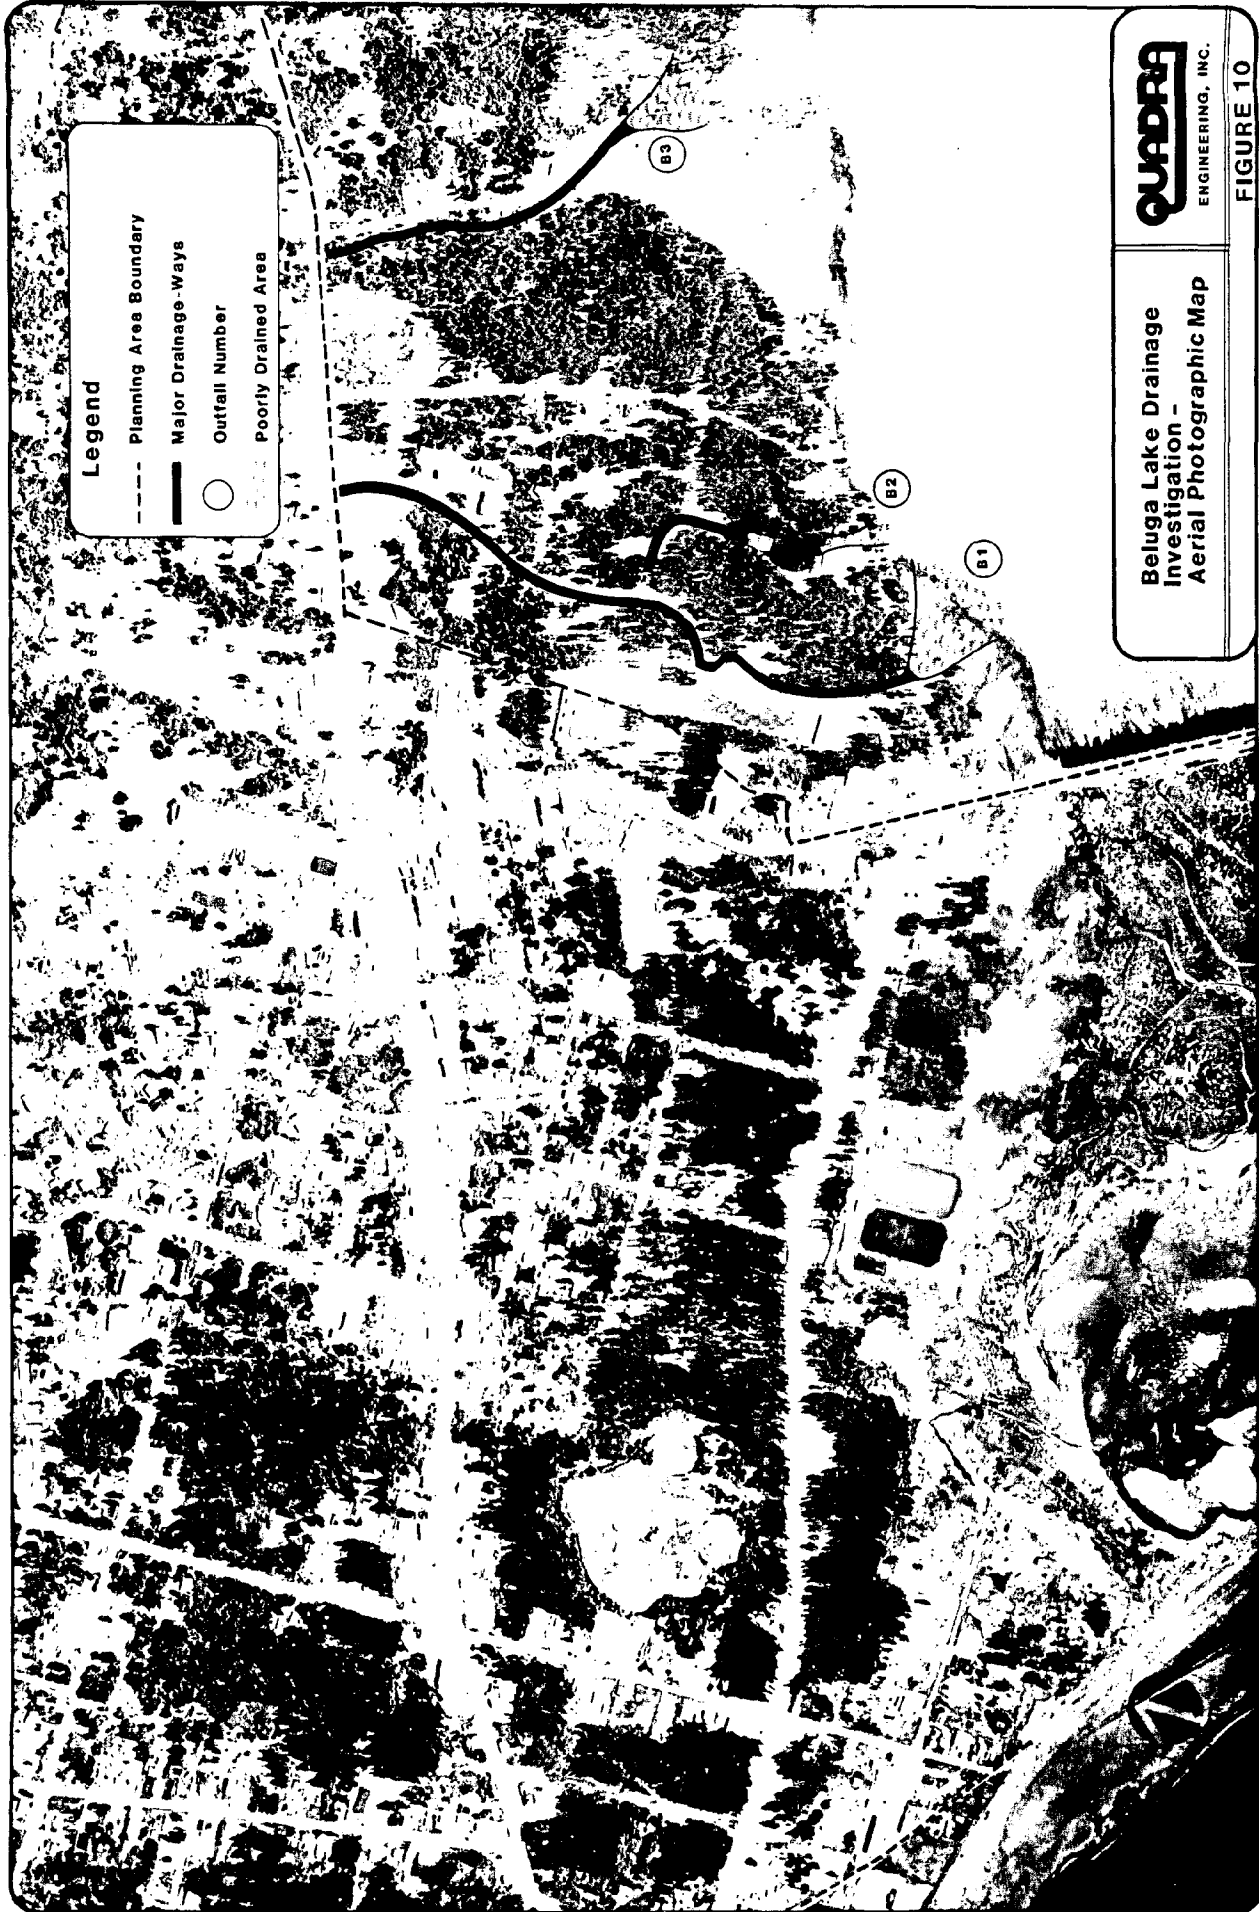
FIGURE 10

**Beluga Lake Drainage
Investigation -
Aerial Photographic Map**

A well-defined drainage system comprised of two separate channels has been developed in the Lakeside Village Subdivision. The first (Outfall # B1) flows along the west side of Ben Walters Lane. The channel has been eroded in places but otherwise the channel pattern and culvert sizes are adequate to contain the expected discharge. Flow from this ditch system is routed to Beluga Lake over a "cat trail" road. With no channel or culvert provided for the drainage to bypass this road, water travels west along the "cat trail" for about 100-feet, and then forms small ponds which overflow to the south and outfall to Beluga Lake.

The other channel in the Lakeside Village Subdivision (Outfall # B2) collects surface runoff from areas east of Ben Walters Lane, and then flows under an old wooden bridge/culvert structure. The channel then spreads out and the stream flows over a wide area east of the residence in Lot 1-A of the A.A. Mattox Subdivision. It finally discharges to the wetland area along the shore of Beluga Lake.
