## **The Containerized Shipping Industry and the Phenomenon of Containers Lost at Sea**

**U.S. Department of Commerce**  
National Oceanic and Atmospheric Administration  
National Ocean Service  
**Office of National Marine Sanctuaries**

March 2014

Oren T. Frey<sup>1</sup> and Andrew P. DeVogelaere<sup>1</sup>

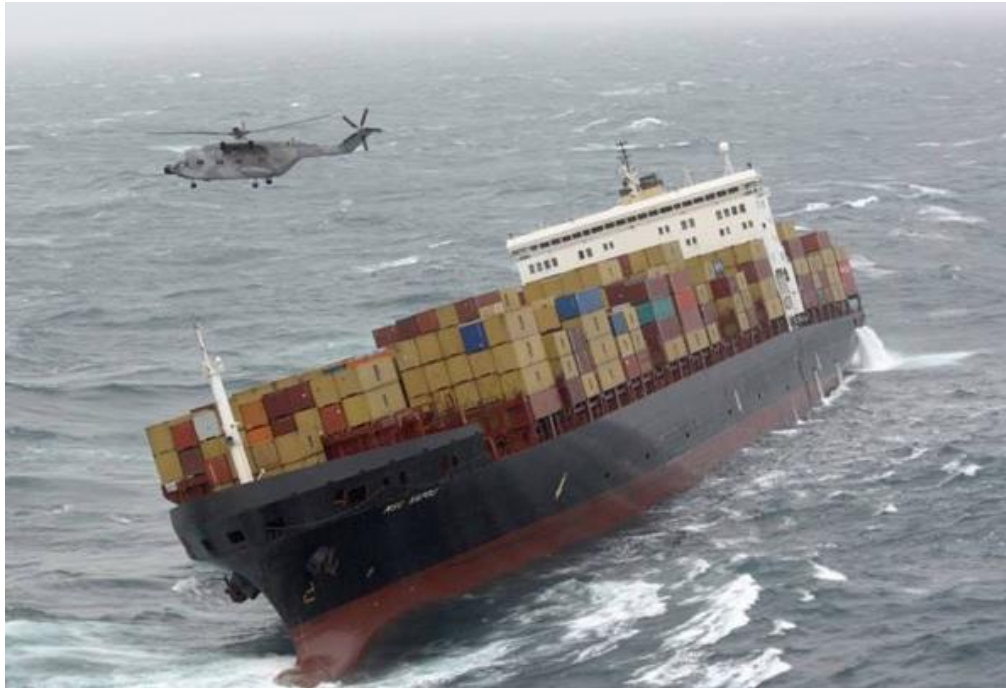
**Figure 6.** The *MSC Napoli*, which broke apart in January 2007 in the English Channel. MAIB investigation determined that 20% of the containers were overweight. Photo from AIMU 2008.

***Misdeclared container weights:*** It is believed that shippers sometimes ignore the weight limitations of shipping containers. The U.K.'s Marine Accident Investigation Branch (MAIB) investigated the failure of the containership *MSC Napoli* in January, 2007 (Figure 6) and found that 137 (20%) of the 660 dry containers stored on deck had actual weights greater than their declared weights. Some containers were overweight by as much as 20 MT (AIMU 2008).

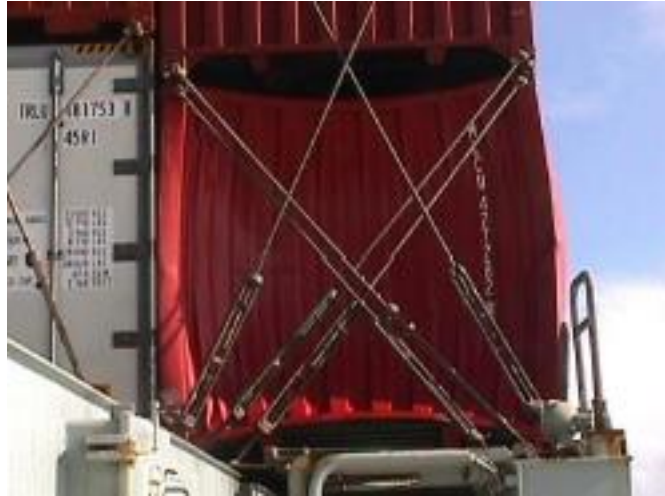
**Figure 7.** Lashing rods tightened by turnbuckles are attached by hand by longshoremen to help secure loads. (This container was damaged by a bow-slammng wave). Figure from Koning 2009.

***Faulty connections between containers:*** Containers in a stack are connected to each other with the use of bottom twistlocks. These are used in combination with lashing rods (Figure 7). The replacement of semi-automatic twistlocks (required for ships calling on U.S. ports) with fully automatic twistlocks (FAT) in the past decade has been a cause for concern. FAT require less work by longshoremen on the dock but are smaller and their failure has been a common factor in several loss incidents (AIMU 2008).

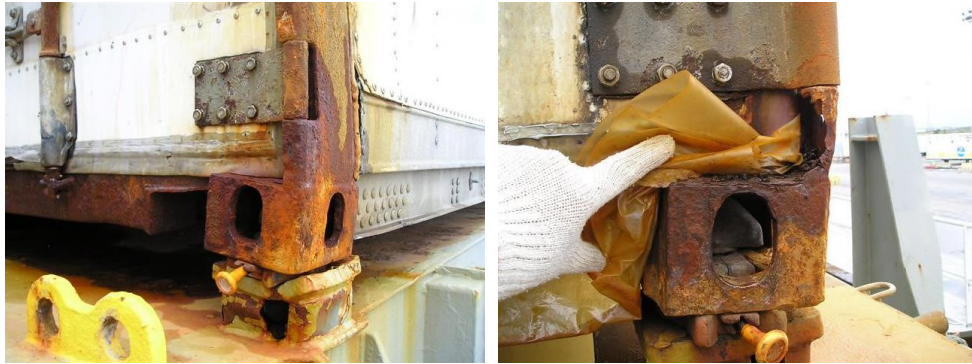
**Figure 8. Container corner posts and fittings in unsatisfactory condition. Figures from AIMU 2008.**

**Containers in poor condition:** During periods of high shipping demand, shortages of containers sometimes result in the use of containers in unsatisfactory structural condition. Container corner posts and structural fittings in a degraded condition or not built to ISO standards in the first place can jeopardize an entire stack of containers (Figure 8).

A study by the IMO from 1996-2002 found that of 19,704 containers inspected, 1,737, or about 9%, had Container Safety Convention (CSC) plate and structural deficiencies (AIMU 2008).

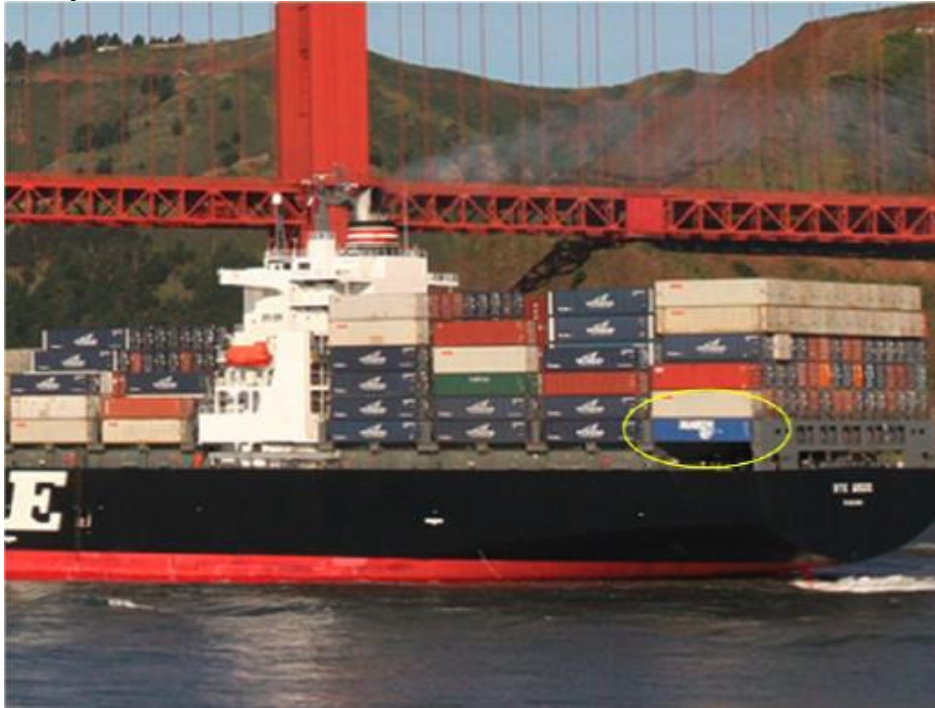
**Figure 19. The *NYK Argus* leaving San Francisco Bay, with an instrumented MARIN container on the bottom tier to help monitor forces while underway. Photo credit: MARIN 2009.**

From 2006-2009, a consortium of 23 participants including ship owners, lashing gear manufacturers, governments and classification societies conducted “Lashing@Sea,” a study organized by MARIN. Methods included a monitoring campaign of five ships in operation, model tests of secured cargo and an extensive crew survey (MARIN 2010). One of the vessels monitored was the *NYK Argus*, which was equipped with an instrumented container carried in the lowest tier to record forces imparted from the stack above and from lashing arrangements (Figure 19). The vessel was also fitted with a grid of 11 acceleration sensors, hull deformation and load sensors, and weather forecast and ship movement data links (MARIN 2009). Lashing@Sea provided the IMO and the International Association of Classification Societies (IACS) with recommendations to improve safety levels.

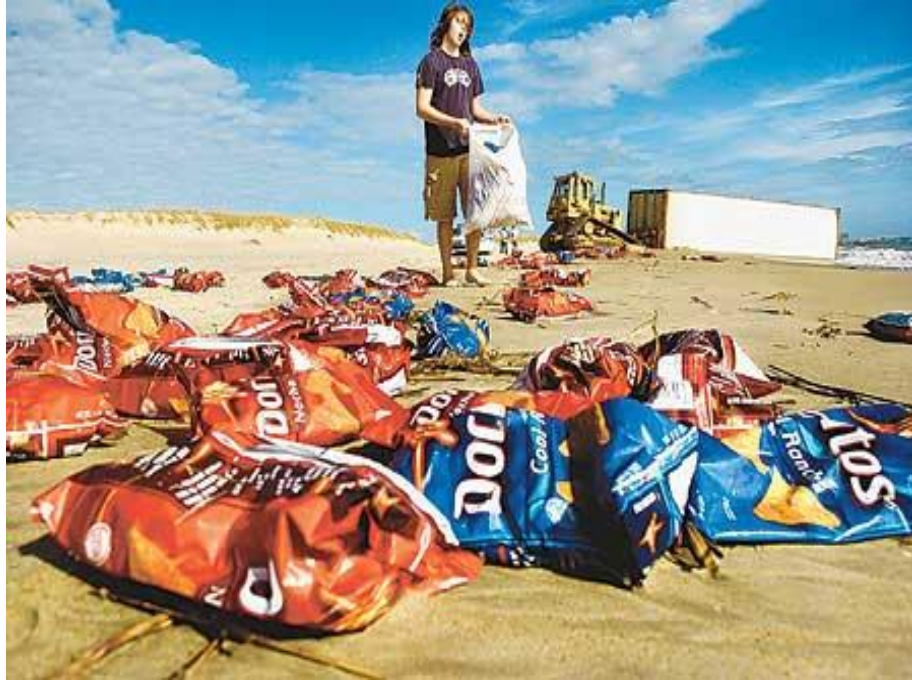
**Figure C-2. Shipping container and cargo of snacks deposited on the Outer Banks, NC. Photo credit: *The Virginian-Pilot*.**

A container washed up on the shore of Frisco, NC, just south of the Cape Hatteras Fishing Pier in the Outer Banks. The container had drifted for several days after falling overboard with three others from the M/V *Courtney L*, underway from Wilmington, Delaware to Costa Rica. Its cargo of Doritos snacks had escaped the container, and thousands of bags of chips also washed up on the beach (Figure C-2; [www.cargolaw.com/2000nightmare\\_singleonly10.html](http://www.cargolaw.com/2000nightmare_singleonly10.html), 2011).

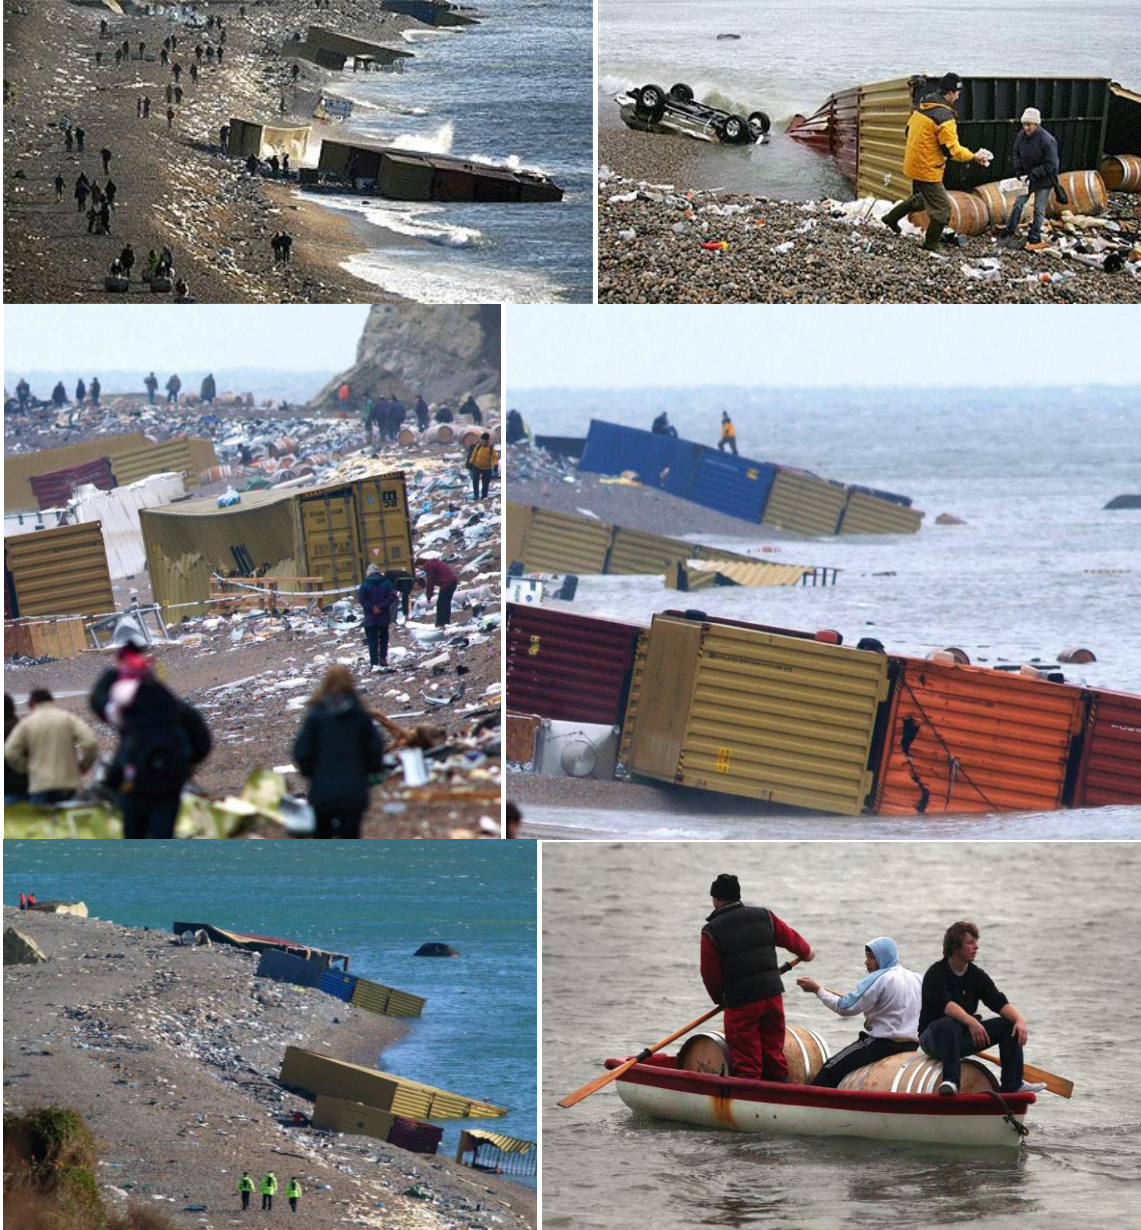
**Figure C-3.** Container loss associated with the February 2007 grounding of the *MSC Napoli*. Many lost containers washed up on Branscombe Beach, allowing “beachcombers” the opportunity for extensive illegal looting, especially after initial reports of “whisky galore.” Photo credits: Mercer 2008.

Following abandonment on January 18, 2007 and subsequent towing, the *MSC Napoli* was beached on the soft seabed less than one nautical mile off Branscombe Beach, Devon (U.K.) on January 20, 2007 (Mercer 2008). The beaching of a loaded containership this close to shore was unprecedented. Salvors managed to remove 2,300 containers from the ship, but at least 50 containers were lost overnight as the ship lay listing. Some sank, while others were deposited on Branscombe Beach (Mercer 2008). Some of the beached containers contained hazardous materials including nitric acid and airbag inflators. “Looting mayhem” ensued on Branscombe Beach over the course of the following days. Although some containers may have opened due to impacts, others are believed to have been forcibly opened by looters (Figure C-3; Mercer 2008).

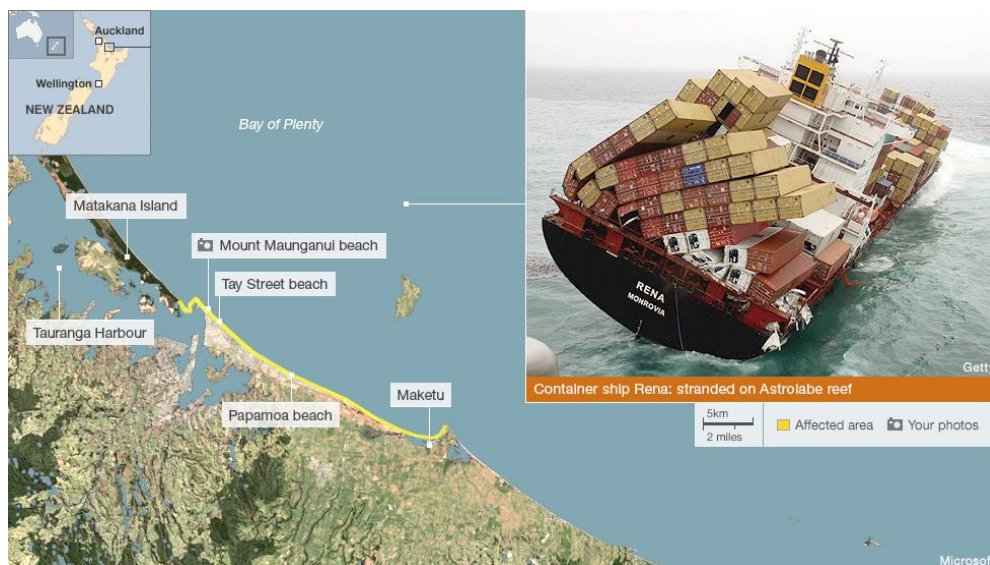
**Figure C-4. MV *Rena* and the location of its stranding near Tauranga, New Zealand. Photo credit: BBC News.**

Just before completing a coastal transit from Napier to Tauranga, the MV *Rena* and its cargo of 1,368 containers ran aground on Astrolabe Reef, off the north coast of New Zealand (Figure C-4). With the front of the ship stuck on the reef, the vessel started to leak oil. Although about 350 tons of oil were released from the *Rena*'s fuel tanks between October 5-11, over 1,300 tons of the 1,712 tons of oil on board at the time of grounding had been recovered (Maritime New Zealand 2012). Still, New Zealand declared the oil spill its “worst ever environmental disaster.” Container loss began to occur as rough seas and winds arrived on the night of October 11. The ship had completely cracked in half by October 14, but remained in place on the reef until the weekend of January 7-8, 2012 when sinking of the stern commenced. Container loss and recovery is summarized in Table C-1. To aid salvage operations, 219 transponders were fitted to containers. Following recovery, transponders have been relocated to other containers as their locations are identified. A gallery of stunning photos of this incident is available at <http://www.maritimenz.govt.nz/Rena/gallery.asp>.
