# **POLLUTION SOURCES AND ENVIRONMENTAL FACTORS AFFECTING WATER QUALITY IN GREAT BAY**

**A Final Report Submitted to  
The New Hampshire Division of Public Health Services, Bureau of Food Protection  
and New Hampshire Office of State Planning, New Hampshire Coastal Program**

**by  
Dr. Stephen H. Jones and Dr. Richard Langan  
Jackson Estuarine Laboratory  
University of New Hampshire**

**Sanitary Survey**  
**for**  
**GREAT BAY AND LITTLE BAY**  
**NEW HAMPSHIRE**

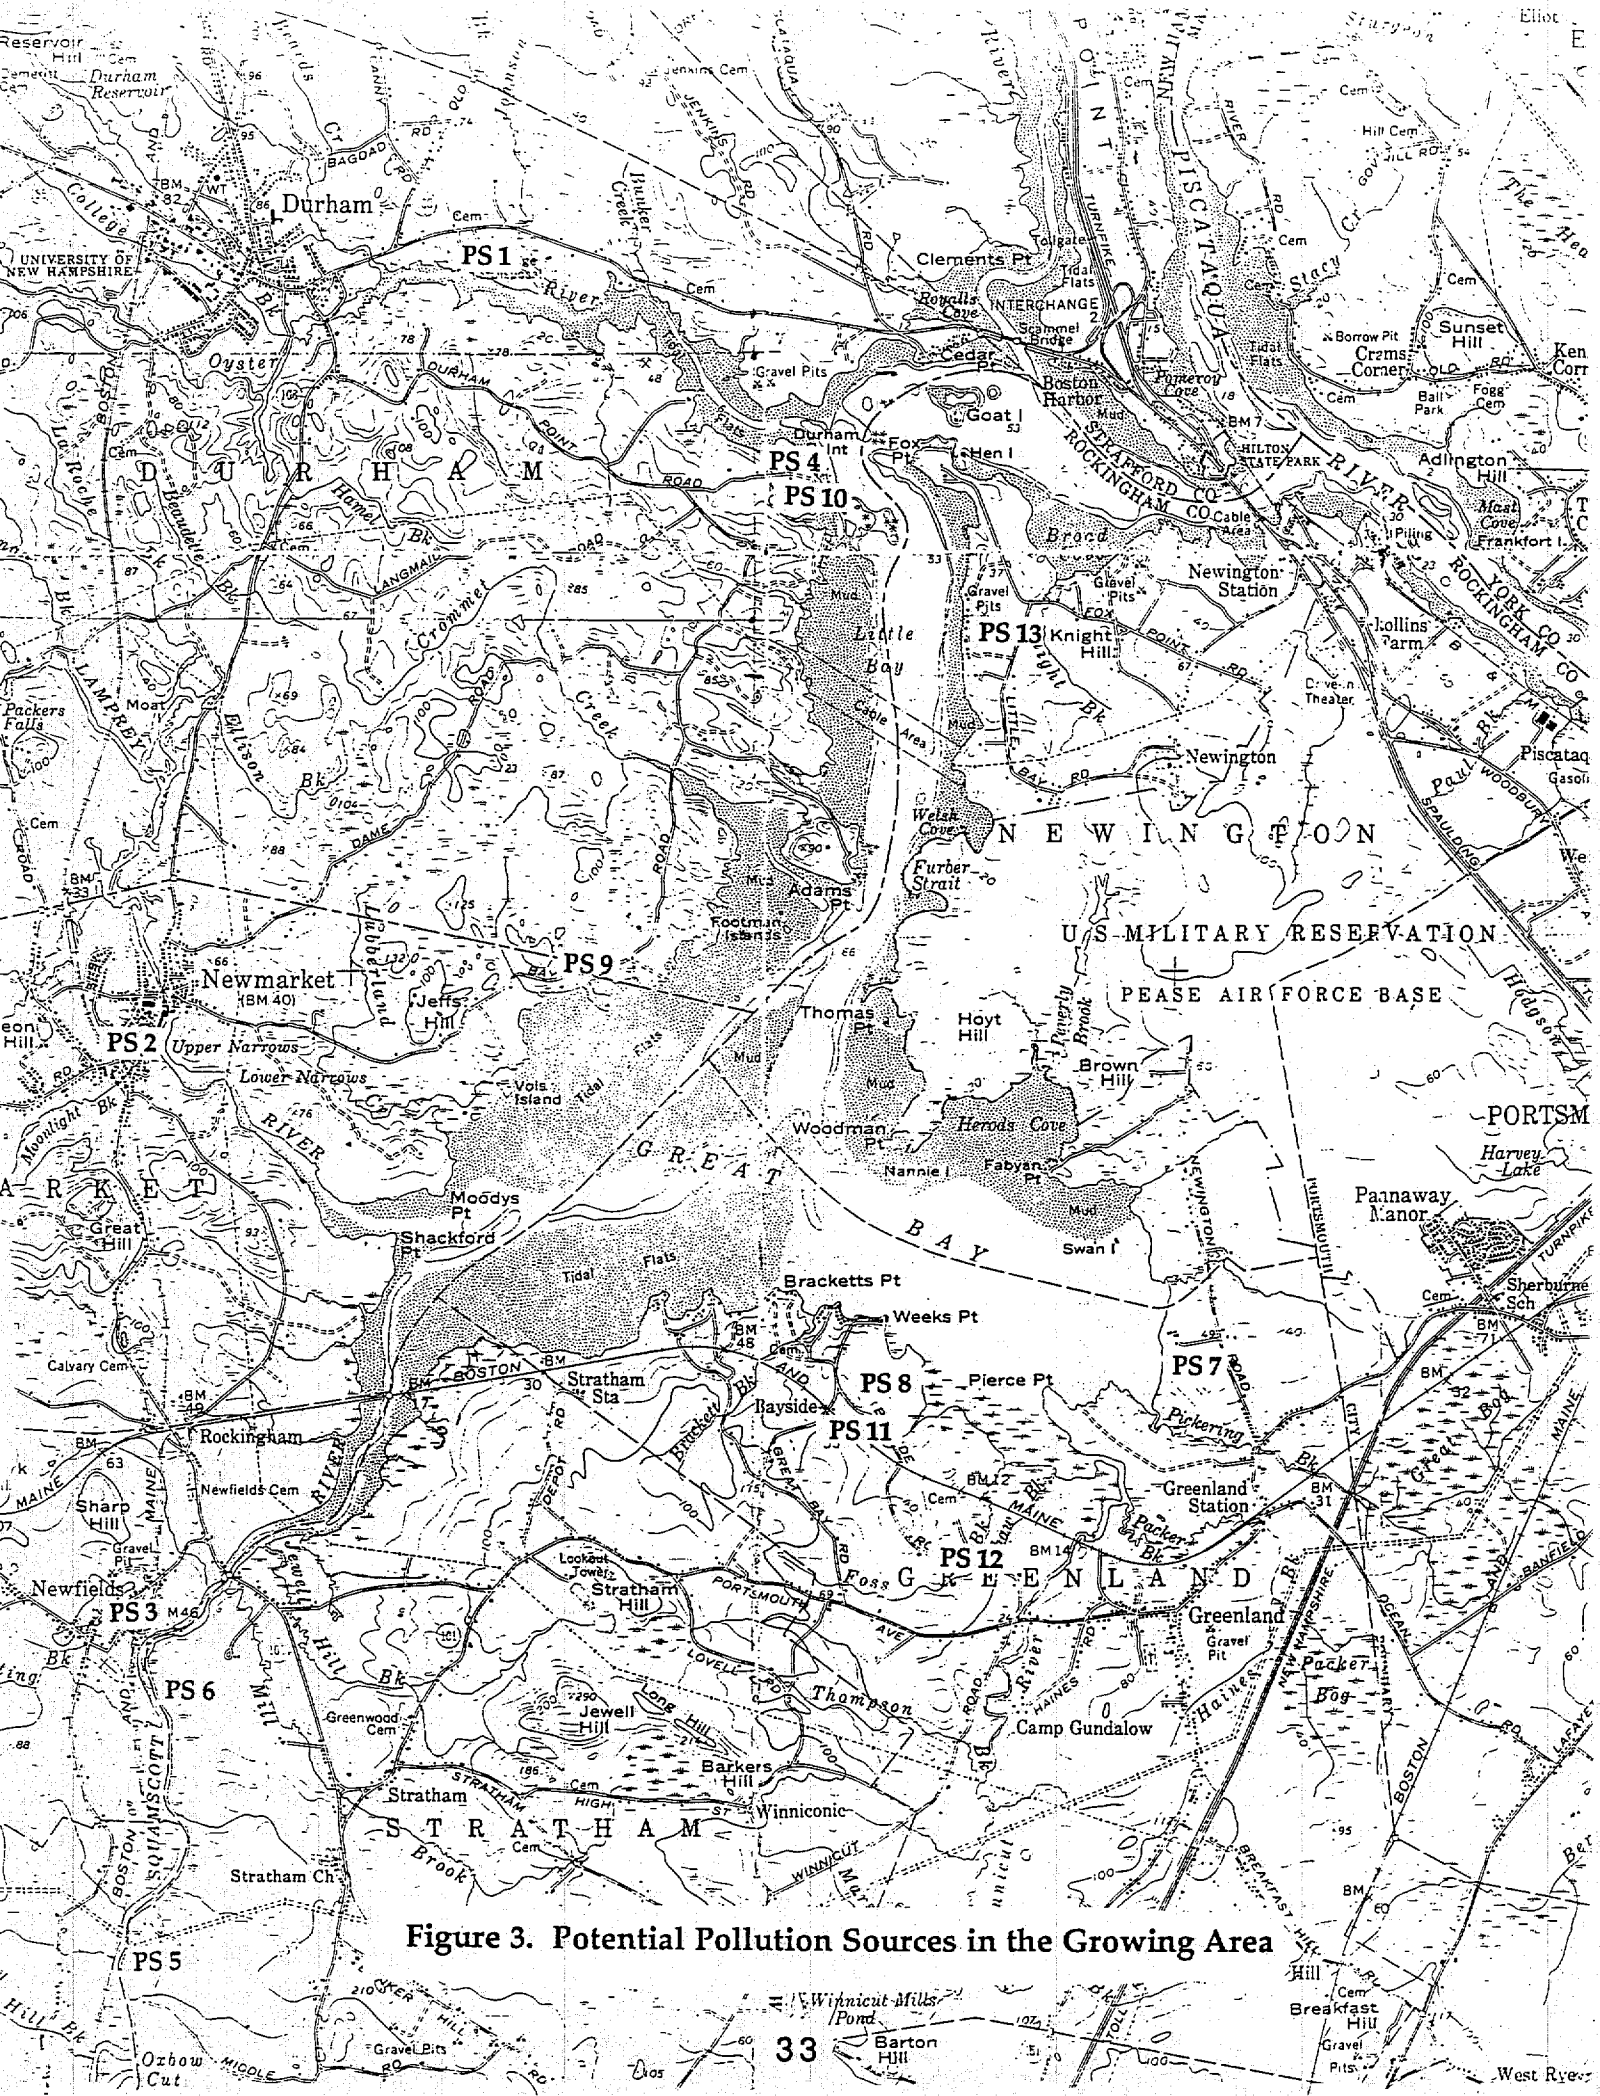
Figure 3. Potential Pollution Sources in the Growing Area

Figure 3 shows the locations of potential pollution sources to the growing area. A discussion concerning each individual source follows in Section 2. The shoreline survey was conducted by boat at both low and high tide in August and September 1994 by Drs. Richard Langan and Stephen Jones and by foot in highly populated areas during April and May 1995 by Paul Raiche, Andrea Tomlinson and Deborah Lamson. By boat, properties were surveyed at high tide in order to gain close access to shore for better observation, while at low tide, any pipes located below the high water mark could be more readily observed. Homes bordering the growing area were evaluated by looking for malfunctioning septic systems, gray water pipes, outhouses and other potential pollution sources. During shoreline reconnaissance by foot, many land and cellar drains were discovered but none were determined as being potential pollution sources. One old, abandoned outhouse with a cement foundation was found on the northwest side of Great Bay and a suspected malfunctioning septic system was discovered in the same vicinity. Another potentially malfunctioning septic system was found on the east side of Little Bay in Newington. Both systems have been reported to the appropriate town and state officials (See Section III A. 2. for results). All major drainage streams (those with a flow of at least 15 gpm) were evaluated and water samples were taken from each of these major streams (see discussion in section III. A. 2.).

Table 1 lists thirteen actual or potential pollution sources found either directly within the growing area or within tributaries which flow into the growing area (Figure 3). Included in Table 1 are "Relevant Sample Sites." These are specific water quality sampling sites that have been designated by both the Division of Public Health Services and the Jackson Estuarine Laboratory staff which will show the effects, if any, that each pollution source listed in Table 1 has on a specific section of the growing area. Figures 4 and 5 show the array of all sampling sites which have been established in order to monitor water quality throughout the growing area. Sites GB1-GB7 (JEL) were established by Jackson Estuarine Laboratory (JEL) based on past and ongoing studies to give a more comprehensive documentation of spacial and temporal water quality trends in the southwest portion of Great Bay (Figure 4). Sites GB4A-GB80 (DPHS) are sites established by DPHS to support the routine classification of the area (Figure 5). Listed below are sampling sites included in Figures 4 and 5 which were routine sample sites in the evaluation of water quality within the growing area for this study.

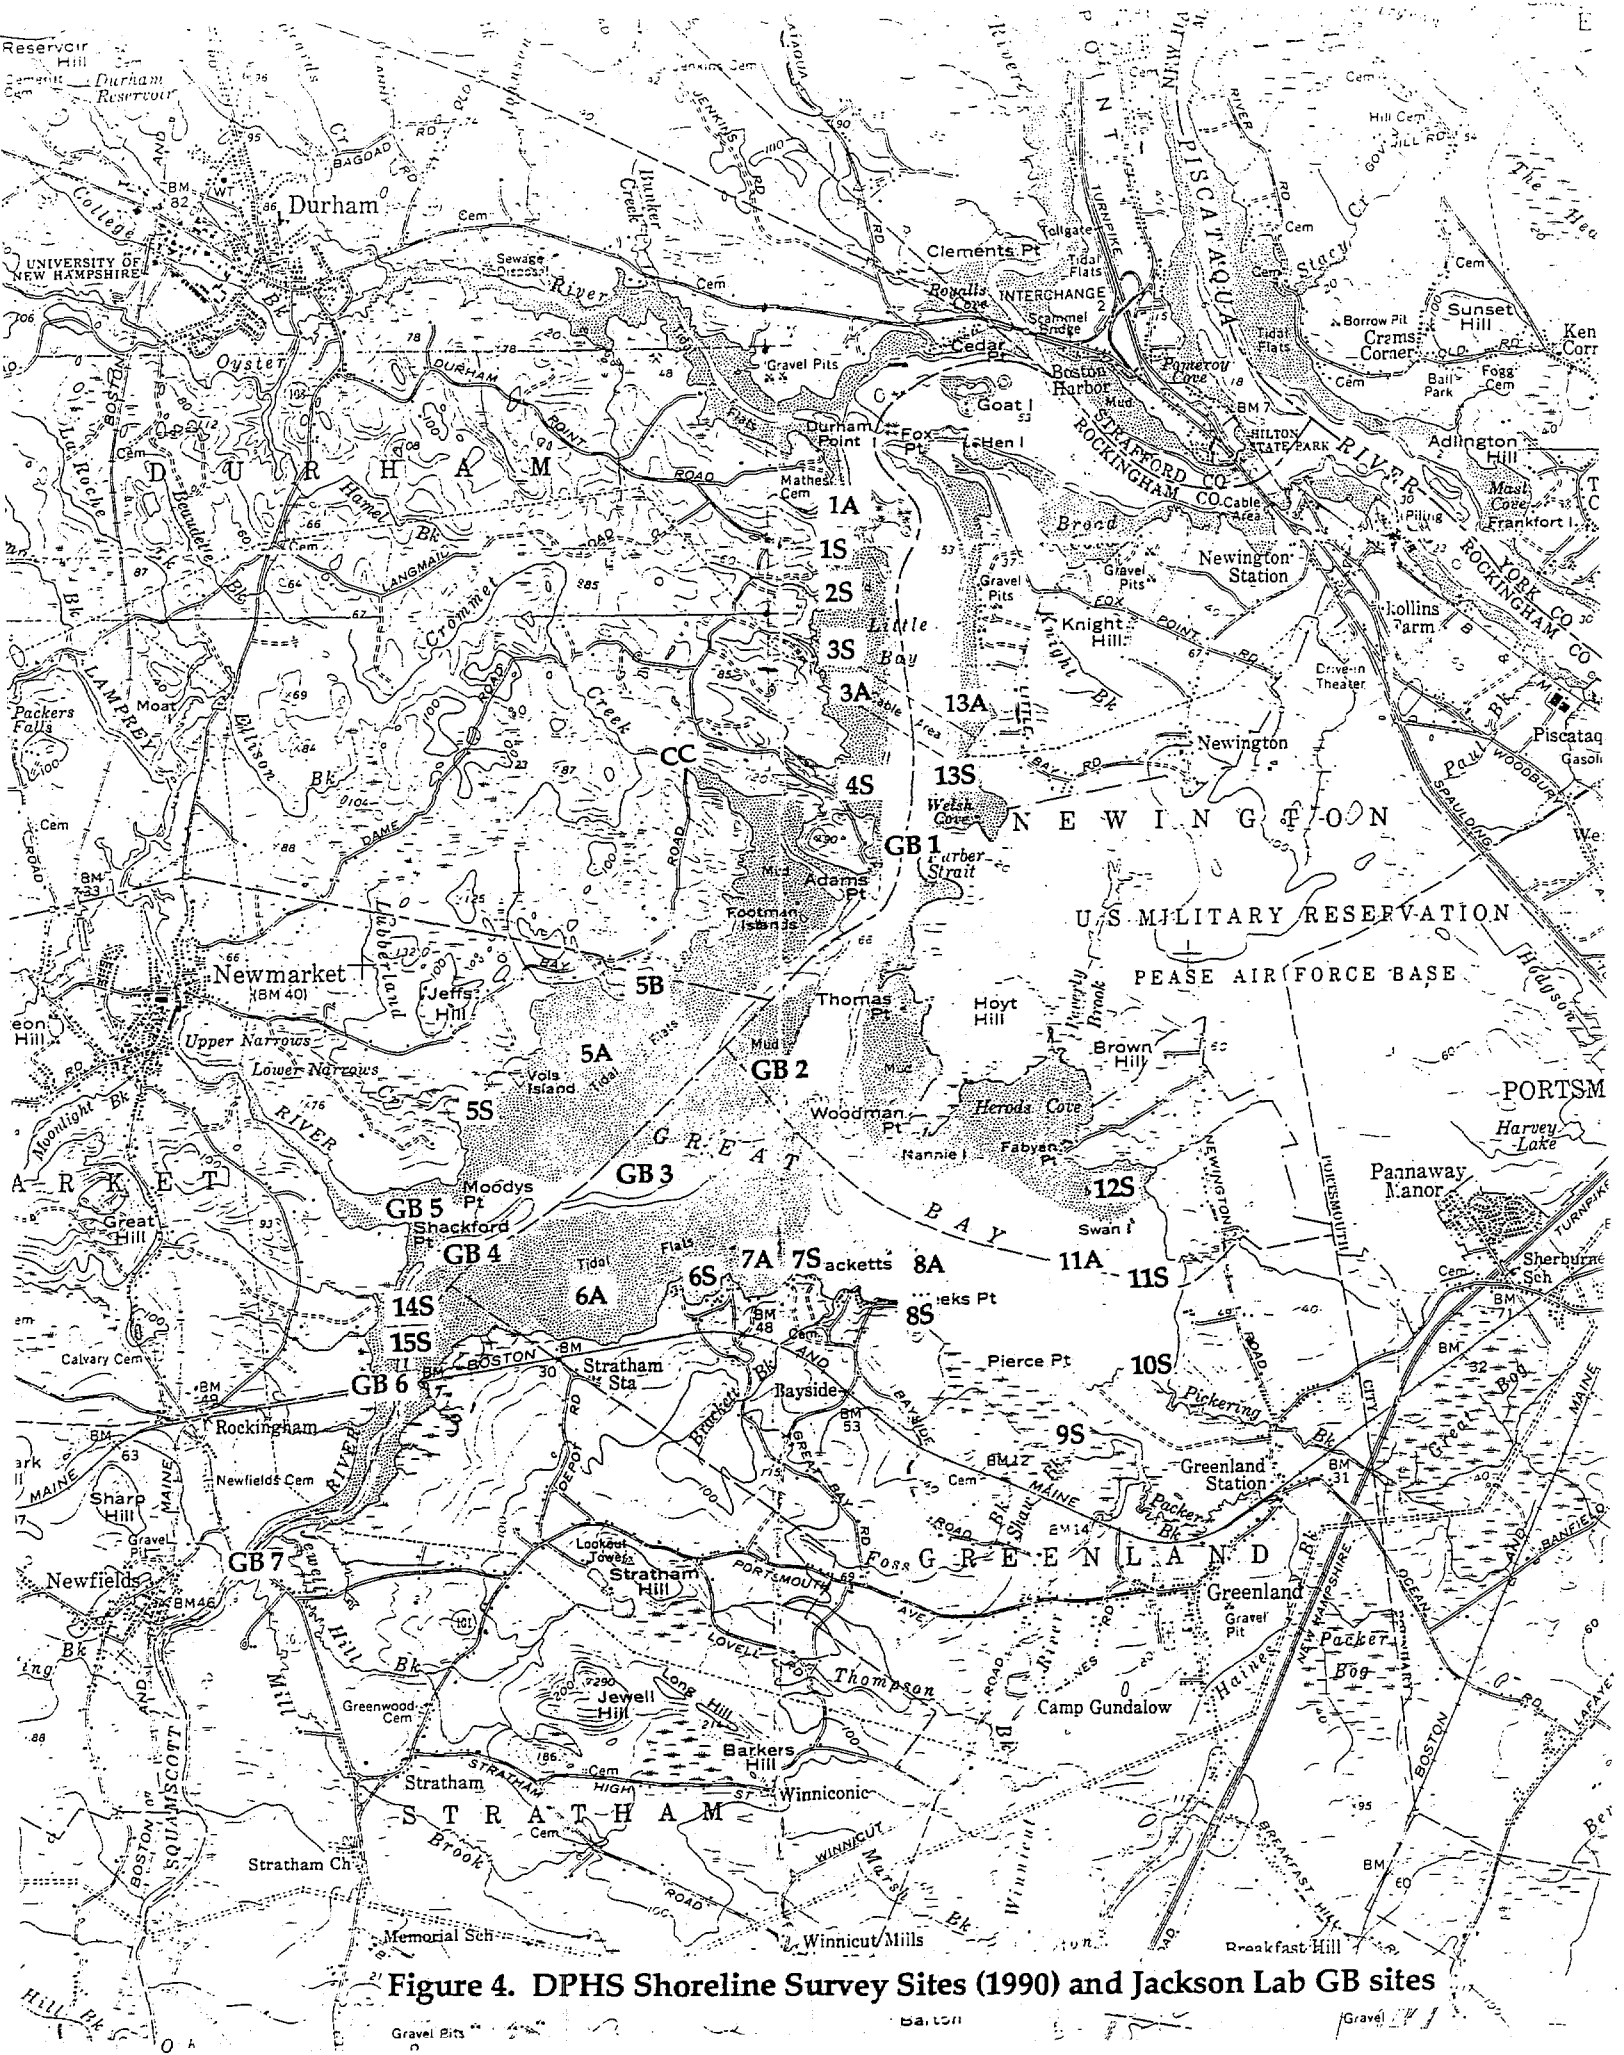
Figure 4. DPHS Shoreline Survey Sites (1990) and Jackson Lab GB sites

for water samples collected from sites 1S/A-15S (Figure 4), which were established as a result of shoreline survey work performed for the 1991 Sanitation Survey, are shown in Table 4. Fecal coliform concentrations were relatively low (<43/100 ml), except at sites CC, 14S and 15S on July 12, and site 5A on August 9. Sites CC and 5A had lower levels on different dates, and the geometric means for these sites were <43/100 ml. Sites 14S and 15S were sampled once, but these are located well into the mouth of the Squamscott River, and should be considered as part of this point source to the growing area.
