*Harford County Shoreline Study*  
*Harford County Department of Planning and Zoning*  
*1981*

# ***Harford County Shoreline Study***

## ***Harford County Department of Planning and Zoning 1981***

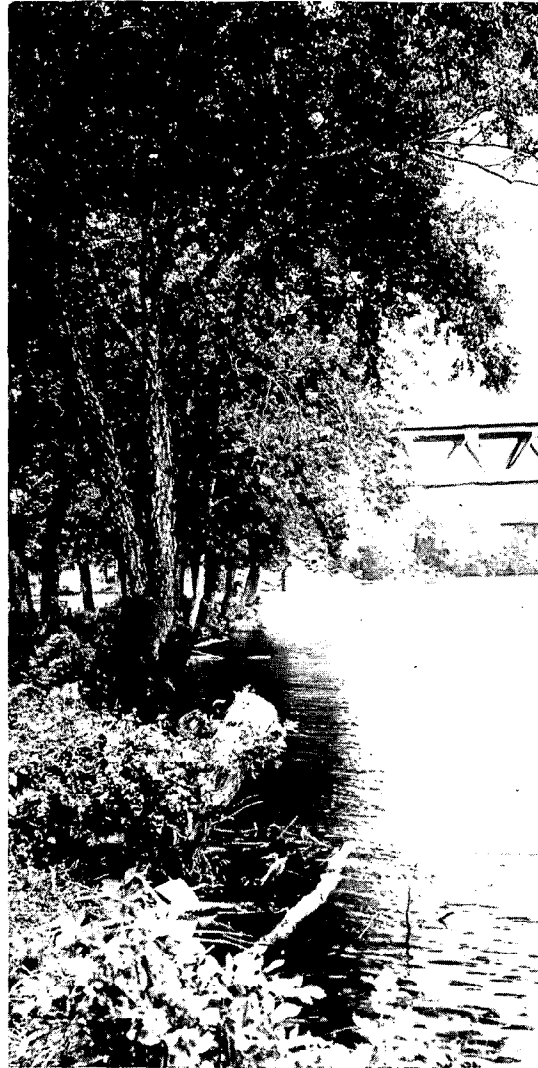
### **Natural/Overhang**

A natural shore with overhanging mixed hardwood vegetation. Found along the Susquehanna River, the Oakington Shore, and the coves of Swan Creek, the Bush and the Gunpowder Rivers.

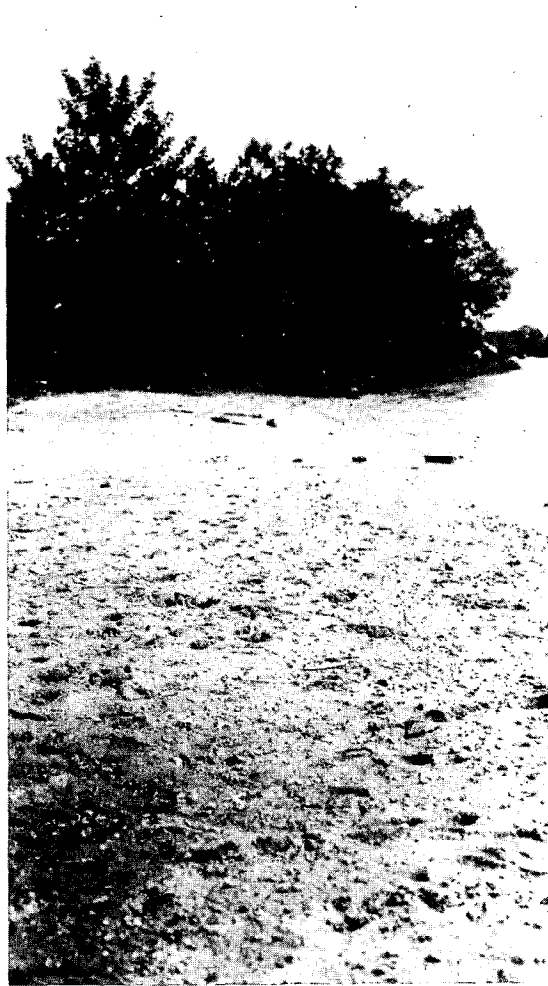
**Sandy/Vegetation**

A sandy beach with mixed hardwood vegetation. In-shore landscape is usually recessed (sloping), but some are bluffed. Found along the Bush and Gunpowder Rivers.

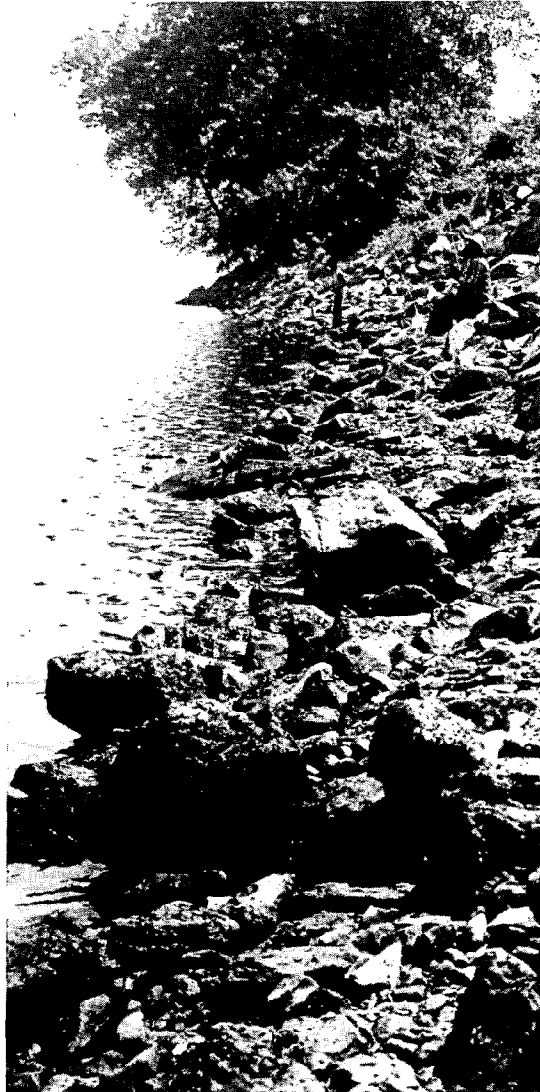
**Gravelly/Vegetation**

Gravelly beach with mixed hardwood vegetation. Found along the Susquehanna River and the Chesapeake Bay.

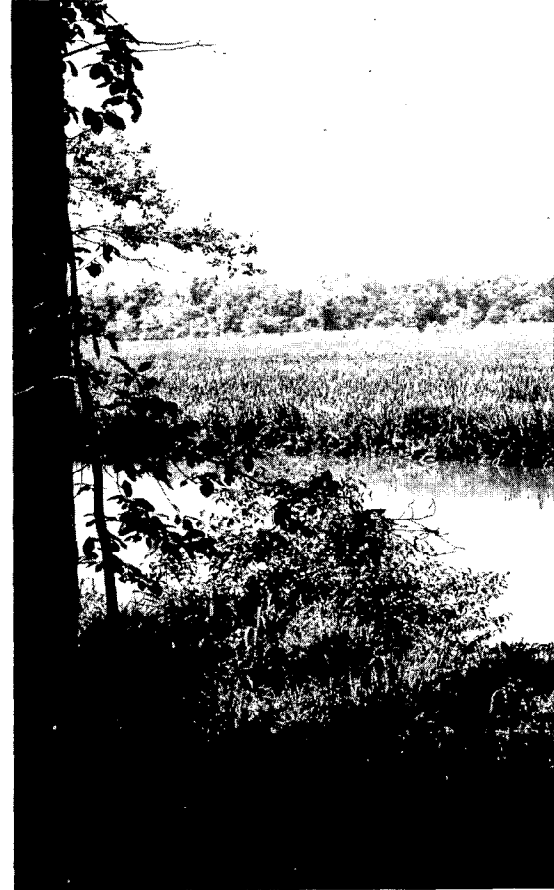
**Marsh**

Low wetland, periodically inundated. Considerable growth of grasses, sedges, cattails, and rushes. Found in the Swan Creek and the Bush and Gunpowder Rivers.
