### Description of the Dive:

Overall Map of ROV Dive Area

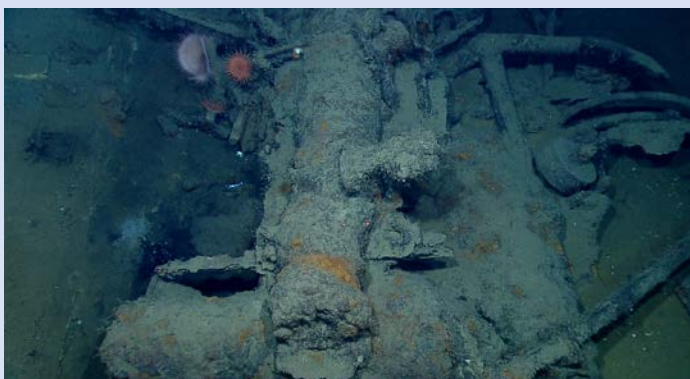
Much of the ship's equipment remained inside the hull, including cannons, the ship's stove, navigational instruments and anchors. A cannon, anchor and the wheel of a gun carriage are visible in the image above.

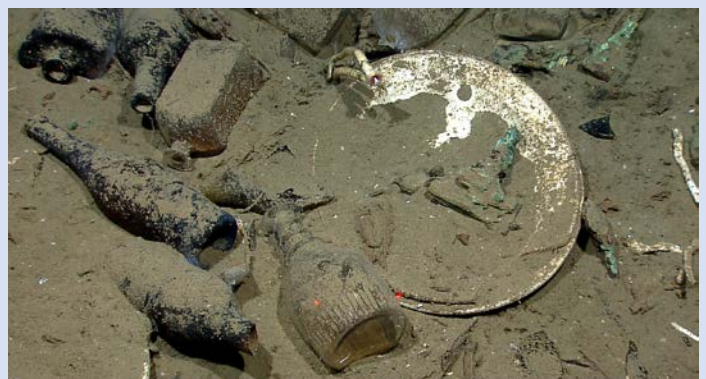
A variety of artifacts inside the ship's hull relates either to daily life on board or the ship's cargo. These artifacts included ceramic plates, platters and bowls, along with glass liquor, wine, medicine and food storage bottles of many shapes and colors (some with the contents still sealed inside).
